SEABROOK STATION
UPDATED FINAL SAFETY
ANALYSIS REPORT

Seabrook Site – 50 Mile Radius Regional Climatological
Data Stations

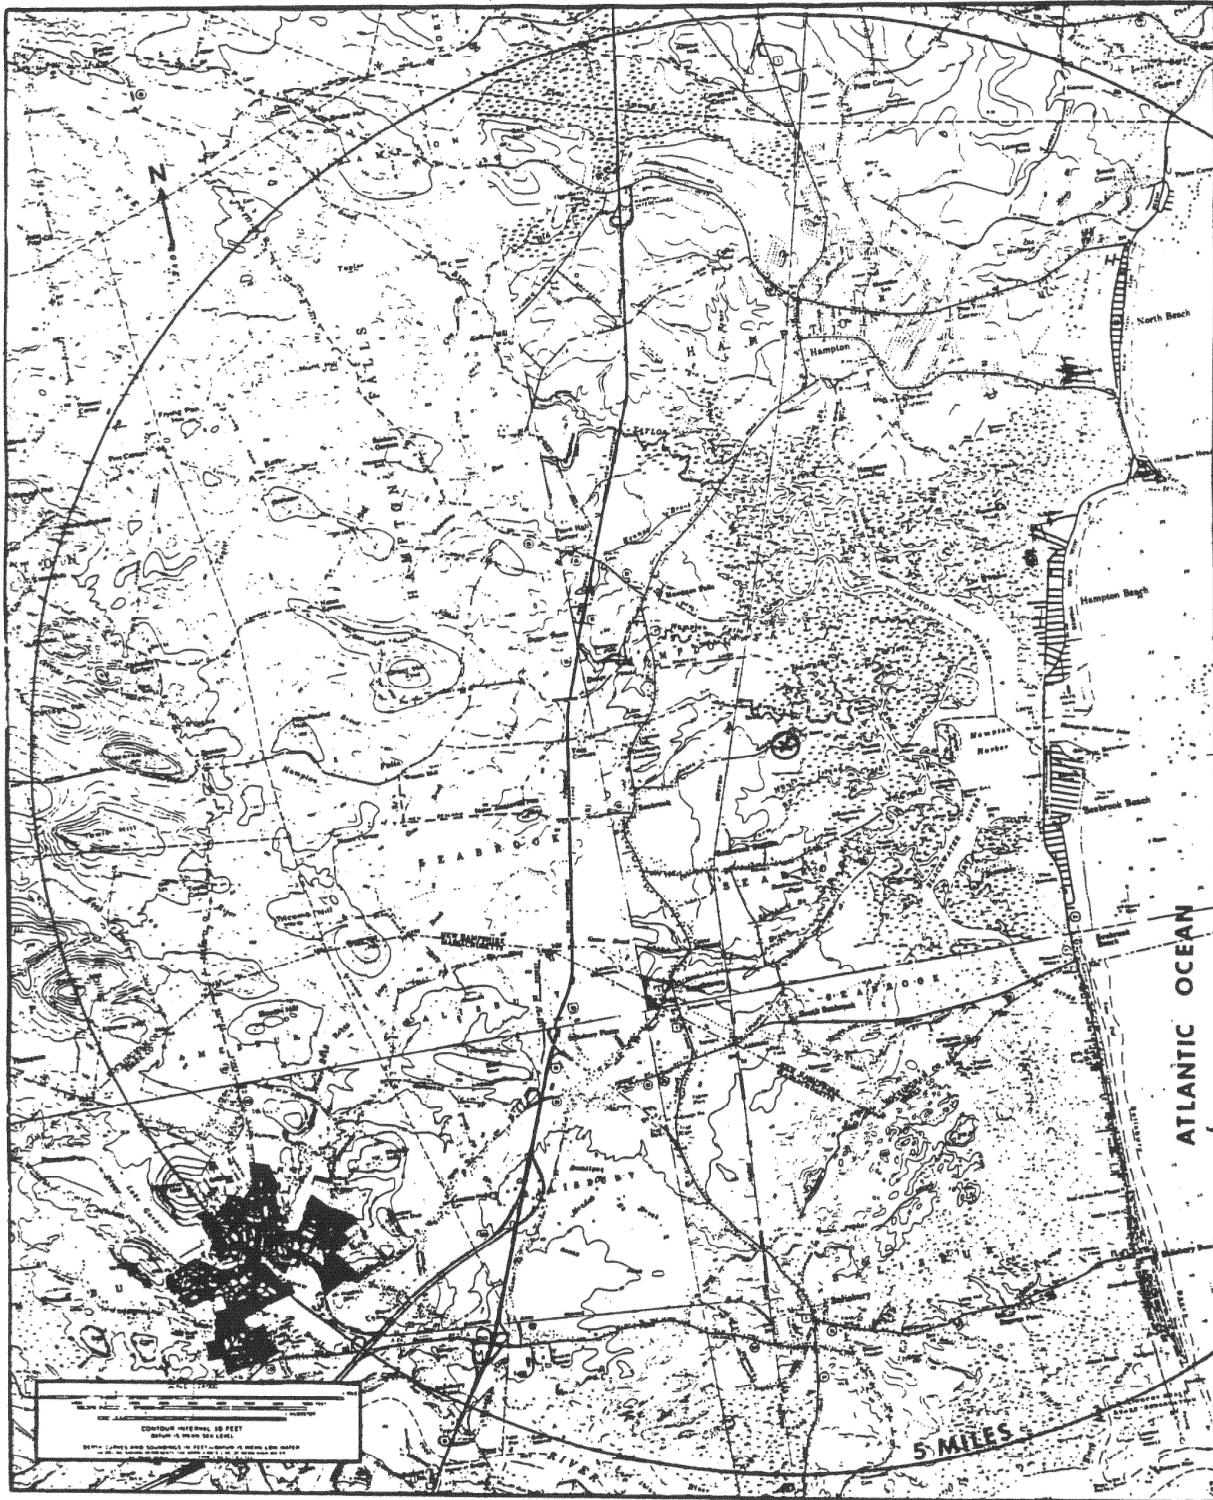
Figure 2.3-7

Topographic Map within a Five Mile Radius of the Seabrook
Site

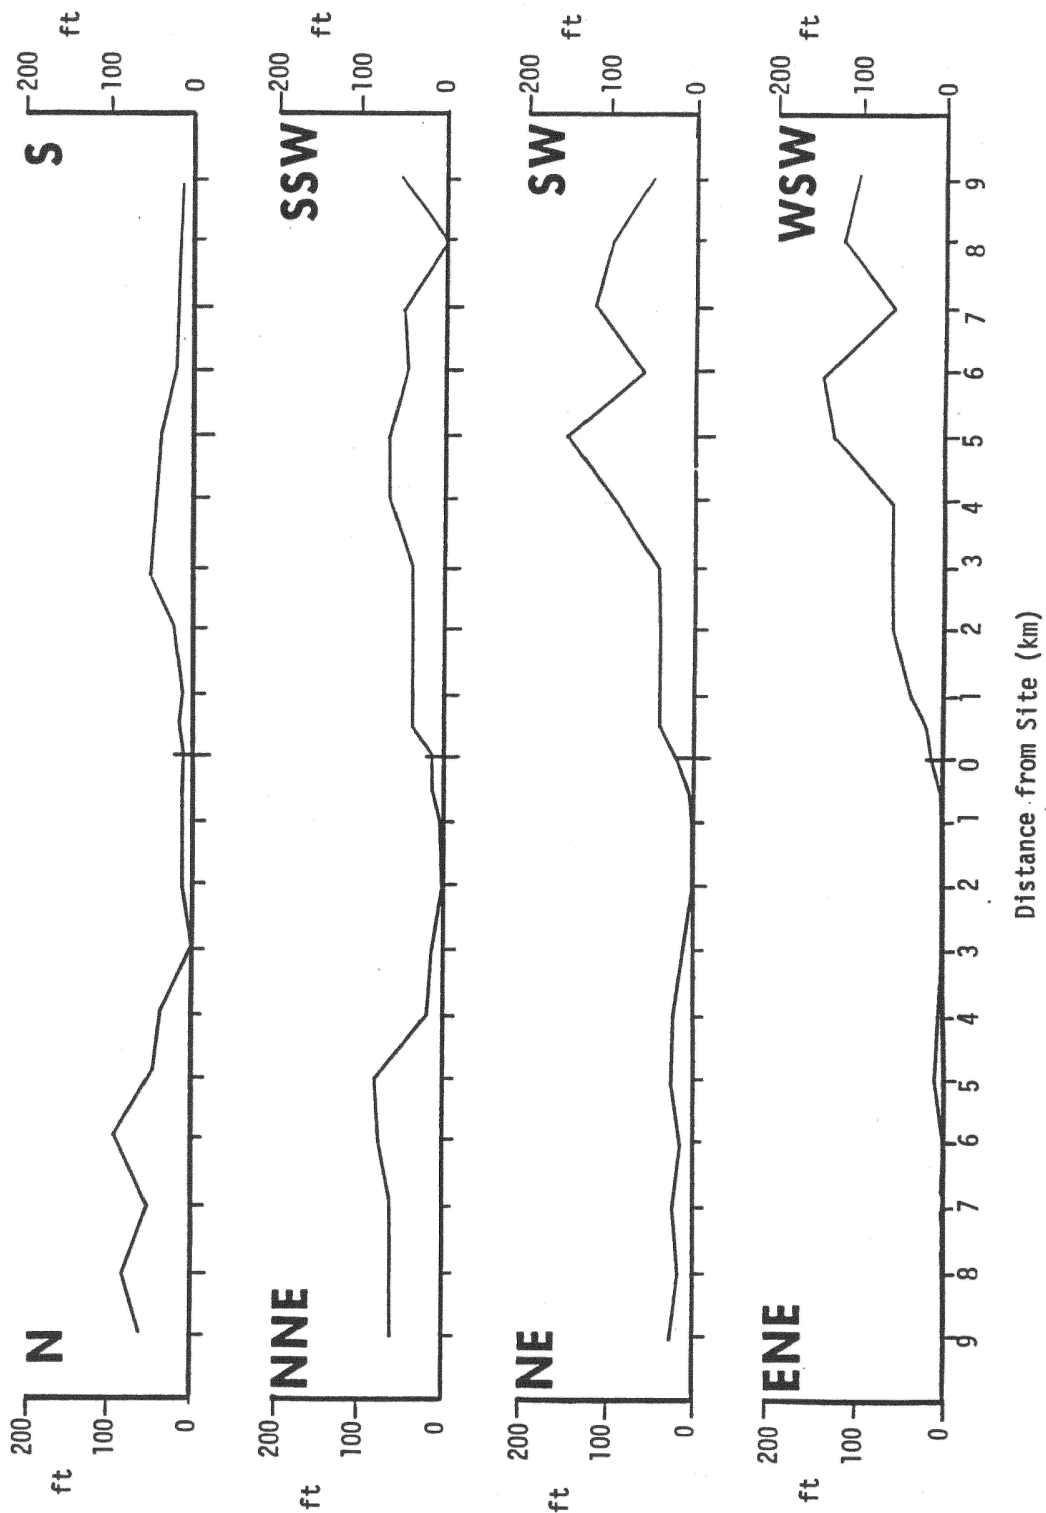
| | | Figure 2.3-8, Sh. 1 of 2 |

| SEABROOK STATION UPDATED FINAL SAFETY ANALYSIS REPORT | Terrain Cross Section [2 Sheets] | |

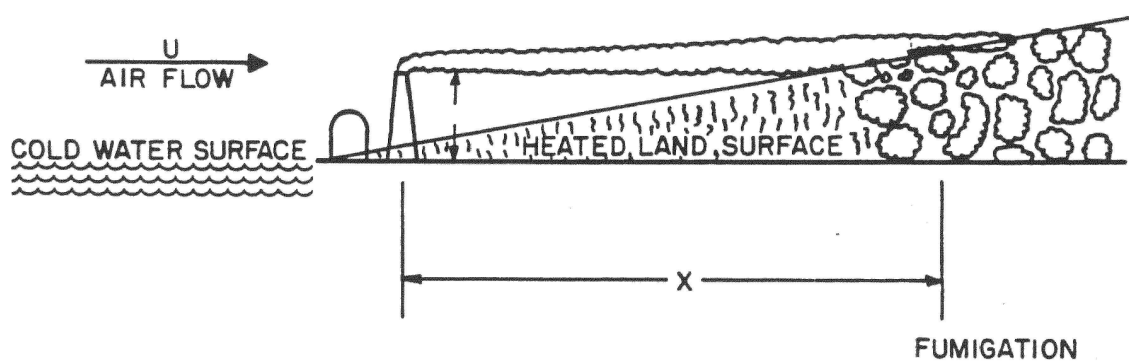
| | | Figure 2.3-11 |

| SEABROOK STATION UPDATED FINAL SAFETY ANALYSIS REPORT | Plume and TIBL Interaction | |
