SEABROOK STATION UFSAR	DESIGN OF STRUCTURES, COMPONENTS EQUIPMENT AND SYSTEMS Containment Liner Anchor Load Tests	Revision 8 Appendix 3G Page 3G-1
---------------------------------------	--	--

APPENDIX 3G CONTAINMENT LINER ANCHOR LOAD TESTS

FINAL REPORT
CONTAINMENT LINER ANCHOR LOAD TESTS

CONTAINMENT LINER ANCHOR LOAD TEST
FABRICATION OF SPECIMENS
SEABROOK PROJECT

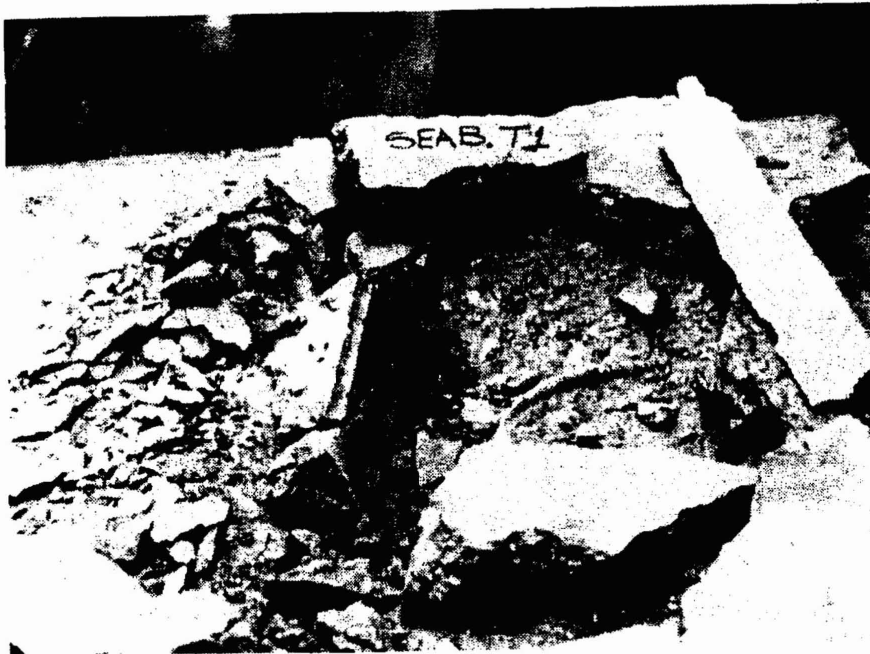
**Plate B3: Specimen T-1. Concrete Surface After Removal of
Liner Plate**

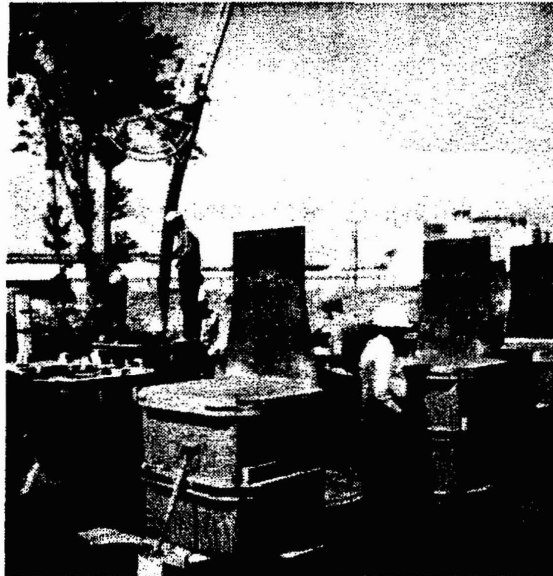
Plate 3: Finished specimens at end of pouring operation

The test block forms were fabricated at the Seabrook site. The liner formed one side of the form as is the case in the containment structure. The tees were oriented vertically during the pouring operation. Before the concrete was poured a thin coating of WD-40 was sprayed on the liner to eliminate bond between the liner and concrete. Concrete was mixed at the Site Batch Plant and brought to the test area by trucks. The concrete was placed into the forms by a pump truck to simulate actual field placement conditions.

Each specimen was fabricated in three lifts. After each lift a vibrator was used to consolidate the concrete and eliminate voids. Two different trucks were used. Twelve cylinders were taken from each truck. In addition, six cylinders were made for each specimen. These were stored on site in a controlled environment curing room. Three were broken on the day of the test of the specimen. At the end of the pour the top of the concrete surface was troweled to a smooth finish. A chemical curing compound was applied to the exposed surface to seal in moisture and thereby replace water curing.
