Nondestructive Evaluation: Ultrasonic Equivalency Testing of Weld Inlaid Components

1016543

Technical Update, April 2008

**Report Summary for Supplements 2 and 10 Flaw Comparisons
between EPRI Block 601 and the Inlay Test Block**

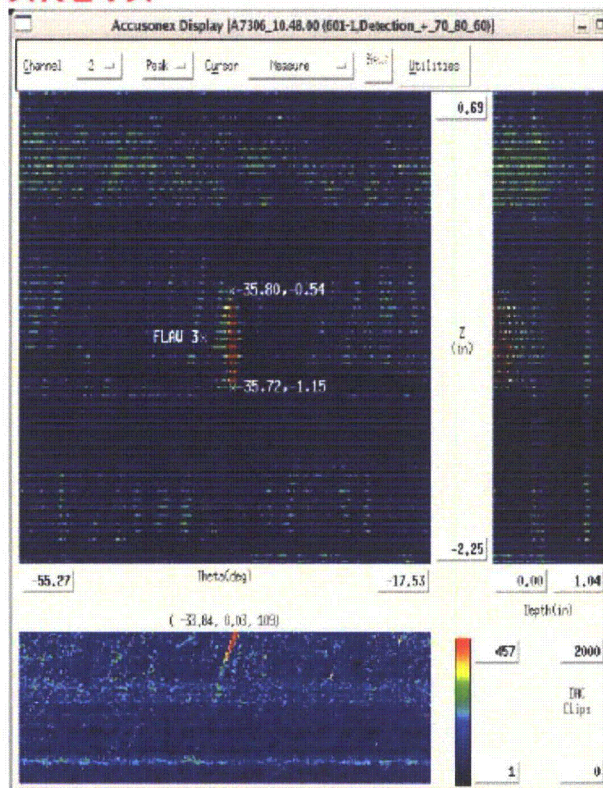
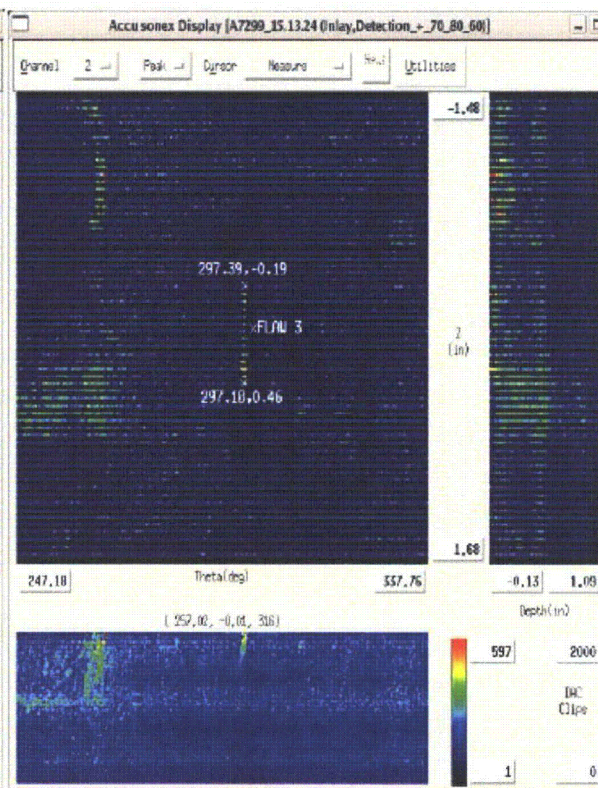
Figure C-29
601-1 Flaw 3: 80°L from Positive Direction
Reference Flaw

Figure C-30
Inlay Mockup Flaw 3-4: 80°L from Positive Direction
Quadrant 4 – 1" Inlay

Figure 3-1
Typical axial flaw image (AREVA) from 601 and 1 in. (2.54 cm) inlay mockup

Figures 3-1 and 3-3 show typical flaw images obtained from the inlay mockup. Although the procedures are not qualified for the detection and sizing of embedded flaws, the embedded flaw in quadrant four was also successfully detected and sized using procedurally acceptable search units and techniques. No procedural changes were required by either vendor during these demonstrations, and the qualified techniques worked as expected.

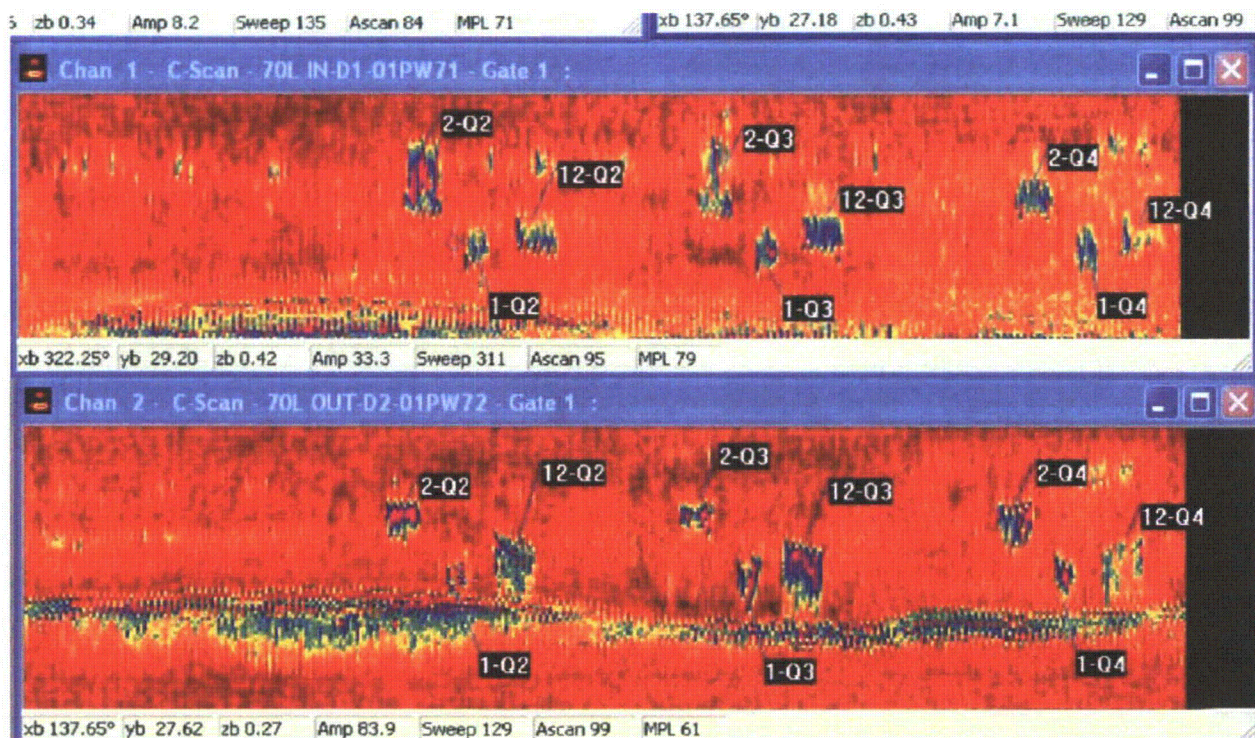
Figure 3-3
Typical ultrasonic image (WesDyne) from inlay mockup of circumferentially oriented flaws (opposite directions)
