Scientific Notebook No. 884: I580 Bridge
Collapse (06/22/2007 through 10/05/2007)

Title: I580 Bridge Collapse

I-580 Sample Collection

Examination of I-580 Bridge Samples

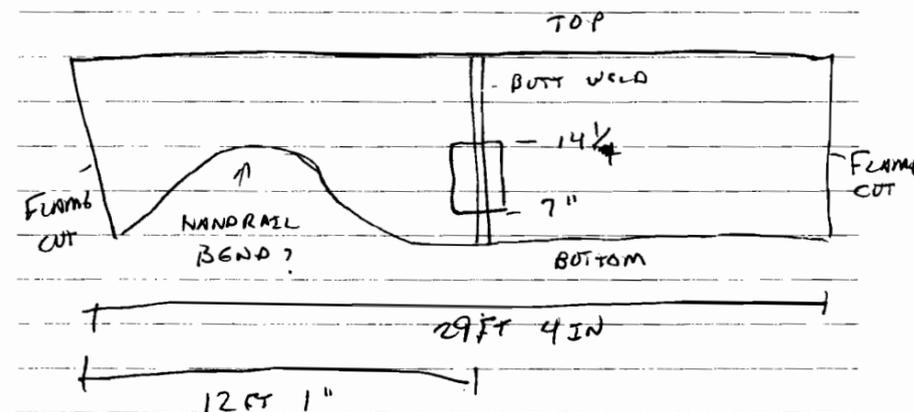
SAMPLE FROM PLATE THAT INCLUDES BUTT WELD

SAMPLE TAKEN FROM NEAR BOTTOM OF PLATE

PLATE GIRDER MAY HAVE BEEN FROM MB 18 TO MB 19 ON SOUTH SIDE OF RR 6/13/07 NORTH SIDE WHICH FELL ON TOP OF HAND RAIL

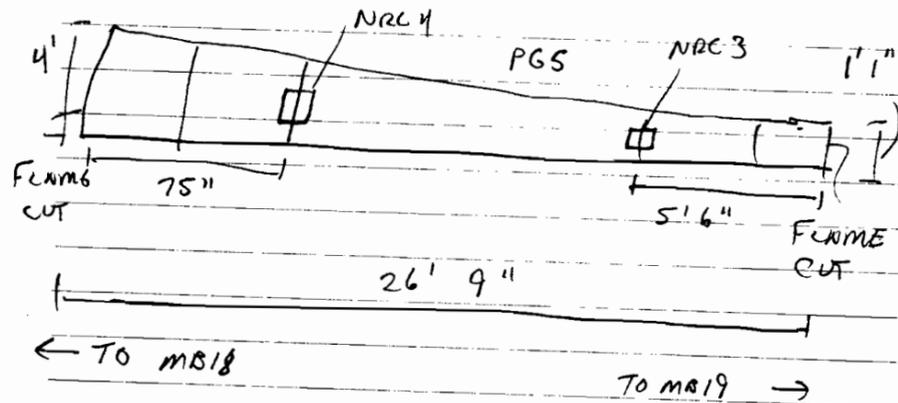
SAMPLES INCLUDE STIFFENER & WELD

PGS WAS MOST LIKELY LOCATED BETWEEN MB 18 & MB 19. THE MOST NEARLY REFORMED END WAS TOWARDS MB 19. BOTH ENDS WERE FRAME CUT SO MOST LIKELY THIS WAS A MID SECTION SPAN.

SAMPLE NRC 3 WAS CONCRETE RUBBLE ADHERING TO THE SURFACE.

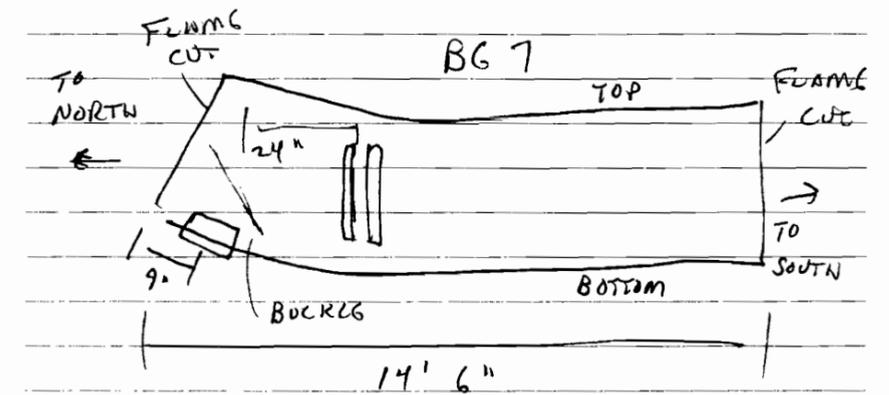
CALTRAW SAMPLE NRC 5

SAMPLE FROM BG 7 WAS FROM THE BOTTOM PLATE WITH THE WELD AND A PORTION OF THE VERTICAL PLATE. THE SAMPLE INCLUDES WELD METAL.

SAMPLE TAKEN FROM END NEAR ~~FOUR~~ ^{6/13/07} NORTH END NEAR BUCKLE ON VERTICAL PLATE.

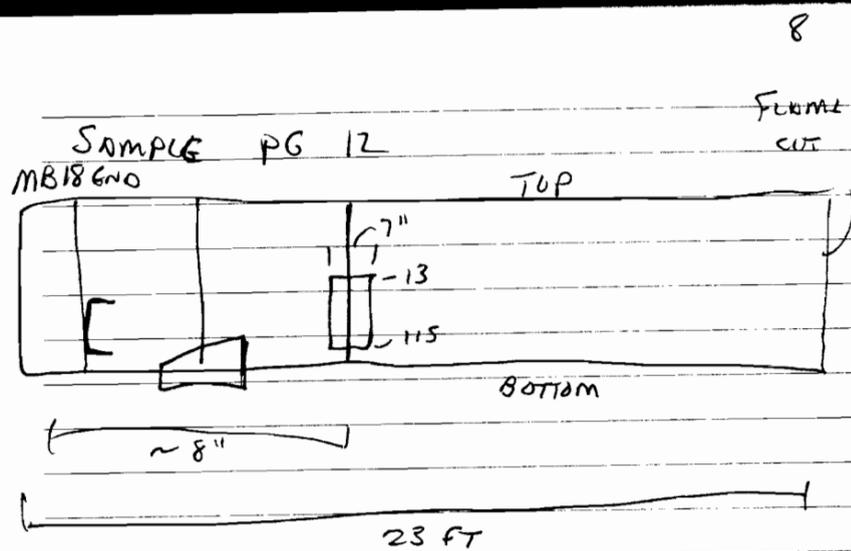
CALTRANS SAMPLE NRC 9

SAMPLE FROM NRC 9 / PG 12 WAS OBTAINED NEAR THE MB 18 END

THE MB 18 END SHOULD BE COOL OR COLDER WITH RESPECT TO THE MB 19 END

SAMPLE INCLUDES STIFFENER AND WELD METAL. SAMPLE HAS INTACT PAINT

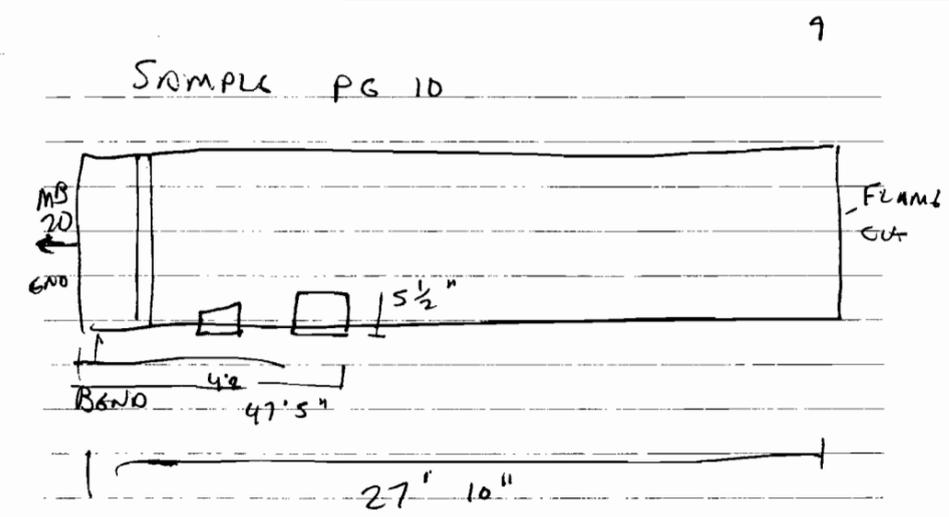
CALTRANS SAMPLE NRC 8

SAMPLE PG 10 WAS TAKEN FROM THE BOTTOM AND INCLUDES WEB & PLATE MATERIAL WITH WELD

SAMPLE SHOULD BE COLDER WITH RESPECT TO MB 19
DO 6/13/07

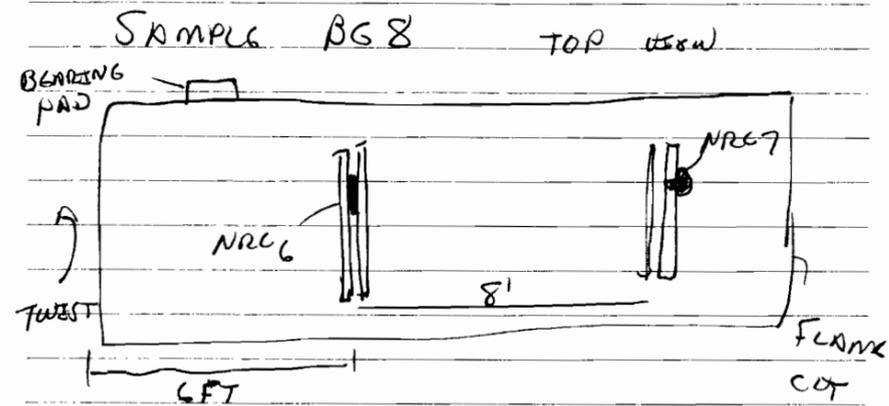
CALTRANS SAMPLE NRC 6

SAMPLES INCLUDE PLATE GIRDER WHICH
 WAS DEFORMED AND STILL ATTACHED
 TO THE ANGLE PLATES WITH NUTS

SAMPLE NRC 7 WAS A NUT WHICH
 WAS LOOSE AND COULD BE REMOVED
 BY HAND

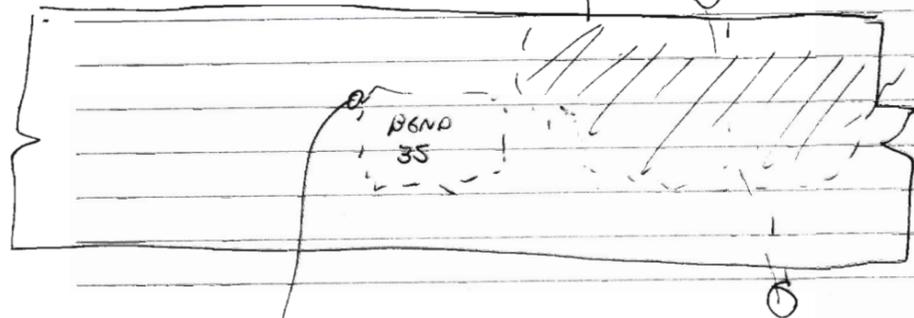
Trunk was aluminum and approximate
1/3 of trunk was melted

W hubs were aluminum and all wheels
were melted

Solidified Al was found on
deck after cooldown and
during cleanup

spalled concrete due to
heat and compression

Drain allowed fuel MB
to drain and burn below 19
I 880 deck: Passage to
Bend 35 Pillar due to fire

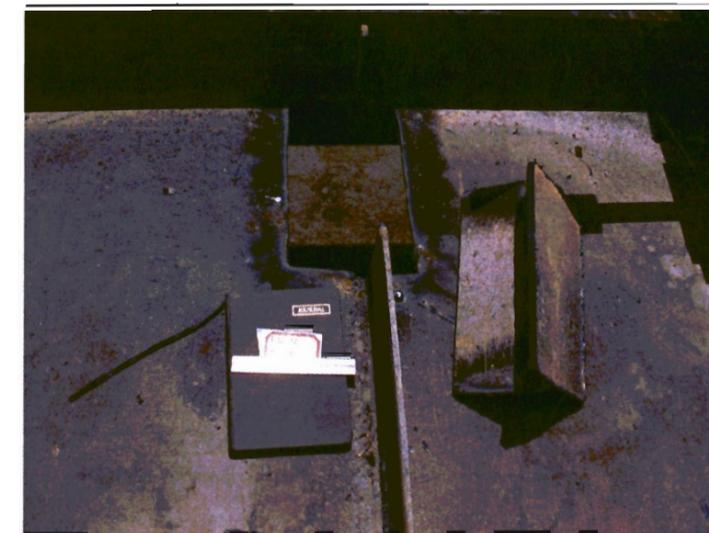
Sample cut from Plate Girder 12

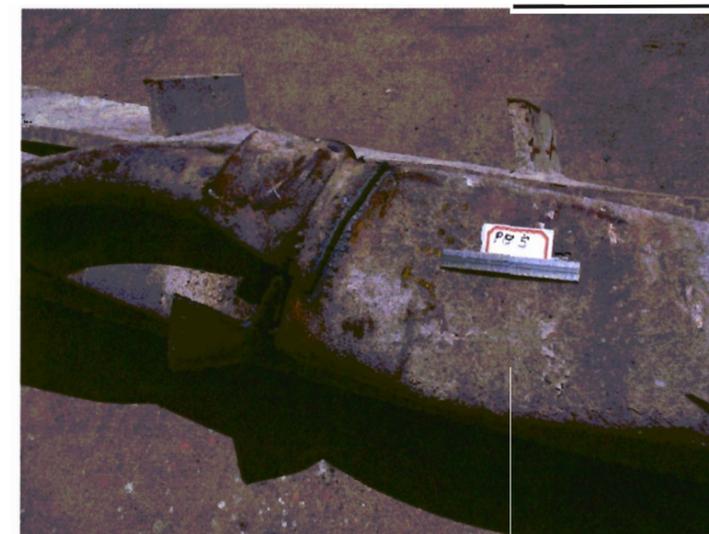
Sample cut From Plate Girder 5

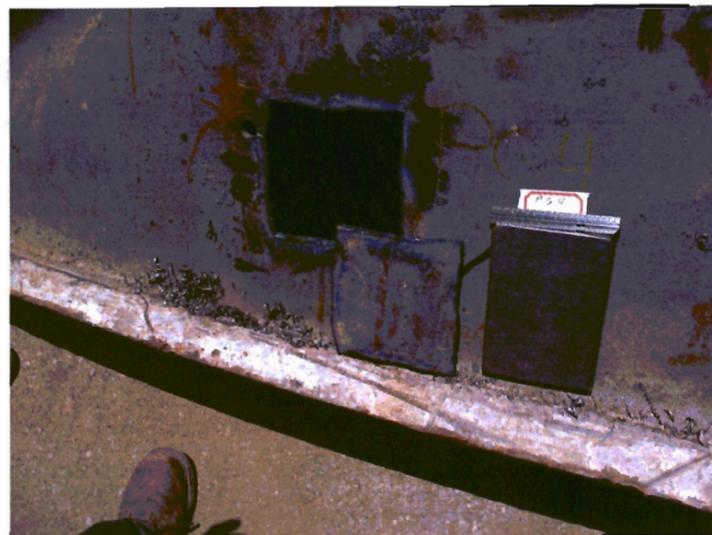
Sample cut from Plate Girder 4

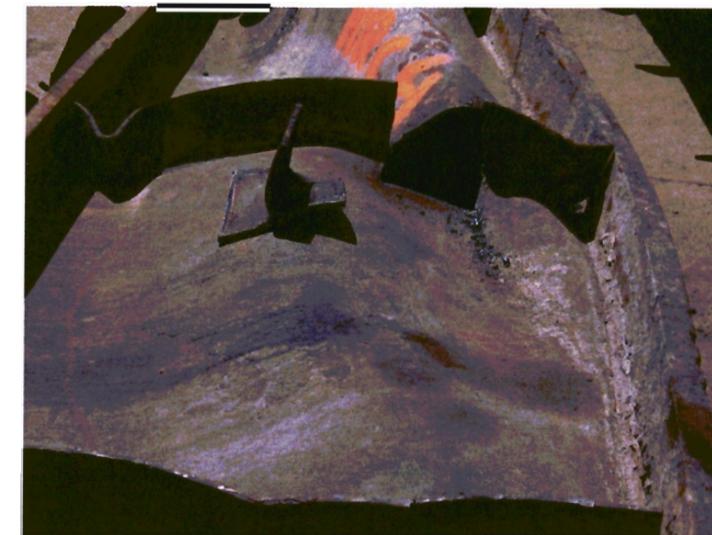
Second samples from plate girder 5

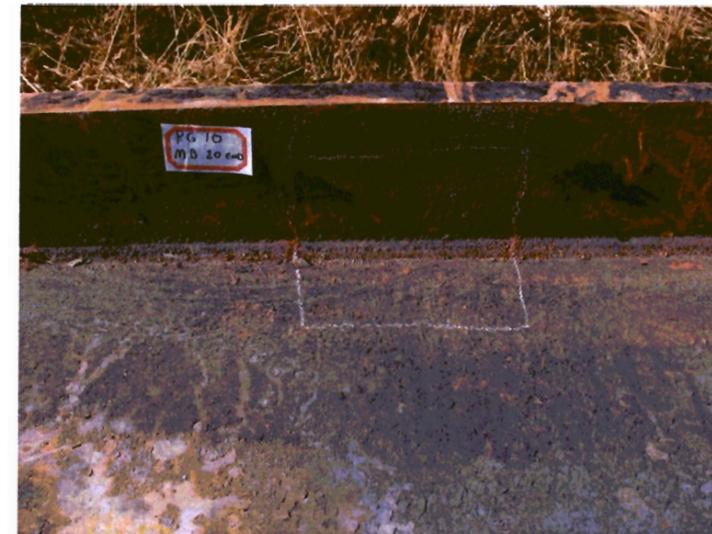
Sample from plate girder 10

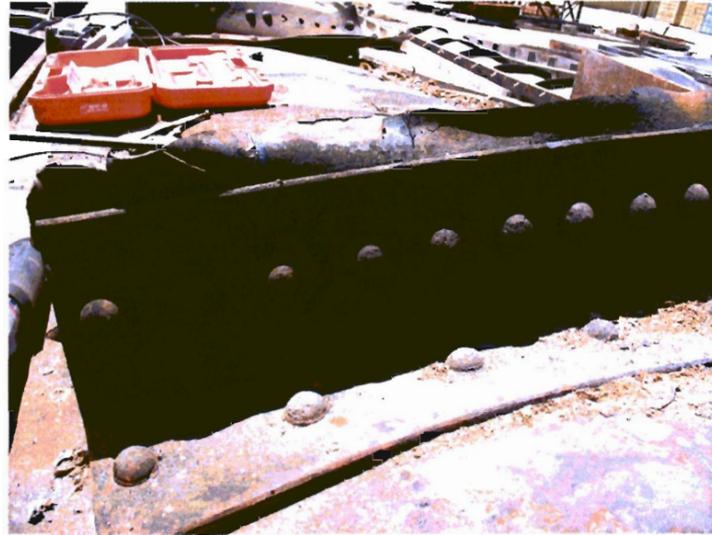
Sample cut From Box Girder 8 (remaining section of plate girder)

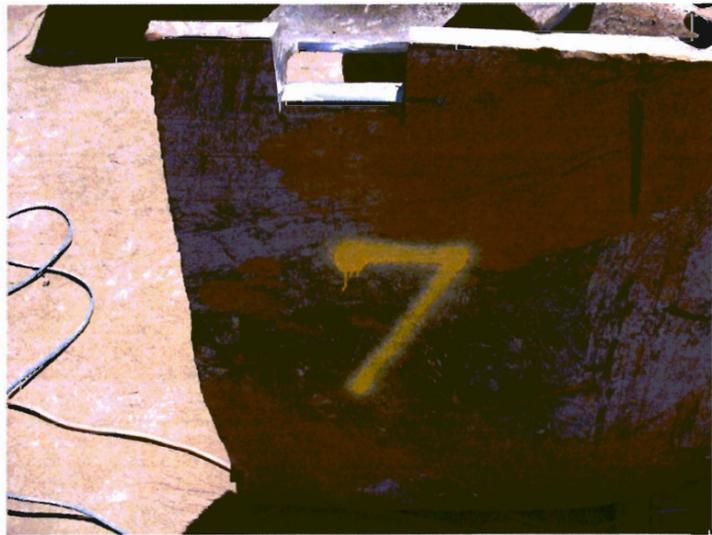
Sample cut from Box Girder 7

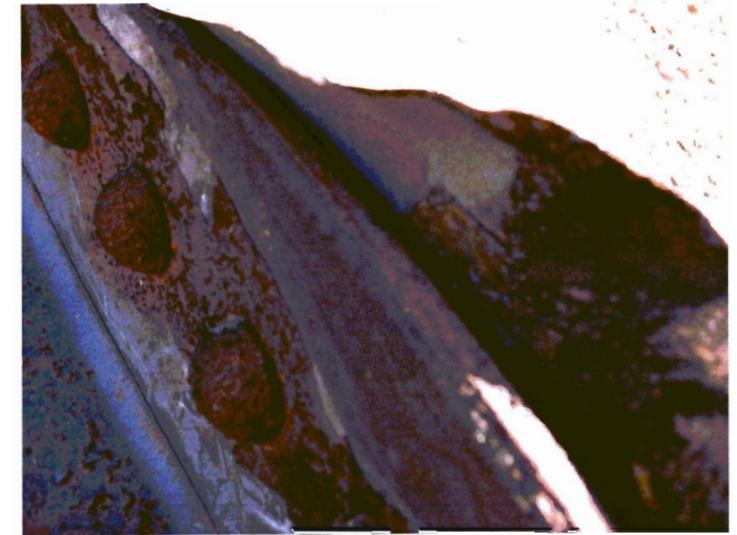
Rivets and scale on box girder 8

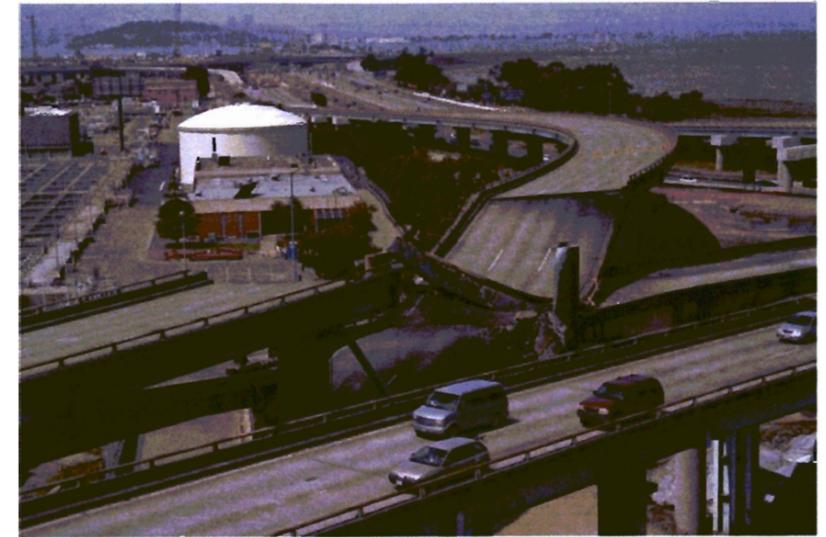
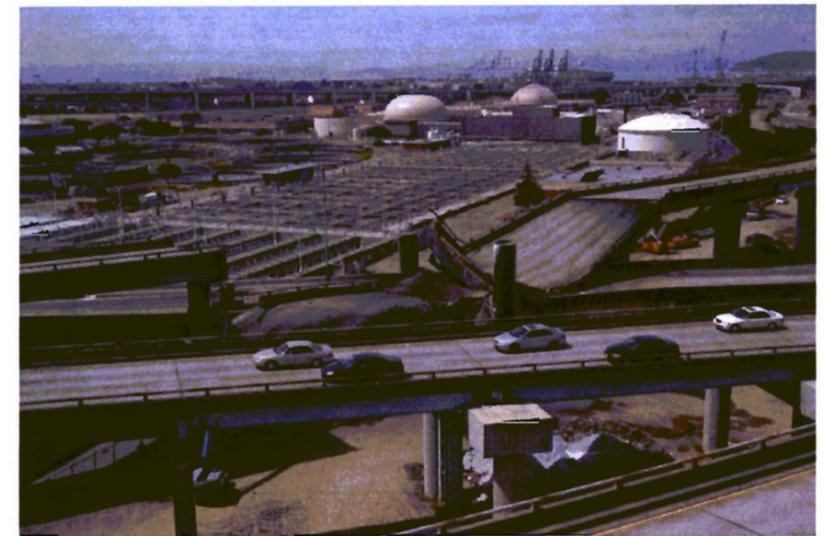
Photos of collapsed I-580 (Caltrans website)

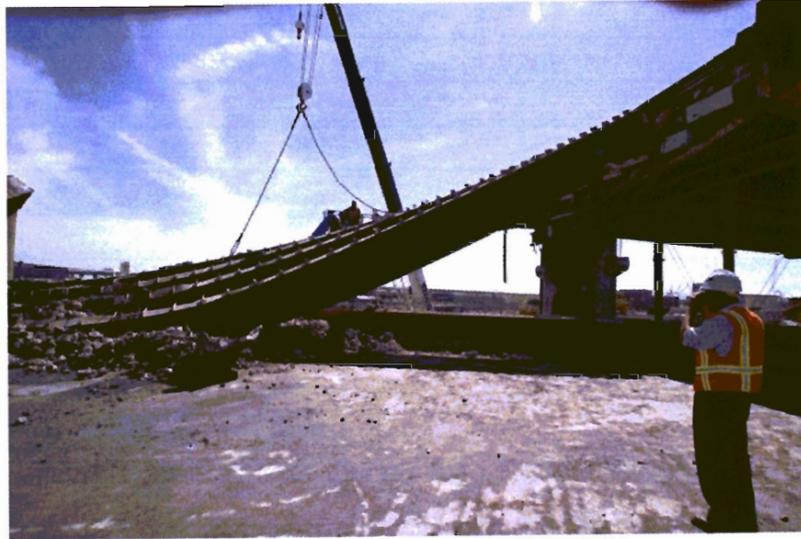
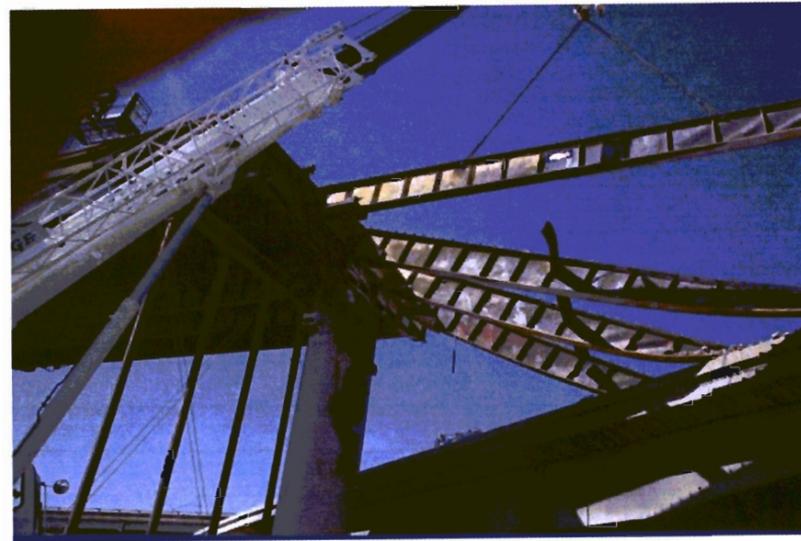
Photos of collapsed I-580 during demolition (Caltrans website)

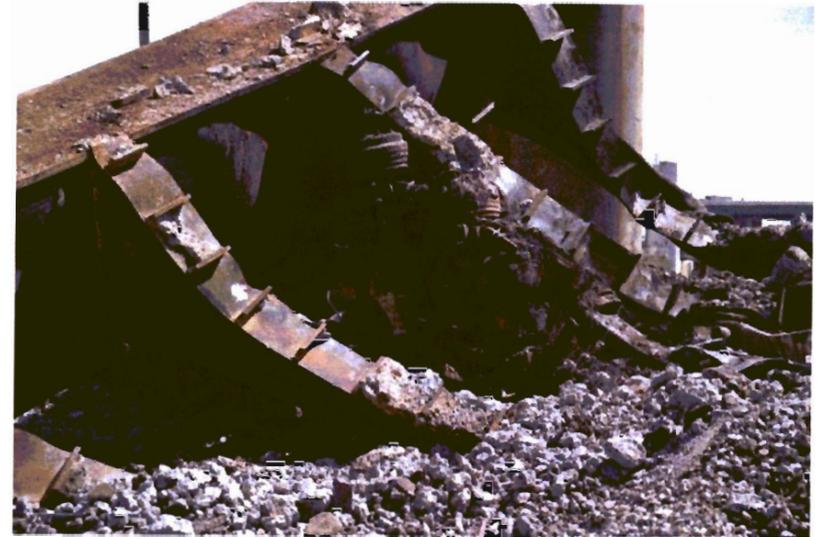
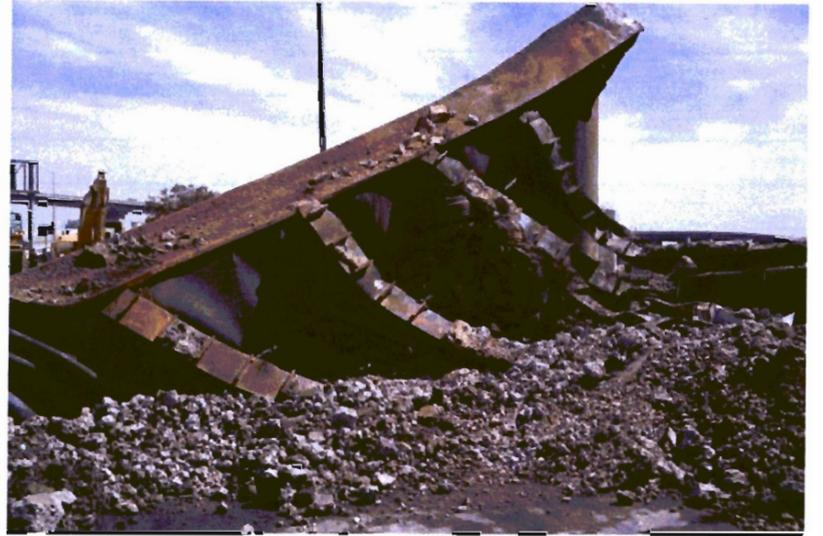
Photos of collapsed I-580 during demolition showing remains of truck (Caltrans website)
