Progress Energy Carolinas
Shearon Harris Nuclear Power Plant
Units 2 and 3
Part 2, Final Safety Analysis Report
New Hill, North Carolina
Photograph of Lithofacies II Sandstone and Siltstone Exposed in the Emergency Service Water Discharge Channel at the HNP Site
FIGURE 2.5.1-234

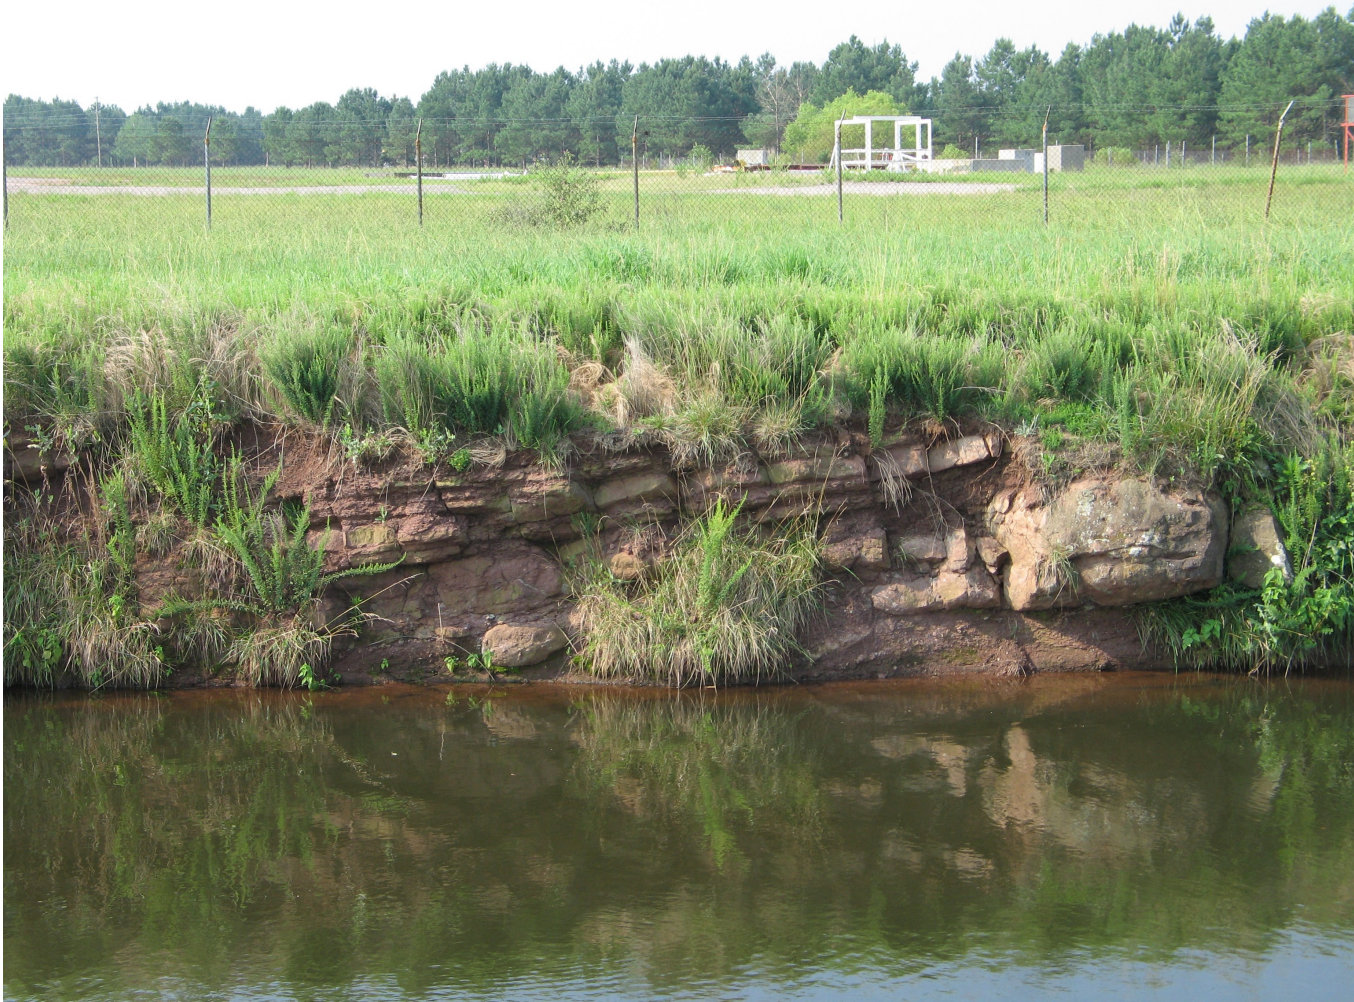
View South
