Progress Energy Carolinas
**Shearon Harris Nuclear Power Plant
Units 2 and 3**
Part 2, Final Safety Analysis Report
New Hill, North Carolina

Photograph Showing the Jonesboro Fault
in the Vicinity of the Main Dam
FIGURE 2.5.3-204

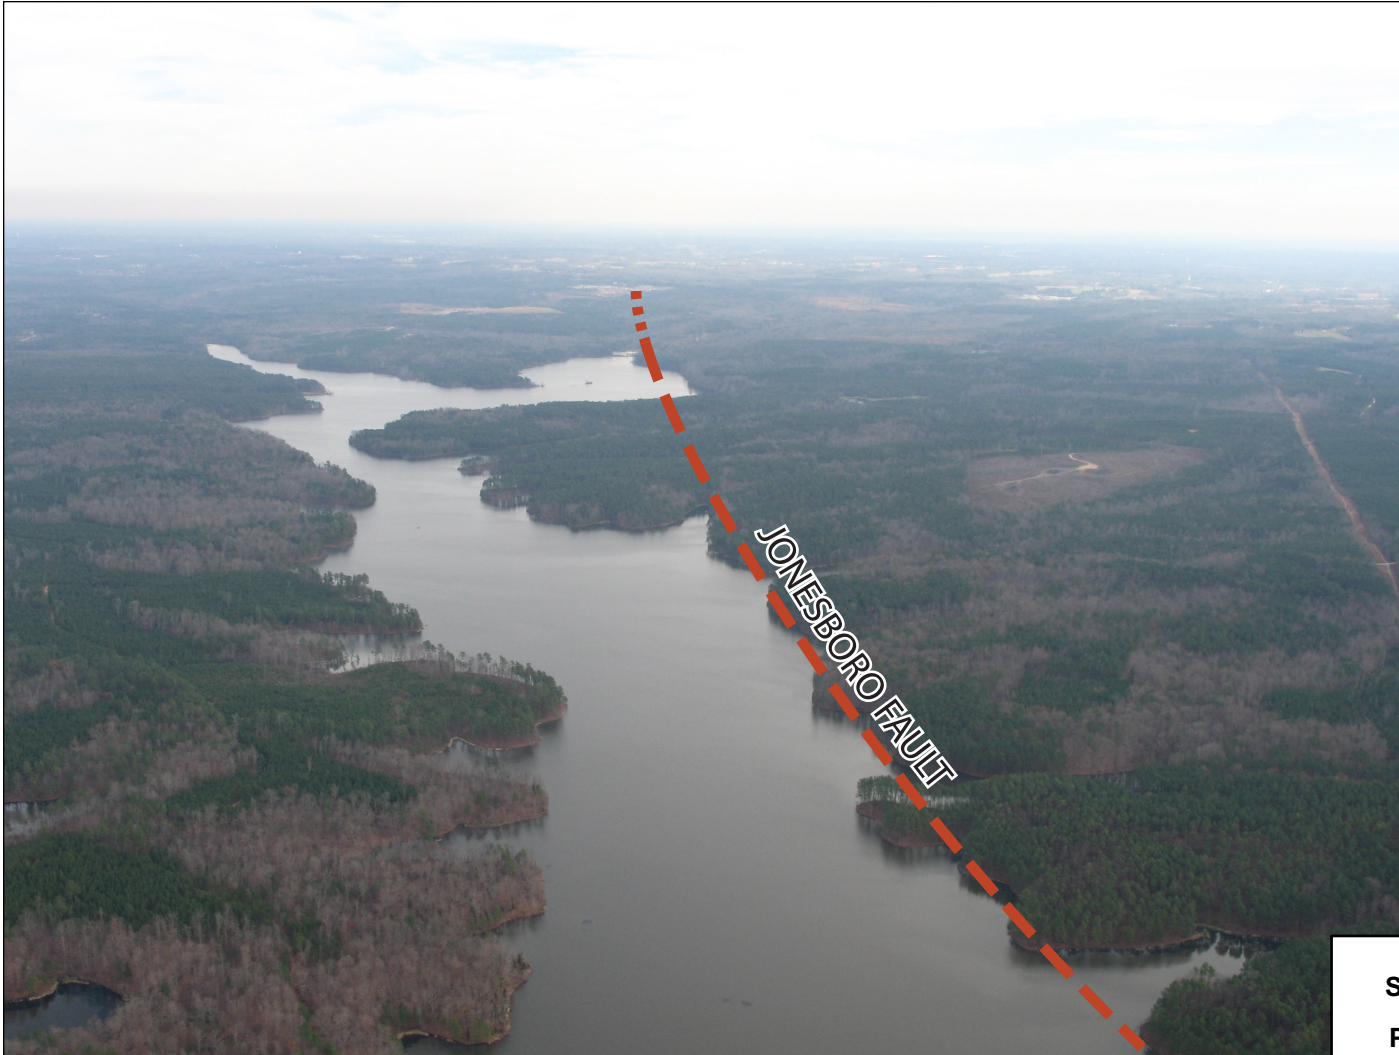
View northeast
