| 8.3.2 Impact (Free-Drop) Test Report

**Test Report:
Drop Tests of the
Alpha Omega Services Shipping Cask
for Radioactive Material**

**Report No. 2007533 Rev 1
May 25, 2007**

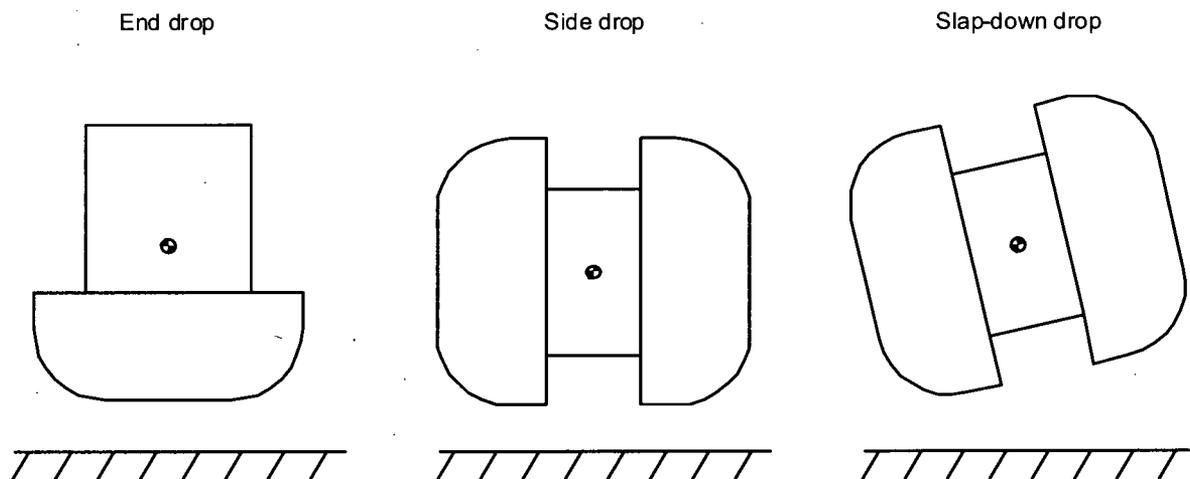
Figure 1 Package orientations for the three drop tests.

The tests were performed in the order shown above with new impact limiters for each test. Previous tests have used the first two orientations successfully². The slap-down orientation is new and is included in place of previous c.g.-over-corner drops on the basis of analysis which indicates that slap-down is a worst-case.

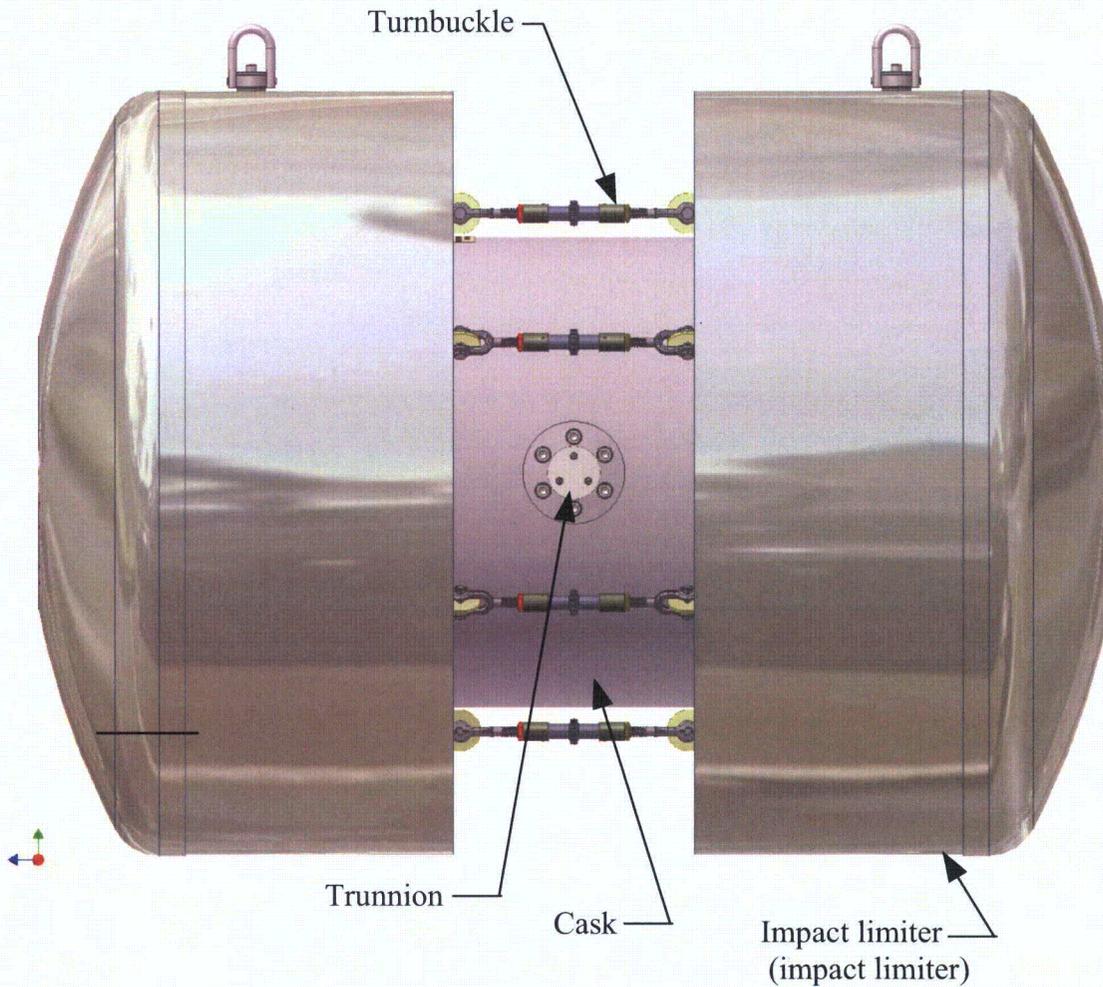
Figure 2 Shipping cask with impact limiters

The test article is a full-scale prototype transport package. It is composed of two main parts: the cask and the impact limiters. The cask (Figure 2) is cylindrical in shape with an outside diameter (excluding trunnion lugs) of 46.20 inches and an axial length of 59.40 inches. Weight of the cask with impact limiters is approximately 38,500 lbs. The cask is composed of stainless steel inner and outer shells with thick tungsten inserts between them for radiation shielding. The central payload cavity is cylindrical in shape with a diameter of 10.72 inches and axial length of 33.63 inches. The cavity is connected to atmosphere by two small ports (shown later in cross section) that are both sealed during normal transport operations.

The impact limiter is in the form of two "caps" that go over the ends of the cask (Figure 2). Each cap is composed of a stainless steel shell filled with castable impact-absorbing foam. The caps are installed over the ends of the cask and secured to each other by six turnbuckles as shown. Each cap has a recess in its outer end to produce the desired crush area and thus the desired crushing force during an end drop. The lifting rings shown at the top of

each impact limiter are for lifting the impact limiter by itself. When assembled, the package is lifted by the side trunnions on the cask.

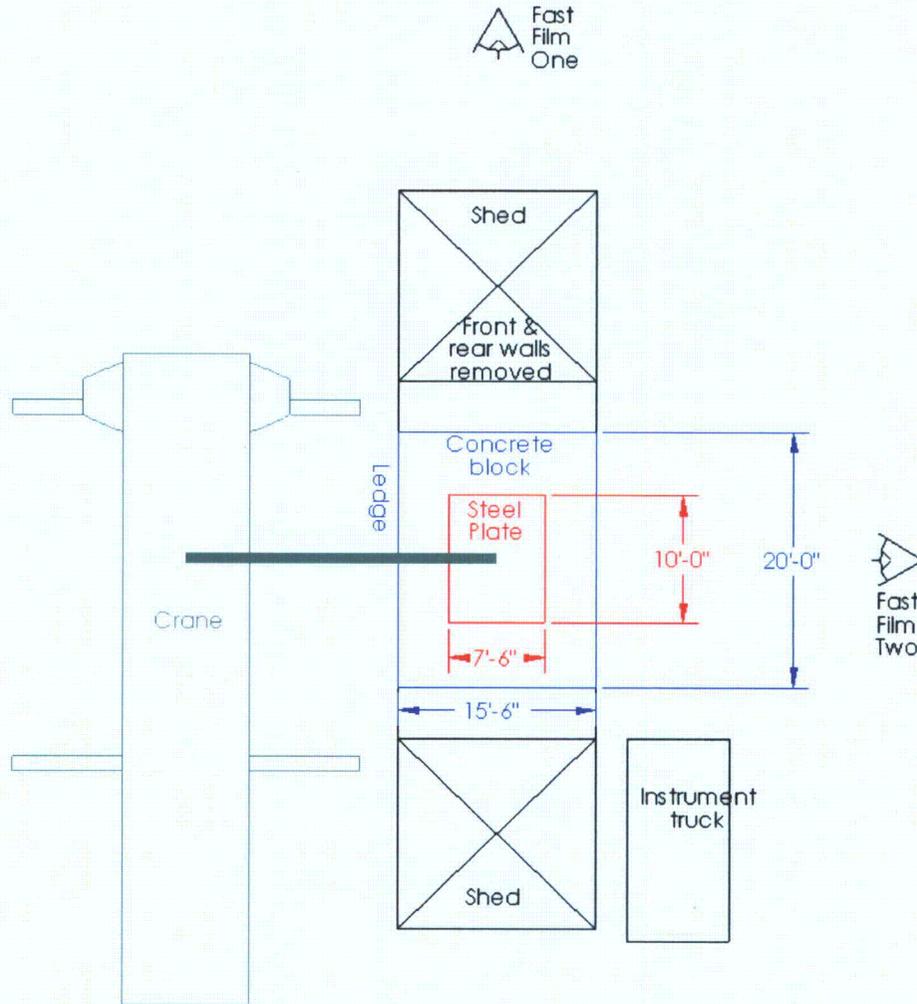
Figure 3 Plan view of drop test site.

The drop target was a large reinforced concrete block embedded in the earth at the General Electric Vallecitos CA site. Figure 3 shows a plan view of the site, including the crane for lifting the test article and the locations for two high-speed cameras. The concrete block is approximately 20' x 15'6" in plan view and six feet thick. It has a steel plate, 120" x 90" x 3", embedded in its horizontal top surface. The target block weighs approximately 290,000 lbs. The concrete has a 28-day cured strength of at least 4500 psi. The site has been used several times before for drop tests. The storage shed on the north side of the drop pad was moved to allow room for the tests. Figure 4 shows an overall view of the site.

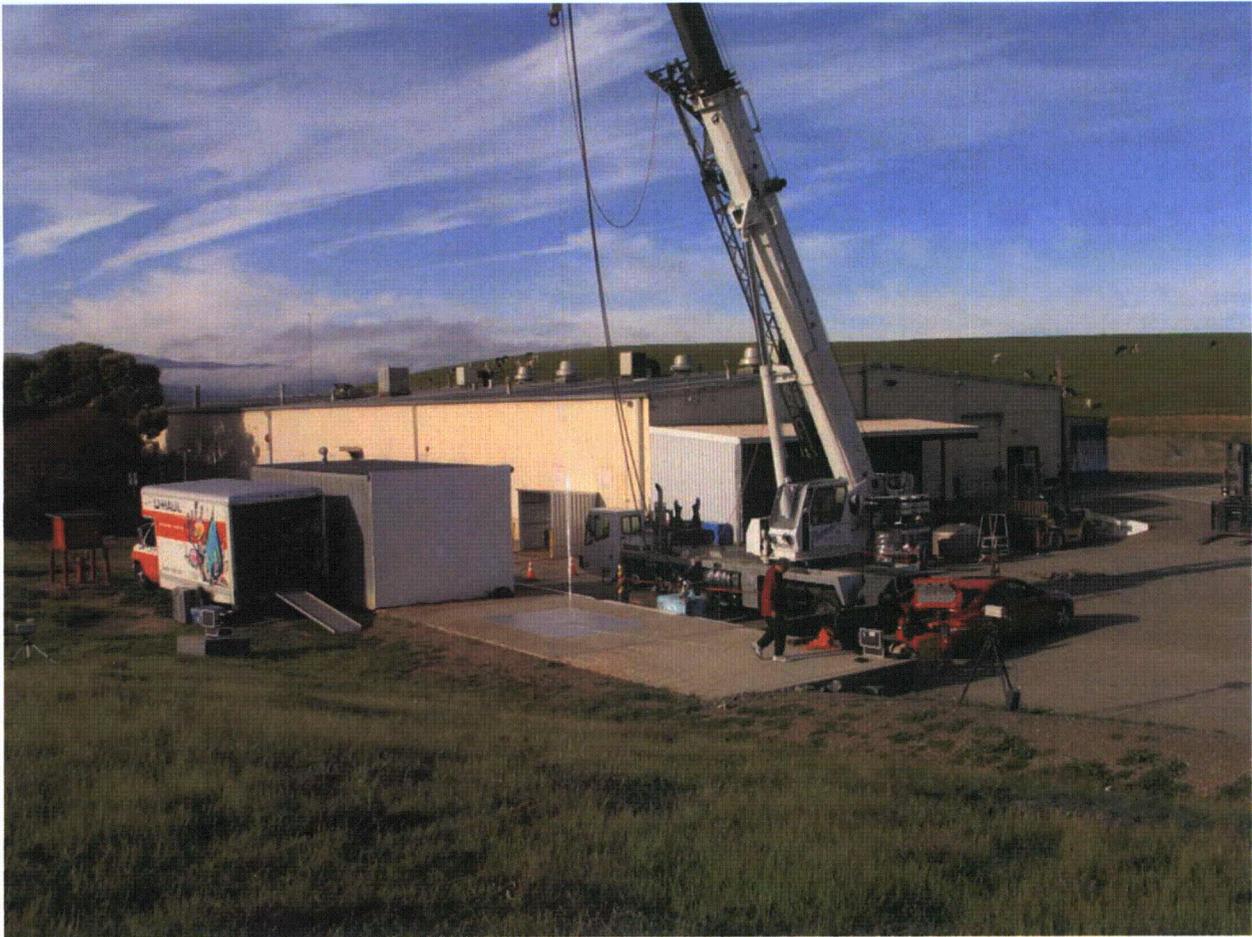
Figure 4 Drop test site with crane and instrument truck in place.

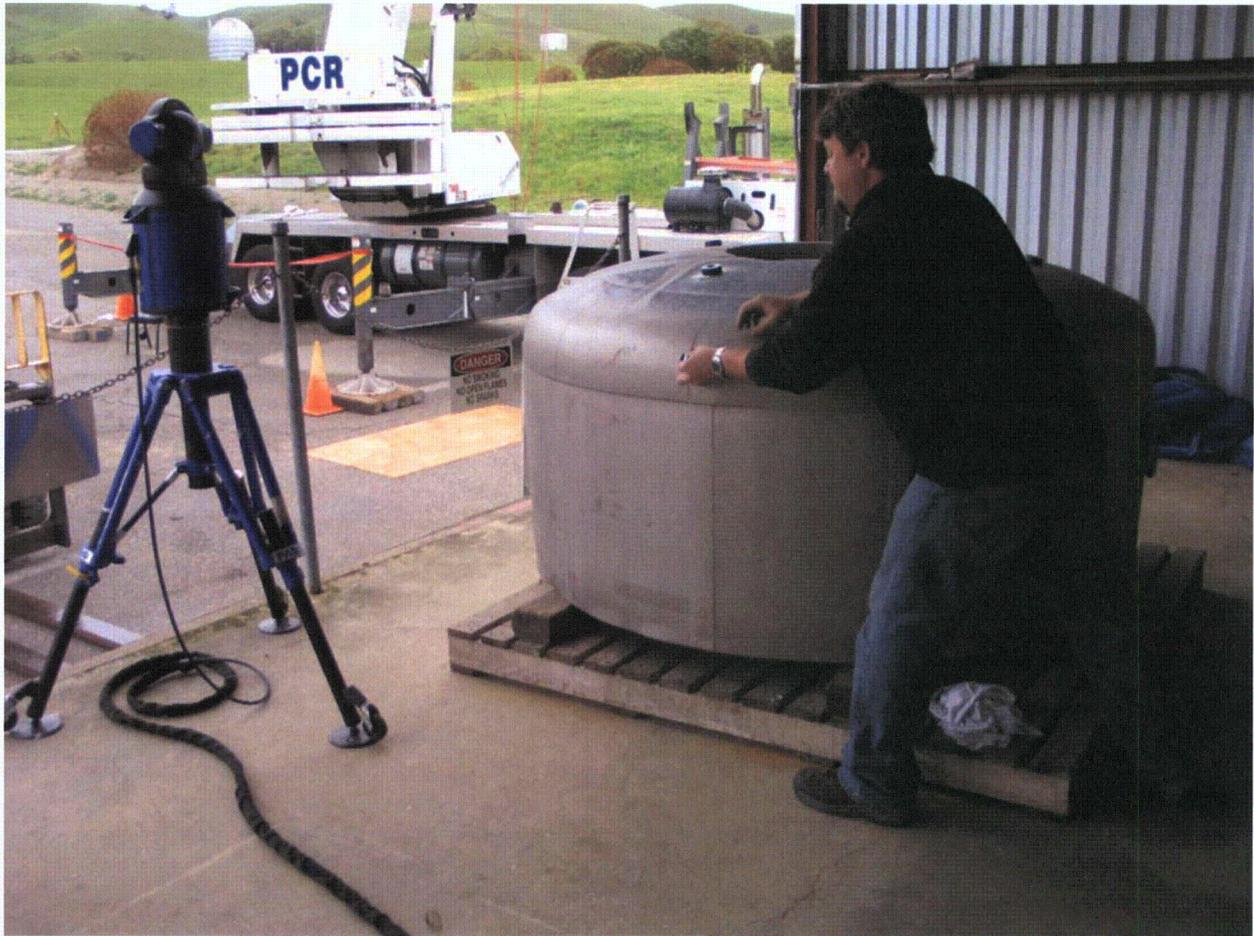
Figure 5 Measuring an impact limiter with the laser tracker.

For the impact limiters, scan data was taken at the 0, 30, 60, 90, 120, 150, 180, 210, 240, 270, 300 and 330 degree profiles. In order to compare each impact limiter in its pre- and post- drop condition, an alignment using the bottom perimeter (opposite the domed-end), measured as a circle, was used as a reference. By measuring it as a circle, the center point and vector of the measured circle were established. The portions of this circle that were deformed due to each drop test were not used in this calculation. The vector of this axis was defined to be the primary datum in this alignment. A point was then measured at the 90 degree lifting lug to establish the second axis in the coordinate system. This process provided the only repeatable means to align each impact limiter and subsequently compare the results.

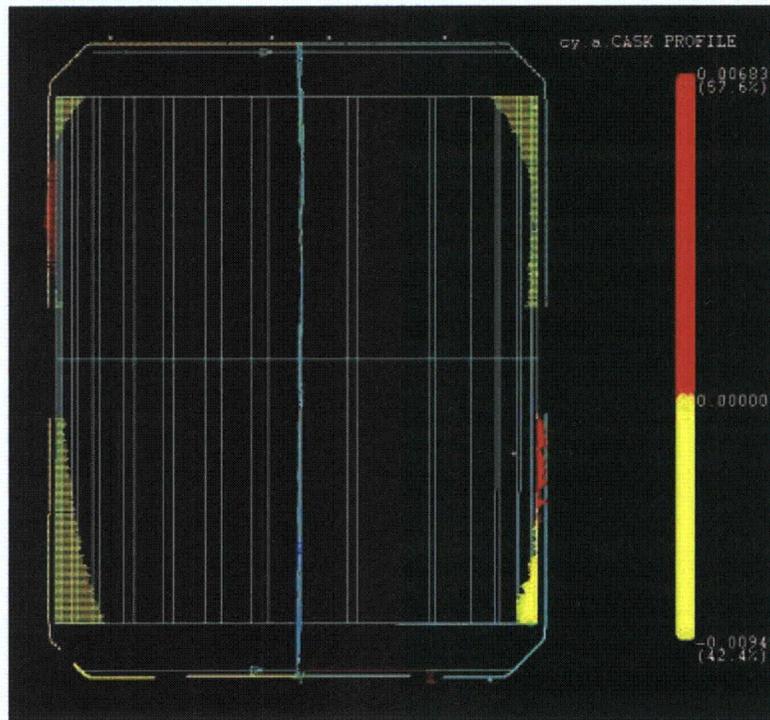
Figure 6 Scan data from cask taken before the first drop, 0-180-degree cross section

For the cask, the 0, 90, 180, and 270 degree profiles were scanned. An alignment using the axis of the cylindrical part of the cask as the controlling datum was used. This axis was then intersected with the "Lid End" of the cask and a point was constructed. Another point was measured at the 90 degree lifting lug to establish the other axis. This alignment was repeated for each measurement of the cask. Results from scans taken before any of the drop tests are shown in Figure 6 and Figure 7. The red areas represent the positive (maximum deviations) and the yellow areas represent the negative (minimum deviations) from the nominal as-designed profile.

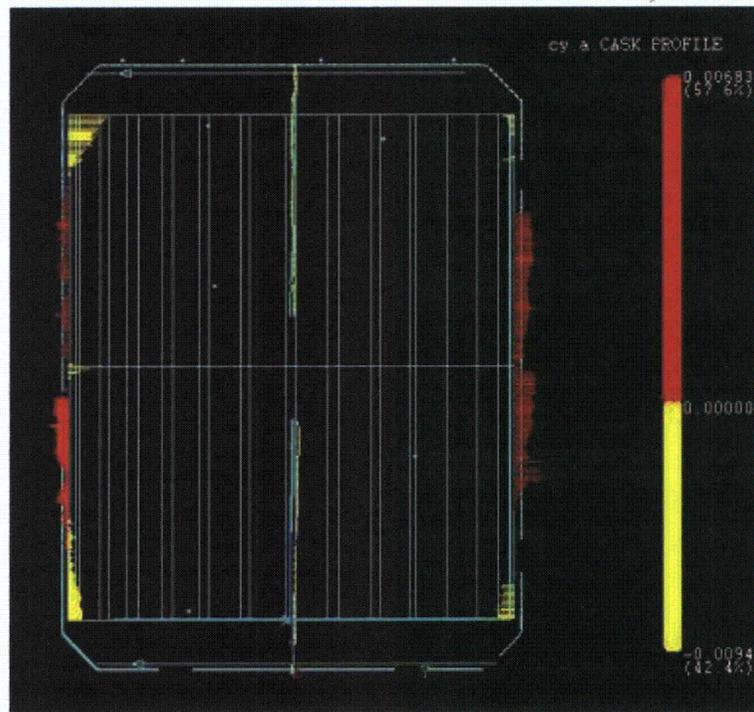
Figure 7 Scan data from cask taken before the first drop, 90-270-degree cross section.

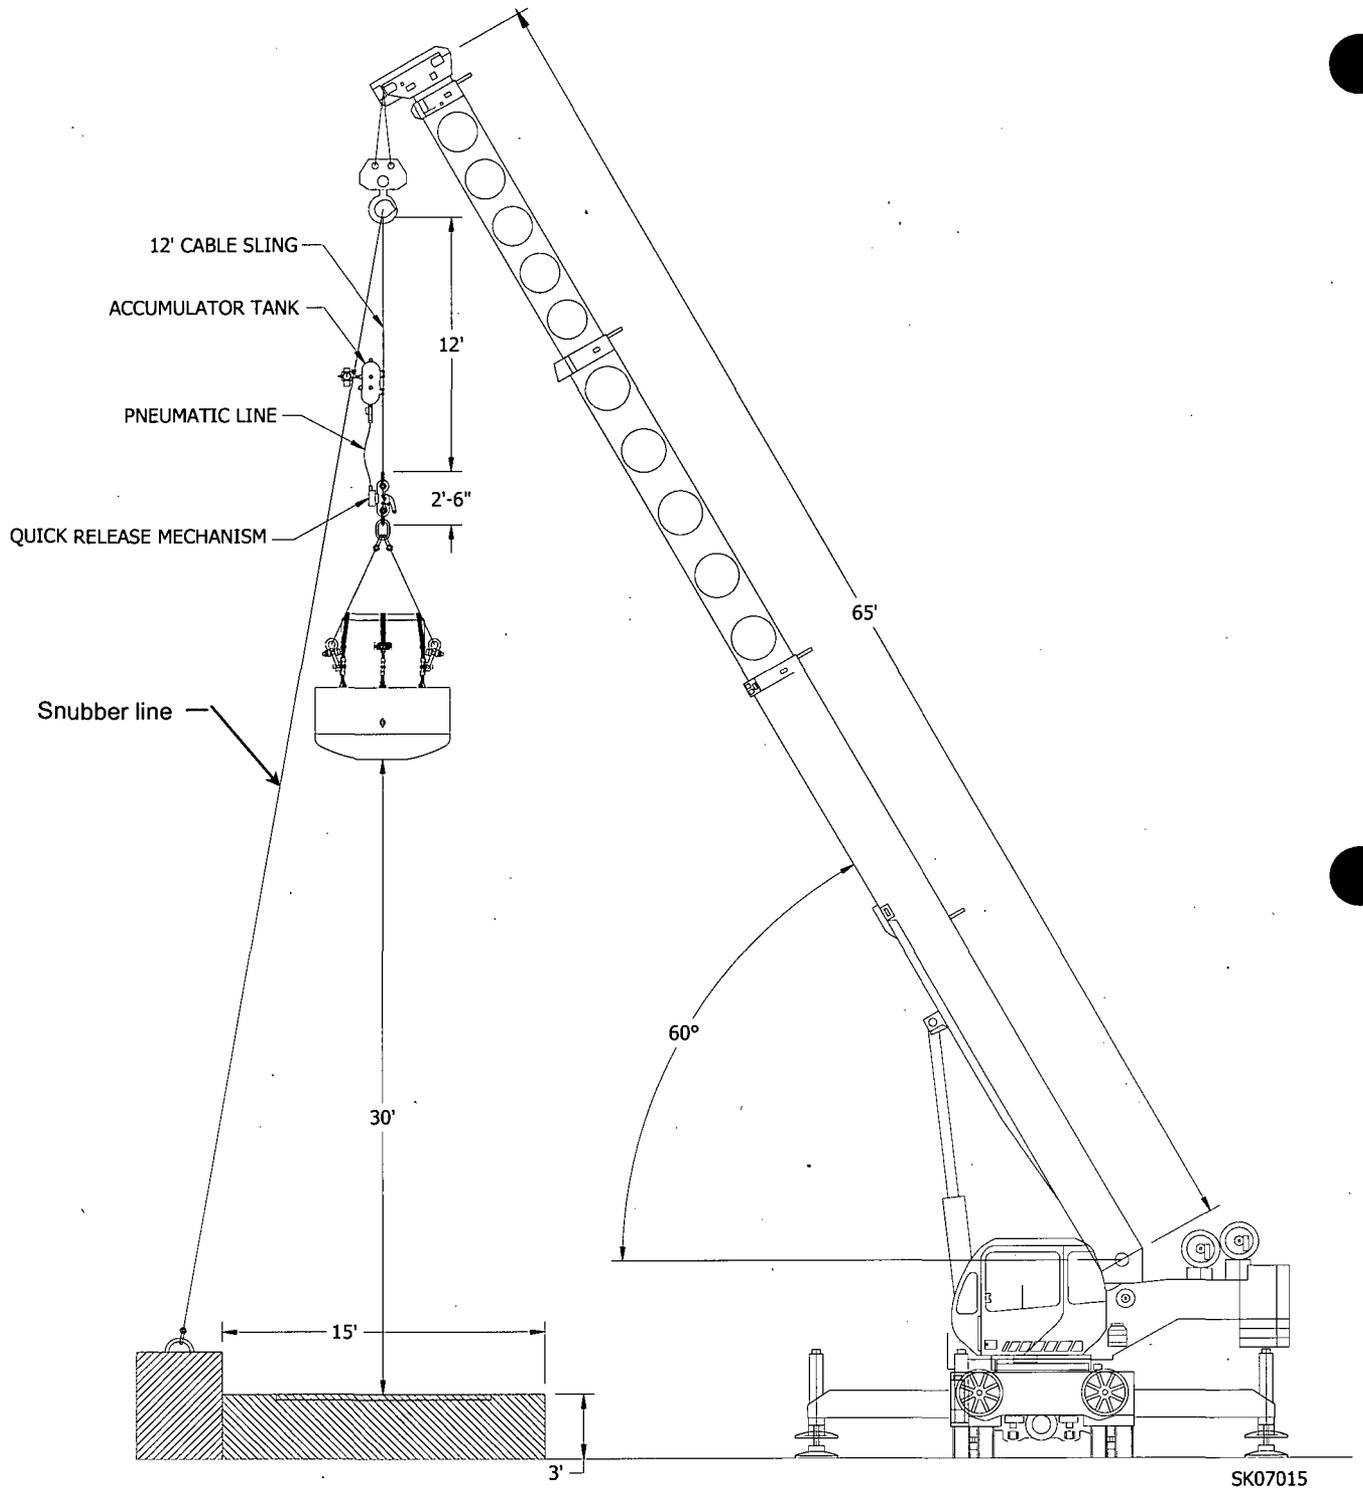
Figure 8 Crane and rigging set up for end drop.

The use of a hydraulic crane required that the crane boom be "snubbed" with heavy wire ropes from the crane hook down to heavy weights on the ground (Figure 8). The snubbing lines restrained the crane boom when the load was released, preventing damage to the hydraulic system. Since the snubber lines were of fixed length and had to be taut at the time of release, they had some effect on the drop height. Shorter rigging as used on the end drop caused the drop height to be greater than for the side and slap-down drops. However the drop height was over 30 feet for each drop. Exact values are given later.

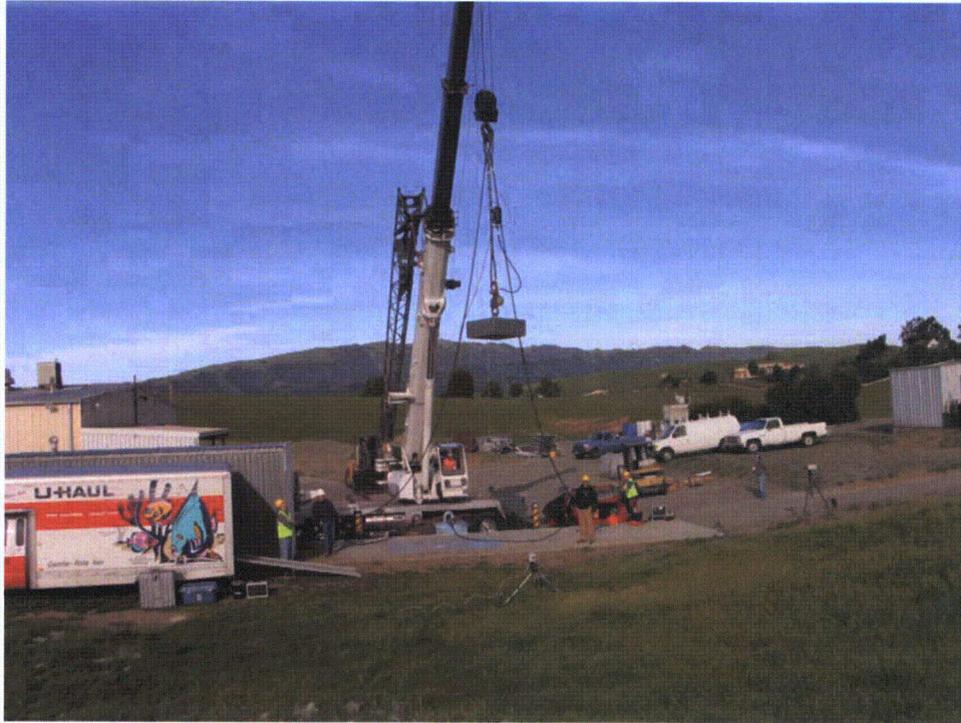
Figure 9 Testing the quick-release mechanism by dropping a dummy weight.

For each drop, the test article was lifted by a 90-ton mobile crane to a height of at least 30 feet⁶ directly above the steel plate drop target. The crane was provided by Peninsula Crane Service under subcontract to GENE. GENE provided the remaining rigging equipment. Figure 8 illustrates the crane setup for the end drop. Figure 9 shows the crane and quick-release mechanism being tested by dropping a dummy weight.

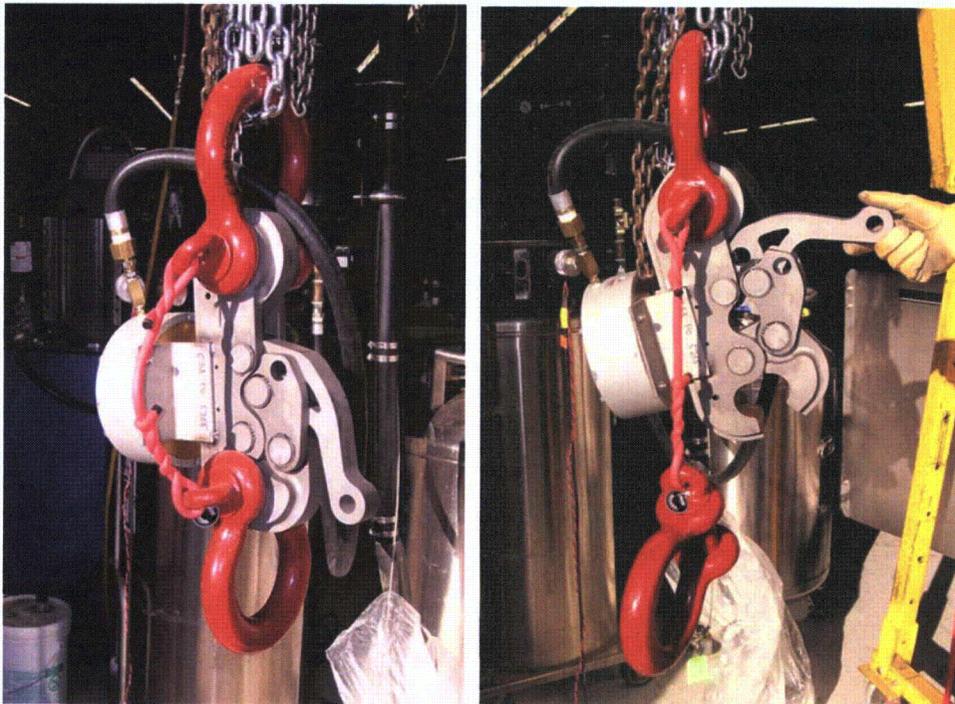
Figure 10 SeaCatch release mechanism before release (left) and after release (right).

The SeaCatch is a model TR15AIR and is rated at 50,200 lbs working load with a safety factor of five. It was proof tested to twice the working load by the manufacturer prior to delivery to CSA. Likewise the wire rope, which is rated for 42,000 lbs, was proof tested to 84,000 lbs.

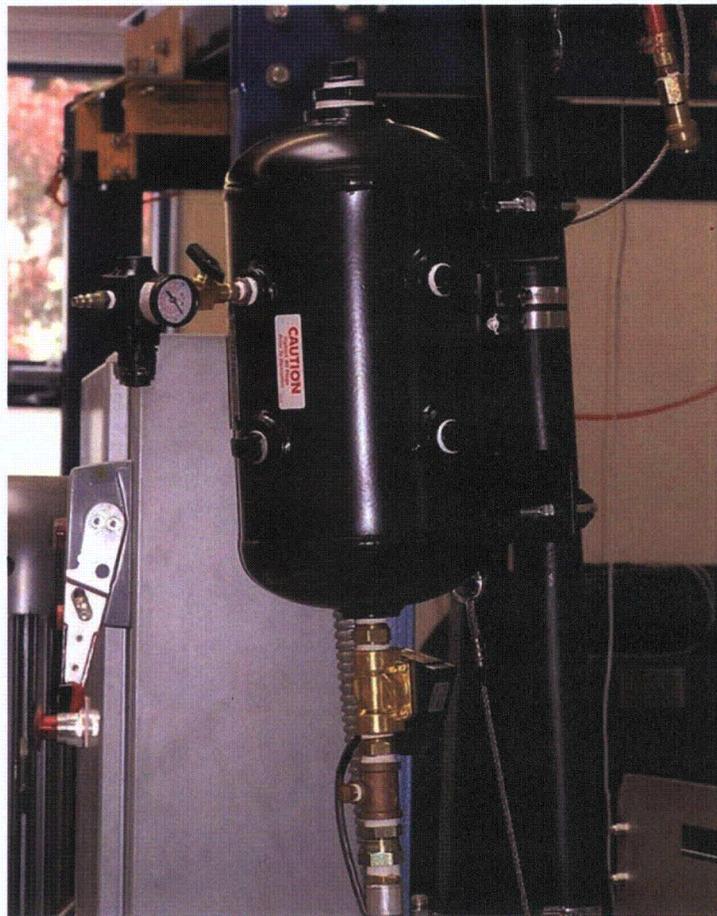
Figure 11 Accumulator tank and fast-acting valve for operating the SeaCatch air piston (left). Entire release system (right).

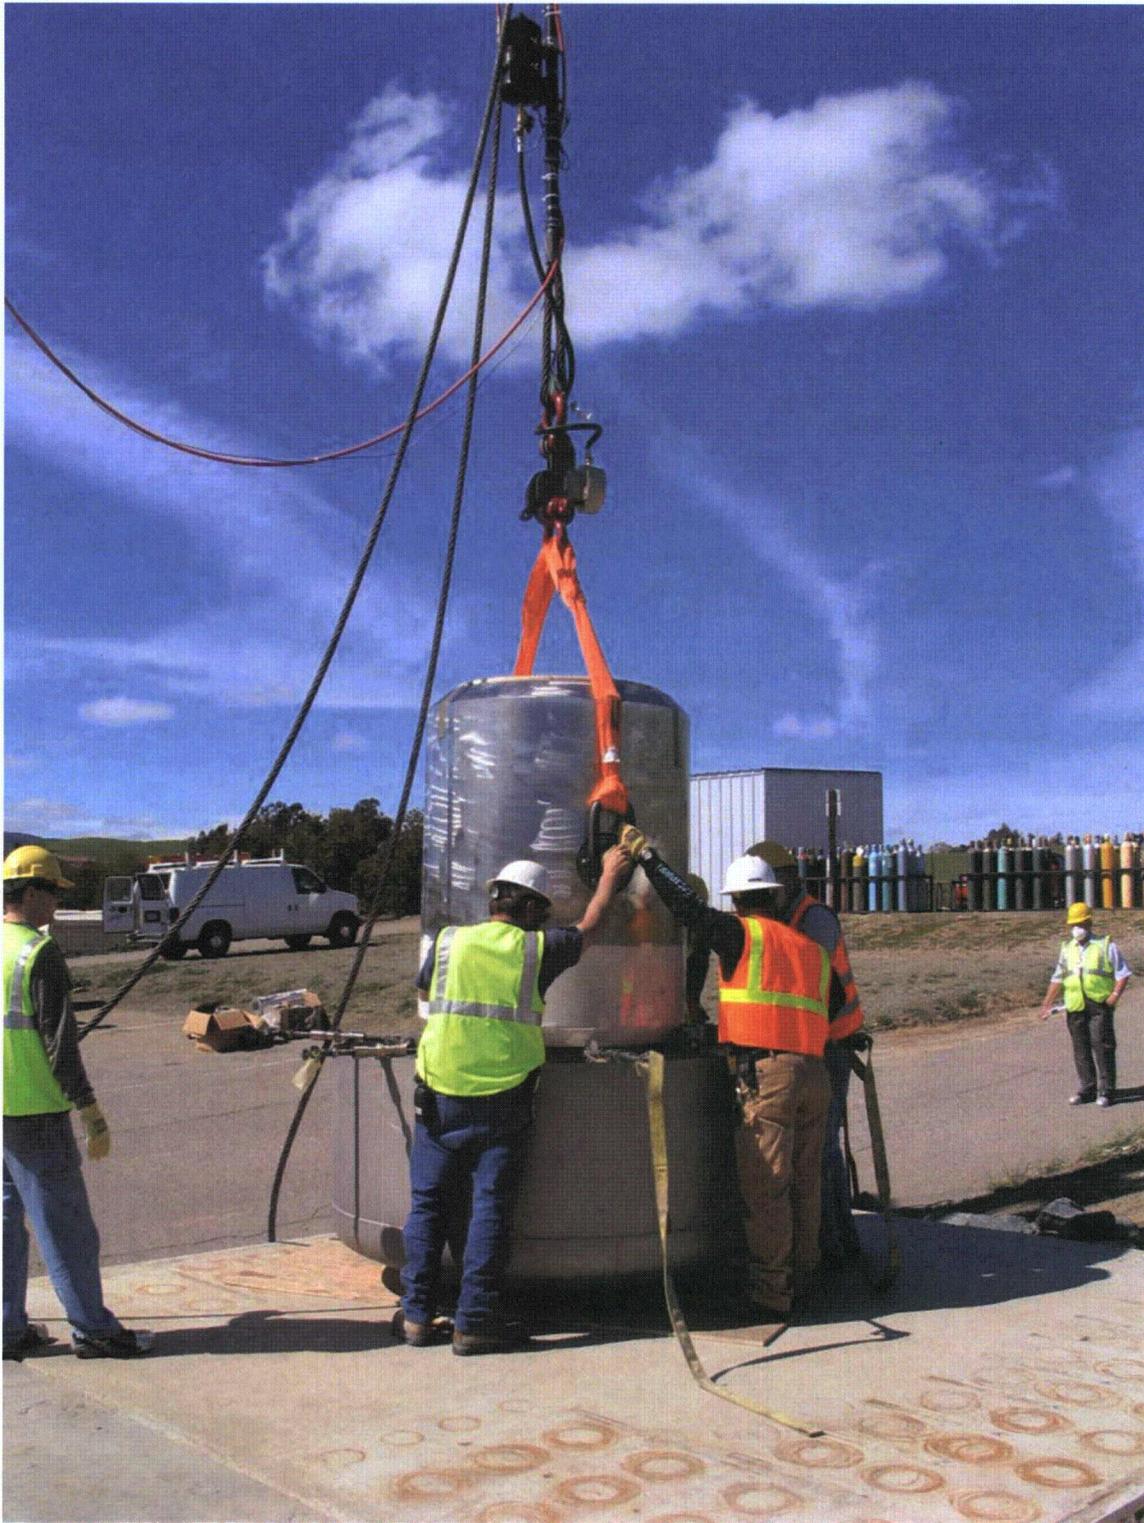
Figure 12 Cask being assembled with impact limiter for the end drop. The quick-release mechanism is visible at the top of the picture. Pressure-sensing paper has been taped to the part of the cask that goes inside the impact limiter.

The package was released using the mechanism shown in the Figure 10, Figure 11, and Figure 12. The heart of the system is the mechanical release mechanism shown in Figure 10. Called a SeaCatch Model TR15Air⁷, it is used in the marine industry for releasing loads while under tension, often underwater. In the photo on the right of Figure 10, the release mechanism is actuated by hand via the lever on the right side. Lifting the lever opens the jaws and allows the lower anchor shackle to fall free. The red rope tied between the shackles in the figures is only for demonstration. In the actual test, the package was hung from the lower shackle, the red rope was not present, and the lower shackle remained attached to the test article as it fell.

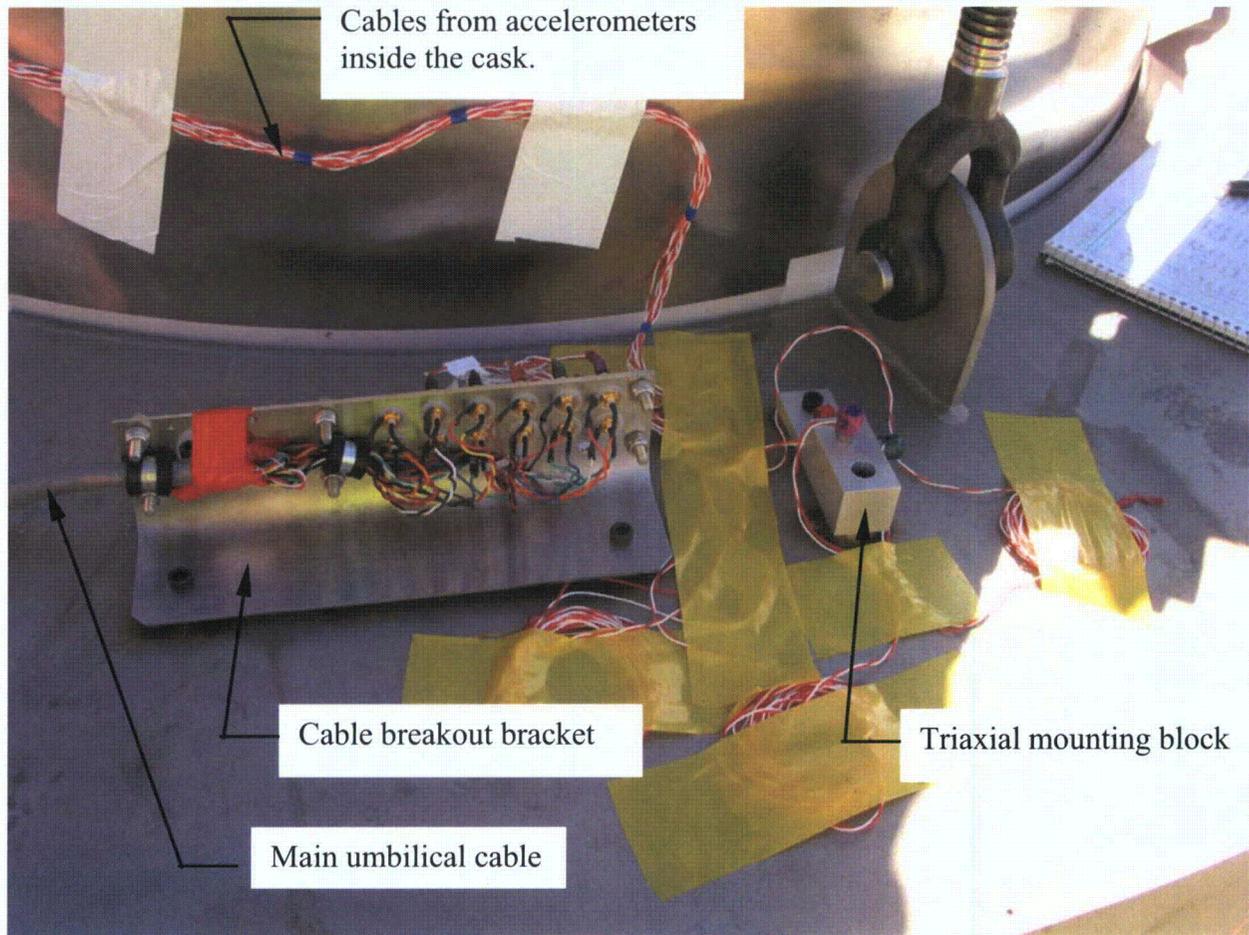
Figure 13 Triaxial accelerometer group mounted on impact limiter. The sheet metal part is a bracket for connecting the 20-conductor umbilical cable to the two-conductor cables of the individual accelerometers.

Acceleration time history data was recorded using accelerometers inside the cask and on the impact limiter. A total of nine uniaxial sensors was used, configured as three triaxial groups. One triaxial group was mounted on the flat surface of the impact limiter (Figure 13). The mounting block is fastened to the impact limiter by two 1/4-20 cap screws threaded into tapped mounting bosses welded to the impact limiter. A cable breakout bracket for mating the main umbilical cable to individual accelerometer cables is likewise mounted to tapped bosses on the impact limiter as shown.

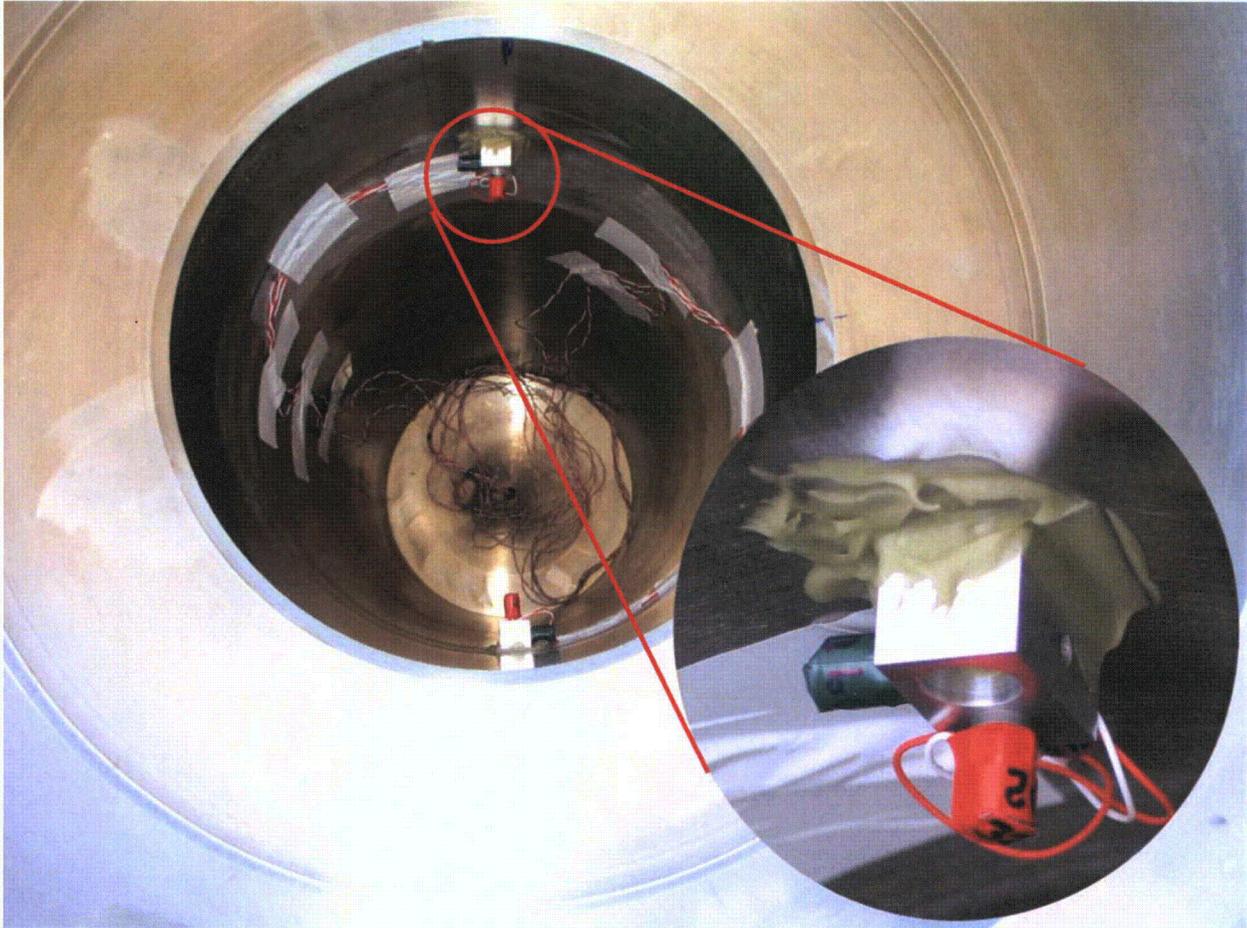
Figure 14 Accelerometers mounted inside the cask. The cables can be seen exiting via the drain port at the bottom of the cask payload cavity.

nominally the cask radial, tangential, and axial directions. The cask was oriented for the side drop and slap-down drop such that a plane containing the cask axis and the accelerometer locations was vertical and the accelerometers on the 90-degree line were on the upward-facing side of the cask. In the photos, the radial accelerometers are marked with red tape, the axials with purple tape, and the tangentials with green tape.

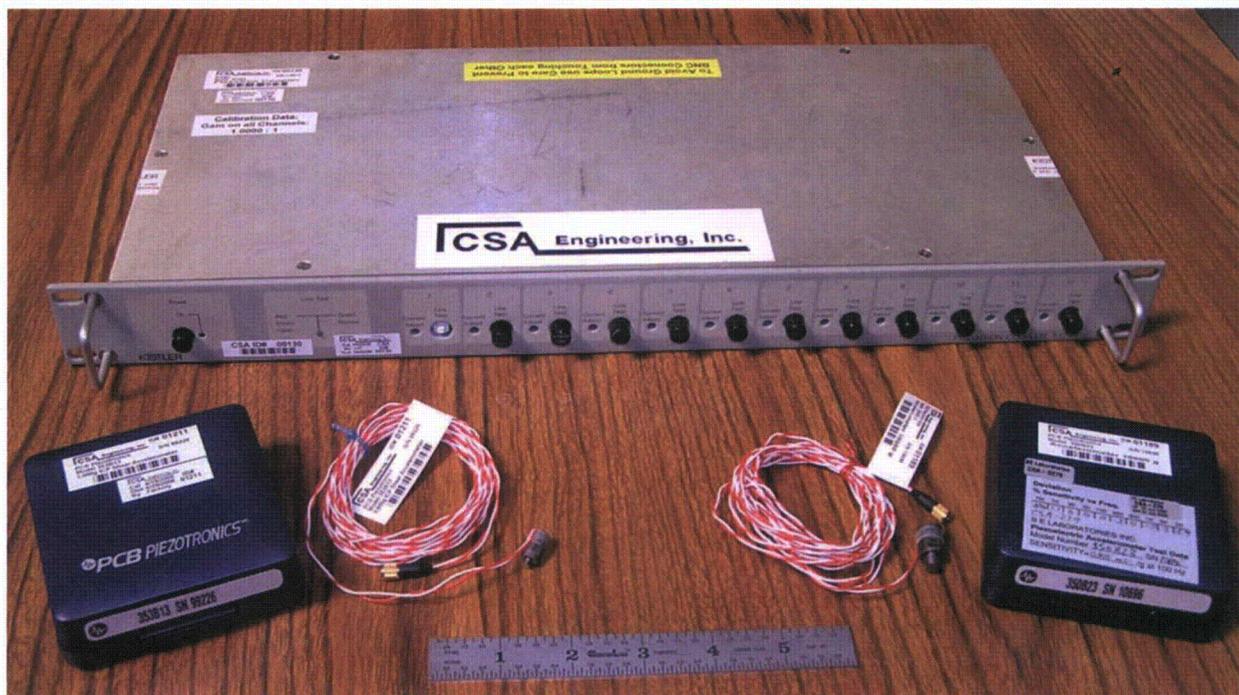
Figure 15 Accelerometers (1,000 g on lower left, 10,000 g on lower right) and power supply / signal coupler.

All accelerometers were of the piezoelectric, integrated amplifier (ICP) type. The accelerometers mounted on the impact limiter were PCB model 350B23 having a nominal range of $\pm 10,000$ g's (0.5 mV/g sensitivity, 0.5 g resolution, range/resolution = 20,000) and a 1-dB bandwidth of 0.4 to 10,000 Hz. The triaxial accelerometers inside the cask were PCB model 353B13 having a nominal range of ± 1000 g's (5 mV/g sensitivity, 0.05 g resolution, range/resolution = 20,000) and a 1-dB bandwidth of 0.7 to 20,000 Hz. All were powered and AC coupled to the recording system by a Kistler model 5124A power supply/coupler. Figure 15 shows the accelerometers and their power supply / signal coupler. There is no pass-fail criterion based on cask acceleration. However the data obtained will be of use in understanding the package behavior during impact and for estimating loads on the cask.

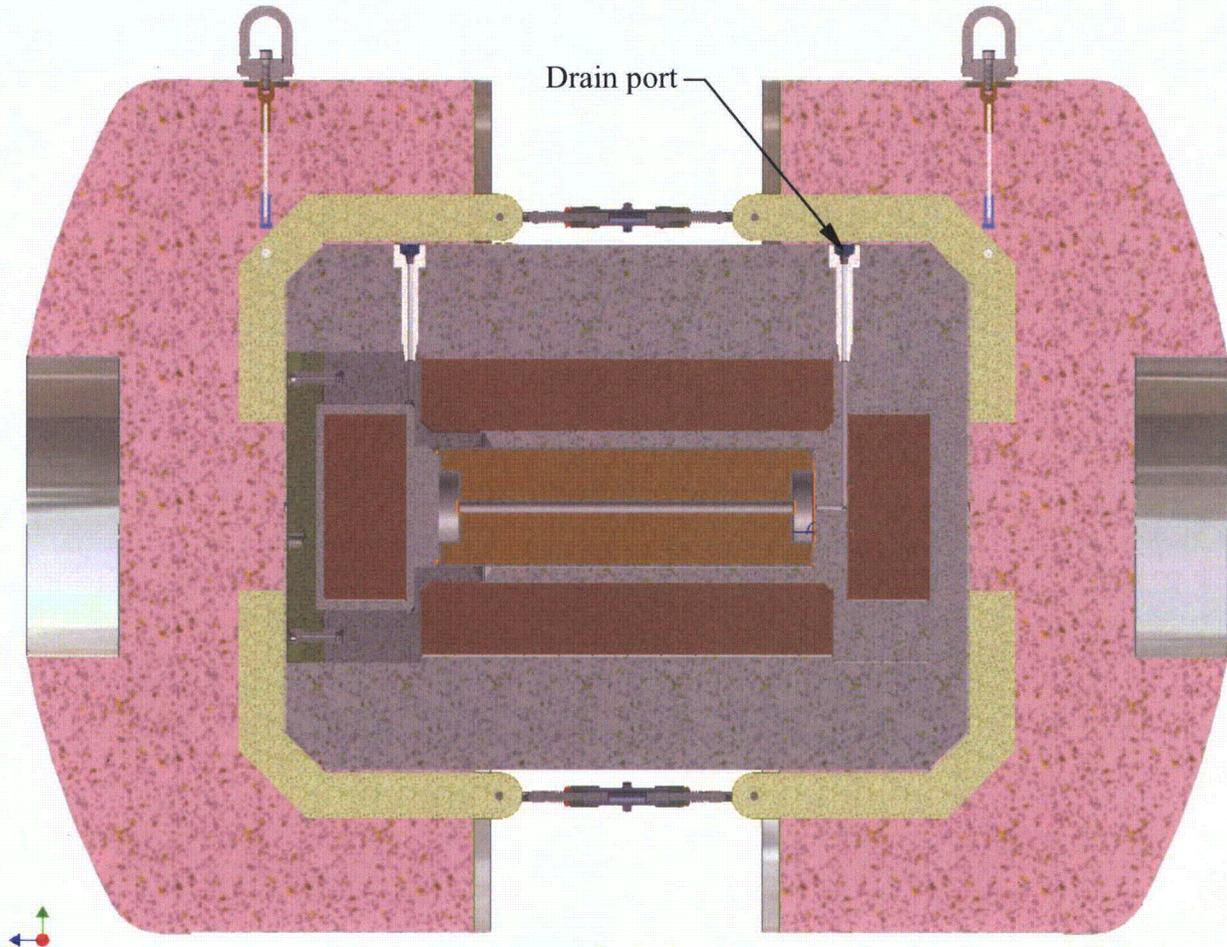
Figure 16 Cross section of cask showing drain port to be used for accelerometer cable routing.

Cables for the accelerometers inside the cask were routed through the water drain port (Figure 16) such that no special feedthroughs or modifications to the cask were needed. During the leak test, the cables were disconnected from the external breakout bracket and pushed back into the drain port so the port can be plugged.

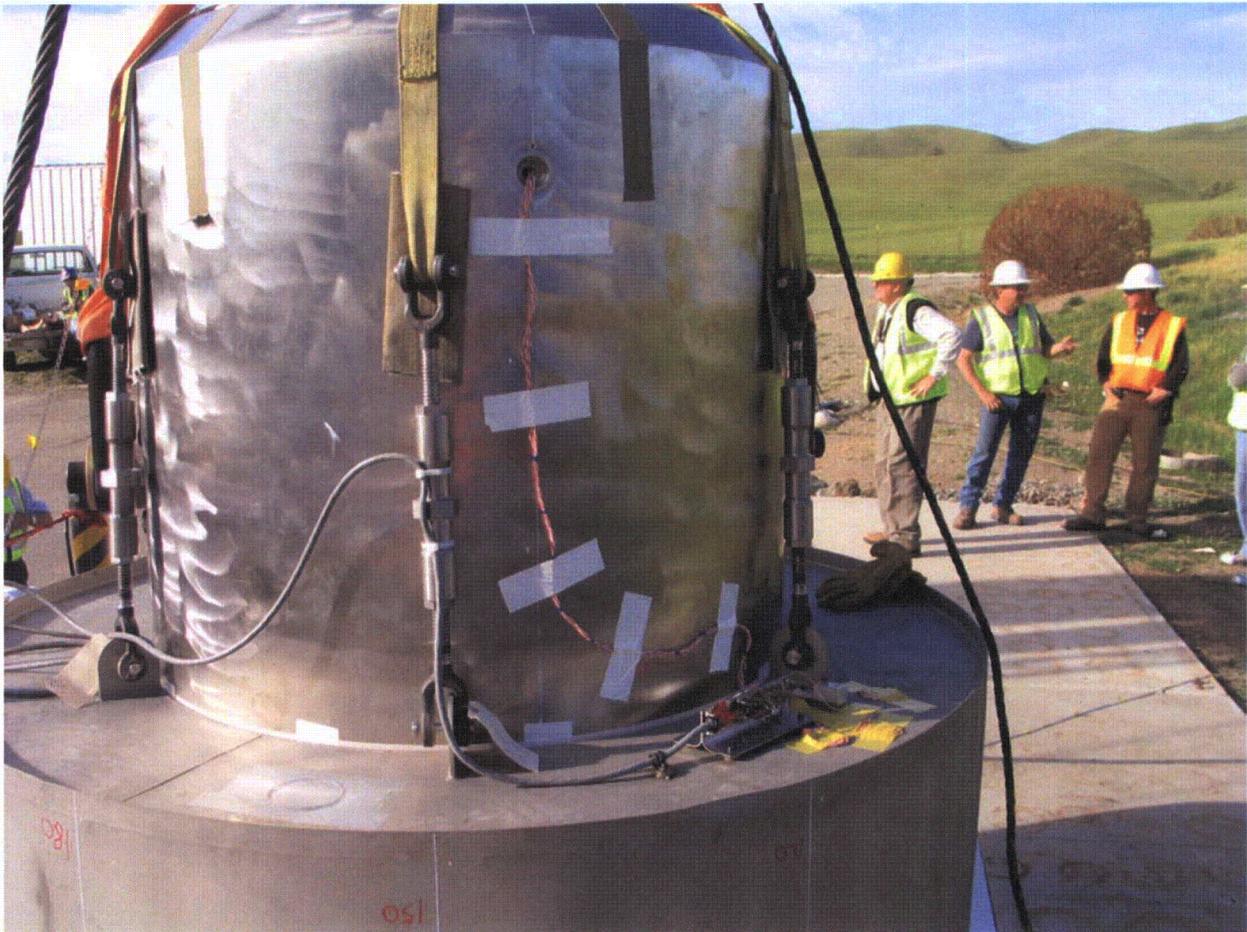
Figure 17 Cables from accelerometers inside the cask were routed through the drain port to the breakout bracket. Configuration shown is for the end drop with only one impact limiter used.

A multi-channel umbilical cord with one shielded, twisted pair for each accelerometer was used to route the signals to a breakout box with BNC connectors on the output side. BNC cables then carried the signals to the Kistler power supply/coupler and from there to the data acquisition system located in the instrumentation truck. The total cable length of approximately 150 feet presented no significant limitation for the relatively low-frequency signals of interest in this test.

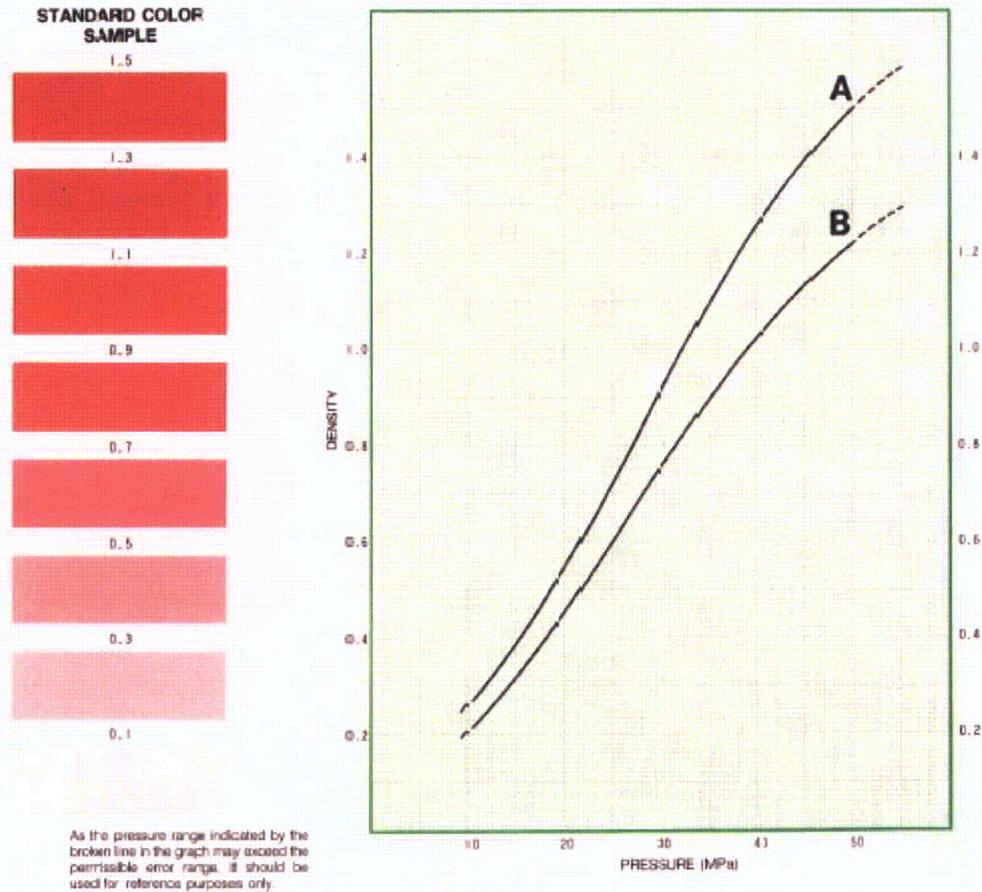
Figure 18 Chart for correlating color to pressure for Fuji medium-range Prescale film.

Pressure sensitive film was installed between the cask and impact limiters prior to each drop. The film (Fuji Prescale P/N M S R270 M10 1) changes color in response to pressure. The single-sheet type contains embedded microcapsules of a chemical that reacts with another chemical impregnated into the film to produce a red color. Higher pressure breaks more capsules and produces a more intense color. The size and density of the microcapsules can be tailored to make the color change occur over various pressure ranges. The film used is for the pressure range from 10 to 50 MPa (1450 to 7250 psi). Pressure can be inferred by comparing the exposed film to a color chart (Figure 18). However for the present application, the intent is simply to use the pressure paper to indicate areas of contact between the cask and impact limiters.
