| 8.3.2 Impact (Free-Drop) Test Report

**Test Report:
Drop Tests of the
Alpha Omega Services Shipping Cask
for Radioactive Material**

**Report No. 2007533 Rev 1
May 25, 2007**

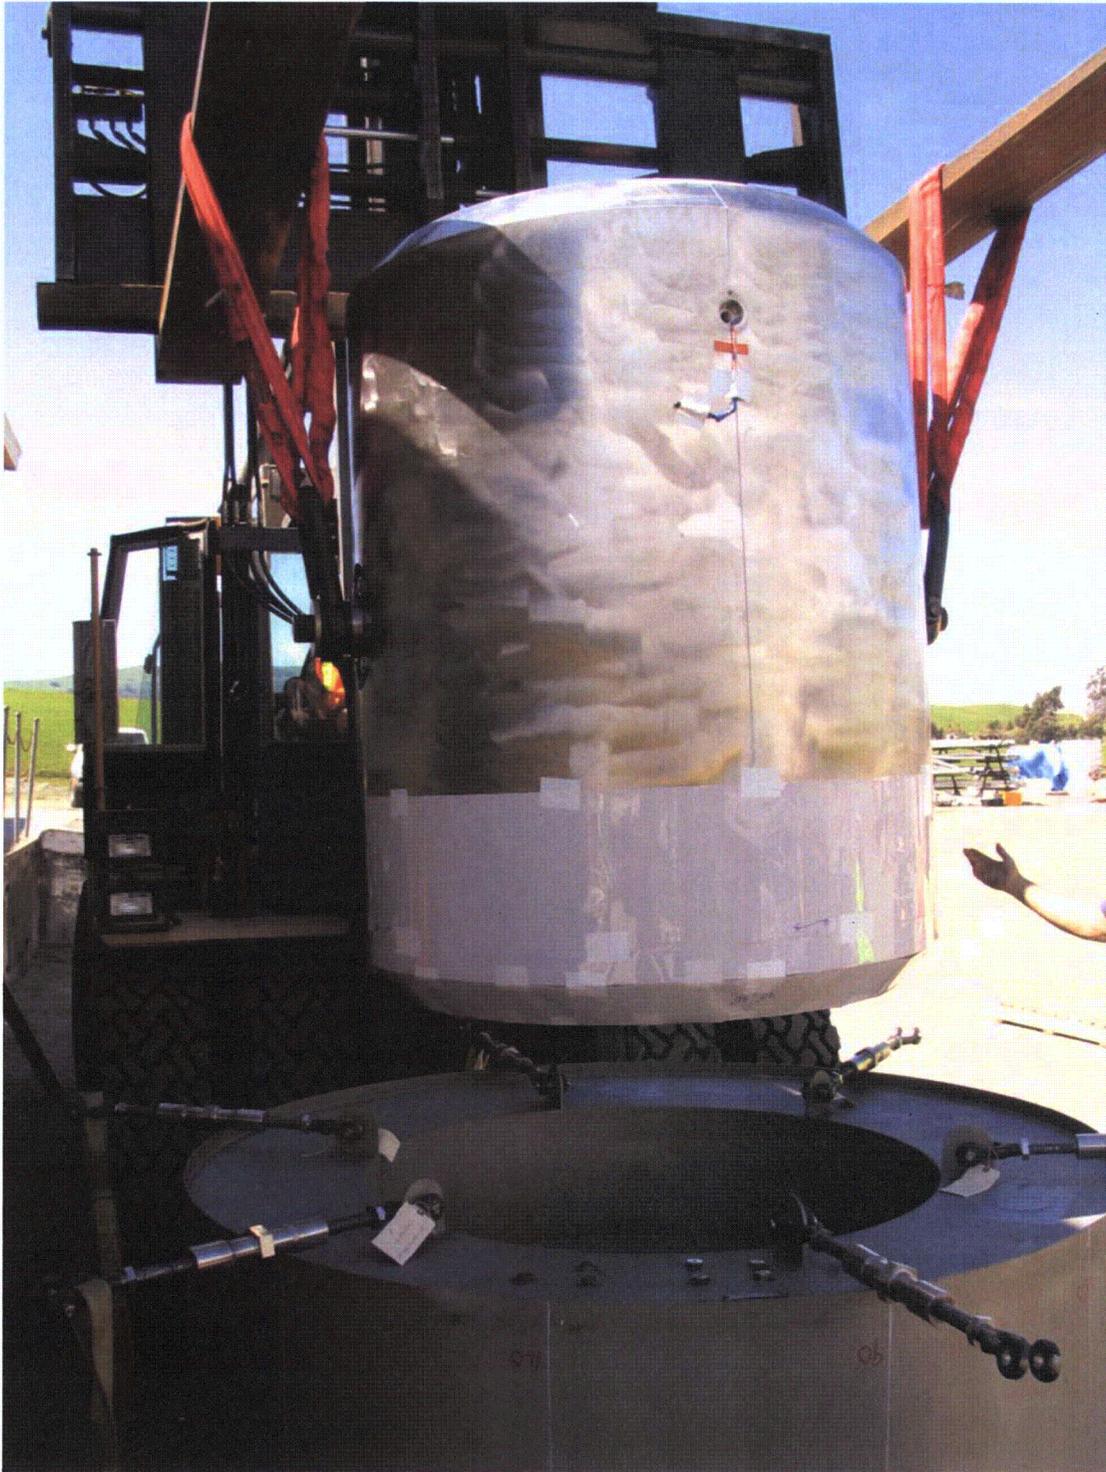
Figure 19 Cask with pressure paper attached being lowered into the impact limiter for the end drop.

Figure 19 shows the cask with pressure-sensing paper attached being assembled into the impact limiter. The paper can also be seen in Figure 17 protruding out slightly beyond the impact limiter.

Figure 30 shows the pressure sensing film from the end drop. The band of film that was taped to the cylindrical surface of the cask (Figure 19) has been cut into four equal pieces which are placed in their respective azimuthal locations in Figure 30. In Figure 30 and in the similar photographs from the side and slap-down drops, the surface of the film which faced away from the cask is towards the camera.

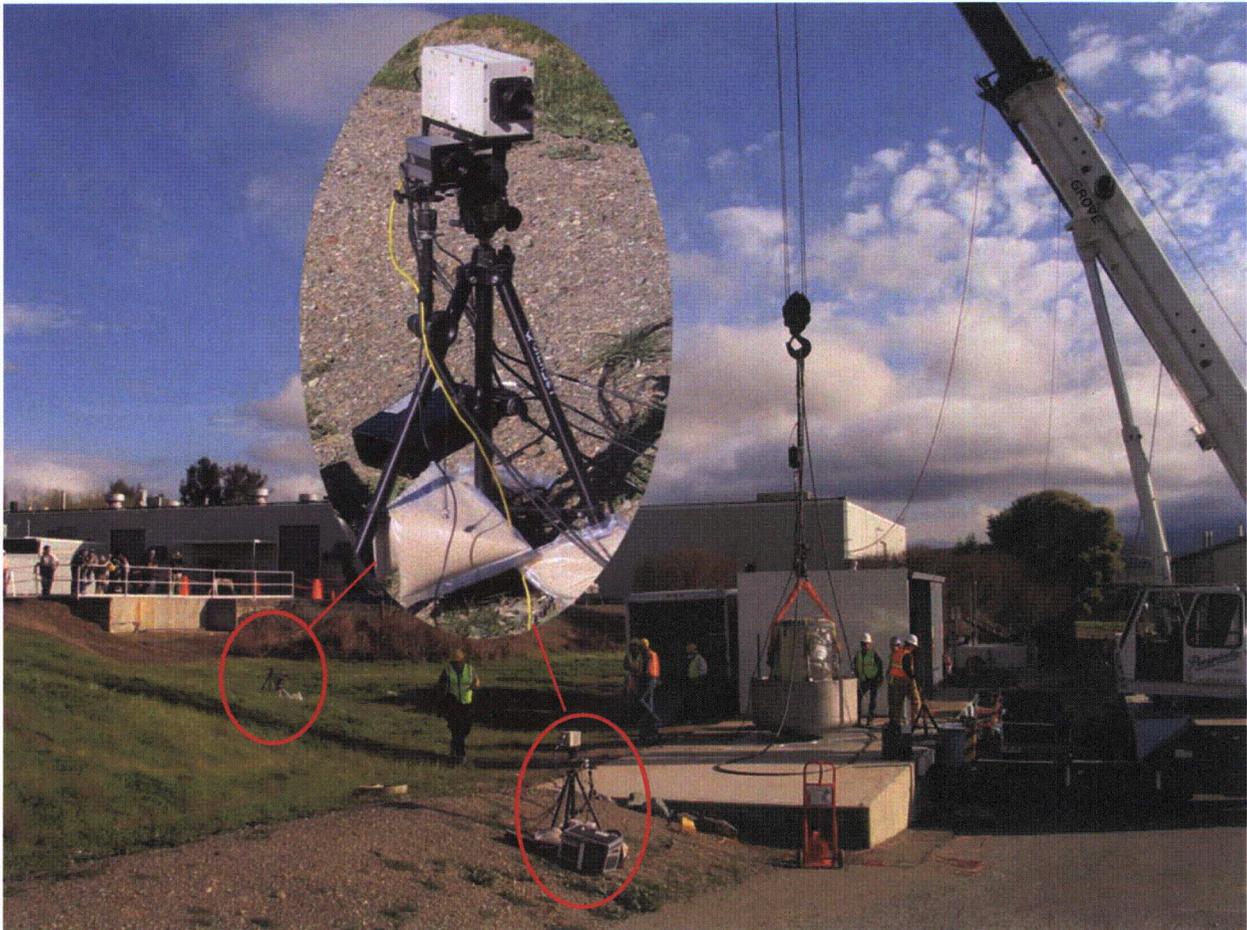
Figure 20 High-speed cameras set up for end drop

High-speed digital video photography was used to record each of the three drops. All cameras were furnished and operated by Speedvision Technologies of San Diego under subcontract to CSA Engineering.. Two high-resolution black-and-white cameras were used with their sight lines at right angles to each other as shown in Figure 3 For the first (end) drop, lower resolution color cameras were located next to each black-and-white camera. Following review of the end drop videos from all four cameras, it was decided that only one color camera would be used for the second and third drops and it would be located at an oblique angle, about midway between the two black-and-white cameras. Figure 20 shows the cameras set up for the end drop.

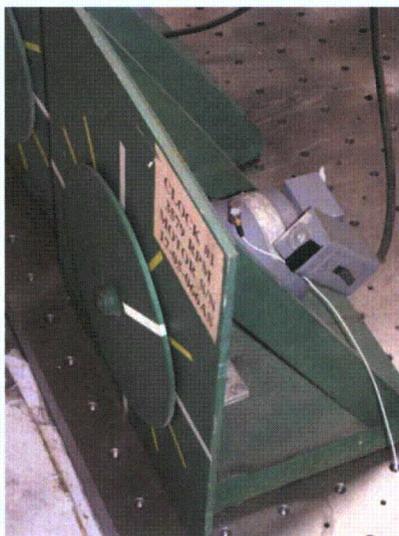
Figure 21 Time scale

A time scale and a length scale were included in the field of view of the each black-and-white camera. The length scales are dark-colored poles mounted vertically with light-colored graduations marked on them at one-inch (yellow marks) and one-foot (white marks) intervals. The poles are placed as close as possible to the vertical drop path and at the same distance from the camera as the drop path in order to minimize parallax and foreshortening error. Time scales, Figure 21, are rotating disks with a light-colored radial line. The background behind the disk has fixed, radial witness lines painted at 30-degree intervals as shown. The disk is rotated by a two-pole induction motor at a constant speed of approximately 3575 RPM or approximately 43 degrees per camera frame at 500 frames per second. The exact rotational speed was determined prior to the test using a digital optical tachometer. Table 1 shows the recent time scale calibration results and those from just before the 1987 test.

The use of time scales was a hold-over from earlier tests where high-speed film photography was used and frame rates could vary significantly from their nominal value. Modern digital video cameras have very accurate frame rate control (a few parts per million) so the time scales are not strictly necessary and are actually less accurate than the cameras themselves.

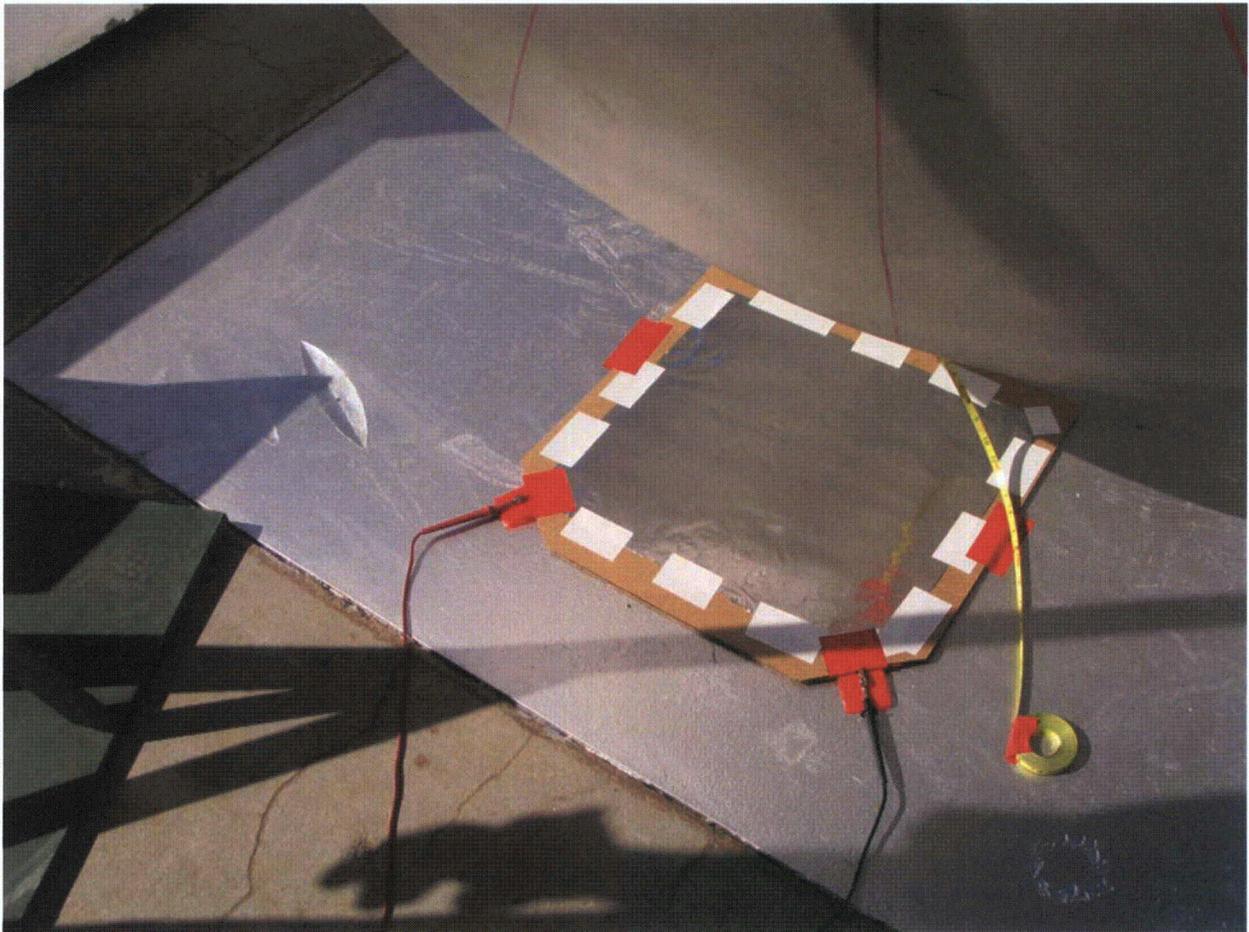
Figure 22 Impact trigger in position for side drop.

At the suggestion of SpeedVision, a simple impact trigger signal generator was constructed and used to provide a time reference signal indicating when the test article first impacted the ground. The trigger was simply a sheet of cardboard approximately two feet square with a grid of 2-inch-square holes cut in it and sandwiched between two sheets of heavy-duty aluminum foil (Figure 22). The sandwich was taped to the impact surface at the location where the test article would first strike the surface. When the impact limiter hit the sandwich, it pressed the two sheets of aluminum foil together and closed a circuit. The resulting voltage signal placed a reference time marker on the stream of video frames to indicate first contact. It also cued the cameras to continue recording for another two seconds and then stop. Finally, it produced a step voltage signal that was recorded on one channel of the VXI data system as a time reference for interpreting the acceleration time histories. The impact trigger was used on the second and third drops and found to work very well.

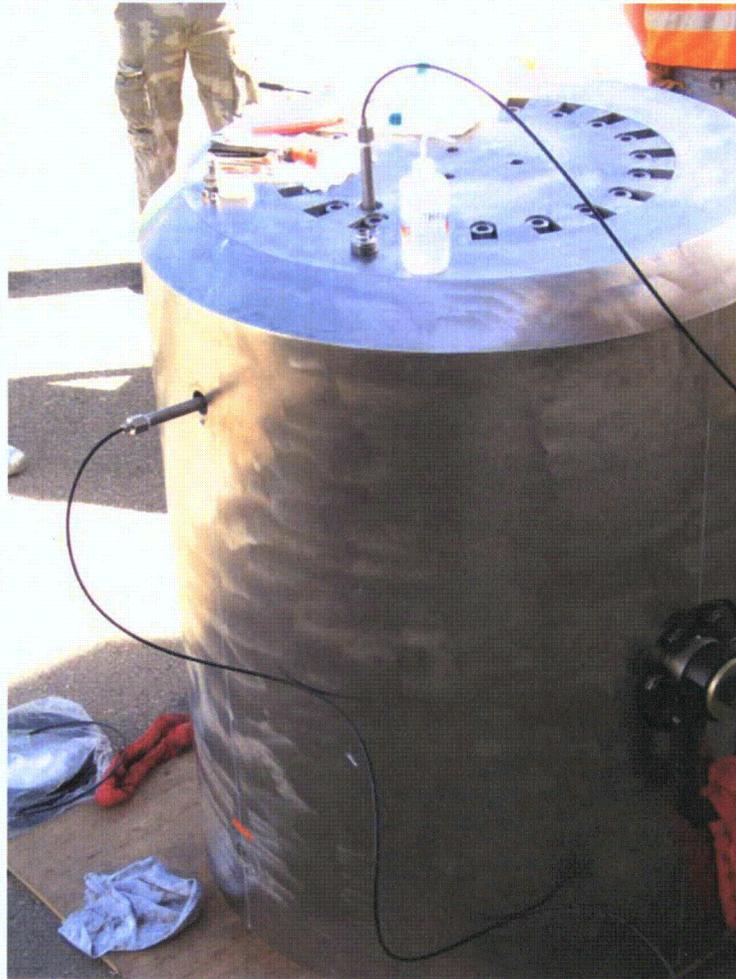
Figure 23 Leak testing the cask.

Integrity of the cask body and its lid seal was tested before and after each drop test by measuring the leak rate. The lid was bolted in place in the normal operating configuration. A helium pressure bottle was connected to one of the ports leading to the payload cavity and the cavity was purged with helium and then maintained at a pressure of 17.0 psia. The vacuum pump of a helium leak detector was connected to the port leading to the volume between the double seals of the lid. The volume between the seals was pumped down to an absolute pressure of less than 1 Torr and the leak rate of helium was measured by the leak. A leak rate of less than 2.96×10^{-7} standard cubic centimeters of helium per second at this pressure differential was considered leak-tight. Leak detection equipment was furnished and operated by GENE personnel.

During the leak test, the cables from the accelerometers inside the cavity were disconnected from the break-out panel on the outside of the cask and pushed back into the port from which they exited the cask. The port was then plugged such that the cavity could be pressurized. Figure 23 shows the cask undergoing its initial leak test.

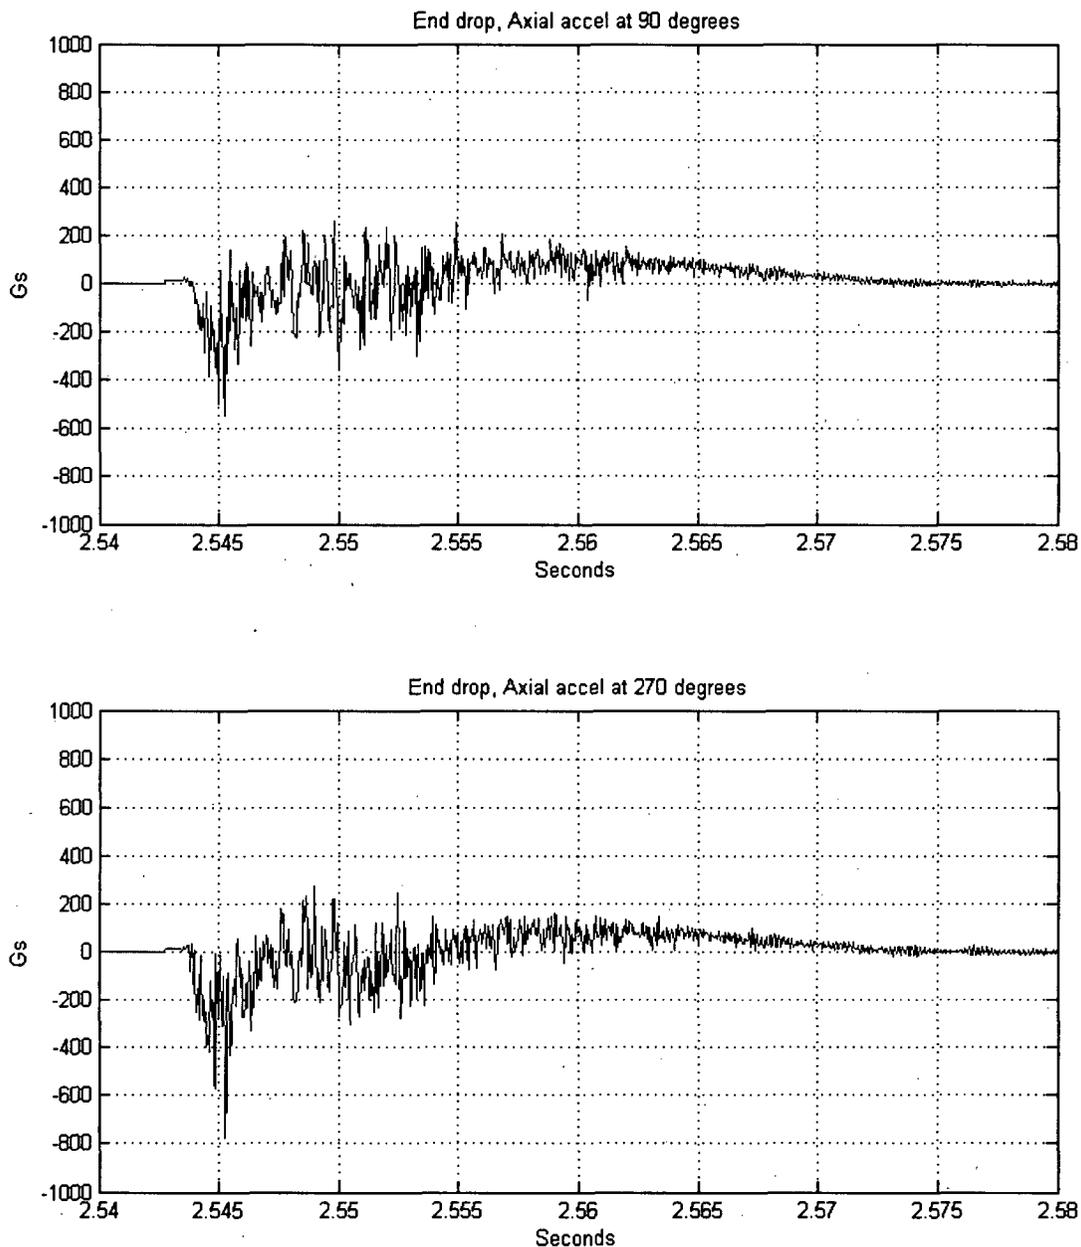
Figure 24 Accelerations measured at impact inside the cask for the end drop.

Figure 24 shows the signals from the two axial accelerometers inside the cask (Figure 14). These two were sensing in the vertical direction for this drop. A positive signal denotes upward acceleration at the accelerometer location.

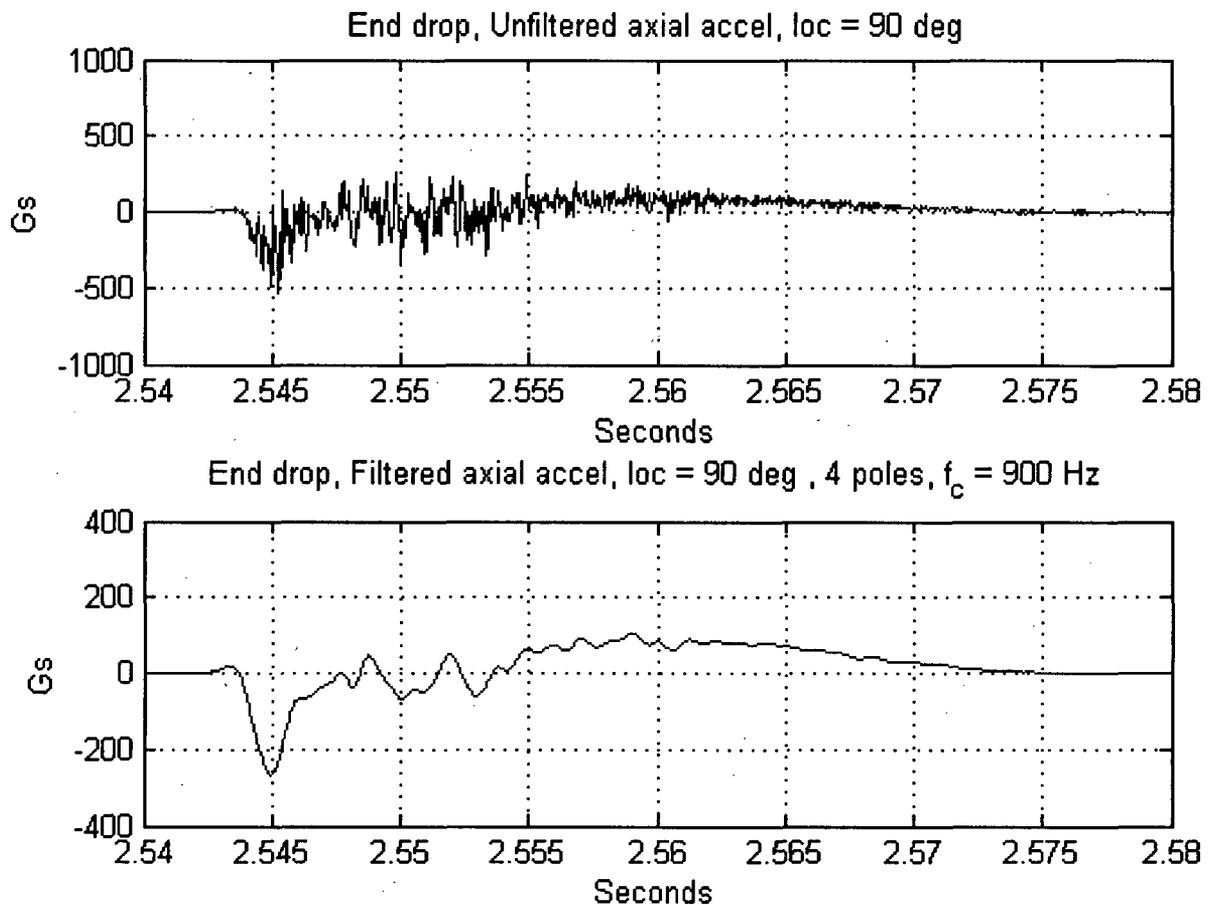
Figure 26 Signal from the axial accelerometer inside the cask on the 90-degree azimuth before (top) and after (bottom) low-pass filtering.

true deceleration of the cask mass center. To this end, the signals were digitally low-pass filtered to reduce the resonant response and make the rigid-body component of the cask deceleration more evident. The filter was a 4-pole phaseless Butterworth⁹ with a cutoff frequency of 900 Hz. Results are shown in Figure 26, Figure 27, and Figure 28.

The vertical acceleration signals in Figure 26 and Figure 27 may seem confusing at first. It appears that the big spike in acceleration is in the downward direction. However the signals make sense when one considers the way the cask is constructed. Referring to Figure 16, the brown areas represent voids between the thick stainless steel walls of the cask. These voids are filled with heavy, tungsten “bricks” which are held in place only by steel wool packing. When the cask first strikes the hard surface, there is in fact a small pulse of upward acceleration

corresponding to the initial deflection of the impact limiter and compression of the steel wool packing. However a millisecond later a secondary collision occurs as the packing goes solid and the tungsten bricks strike the lid end of the cask (recall that the cask is upside down) driving it downwards into the ground. The phenomenon is similar to a car accident where the occupants don't have their seat belts buckled, except that in this case the "occupants" are the heavy tungsten bricks. The secondary collision causes the large negative spike. Following that, a much longer period of upward acceleration occurs, which corresponds to the decay in the initial downward impact velocity. The signal corresponding to this latter positive acceleration is slightly attenuated by the AC coupling of the accelerometers themselves and also by the AC coupling of the signal to the data acquisition system.

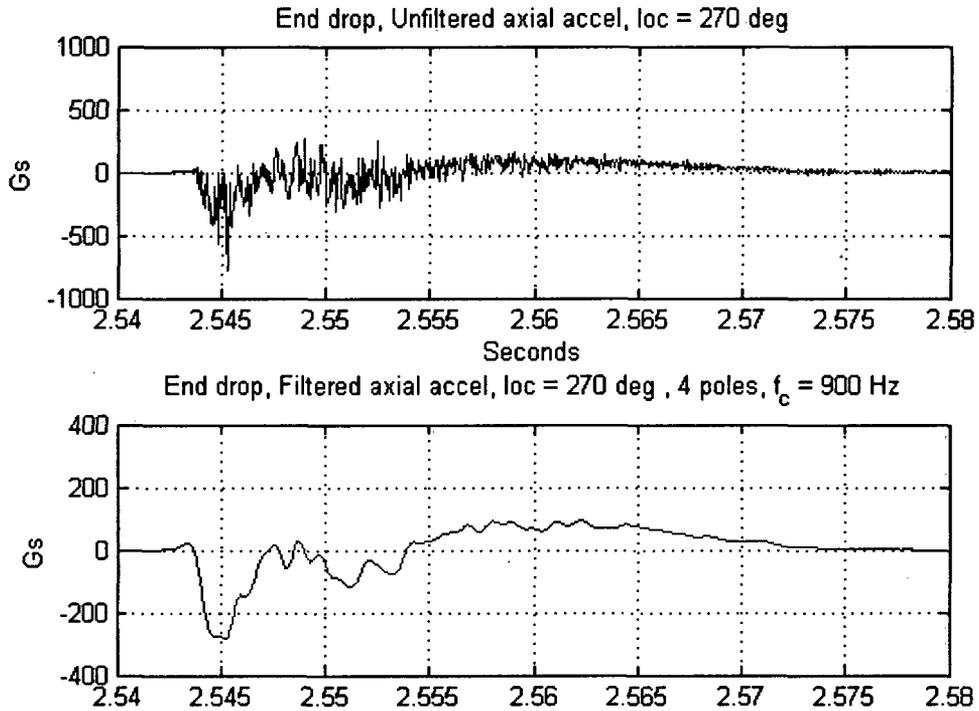
Figure 27 Signal from the axial accelerometer inside the cask on the 270-degree azimuth before (top) and after (bottom) low-pass filtering.

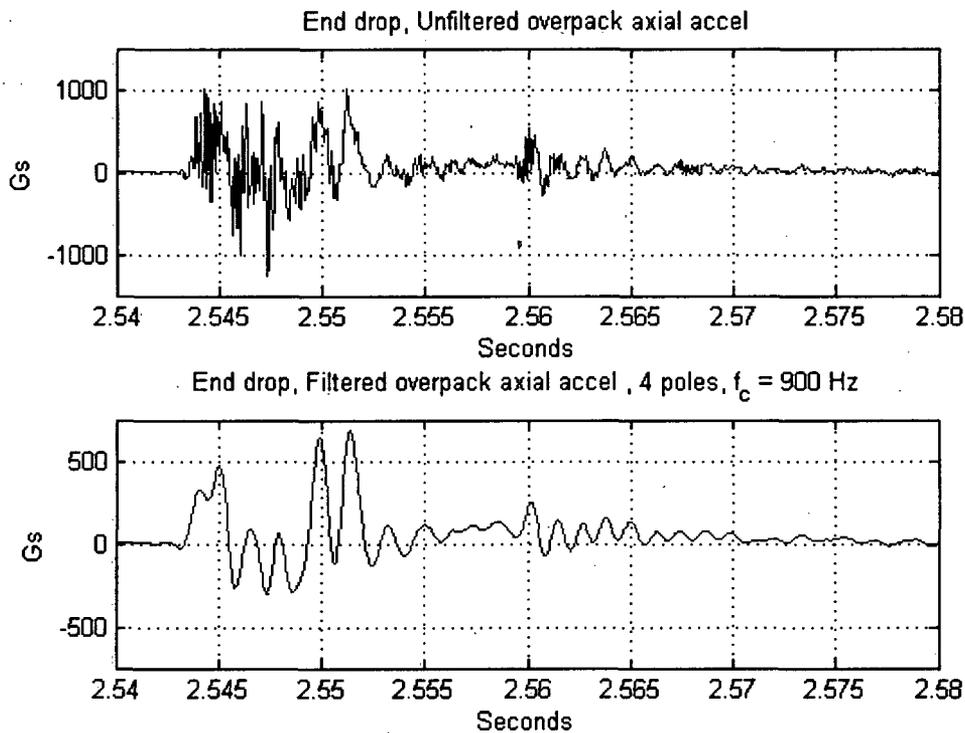
Figure 28 Signal from the axial accelerometer on the impact limiter before (top) and after (bottom) low-pass filtering.

The effect of the secondary collisions is much less pronounced in the axial acceleration measured on the impact limiter (Figure 28), probably because the surface of the impact limiter mounting the accelerometer is only loosely coupled to the cask body. At this surface, the initial pulse of acceleration is quite large and is in the upward direction as one would expect.

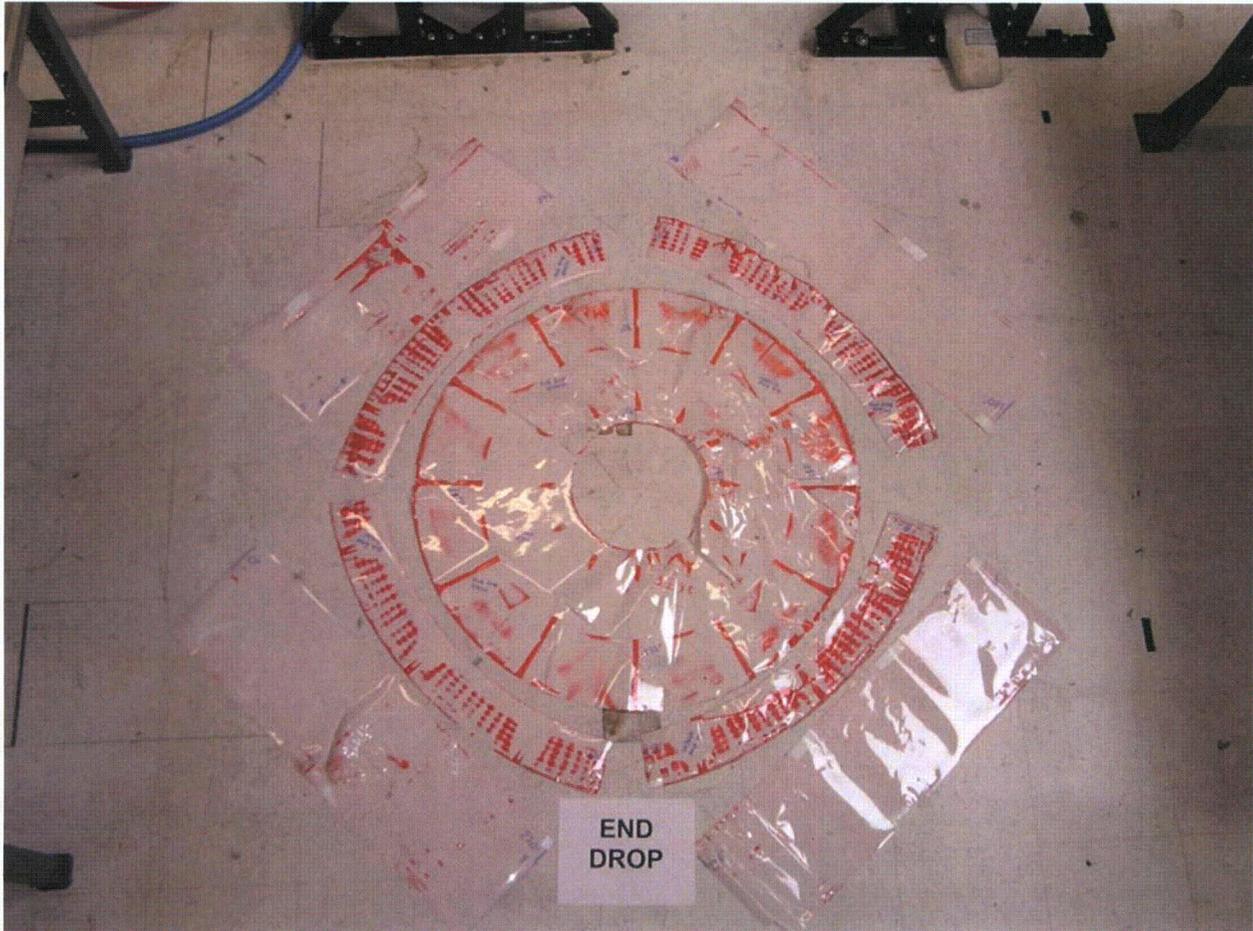
Figure 30 Pressure sensing film removed from the cask after the end drop.

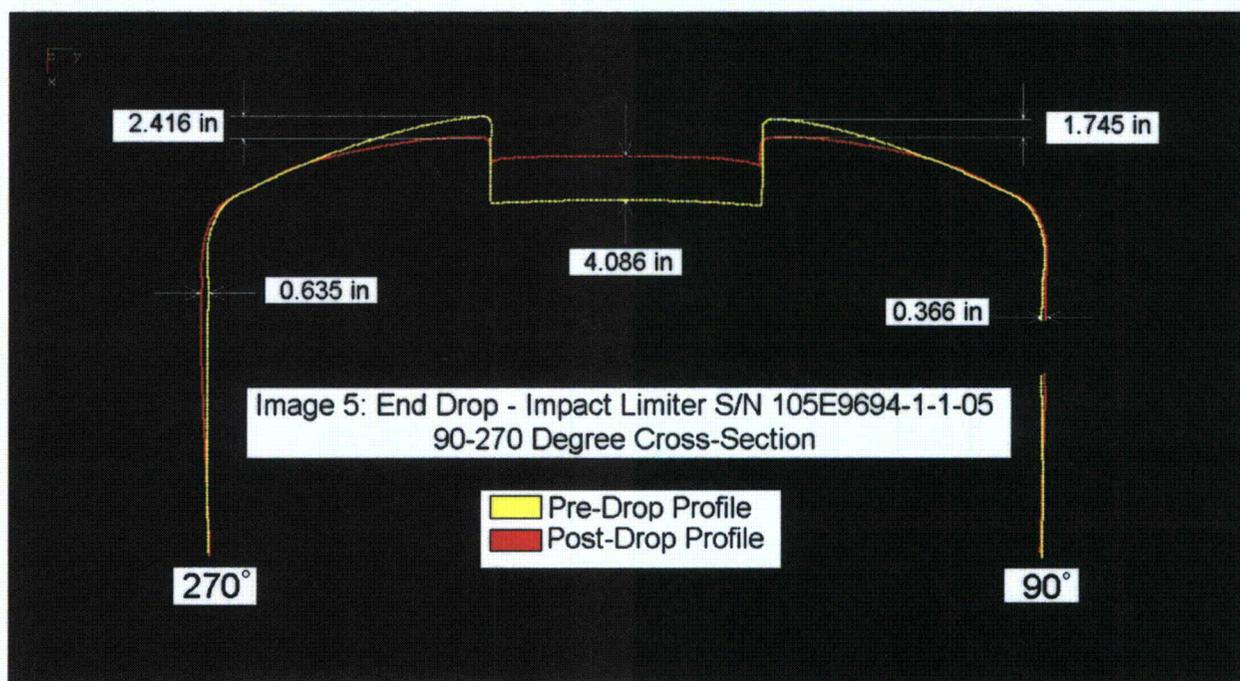
Figure 31 Profiles of the impact limiter before and after the end-drop

Figure 31 shows an overlay of the profile of the impact limiter before and after the end drop.

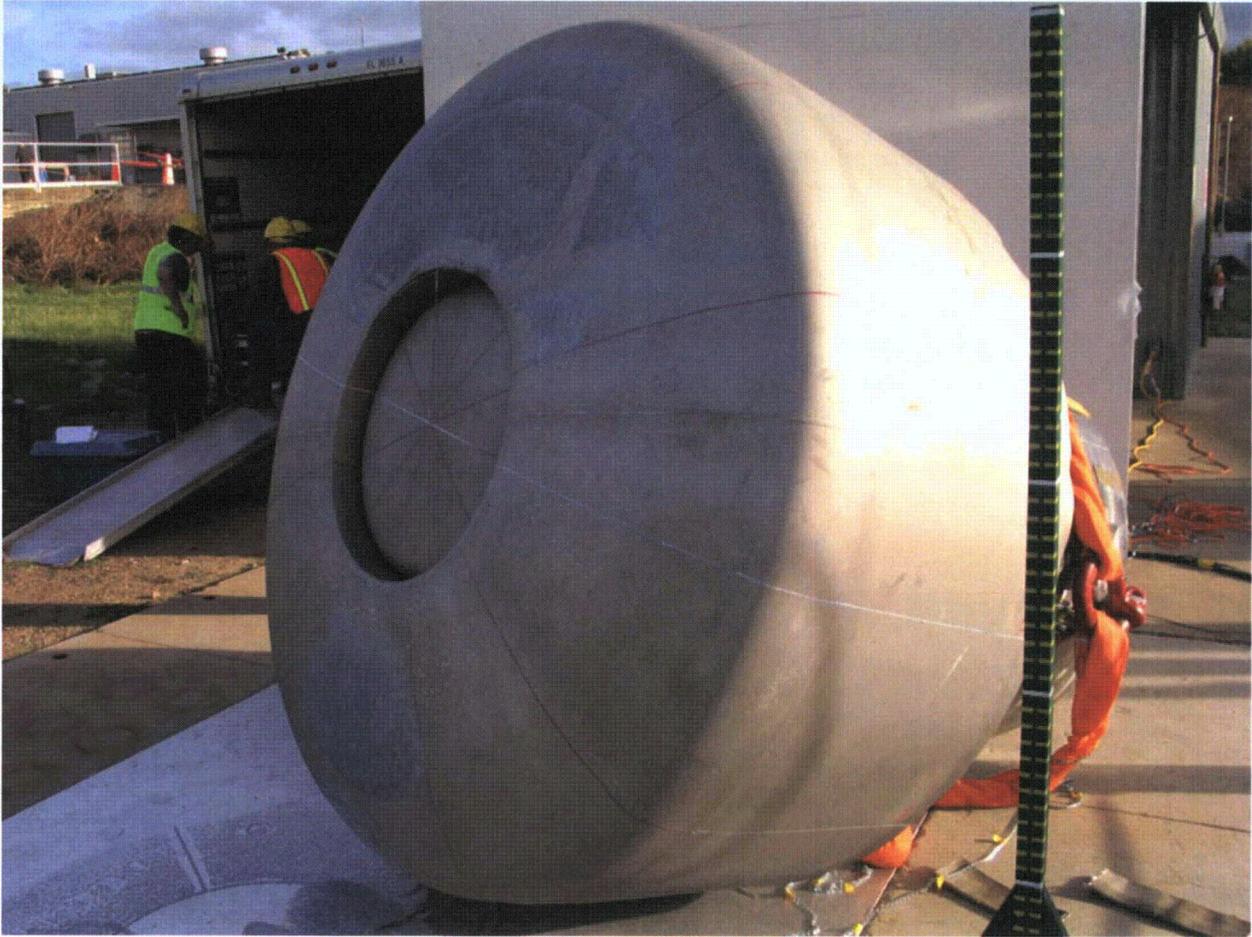
Figure 32 Cask and impact limiter immediately following the end drop.

Figure 32 shows the impact end of the impact limiter after the end drop. The previously flat surface in the large center relief on the end of the impact limiter has been bulged out over four inches by the force from the cask transmitted through the foam. The weld around the edge of the relief has split over a small part of the circumference.

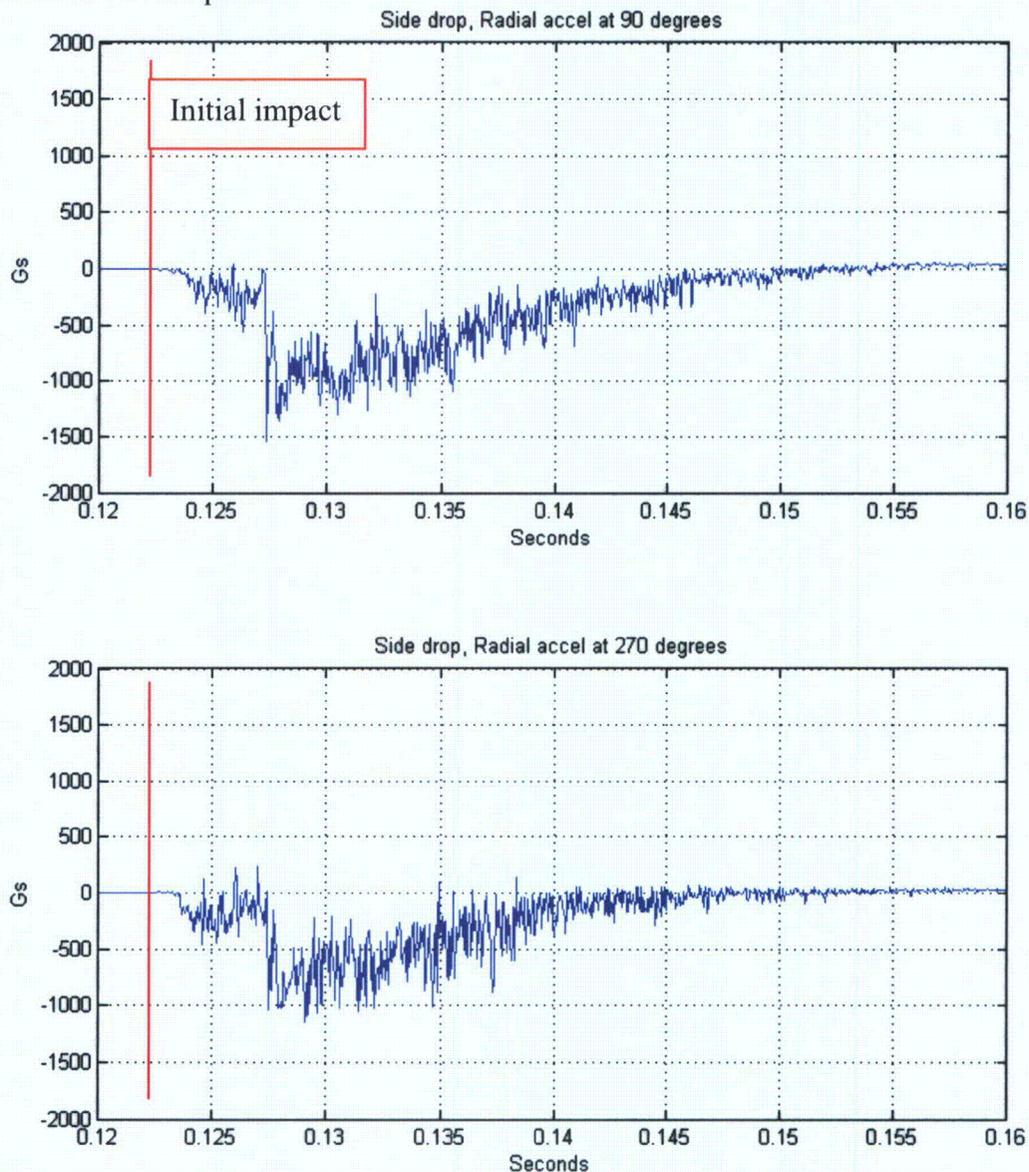
Figure 33 Vertical accelerations measured at impact inside the cask for the side drop.

For the side drop, the two radial accelerometers inside the cask were oriented in the vertical direction but facing in opposite directions. The sensor at 90 degrees azimuth faced downwards so upwards acceleration gave a negative signal. Figure 33 shows the signals from these two sensors during the initial impact.. Initial contact as sensed by the impact trigger was at time = 0.1217 seconds¹¹ in the plot.

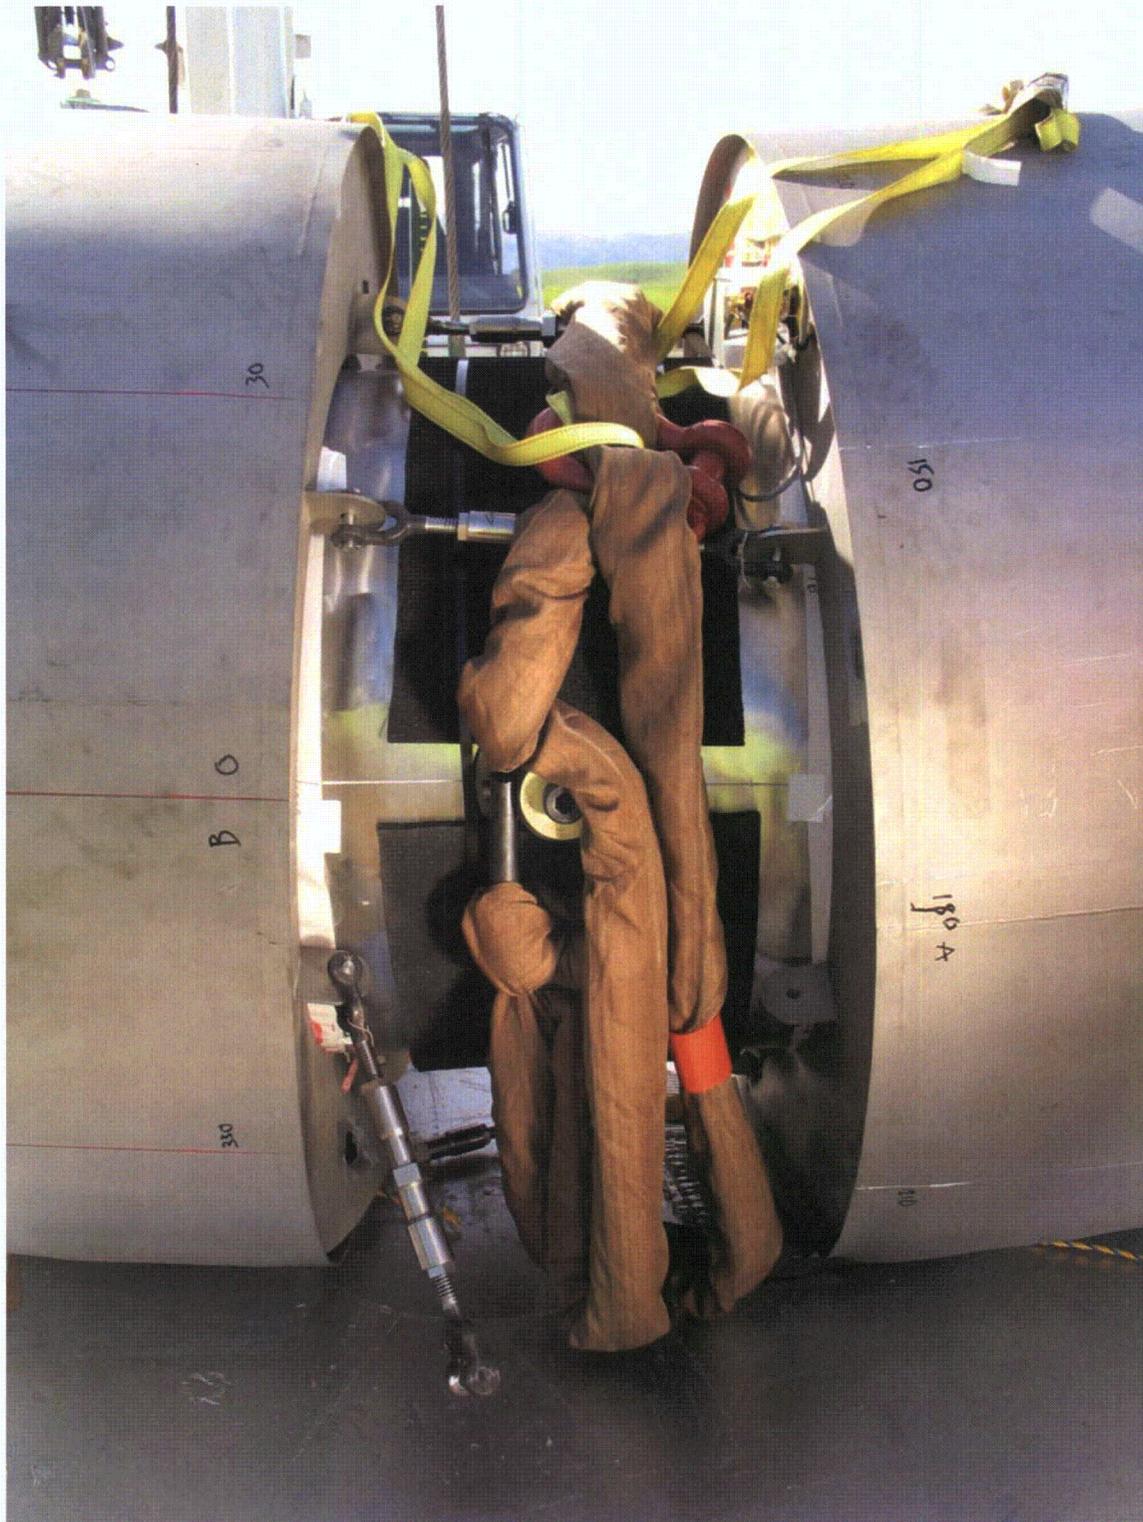
Figure 38 Cask and impact limiters following the side drop.

Figure 38 shows the cask with impact limiters after the drop. Three of the six heavy steel turnbuckles holding the impact limiters against the cask failed when their clevis pins sheared. This allowed the lower parts of the two impact limiters to move away from each other. This may have caused another secondary impact effect when the impact limiters rotated outwards as far as they could and jammed against the cask outer diameter, thus suddenly stopping the descent of the heavy cask.

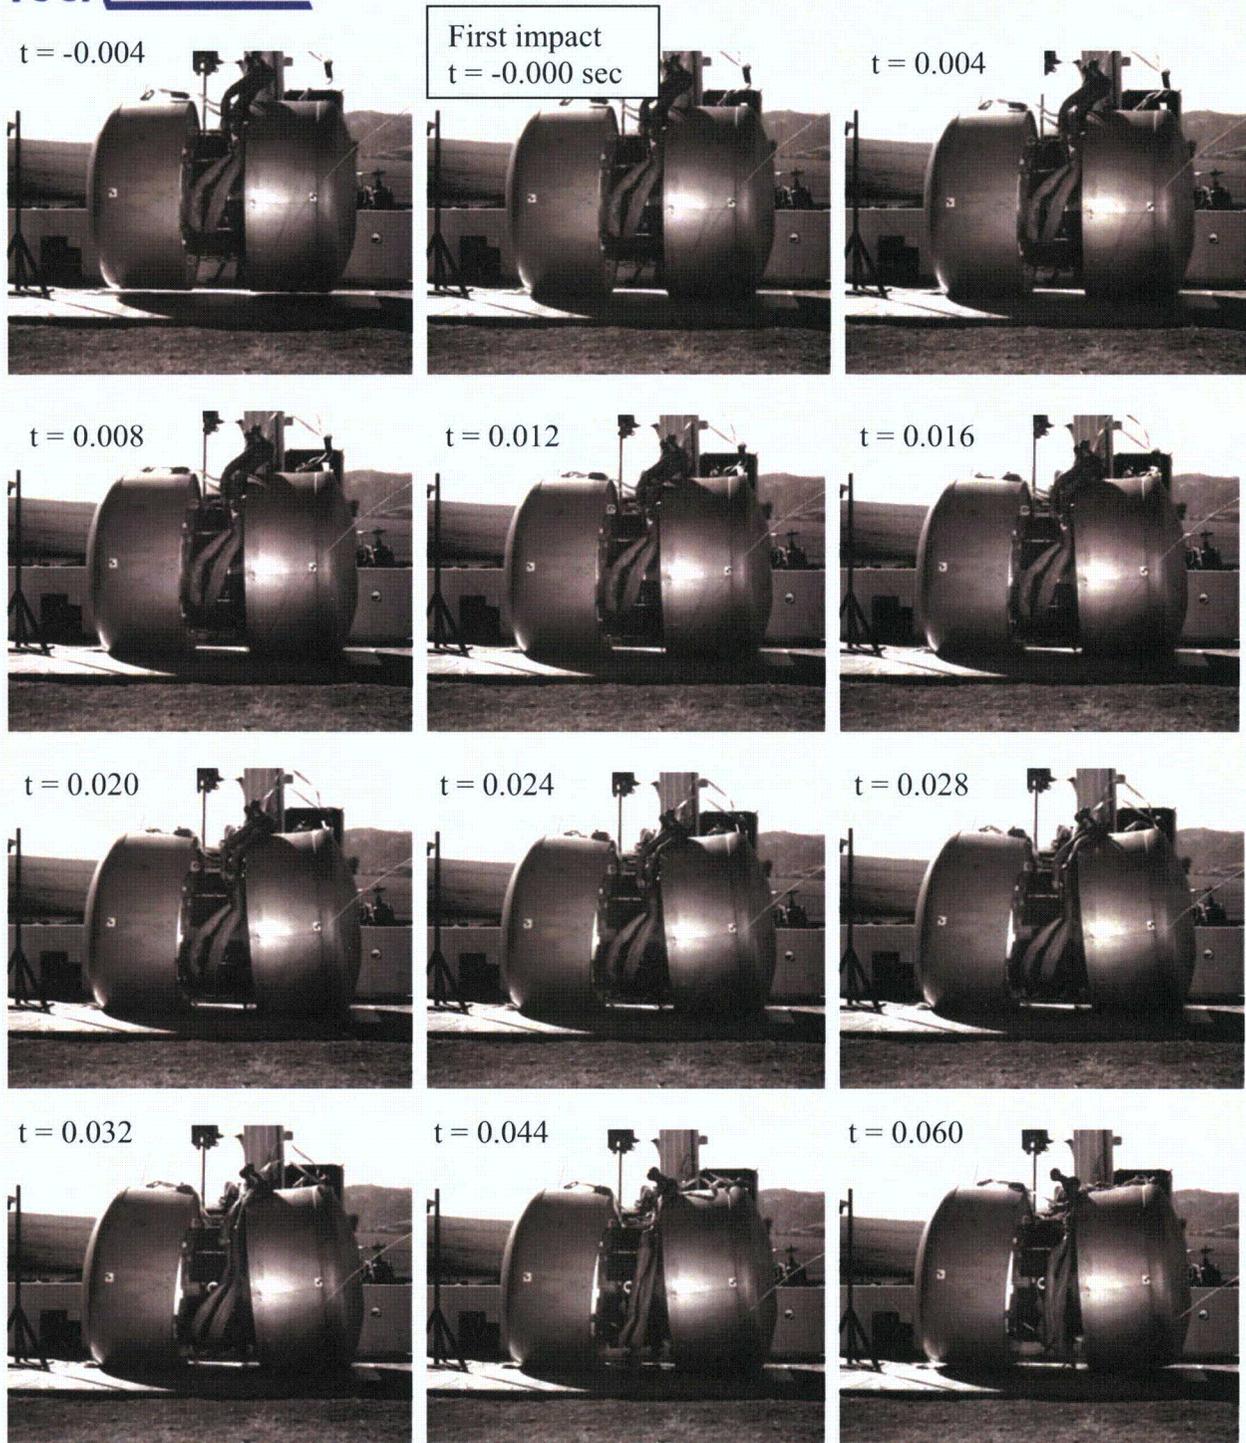
Figure 39 Frames from high-speed video of side drop

Figure 39 shows frames from one of the three high-speed video cameras. The impact time denoted as $t = 0.000$ seconds in the video frames corresponds to $t = 0.1217$ seconds in the acceleration time histories. The video sequence shows clearly how the lower sides of the two impact limiters pulled away from each other at impact, causing the lower turnbuckles to fail. This may have been due to a wedging action of the chamfered ends of the cask against the conical section of the mating recess in the impact limiters. It might also have been caused by the centroid of the impact force against the lowest surface of each impact limiter being outboard of the cask ends, causing a rotational moment on the impact limiters.

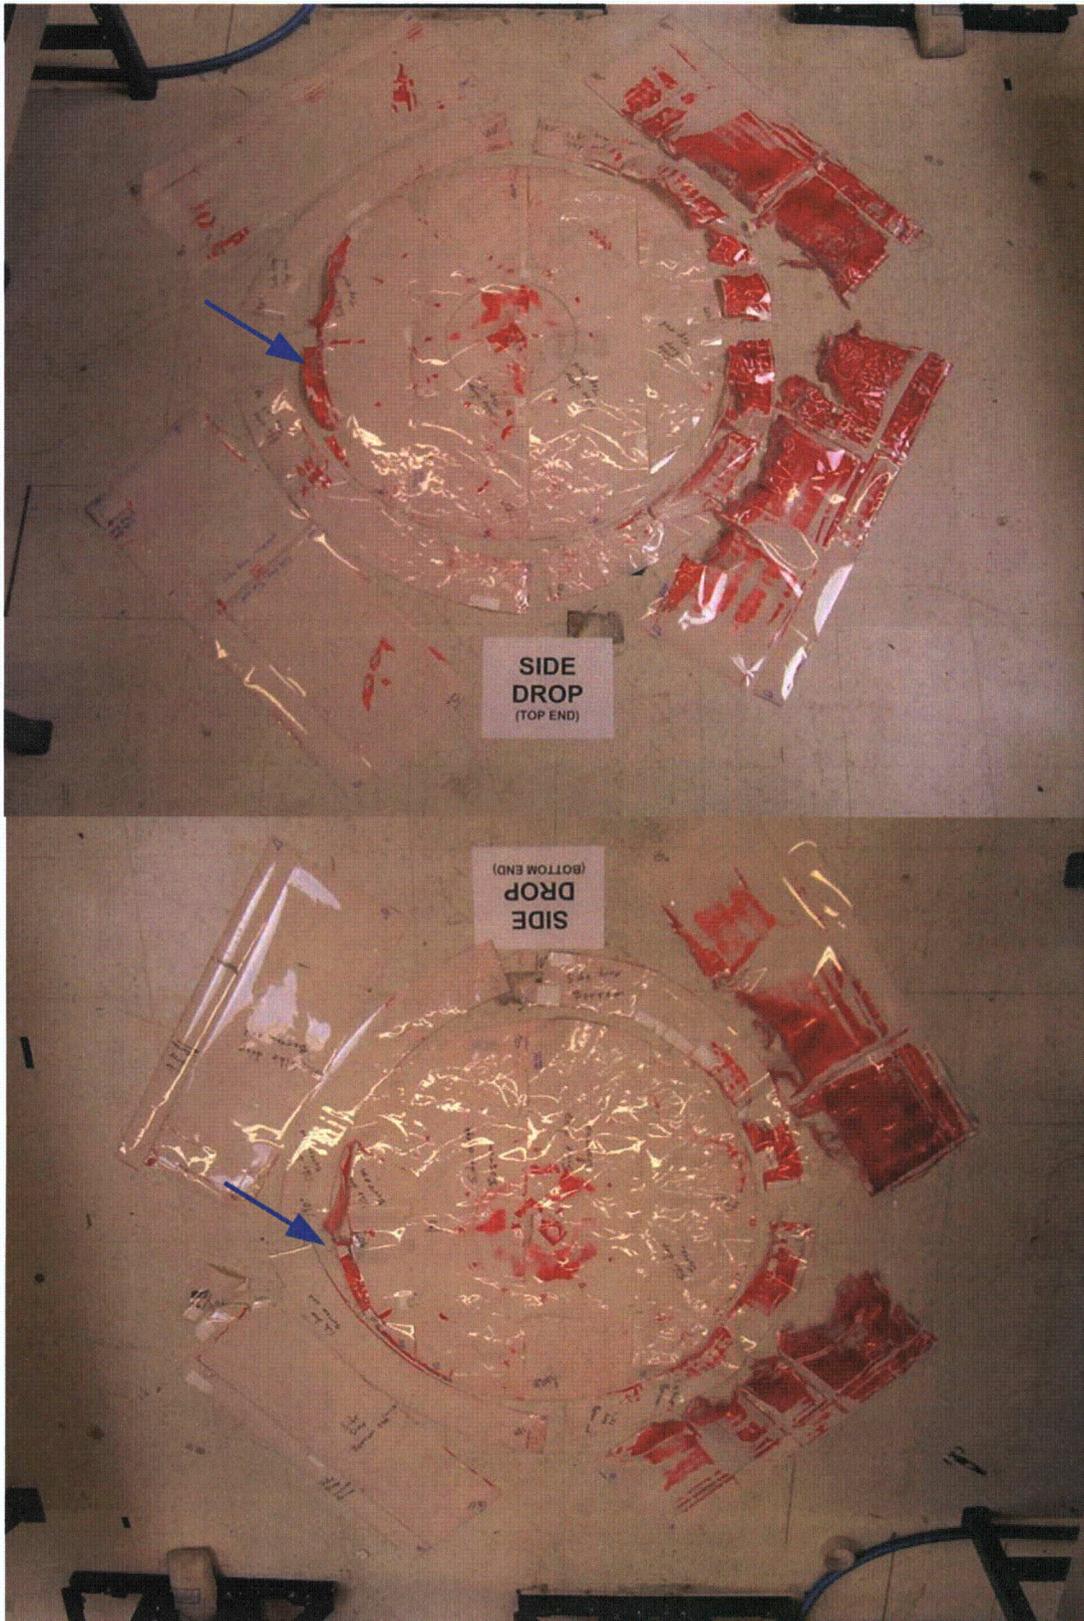
Figure 40 Pressure sensing film removed from the cask after the side drop.

downward facing part of the conical surface, as would be expected. However, there is also a significant amount of red on the paper that was on the uppermost part of the flat, circular end surfaces of the cask (blue arrows in the figure). Pressure against these areas is further evidence of secondary impact after the turnbuckles failed, the impact limiters rotated outwards, and their lower parts moved away from each other.

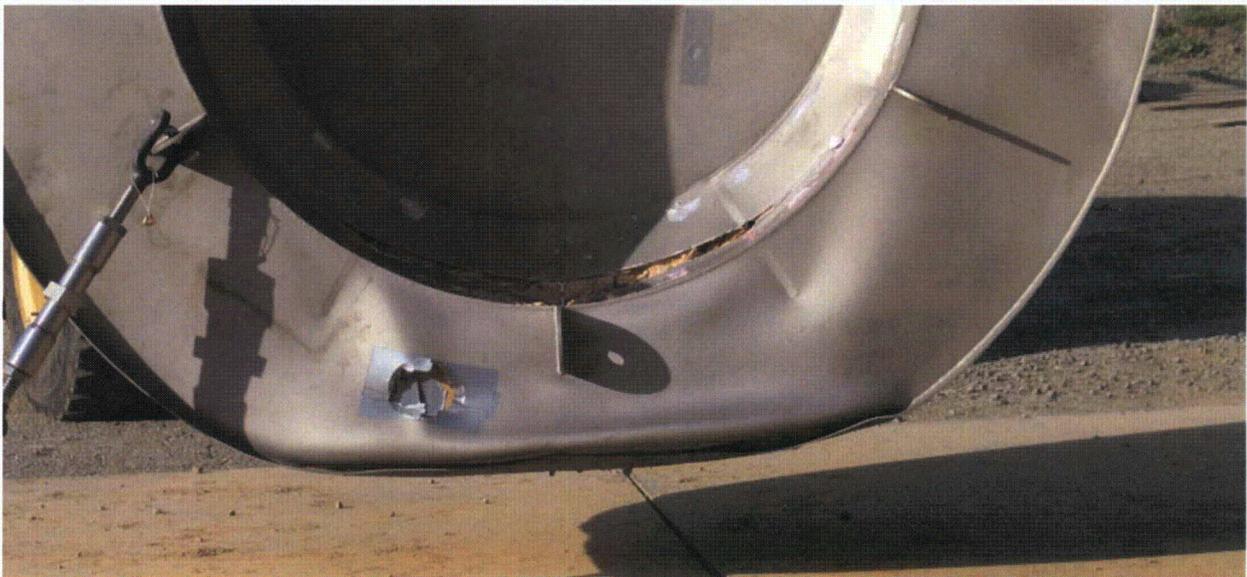
Figure 41 shows one of the impact limiters after removal from the cask. One of the welds between the conical and cylindrical sections has split open, revealing the energy absorbing foam within. Figure 42 shows an overlay of the measured impact limiter profiles before and after the side drop.

Figure 41 Damage to impact limiter from side drop.
