| 8.3.2 Impact (Free-Drop) Test Report

**Test Report:
Drop Tests of the
Alpha Omega Services Shipping Cask
for Radioactive Material**

**Report No. 2007533 Rev 1
May 25, 2007**

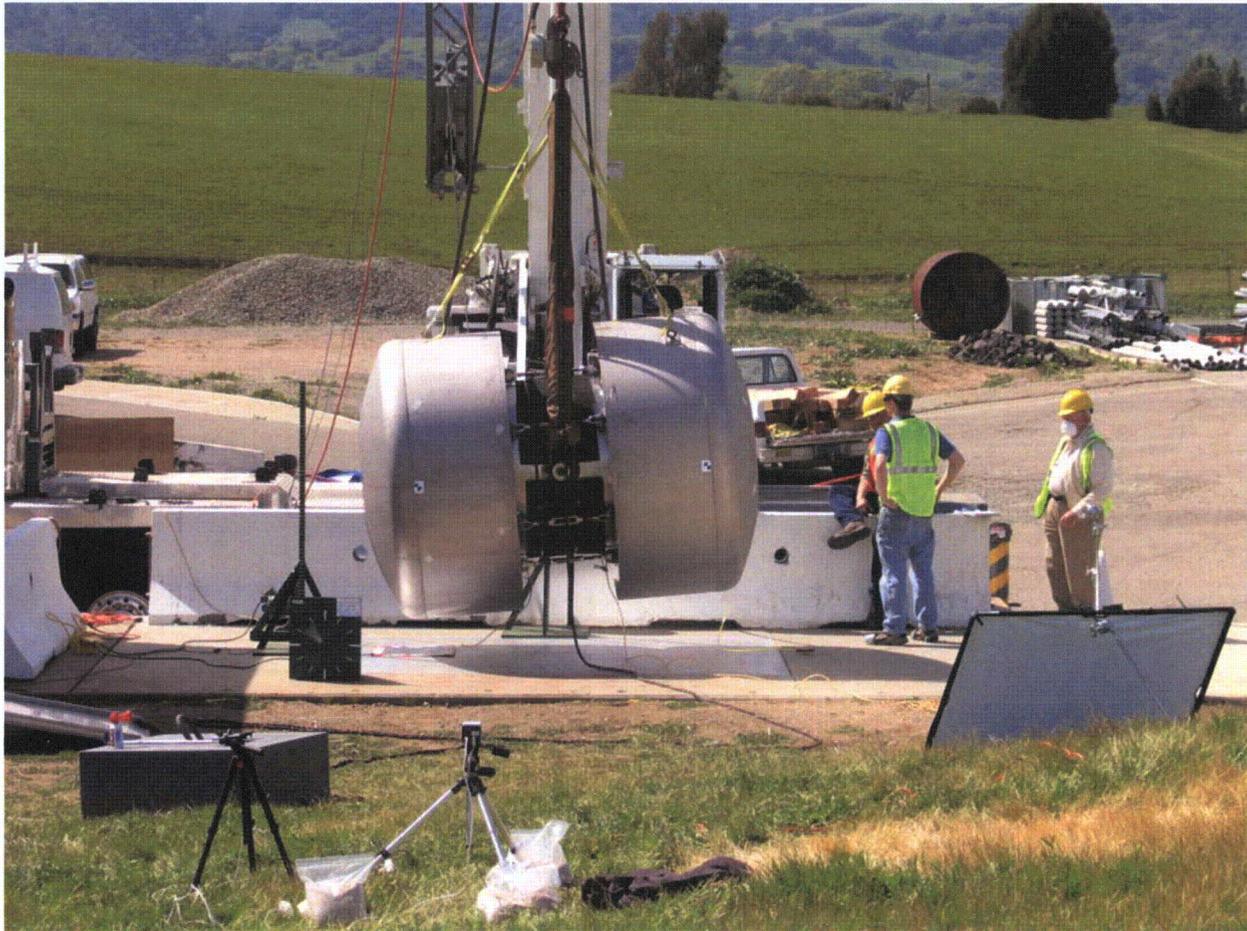
Figure 43 Package rigged for the slap-down drop.

Figure 43 shows the package rigged for the slap-down drop. The weight of the package is held by the brown rigging straps which lift at the cask trunnions. The yellow straps on either side were adjusted to hold the package such that its left end was about 10 inches higher than its right end. This had been determined by analysis to be the worst case. The lid end of the cask is on the left in the photo. The impact limiters on the left and right will be referred to as the “lower” and “higher” respectively.

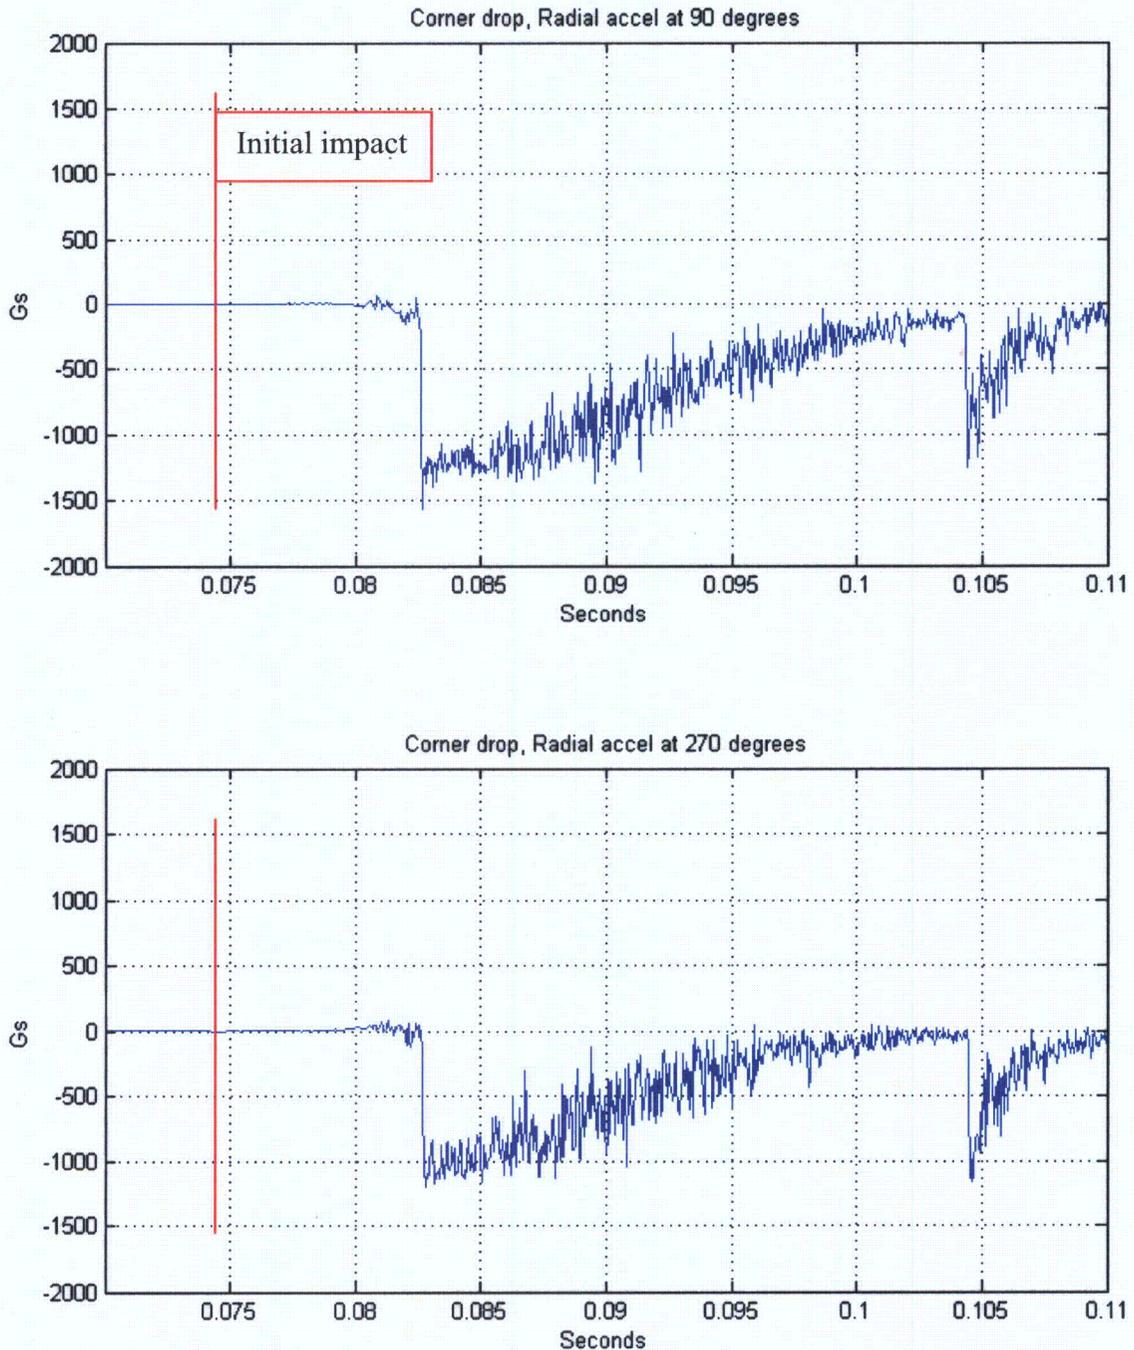
Figure 44 Near-vertical accelerations measured inside the cask for the slap-down drop.

Referring to Figure 44, there are two major events, one at 0.0822 seconds and one at 0.1042 seconds. Comparing this time interval to the high-speed video (Figure 49), these two impacts are obviously due to the initial strike of the lower impact limiter (on the left in Figure 49) and the strike of the higher impact limiter (on the right in Figure 49). Like the side drop, the initial impact causes the accelerometers to over-range so the only quantitative conclusion that can be drawn is that the accelerometers saw over 1000 g's. The exact peak level is unknown.

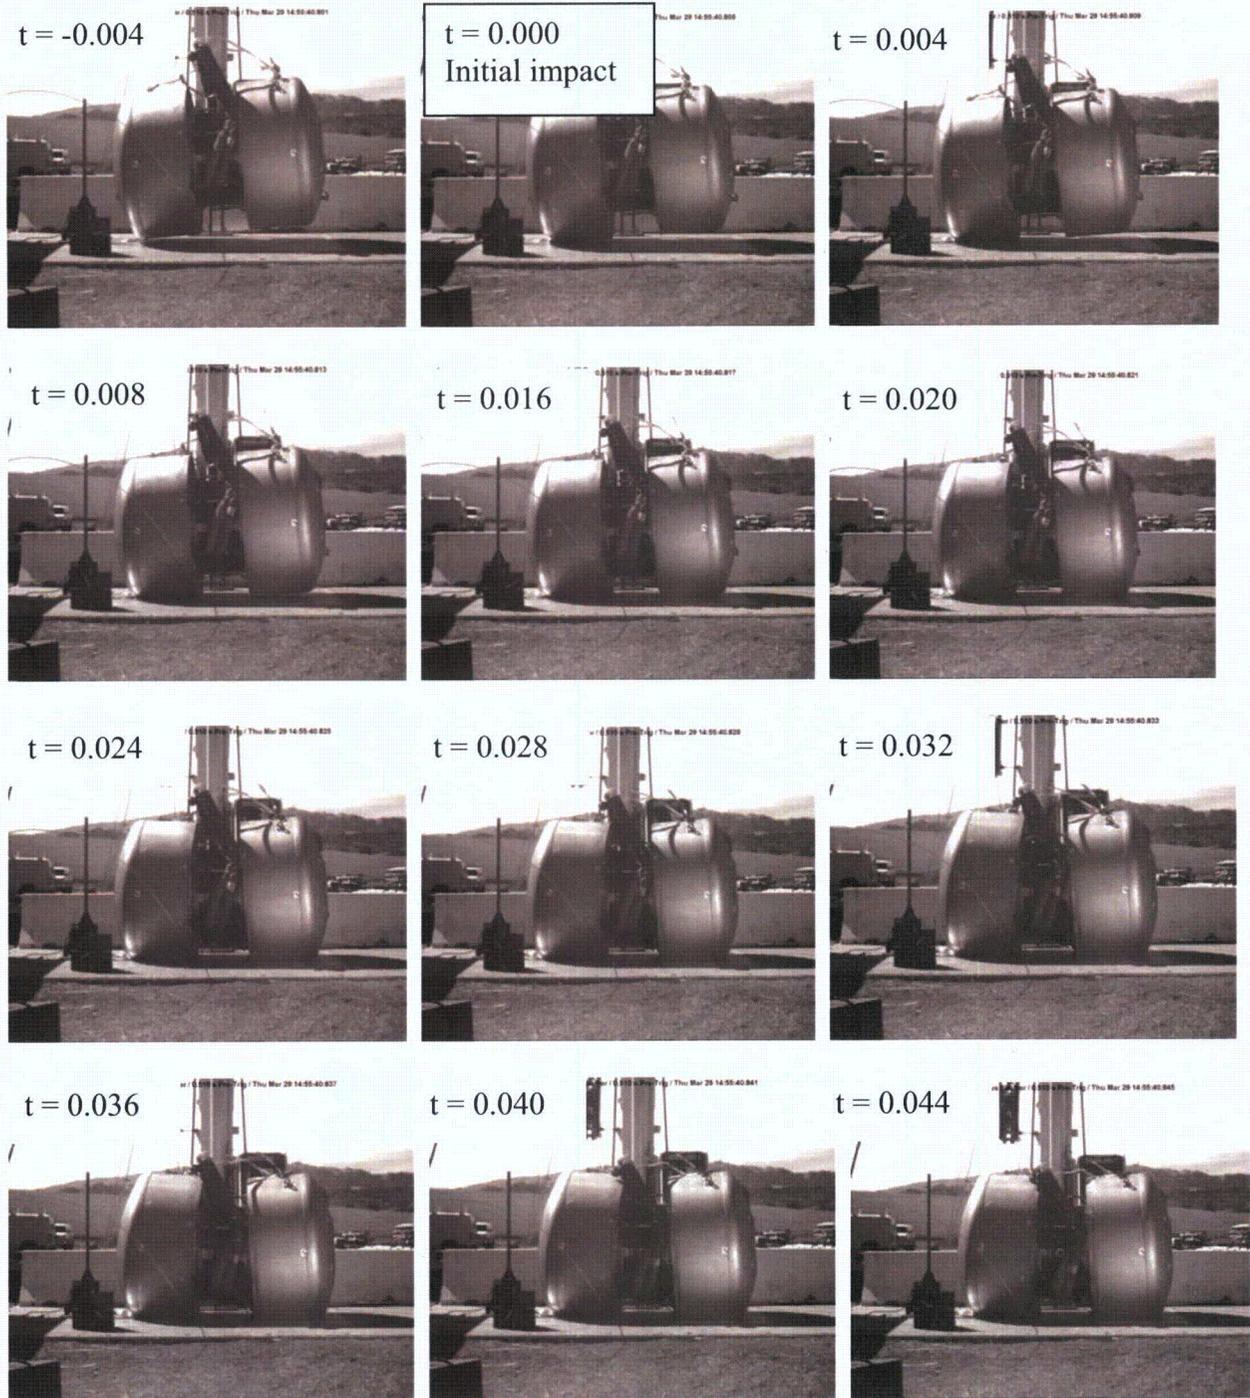
Figure 49 Frames from high-speed video of slap-down drop.

drop used heavier clevis pins which did not break on impact. However the upper turnbuckles buckled which caused them to become shorter so there was still considerable relative rotation between the two impact limiters, as evident in the video frames. Figure 50 shows the uppermost turnbuckle following the drop.

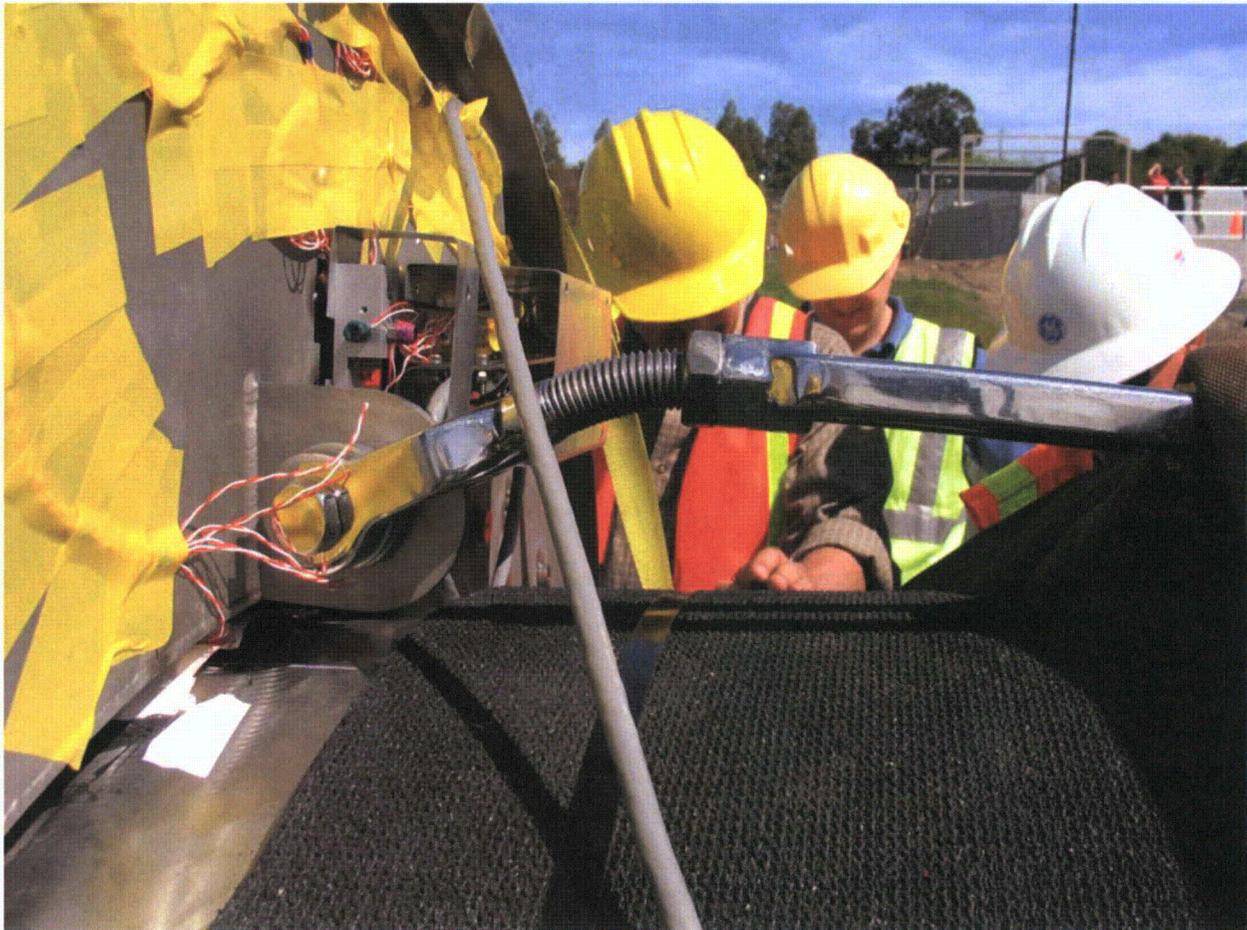
Figure 50 Uppermost turnbuckle after the slap-down drop.

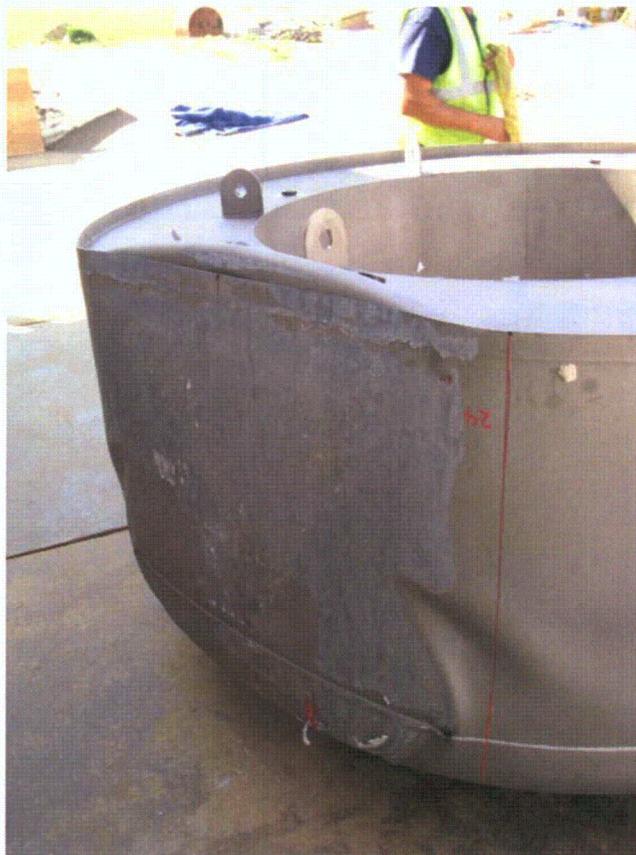
Figure 53 Damage to the impact limiter from the "slap-down" end of the cask.

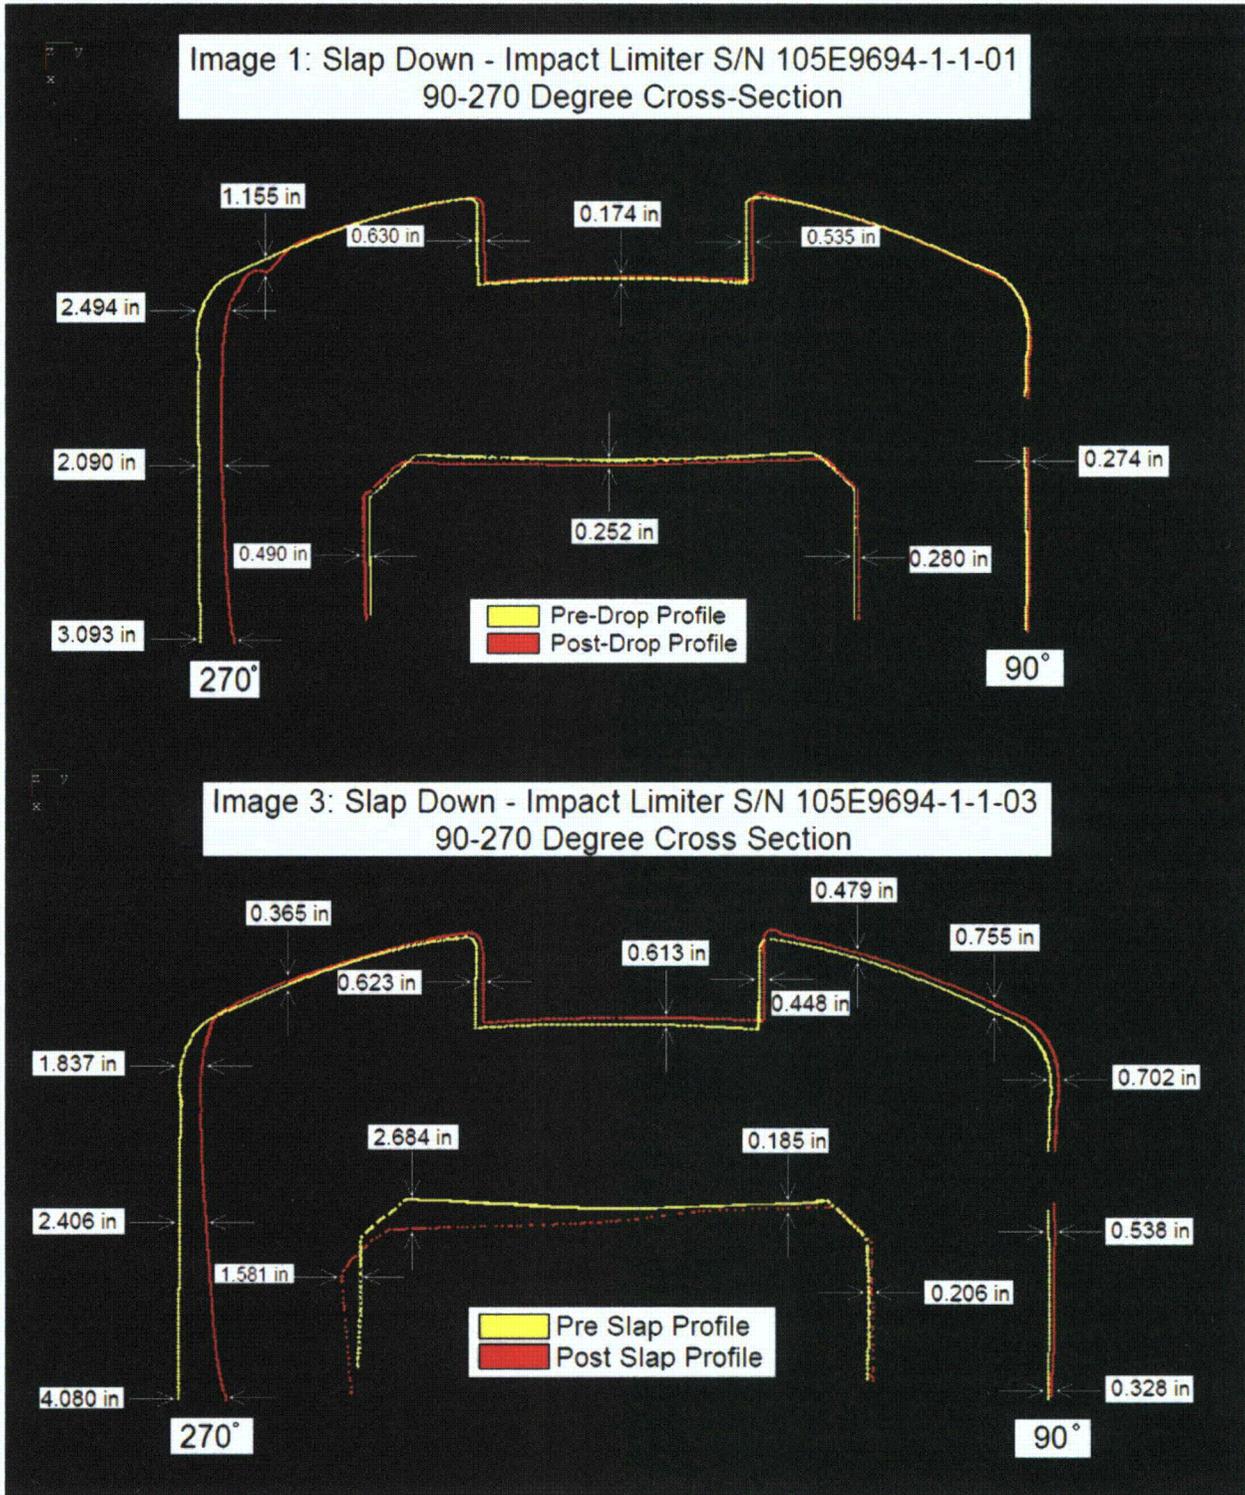
Figure 54 Profiles of the higher (top) and lower (bottom) impact limiters before and after the slap-down drop.

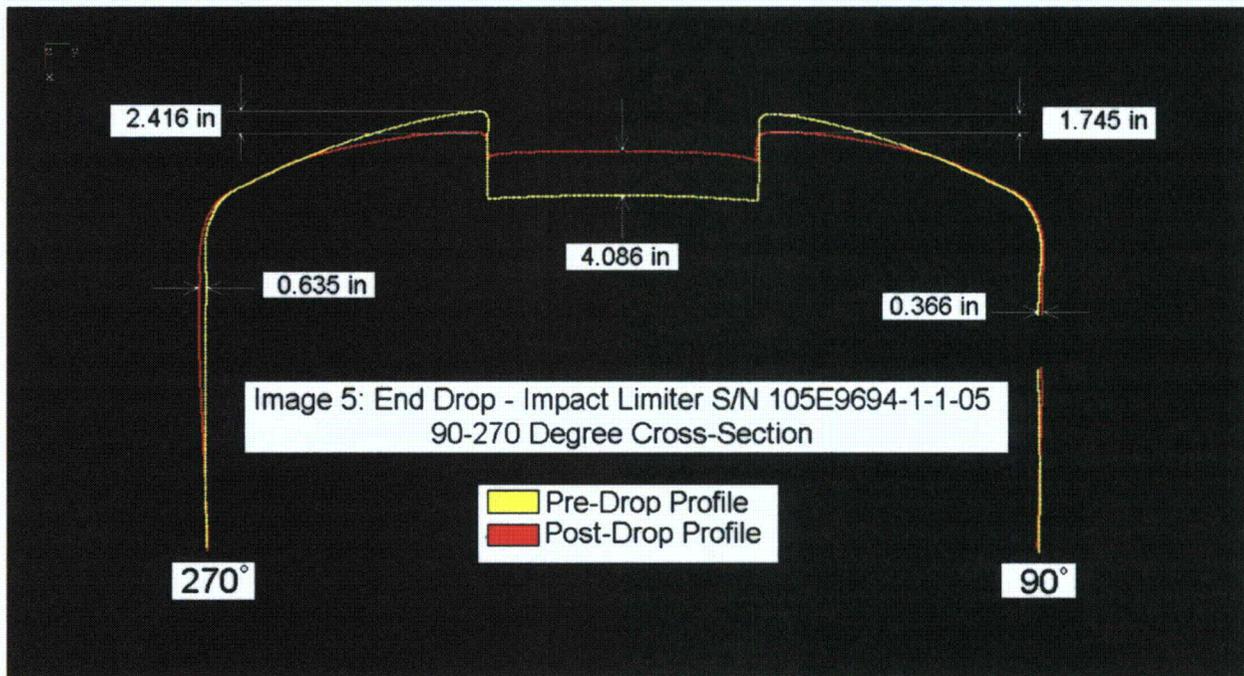
Once the pre- and post-drop scan data was collected for each Impact Limiter, the 90-270 degree profile cross-sections were overlaid in order to calculate the magnitude of deformation for each drop. In the images below, each Impact Limiter has been analyzed in this manner and the deformations reported. They are listed below in the same order that the drop tests occurred: End Drop (Impact Limiter 5), Side Drop (Impact Limiters 1 & 3) and Slap Down (Impact Limiters 2 & 4).

Image 5: Impact Limiter Serial No. 105E9694-1-1-05 - End Drop Cross-Section Overlay

For the Impact Limiters, scan data was taken at the 0, 30, 60, 90, 120, 150, 180, 210, 240, 270, 300 and 330 degree profiles. In order to compare each impact limiter in its pre- and post-drop condition, an alignment using the bottom perimeter (opposite the domed-end), measured as a circle, was used as a reference. By measuring it as a circle, the center point and vector of the measured circle were established. The portions of this circle that were deformed due to each drop test were not used in this calculation. The vector of this axis was defined to be the primary datum in this alignment. A point was then measured at the 90 degree lifting lug to establish the second axis in the coordinate system. This process provided the only repeatable means to align each impact limiter and subsequently compare the results.
