**LEVY COUNTY NUCLEAR POWER PLANT, UNITS 1 AND 2  
DOCKET NOS. 52-029 AND 52-030  
RESPONSE TO REQUEST FOR ADDITIONAL INFORMATION LETTER NO. 035 RELATED TO  
SURFACE FAULTING**

**Levy Nuclear Power Plant Units 1 and 2  
Response to NRC Request for Additional Information Letter No. 035 Related to  
SRP Section 2.5.3 for the Combined License Application, dated May 8, 2009**

# Fractures and Photolineaments: Introduction and Analysis Methodology

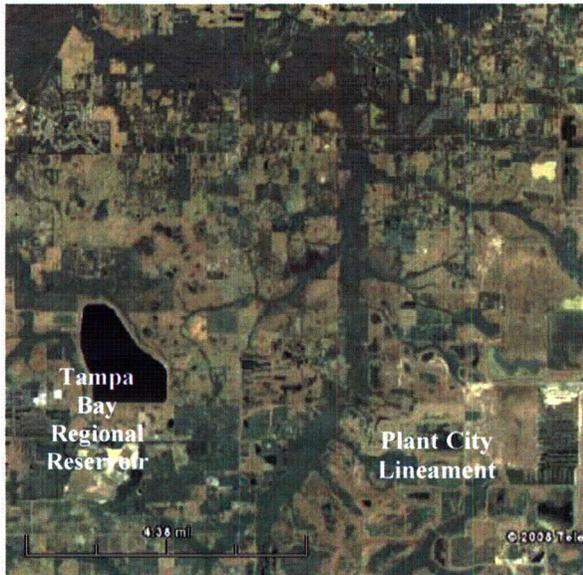
**Figure 2 – The Plant City (Florida) Lineament.** This north-south photolineament was confirmed as a fracture trace related to faulting in pre-Tertiary basement rocks using microgravity techniques (Culbreth, 1988).

Figure 2 illustrates a satellite image of a portion of eastern Hillsborough County, Florida, and a linear stream segment that is incised in a photolineament that is over 25 miles in length. This lineament, the Plant City Lineament, can be recognized by alignments of stream segments, sinkholes, and other karst-related landforms. The trace seen in the satellite image is properly termed a photolineament until it can be confirmed as a fracture. In the example shown in Figure 2, the feature was confirmed as a fracture by microgravity (Culbreth, 1988).

Today, there is a large body of work demonstrating the utility of identification of fractures for sinkhole risk evaluations and for groundwater exploration. Most of the identification work is performed utilizing aerial photographs and satellite images (Figure 2).
