NRC – Luminant Power Public Meeting

Comanche Peak Nuclear Power Plant
Emergency Sump Performance
July 9th
2009

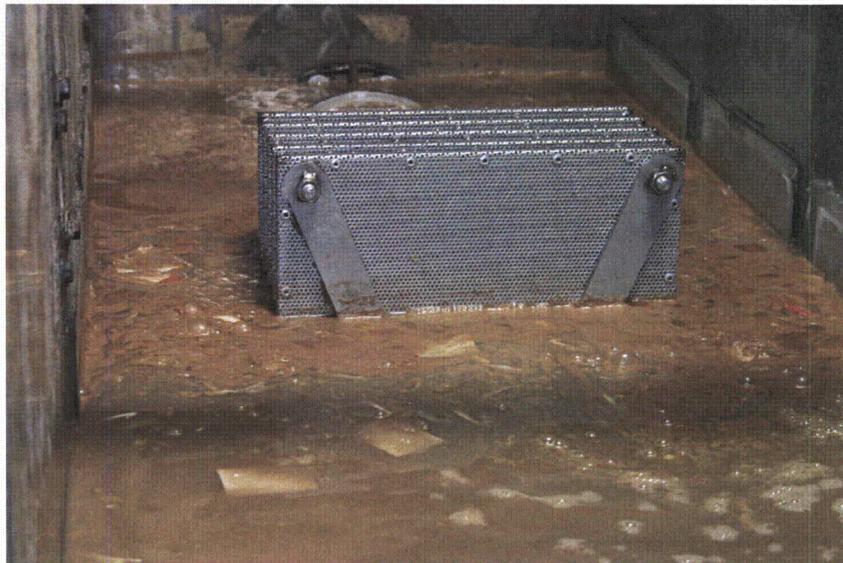
Transient Flood Up Testing

- **Water level at ECCS switchover. All debris introduced at the prototype prior to pump start. Debris mixed at start.**
- Initial flow at maximum ECCS (39.5% of design flow)
- Flood up at minimum flood rate was 25 min. (< 1 pool turnover).
- 100% flow at CSS switchover flood level.

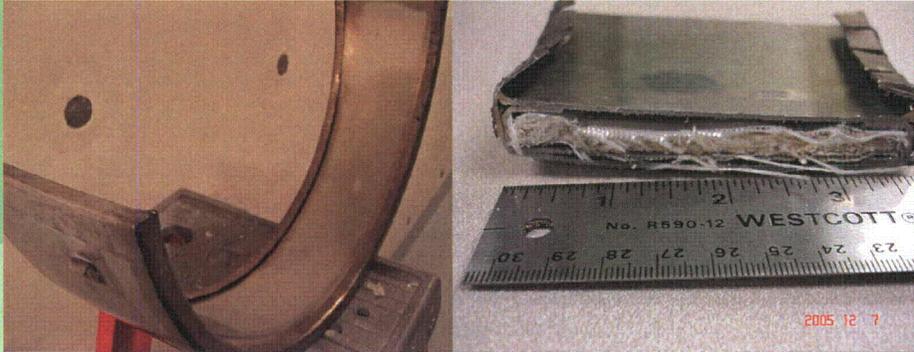
Min-K encapsulation is 0.050 inch thick stainless steel

Robust design -Weld are continuous. The end profile is low.
Maximum specified Min-K thickness 0.5 inches assumed.

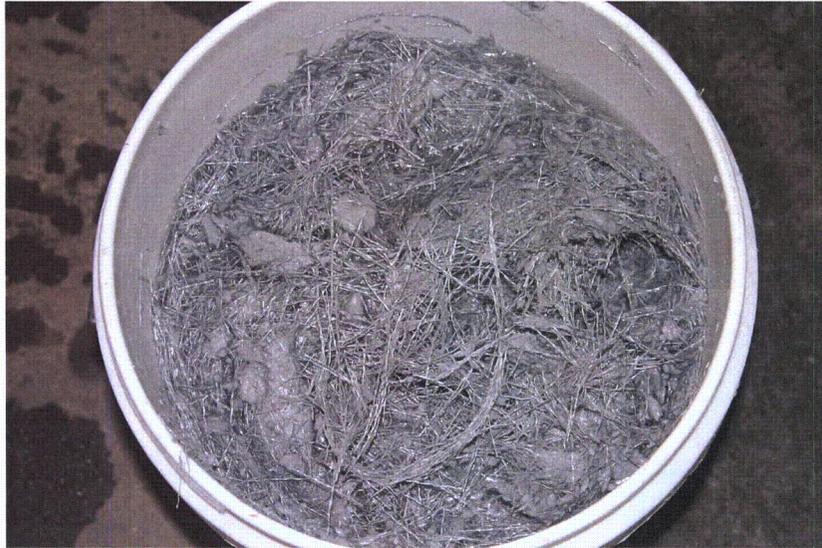
Lead Blanket Cover Fines

Size consistent with LDFG smalls

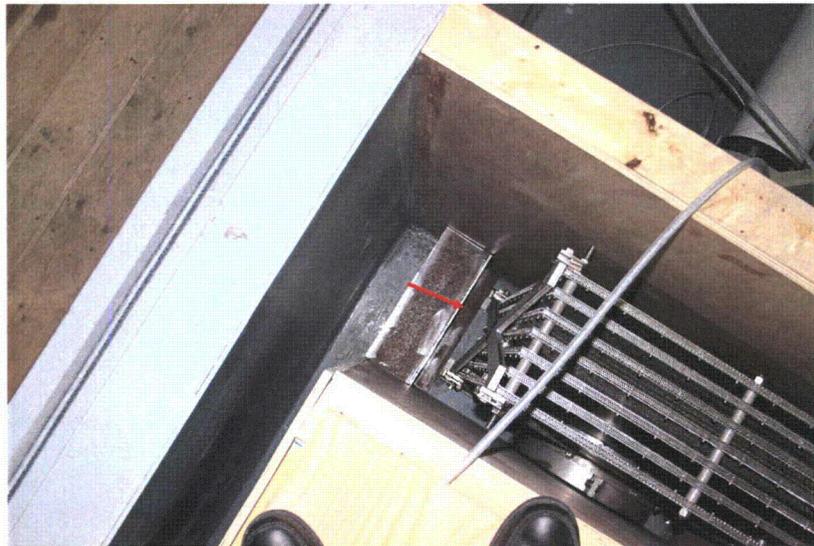
Debris interceptor – 12 inches tall, 6 inch top

0.18 fps test vs 0.12 fps avg

- Separate flumes were used for miscellaneous debris testing because the transport over the debris interceptor was 0.18 fps as opposed to 0.12 fps in the plant. The average transport velocity in front of the debris interceptor is 0.08 fps; therefore, a minimum of 0.1 fps was used for testing.
- Some label testing was done in the main flume.
