LAB NO.: M06074	WORK TRACKING NO.: 14878	PAGE 8 OF 78
PLANT & UNIT: BEAVER VALLEY #1	PART: CONTAINMENT MATERIALS	DATE: 3/9/2006

**MATERIAL ANALYSIS REPORT**  
**TABLE 1, TESTS PERFORMED and RESULTS**  
(See Attachment #1 for Test/Equipment Specifications)

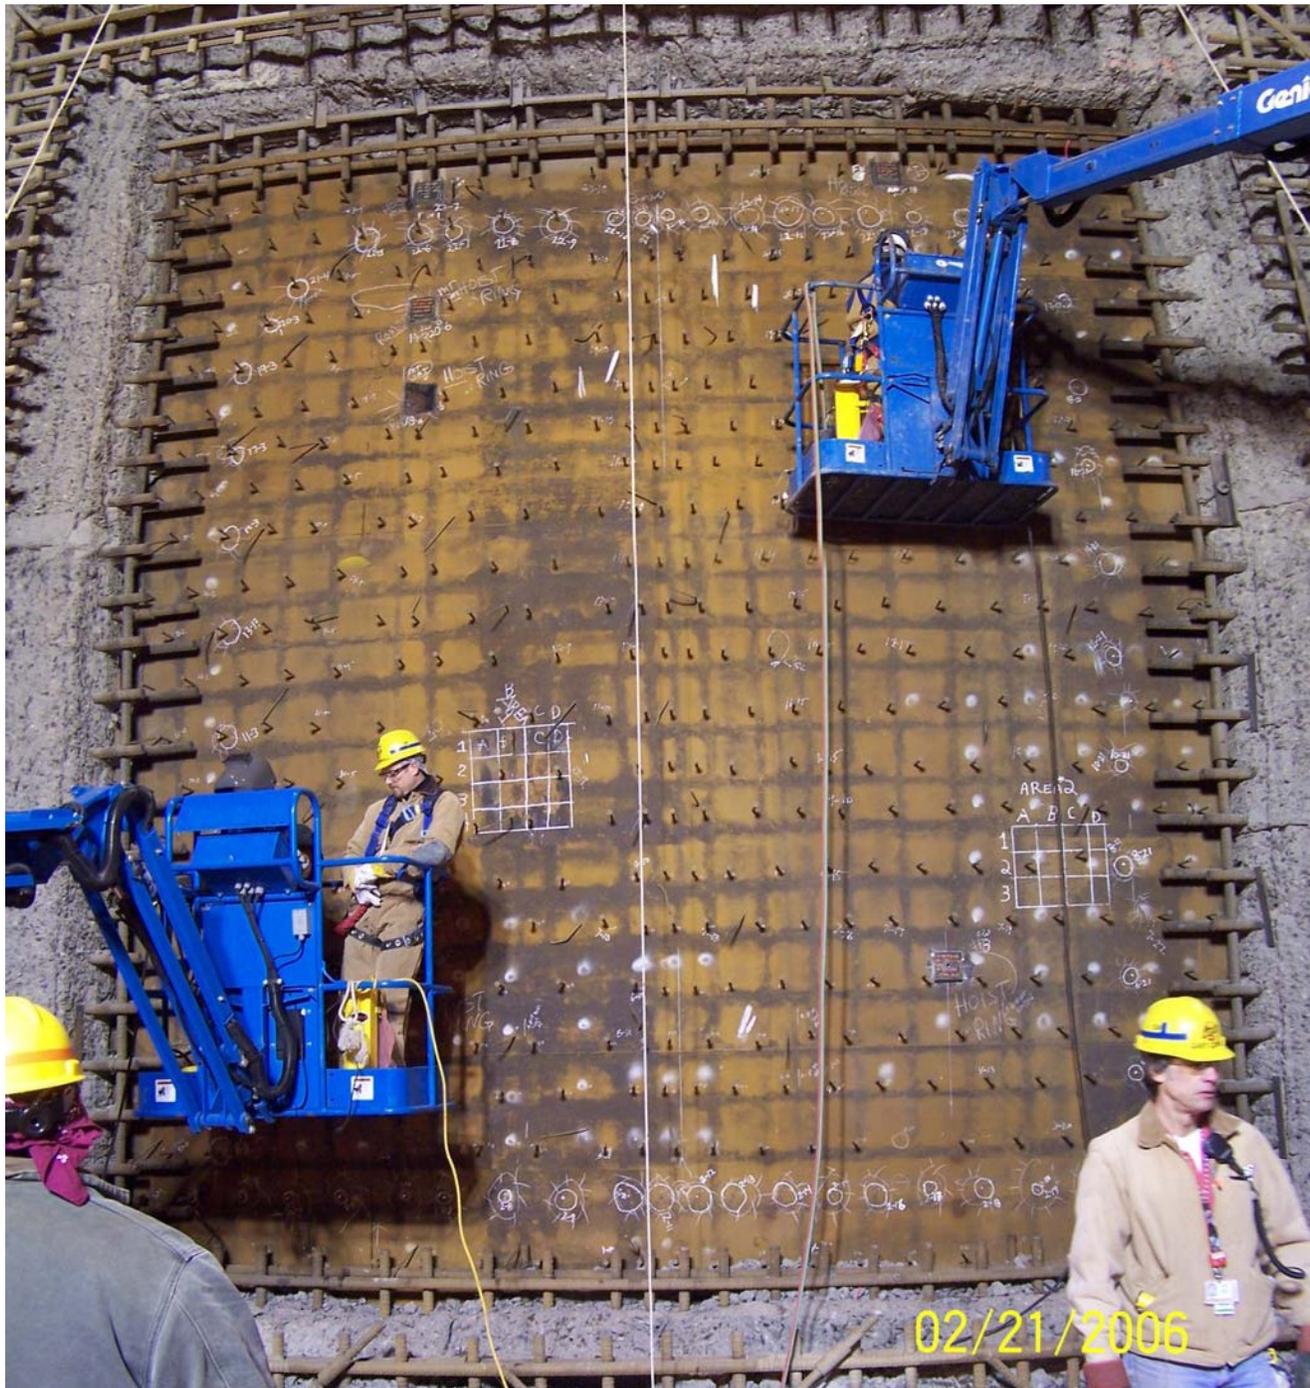
**FIGURE 1, AS-FOUND LINER APPEARANCE IN-SITU IN THE PLANT, COURTESY OF PLANT PERSONNEL. AREA #1 IS AT THE LEFT; AREA #2 AT THE RIGHT.**

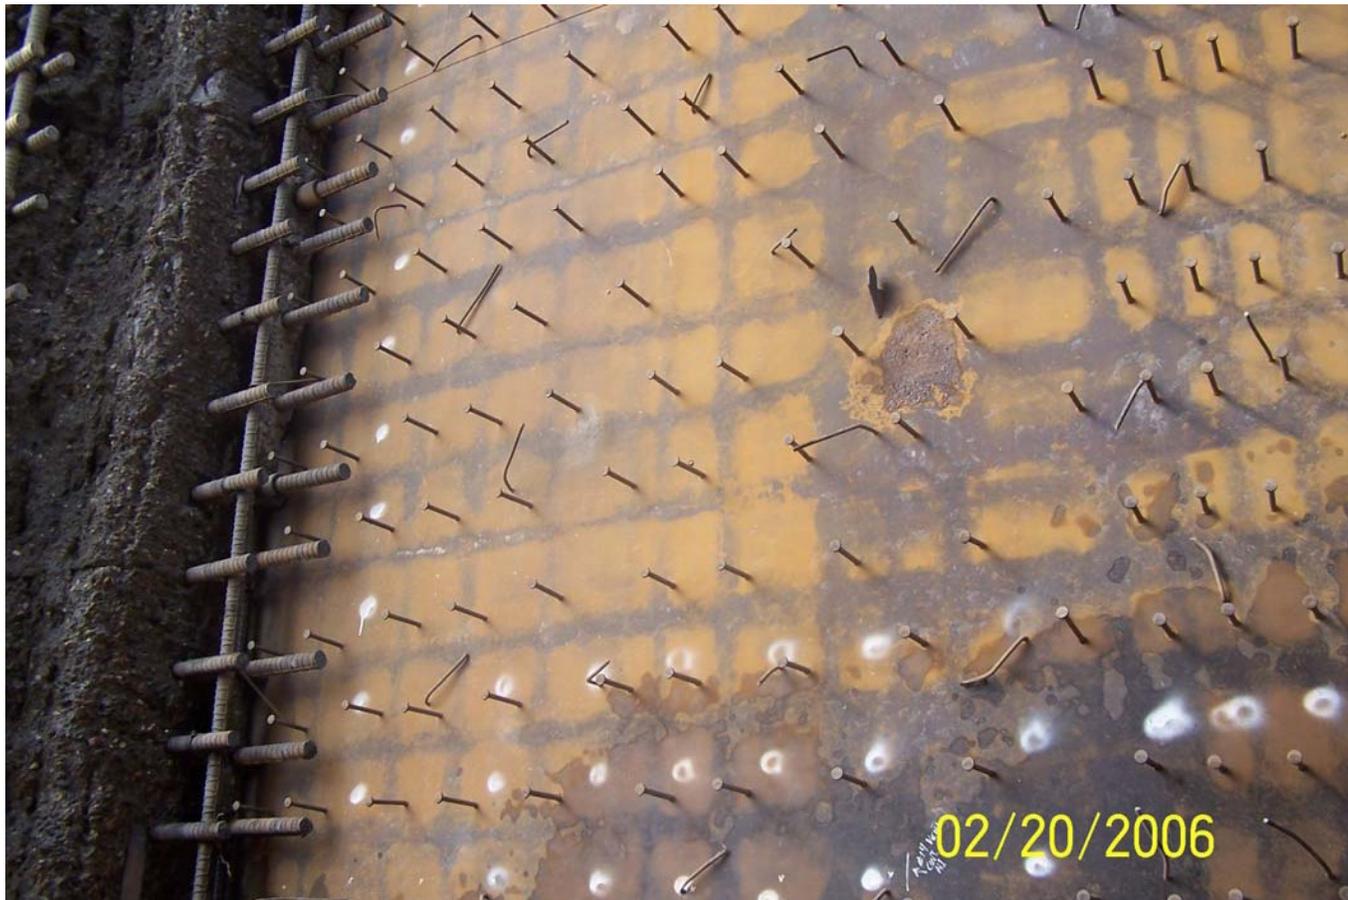
**FIGURE 2A, LINER AREA #1-1, OVERVIEW IN-SITU IN THE PLANT, COURTESY OF PLANT PERSONNEL.**

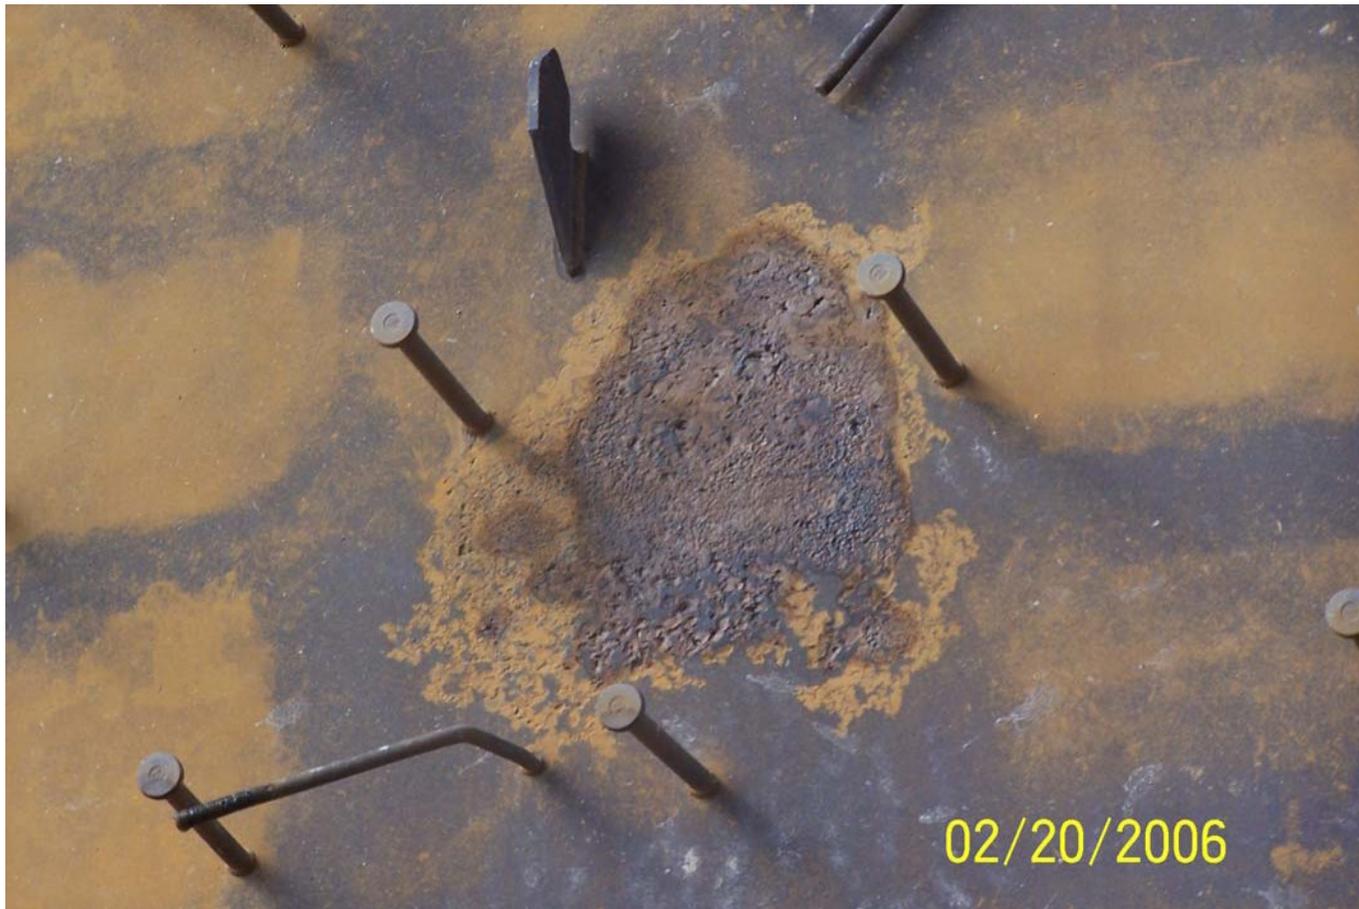
**FIGURE 2B, LINER AREA #1-2, CLOSER-VIEW, IN-SITU IN THE PLANT, COURTESY OF PLANT PERSONNEL.**

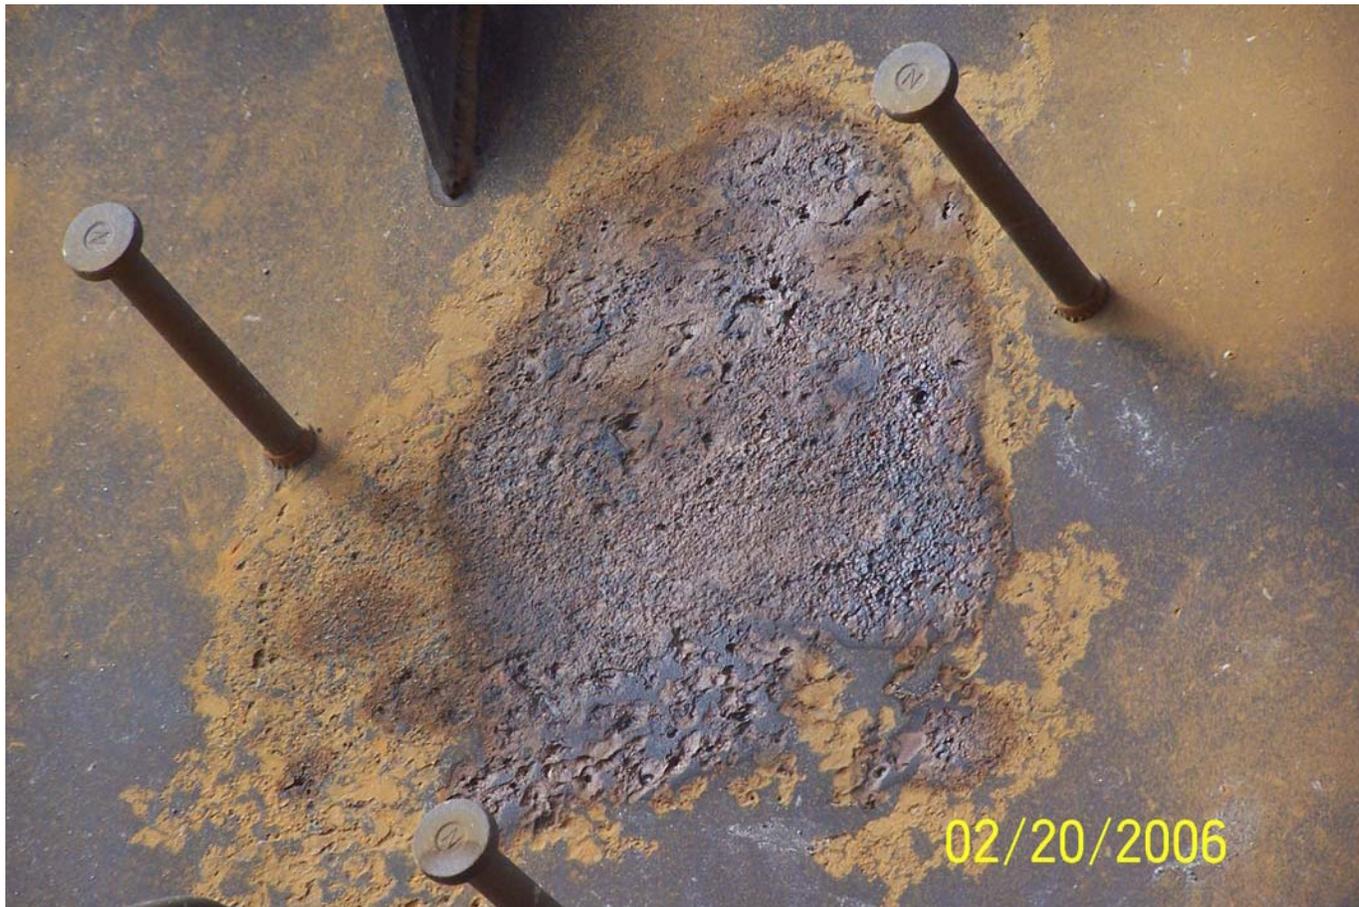
**FIGURE 2C, LINER AREA #1-3, DETAIL, IN-SITU IN THE PLANT, COURTESY OF PLANT PERSONNEL.**

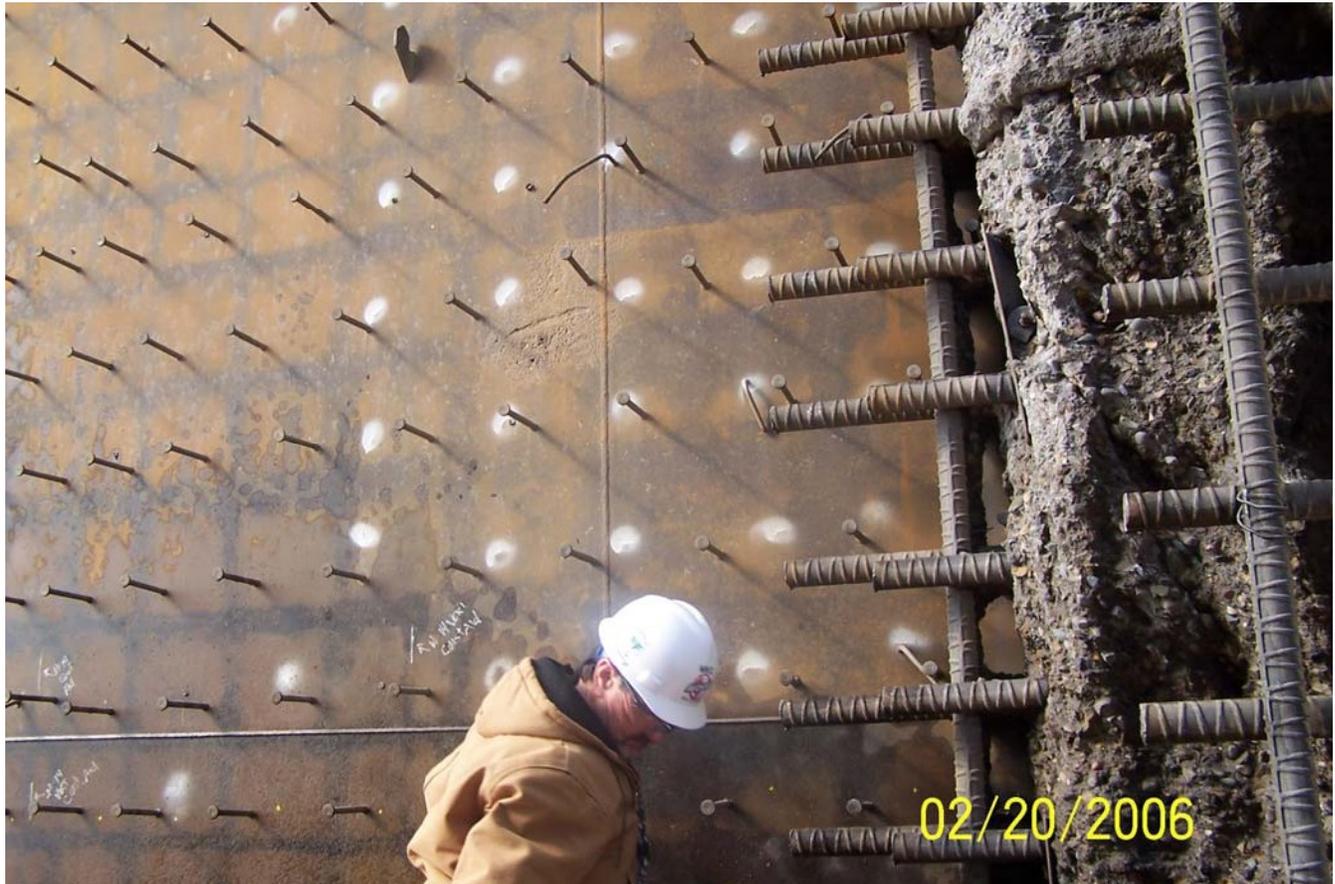
**FIGURE 3A, LINER AREA #2-1, OVERVIEW IN-SITU IN THE PLANT, COURTESY OF PLANT PERSONNEL.**

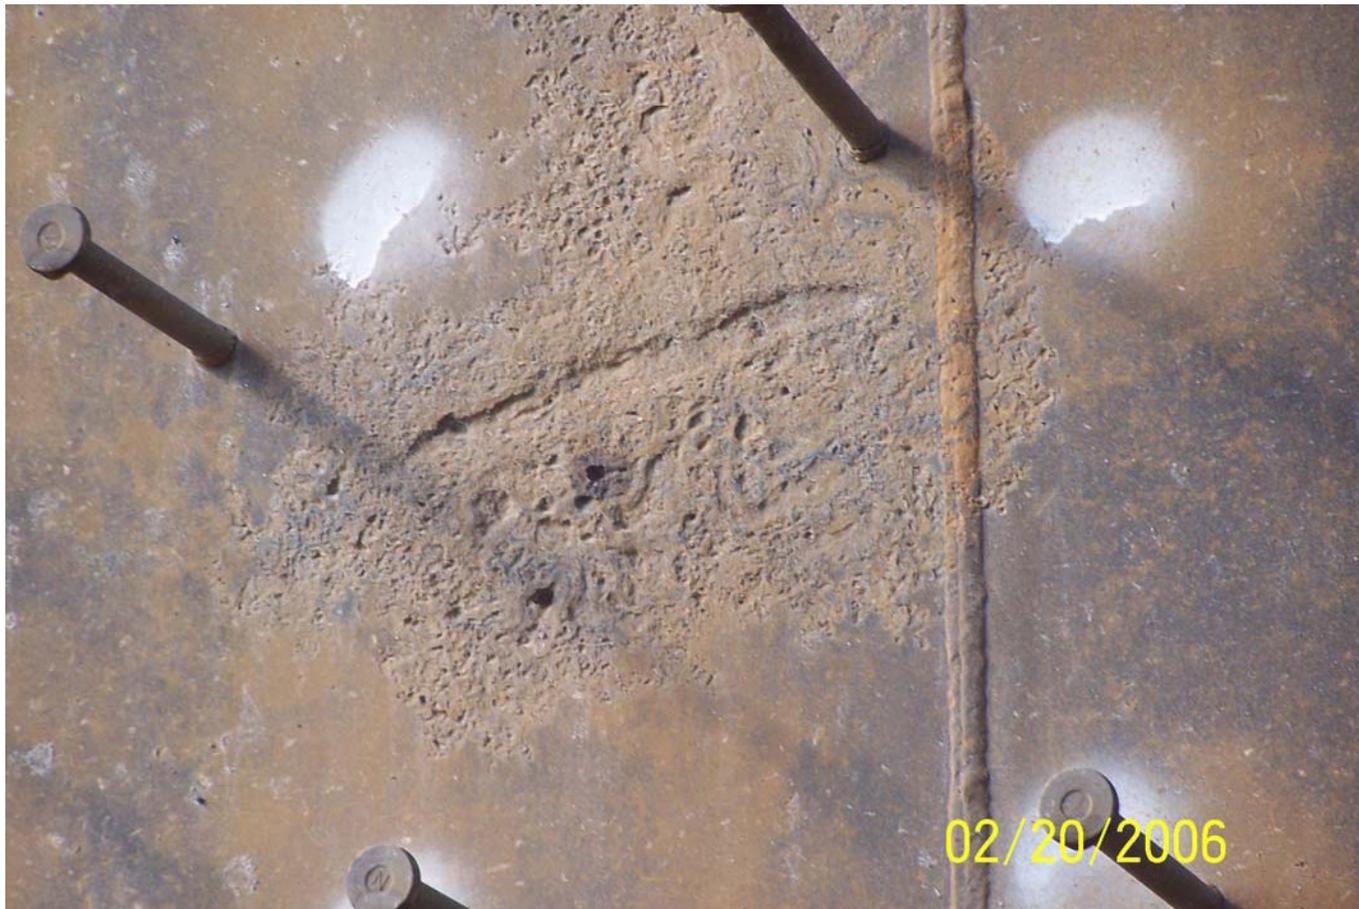
**FIGURE 3B, LINER AREA #2-2, CLOSER-VIEW, IN-SITU IN THE PLANT, COURTESY OF PLANT PERSONNEL.**

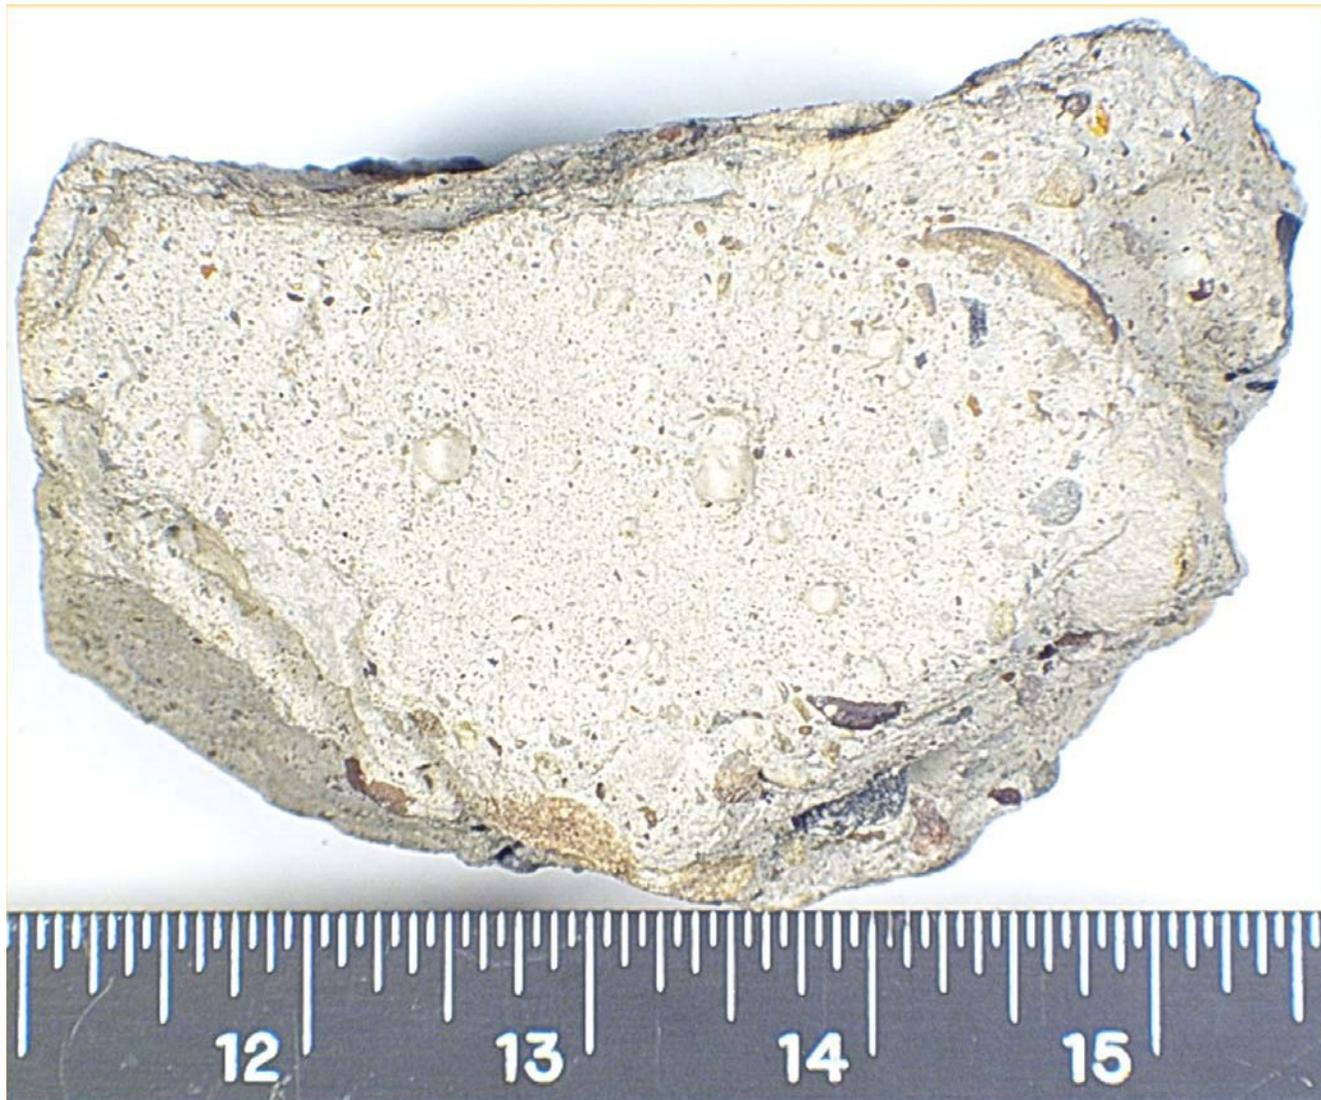
**FIGURE 5A, LARGER CONCRETE SAMPLE PIECE (BAG-MARKED #1), “FLAT” FACE.**  
 THIS SURFACE IS THOUGHT TO REPRESENT THE CONTACT AREA WITH THE LINER PLATE.  
 NOTE: REPORTEDLY, THIS SAMPLE HAD TO BE FOAM-CLEANED TO BE RELEASED FROM THE PLANT.

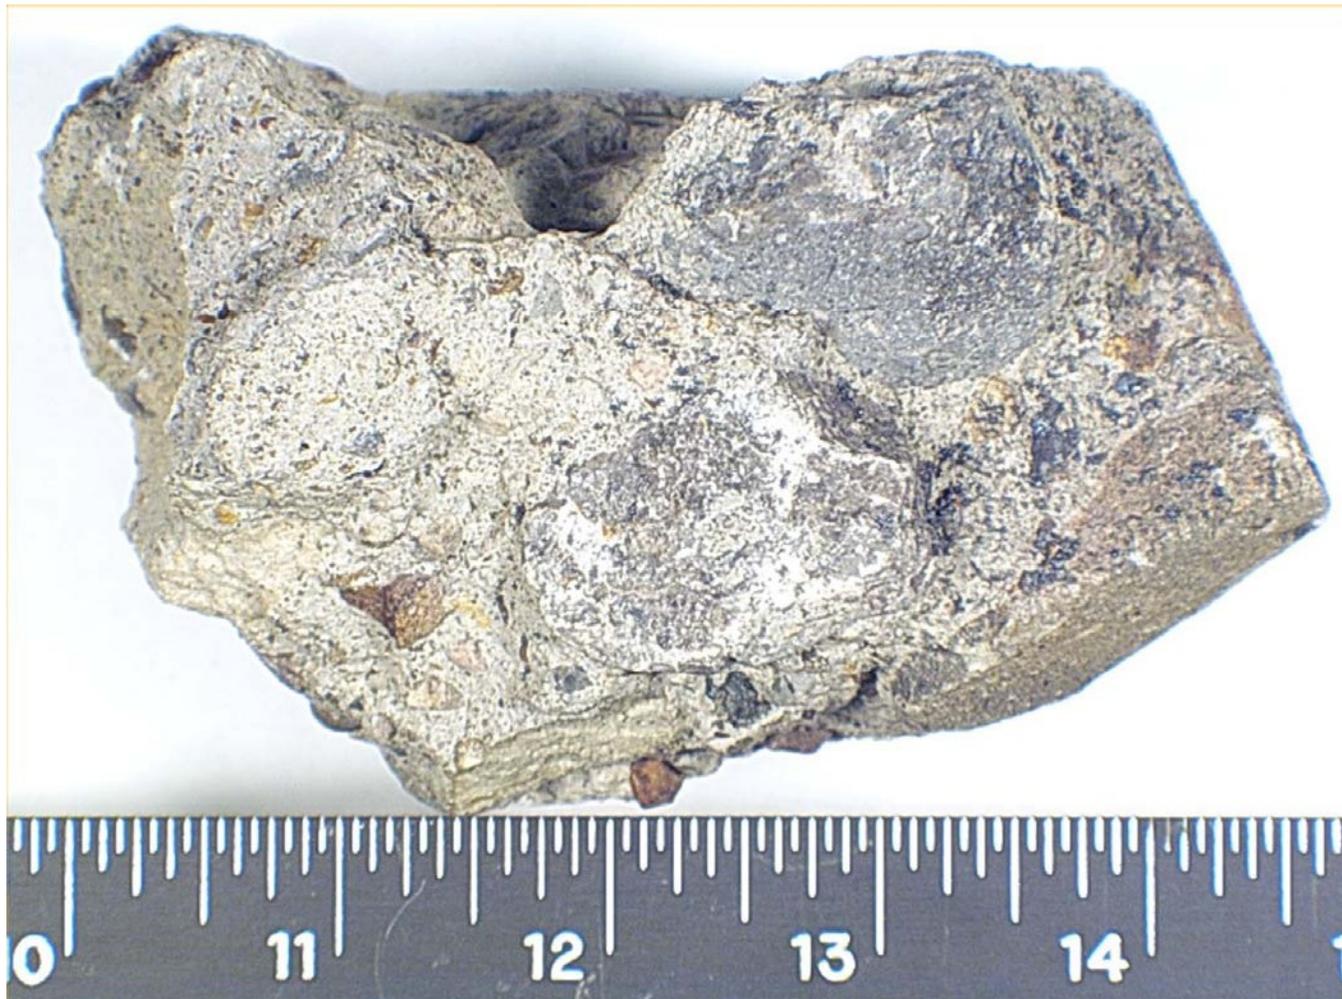
**FIGURE 5B, LARGER CONCRETE SAMPLE PIECE (BAG-MARKED #1), “ROUGH” FACE.**

THIS SURFACE IS THOUGHT TO AT OR NEAR THE INNER-MOST COURSE OF RE-BAR.

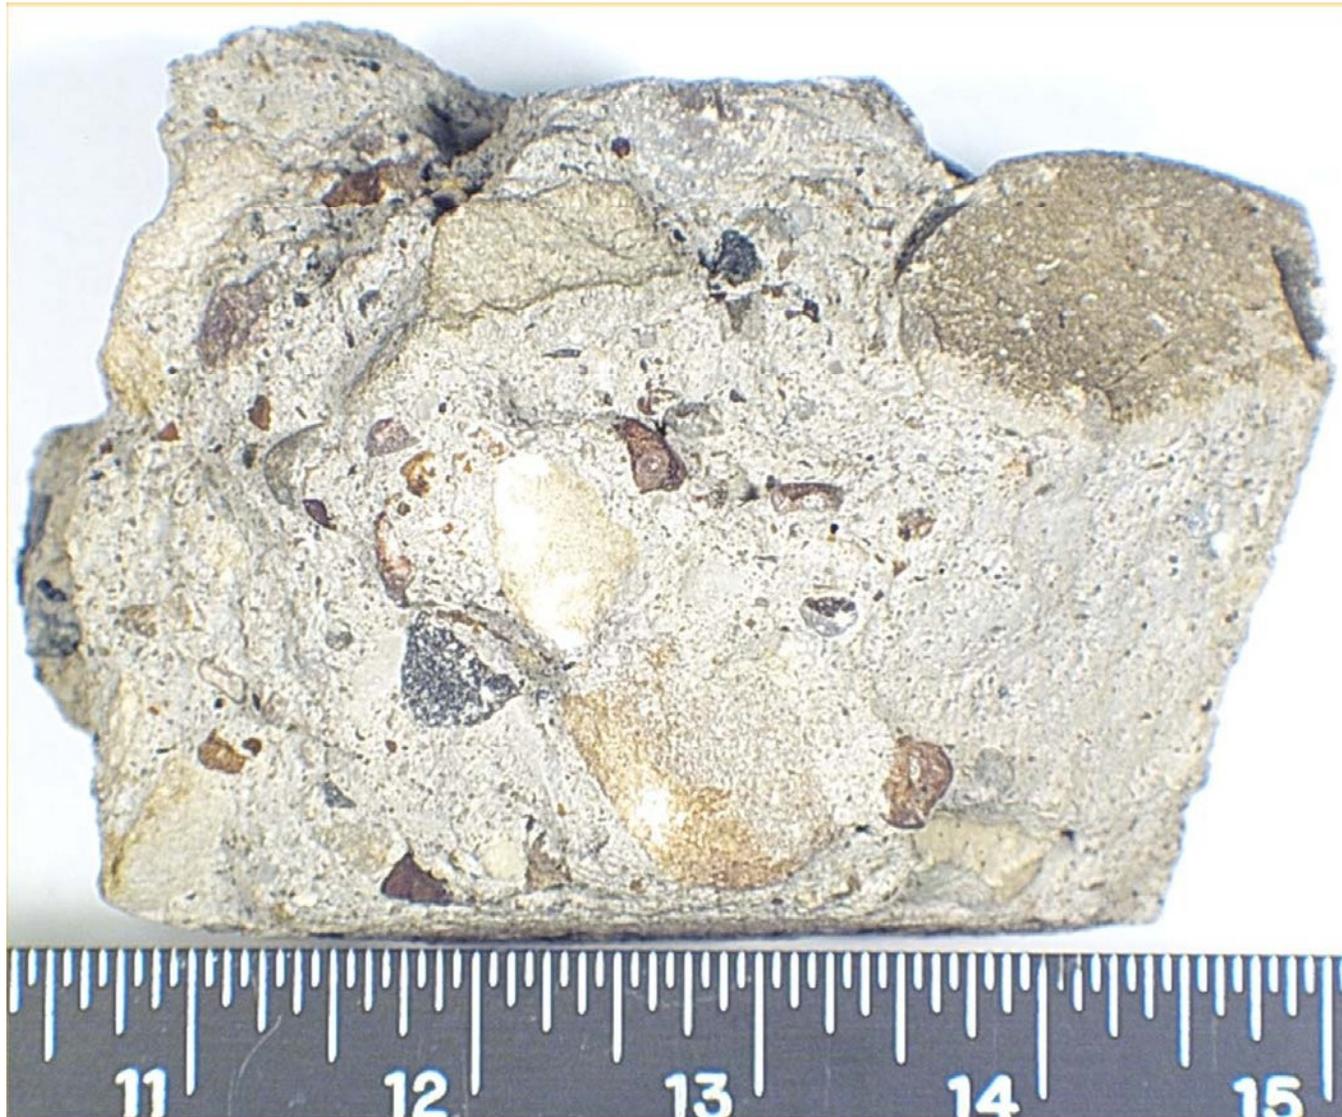
**FIGURE 5C, LARGER CONCRETE SAMPLE PIECE (BAG-MARKED #1), SIDE 1.**

NOTES: THE FLAT FACE IS SEEN AT THE BOTTOM IN THIS VIEW.

REPORTEDLY, THIS SAMPLE HAD TO BE FOAM-CLEANED TO BE RELEASED FROM THE PLANT.

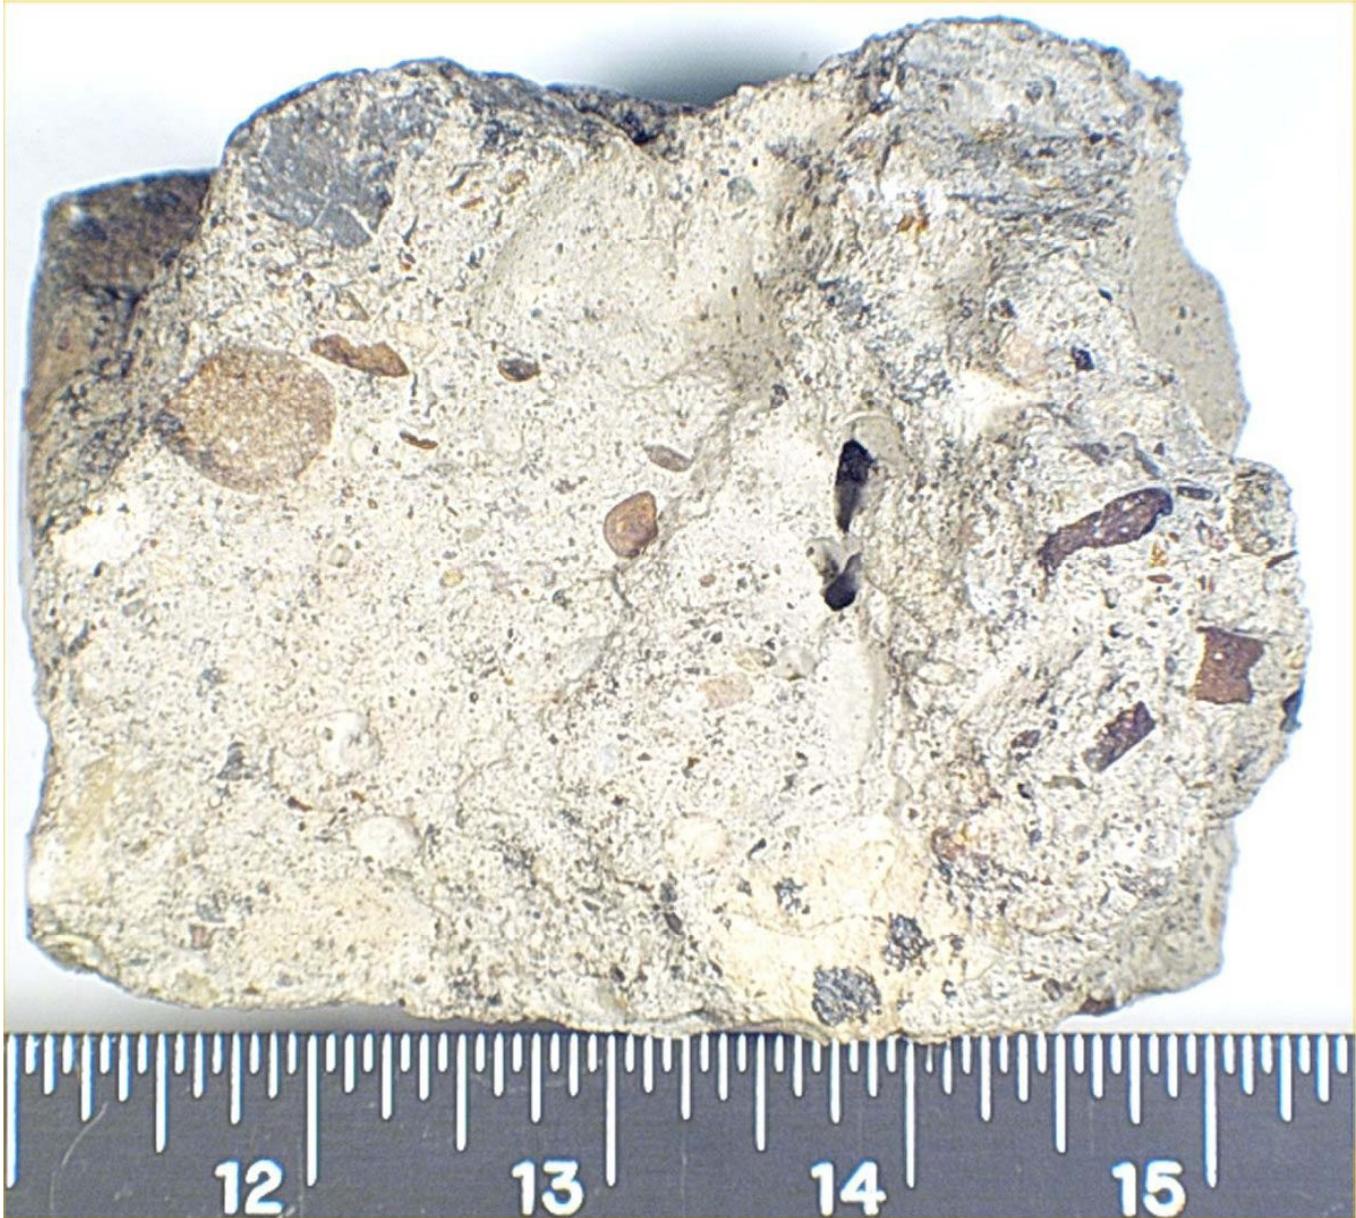
**FIGURE 5D, LARGER CONCRETE SAMPLE PIECE (BAG-MARKED #1), SIDE 2.**

NOTES: THE FLAT FACE IS AT THE BOTTOM IN THIS VIEW.

REPORTEDLY, THIS SAMPLE HAD TO BE FOAM-CLEANED TO BE RELEASED FROM THE PLANT.

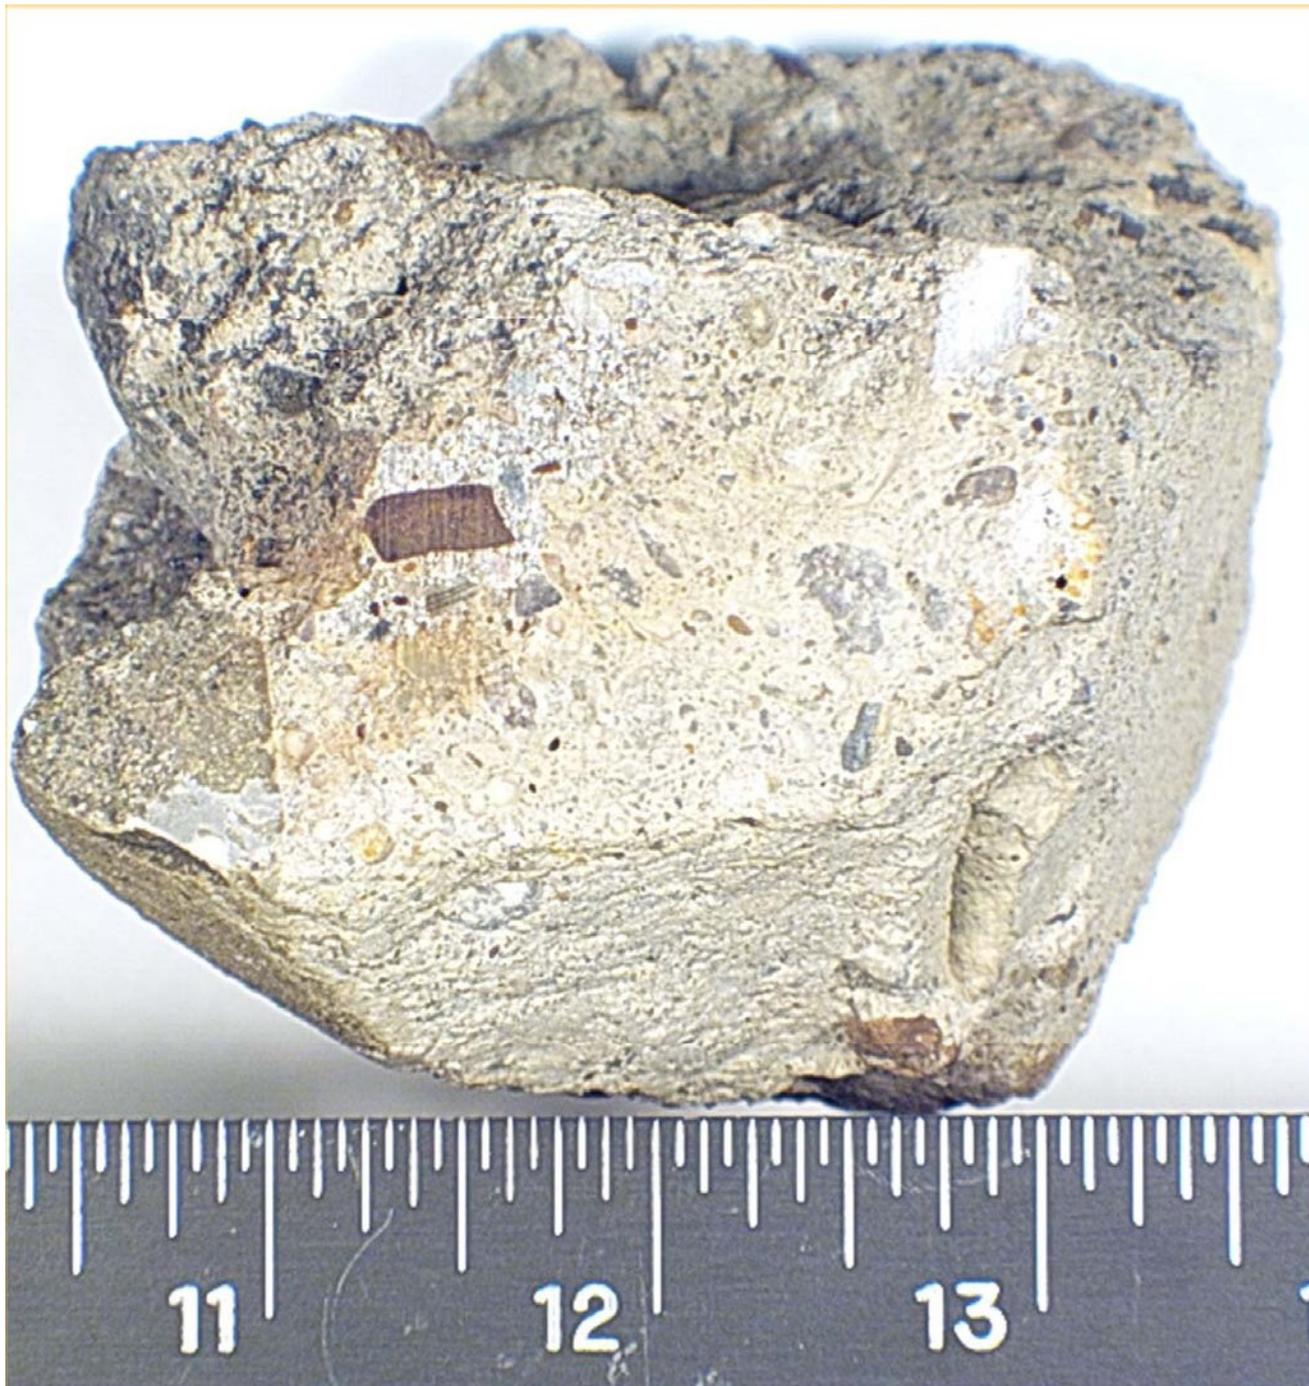
**FIGURE 5E, LARGER CONCRETE SAMPLE PIECE (BAG-MARKED #1), END 1.**

NOTES: REPORTEDLY, THIS SAMPLE HAD TO BE FOAM-CLEANED TO BE RELEASED FROM THE PLANT.

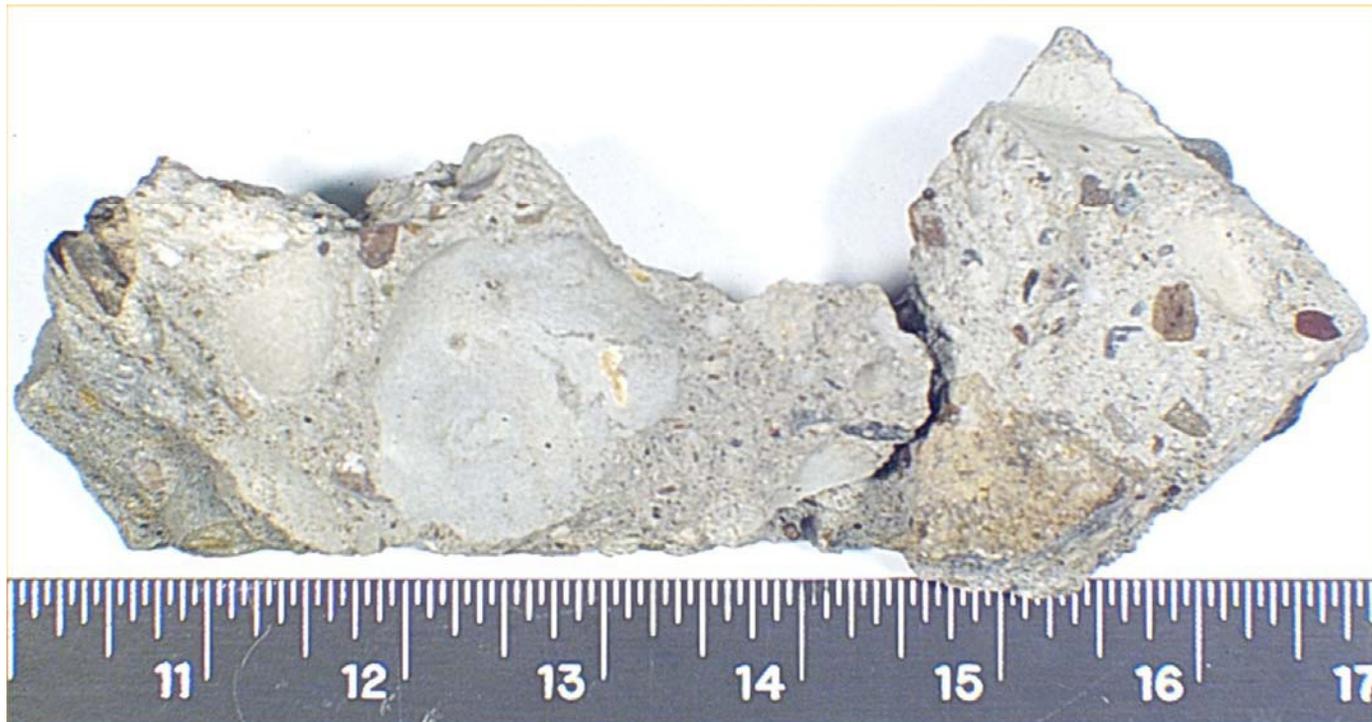
**FIGURE 6B, SMALLER CONCRETE SAMPLE PIECES (BAG-MARKED #2), SIDE 2.**  
REPORTEDLY, REMOVED FROM ~12" FROM THE INNER REBAR LAYER.

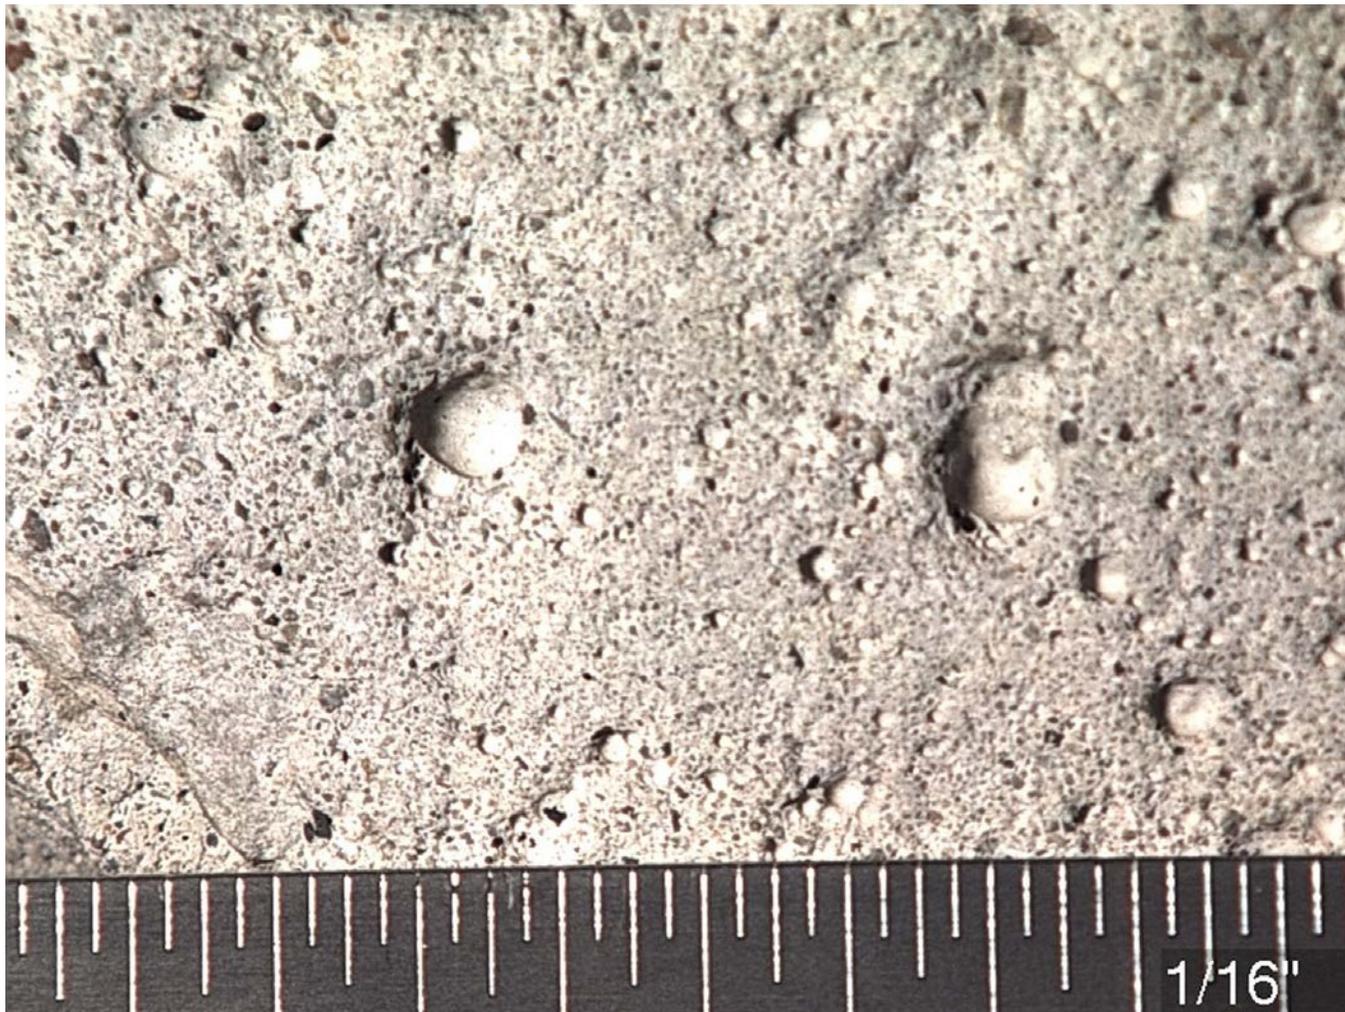
**FIGURE 7, LARGER CONCRETE SAMPLE PIECE (BAG-MARKED #1), "FLAT" FACE DETAIL.**  
 THIS SURFACE IS THOUGHT TO REPRESENT THE CONTACT AREA WITH THE LINER PLATE, CONTAINS SEVERAL  
 SMOOTH AND CLEAN SPHEROIDAL VOIDS, THE LARGEST SEEN HERE ~1/8" Ø.

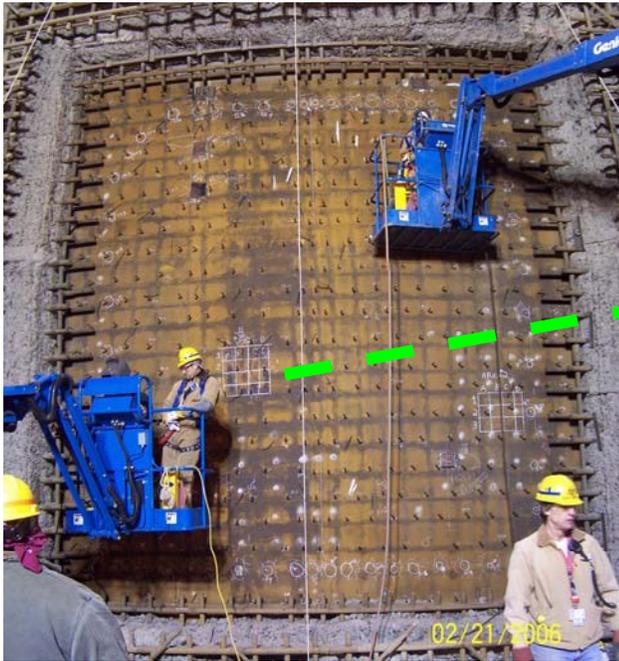
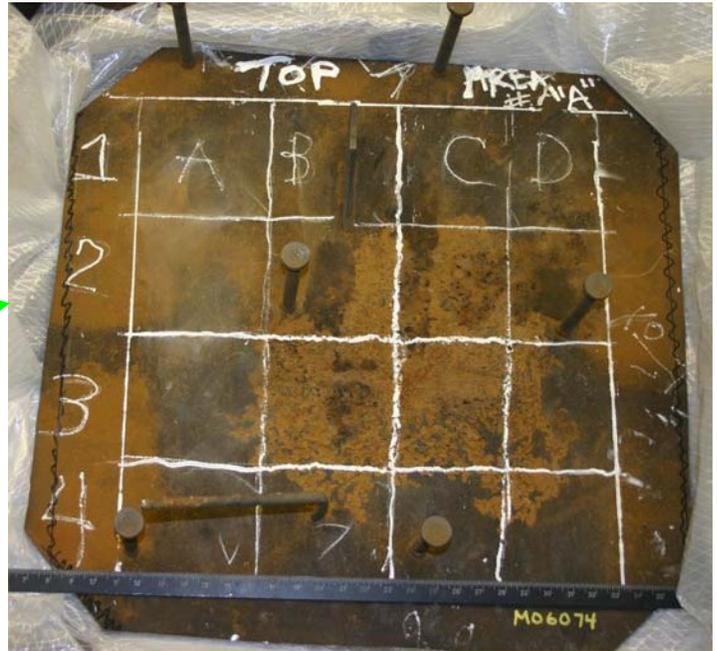
**FIGURE 8(A&B), LINER SAMPLE "A", EXTERNAL OVERVIEWS.**  
THIS SAMPLE APPEARS TO CORRESPOND TO THE AREA 1 IN THE IN-SITU IMAGE.

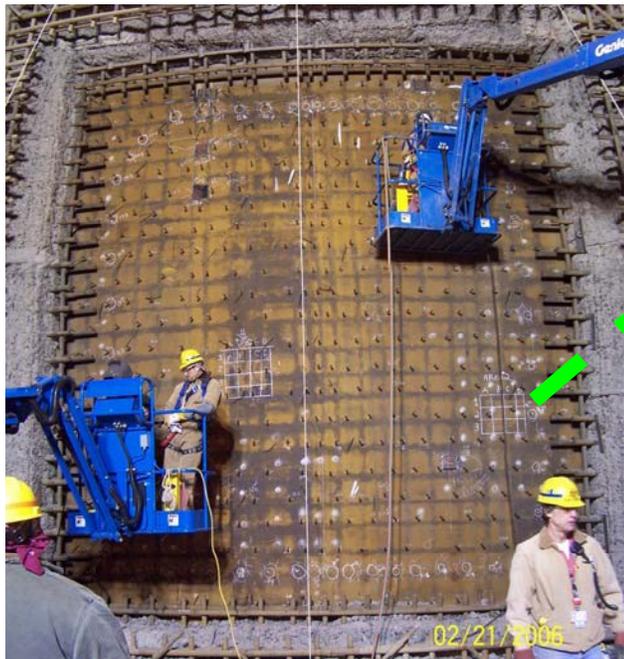
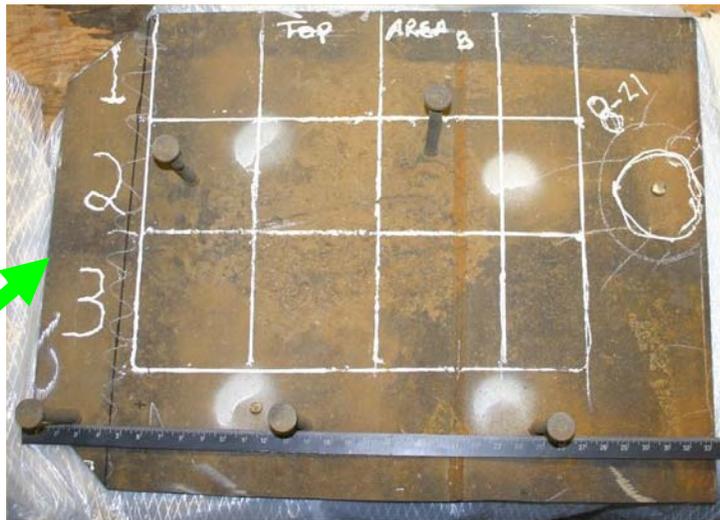
**FIGURE 9(A&B), LINER SAMPLE "B", EXTERNAL OVERVIEWS.**  
THIS SAMPLE APPEARS TO CORRESPOND TO AREA 2 IN THE IN-SITU PLANT IMAGE.

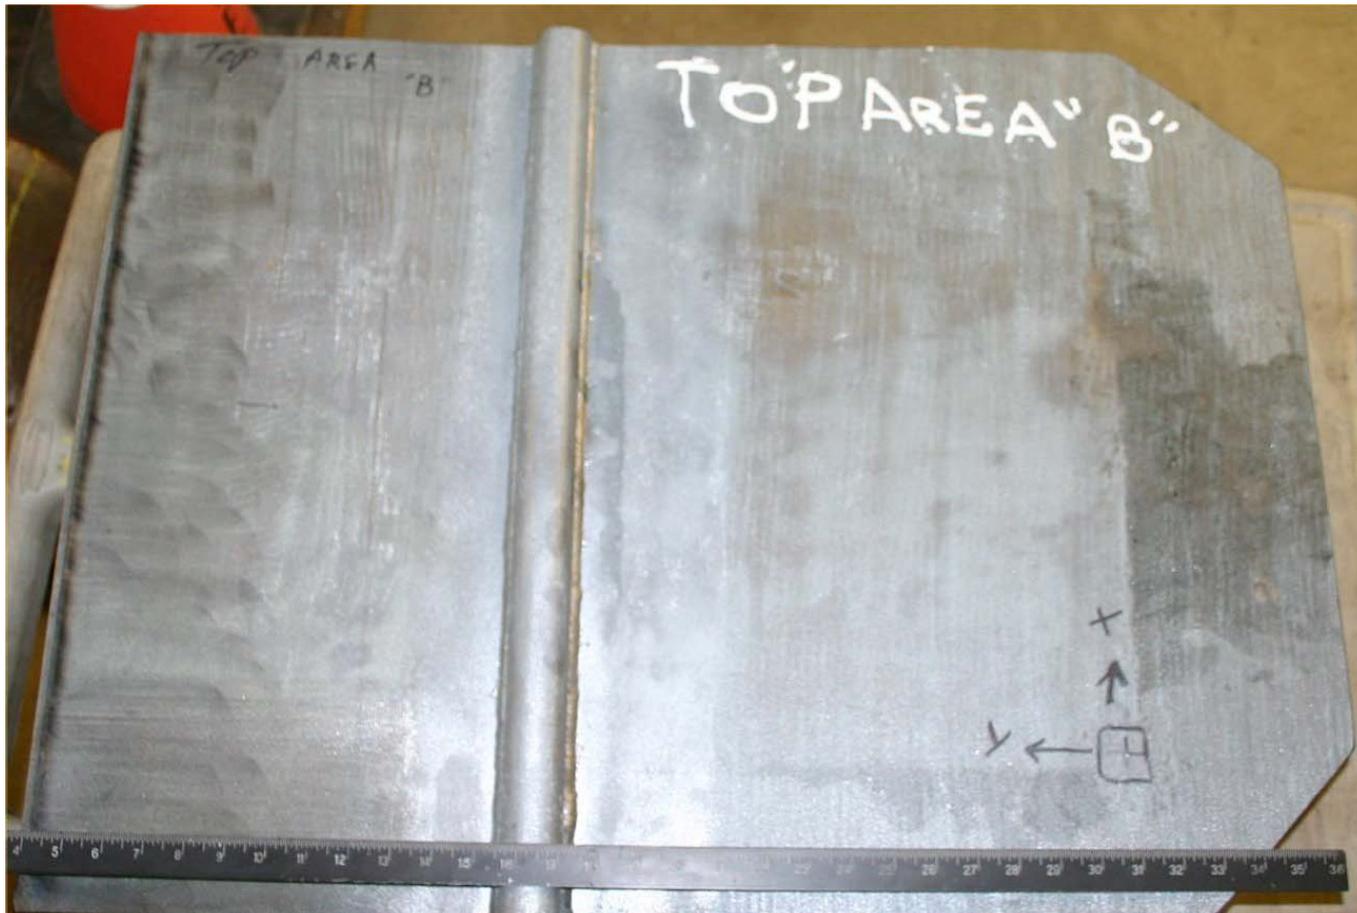
**FIGURE 9D, LINER SAMPLE "B", INTERNAL OVERVIEW, AS-RECEIVED AT BETA.  
THE LINER WELD PRESSURE TEST CHANNEL IS EVIDENT.**

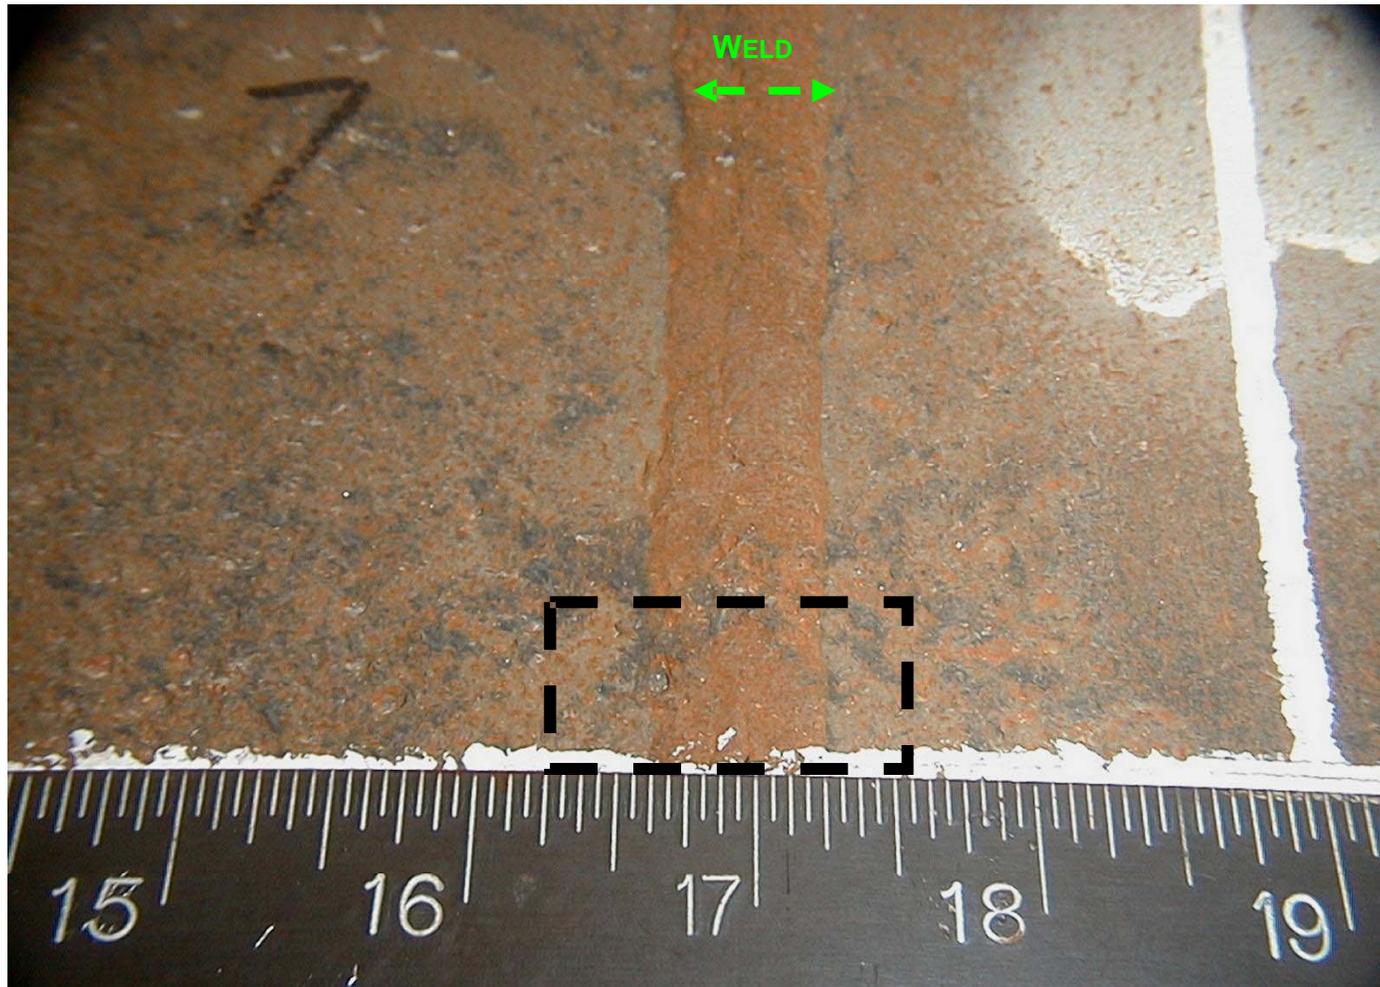
**FIGURE 9E, LINER SAMPLE "B", WELD EXTERNAL CORROSION AREA, AS-RECEIVED AT BETA.  
SECTIONED, APPROXIMATELY AS-MARKED, FOR STUDY.  
NOTE: THE SURFACE CORROSION DISTRESS INCLUDES THE WELD SURFACES.**
