LAB NO.: M06074	WORK TRACKING NO.: 14878	PAGE 8 OF 78
PLANT & UNIT: BEAVER VALLEY #1	PART: CONTAINMENT MATERIALS	DATE: 3/9/2006

**MATERIAL ANALYSIS REPORT**  
**TABLE 1, TESTS PERFORMED and RESULTS**  
(See Attachment #1 for Test/Equipment Specifications)

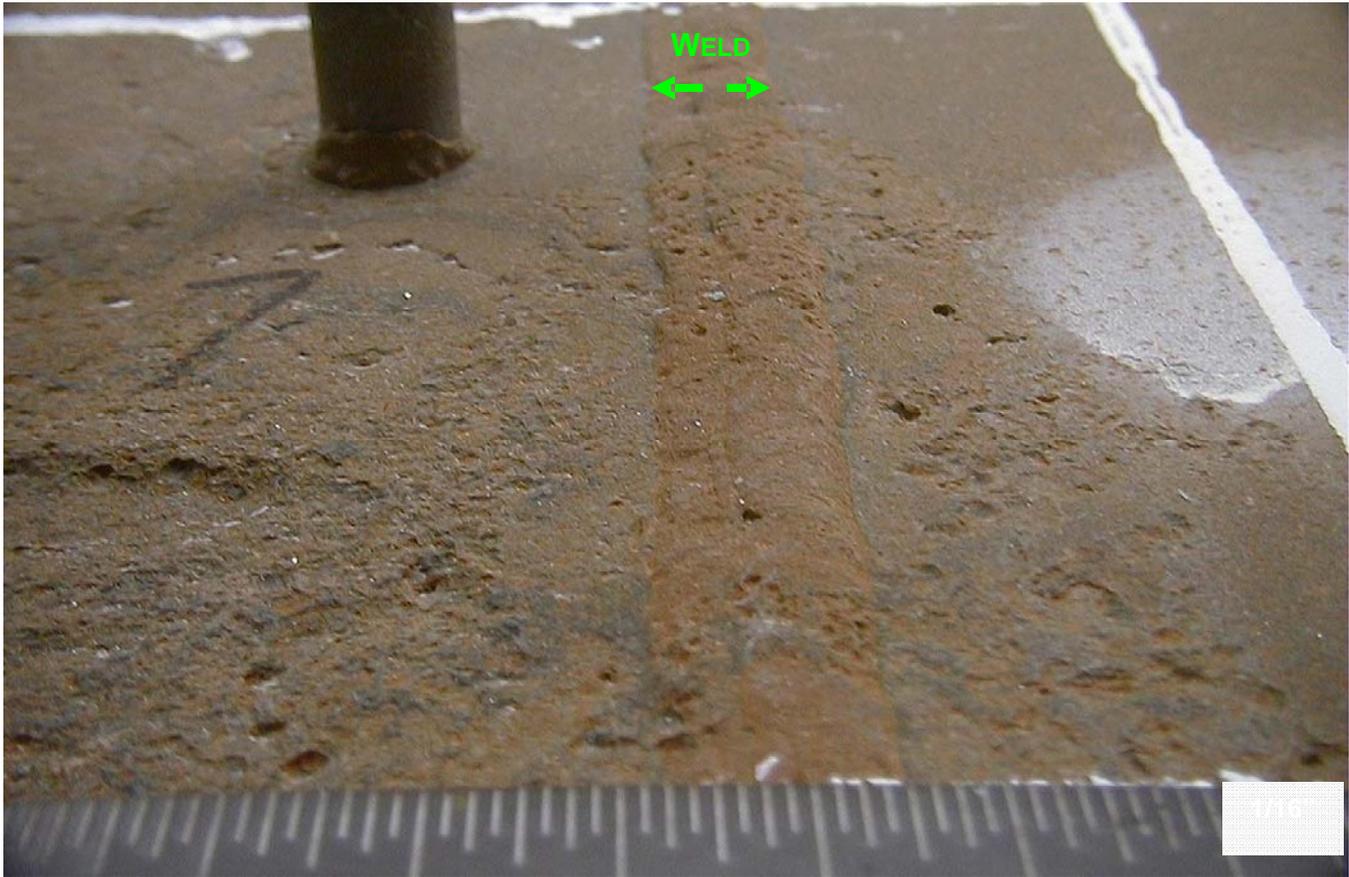
**FIGURE 9F, LINER SAMPLE “B”, WELD EXTERNAL CORROSION AREA DETAIL, AS-RECEIVED AT BETA.**  
 THIS IS AN OBLIQUE VIEW, WITHOUT A FLASH, DIGITALLY AUGMENTED FOR IMPROVED CONTRAST.  
 NOTE: THE SURFACE CORROSION DISTRESS INCLUDES THE WELD SURFACES.

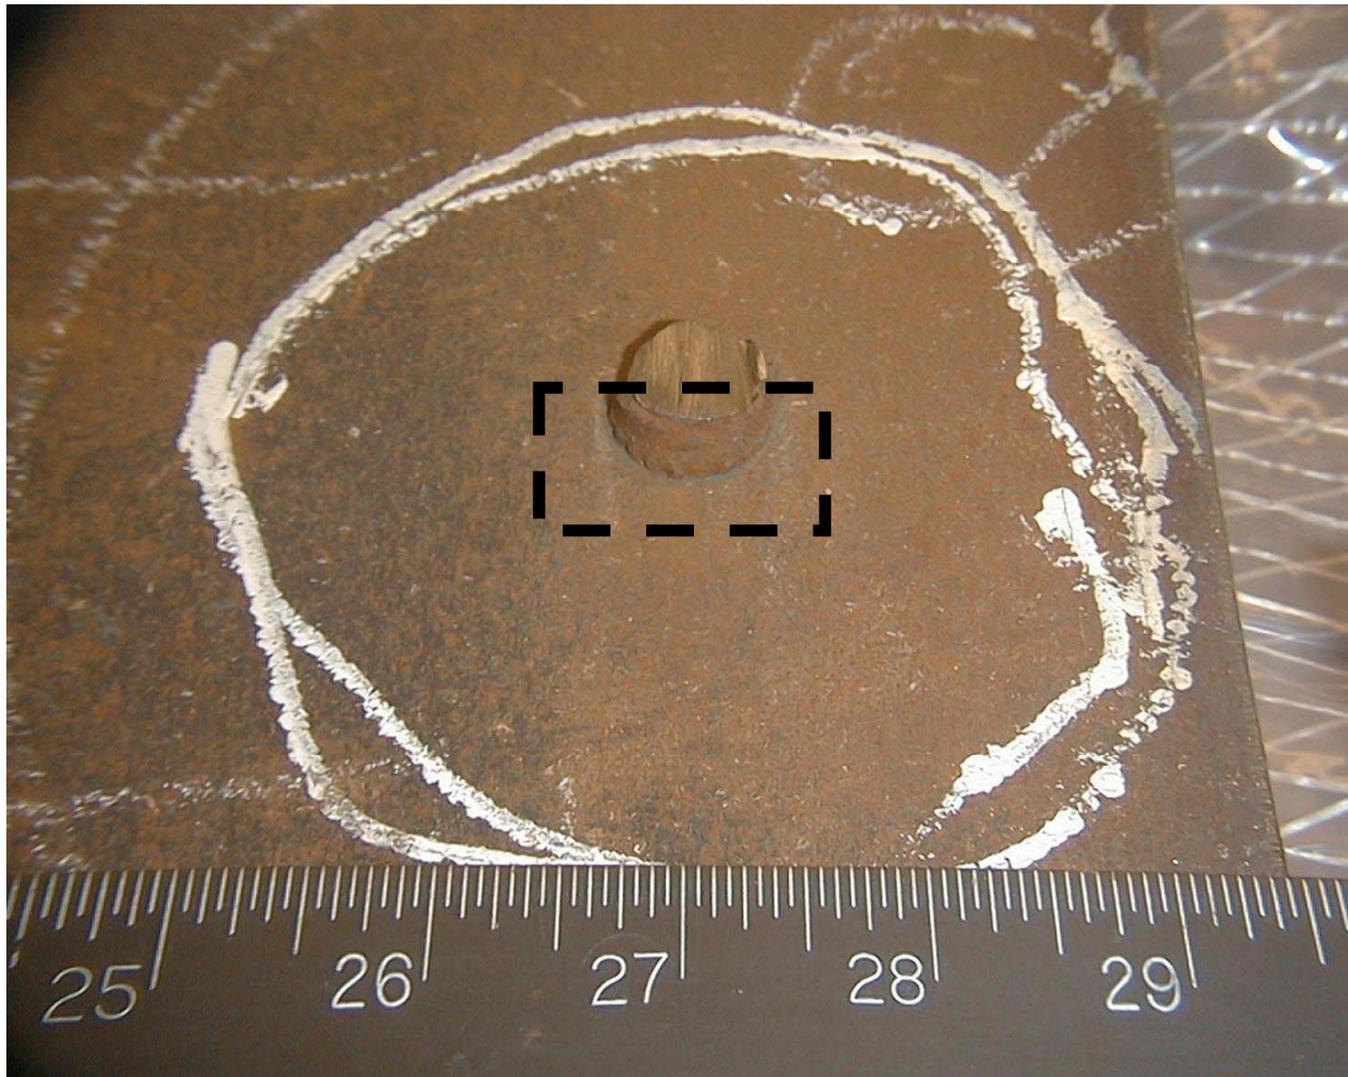
**FIGURE 9G, LINER SAMPLE "B", STUD-WELD SAMPLE AREA DETAIL, AS-RECEIVED AT BETA.  
THE STUD-WELD HAD ALREADY BEEN REMOVED BY OTHERS.  
SECTIONED, APPROXIMATELY AS-MARKED, FOR STUDY.**

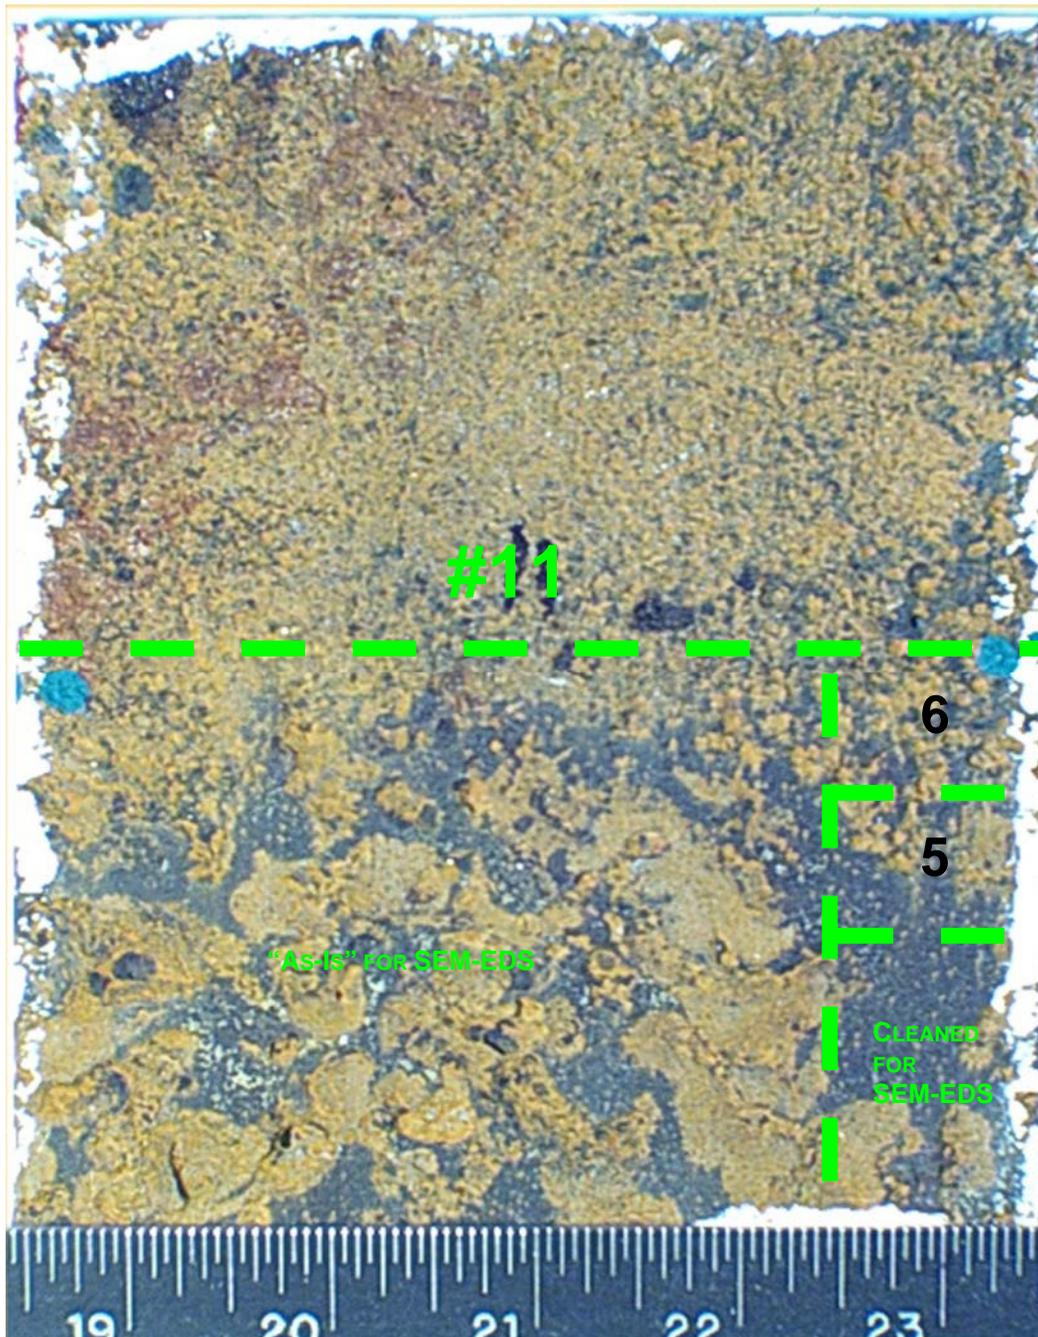
**FIGURE 10, LINER SAMPLE "A", EXTRACTED GRID QUADRANT #11 PIECE;  
SEM AND 2<sup>ND</sup> SET OF METALLOGRAPHY SECTIONS.**  
SURFACES, VARYING FROM ROUGH TO SMOOTH, ARE SEEN.  
THIS PIECE WAS SECTIONED, APPROXIMATELY AS-MARKED, FOR FURTHER STUDY.

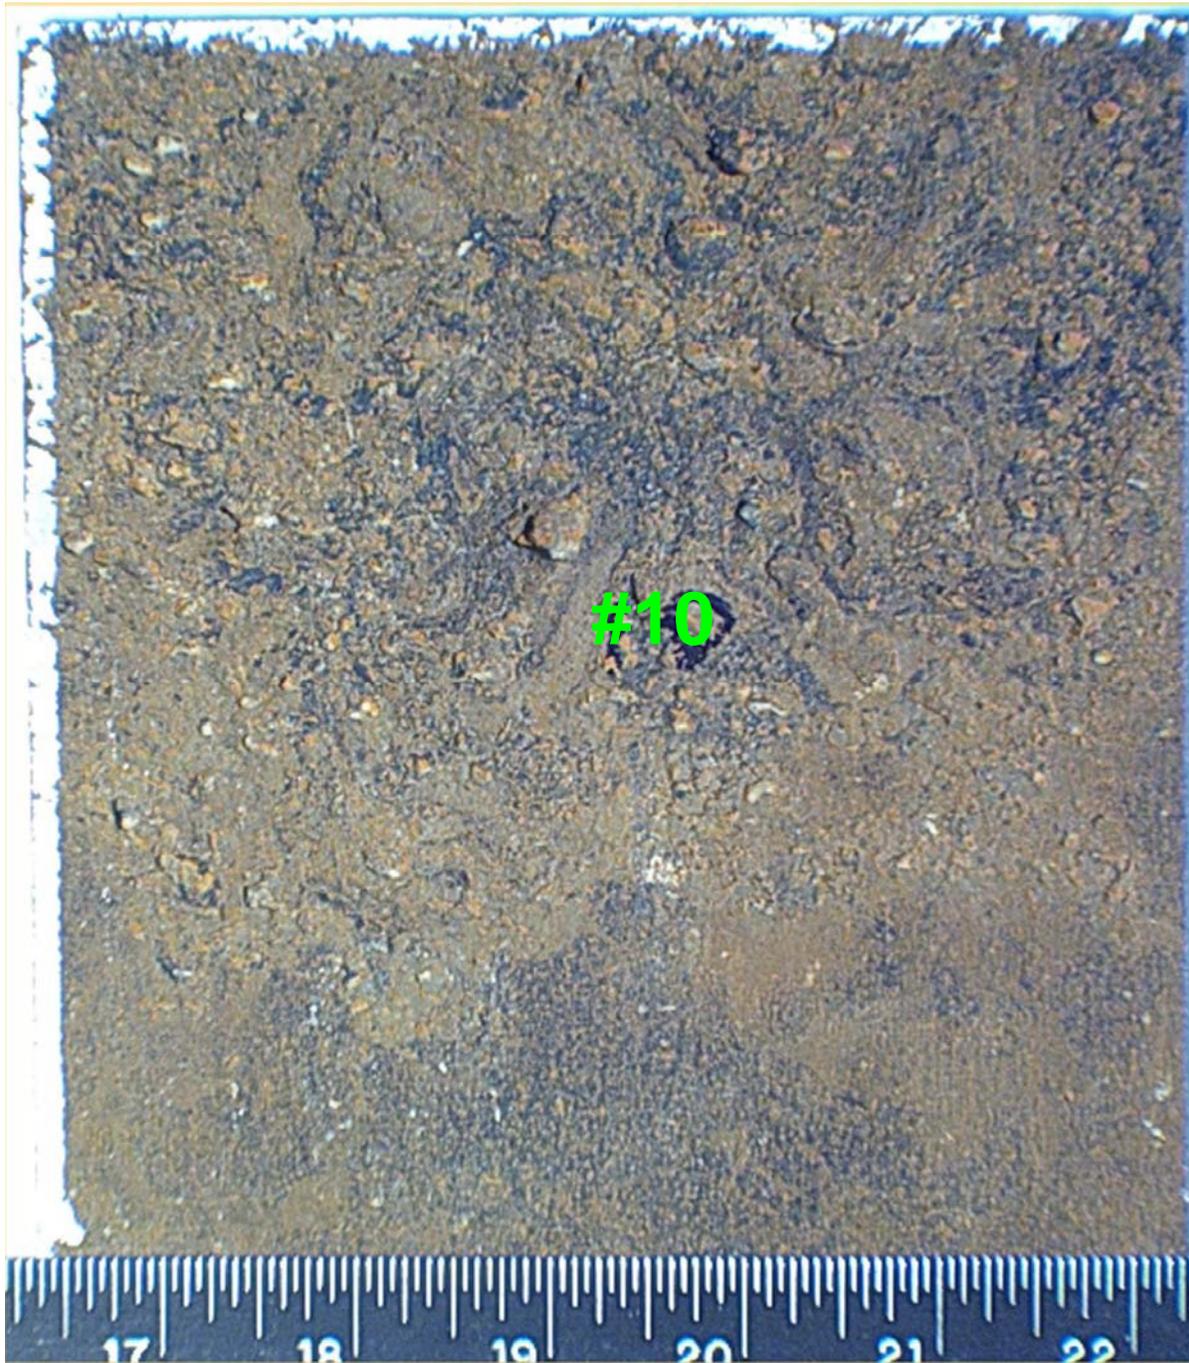
**FIGURE 12, LINER SAMPLE "B", EXTRACTED GRID QUADRANT #10 PIECE, AS-FOUND.  
SURFACES, VARYING FROM ROUGH TO SMOOTH, ARE SEEN.**

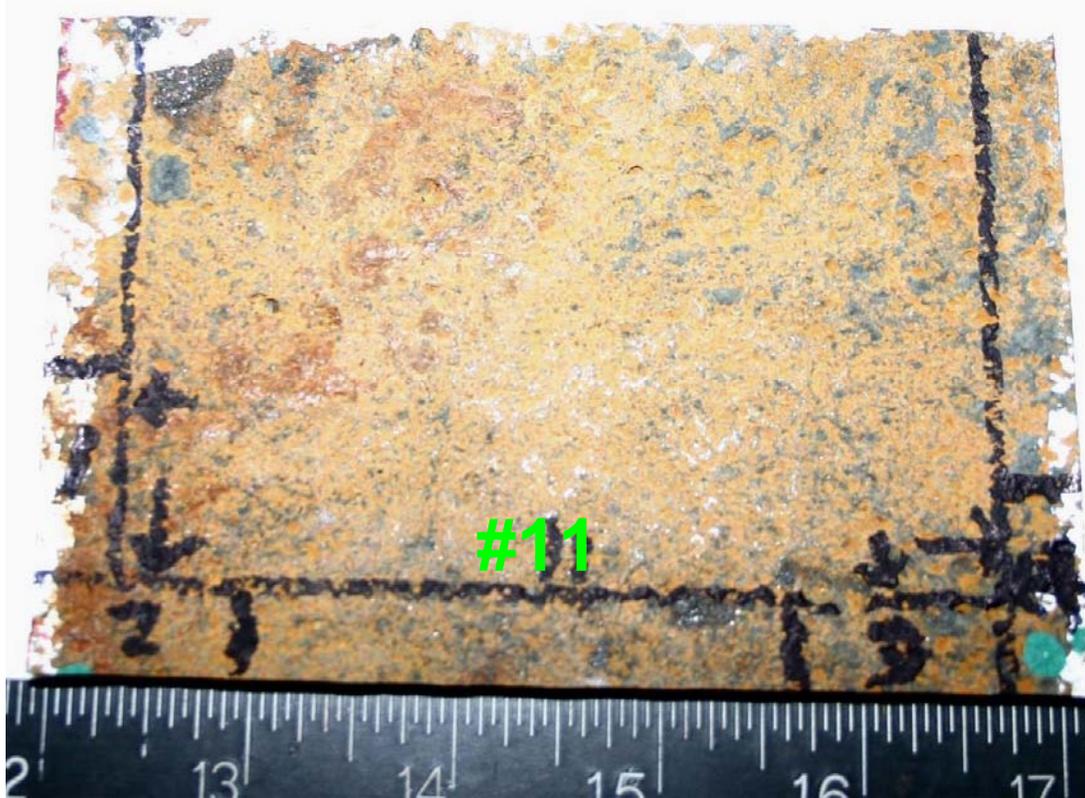
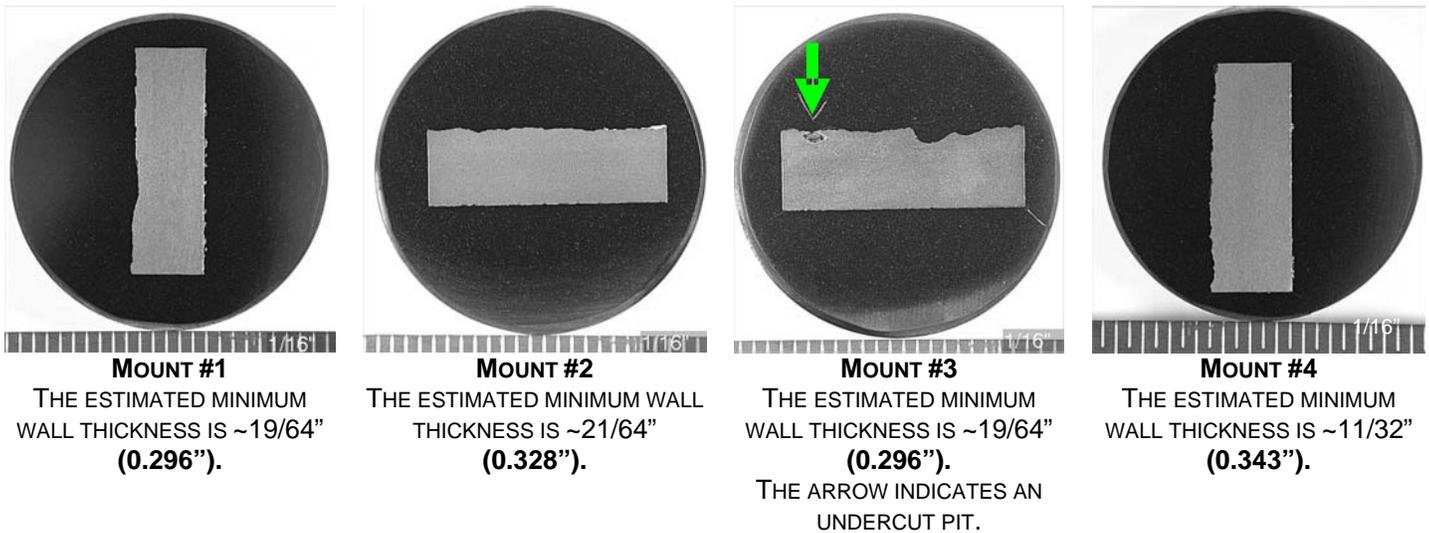
**FIGURE 14, LINER SAMPLE "A", 1<sup>ST</sup> SET OF METALLOGRAPHIC SECTIONS, 2% NITAL MACRO-ETCH.**  
 SAMPLES ORIENTED BASED ON THE AS-RECEIVED "TOP" MARKING, AS APPLICABLE  
 THE ESTIMATED "NOMINAL" WALL THICKNESS OF THE PLATE IS  $\sim 3/8$ ".

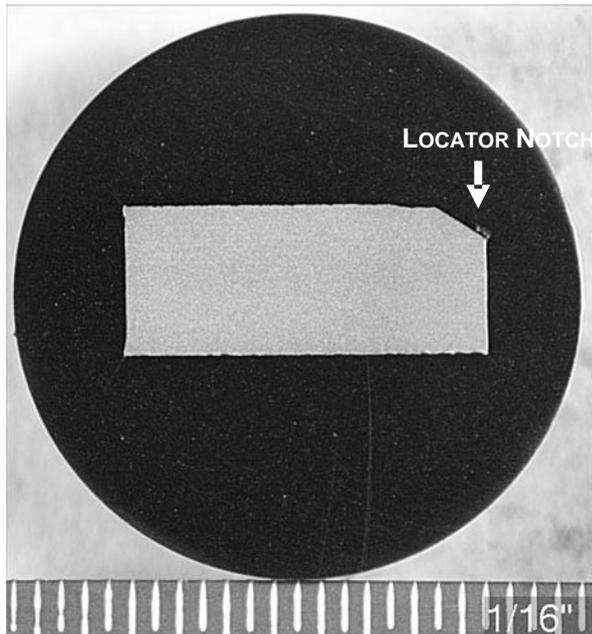
**MOUNT #5**

THE ESTIMATED MINIMUM WALL THICKNESS THIS APPARENTLY UNAFFECTED AREA IS  $\sim 25/64$ " (**0.390"**).

**FIGURE 15, LINER SAMPLE "A", 2<sup>ND</sup> SET OF METALLOGRAPHIC SECTIONS, 2% NITAL MACRO-ETCH.  
THE ESTIMATED "NOMINAL" WALL THICKNESS OF THE PLATE IS  $\sim 3/8$ ".**

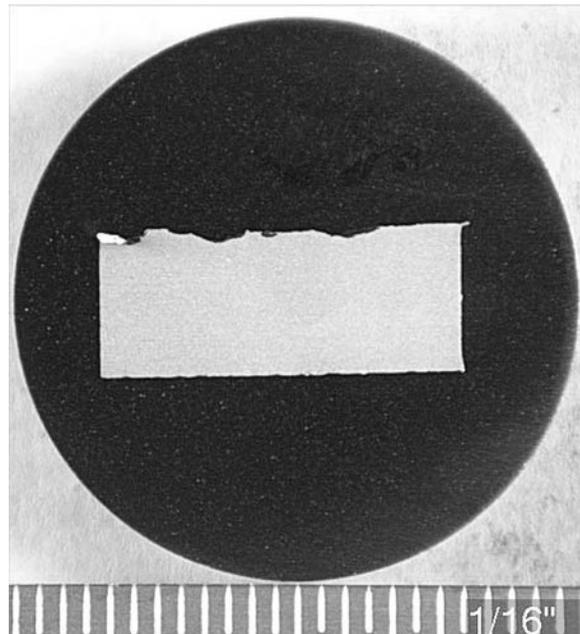
**MOUNT #6**

THE ESTIMATED MINIMUM WALL THICKNESS HERE IS  $\sim 23/64$ " (**0.359"**).

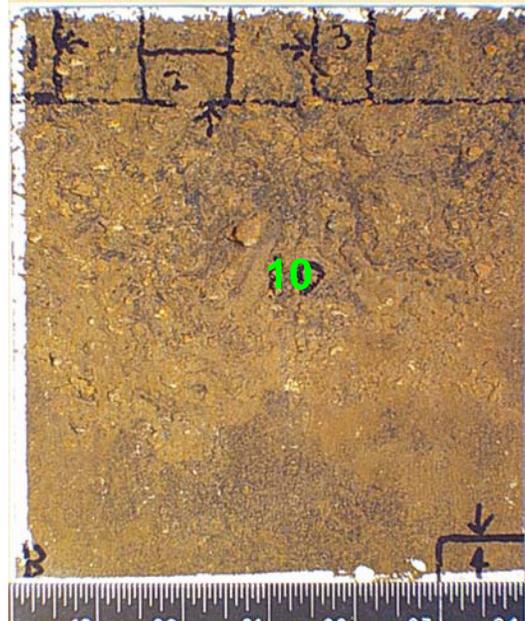
**MOUNT #1**

THE ESTIMATED MINIMUM WALL THICKNESS IS  $\sim 11/32"$  (**0.343"**).

**FIGURE 16, LINER SAMPLE "B", 1<sup>ST</sup> SET OF METALLOGRAPHIC SECTIONS, 2% NITAL MACRO-ETCH.**

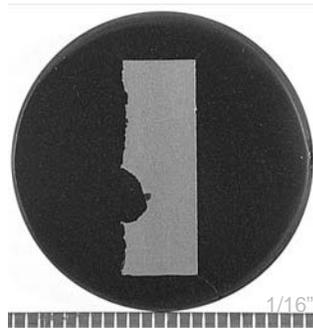
**MOUNT #3**

THE ESTIMATED MINIMUM WALL AT THE BOTTOM OF THIS PIT IS  $\sim 7/32"$  (**0.218"**).

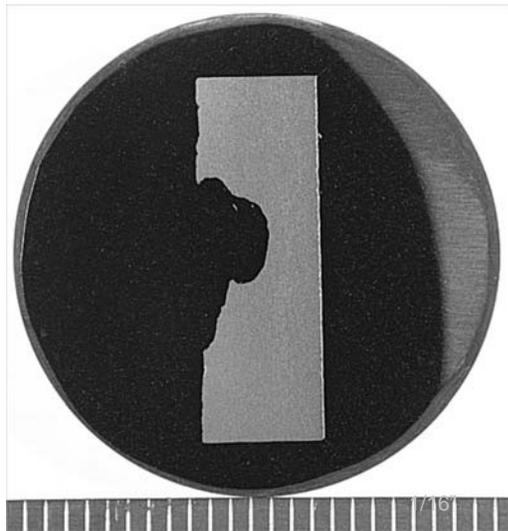
**MOUNT #5**

THE ESTIMATED MINIMUM WALL THICKNESS AT THE BOTTOM OF THIS PIT IS  $\sim 5/32$ " (0.156").

**FIGURE 17, LINER SAMPLE "B", 2<sup>ND</sup> SET OF METALLOGRAPHIC SAMPLES, 2% NITAL MACRO-ETCH.**  
 ALL SAMPLES ORIENTED BASED ON THE AS-RECEIVED "TOP" MARKING.  
 THE ESTIMATED "NOMINAL" WALL THICKNESS OF THE PLATE IS  $\sim 3/8$ ".

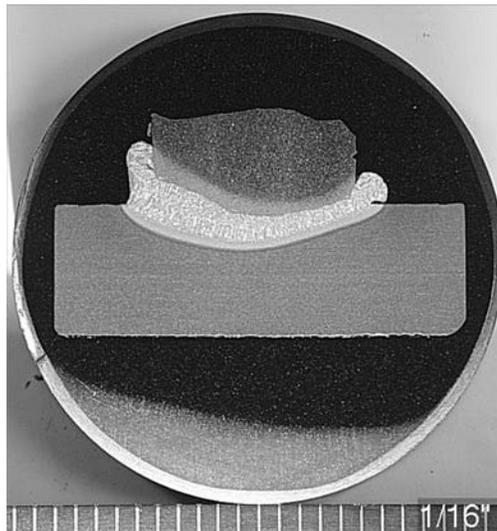
**STUD-WELD MOUNT**

A TYPICAL FUSION/ FLASH AND HEAT-AFFECTED ZONE (HAZ) ARE SEEN.

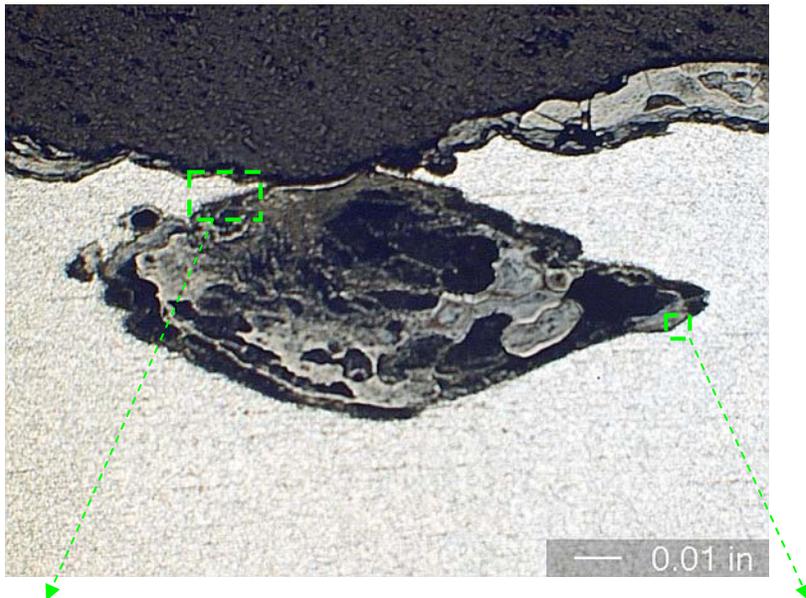
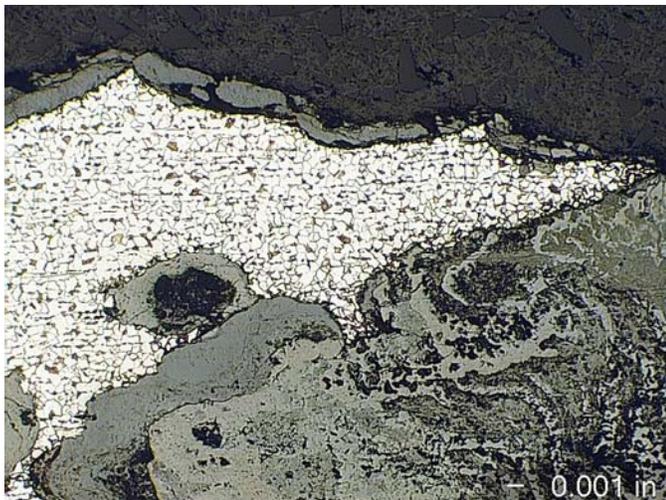
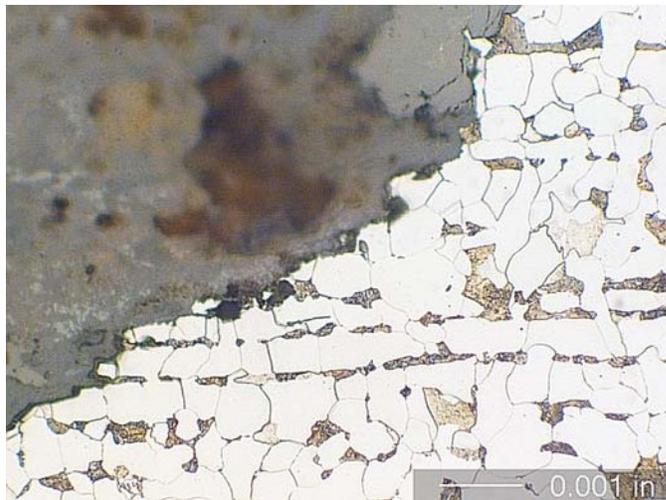
**FIGURE 18, LINER SAMPLE "A", QUADRANT #11, SECTION #3, UNDERCUT OD PIT MICROSTRUCTURES.**

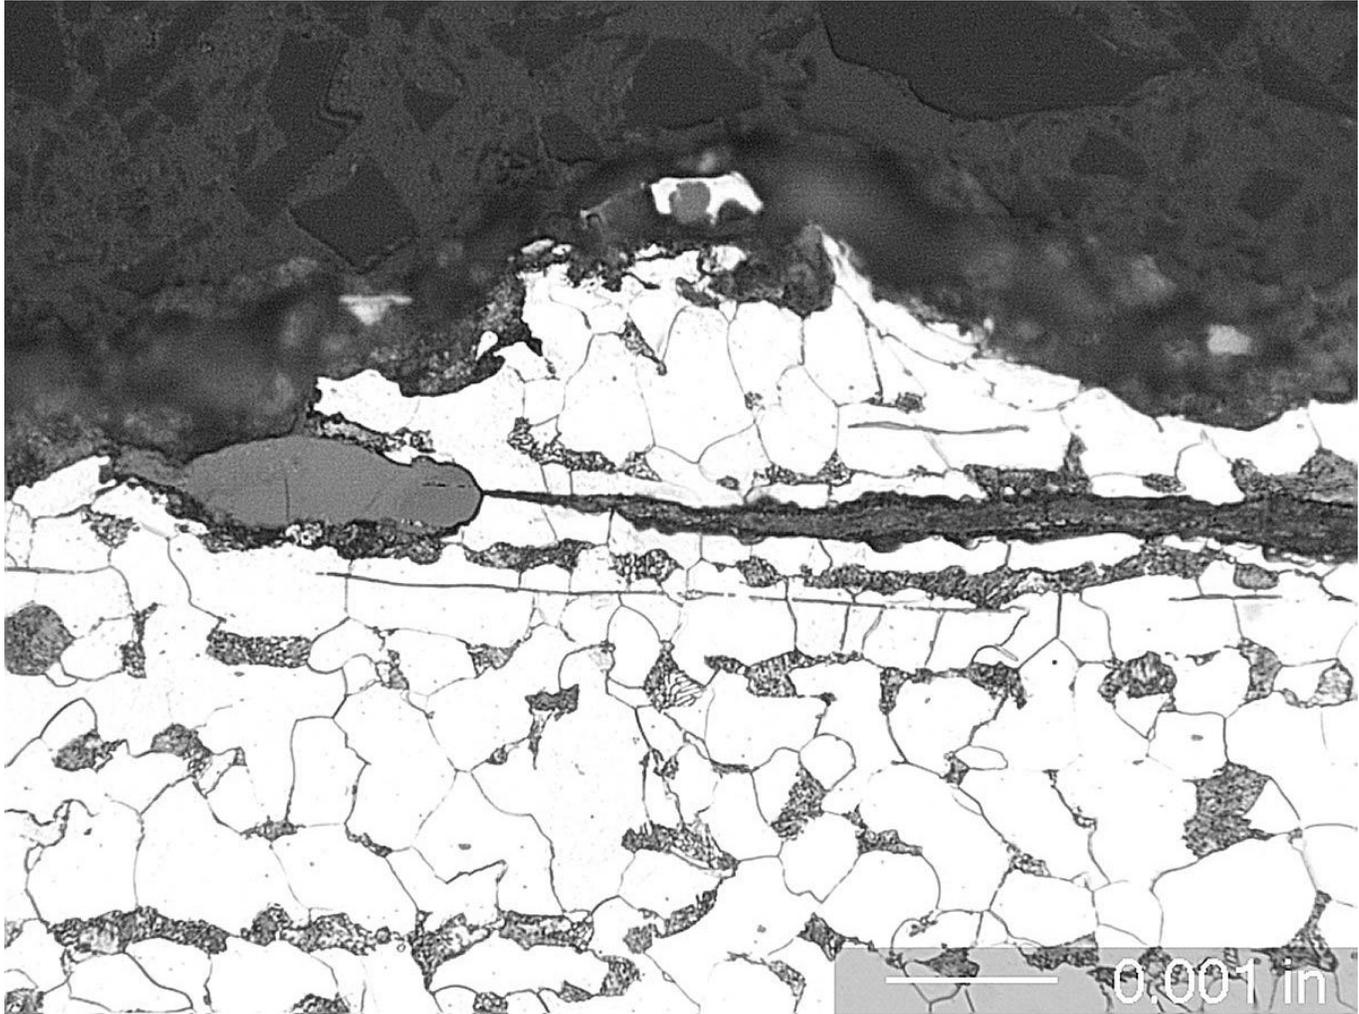
**FIGURE 19, TYPICAL LINER EXTERNAL (OD) CORROSION AREA SURFACE MICROSTRUCTURES**  
 END GRAIN CORROSION, SOME ALONG THE STRINGER INCLUSIONS, IS SEEN.  
 NOTE: THIS IS TEST SAMPLE B-Q10-#2.

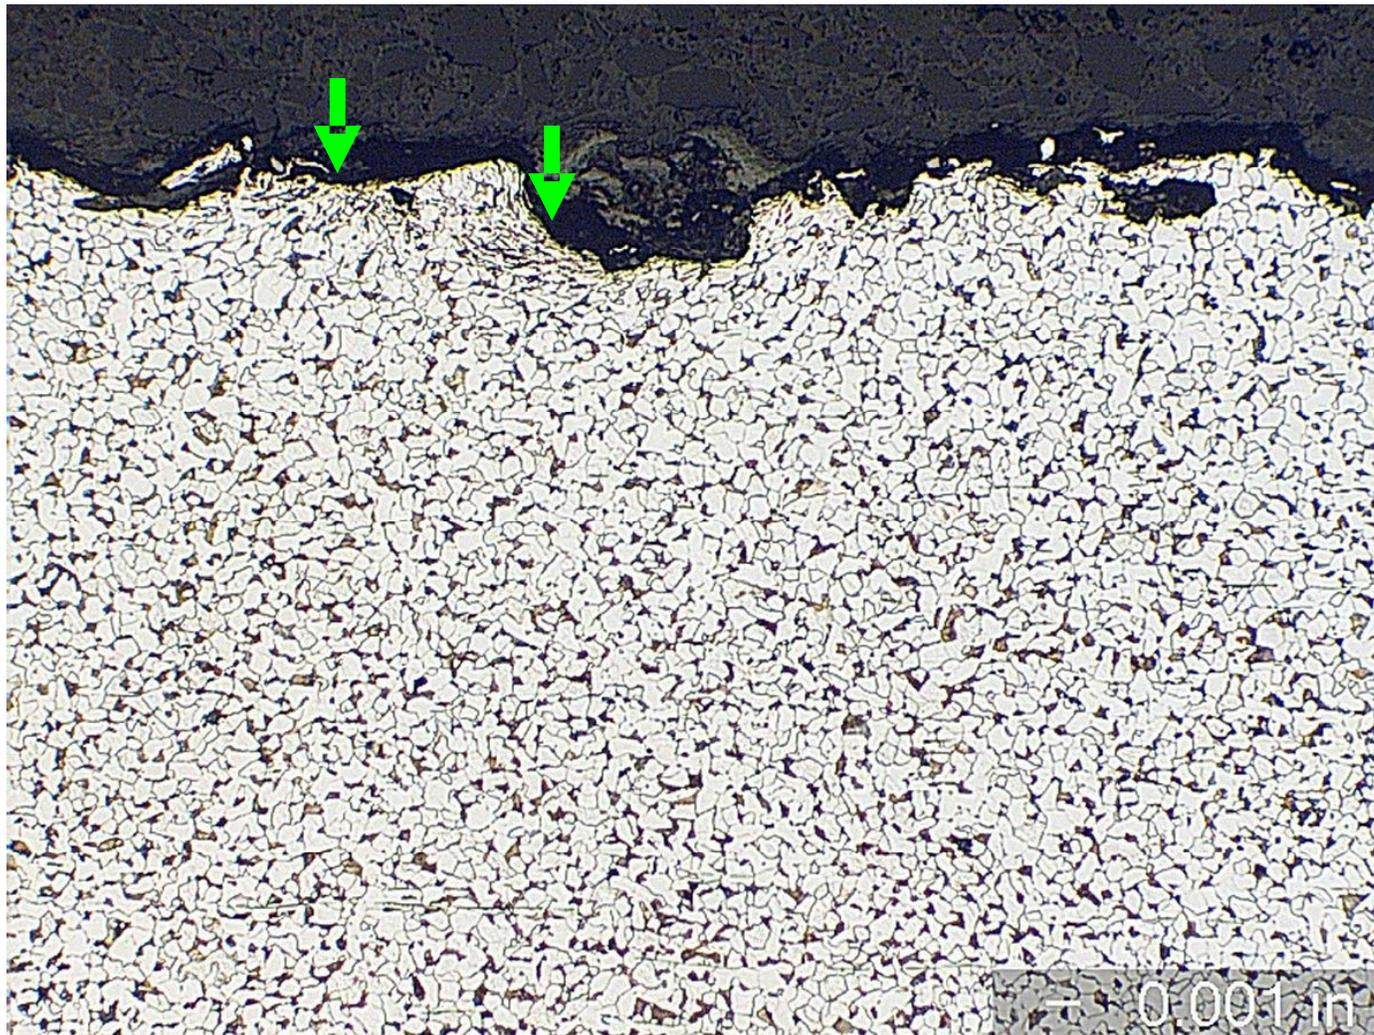
**FIGURE 20, TYPICAL LINER EXTERNAL (OD) RELATIVELY UNAFFECTED AREA SURFACE MICROSTRUCTURES.**

TRACE COLD-WORK DISTORTION (ARROWS) IS SEEN IN THIS SAMPLE, B-Q10-#4.

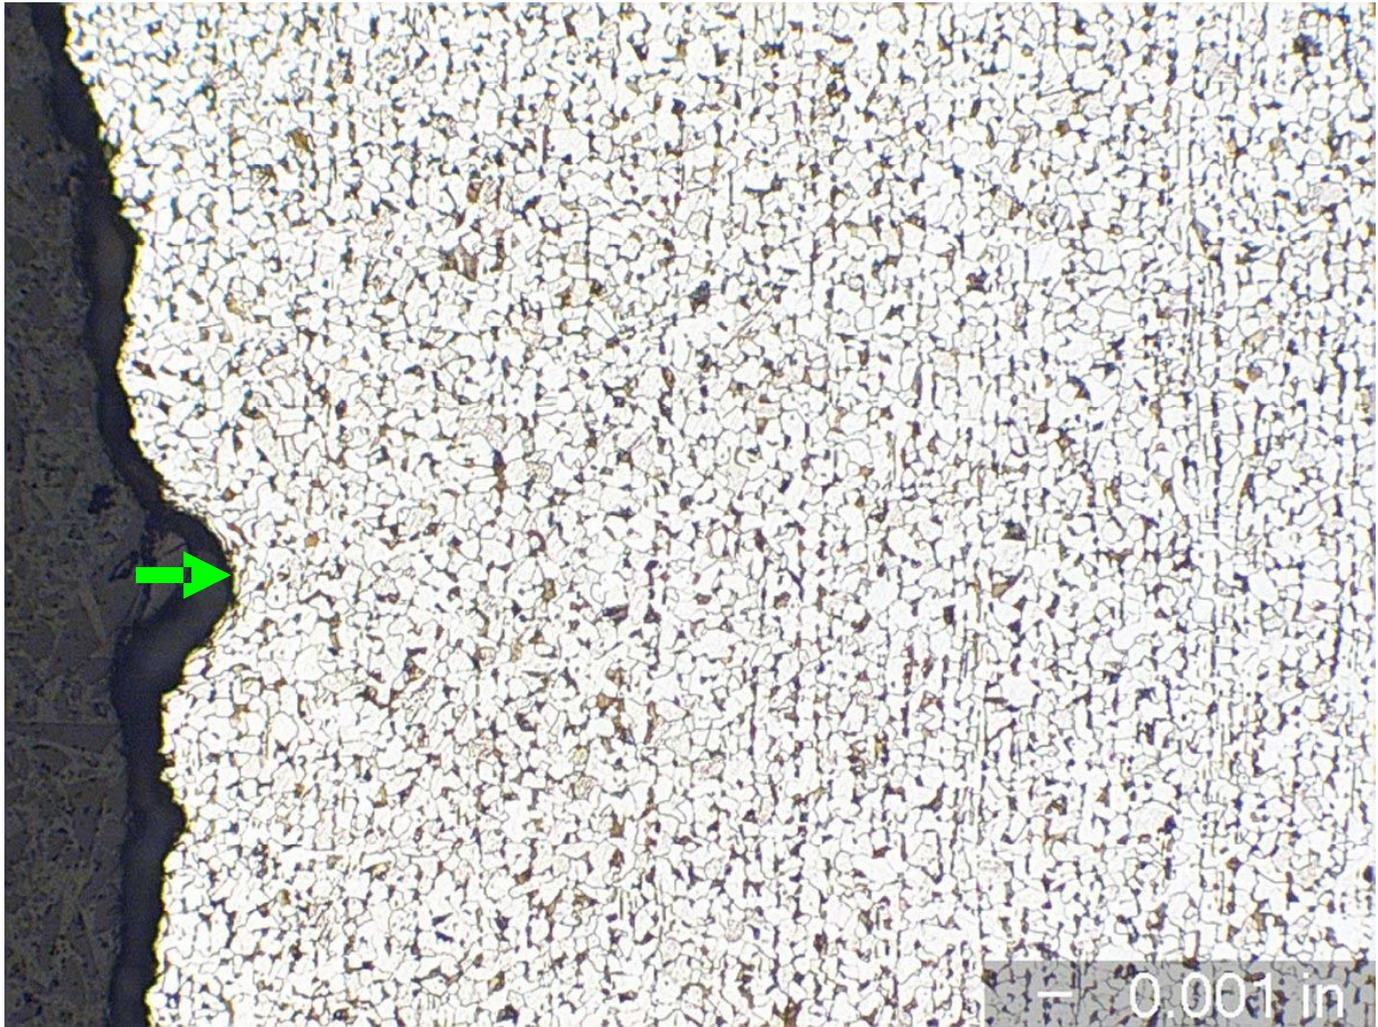
**FIGURE 21, TYPICAL LINER EXTERNAL (OD) SURFACE CORROSION AREA WITH LOCAL COLD-WORK MICROSTRUCTURES.**

TRACE COLD-WORK DISTORTION (ARROW) IS SEEN IN THIS SAMPLE, B-Q10-#1.

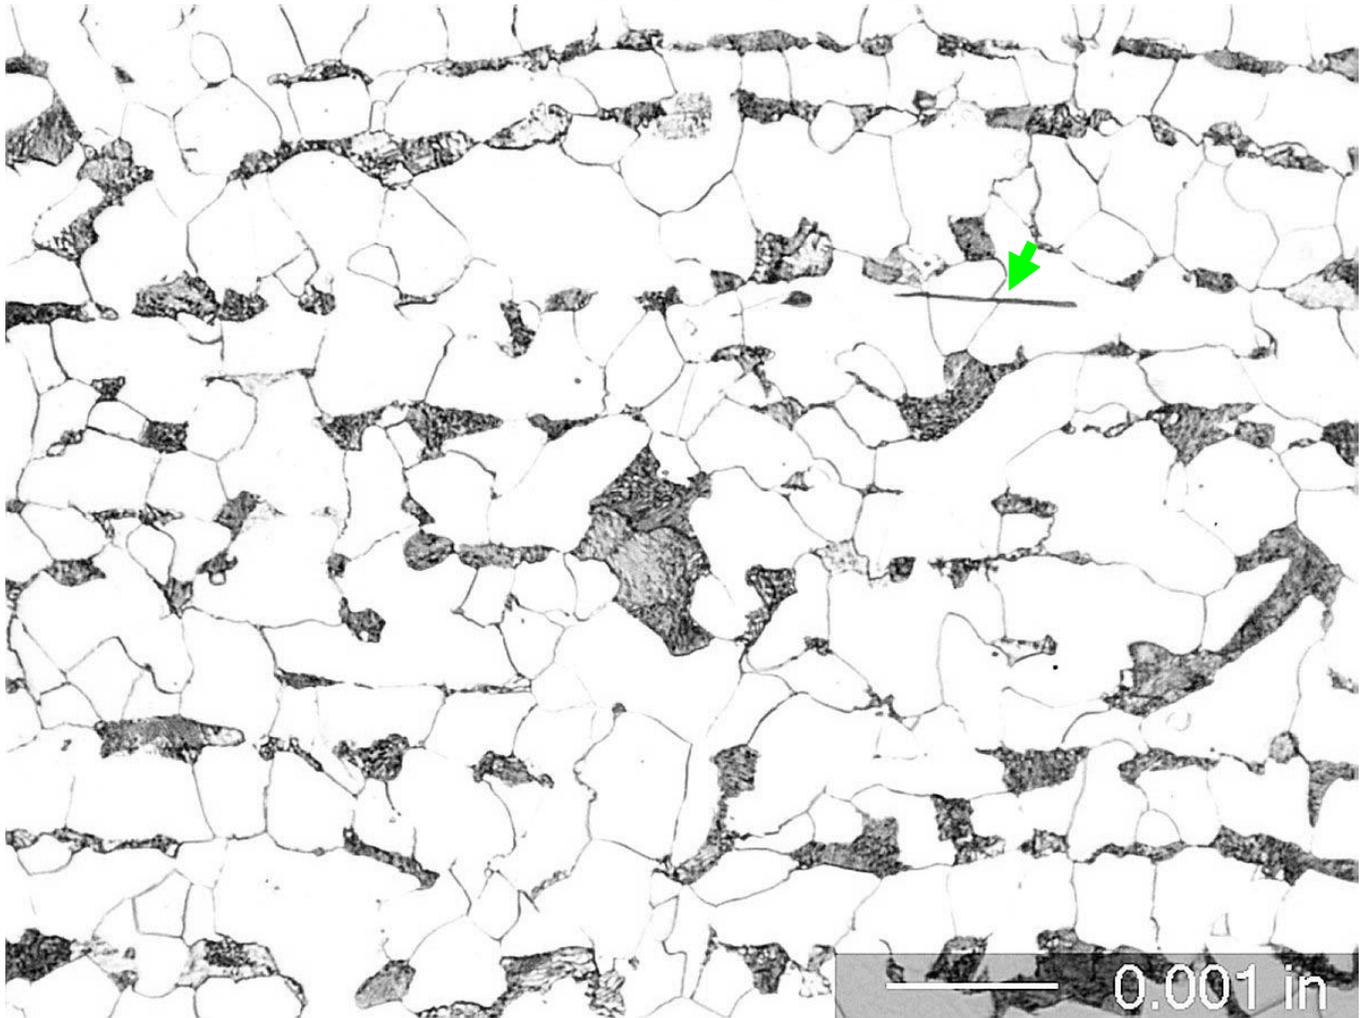
**FIGURE 22, TYPICAL LINER MID-WALL MICROSTRUCTURES.**

MICROSTRUCTURES CONSISTING OF PEARLITE COLONIES (GRAY) AND STRINGER INCLUSION (ARROW) IN A FERRITE (WHITE) MATRIX ARE SEEN.

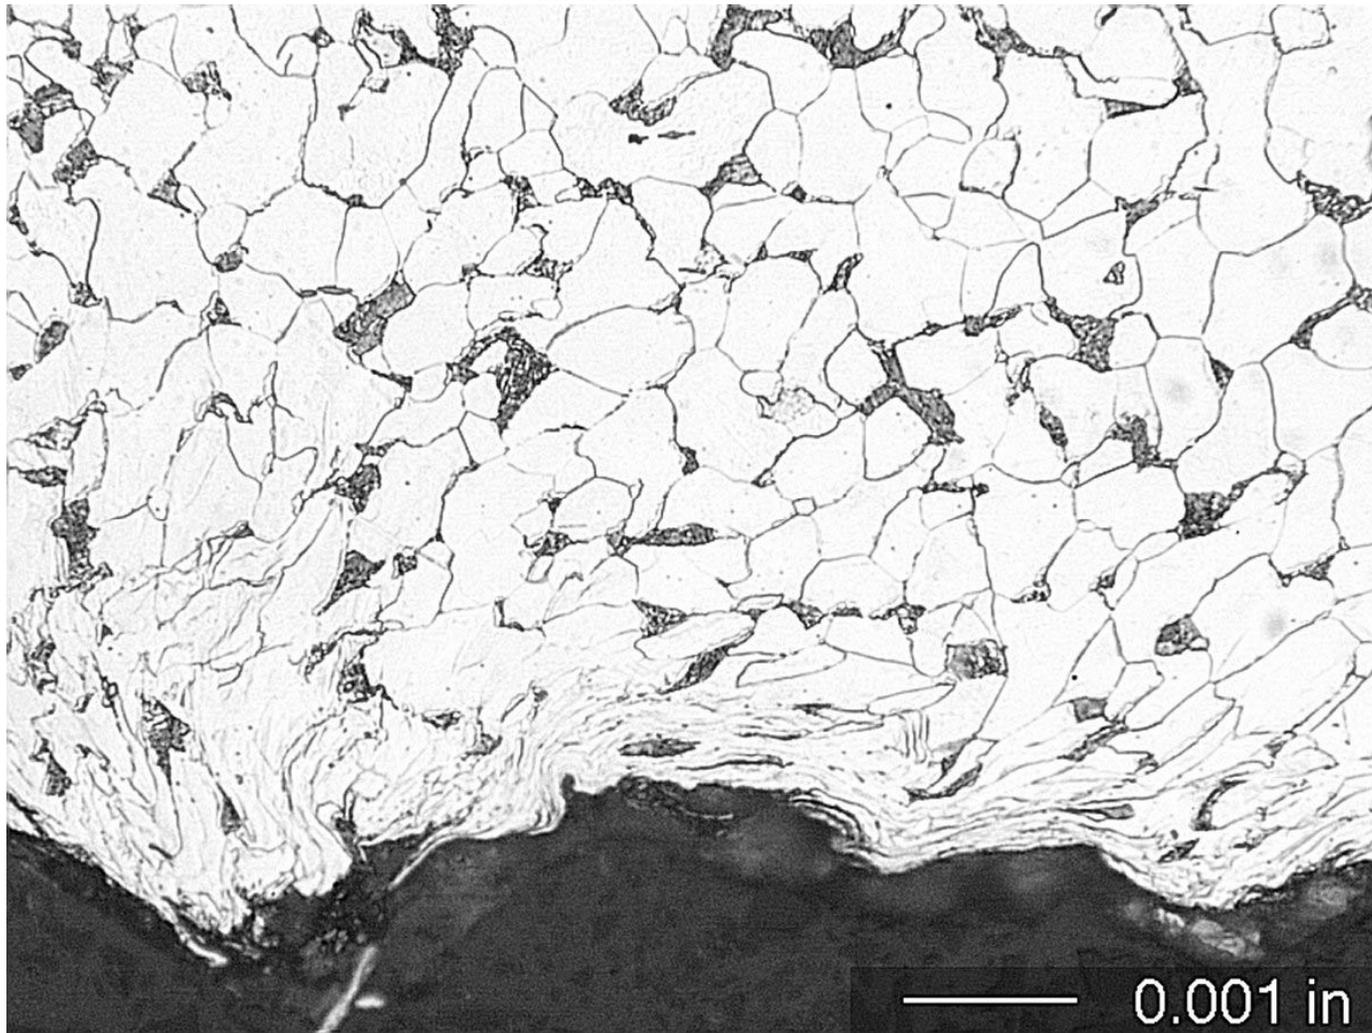
**FIGURE 23, TYPICAL LINER INTERNAL (ID) SURFACE MICROSTRUCTURES.**  
 ABUNDANT COLD-WORK, TYPICAL OF MANY CLEANING PROCESSES, IS EVIDENT.  
 NOTE: THIS IS TEST SAMPLE B-Q10-#2.

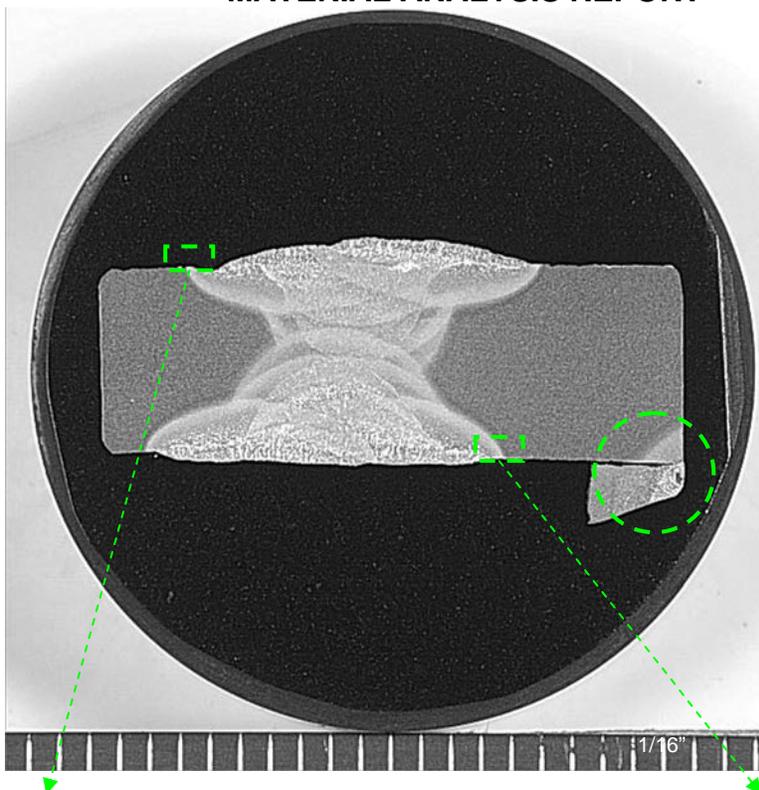
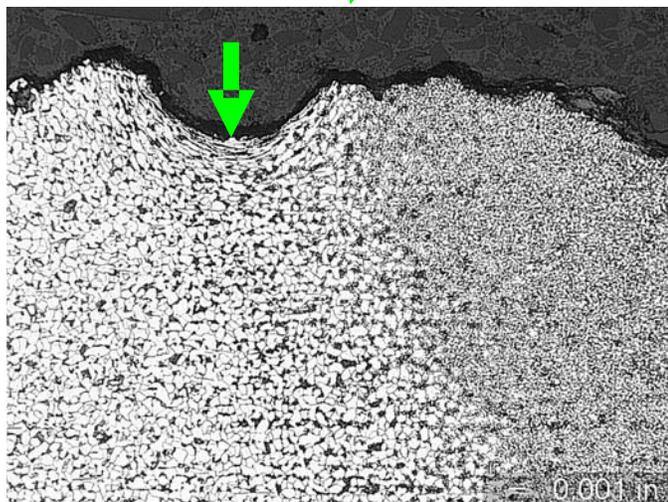
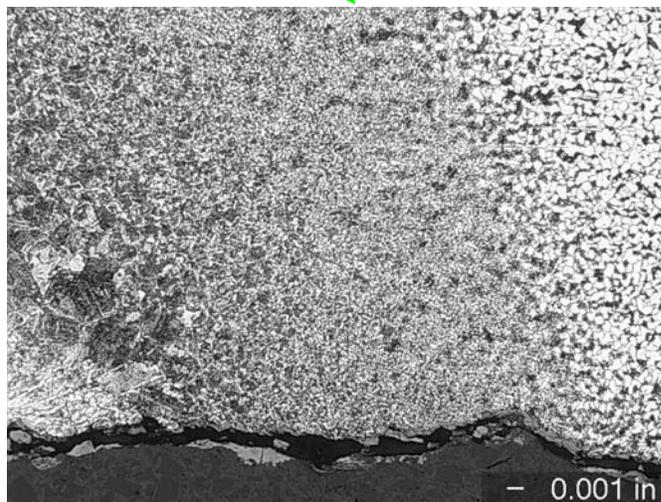
**FIGURE 24, LINER SAMPLE “B”, WELD SECTIONING RESULTS.**

A SOUND MULTI-PASS WELD, MADE FROM BOTH SIDES, IS REVEALED.

SOME COLD-WORK DISTORTION IS SEEN (ARROW) ON THE EXTERNAL (OD, CONCRETE SIDE) SURFACES.

NOTE: THE REMAINS OF PART OF ONE OF THE PRESSURE-TEST CHANNEL WELDS IS CIRCLED.

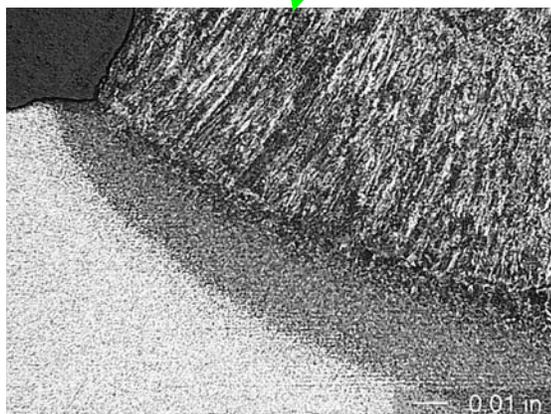
HEAT AFFECTED ZONE (HAZ) AND COARSE-GRAINED METAL TYPICAL OF A STUD-WELD.

**FIGURE 25, LINER SAMPLE "B", STUD-WELD SAMPLE SECTION RESULTS.**

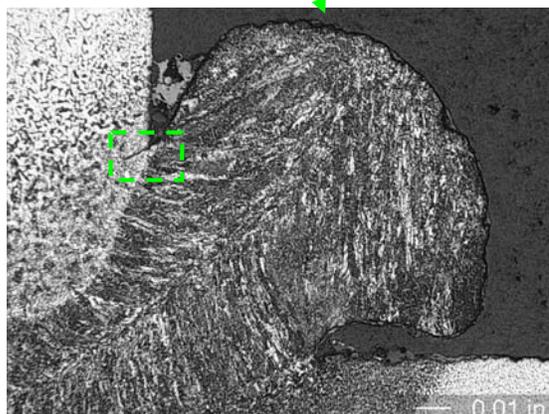
EXTRUDED FLASH TYPICAL OF A STUD-WELD; A SMALL CRACK-LIKE INDICATION IN THE STUD IS BOXED.

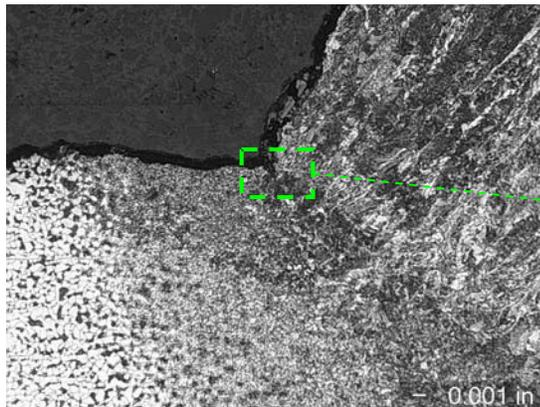
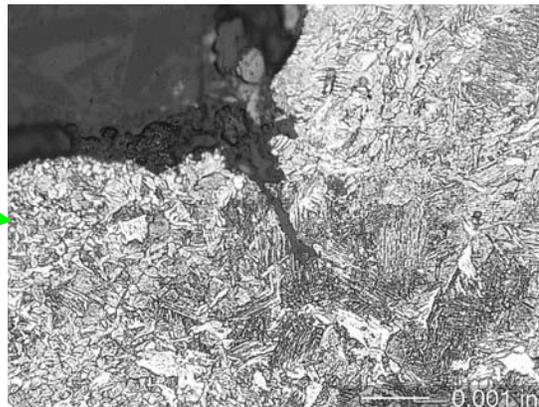
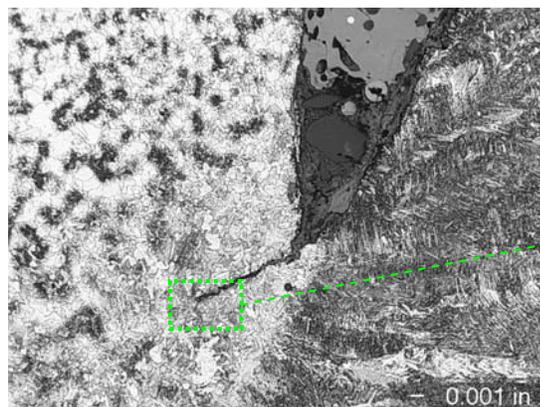
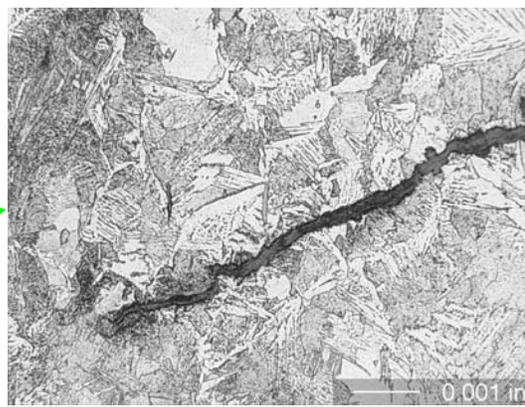
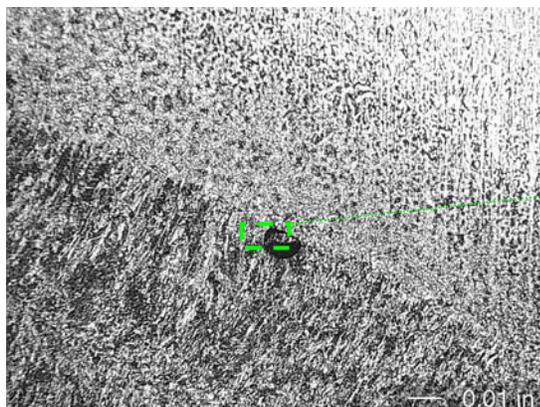
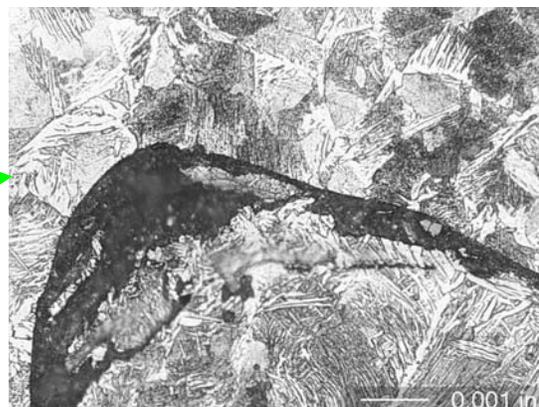
**A. STUD BASE METAL, LEFT SHOULDER INDICATION.**

**C. STUD BASE METAL, RIGHT SHOULDER INDICATION.**

**E. STUD FUSION LINE PORE OR VOID.**

**FIGURE 26, LINER SAMPLE "B", STUD-WELD SAMPLE SECTION MICROSTRUCTURES.**

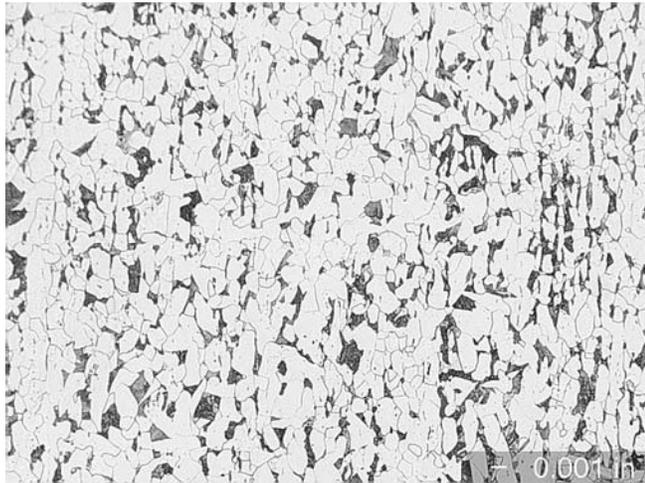
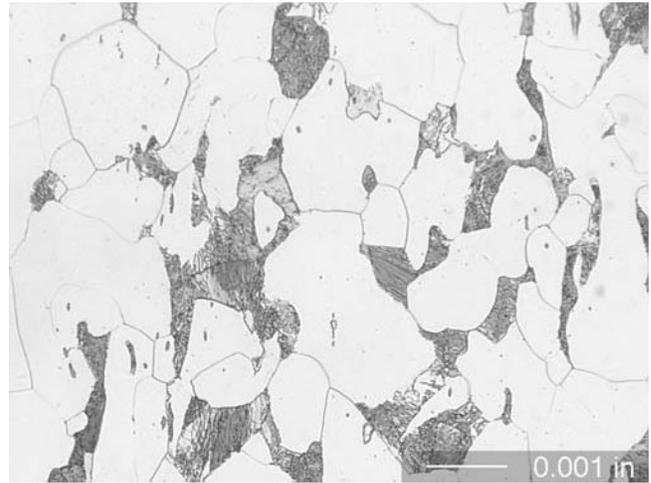
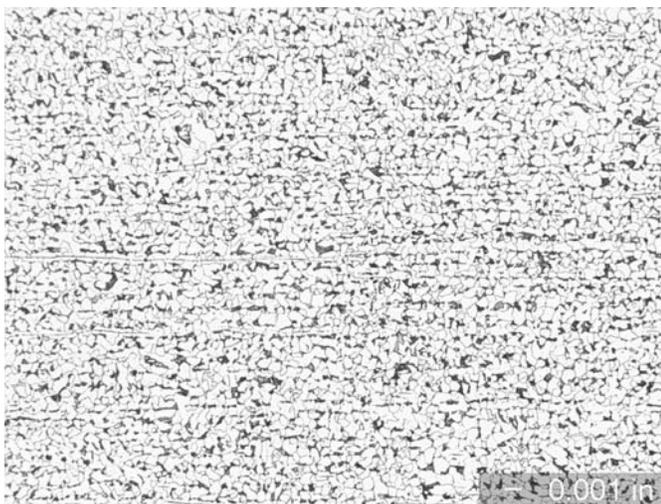
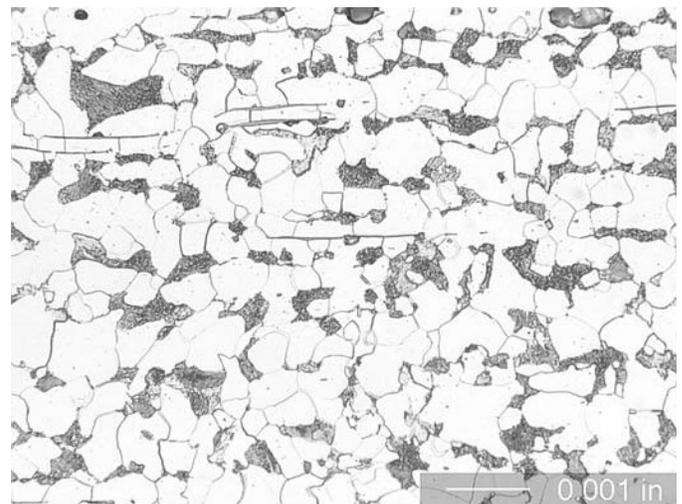
**FIGURE 27, LINER SAMPLE "B", STUD-WELD SAMPLE SECTION, BASE METALS;  
TYPICAL MID-WALL MICROSTRUCTURES.  
FERRITE (WHITE) AND PEARLITE (GRAY) WITH STRINGER INCLUSIONS.**
