LAB NO.: M06074	WORK TRACKING NO.: 14878	PAGE 8 OF 78
PLANT & UNIT: BEAVER VALLEY #1	PART: CONTAINMENT MATERIALS	DATE: 3/9/2006

**MATERIAL ANALYSIS REPORT**  
**TABLE 1, TESTS PERFORMED and RESULTS**  
(See Attachment #1 for Test/Equipment Specifications)

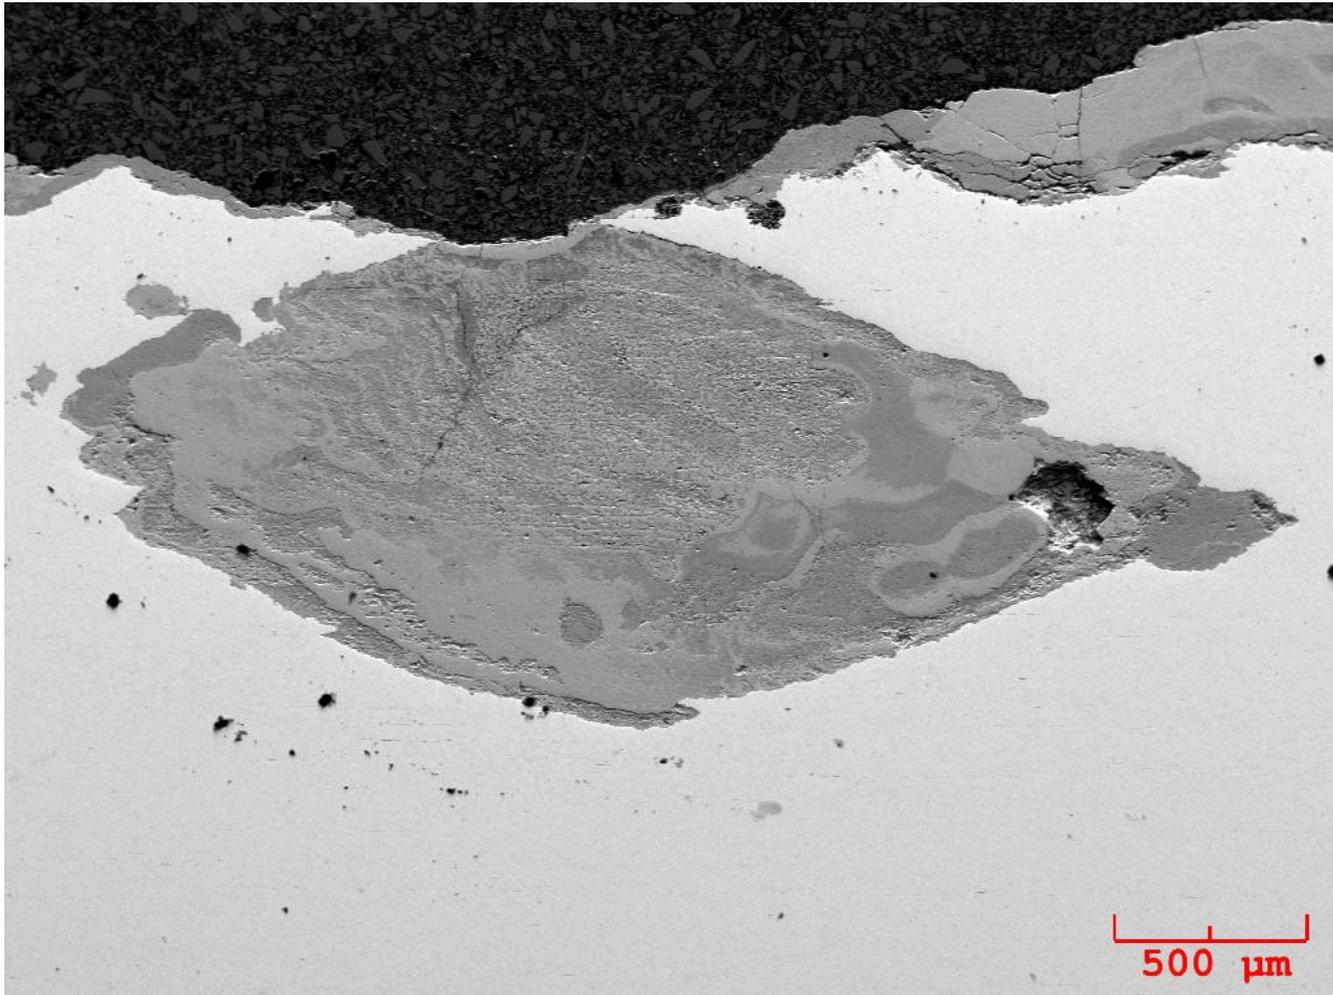
**FIGURE 28, LINER SAMPLE "A", QUADRANT #11, SECTION #3, UNDERCUT OD PIT IN THE SEM.**

TEST SAMPLE <sup>^</sup>	FIGURE	CHEMICAL COMPOSITION, WT. %												
		O	NA	MG	AL	SI	S	K	CL	CA	TI	CR	MN	FE
"A", Q11-#3, PIT-1	29	23.3	ND	ND	ND	0.3	ND	ND	ND	0.3	ND	ND	0.3	76.6
"A", Q11-#3, PIT-2	29	19.0	ND	ND	ND	0.6	ND	ND	ND	ND	ND	ND	0.3	80.2
"A", Q11-#3, PIT-3	29	23.7	ND	ND	2.7	1.8	ND	ND	ND	0.5	ND	ND	1.2	70.0
"A", Q11-#5, "SCALE"	35	23.4	ND	ND	0.3	0.7	0.7	ND	ND	2.3	ND	ND	0.4	72.1
"A", Q11-#6, "SCALE"	36	15.9	ND	ND	ND	1.6	ND	ND	ND	0.4	ND	ND	0.5	81.7
"B", Q10-#3, PIT-1	32	ND	ND	ND	ND	0.4	ND	ND	ND	ND	ND	ND	0.6	99.0
"B", Q10-#3, PIT-2	32	18.3	ND	ND	0.9	0.6	ND	0.3	ND	0.2	ND	ND	0.4	79.2

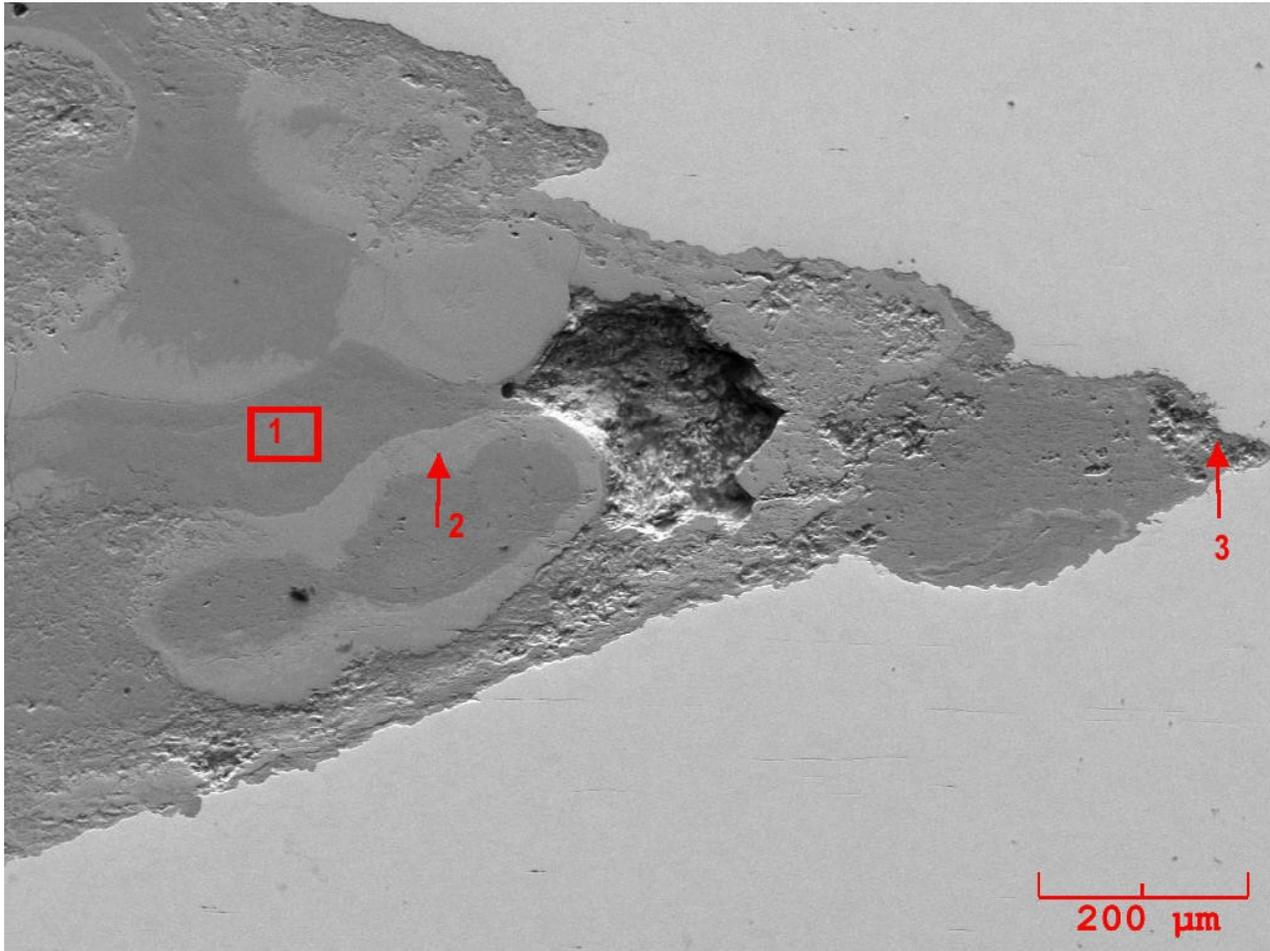
**FIGURE 29, LINER SAMPLE "A", QUADRANT #11, SECTION #3, UNDERCUT OD PIT, DETAIL IN THE SEM**

TEST SAMPLE <sup>^</sup>	CHEMICAL COMPOSITION, WT. %												
	O	NA	Mg	AL	SI	S	K	CL	CA	TI	CR	MN	FE
"BOX" 1	23.3	ND	ND	ND	0.3	ND	ND	ND	0.3	ND	ND	0.3	76.6
"SPOT" 2	19.0	ND	ND	ND	0.6	ND	ND	ND	ND	ND	ND	0.3	80.2
"SPOT" 3	23.7	ND	ND	2.7	1.8	ND	ND	ND	0.5	ND	ND	1.2	70.0

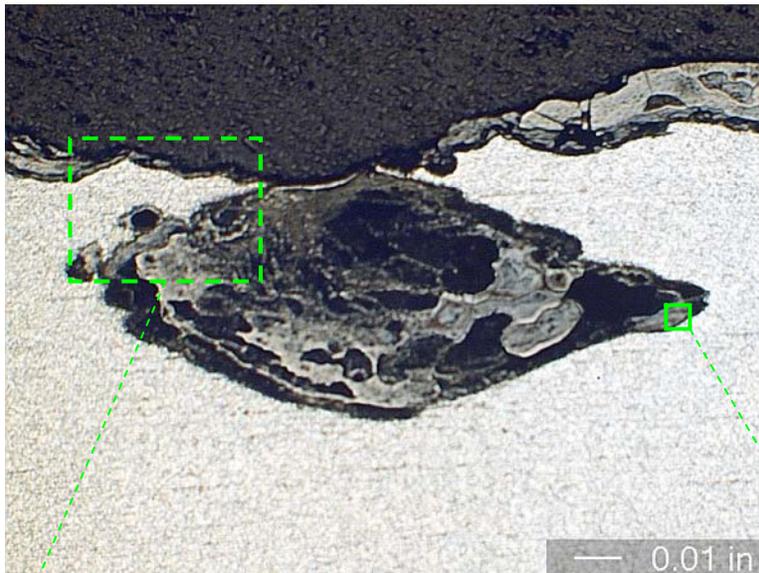
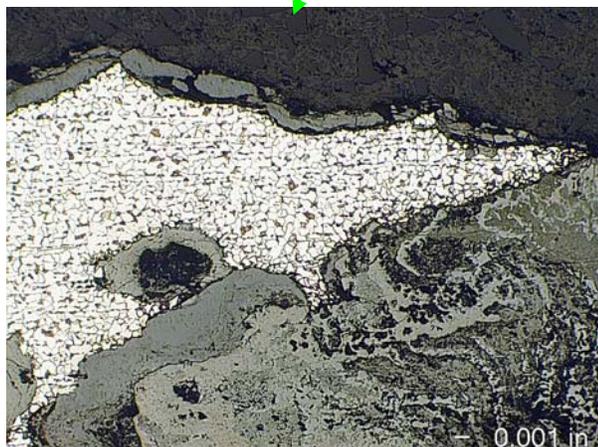
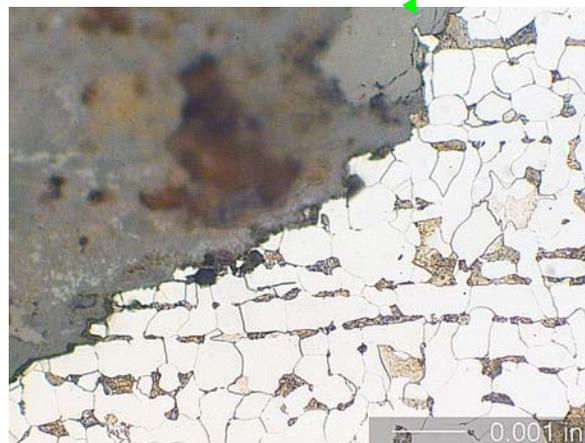
**FIGURE 30, LINER SAMPLE “A”, QUADRANT #11, SECTION #3, UNDERCUT OD PIT MICROSTRUCTURES.**

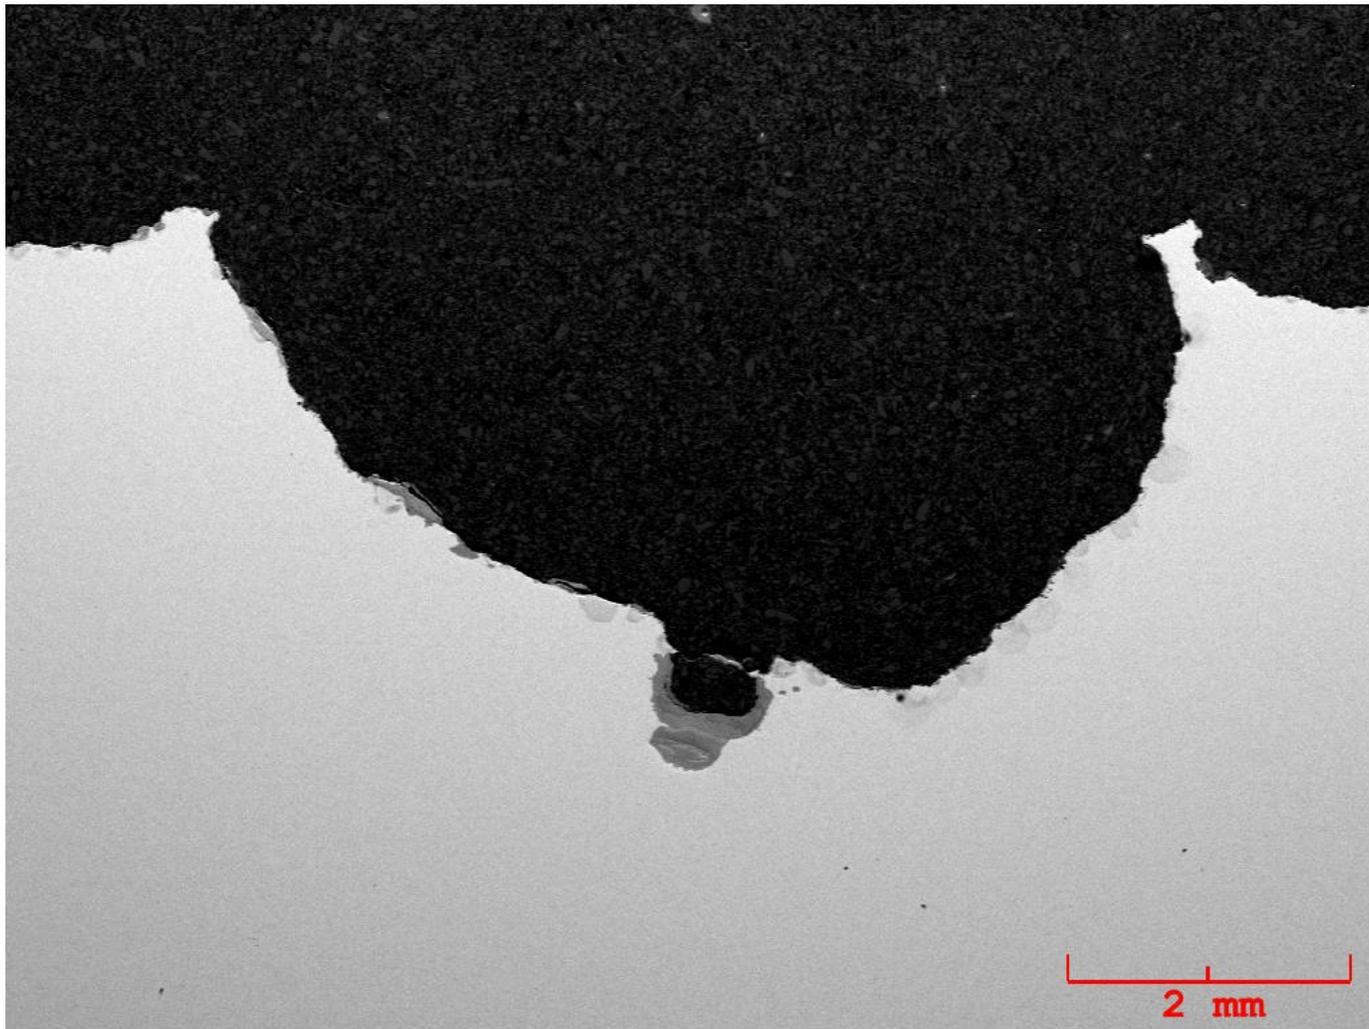
**FIGURE 31, LINER SAMPLE "B", QUADRANT #10, SECTION #3, OD PIT IN THE SEM.**
