May 19, 1997

**Re: Monthly Status Report**  
**Period of Work: April 1 through April 30, 1997**  
**Former EPEC Polymers Facility Located at**  
**Industrial Highway, Fords, New Jersey**

This report contains sections summarizing removal activities, site screening and surveys, materials handling, and other miscellaneous activities. Other sections in the report pertain to personal dosimetry, site visitors, and future on-site activities. Relevant figures and tables are also provided and referenced in the report.

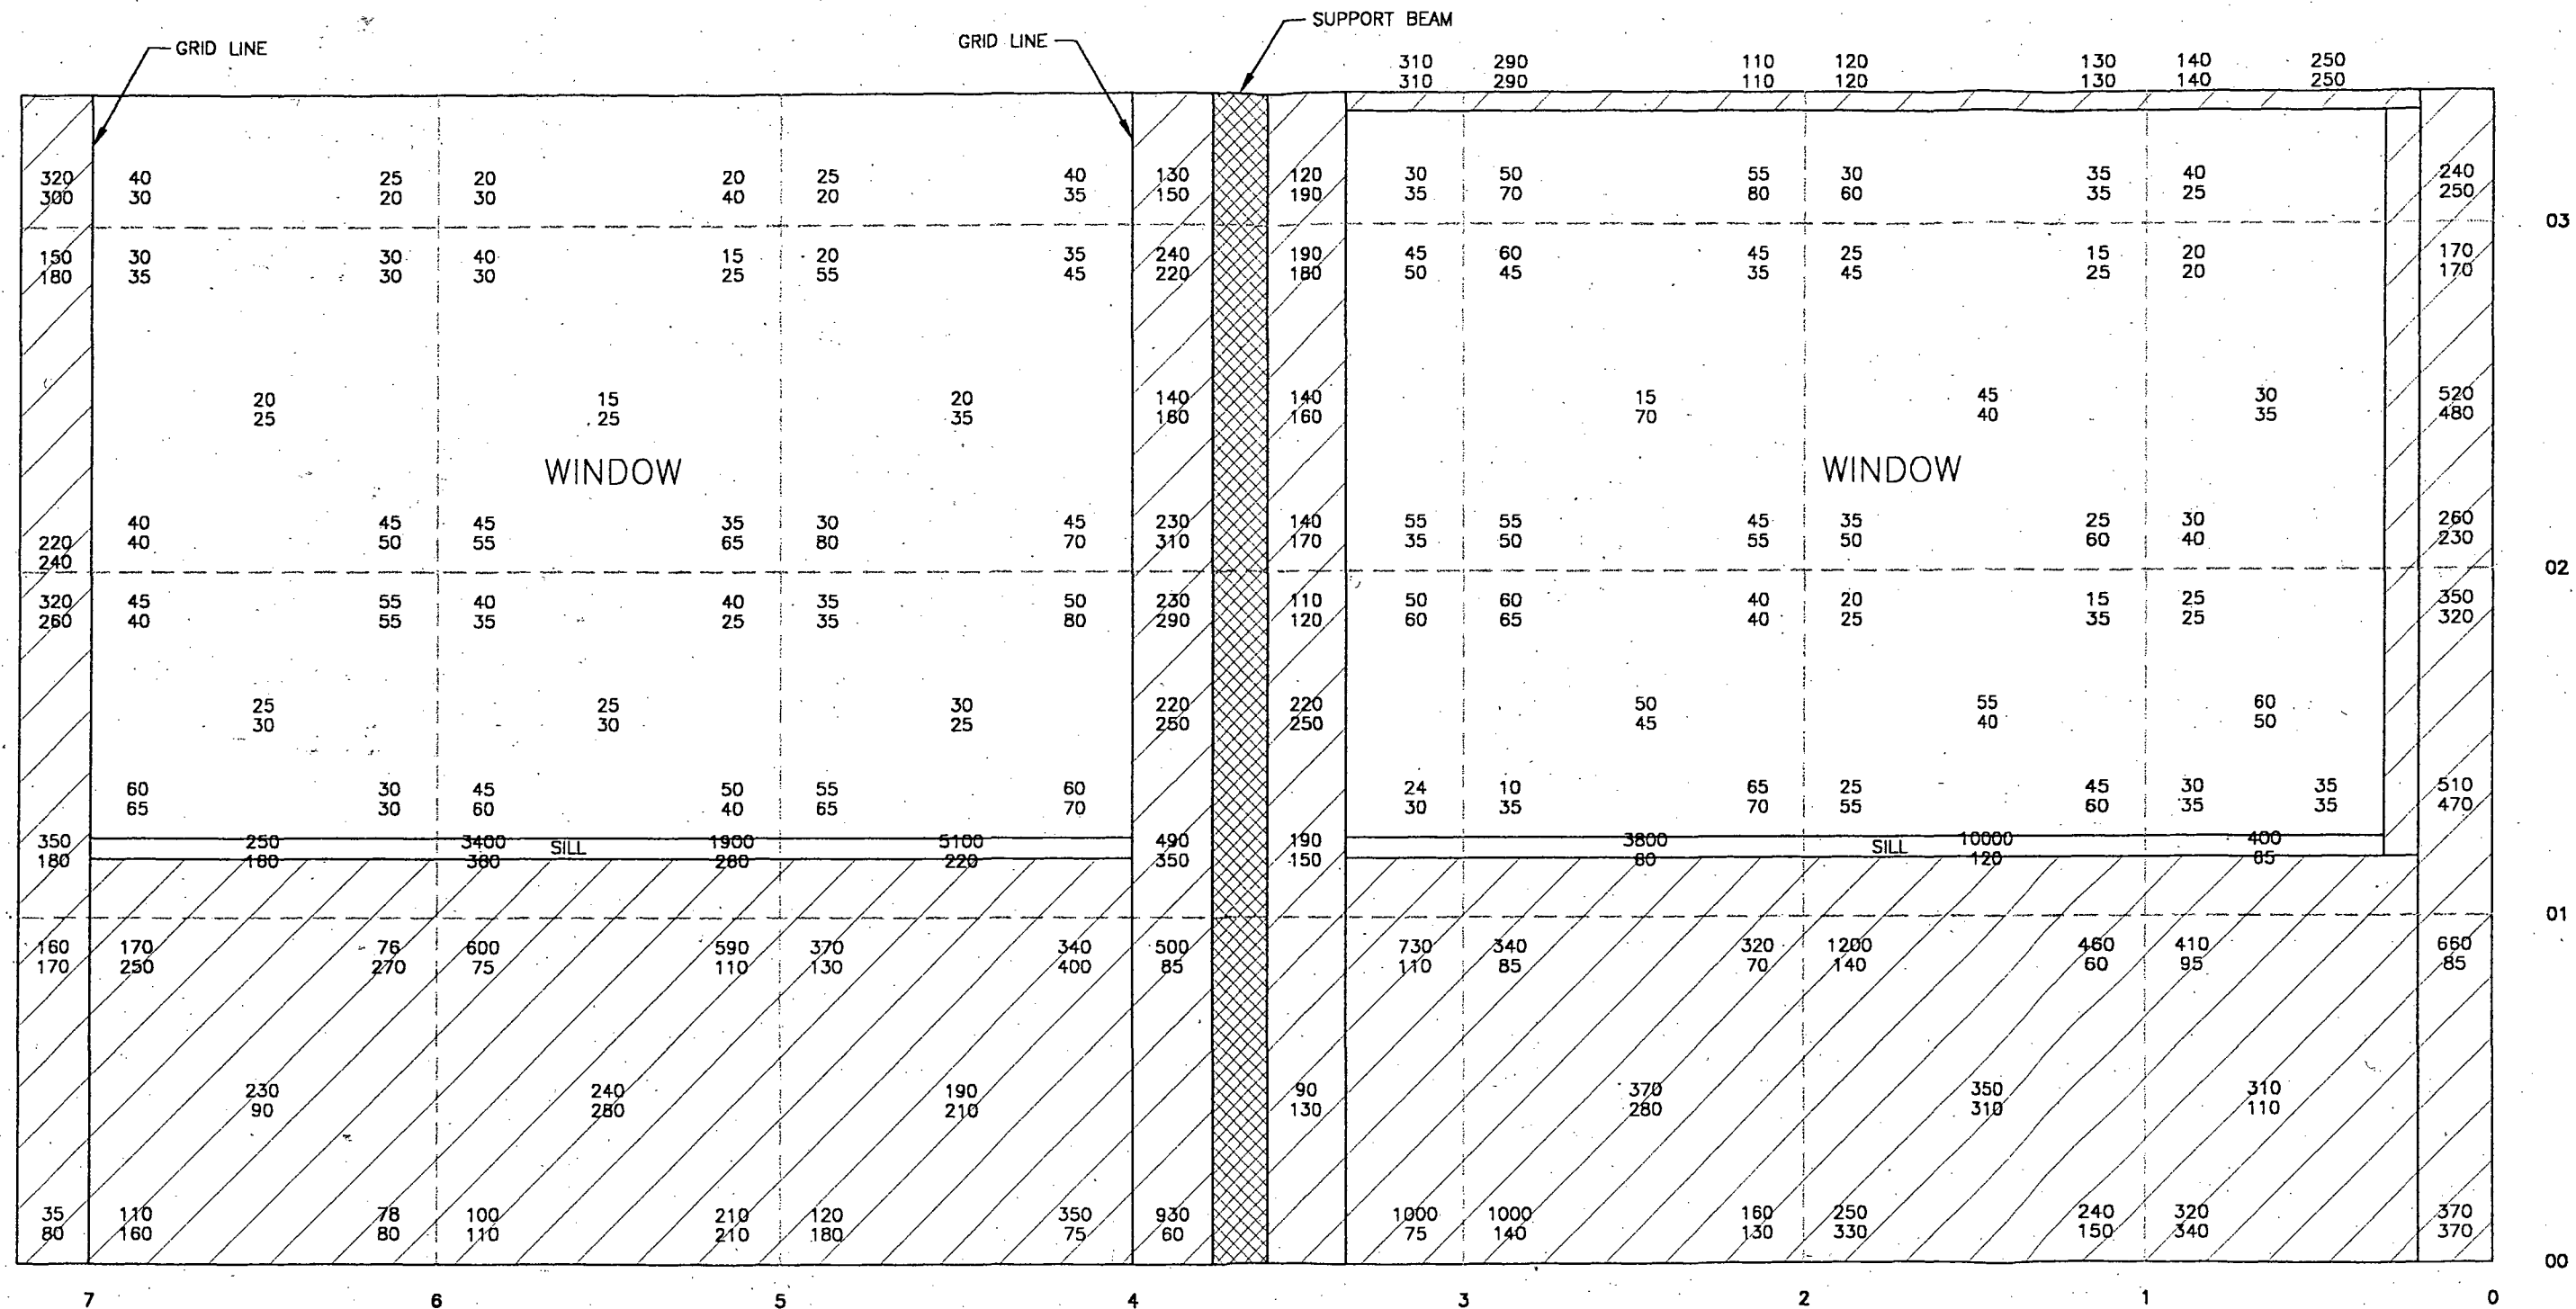
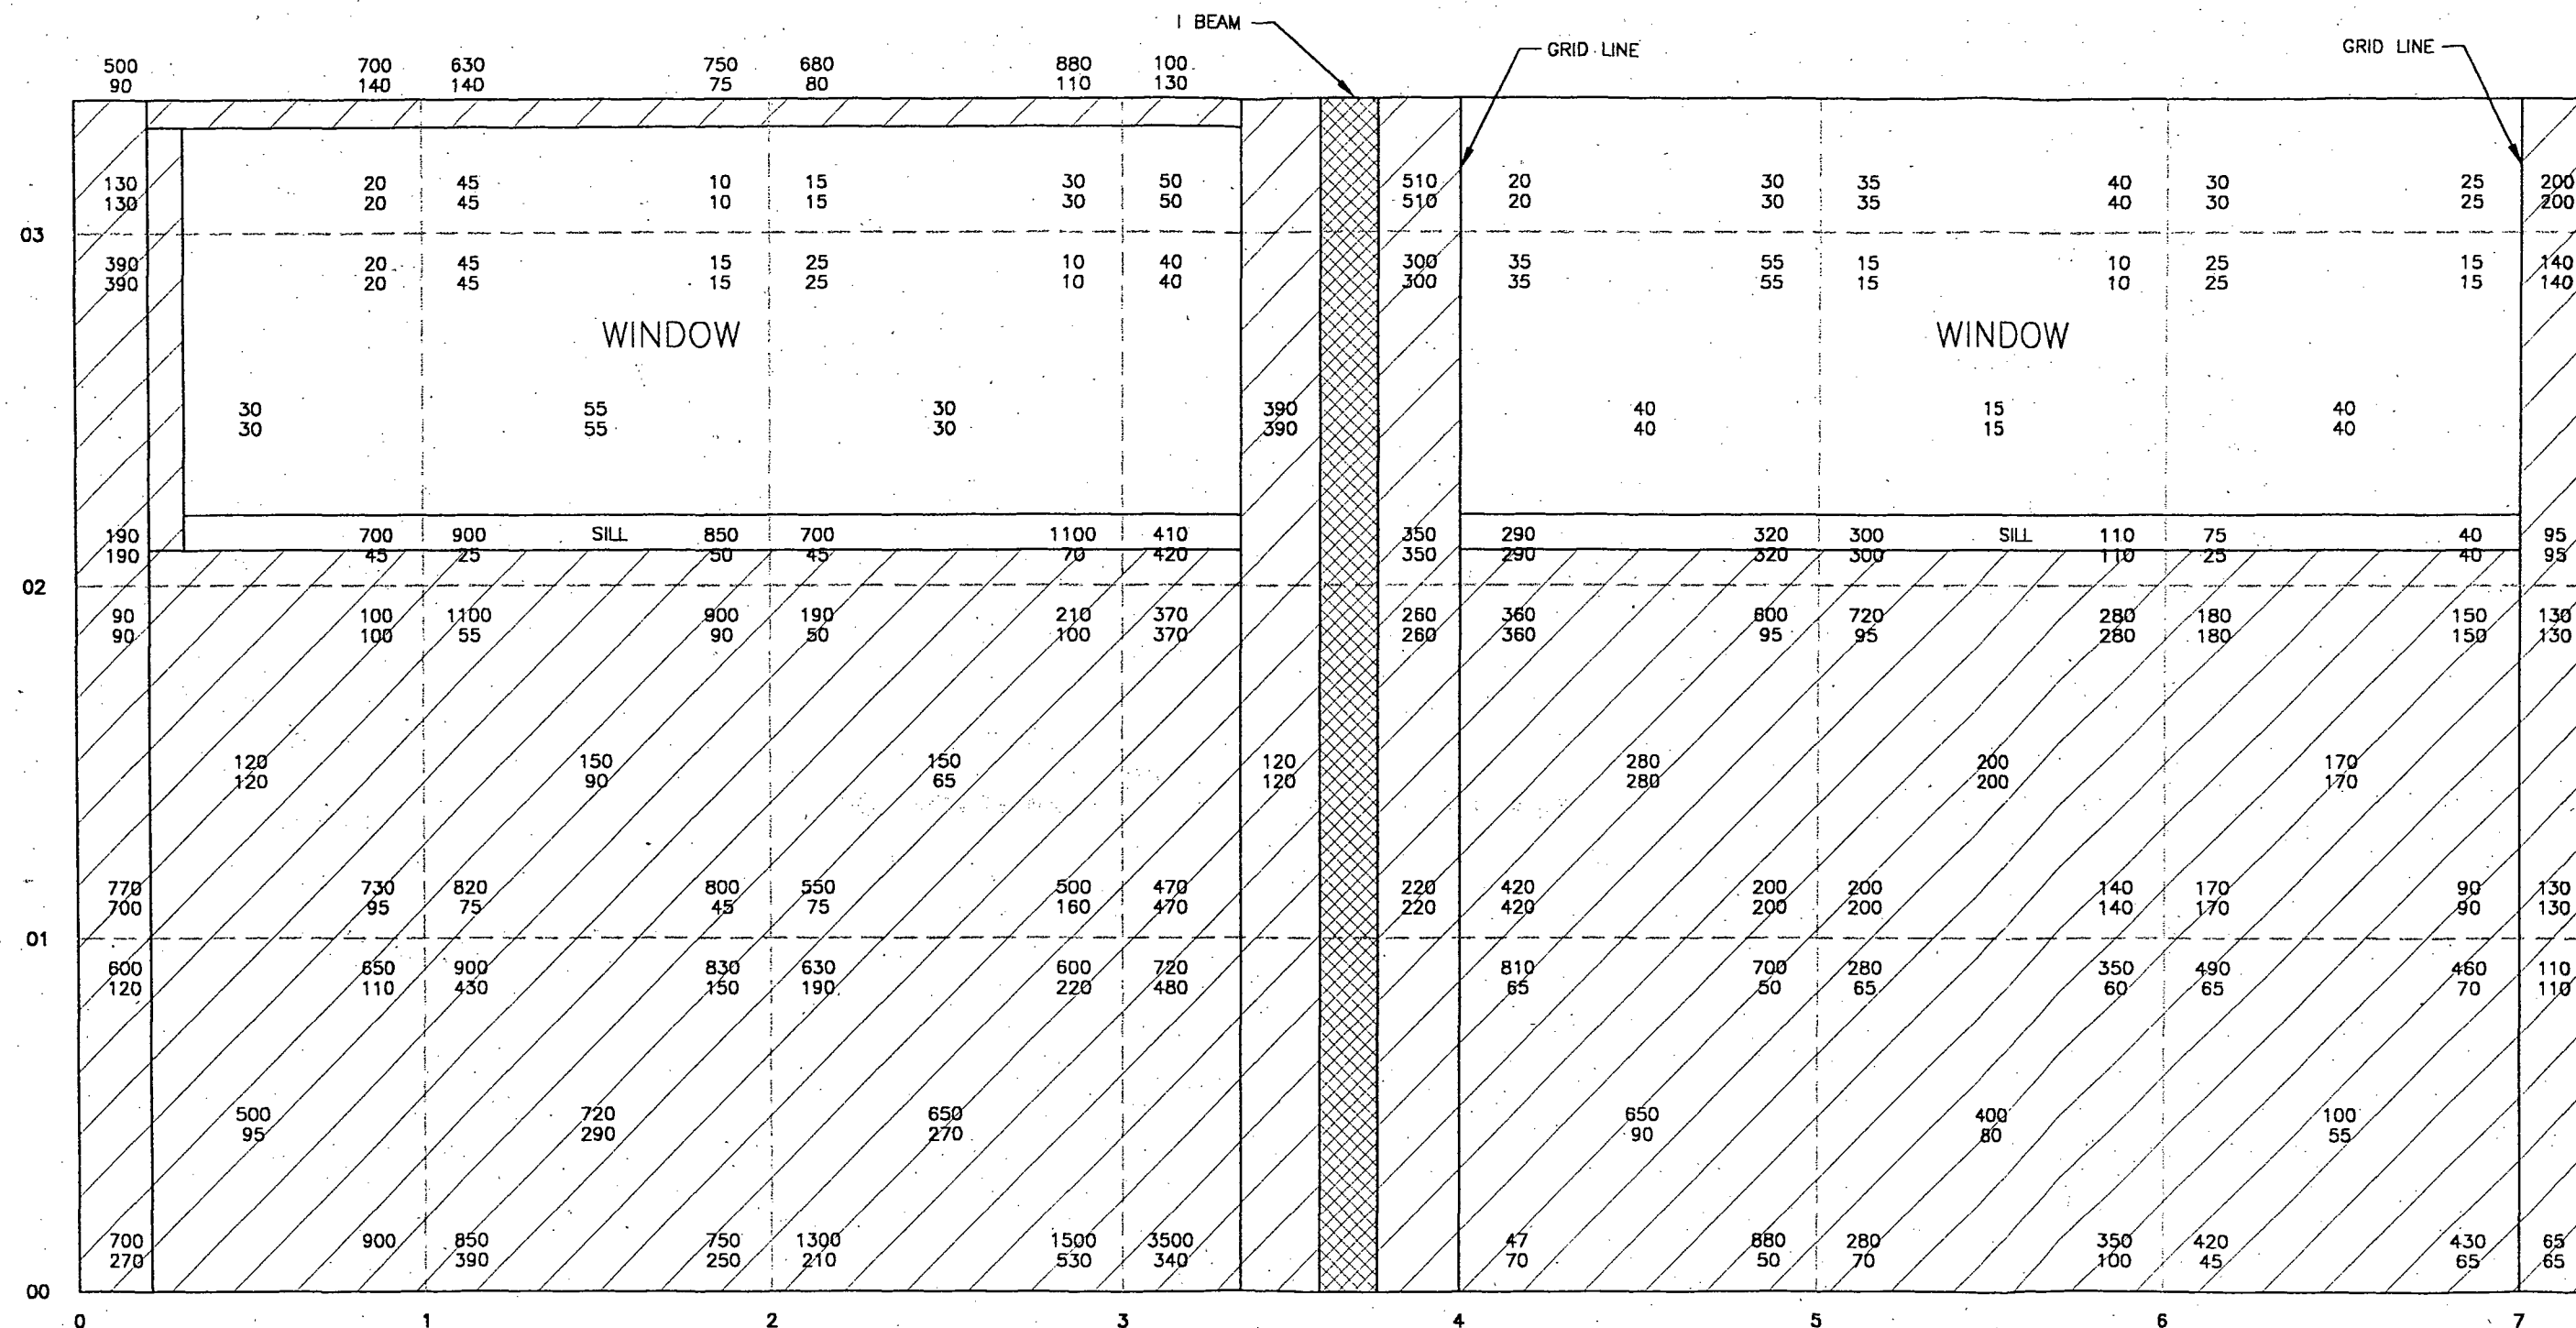
- Portions of the north and south walls were scabbled with a rotary hammer equipped with a chisel bit. Since radioactive surface contamination was discovered on portions of the entire north and south walls, scabbling coverage was not limited to the lower walls but continued to the ceiling in some areas. Contaminated concrete pieces were placed in a drum and clean concrete was placed in the clean material stockpile area in Building 31.

- Figures 9 and 10 provide the screening results prior to and after scabbling of the north and south walls in the CPR. The walls consist of a red brick whose background radiation was determined by collecting 5 measurements from the second floor, 5 measurements from the third floor, 5 measurements from the fourth floor, 5 measurements from the chimney, and 5 measurements from the exterior of Building K-12. The measurements were collected with the Ludlum Model 2221 attached to the Ludlum Model 44-40 G-M detector. The average brick background value is 70 cpm and the standard deviation is 14 cpm. The values that are used for fixed radioactive surface contamination are 300 cpm averaged over 1 square meter and 900 cpm maximum.
