Figure 2-15. Failure stress vs. time-to-failure for second round testing of 185 Keno specimens. Forty one specimens have failed as of December 2003.

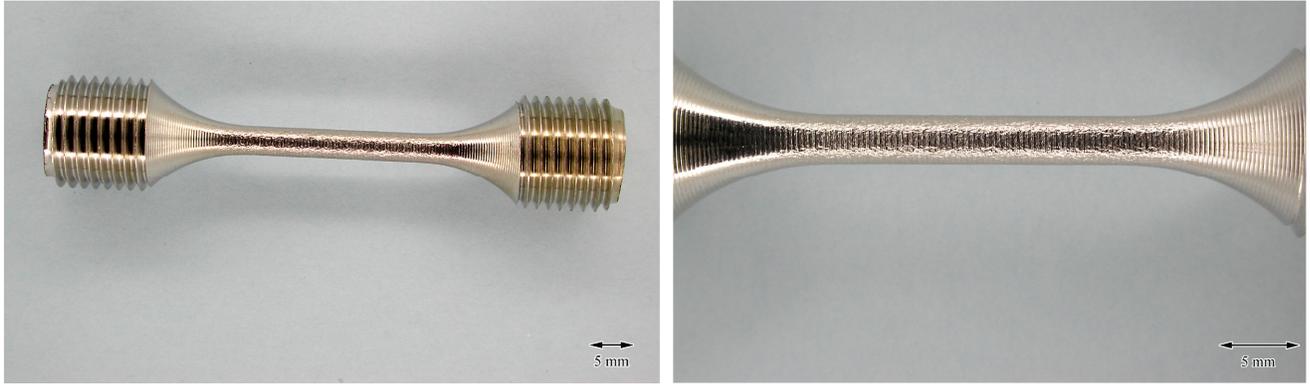
Figure 2-16. Specimen 45 (run 2): 316 NG as-received specimen; no signs of corrosion after 2462 hrs exposure at 70 ksi.

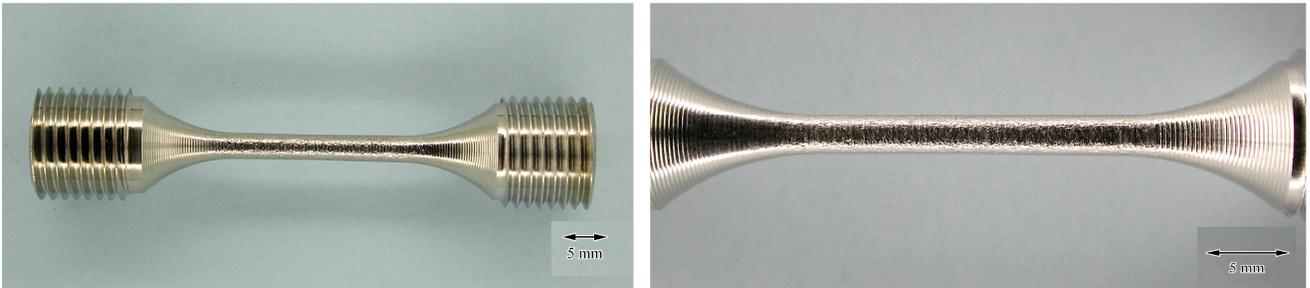
Figure 2-17. Specimen 100 (run 2): C-22 as-rec + HT1 (TCP) . No signs of corrosion after 2462 hrs at 93 ksi

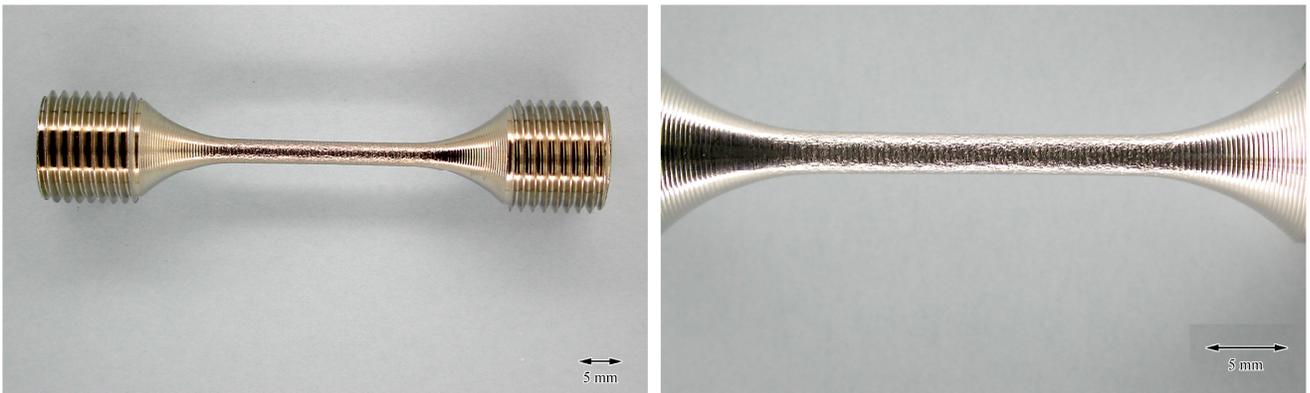
Figure 2-18. Specimen 87 (run 2): C-22 as-received; no signs of corrosion after 2462 hrs at 100 ksi
