PNNL-18596

Technical Letter Report

Assessment of Ultrasonic Phased Array Inspection Method for Welds in Cast Austenitic Stainless Steel Pressurizer Surge Line Piping

JCN N6398, Task 1B

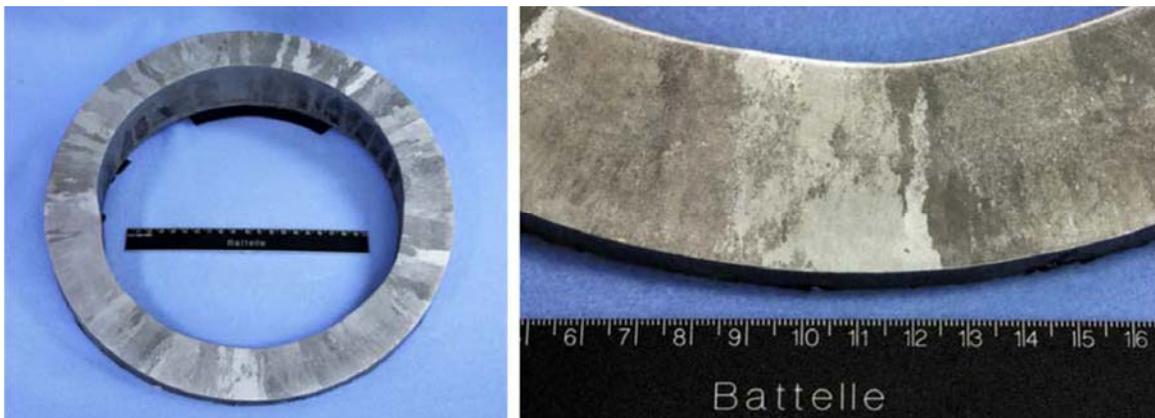
Figure 3.4. WNP-3 Surge Line Elbow Microstructure

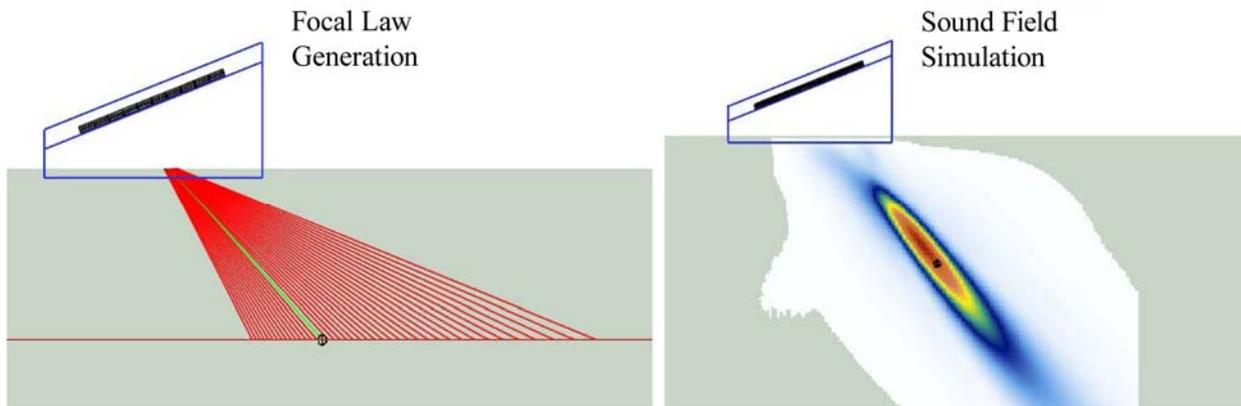
Figure 4.1. The ZETEC[®] Advanced Phased Array Calculator is Useful for Generating Focal Laws (left) and Simulating the Sound Field for the Focal Law (right) to Determine Beam Characteristics

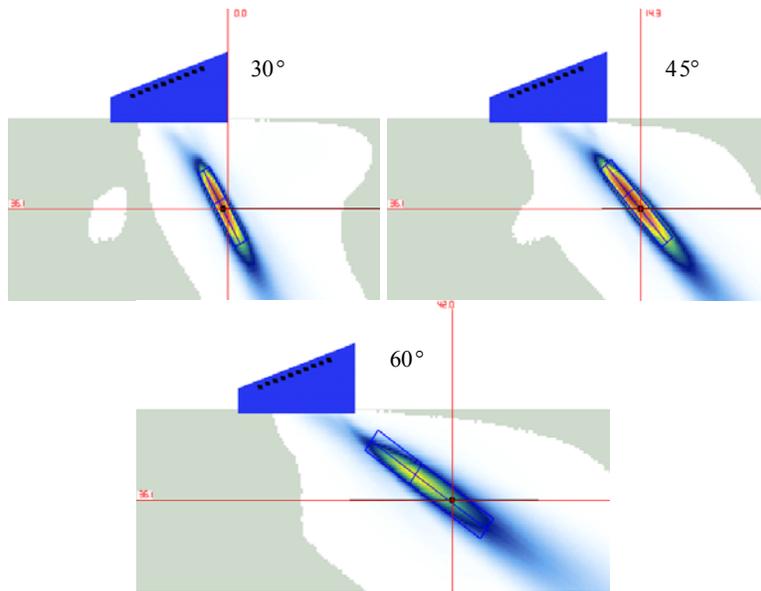
Figure 4.5. Simulations of the Beams Created by the 1.5-MHz TRL Arrangement for 30°, 45°, and 60°

Example simulations of the 1.5-MHz probe steered to 30°, 45°, and 60°, focused at a depth of 36 mm (1.4 in.), is shown in Figure 4.5. The wavelength for a 1.5-MHz probe is 3.8 mm (0.15 in.). From Figure 4.6, the 1.5-MHz probe was found to produce a beam with a horizontal width of 5.01 mm (0.20 in.) by vertical width of 3.81 mm (0.15 in.) at 45° at the -3dB points.

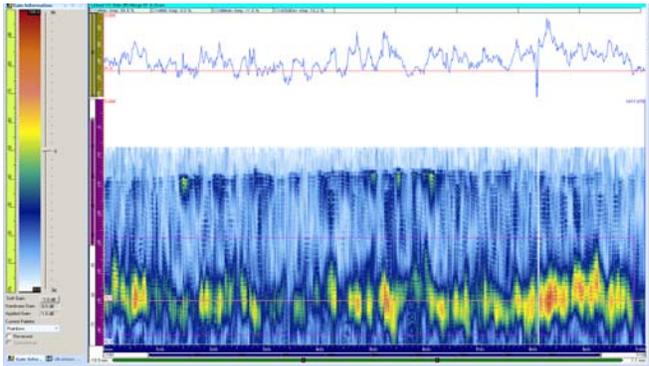
Figure 7.17. Pipe End Corner Response on 9C-002 at 800 kHz. The end view is on the left and the polar view on the right. A signal dropout of 14.4% is measured from the contour line in the end view.
