RAI 7

Three Mile Island, Unit 1
 DRAFT RAI Responses Provided in
 Support of Discussions with NRC on Sept. 23, 2009

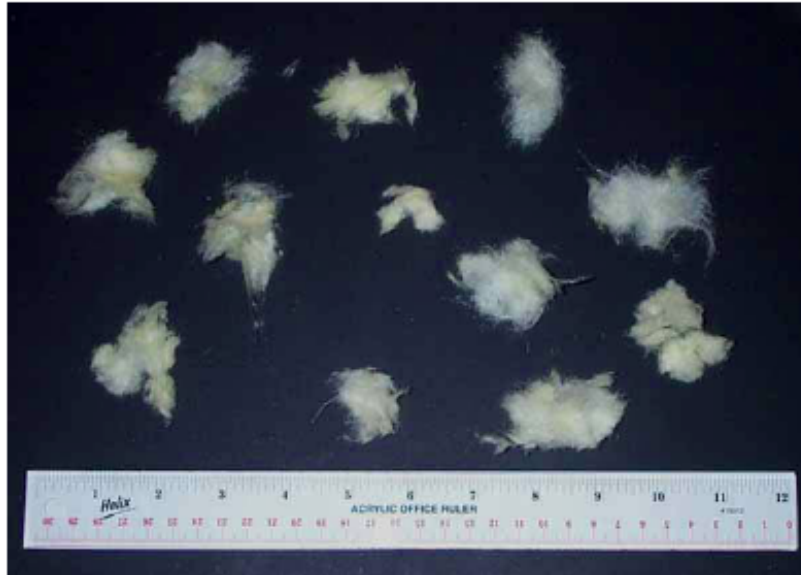
Historically, small-fines have been considered to be Class 1 through 6 as described in NUREG/CR-6224 (see Table 3-2 below). Based on the assumed size definition of less than 4” nominally, Classes 1 through 6 represent “small-fines.” For illustration, Class 5 debris is shown in Figure 7-1 and represents fiberglass fragments that are defined as “transportable” as they tumble and slide along the floor.

Fiberglass shreds in size Class 5

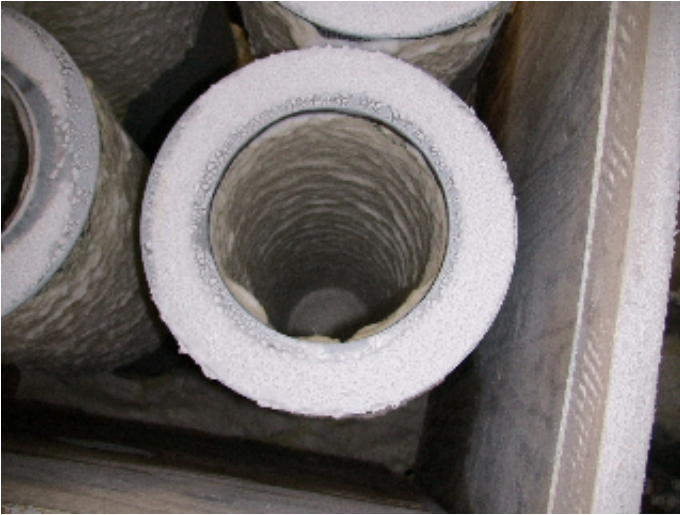
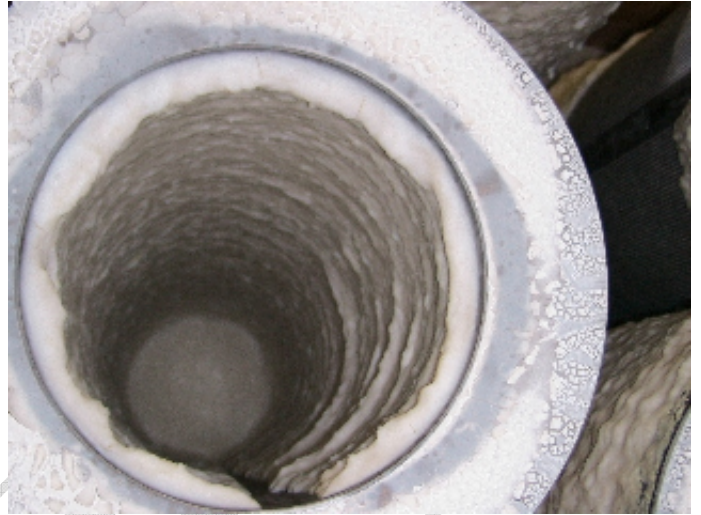
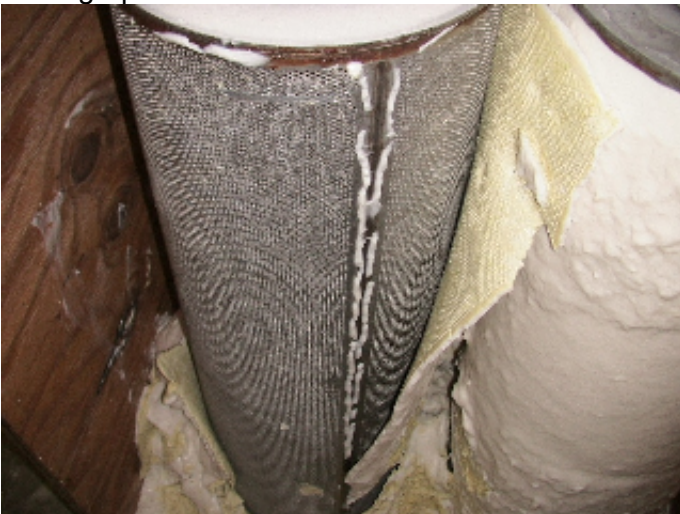
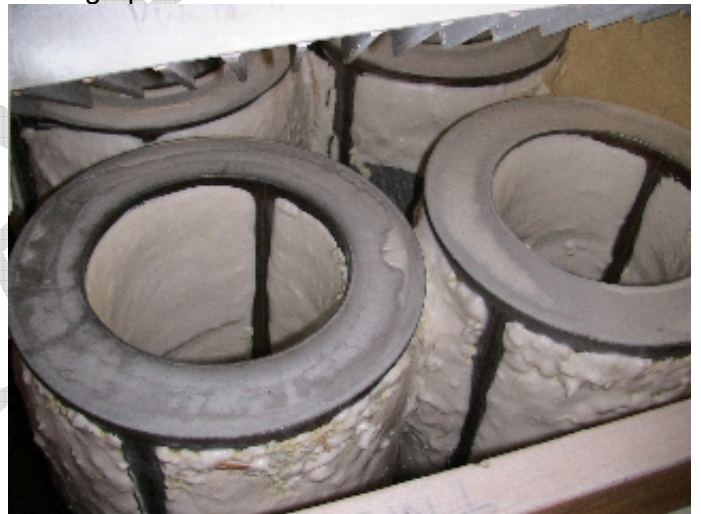
following photographs were taken following draindown after the NRC witnessed 2006 Test 1B.
Note the uniform deposition and fineness of the debris at the screen surface in Photo #3.

Photograph #1: 2007 Test 1B

Photograph #2: 2007 Test 1B

Photograph #3: 2007 Test 1B

Photograph #4: 2007 Test 1B

Review of the 2006 Test 1, 3, 4 and 2007 Test 1B indicates that under a variety of load conditions, the screen design is not susceptible to thin-bed effects as has been Alion's experienced with this screen design. This is due to the non-uniform approach velocity and debris deposition. The Mar-2007 1B testing, as well as the earlier 2006 testing, did notice considerable debris settling of small pieces; however, the screen was completely covered in fines, which is a realistic scenario to produce a thin-bed effect considering some settling of small pieces. In all four cases involving small debris quantities with sedimentation of the larger "small/fine" debris fragments (2006 tests 1, 3, and 4 and 2007 test 1B), the thin-bed head loss is consistently much lower than the limiting load cases head losses, from which one can conclude that the thin-bed does not produce limiting head losses. In particular, 2006 Test 3 and 2007 1B produced essentially identical results, and both tests were completely covered in "fines." The

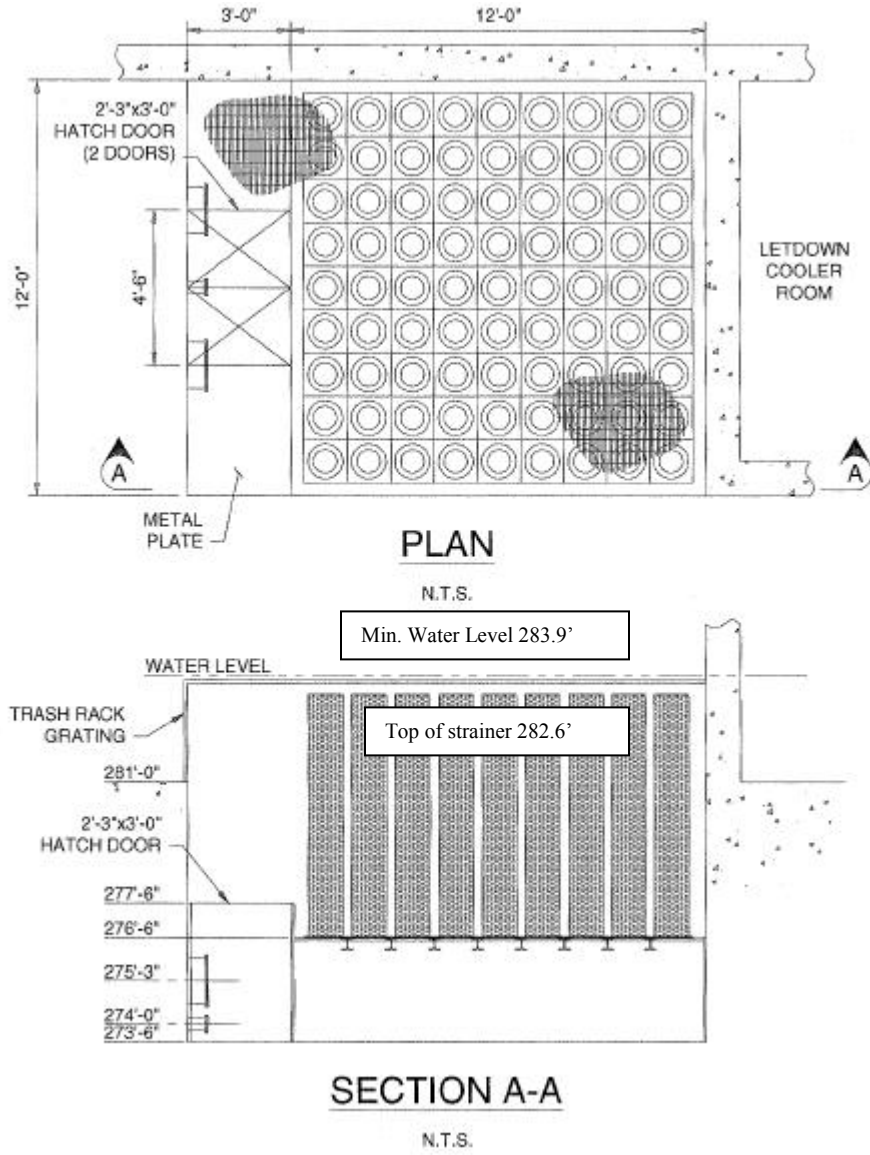
Figure 11-1: TMI-1 Containment Sump Configuration

An illustration of the TMI-1 strainer is provided in Figure 11-1. The minimum water level is at elevation 283.9' and the top of the strainer top hat is at elevation 282.6' which provides approximately 1.3' of submergence to the top of the strainer top hat. As shown in the figure, the Emergency Core Coolant System (ECCS) pump suction inlet centerline is at elevation 275'-3" which provides approximately 8.5' submergence. Given the orientation of the vertical top hat strainer at TMI-1, flashing within the strainer at the debris bed due to potentially minimum submergence would, if it occurred at all, occur at the top of the strainers first. Therefore, the flashing analysis evaluates hydraulic conditions at the upper top hat elevation.

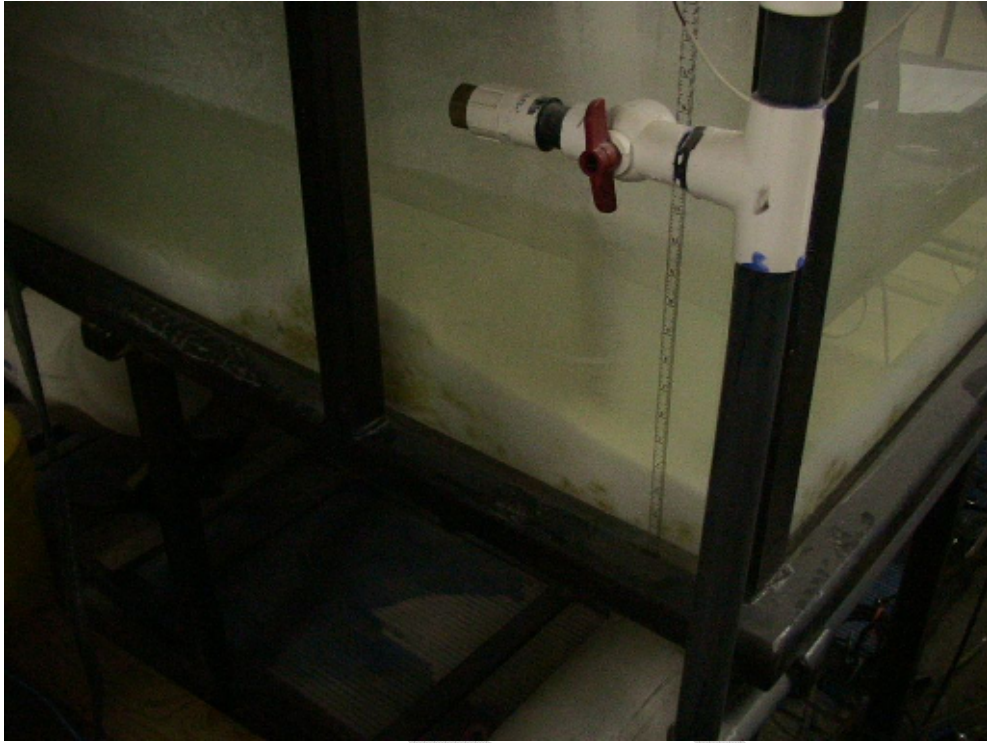
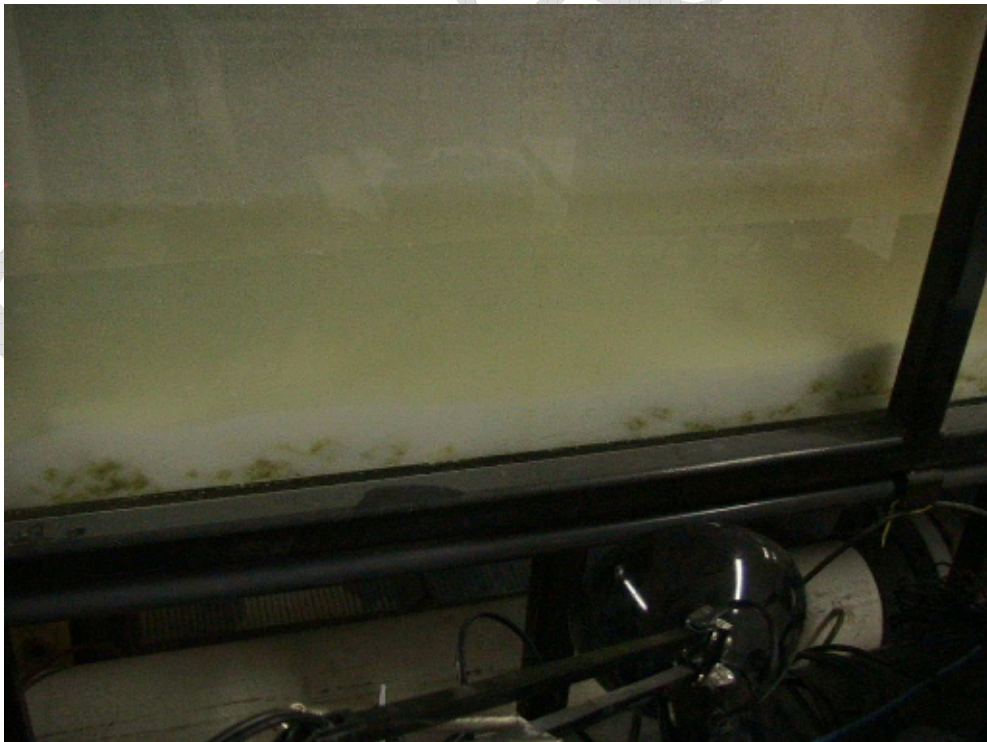
The test configuration previously used in Alion Tests employed top hat arrays consisting of 9 total top hats (3 x 3 array). However, in order to accommodate the volume of chemical precipitates introduced to the tank in the March 2007 test, the array size was reduced to utilize a total of 4 top hats (2 x 2 array). This required a lower overall test flow rate to maintain the proper approach velocity at the strainer surface. For the 2 x 2 array, flow was reduced to 44% of the rate associated with the 3 x 3 arrays previously tested. This greatly reduced the effectiveness of the standard diffuser and allowed for the accumulation of settled physical and chemical debris on the floor of the test tank. Manual agitations of the tank were also not effective in suspending the settled debris sufficiently. Photographs 1 and 2 show the settled debris visible in the tank at the end of the March 2007 testing.

Photograph 1 – Settled Debris from TMI-1 Test Conducted 3/07 (southwest corner)

Photograph 2 – Settled debris from TMI-1 Test Conducted 3/07 (front edge)

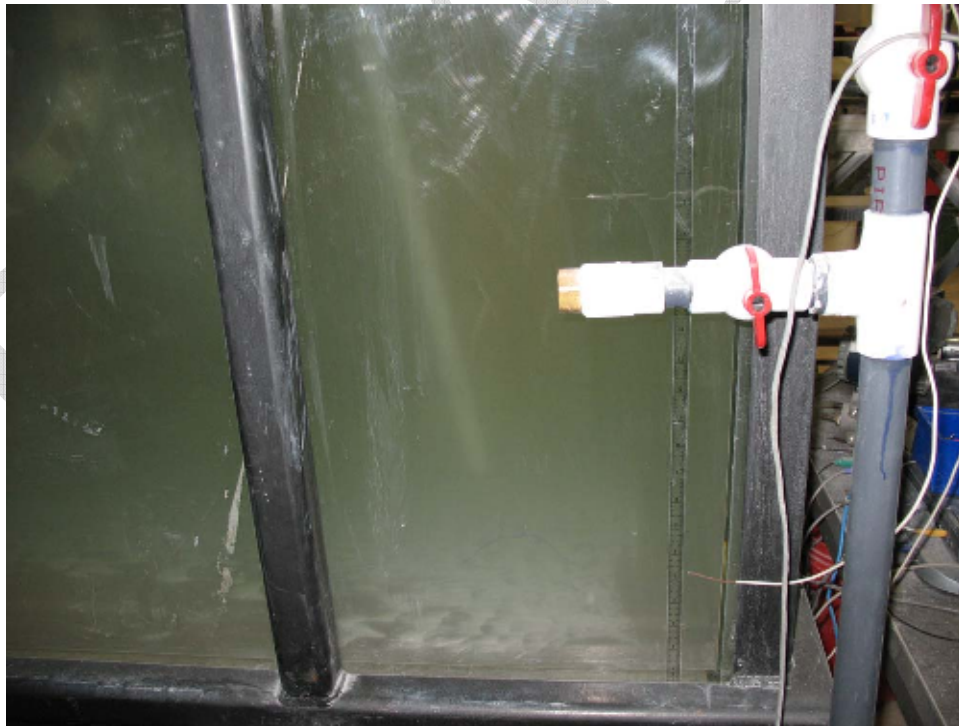
Photograph 3 – Post Debris Addition TMI-1 Test 11/07 (southwest corner)

At the conclusion of the test, it could be seen that Alion’s improvements to tank agitation methods greatly reduced the amount of settled debris. Photograph 3 below illustrates the tank condition after all debris had been introduced to the experiment. This photograph shows the southwest corner of the tank and can be directly compared to Photograph 1 from the March 2007 test (1B).

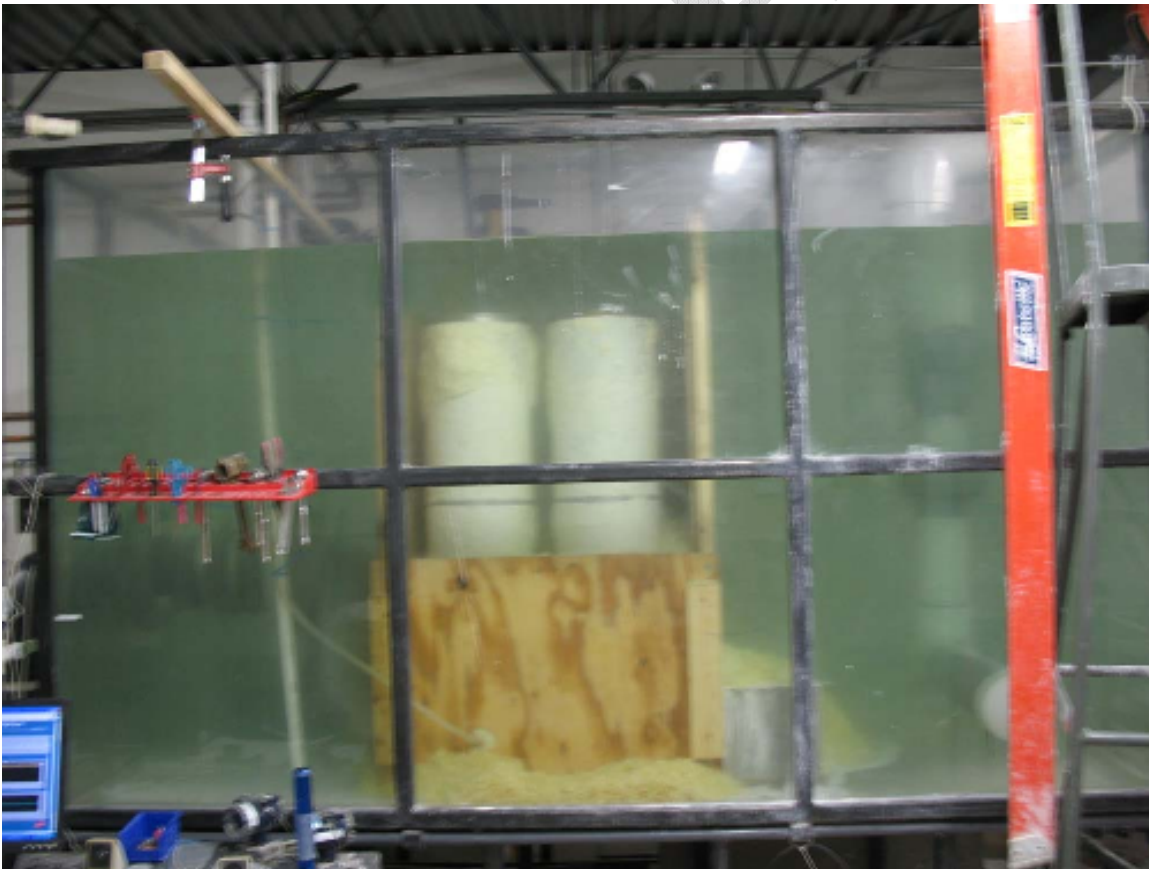
Photograph 4 – TMI-1 Test 11/07

After all debris had been introduced to the tank and consistent attempts to keep the debris in suspension were performed, a small amount of fibrous debris could still be observed in isolated areas of the test tank floor. Photograph 4 shows the final condition of the test. By observation, the only debris component observed to have settled is the largest fiber class. The majority of the fibrous debris, along with the particulate and chemical precipitate debris had accumulated on the sump screen. The amount of settled fiber at the end of Test 2B is estimated to be approximately 10%. Since the bed thickness in this full load case is 1.1", a reduction of 10% would change the bed thickness to 1". A difference of 0.1" in bed thickness in the maximum load case is negligible. As shown, based on the clarity of the water, the particulate has been filtered and the head loss is in general higher with higher particulate to fiber ratios (thinner bed) assuming fiber loads that do not fill in the interstitial volume (which is the case here). The head loss at this point is dominated by the thin, tightly packed debris layer on the surface of the screen. The settled debris is extremely "fluffy" (roughly 98% voids), therefore the impact of this debris on the measured head loss would be insignificant. As can be seen in the photograph, there is already a considerable amount of the fluffy debris within the sump box. Based on this, the settled debris does not have a significant effect on the results.

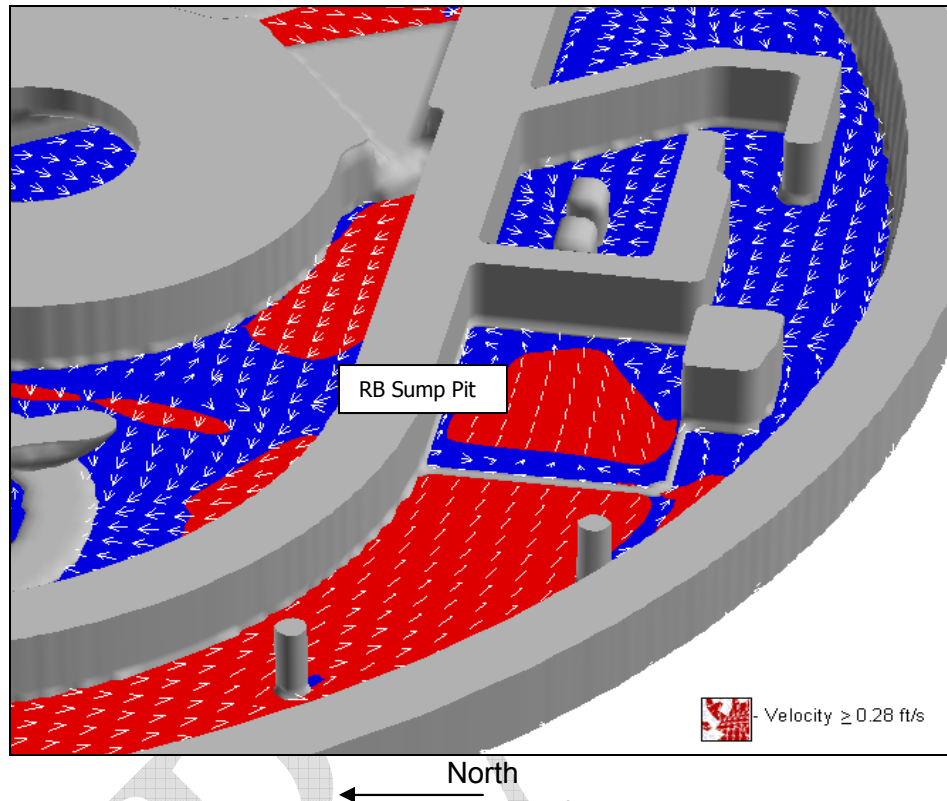
Figure 2 – Flow Profile During ECCS Operation, RB 281' Elevation

For reference, Figure 2 below illustrates flow patterns and relative velocities generated within the flooded containment during ECCS operation. From this figure, it can be seen that the majority of the water entering the sump pit approaches from the west side of the structure.
