U.S. NUCLEAR REGULATORY COMMISSION
REGION IV

Inspection Report: 70-925/95-01

Licensee: Kerr-McGee Corporation

Inspection At: Cimarron Facility, Crescent, Oklahoma

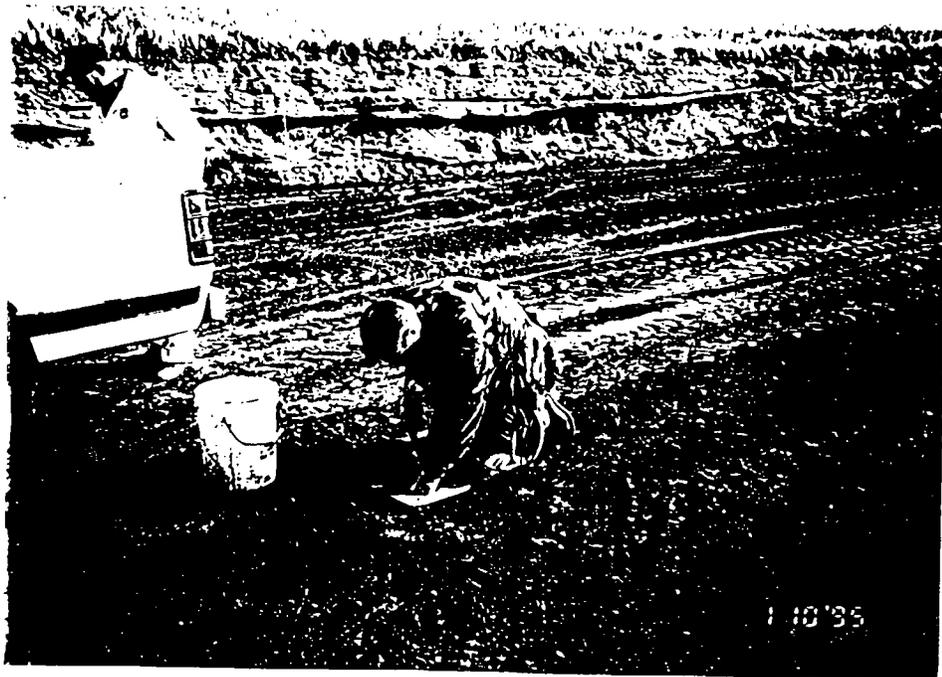
Photograph 2: Soil density testing in disposal cell (licensee supplied photograph)

When a 1-foot lift was completed, a contractor was used to verify that the soil was compacted to at least 95 percent of the maximum dry density for this type of soil. Testing was performed at eight locations for Lifts 1 and 2 while four tests were performed for Lift 3. Four tests per lift will be performed for subsequent lifts. Following confirmation that the soil was properly compacted, the next lift would commence. Airborne particulates were sampled using a portable aerosol detection meter. A water truck was available to spray water on the work areas as necessary to control dust. The licensee was keeping daily records of the number of dump truck loads of soil being transferred to the disposal cell.

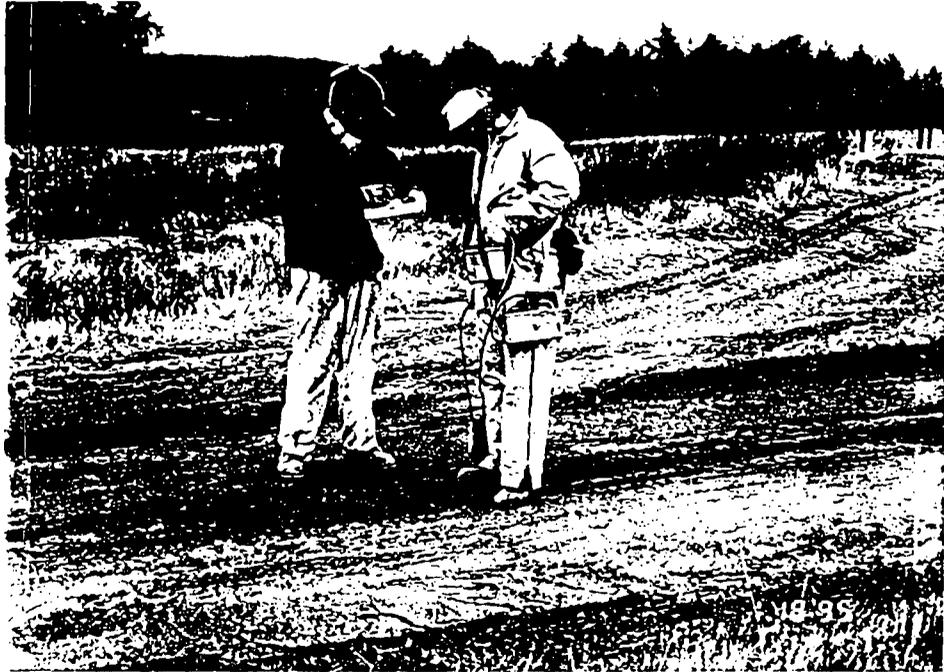
Photograph 3: Weekly survey of the road (licensee supplied photograph)

Radiological surveys were conducted within the restricted area to determine exposure rates and contamination levels. Surveys for radioactive materials included weekly surveys of the road used for the transfer of the contaminated soil, daily surveys of the radioactive exposure at the work locations using a microRoentgen per hour ($\mu\text{R/hr}$) meter, and daily equipment swipes/smears for contamination. With a background exposure rate of about $7 \mu\text{R/hr}$, the soil being moved measured about 12 to 14 $\mu\text{R/hr}$. A weekly composite of soil samples from each dump truck's load was being collected for analysis. These sample results will be used to estimate the total activity of the contamination in the disposal pit. Split samples are being sent offsite for analysis for independent determination of the uranium, radium, plutonium, thorium, and their daughter product concentrations in the soil.
