KERR-McGEE NUCLEAR CORPORATION

CIMARRON FACILITY

LIQUID WASTE CONTROL PONDS - PROPOSED DECOMMISSIONING

13.0 Uranium Plant Yard

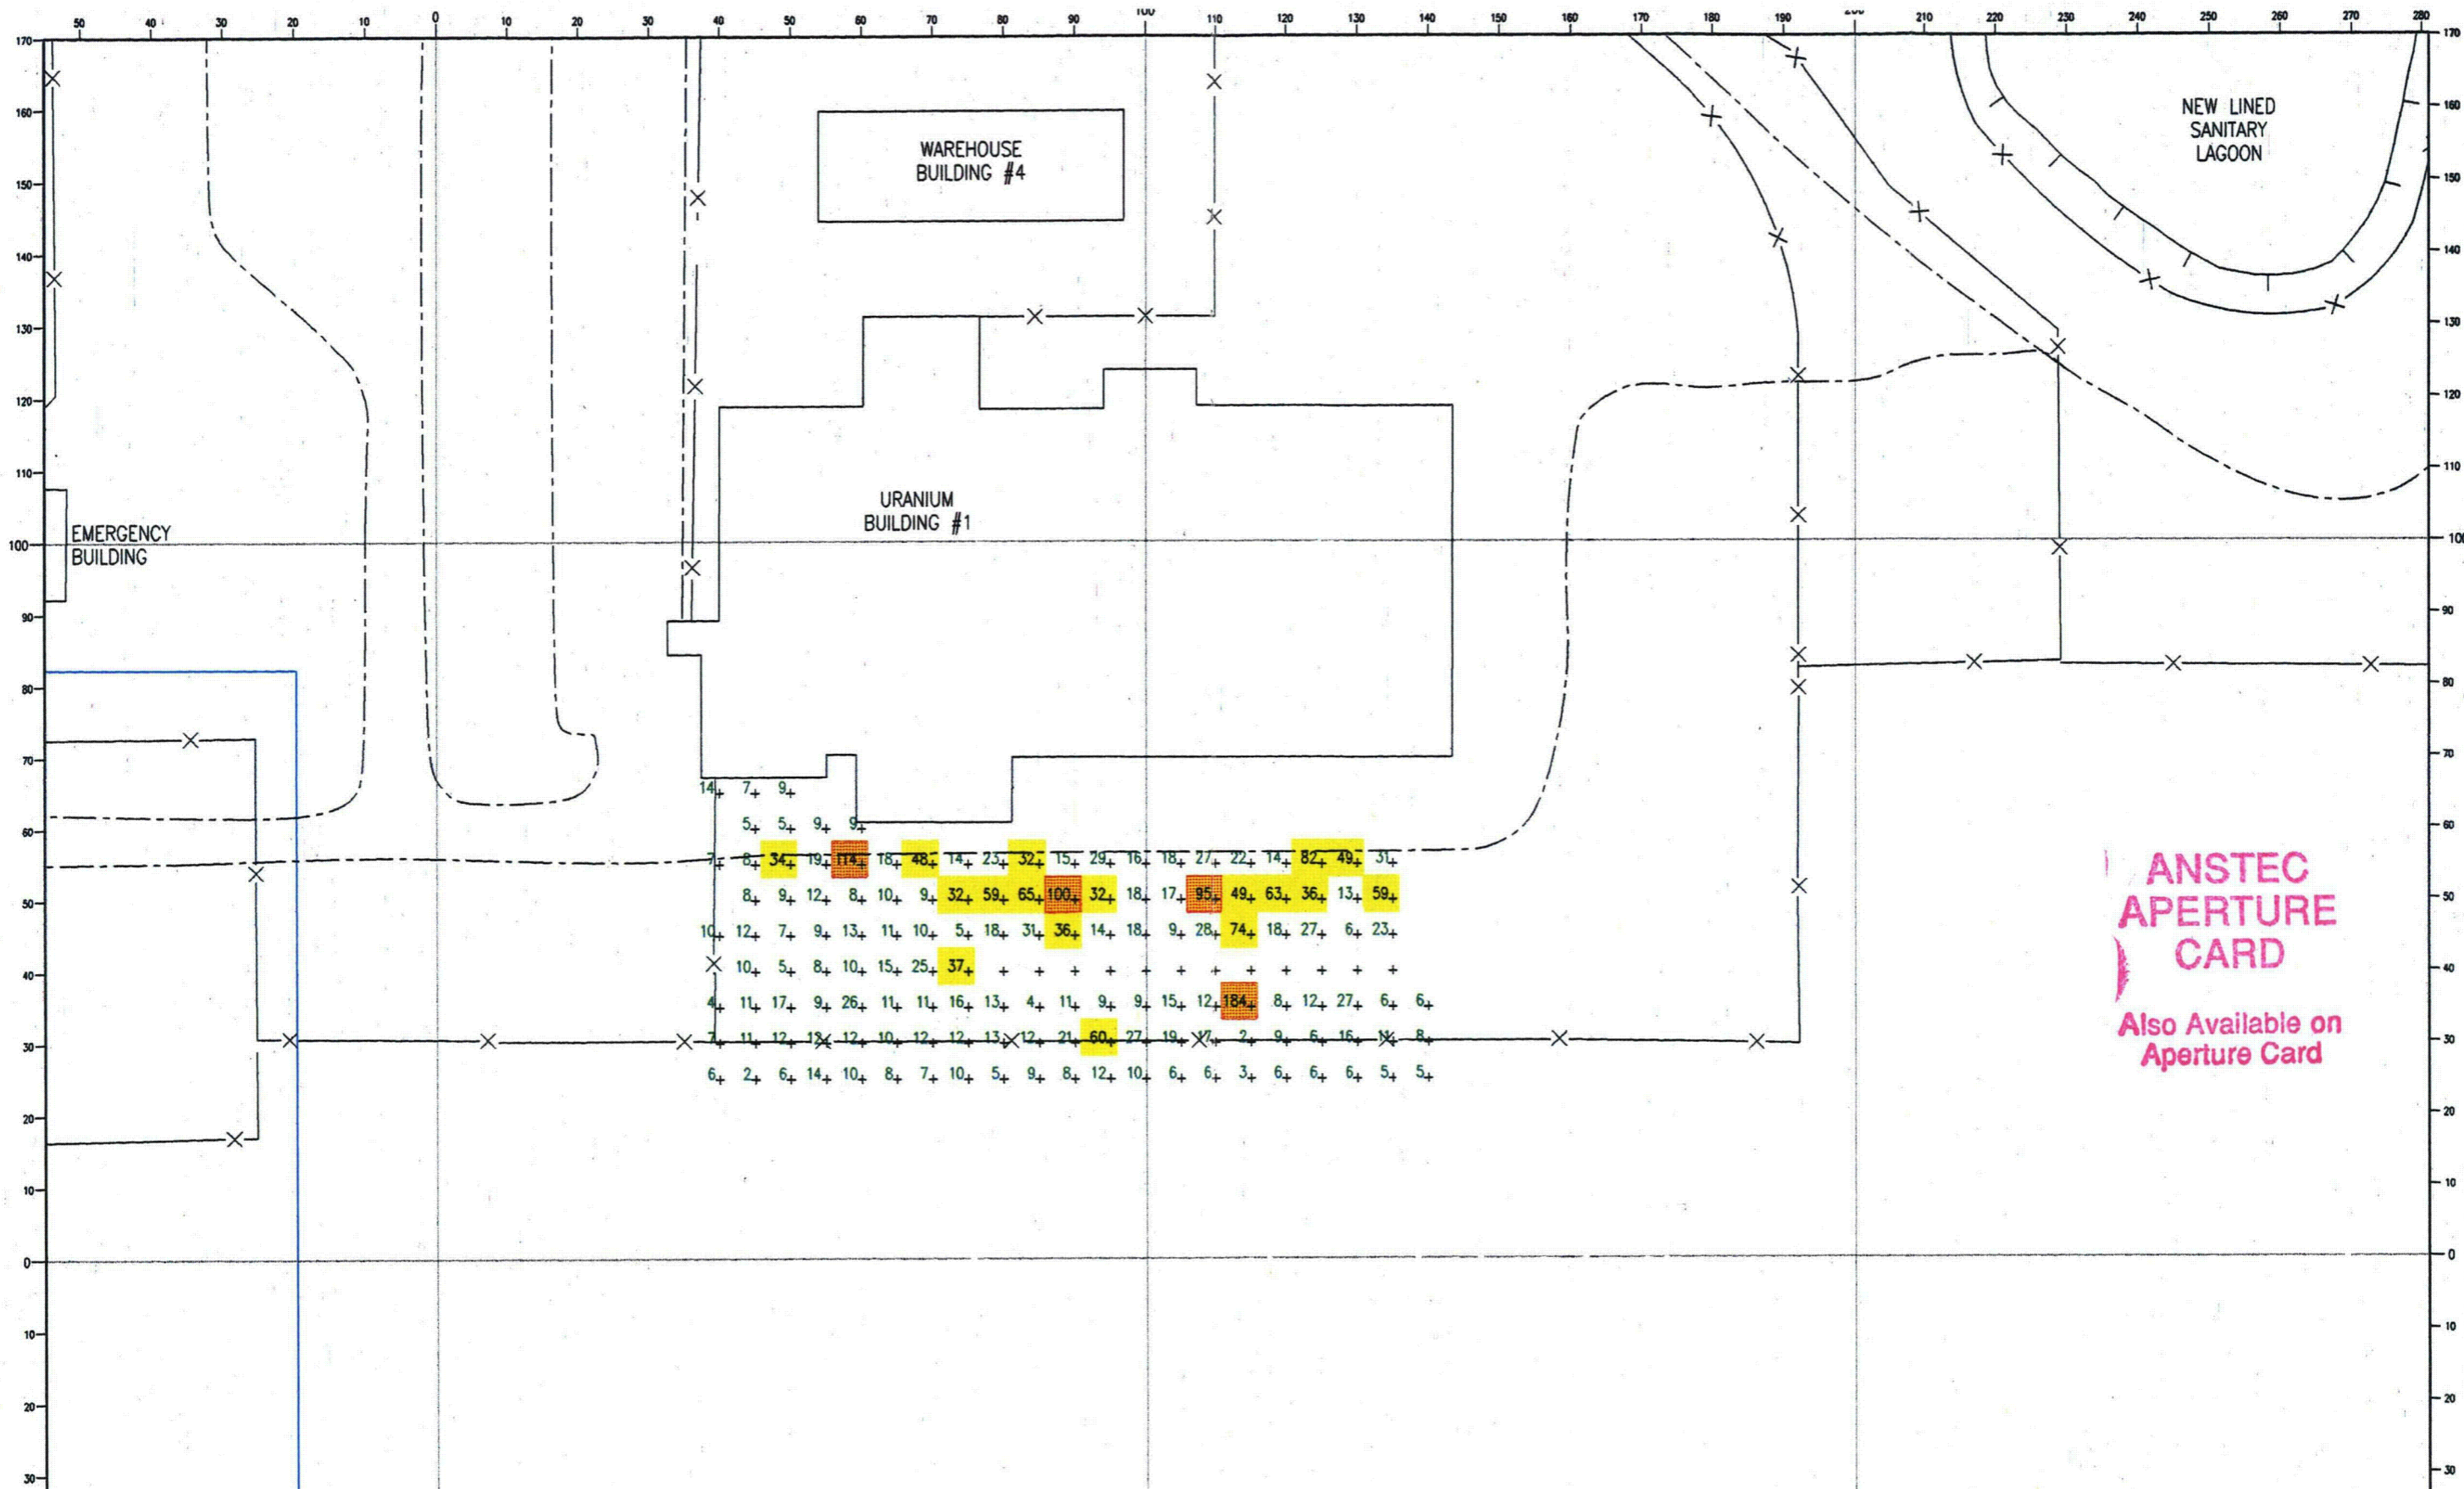
READINGS ARE IN PICO-CURES PER GRAM URANIUM (pCi/g U). CIMARRON GAMMA SPEC SOIL COUNTER. SITE SOIL BACKGROUND OF APPROXIMATELY 6 pCi/g U. NOT SUBTRACTED. SAMPLES TAKEN ON A 5 METER X 5 METER GRID.		LEGEND 6+ 1 - 29 pCi/g 54+ 30 - 89 pCi/g 126+ 90 - 250 pCi/g 527+ > 251 pCi/g NO SAMPLE - STOCKPILE AREA OR HIT ROCK OR METAL	 CIMARRON CORPORATION SOUTH URANIUM YARD PRE-REMEDIATION SOIL SAMPLE RESULTS (1993) SOIL SAMPLE ALIQUOT: 1'-2' DEEP CLIENT DRAWING NO.
JOB NO.	DRAWING NO. 93PRSUSS-2	REV. 0	SCALE: AS SHOWN

The soil sampling was conducted to a depth of 4 ft. The soil sample results are shown on Drawings No. 90PRSUSS-0 through 90PRSUSS-4. Several surface readings exceeded the Option #1 uranium guideline value (the maximum concentration was 119 pCi/g). The survey results for a gamma survey and two Micro-R surveys completed in 1990 are included on Drawings No. 90PRSU3D-0, 90PRSUUR-0 and 90PRSUUR-1.
