11.0 Sanitary Lagoons

11.1 East Sanitary Lagoon & West Sanitary Lagoon

11.2 New Sanitary Lagoon

12.0 Five Former Waste Water Ponds

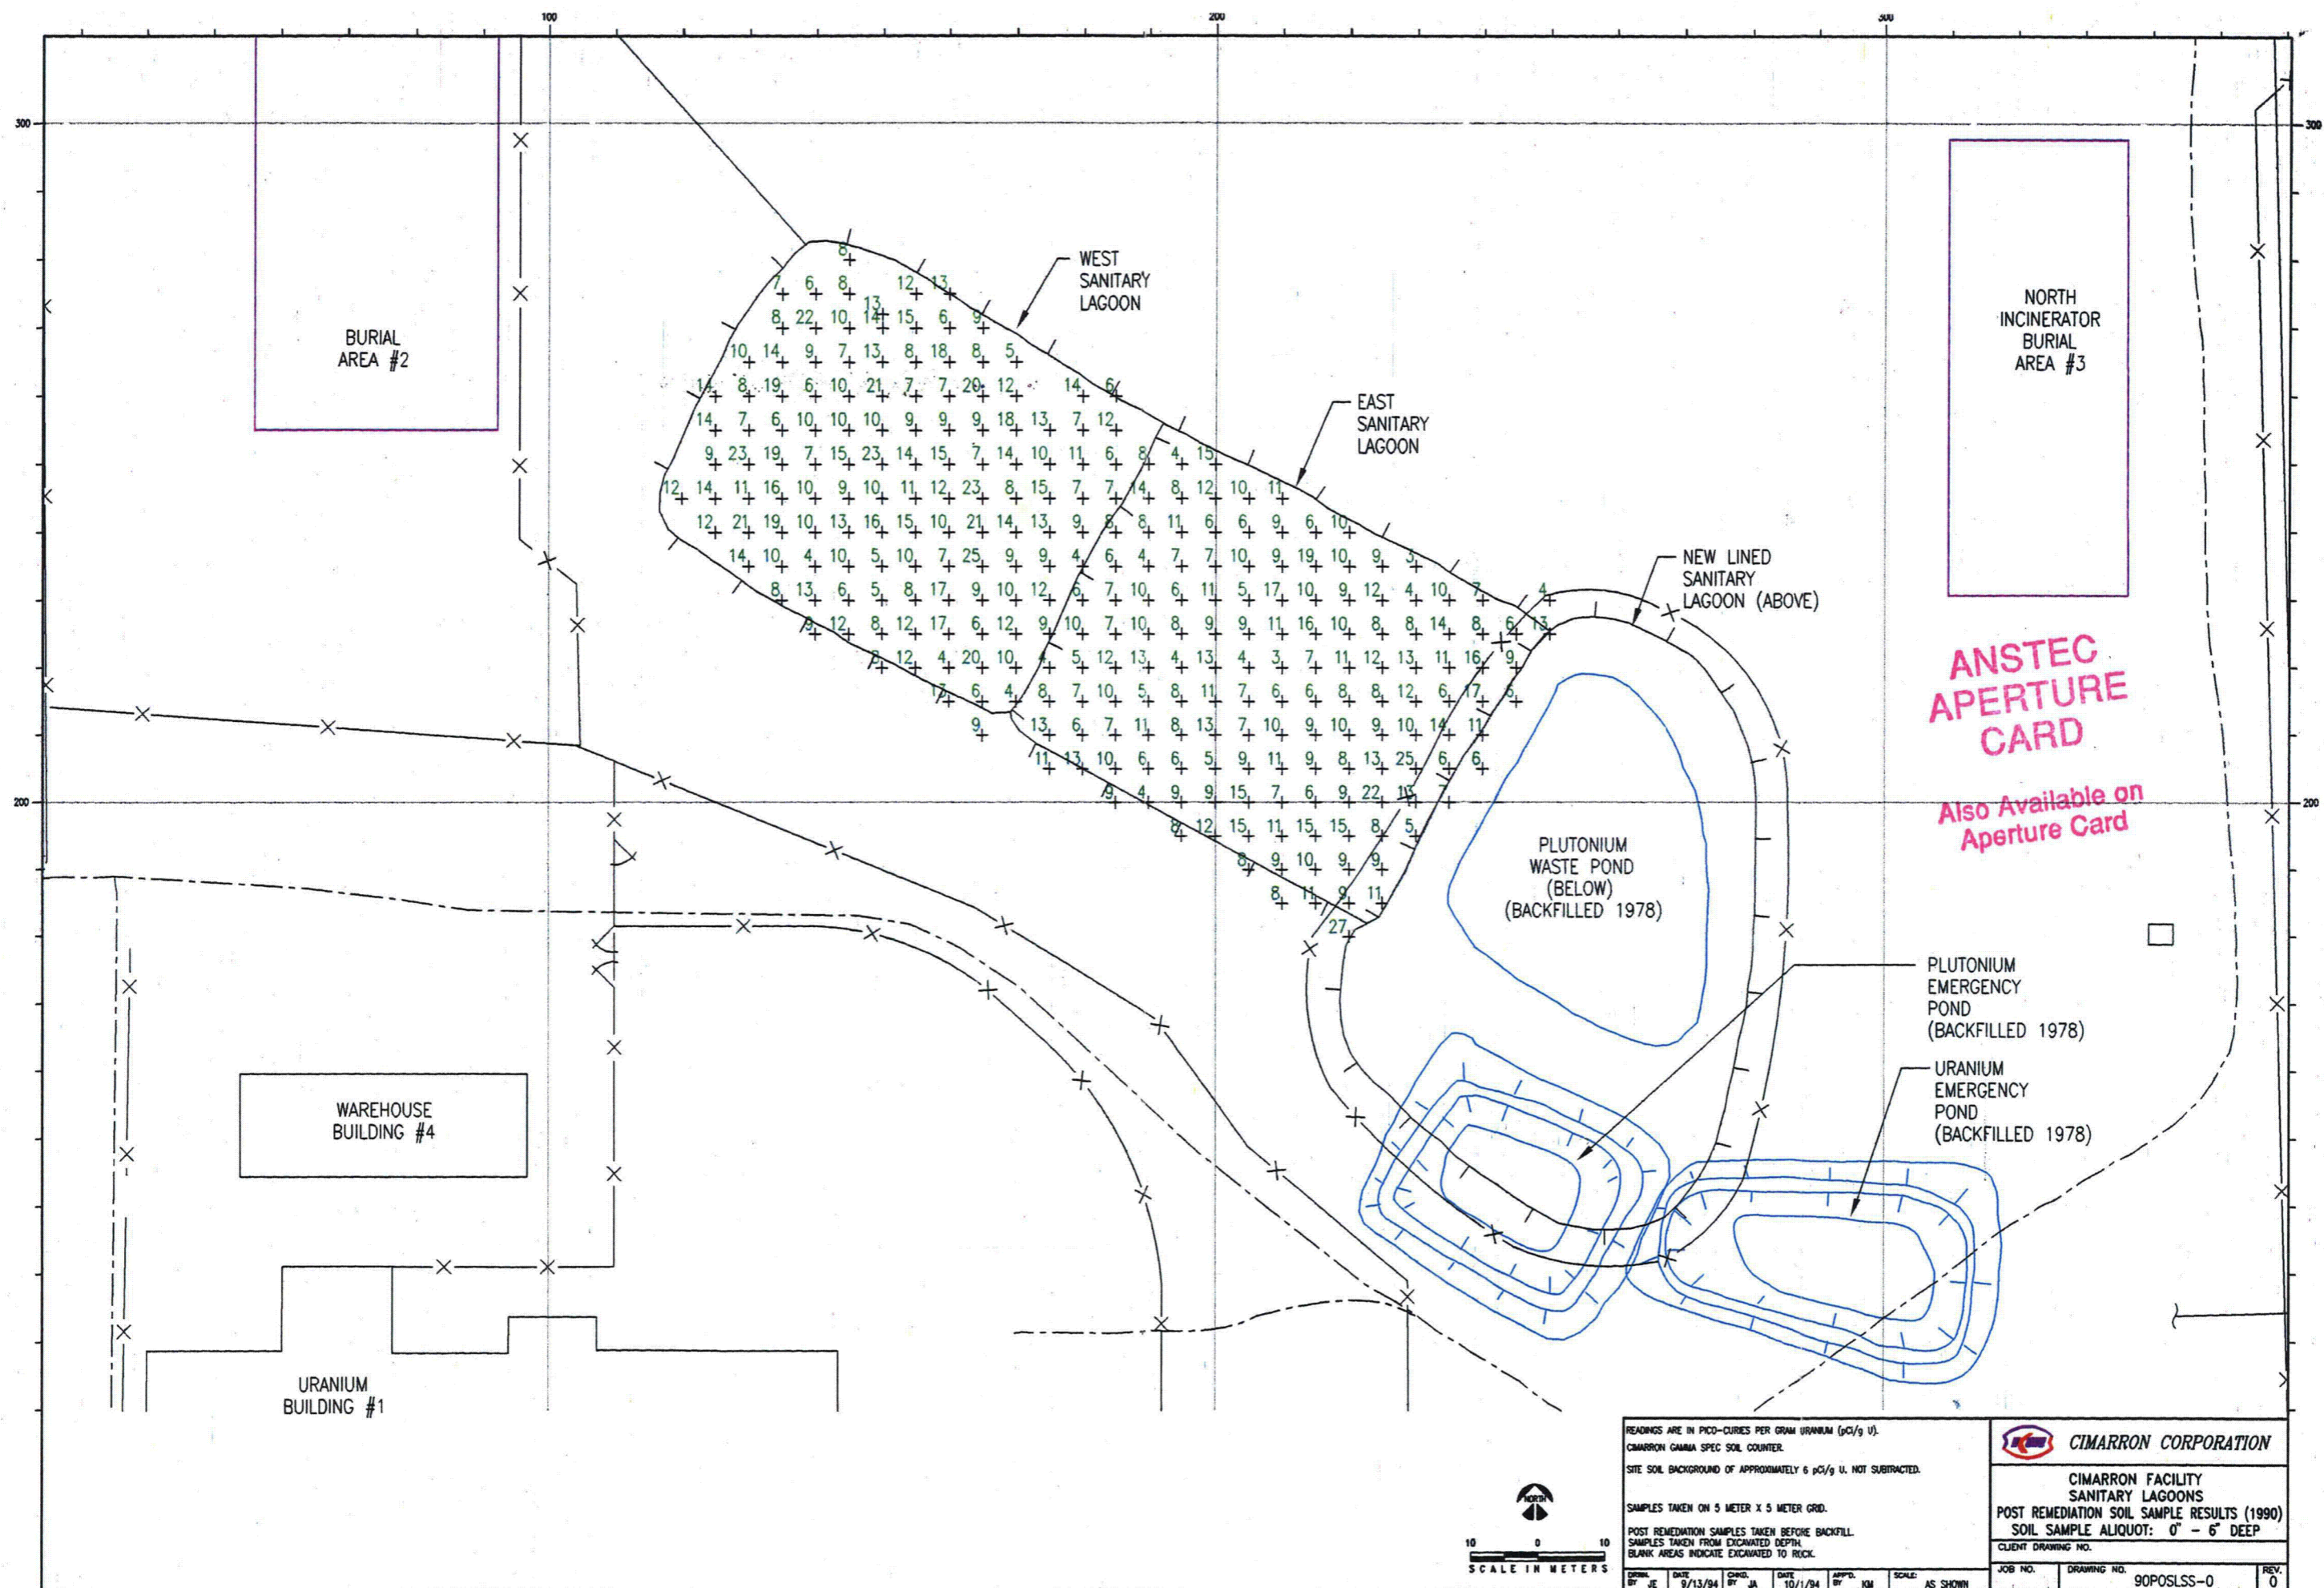
DATE	9/13/94	DATE	10/1/94	SCALE	AS SHOWN
BY	JE	BY	KM	JOB NO.	DRAWING NO.
				90POSLS-0	REV. 0

READINGS ARE IN PICO-CURIES PER GRAM URANIUM (pCi/g U).
 CIMARRON GAMMA SPEC SOIL COUNTER.
 SITE SOIL BACKGROUND OF APPROXIMATELY 6 pCi/g U. NOT SUBTRACTED.

SAMPLES TAKEN ON 5 METER X 5 METER GRID.
 POST REMEDIATION SAMPLES TAKEN BEFORE BACKFILL.
 SAMPLES TAKEN FROM EXCAVATED DEPTHA
 BLANK AREAS INDICATE EXCAVATED TO ROCK.

CIMARRON FACILITY
 SANITARY LAGOONS
 POST REMEDIATION SOIL SAMPLE RESULTS (1990)
 SOIL SAMPLE ALIQUOT: 0" - 6" DEEP
 CLIENT DRAWING NO.

completed in September, 1990. A 5m x 5m grid system was utilized for this sampling effort. Soil analytical data is shown on Drawings No. 90POSLSS-0 through 90POSLSS-4. This sampling program involved the use of composite samples taken from depths of 0 to 6 in., 6 in. to 1 ft., 1 to 2 ft., 2 to 3 ft., and 3 to 4 ft. All results show total uranium concentrations less than the Option #1 guideline value of 30 pCi/g. A Micro-R survey was also conducted in 1990 on the same 5m x 5m grid and the results are shown on Drawing No. 90POSLUR-1.

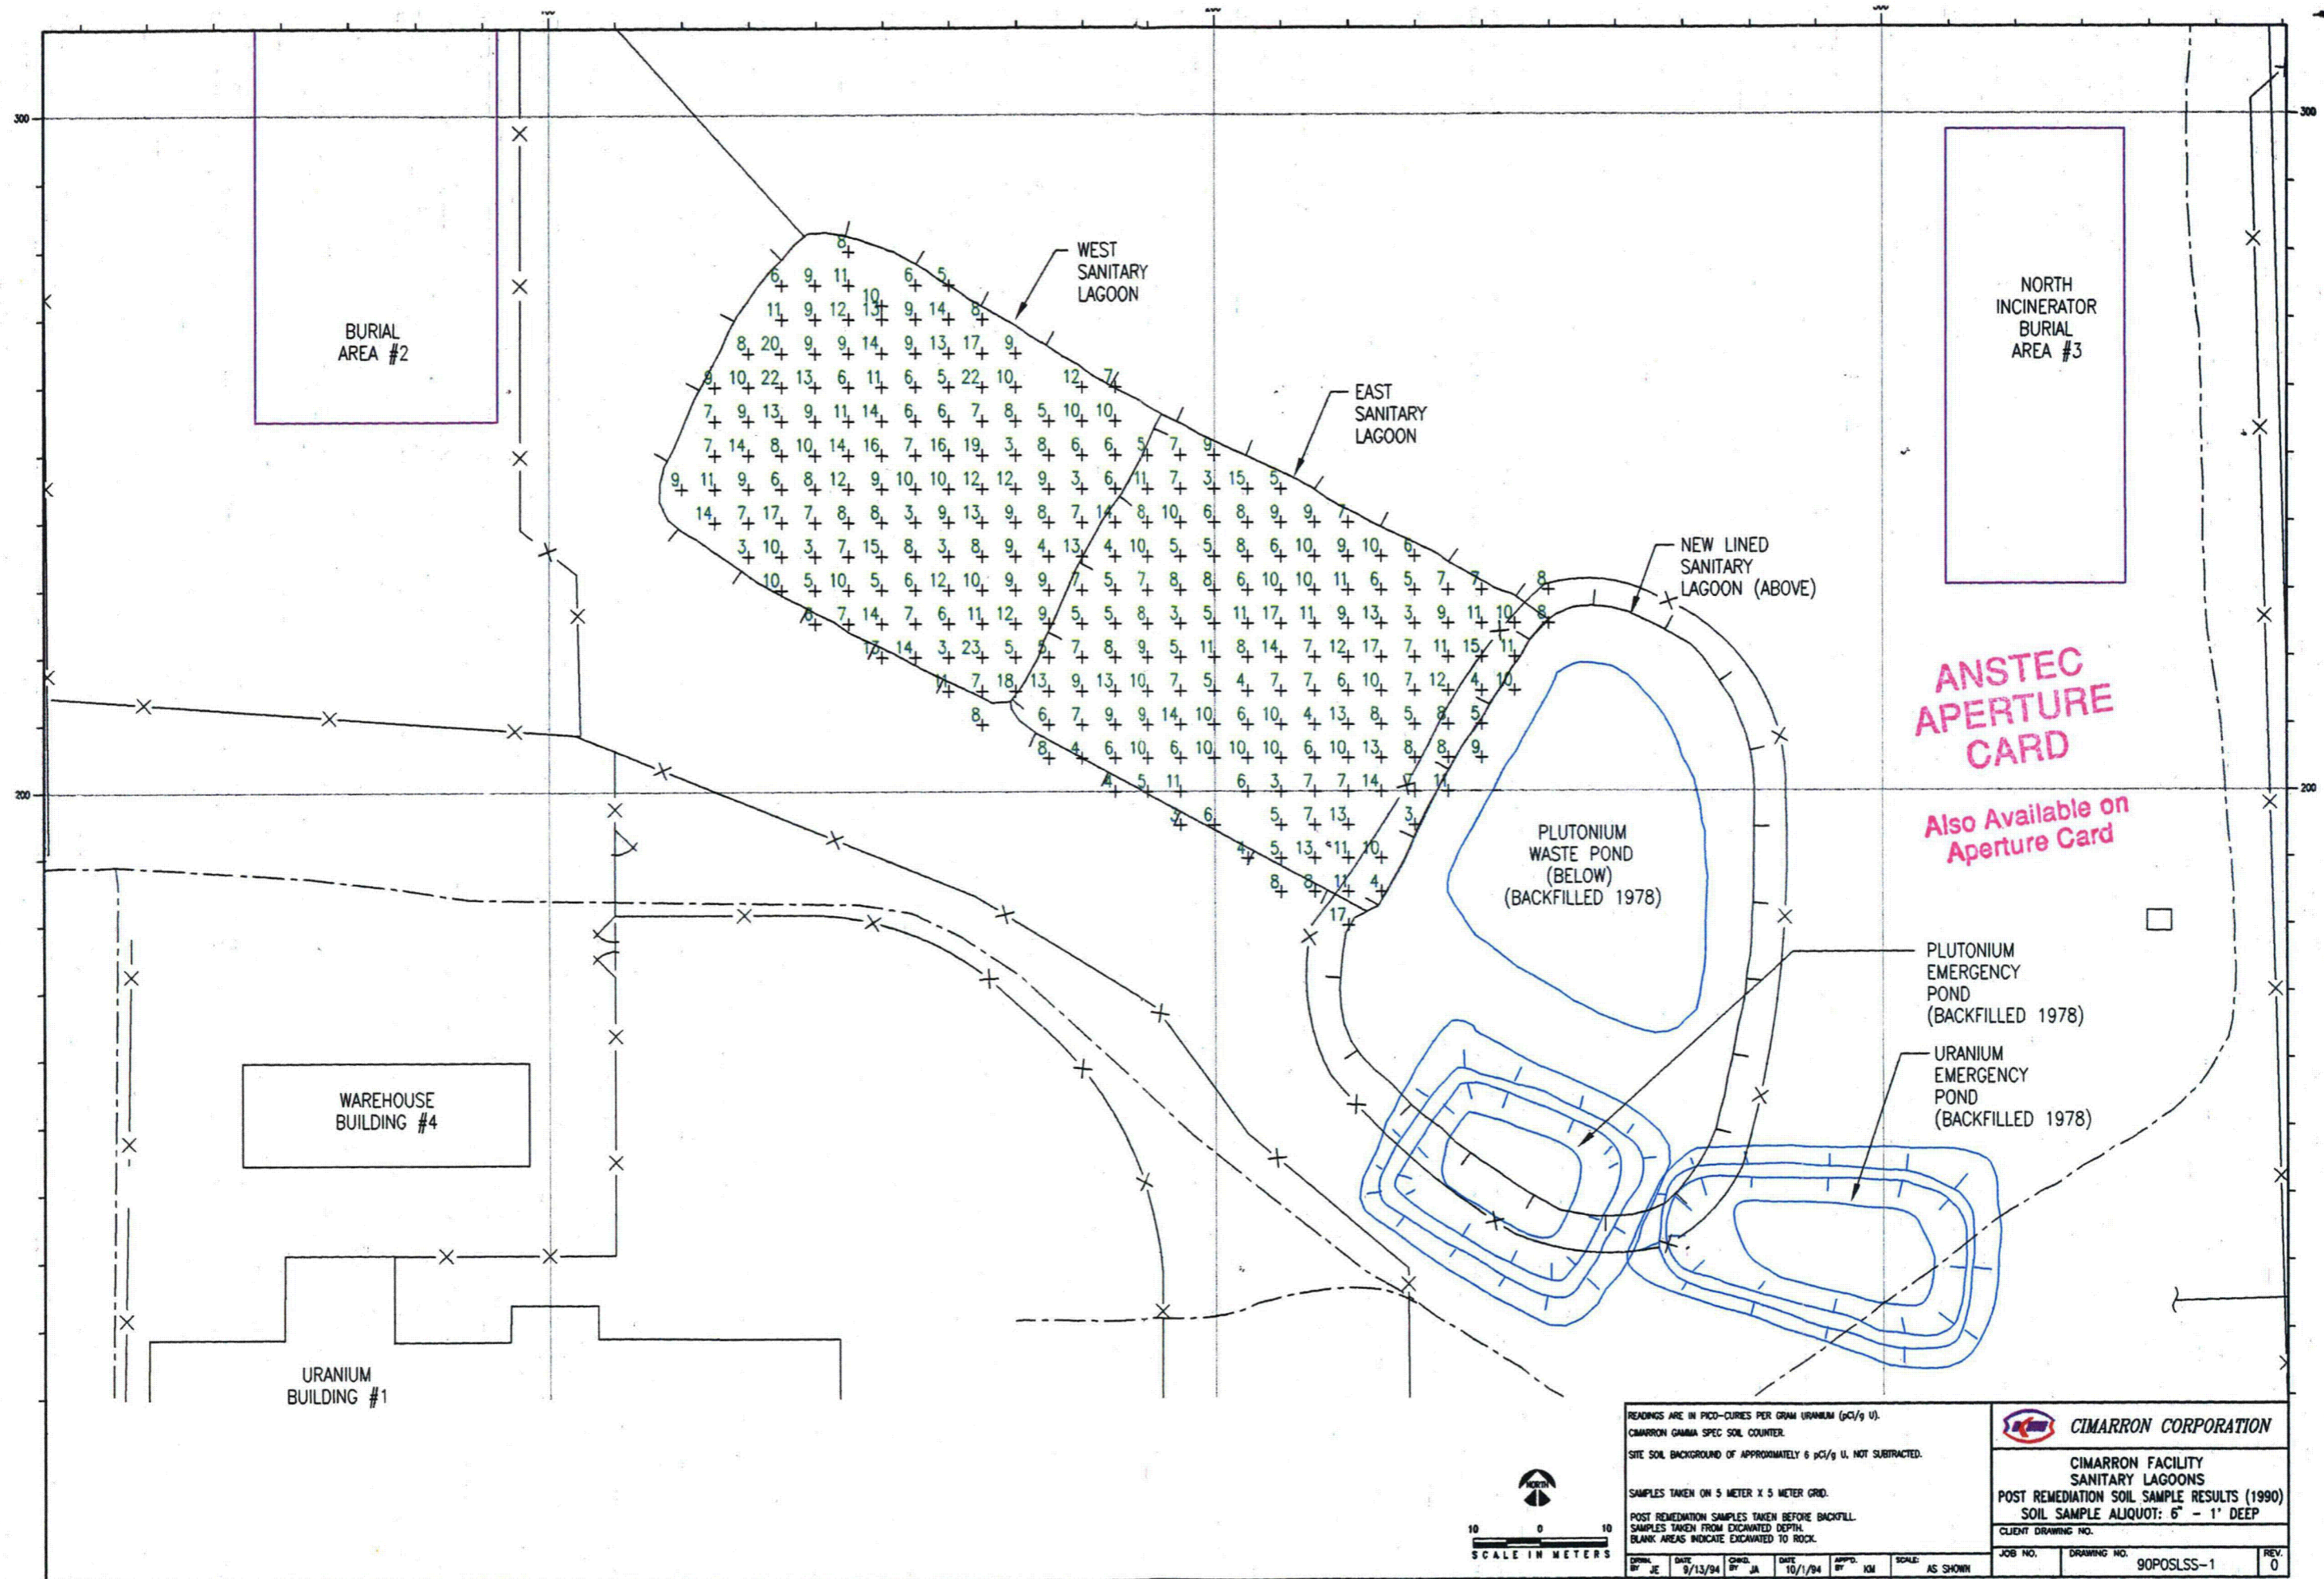
READINGS ARE IN PICO-CURIES PER GRAM URANIUM (pCi/g U). CIMARRON GAMMA SPEC SOIL COUNTER. SITE SOIL BACKGROUND OF APPROXIMATELY 6 pCi/g U, NOT SUBTRACTED.			
SAMPLES TAKEN ON 5 METER X 5 METER GRID. POST REMEDIATION SAMPLES TAKEN BEFORE BACKFILL. SAMPLES TAKEN FROM EXCAVATED DEPTH. BLANK AREAS INDICATE EXCAVATED TO ROCK.		CIMARRON CORPORATION CIMARRON FACILITY SANITARY LAGOONS POST REMEDIATION SOIL SAMPLE RESULTS (1990) SOIL SAMPLE ALIQUOT: 6" - 1' DEEP	
CLIENT DRAWING NO.	JOB NO.	DRAWING NO.	REV.
90POSLS-1	90POSLS-1	90POSLS-1	0

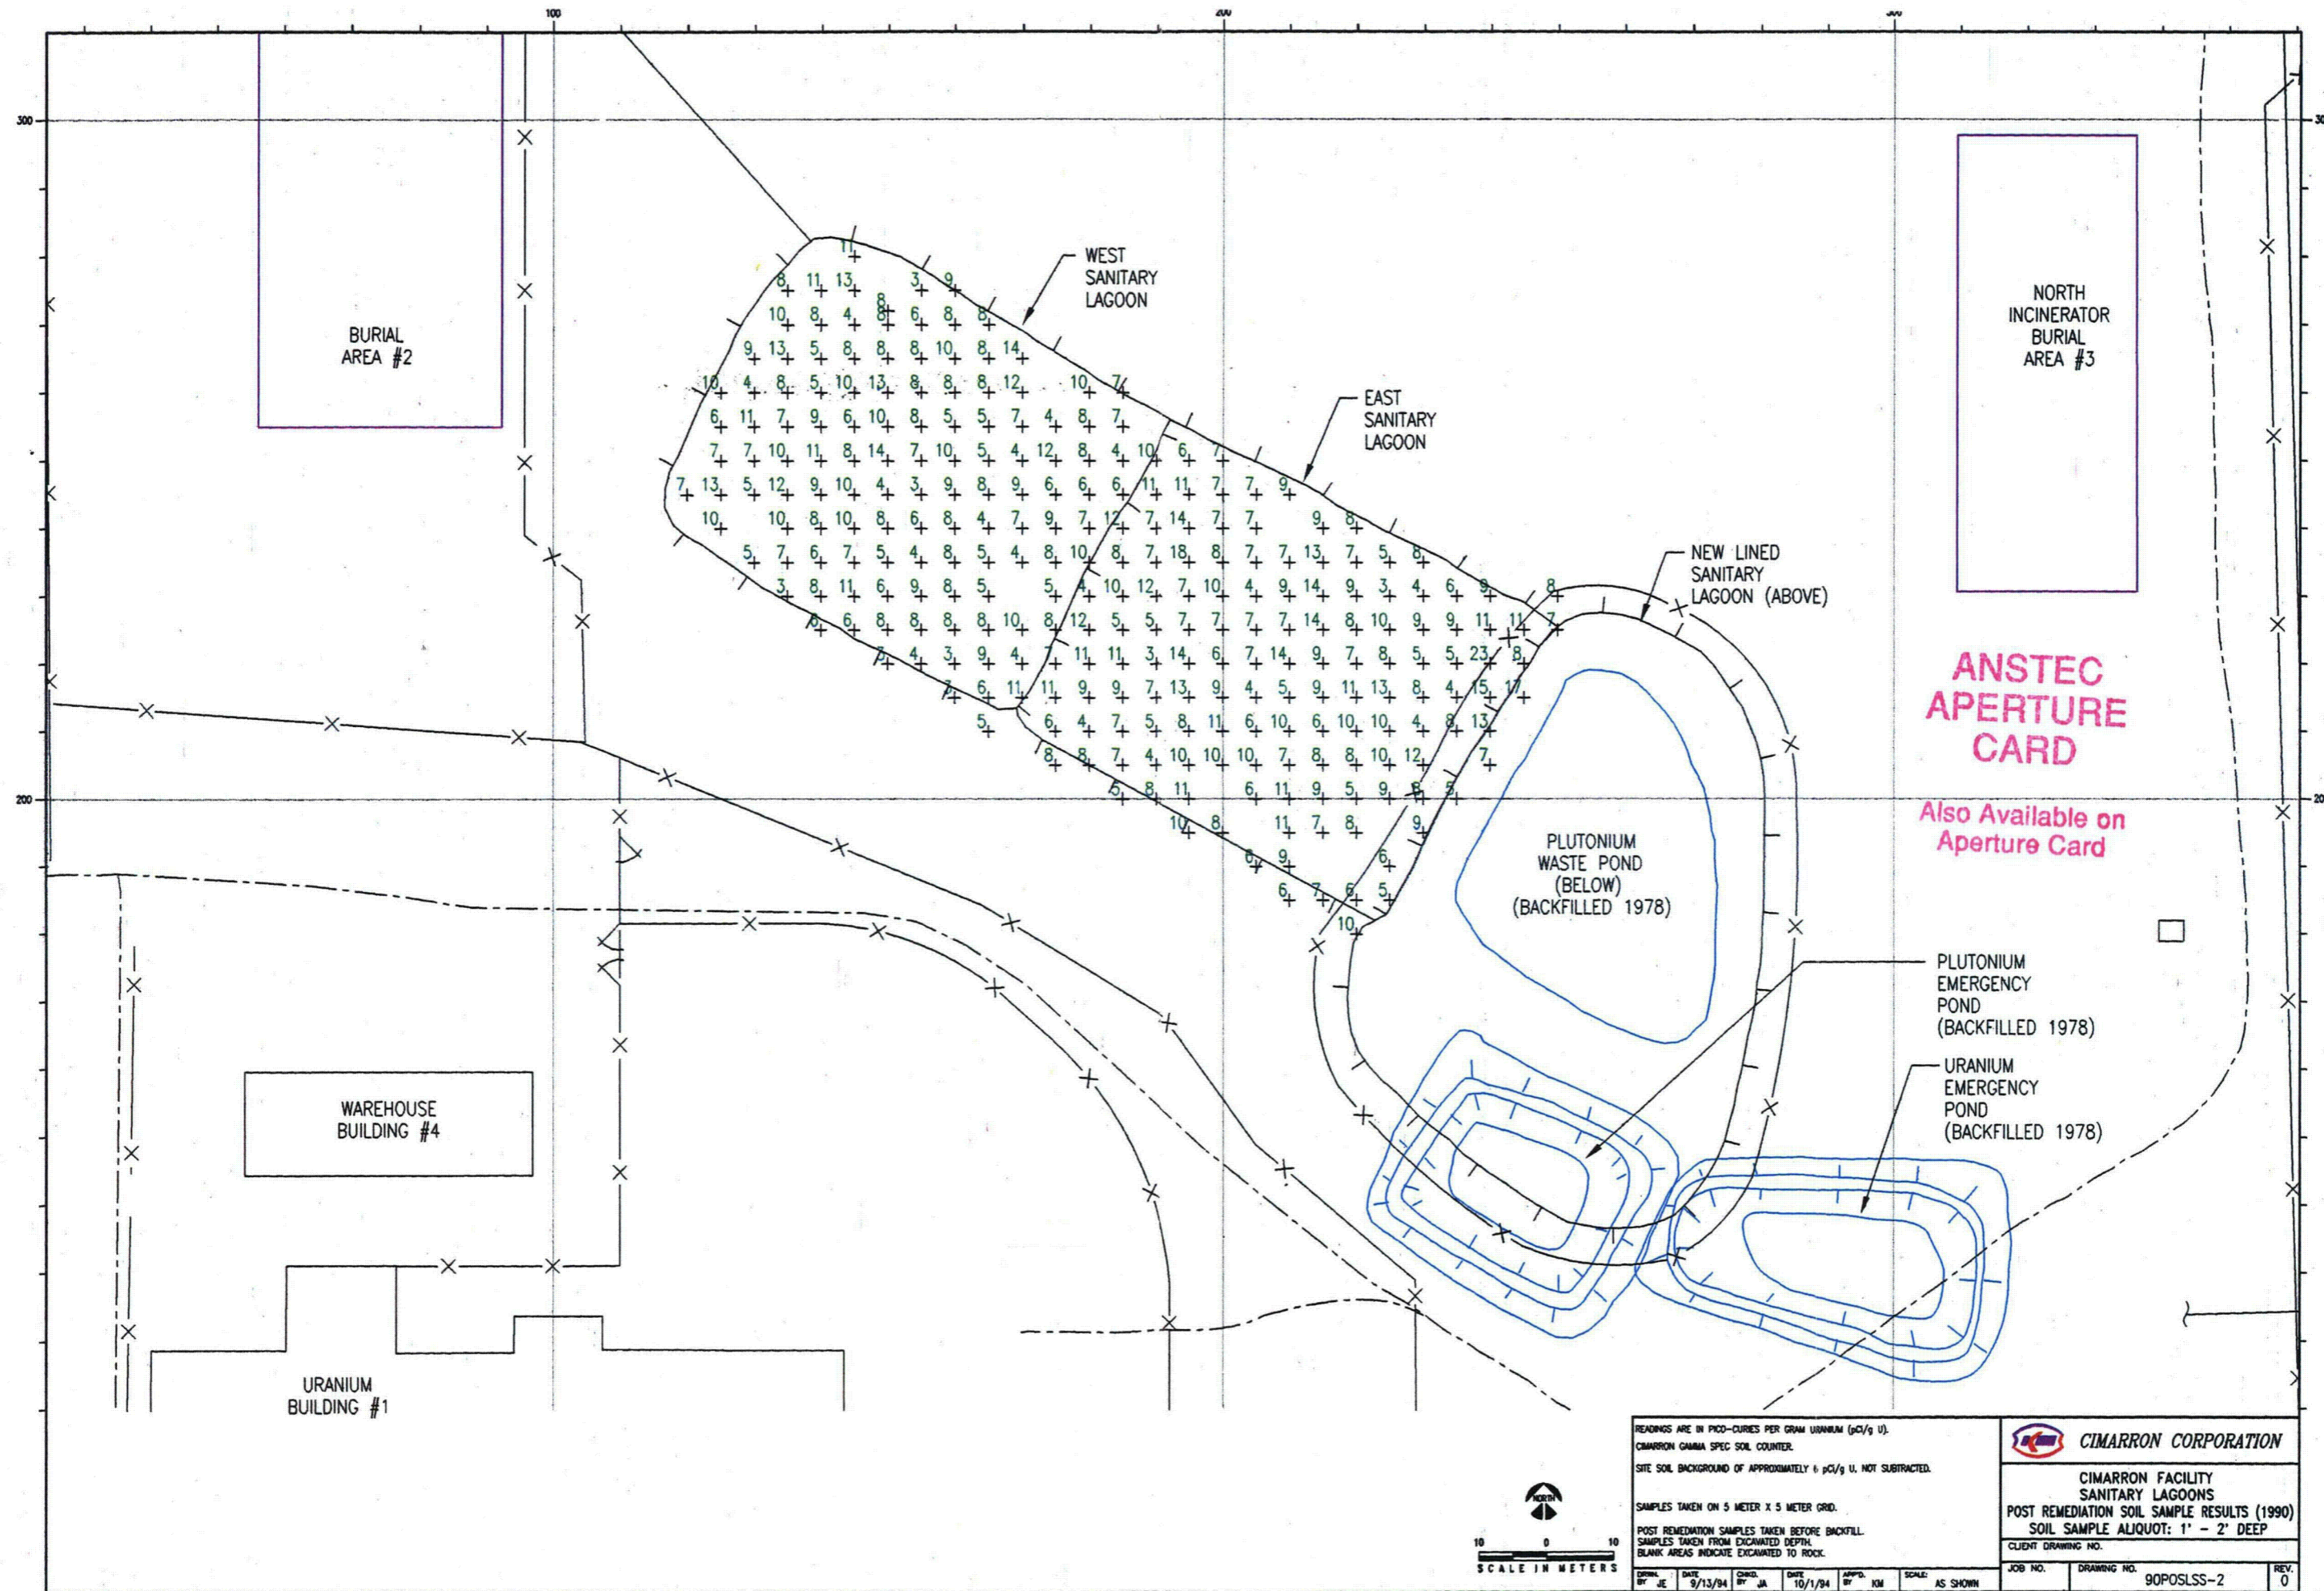
READINGS ARE IN PICO-CURIES PER GRAM URANIUM (pCi/g U). CIMARRON GAMMA SPEC SOIL COUNTER. SITE SOIL BACKGROUND OF APPROXIMATELY 6 pCi/g U. NOT SUBTRACTED.			
SAMPLES TAKEN ON 5 METER X 5 METER GRID. POST REMEDIATION SAMPLES TAKEN BEFORE BACKFILL. SAMPLES TAKEN FROM EXCAVATED DEPTH. BLANK AREAS INDICATE EXCAVATED TO ROCK.		CIMARRON FACILITY SANITARY LAGOONS POST REMEDIATION SOIL SAMPLE RESULTS (1990) SOIL SAMPLE ALIQUOT: 1' - 2' DEEP	
CLIENT DRAWING NO.		JOB NO. DRAWING NO. 90POSSLSS-2 REV. 0	
DRAWN BY: JE	DATE: 9/13/94	CHECKED BY: JA	DATE: 10/1/94
APP'D BY: KM	SCALE: AS SHOWN

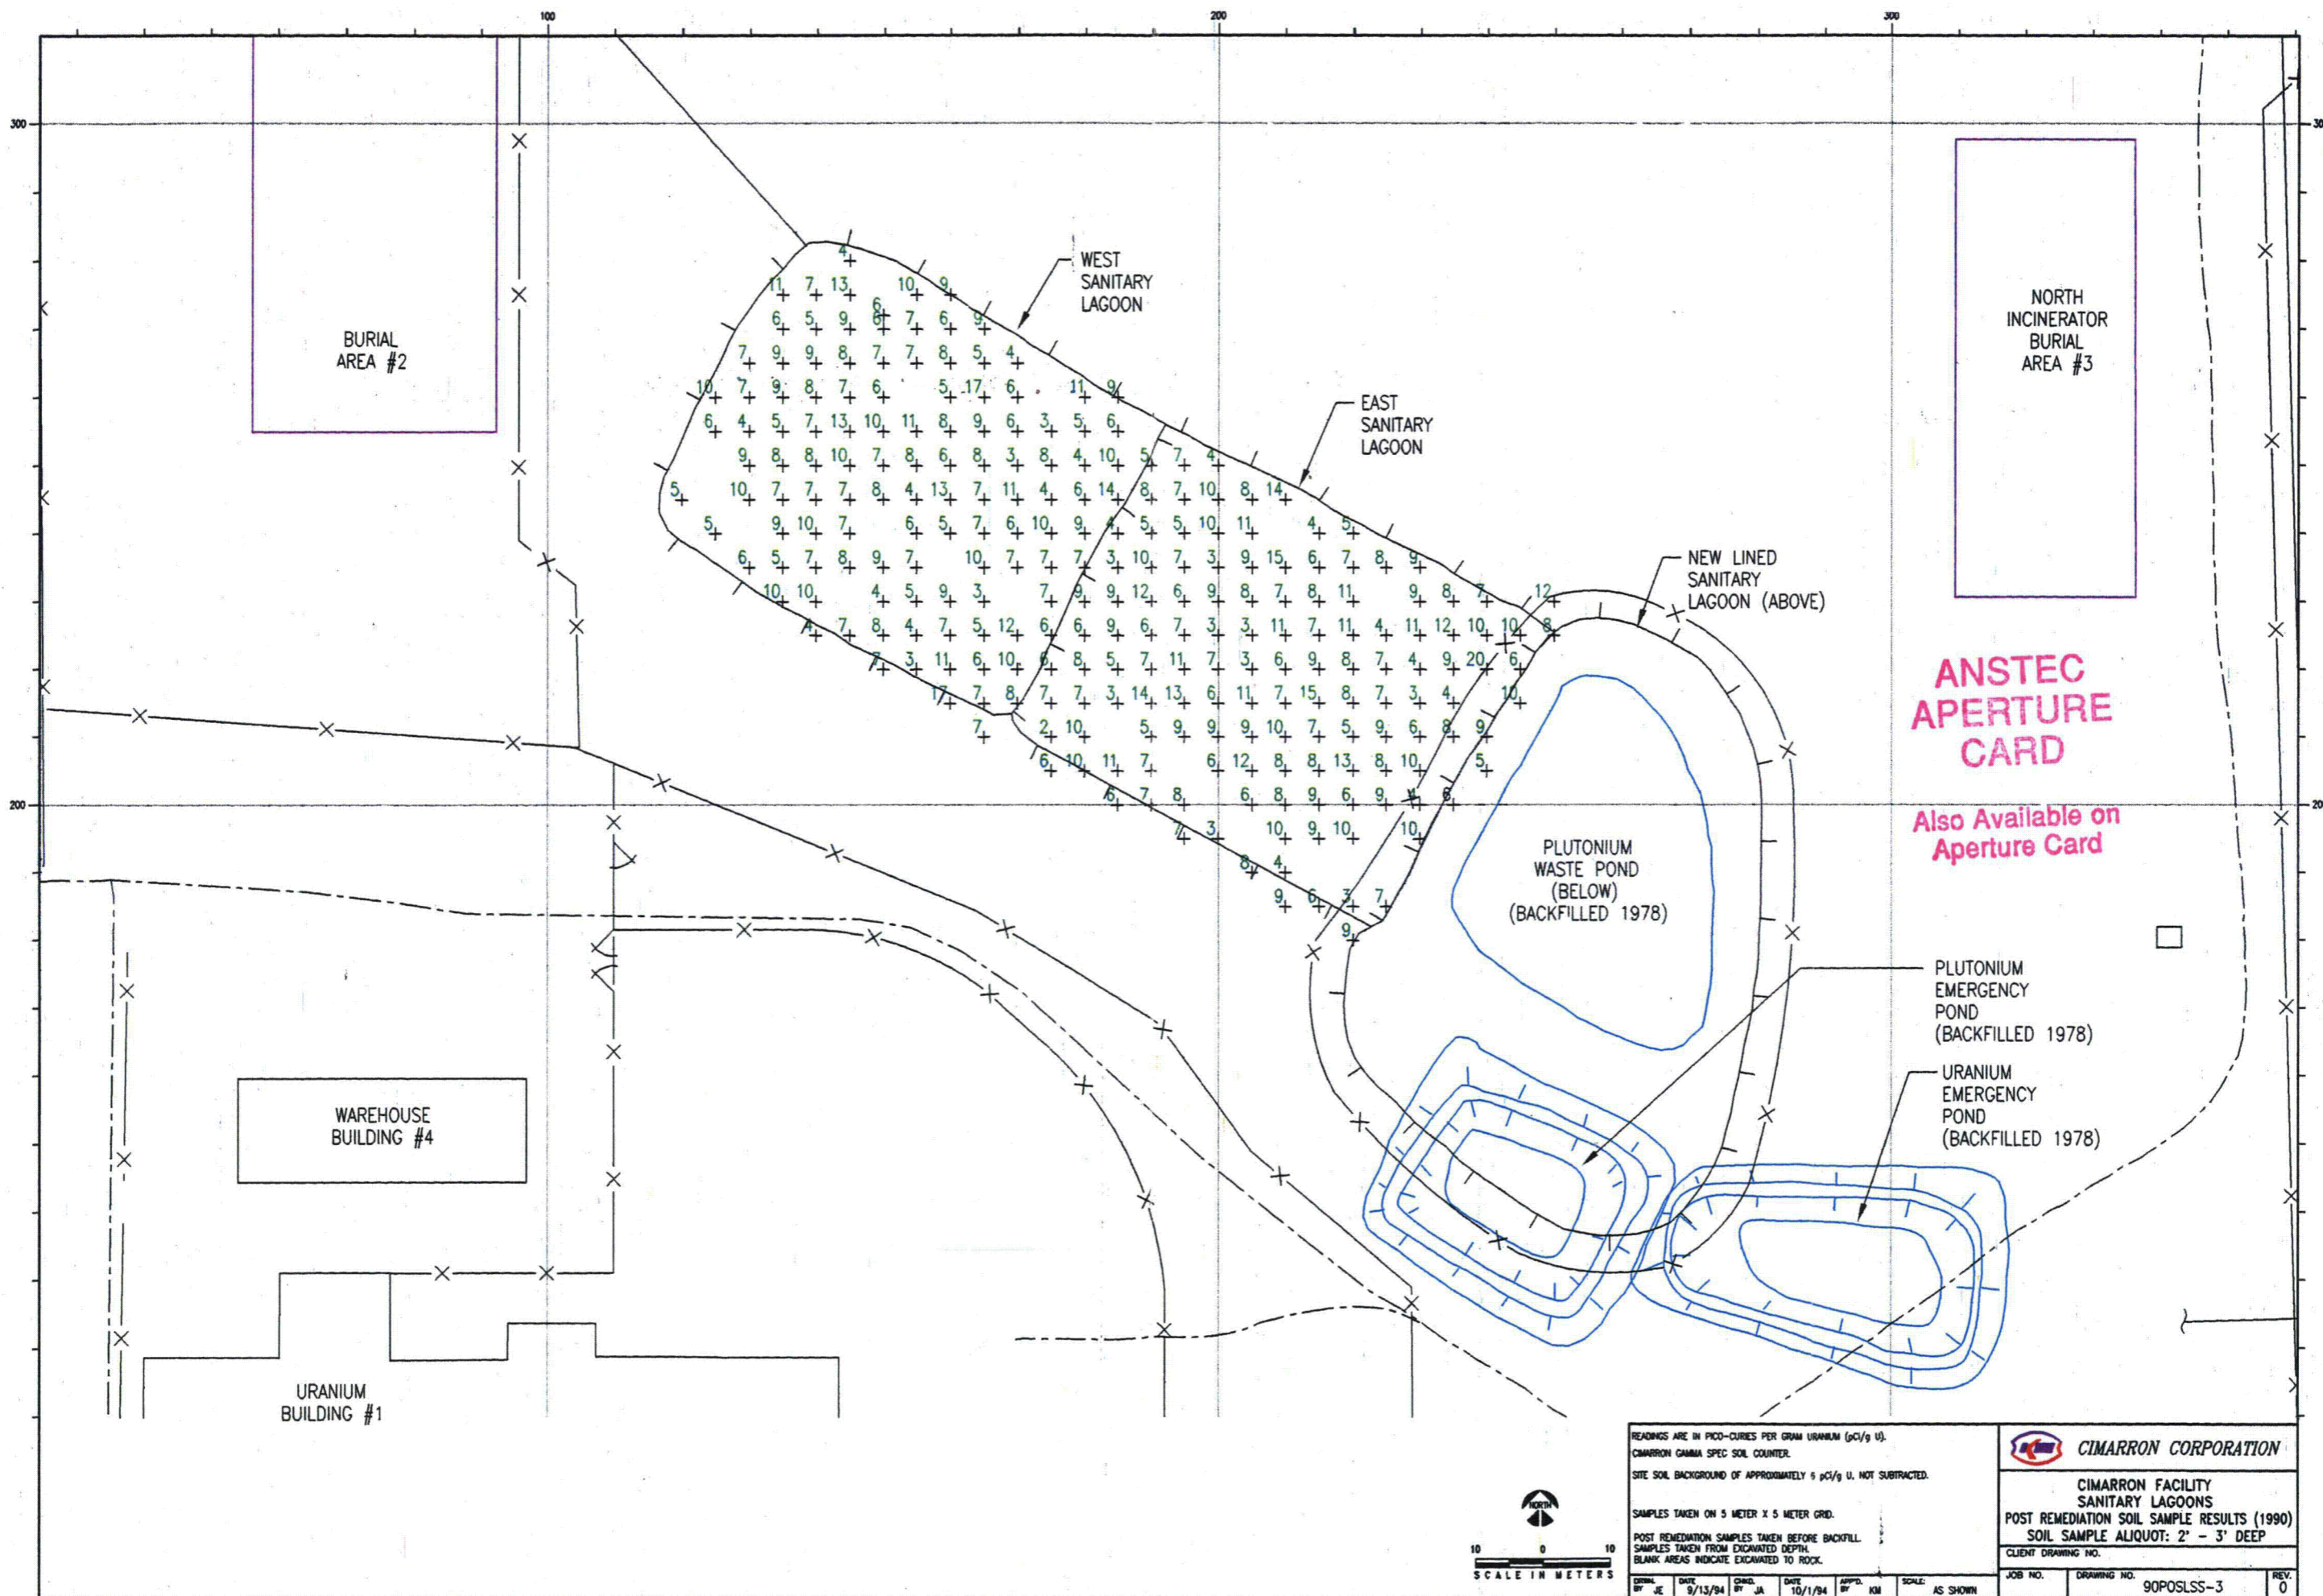
READINGS ARE IN PICO-CURIES PER GRAM URANIUM (pCi/g U).
 CIMARRON GAMMA SPEC SOIL COUNTER.
 SITE SOIL BACKGROUND OF APPROXIMATELY 5 pCi/g U. NOT SUBTRACTED.
 SAMPLES TAKEN ON 5 METER X 5 METER GRID.
 POST REMEDIATION SAMPLES TAKEN BEFORE BACKFILL.
 SAMPLES TAKEN FROM EXCAVATED DEPTH.
 BLANK AREAS INDICATE EXCAVATED TO ROCK.

CIMARRON FACILITY SANITARY LAGOONS	
POST REMEDIATION SOIL SAMPLE RESULTS (1990)	
SOIL SAMPLE ALIQUOT: 2' - 3' DEEP	
CLIENT DRAWING NO.	
JOB NO.	DRAWING NO. 90POSLS-3
REV. 0

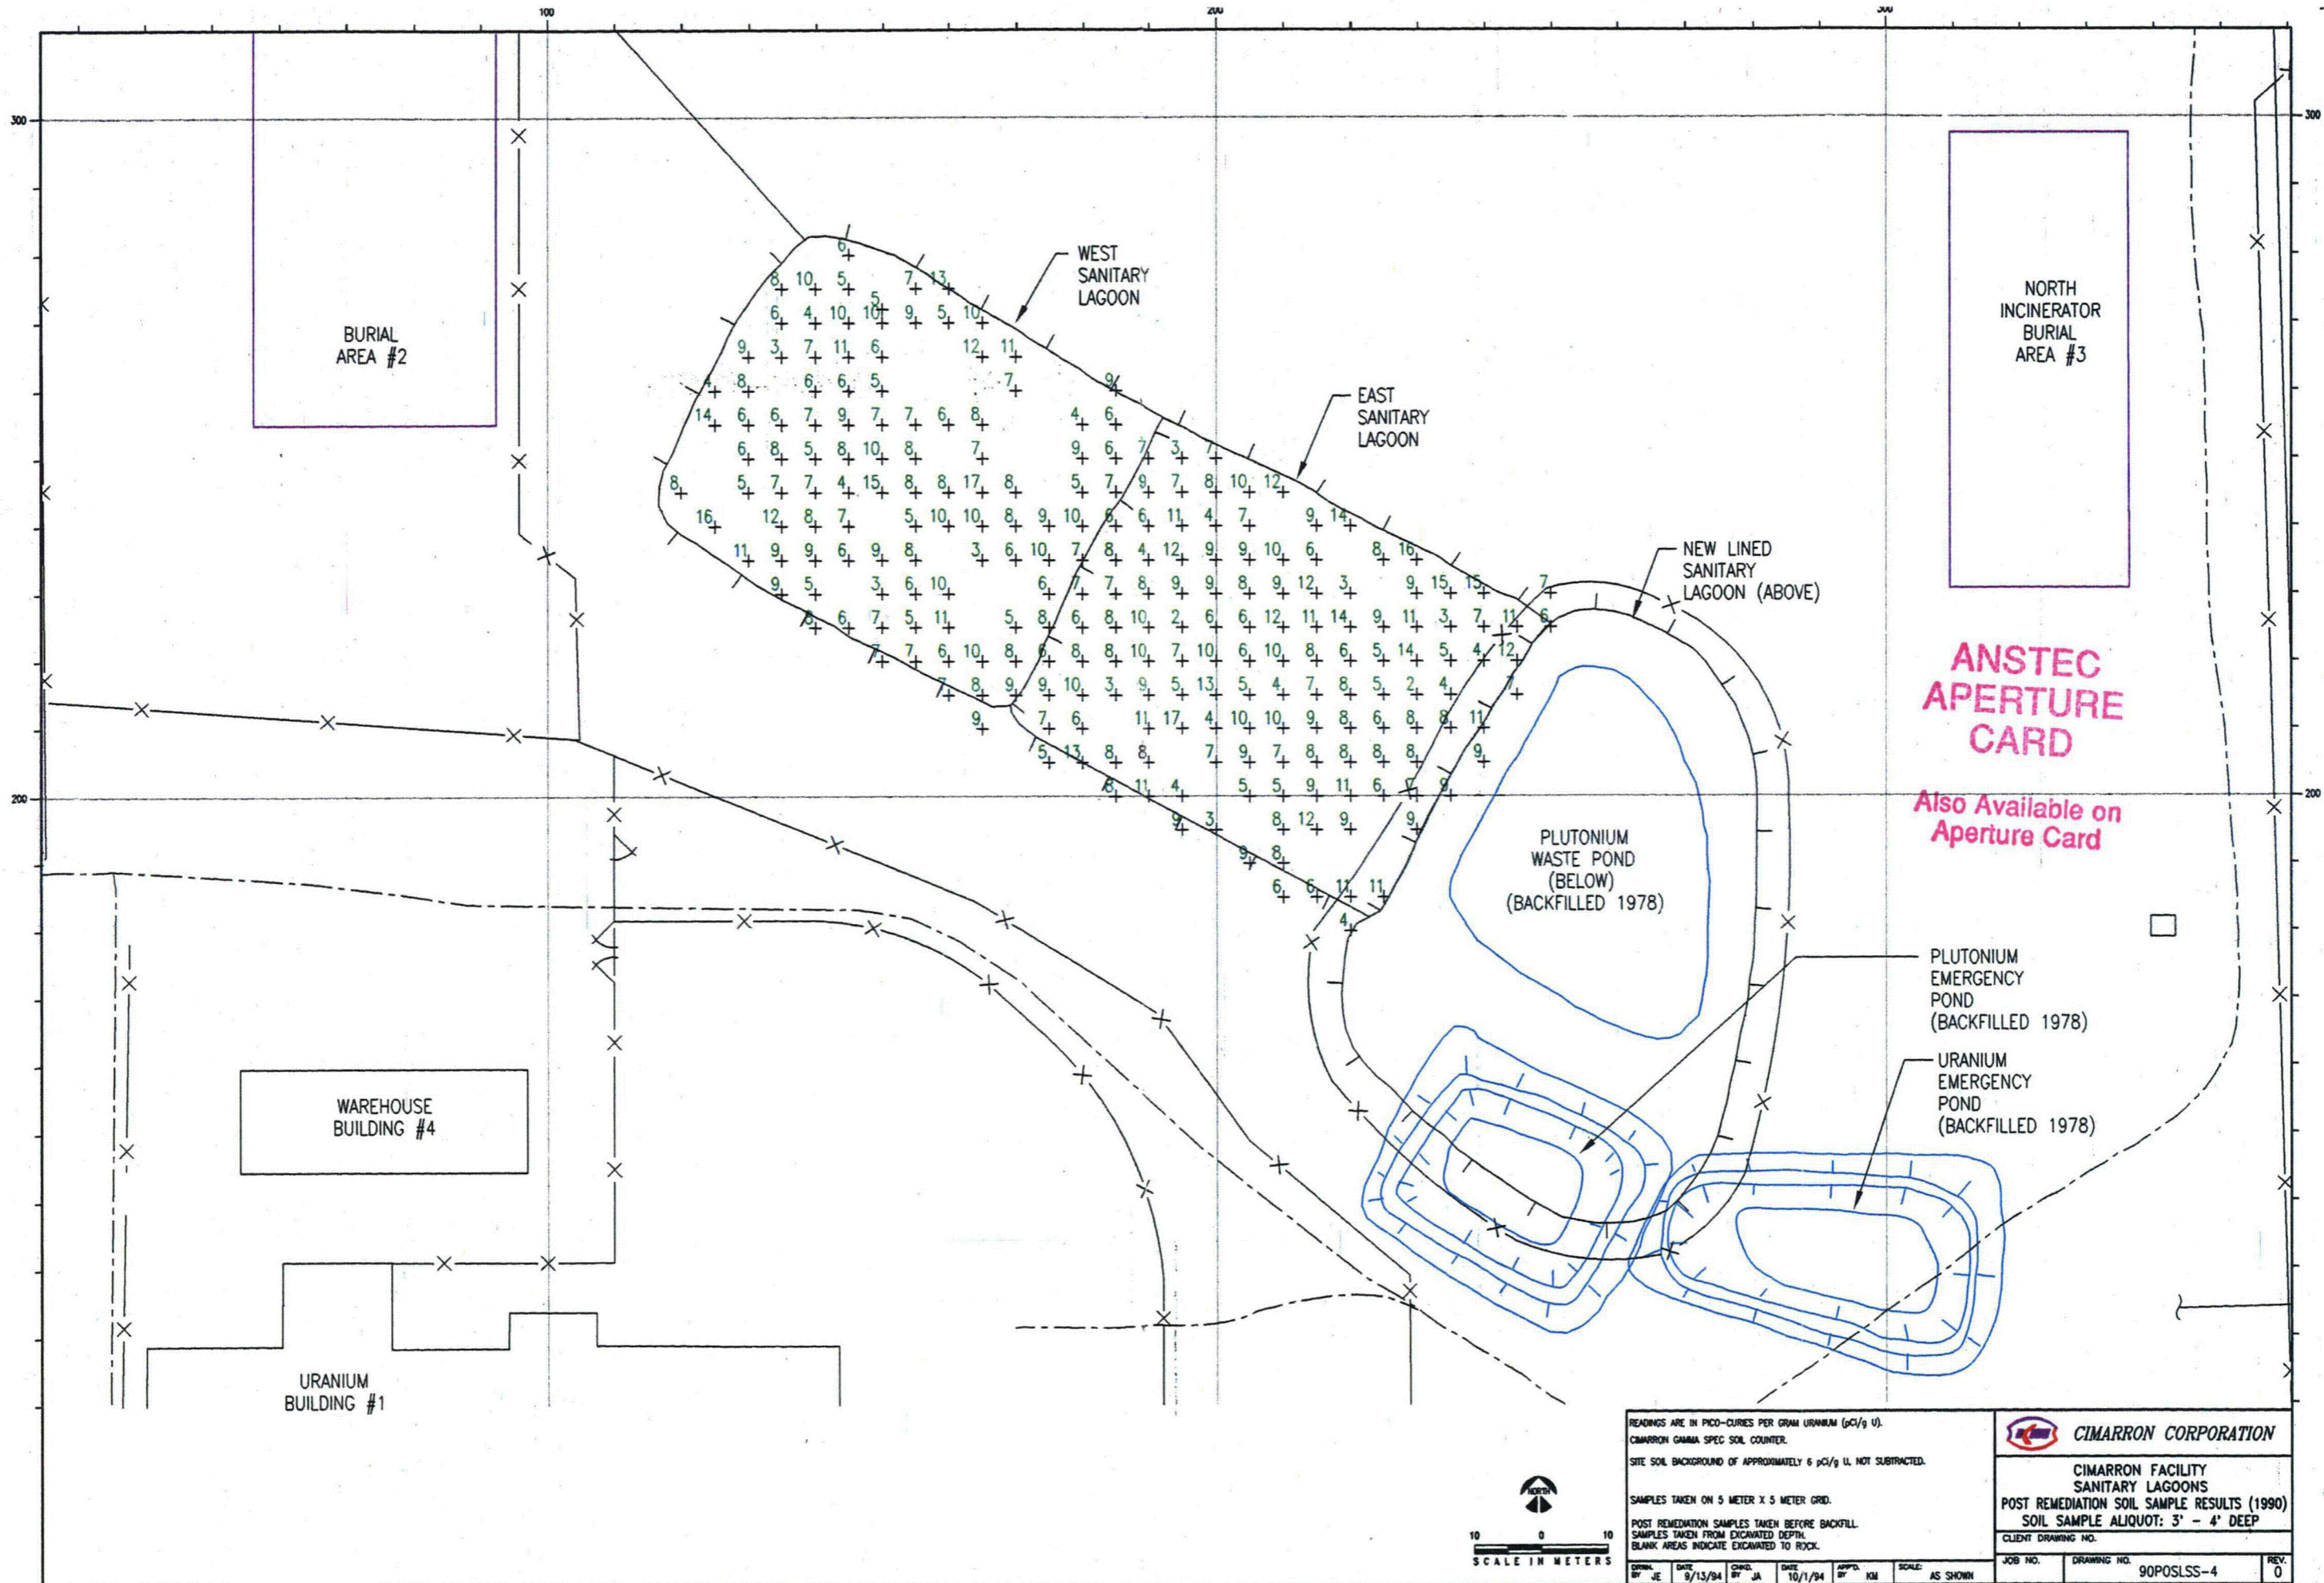
READINGS ARE IN PICO-CURIES PER GRAM URANIUM (pCi/g U).
CIMARRON GAMMA SPEC SOIL COUNTER.
SITE SOIL BACKGROUND OF APPROXIMATELY 6 pCi/g U, NOT SUBTRACTED.
SAMPLES TAKEN ON 5 METER X 5 METER GRID.
POST REMEDIATION SAMPLES TAKEN BEFORE BACKFILL.
SAMPLES TAKEN FROM EXCAVATED DEPTH.
BLANK AREAS INDICATE EXCAVATED TO ROCK.

CIMARRON CORPORATION CIMARRON FACILITY SANITARY LAGOONS POST REMEDIATION SOIL SAMPLE RESULTS (1990) SOIL SAMPLE ALIQUOT: 3' - 4' DEEP CLIENT DRAWING NO.	
JOB NO.	DRAWING NO. 90POSLS-4
REV. 0
