11.0 Sanitary Lagoons

11.1 East Sanitary Lagoon & West Sanitary Lagoon

11.2 New Sanitary Lagoon

12.0 Five Former Waste Water Ponds

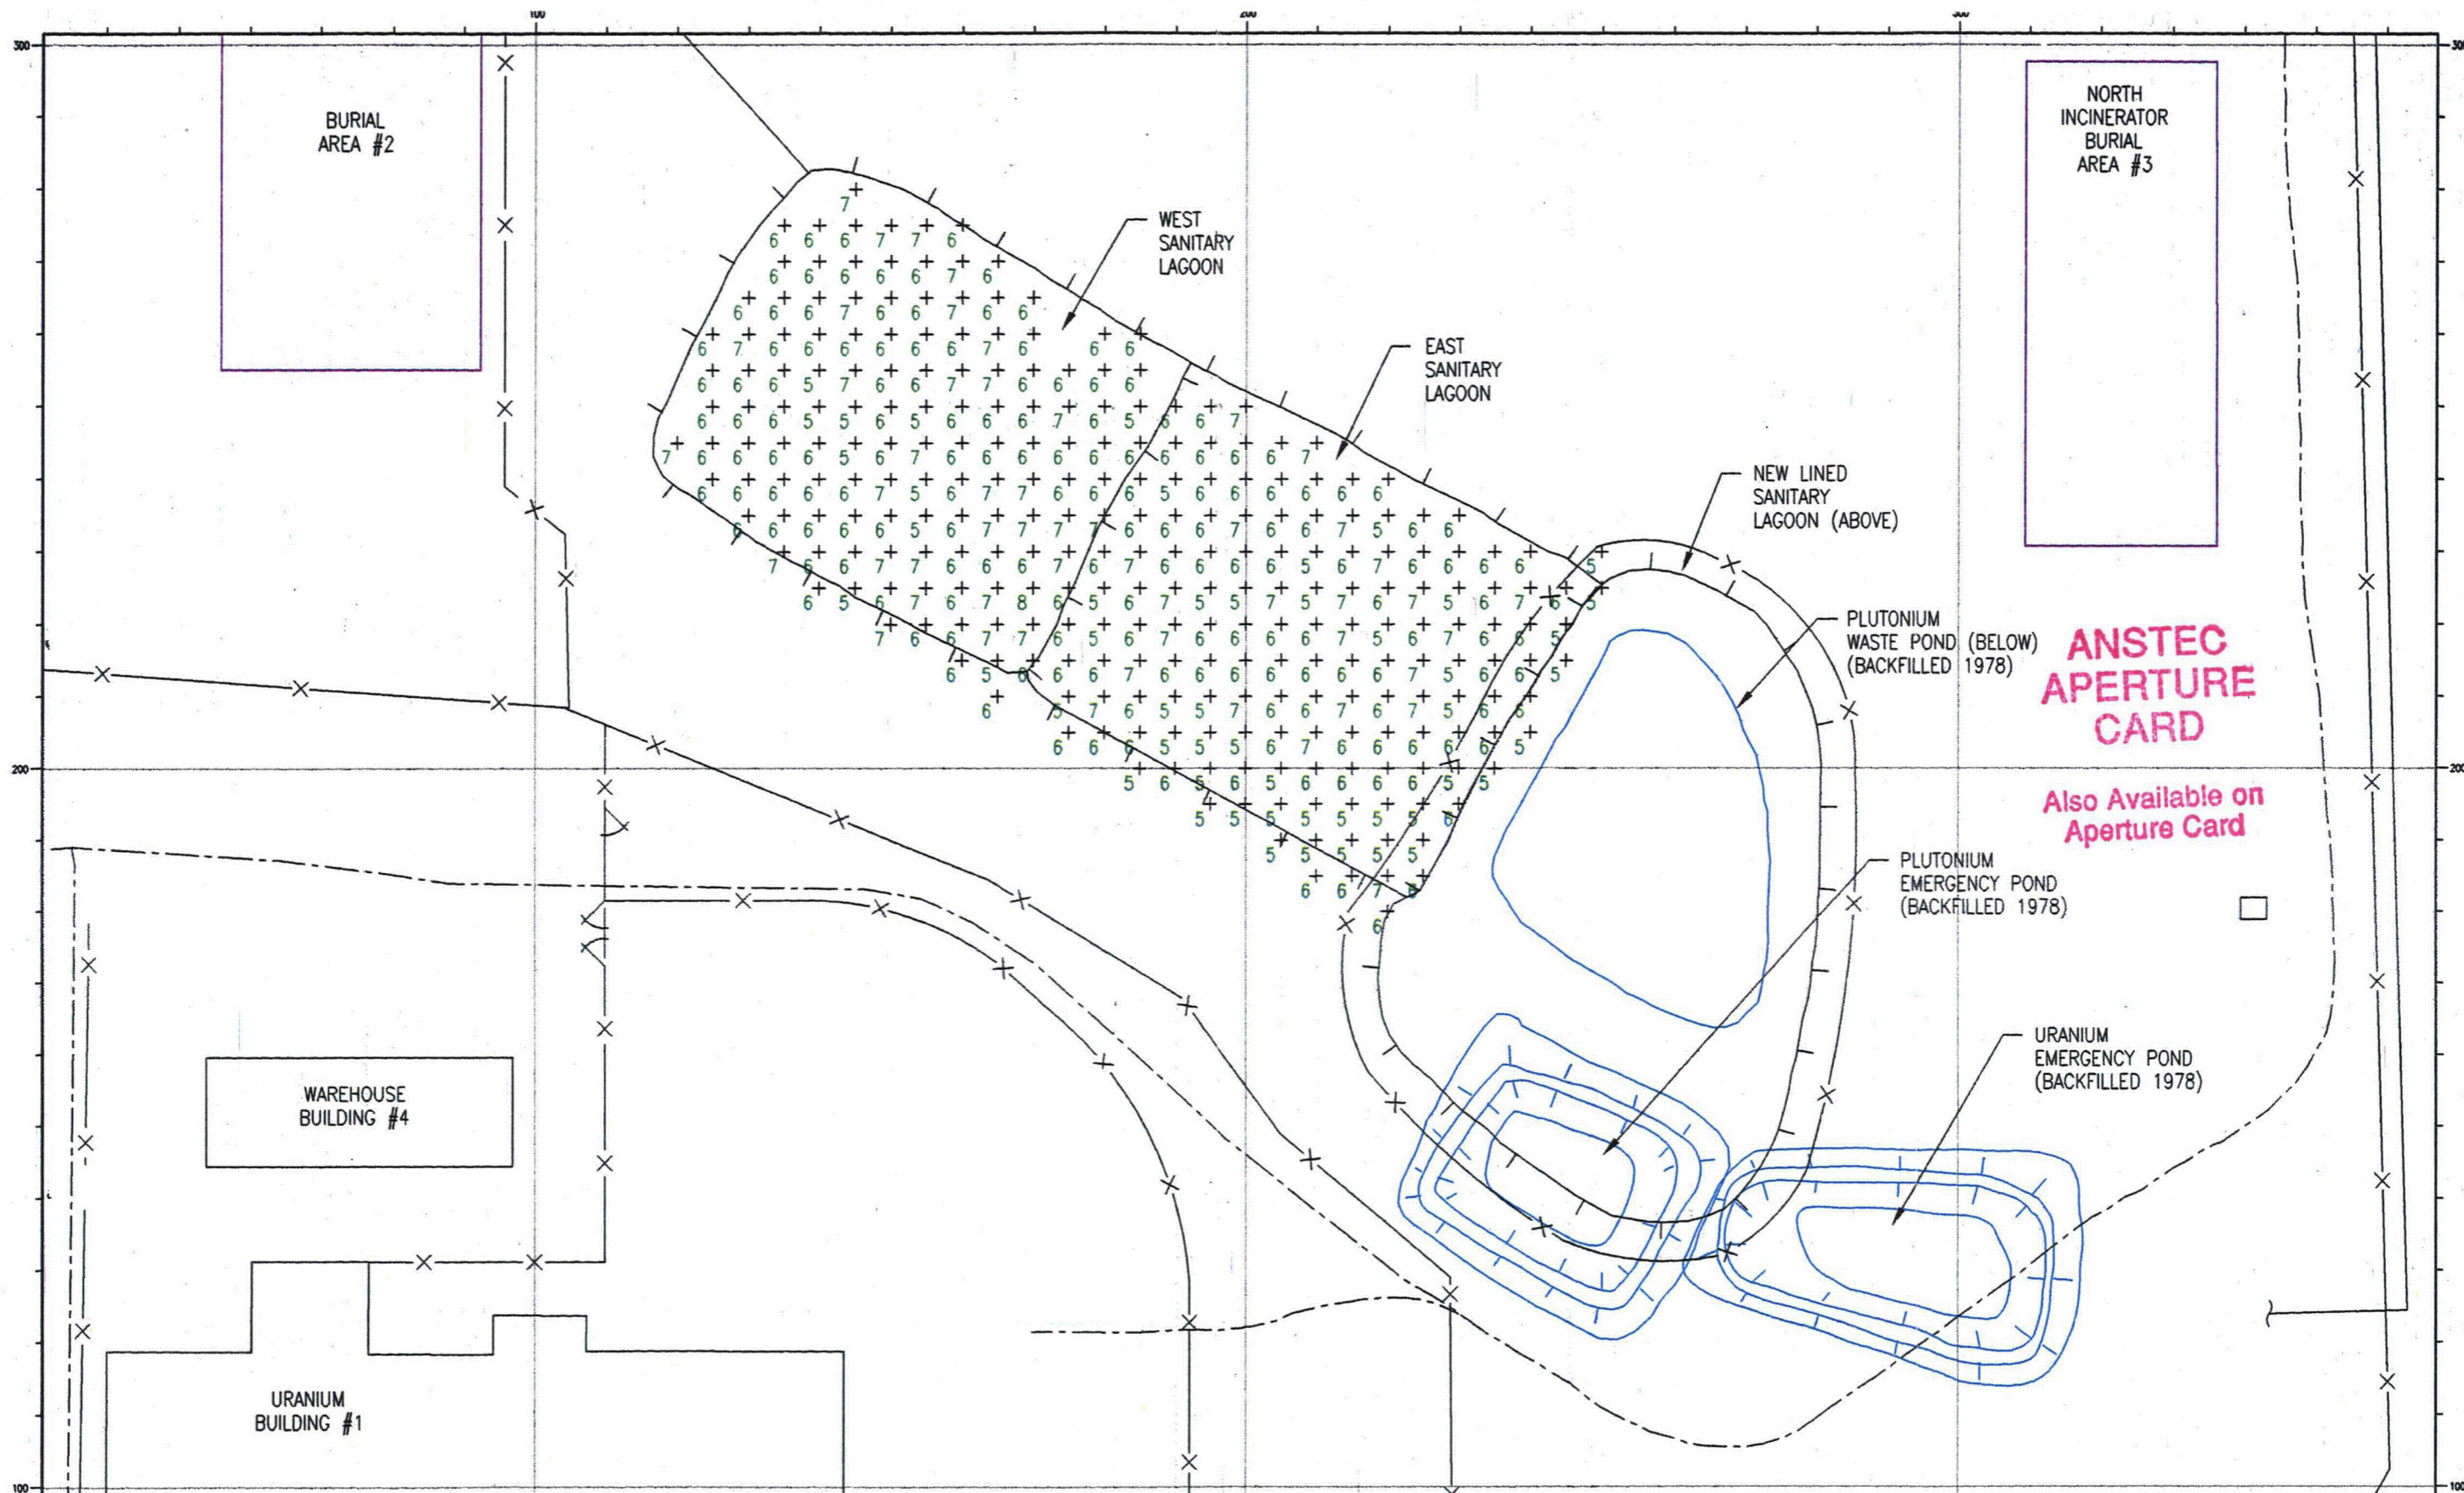
CLIENT DRAWING NO. _____
 JOB NO. _____ DRAWING NO. 90POSUR-1 REV. 0

READINGS ARE IN MICRO-R/HR. ($\mu\text{R}/\text{hr.}$)
 INSTRUMENT: LUDLUM MICRO-R METER
 MODEL NO: 125
 SERIAL NO: 9081

ESTABLISHED SITE BACKGROUND OF 7 $\mu\text{R}/\text{hr.}$, NOT SUBTRACTED.
 SAMPLES TAKEN ON A 5 METER X 5 METER GRID.

READINGS WERE TAKEN AFTER REMEDIATION, BUT BEFORE BACKFILL.

CIMARRON FACILITY
 SANITARY LAGOONS
 POST REMEDIATION MICRO-R SURVEY (1990)
 AT ONE METER ABOVE SURFACE

completed in September, 1990. A 5m x 5m grid system was utilized for this sampling effort. Soil analytical data is shown on Drawings No. 90POSLSS-0 through 90POSLSS-4. This sampling program involved the use of composite samples taken from depths of 0 to 6 in., 6 in. to 1 ft., 1 to 2 ft., 2 to 3 ft., and 3 to 4 ft. All results show total uranium concentrations less than the Option #1 guideline value of 30 pCi/g. A Micro-R survey was also conducted in 1990 on the same 5m x 5m grid and the results are shown on Drawing No. 90POSLUR-1.

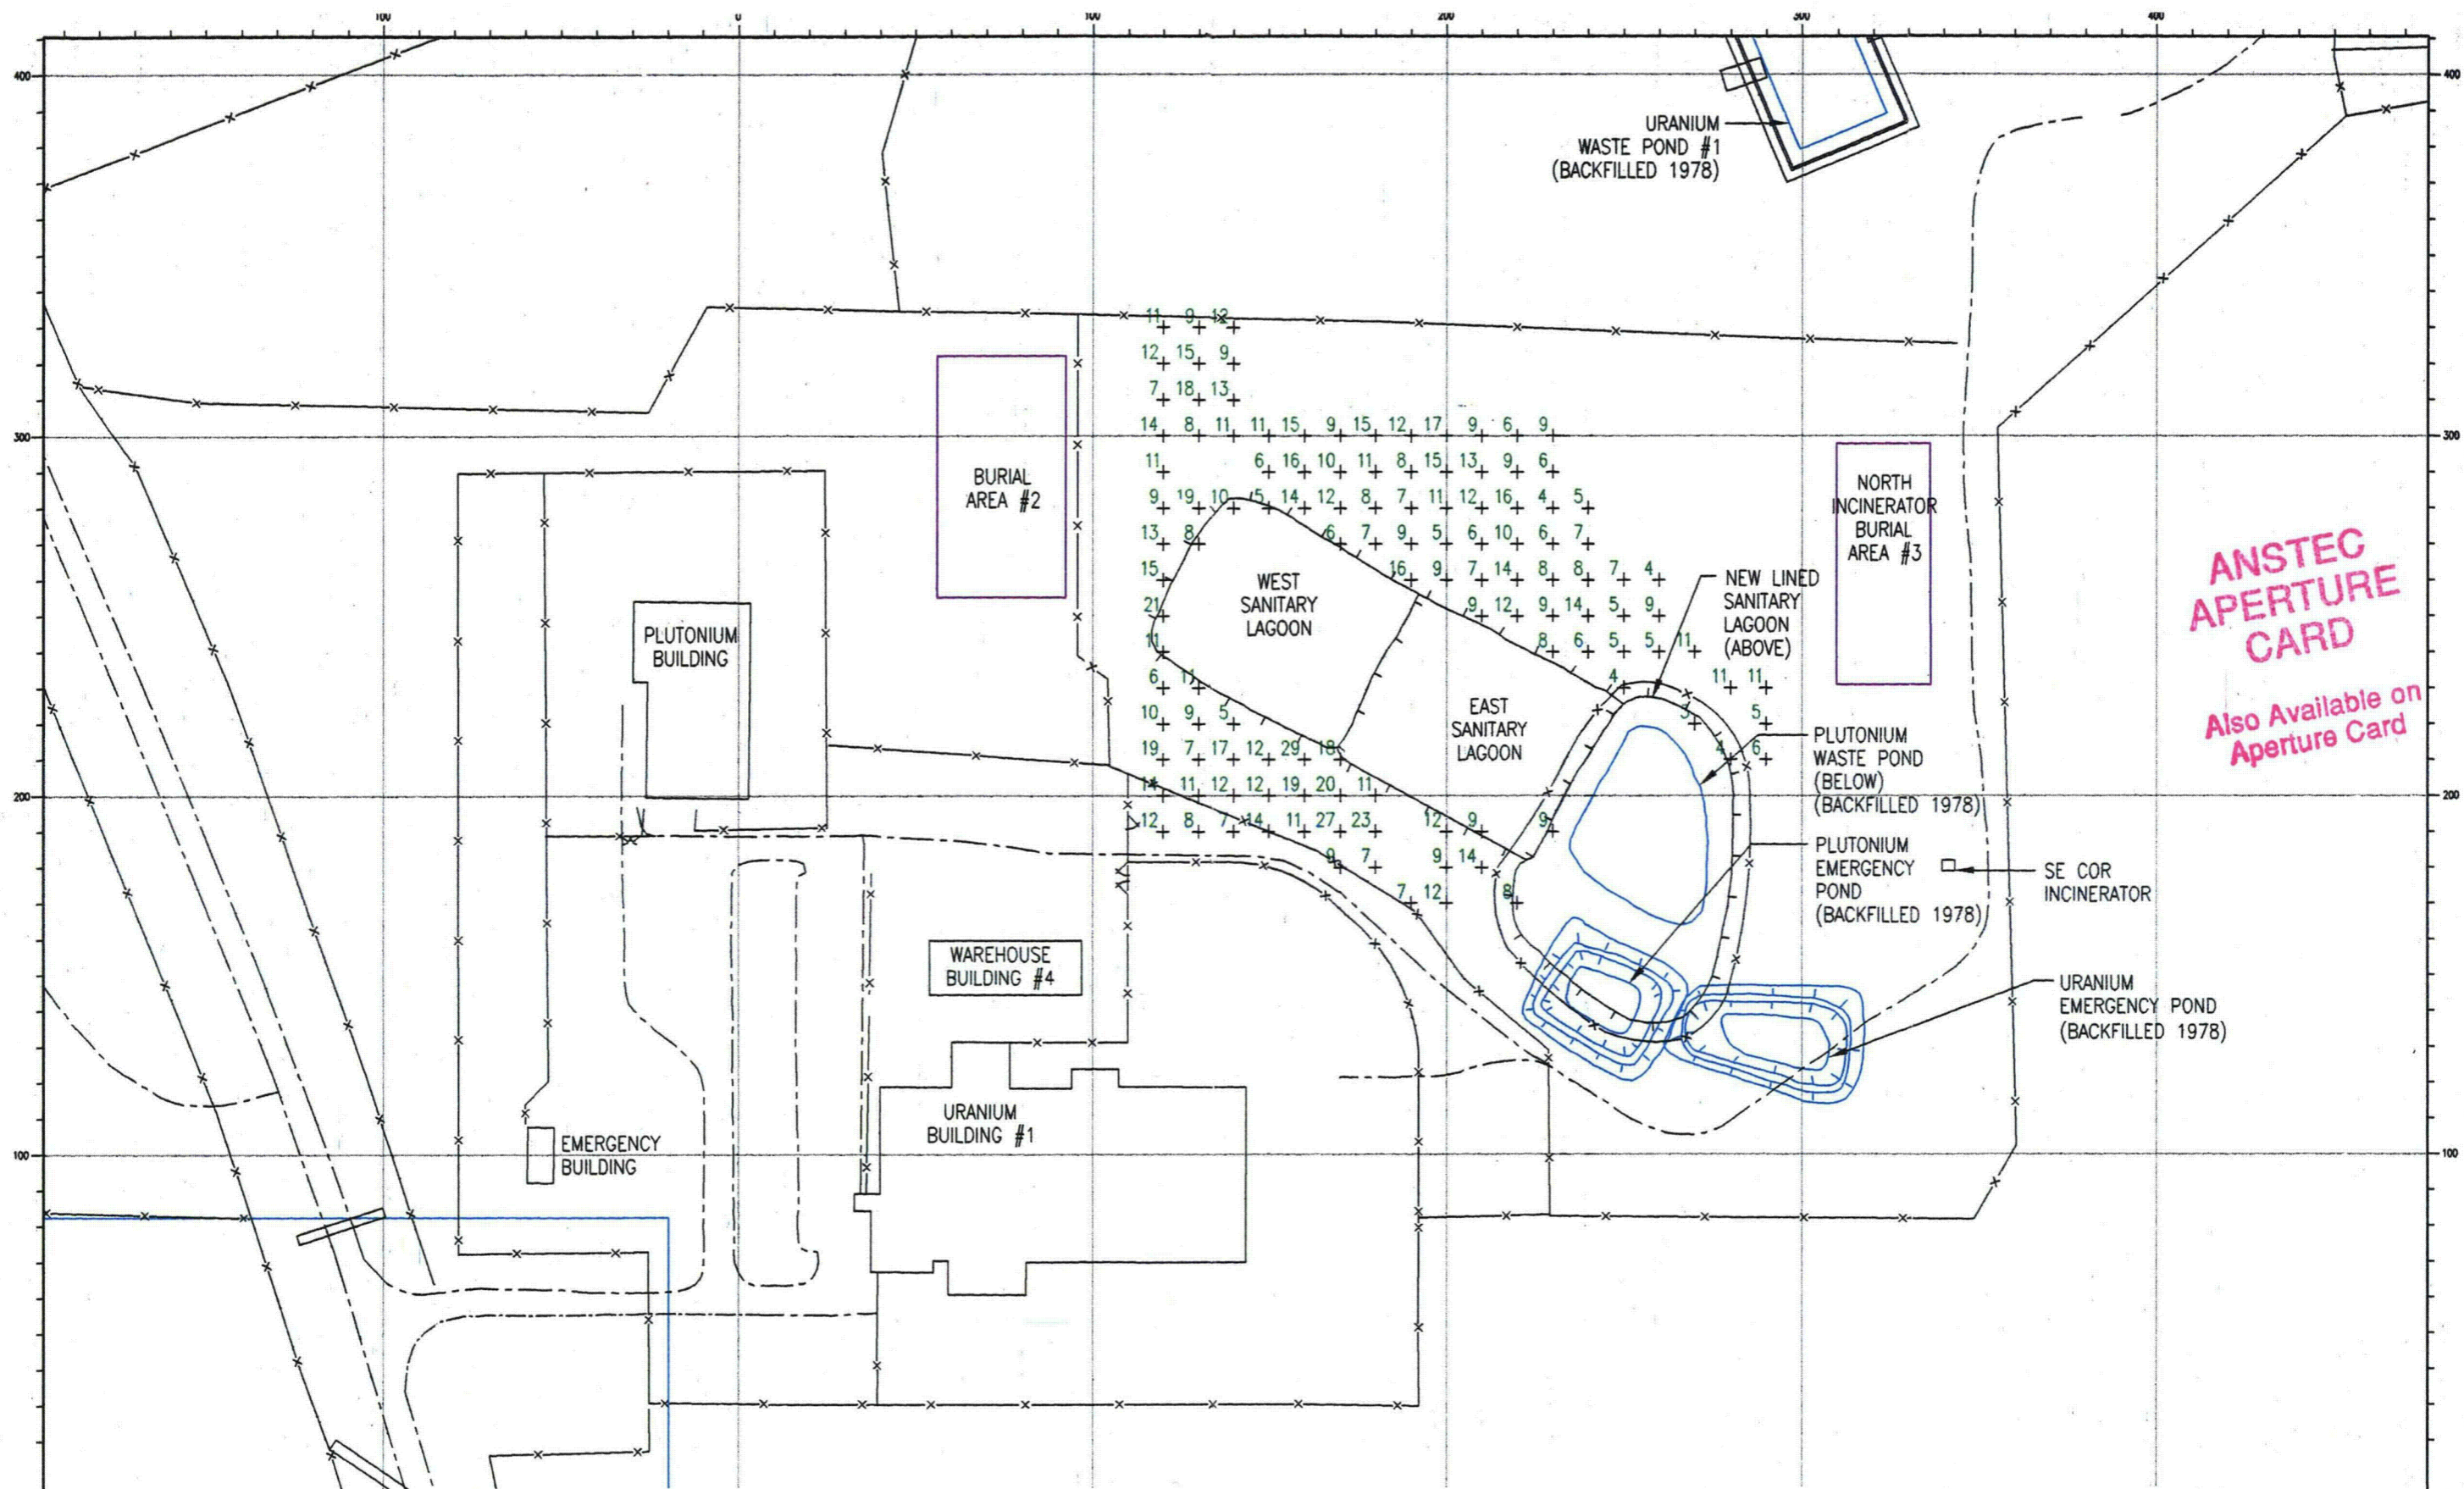
READINGS ARE IN PICO-CURIES PER GRAM URANIUM (pCi/g U). CIMARRON GAMMA SPEC SOIL COUNTER. SITE SOIL BACKGROUND OF APPROXIMATELY 6 pCi/g U, NOT SUBTRACTED. SAMPLES TAKEN ON 10 METER X 10 METER GRID. SAMPLES TAKEN BEFORE REMEDIATION.		LEGEND 1 - 29 pCi/g U 30 - 89 pCi/g U > 90 pCi/g U		CIMARRON CORPORATION CIMARRON FACILITY SANITARY LAGOONS PRE-REMEDIATION SOIL SAMPLE RESULTS (1990) SOIL SAMPLE ALIQUOT: 0"-6" DEEP CLIENT DRAWING NO.
CONTROL BY: JE DATE: 9/13/94 CHECKED BY: JA DATE: 10/1/94 APPROVED BY: KM SCALE: AS SHOWN	JOB NO. 90PRSLSS-0 DRAWING NO. 90PRSLSS-0 REV. 0

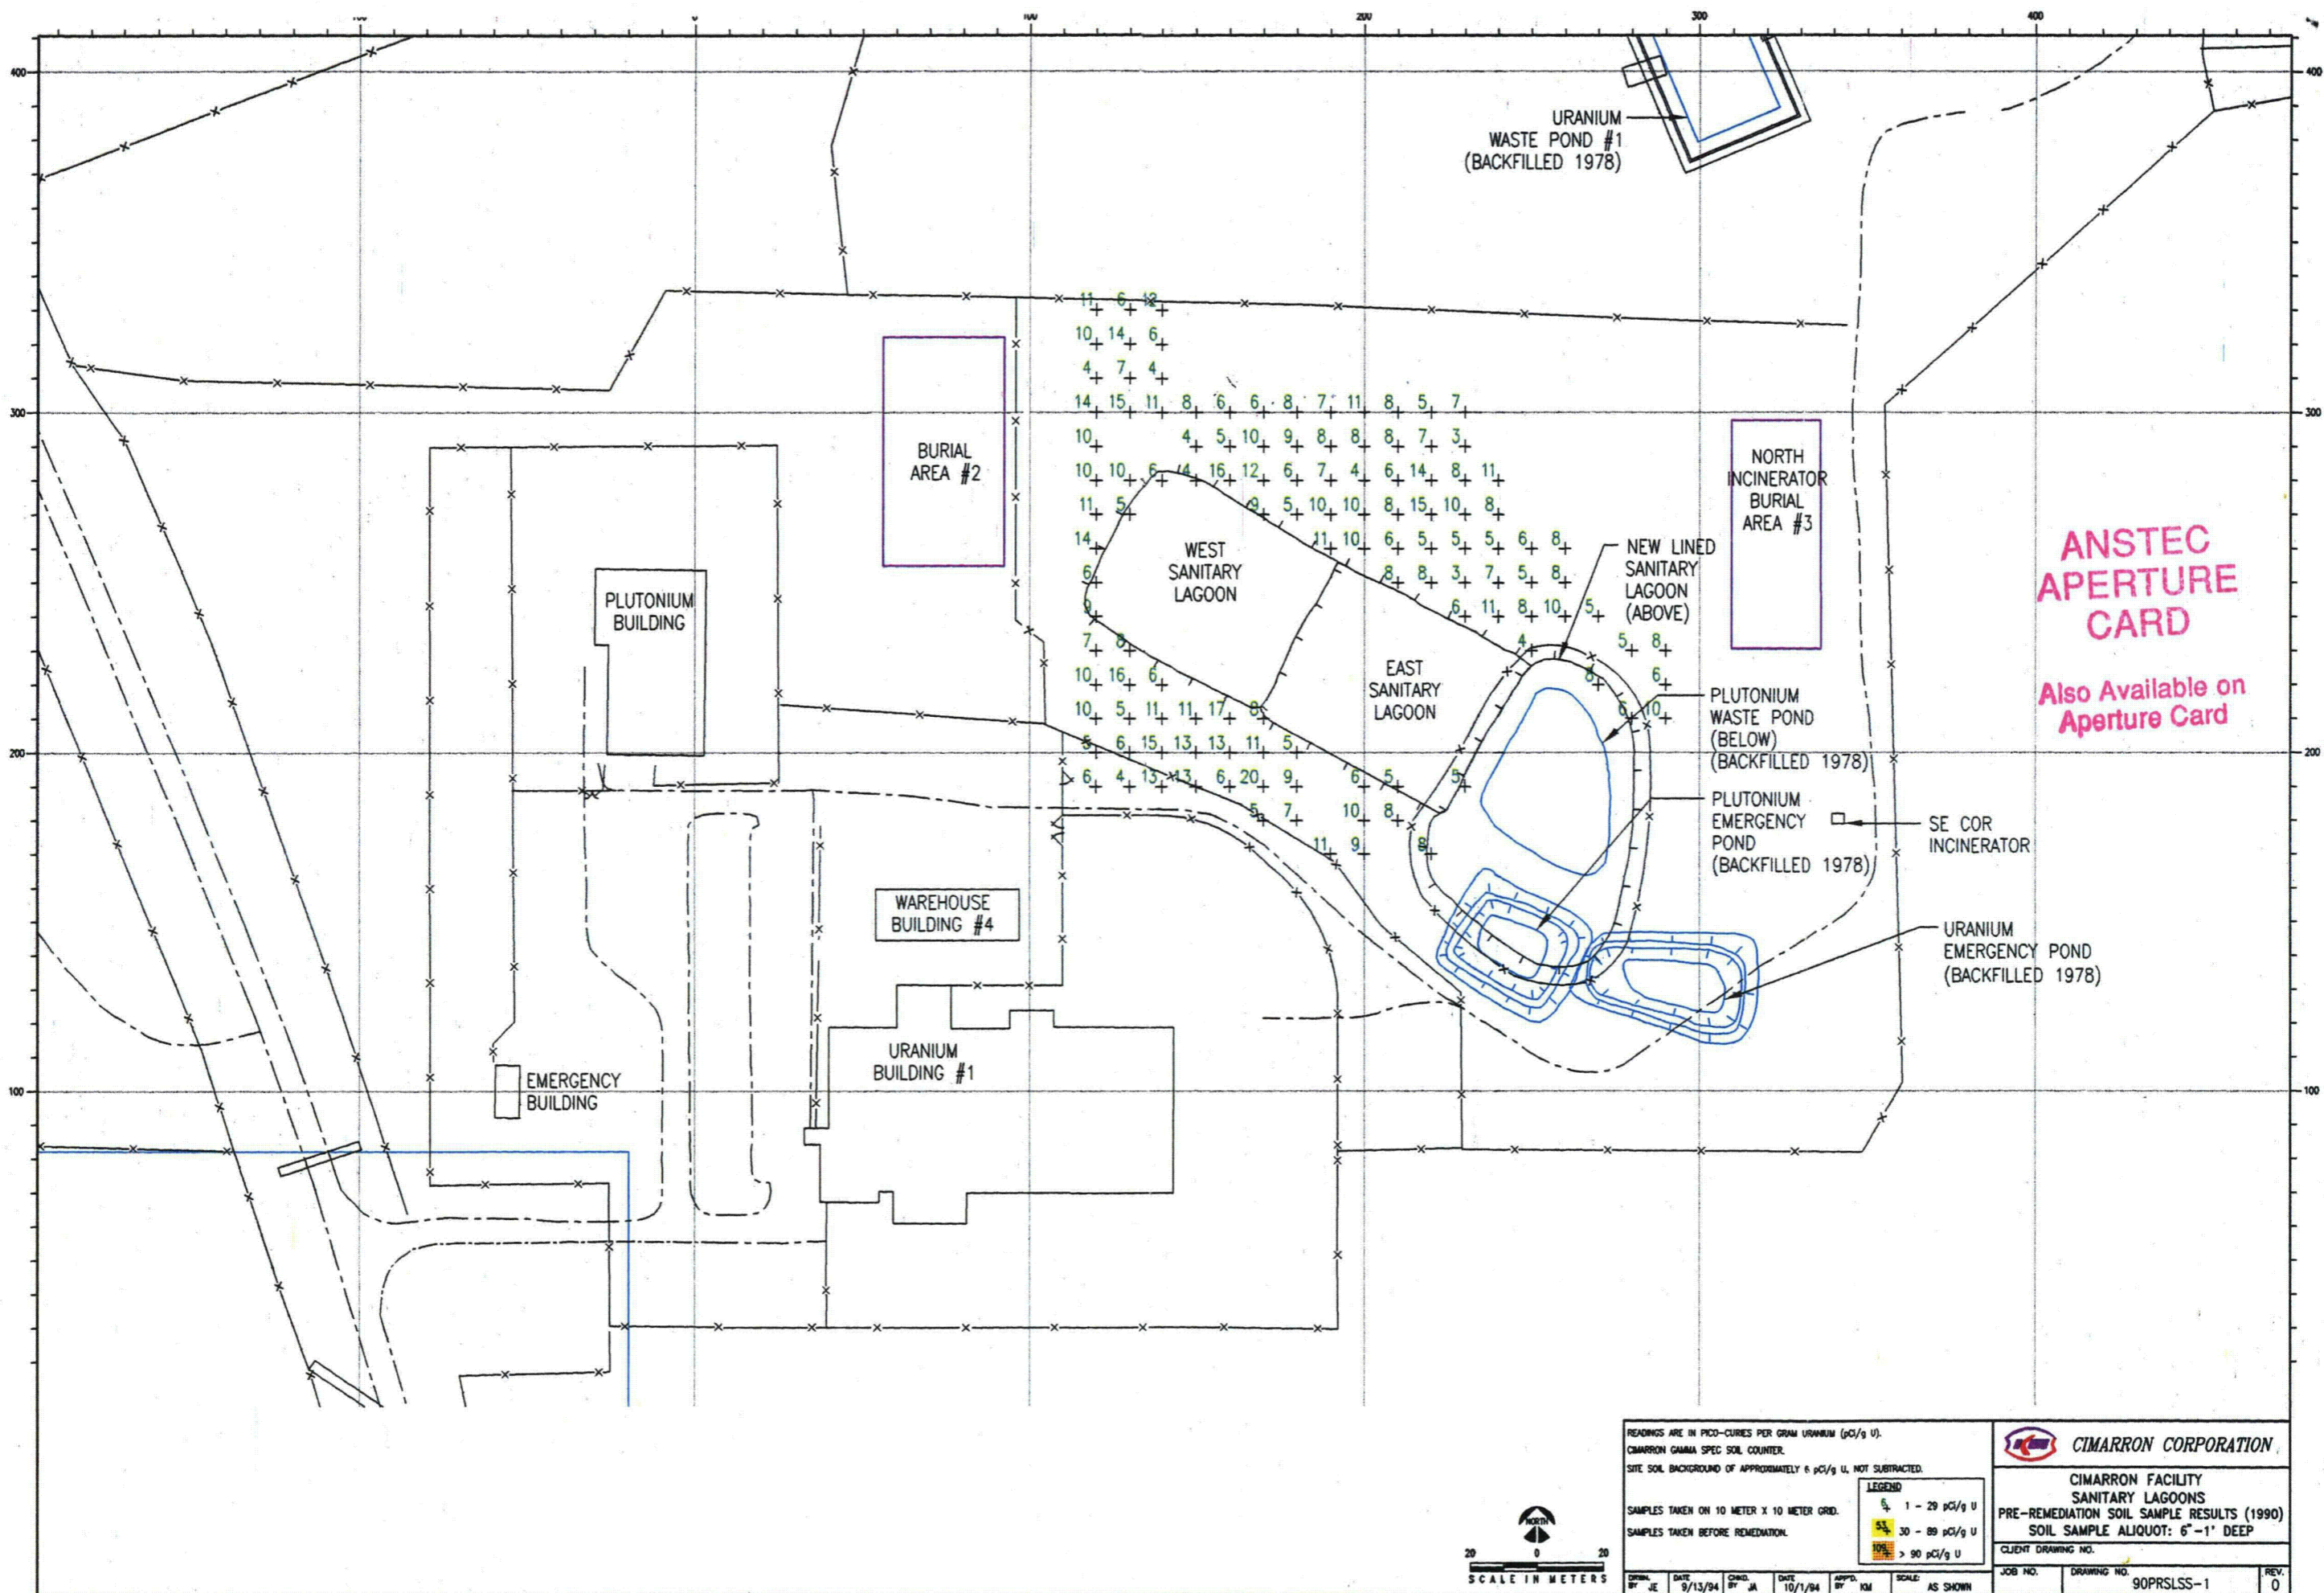
READINGS ARE IN PICO-CURIES PER GRAM URANIUM (pCi/g U). CIMARRON GAMMA SPEC SOIL COUNTER. SITE SOIL BACKGROUND OF APPROXIMATELY 6 pCi/g U, NOT SUBTRACTED.			
SAMPLES TAKEN ON 10 METER X 10 METER GRID. SAMPLES TAKEN BEFORE REMEDIATION.		LEGEND 1 - 29 pCi/g U 30 - 89 pCi/g U > 90 pCi/g U	
JOB NO. 90PRSLSS-1 DRAWING NO. 90PRSLSS-1 REV. 0		CLIENT DRAWING NO.

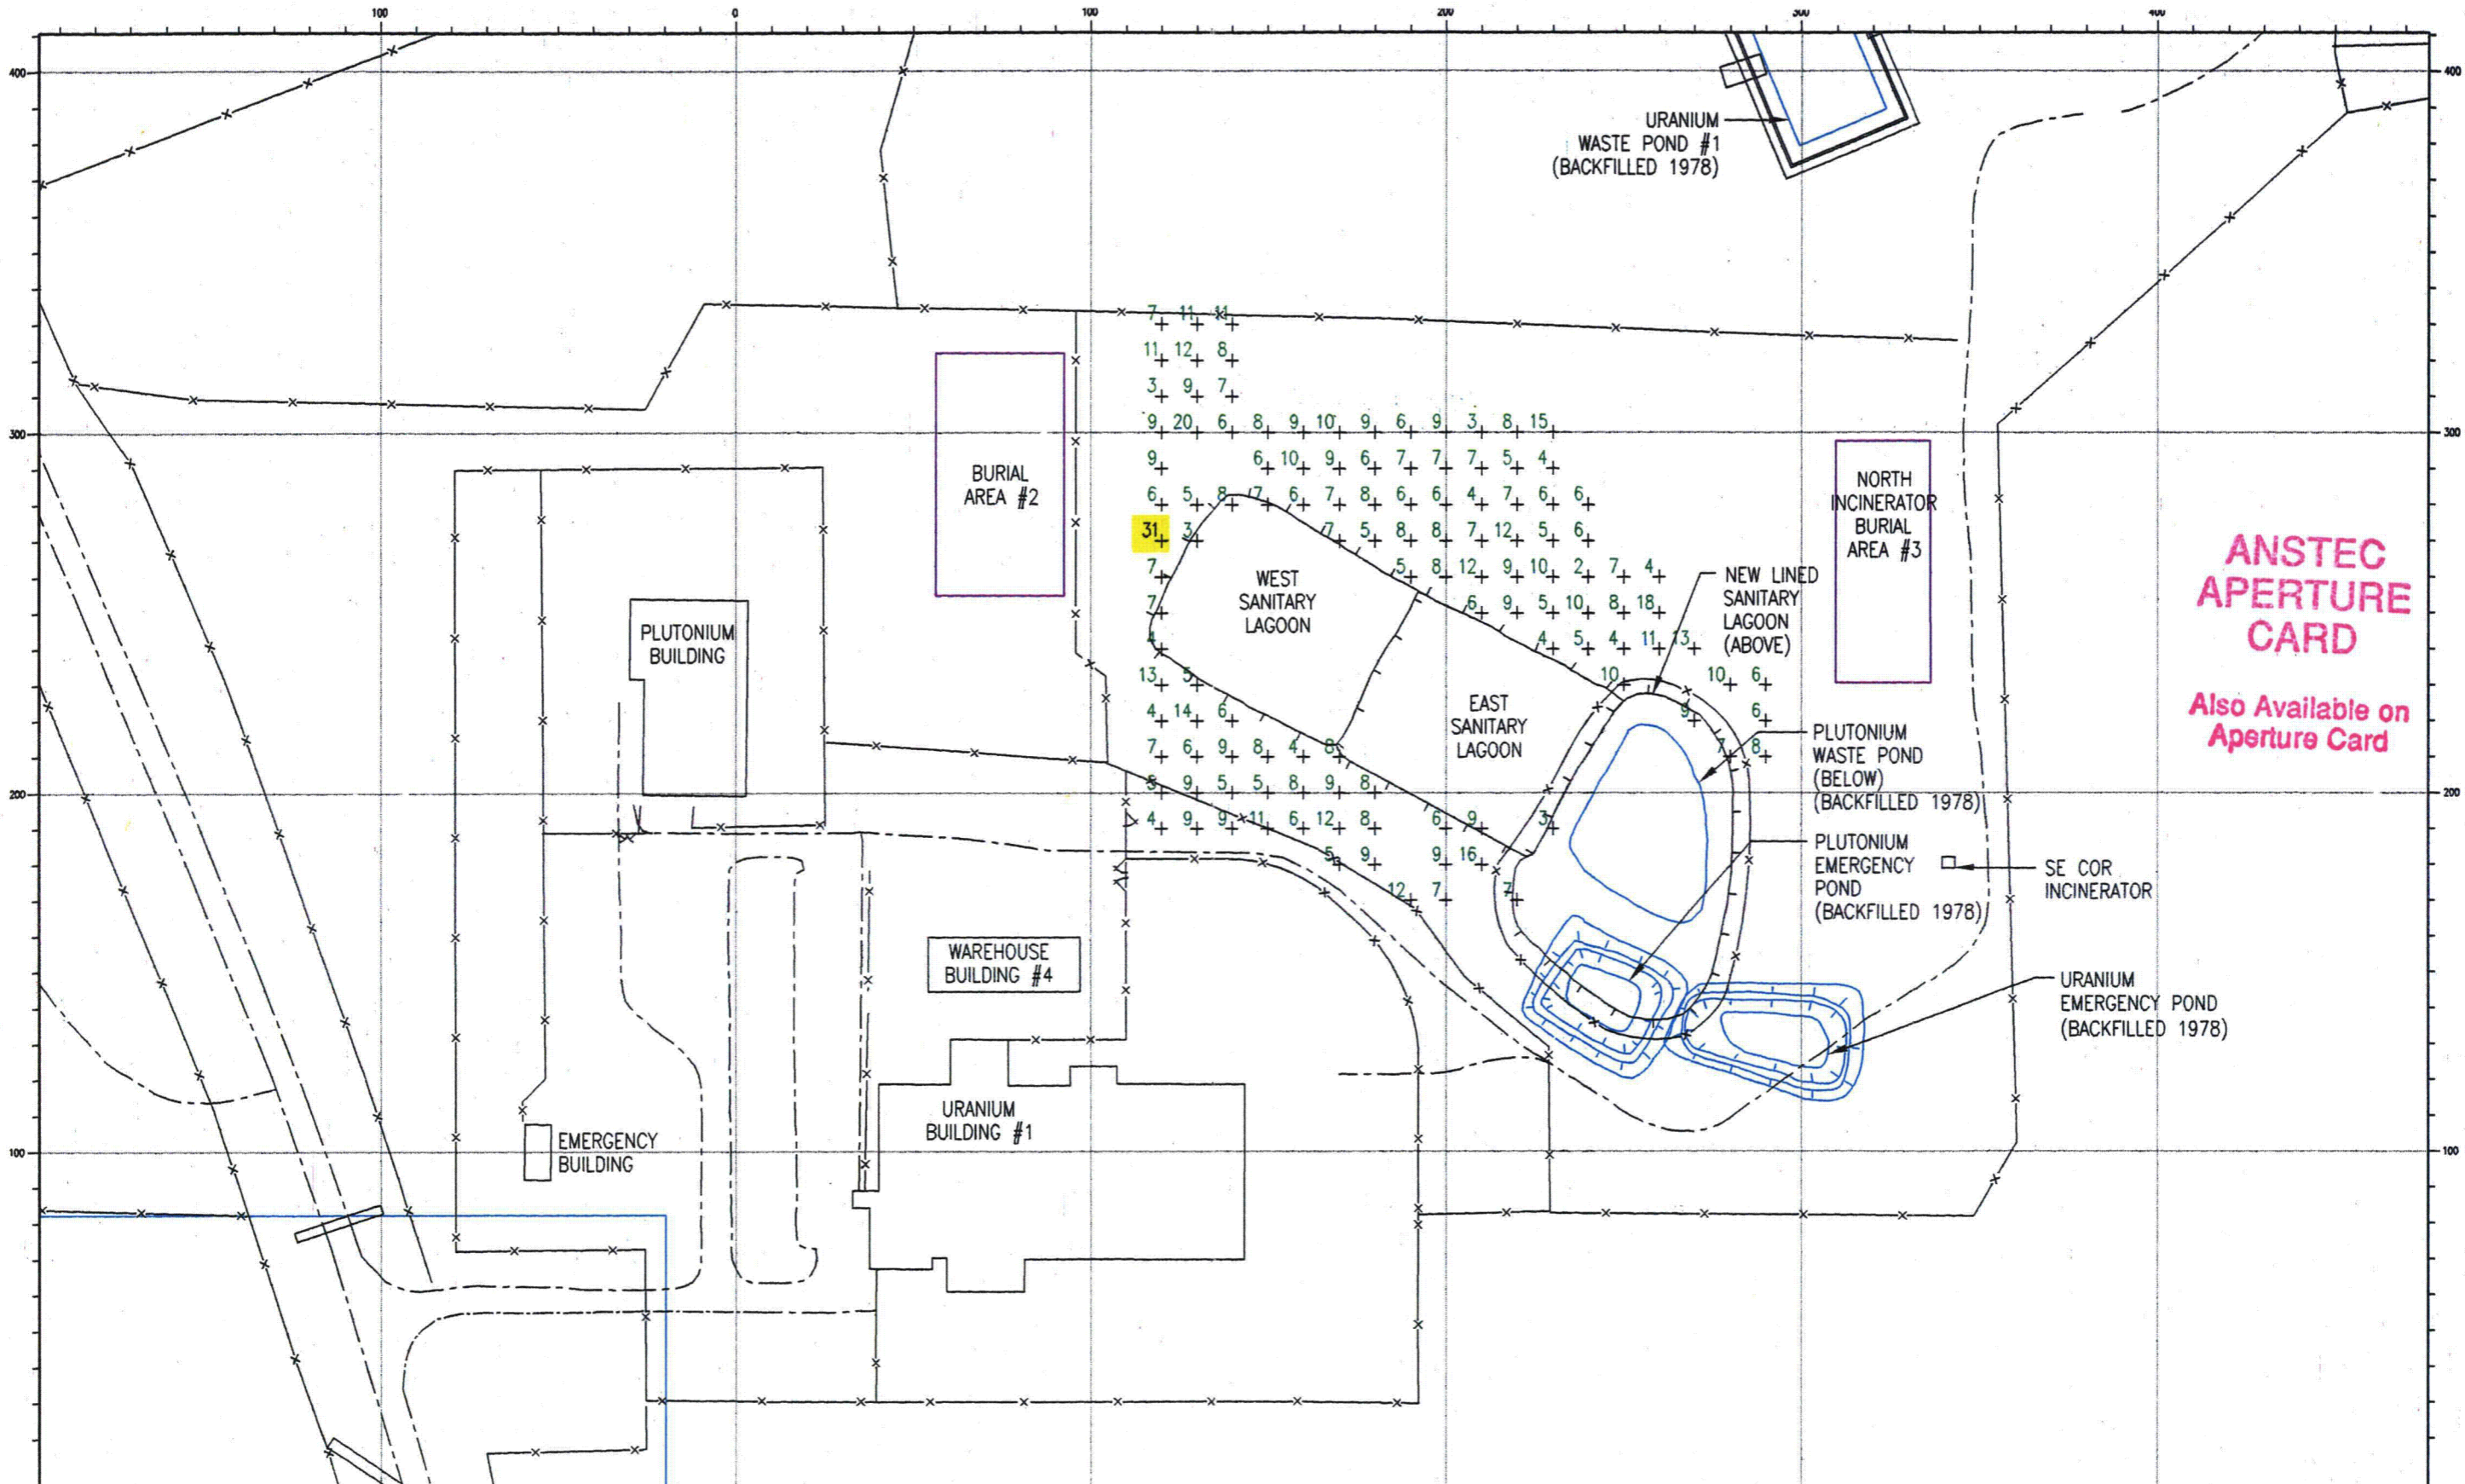
READINGS ARE IN PICO-CURIES PER GRAM URANIUM (pCi/g U). CIMARRON GAMMA SPEC SOIL COUNTER. SITE SOIL BACKGROUND OF APPROXIMATELY 6 pCi/g U, NOT SUBTRACTED.		CIMARRON CORPORATION CIMARRON FACILITY SANITARY LAGOONS PRE-REMEDIATION SOIL SAMPLE RESULTS (1990) SOIL SAMPLE ALIQUOT: 1'-2' DEEP CLIENT DRAWING NO.	
SAMPLES TAKEN ON 10 METER X 10 METER GRID. SAMPLES TAKEN BEFORE REMEDIATION.		LEGEND 1 - 29 pCi/g U 30 - 89 pCi/g U > 90 pCi/g U	
SIGNAL BY: JE DATE: 9/13/94 CHECKED BY: JA DATE: 10/1/94 APPROVED BY: YM SCALE: AS SHOWN	JOB NO. 90PRSLSS-2 DRAWING NO. 90PRSLSS-2 REV. 0

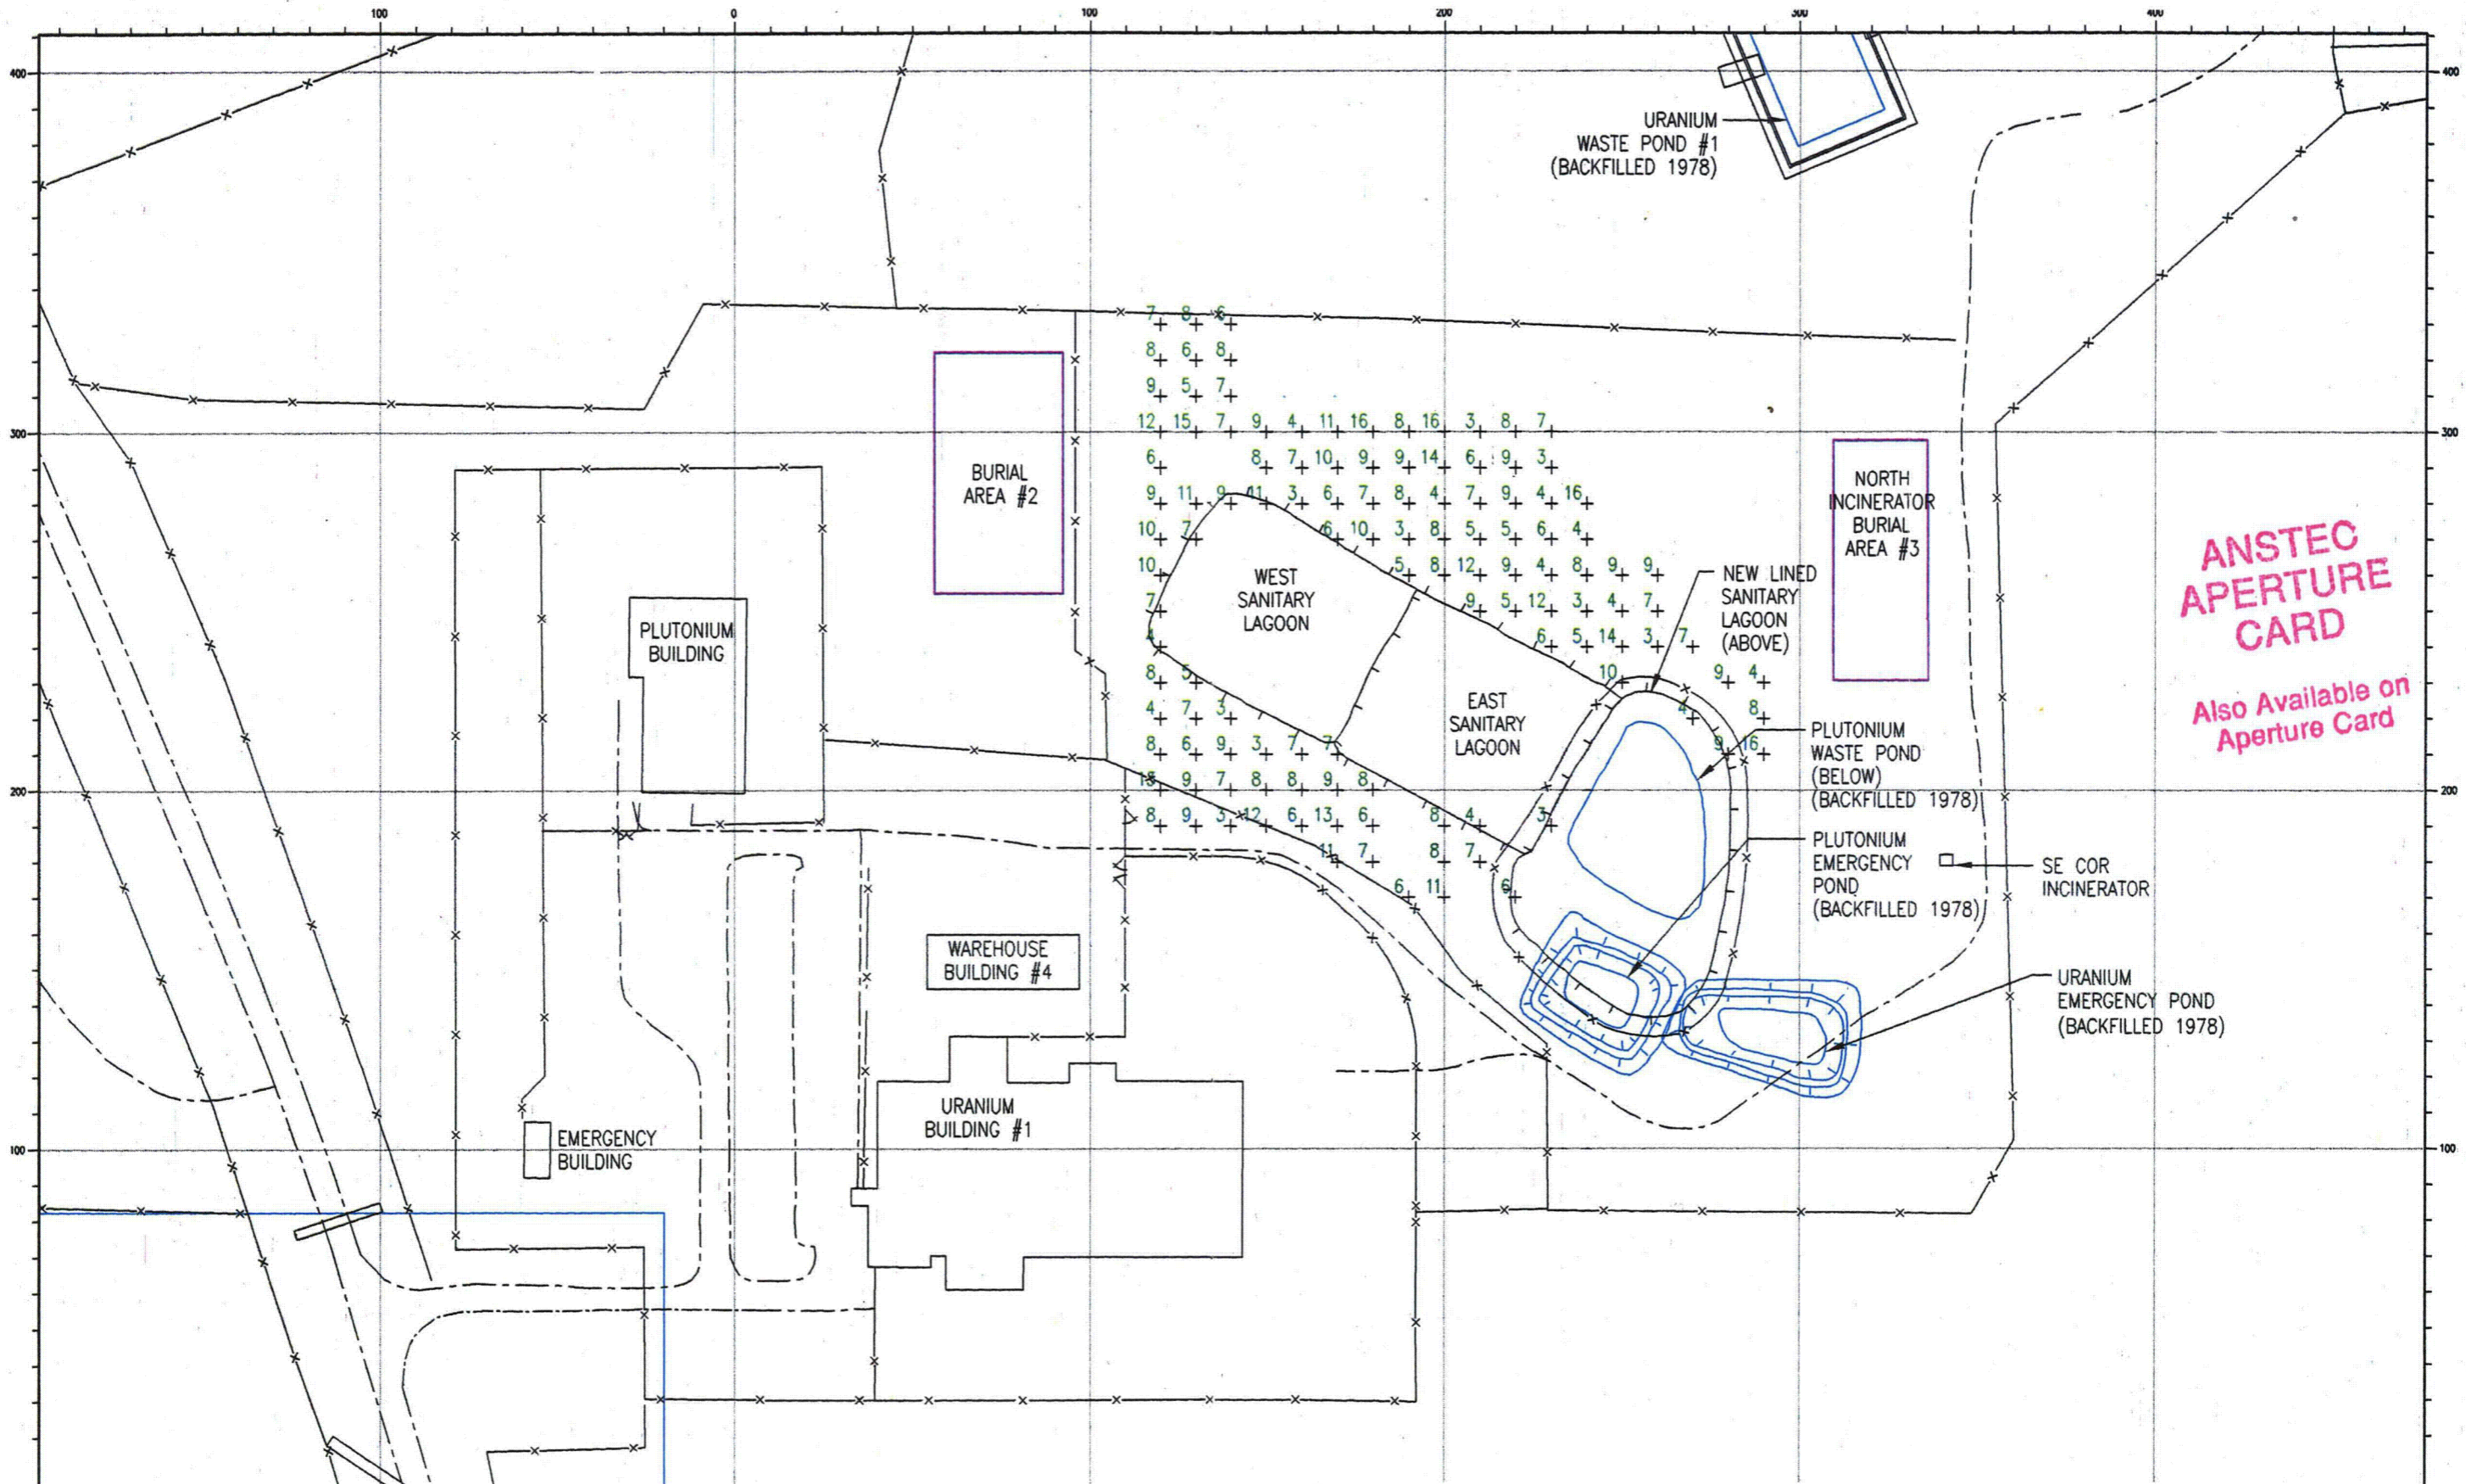
READINGS ARE IN PICO-CURIES PER GRAM URANIUM (pCi/g U).
 CIMARRON GAMMA SPEC SOIL COUNTER.
 SITE SOIL BACKGROUND OF APPROXIMATELY 6 pCi/g U, NOT SUBTRACTED.

SAMPLES TAKEN ON 10 METER X 10 METER GRID.
 SAMPLES TAKEN BEFORE REMEDIATION.

CIMARRON CORPORATION
 CIMARRON FACILITY
 SANITARY LAGOONS
 PRE-REMEDIATION SOIL SAMPLE RESULTS (1990)
 SOIL SAMPLE ALIQUOT: 2"-3" DEEP
 CLIENT DRAWING NO. 90PRSLSS-3
 JOB NO. DRAWING NO. 90PRSLSS-3 REV. 0
