11.0 Sanitary Lagoons

11.1 East Sanitary Lagoon & West Sanitary Lagoon

11.2 New Sanitary Lagoon

12.0 Five Former Waste Water Ponds

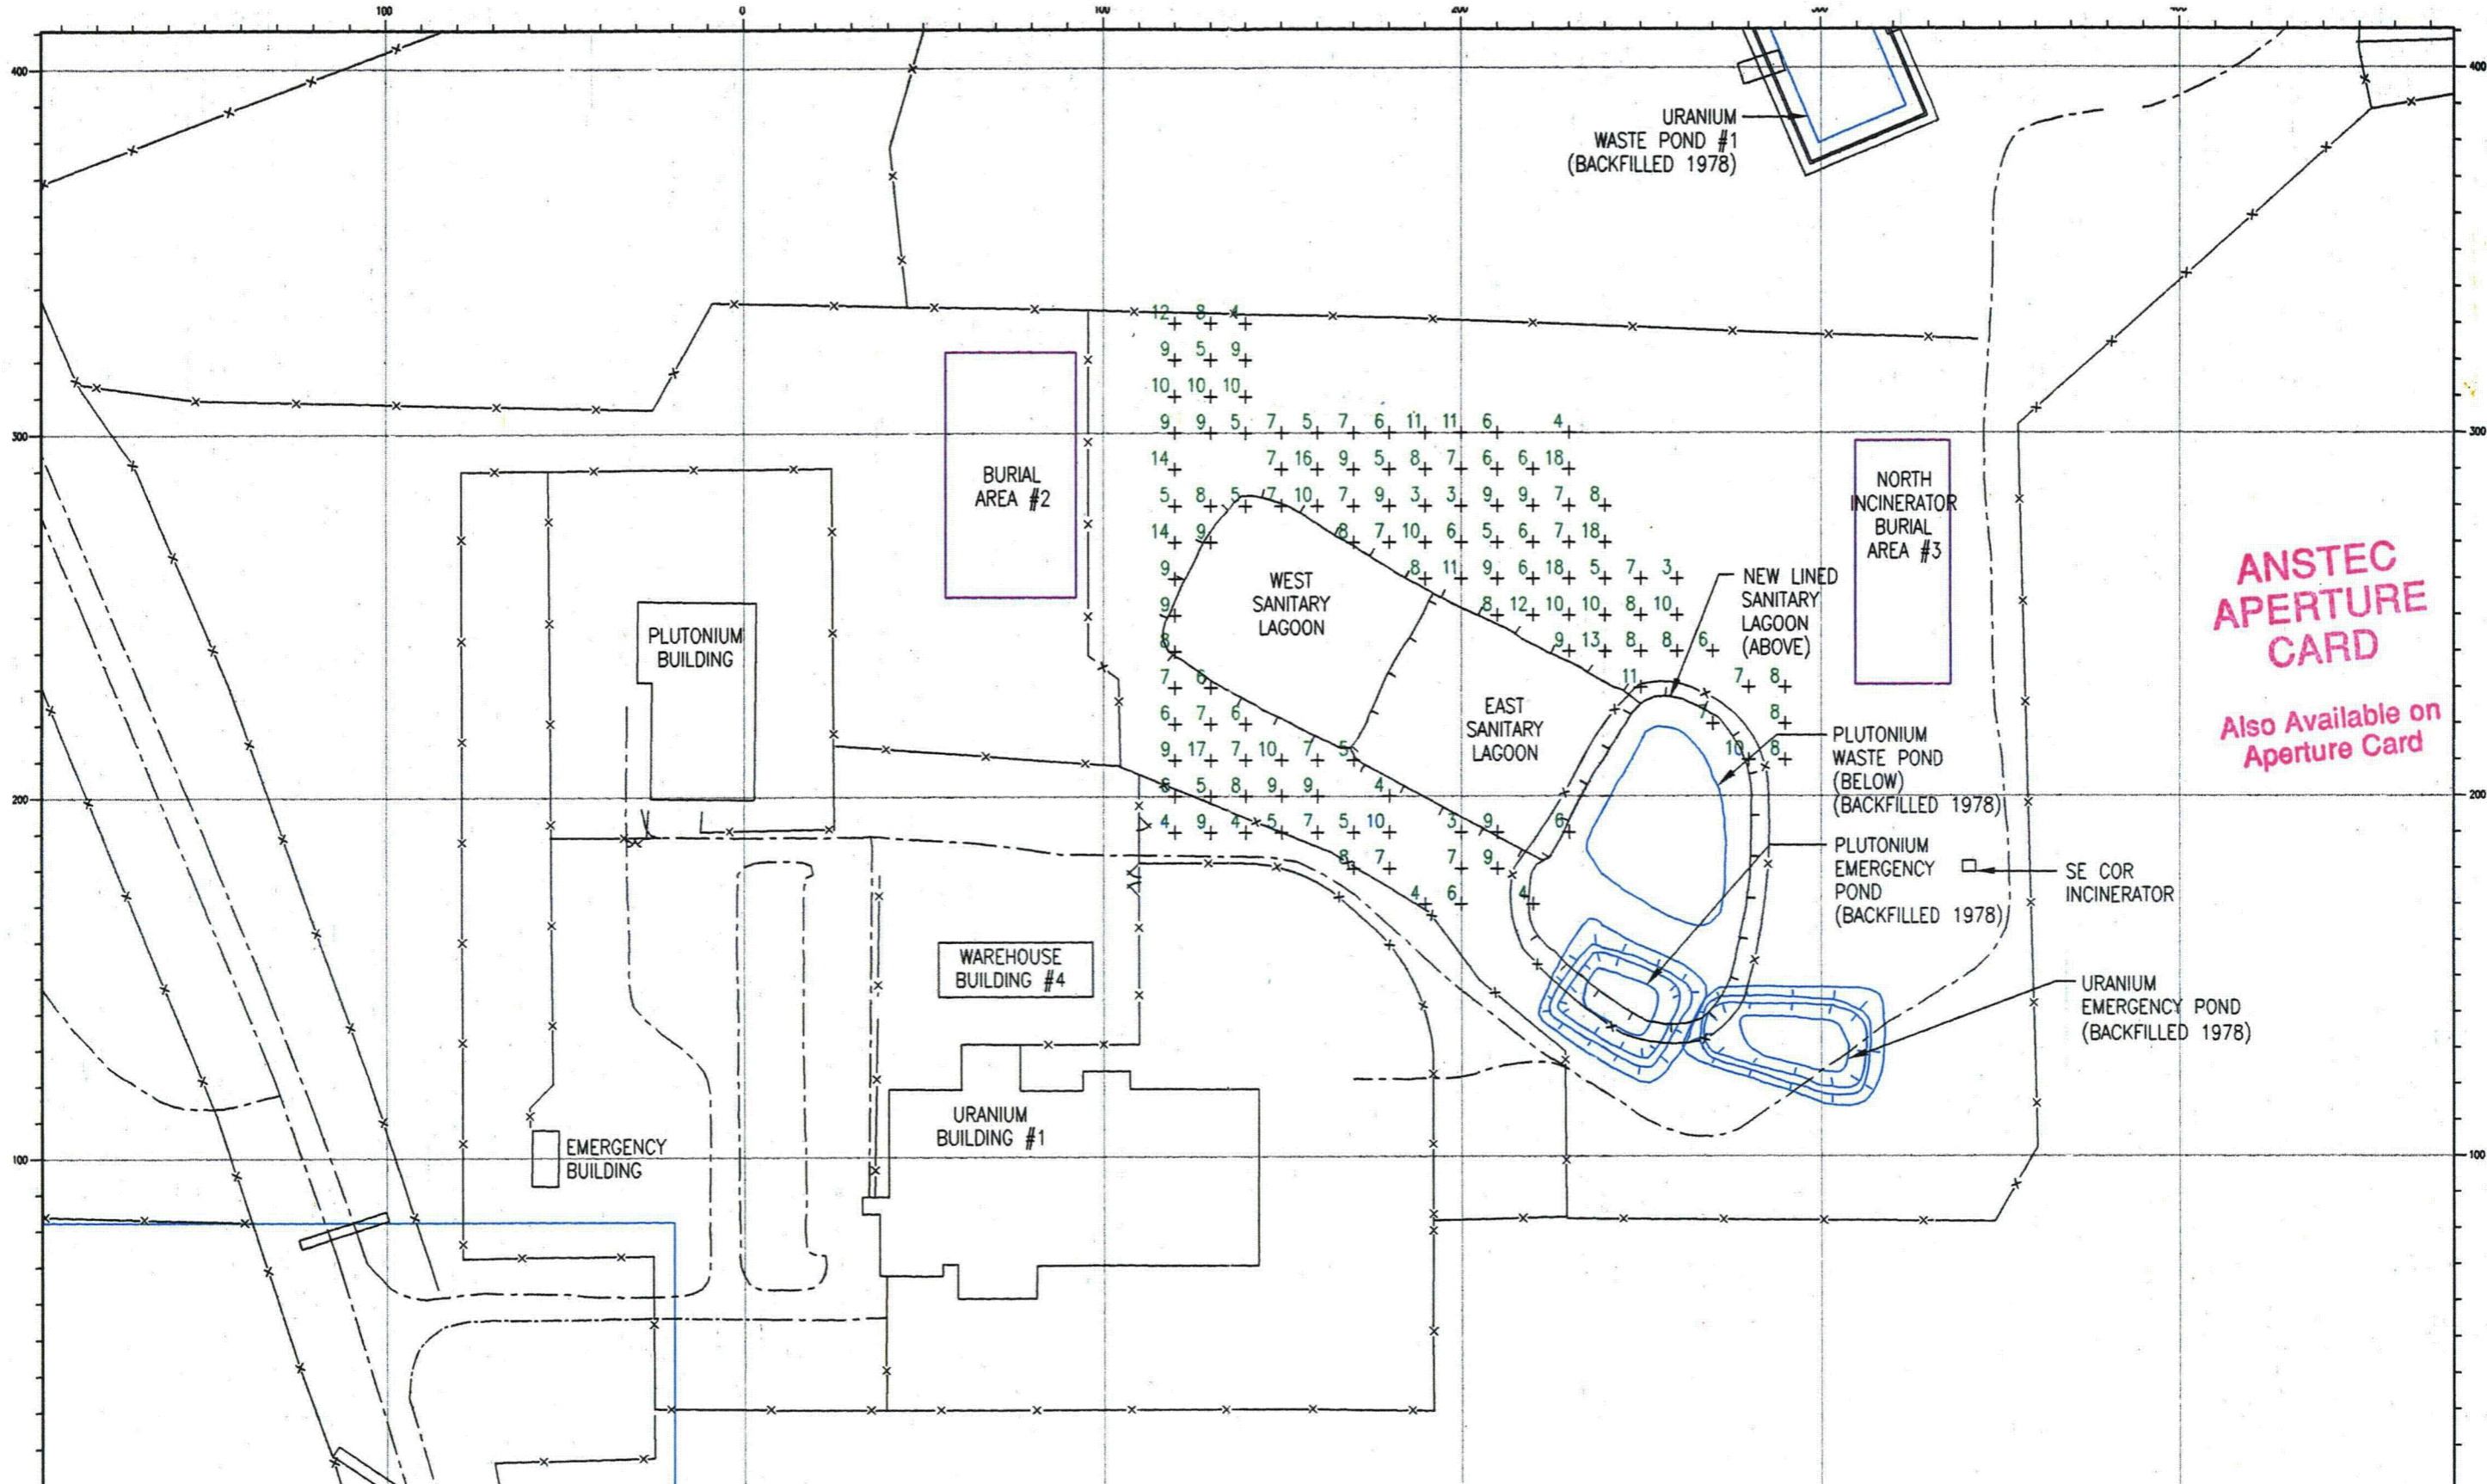
READINGS ARE IN PICO-CURIES PER GRAM URANIUM (pCi/g U). CIMARRON GAMMA SPEC SOIL COUNTER. SITE SOIL BACKGROUND OF APPROXIMATELY 6 pCi/g U, NOT SUBTRACTED.			
SAMPLES TAKEN ON 10 METER X 10 METER GRID. SAMPLES TAKEN BEFORE REMEDIATION.		LEGEND 1 - 29 pCi/g U 30 - 89 pCi/g U > 90 pCi/g U	
CLIENT DRAWING NO.		JOB NO.	
DRAWING NO. 90PRSLSS-4		REV. 0

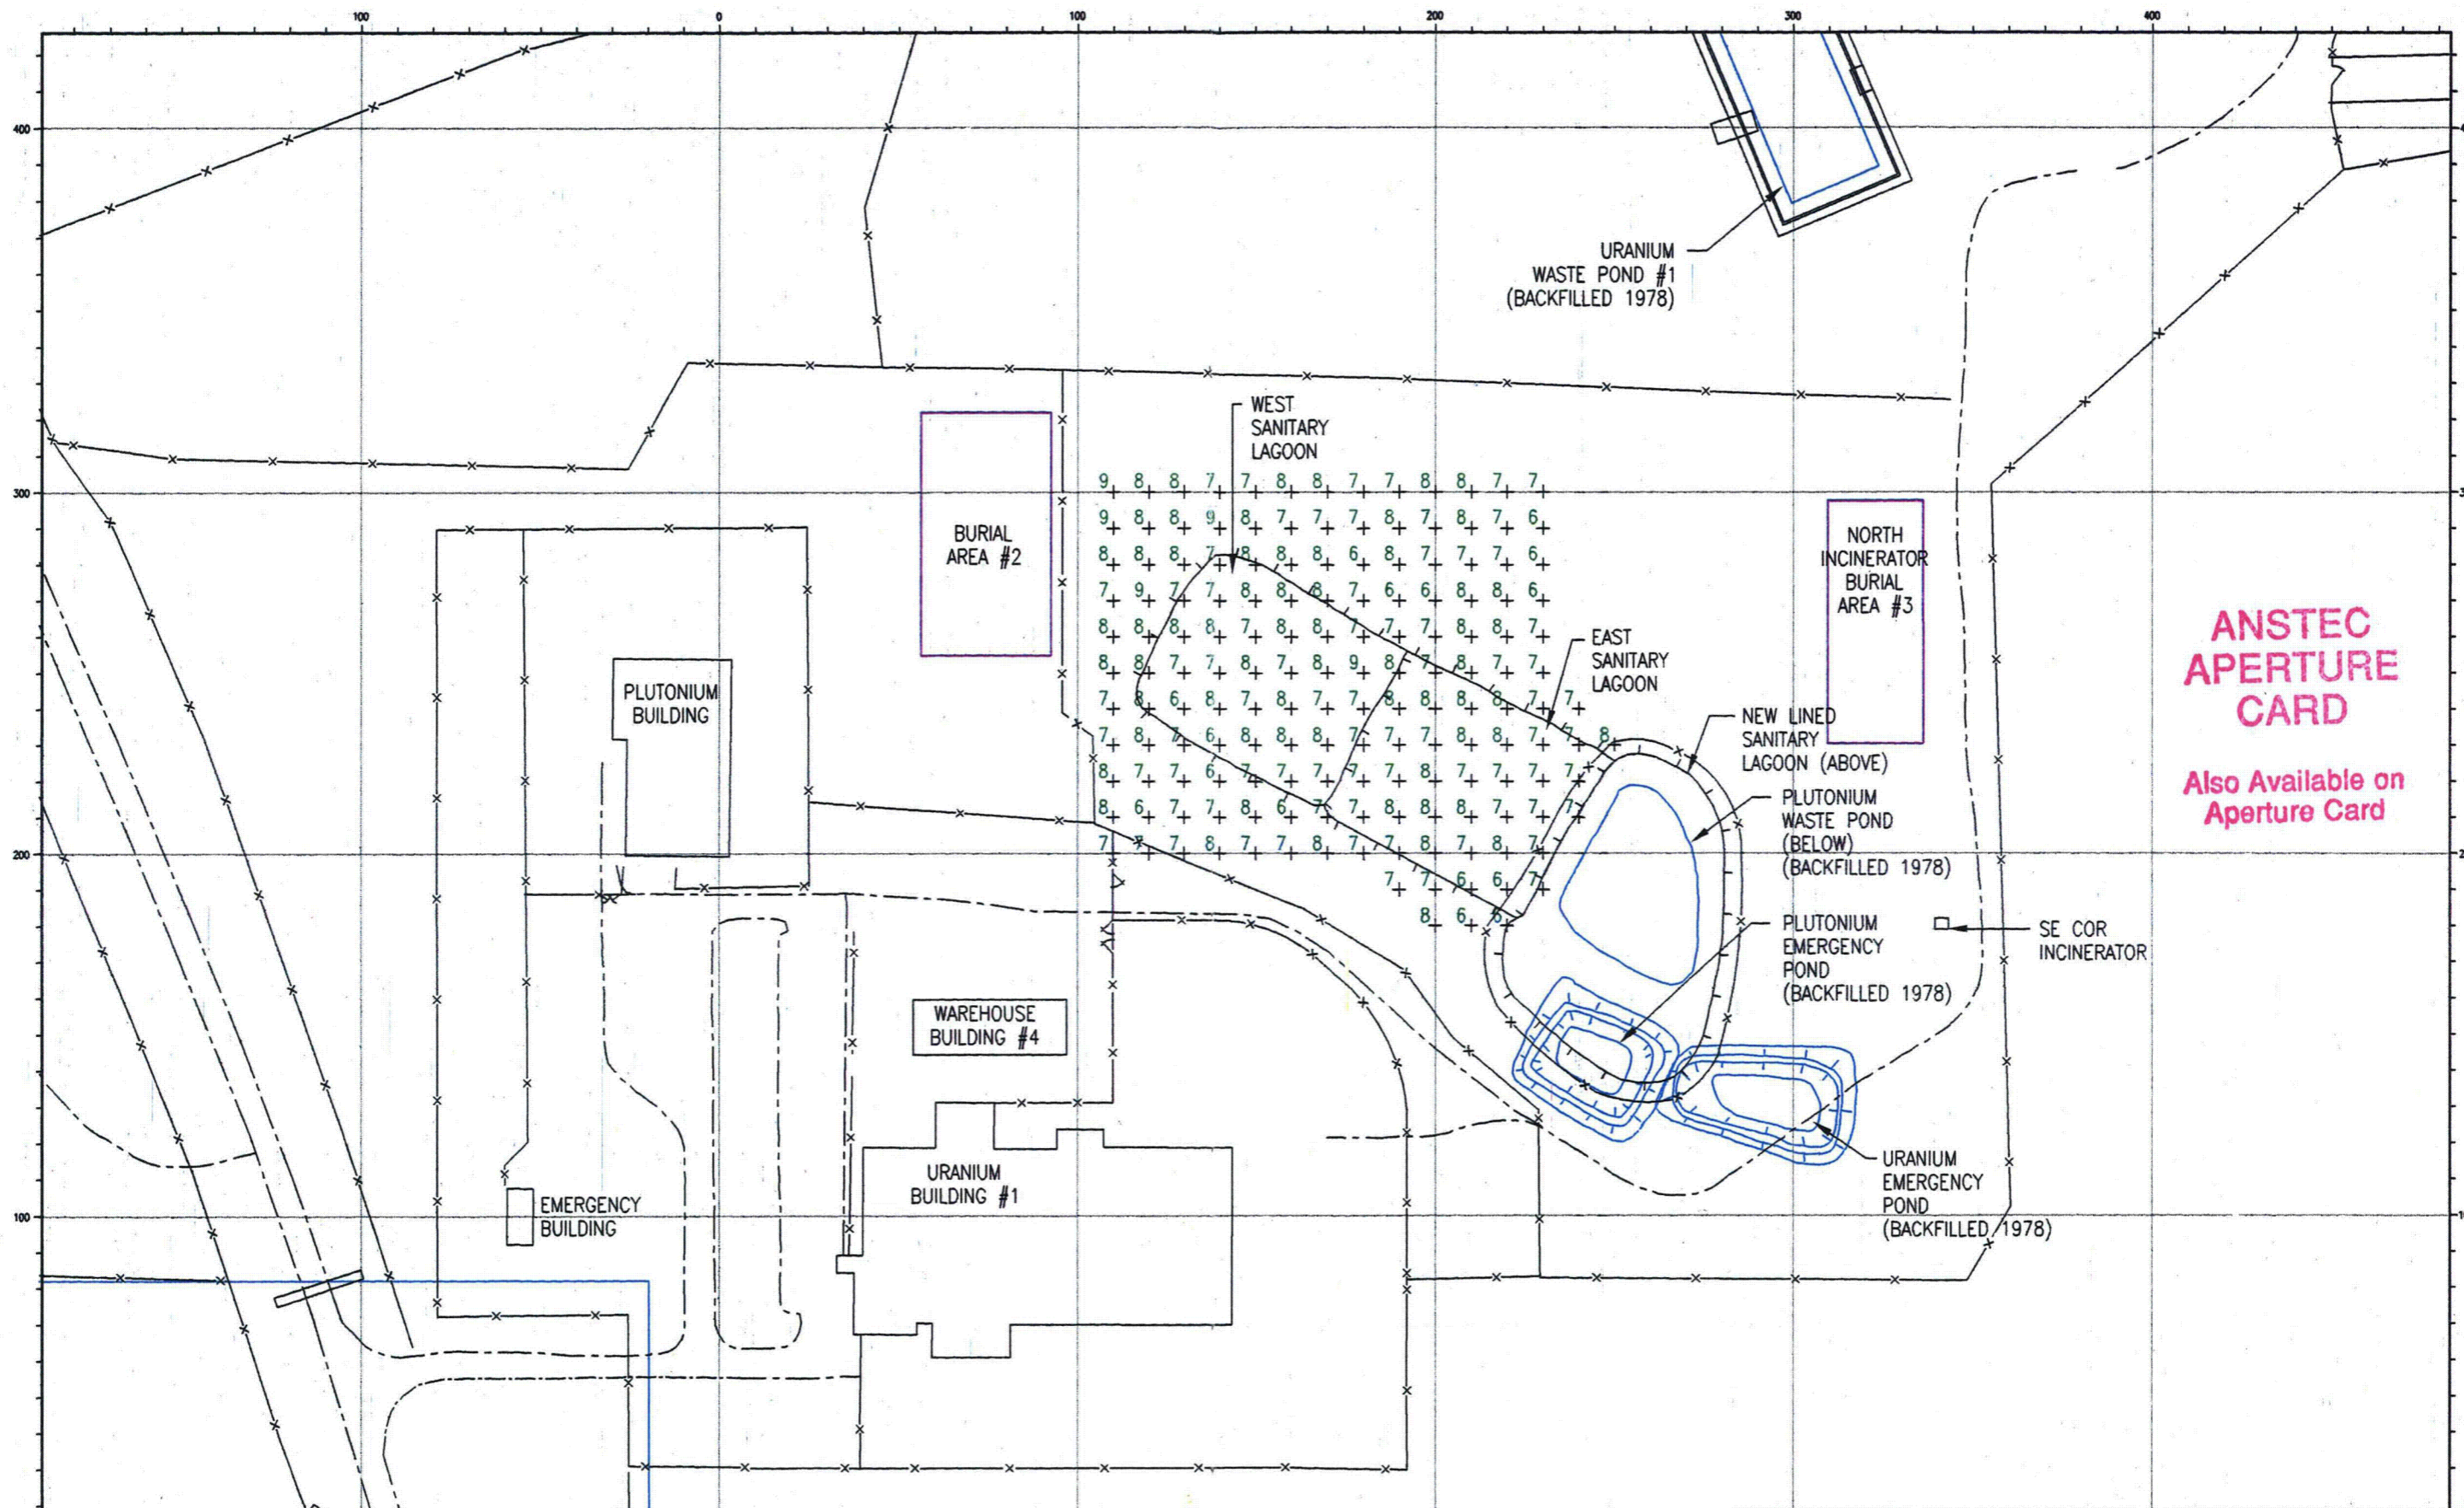
JOB NO. DRAWING NO. 93FISLUR-0 REV. 0

READINGS ARE IN MICRO-R/Hr (μ R/Hr).

INSTRUMENT: LUDLUM MICRO-R METER
 MODEL NO: 19
 SERIAL NO: 75544
 BACKGROUND: 7 MICRO-R/Hr., NOT SUBTRACTED.
 READINGS TAKEN ON A 10 METER BY 10 METER GRID.
 READINGS TAKEN AFTER REMEDIATION AND BACKFILL OF LAGOONS.

CIMARRON FACILITY
 SANITARY LAGOONS
 FINAL MICRO-R SURVEY (1993)
 AT LAND SURFACE

Upon completion of the lagoon backfilling, the surface of the backfilled areas was randomly sampled for total uranium at a depth of 0 to 6 in.. These sample results are shown on Drawing No. 93FISLSS-0. A Micro-R survey and a gamma survey also were performed between August 12 and September 12, 1993 for this area utilizing a 10m x 10m grid. The Micro-R survey results are shown on Drawings No. 93FISLUR-0 and 93FISLUR-1. The gamma survey results are shown on Drawing 93FISL3D-0.

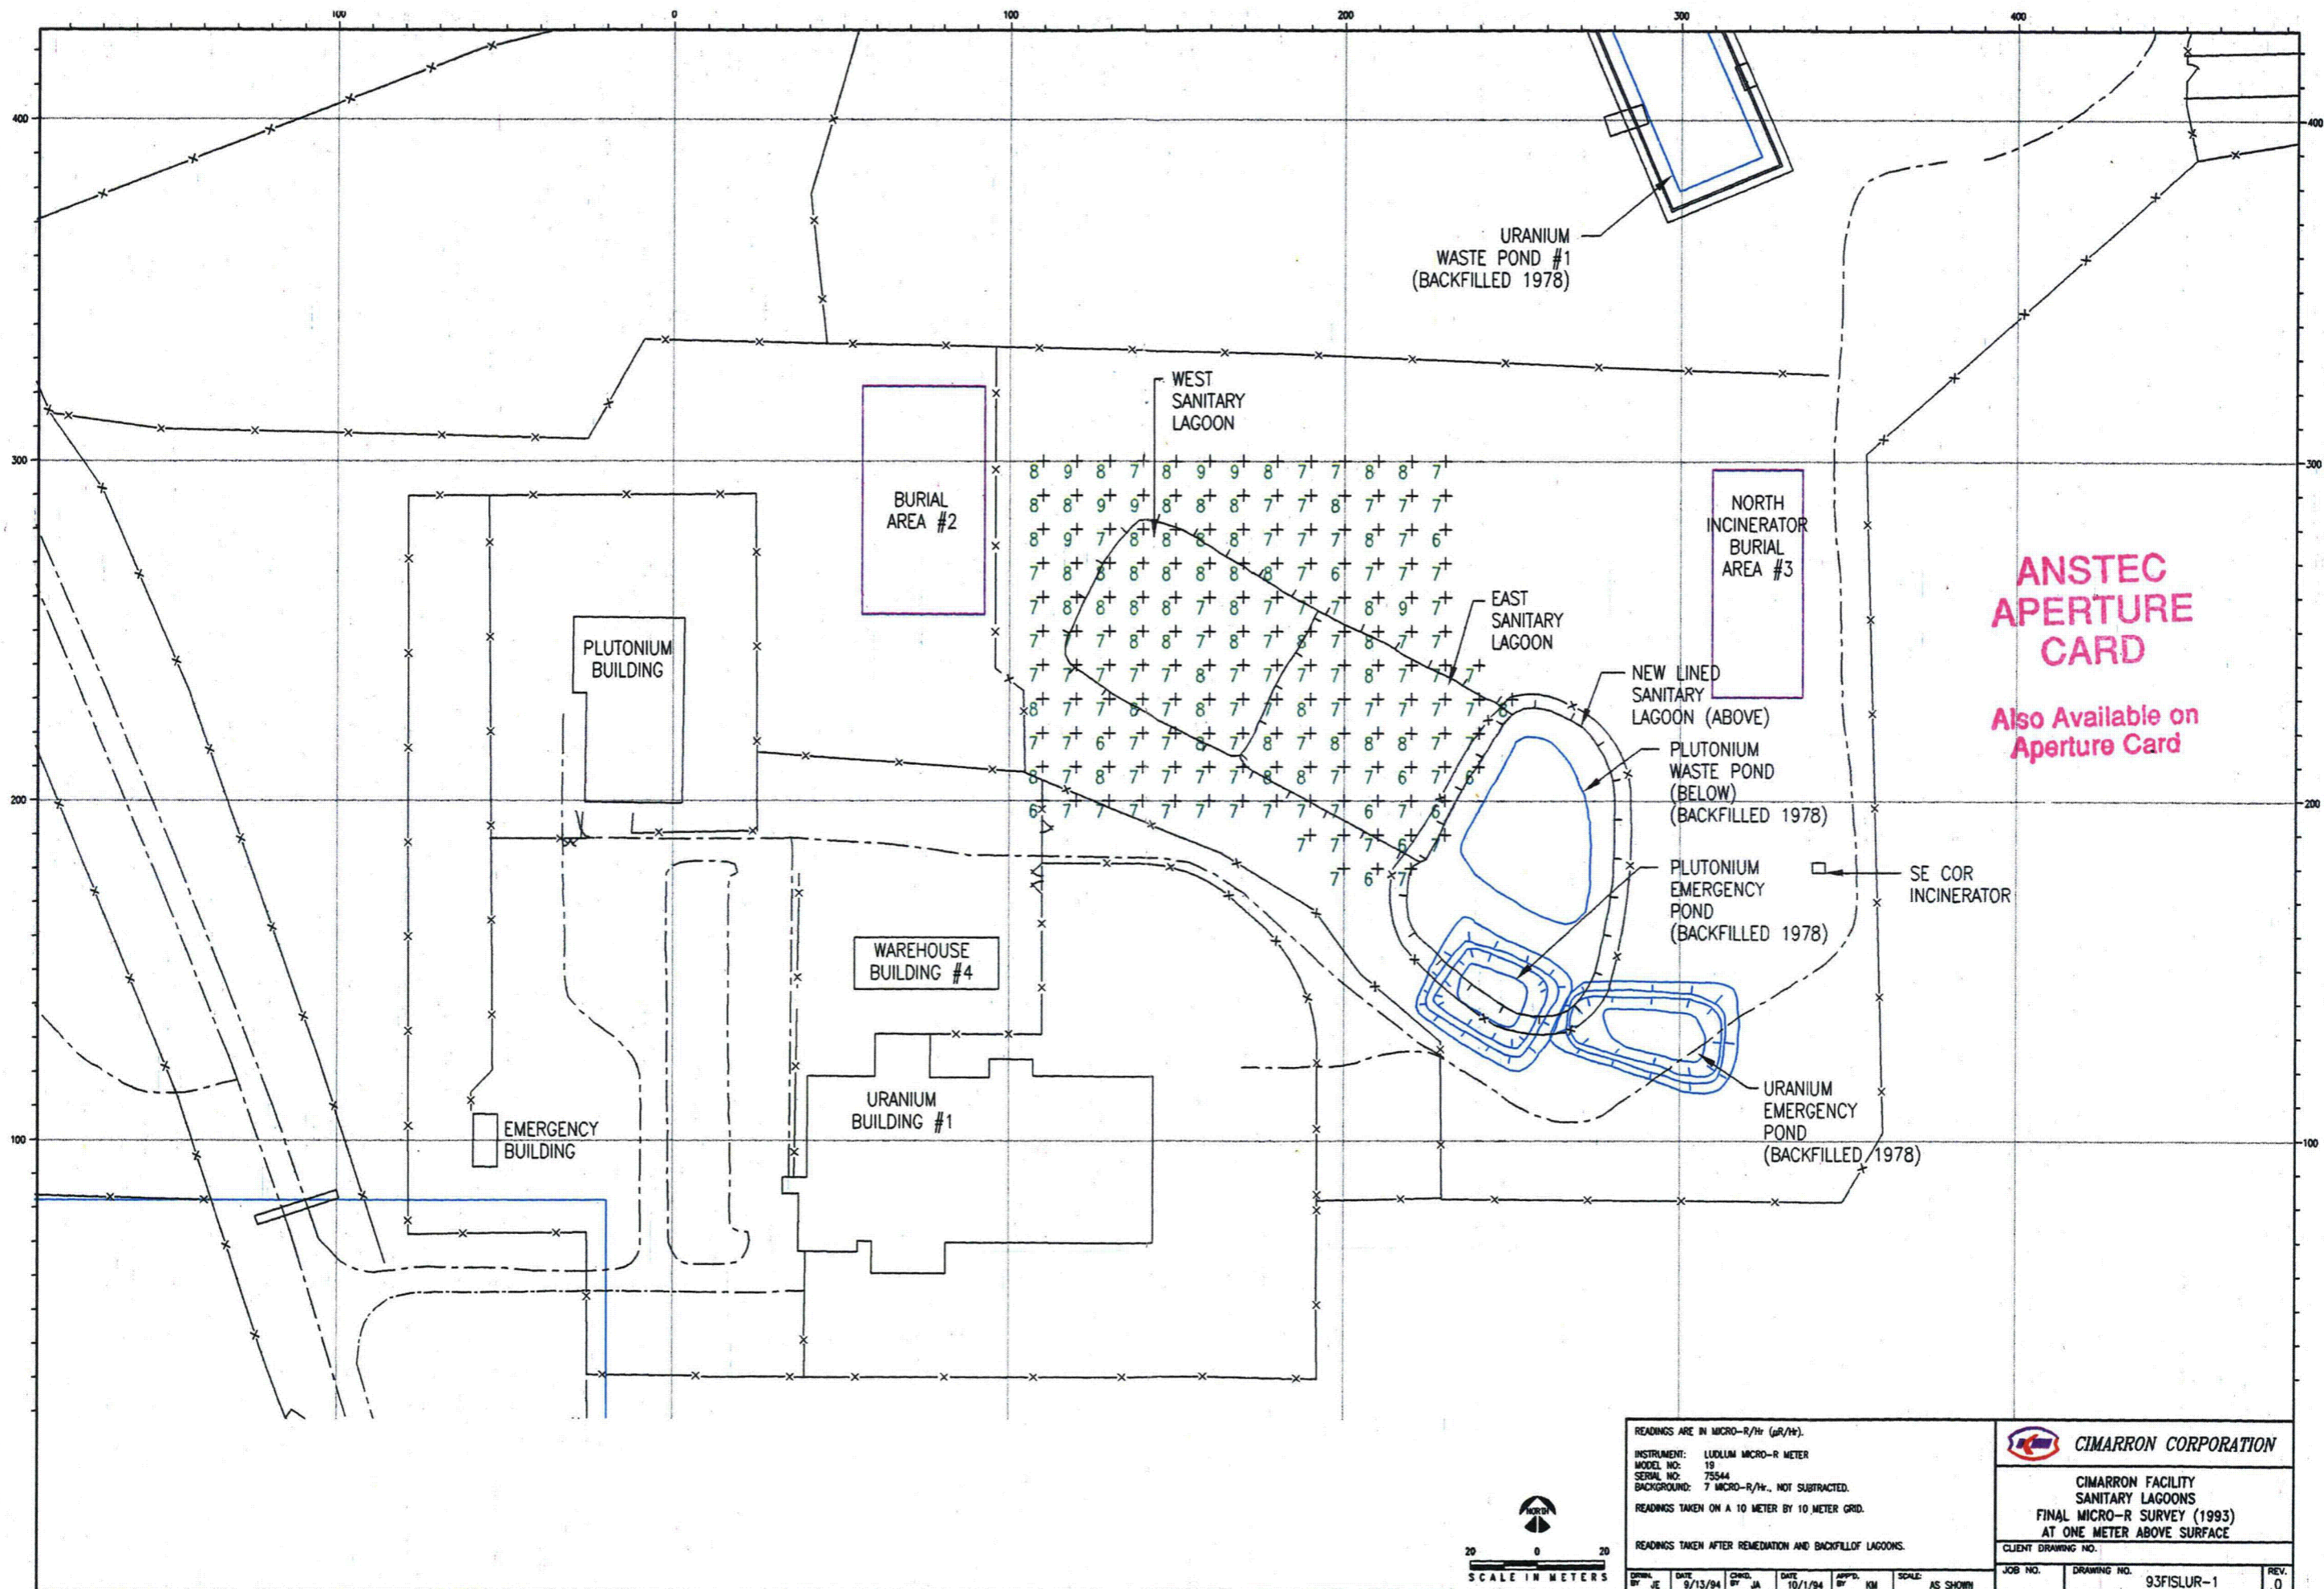
CLIENT DRAWING NO. 93FISLUR-1

READINGS ARE IN MICRO-R/HR ($\mu R/HR$).

INSTRUMENT: LUDLUM MICRO-R METER
 MODEL NO: 19
 SERIAL NO: 75544
 BACKGROUND: 7 MICRO-R/HR., NOT SUBTRACTED.

READINGS TAKEN ON A 10 METER BY 10 METER GRID.

READINGS TAKEN AFTER REMEDIATION AND BACKFILL OF LAGOONS.

CIMARRON FACILITY
 SANITARY LAGOONS
 FINAL MICRO-R SURVEY (1993)
 AT ONE METER ABOVE SURFACE

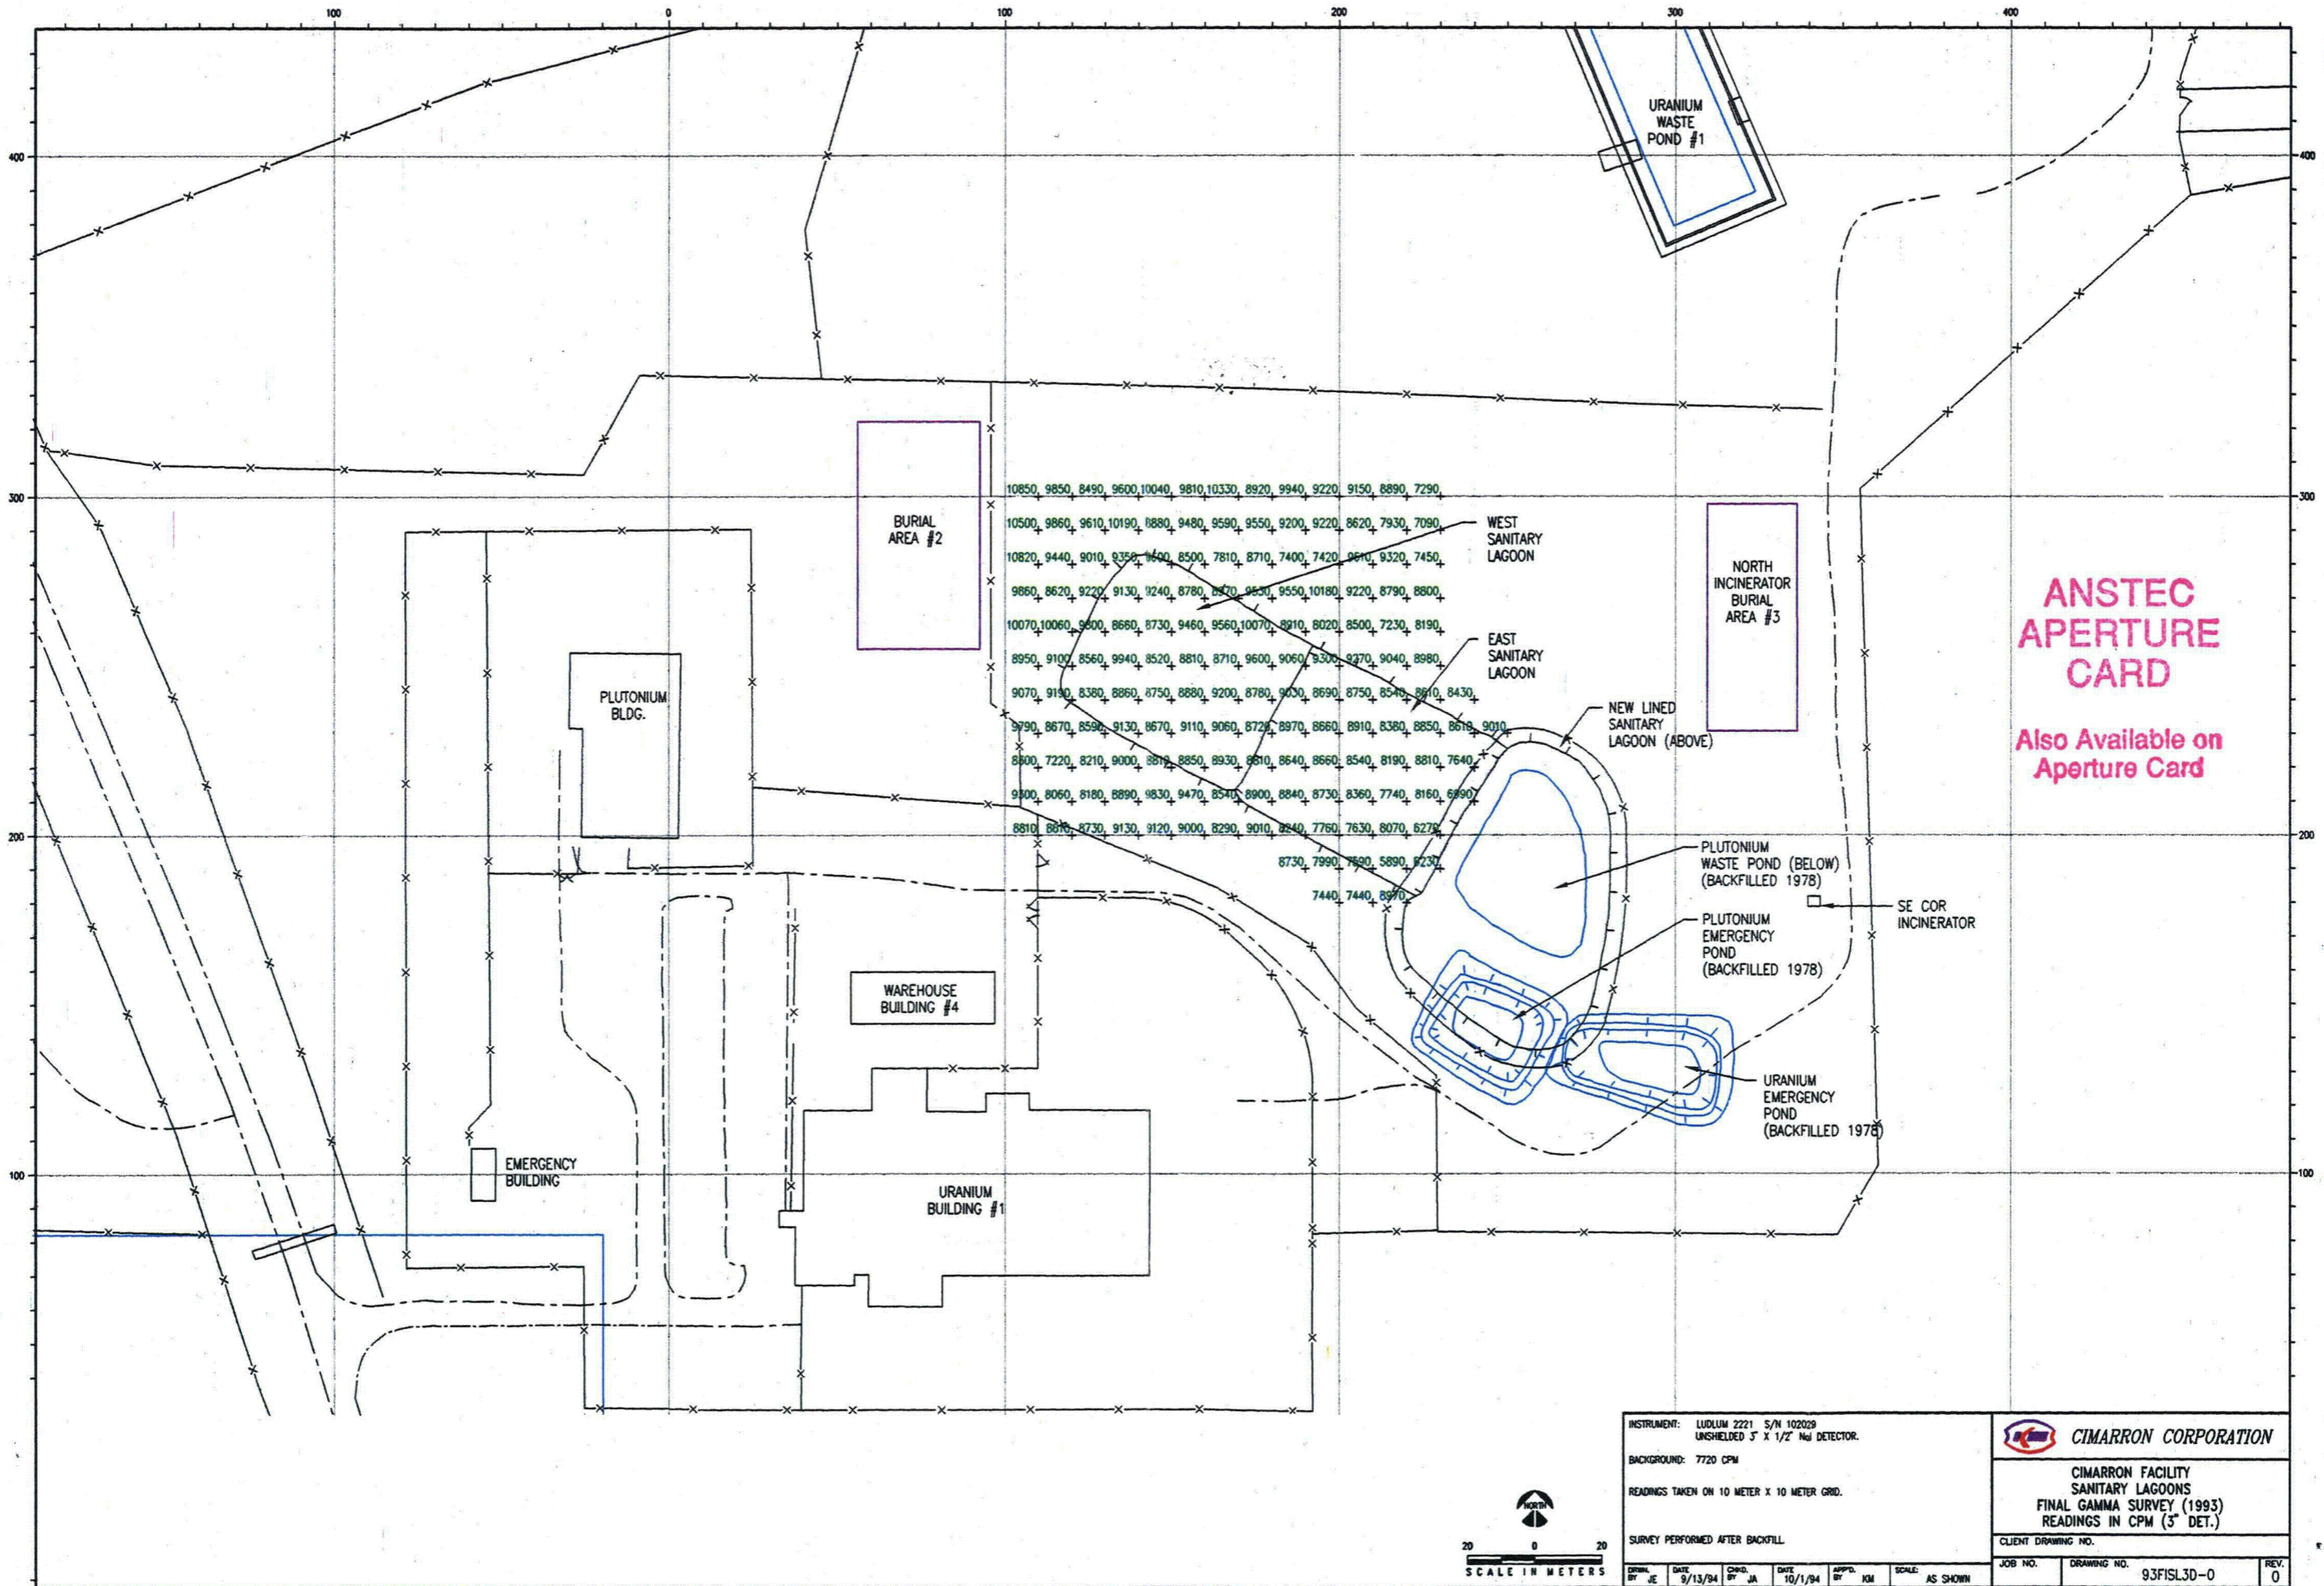
INSTRUMENT: LUDLUM 2221 S/N 102029 UNSHIELDED 5' X 1/2' NaI DETECTOR.		CIMARRON CORPORATION	
BACKGROUND: 7720 CPM		CIMARRON FACILITY SANITARY LAGOONS FINAL GAMMA SURVEY (1993) READINGS IN CPM (3" DET.)	
READINGS TAKEN ON 10 METER X 10 METER GRID.		CLIENT DRAWING NO.	
SURVEY PERFORMED AFTER BACKFILL.		JOB NO. DRAWING NO. 93FISL3D-0 REV. 0	
DATE: 9/13/94	BY: JE	DATE: 10/1/94	BY: KM
SCALE: AS SHOWN

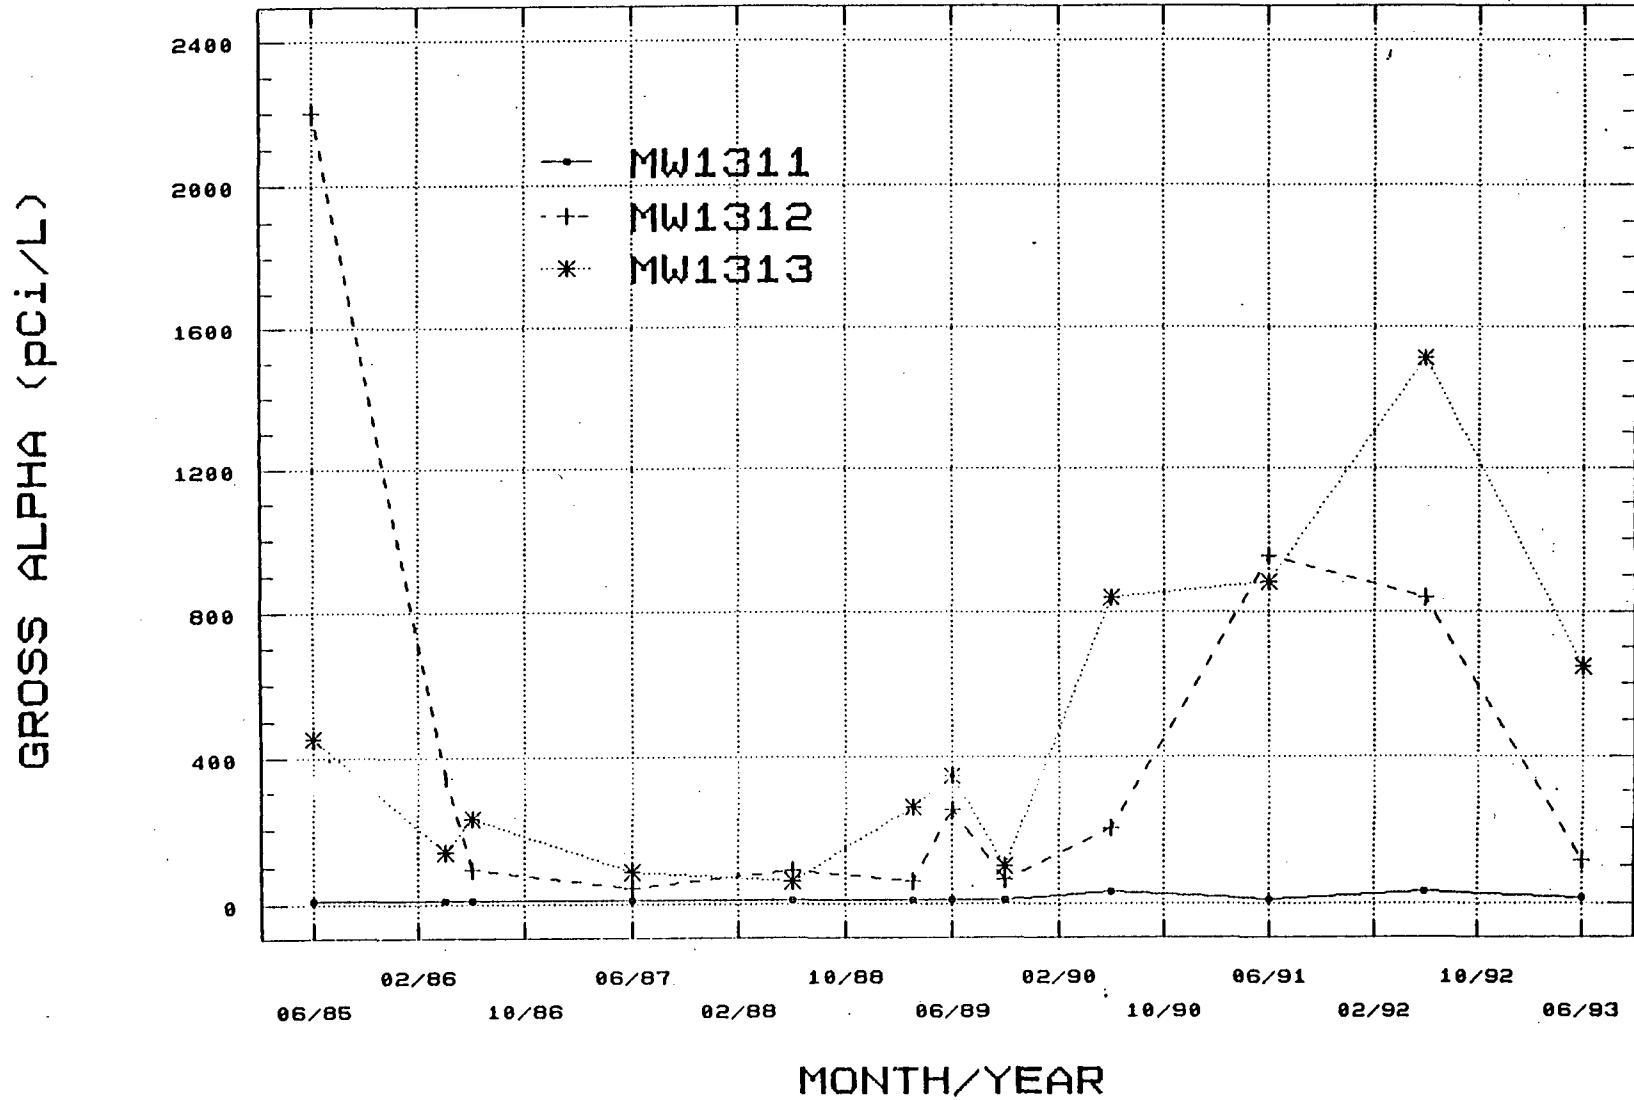
Figure 12.1

KERR MCGEE--CIMARRON
GROSS ALPHA-WELLS 1311, 1312, 1313

Concentrations of gross alpha activity in wells #1311, #1312, and #1313 ranged from less than detectable (< 10 pCi/L) to 2200 pCi/L (well #1312, June 21, 1985) during the monitoring period from 1985 through 1993. Sample results are presented in Figure 12.1. Gross alpha concentrations in well #1311 remained low throughout the 1985-1993 monitoring period, reaching a maximum of 32 pCi/L in 1990 and 1992. Concentrations in wells #1312 and #1313 decreased to near background levels during 1986 through 1988 and then increased to a maximum of 1510 pCi/L in well #1313 on June 12, 1992. Sample concentrations for wells #1312 and #1313 decreased in 1993 to 116 pCi/L and 647 pCi/L, respectively. Assuming that all alpha activity comes from uranium isotopes, the 10 CFR 20 Appendix B Table 2, Column 2 value for uranium (300 pCi/L) was exceeded in 1993 at well #1313. As the direction of the trend is downward for wells #1312 and #1313, it is likely that gross alpha concentrations will continue to decline.

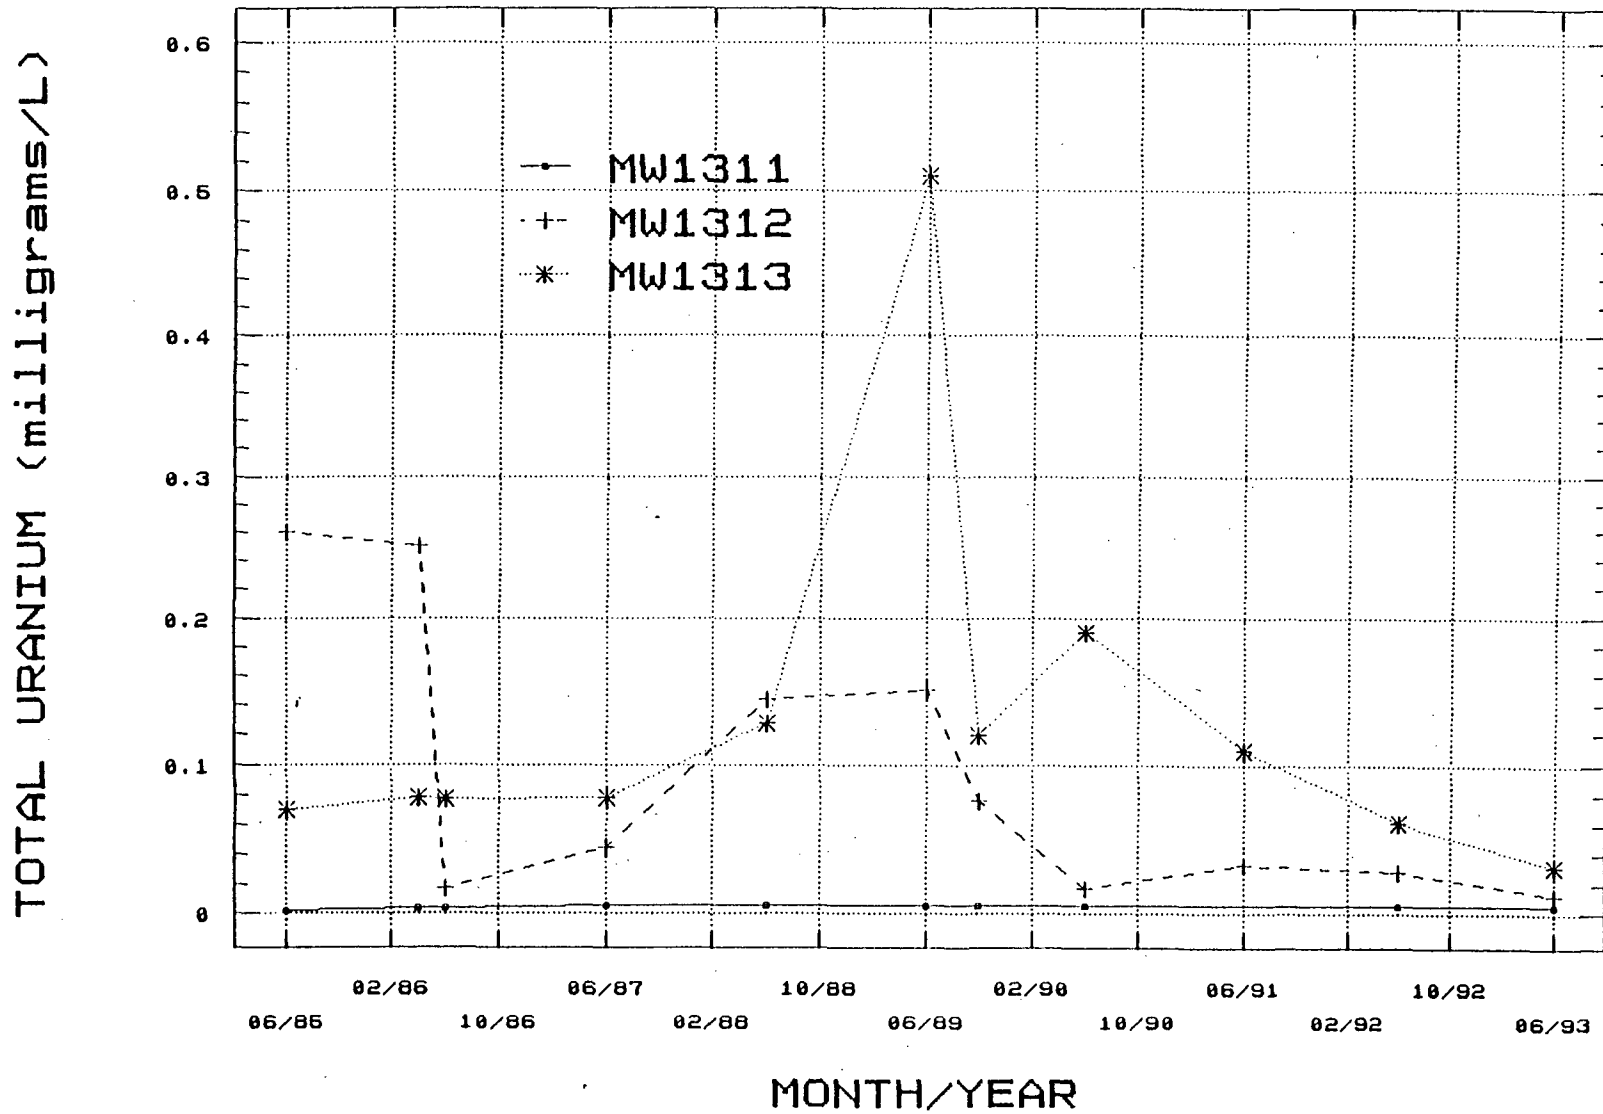
KERR MCGEE--CIMARRON
 TOTAL URANIUM--WELLS 1311, 1312, 1313

Total uranium concentrations in wells #1311, #1312, and #1313 followed essentially the same trend as the gross beta concentration. Figure 12.3 shows total uranium concentrations over time. Total uranium concentrations ranged from less than 0.002 milligrams per liter (mg/L) at well #1311 to 0.51 mg/L at well #1313 in 1989. Since 1989, concentrations have decreased to 0.012 mg/L in well #1312 and 0.032 mg/L in well #1313. Assuming a uranium enrichment of 2.7 weight percent, the specific activity is calculated as 1.5×10^{-6} Ci/g, using the equation from footnote 3 to Appendix B, 10 CFR 20. Using this conversion factor, the 1993 total uranium concentrations are estimated at 17 pCi/L and 46 pCi/L for wells #1312 and #1313, respectively. These values are well below the Table 2, Column 2 limit for mixtures of uranium isotopes.
