11.0 Sanitary Lagoons

11.1 East Sanitary Lagoon & West Sanitary Lagoon

11.2 New Sanitary Lagoon

12.0 Five Former Waste Water Ponds

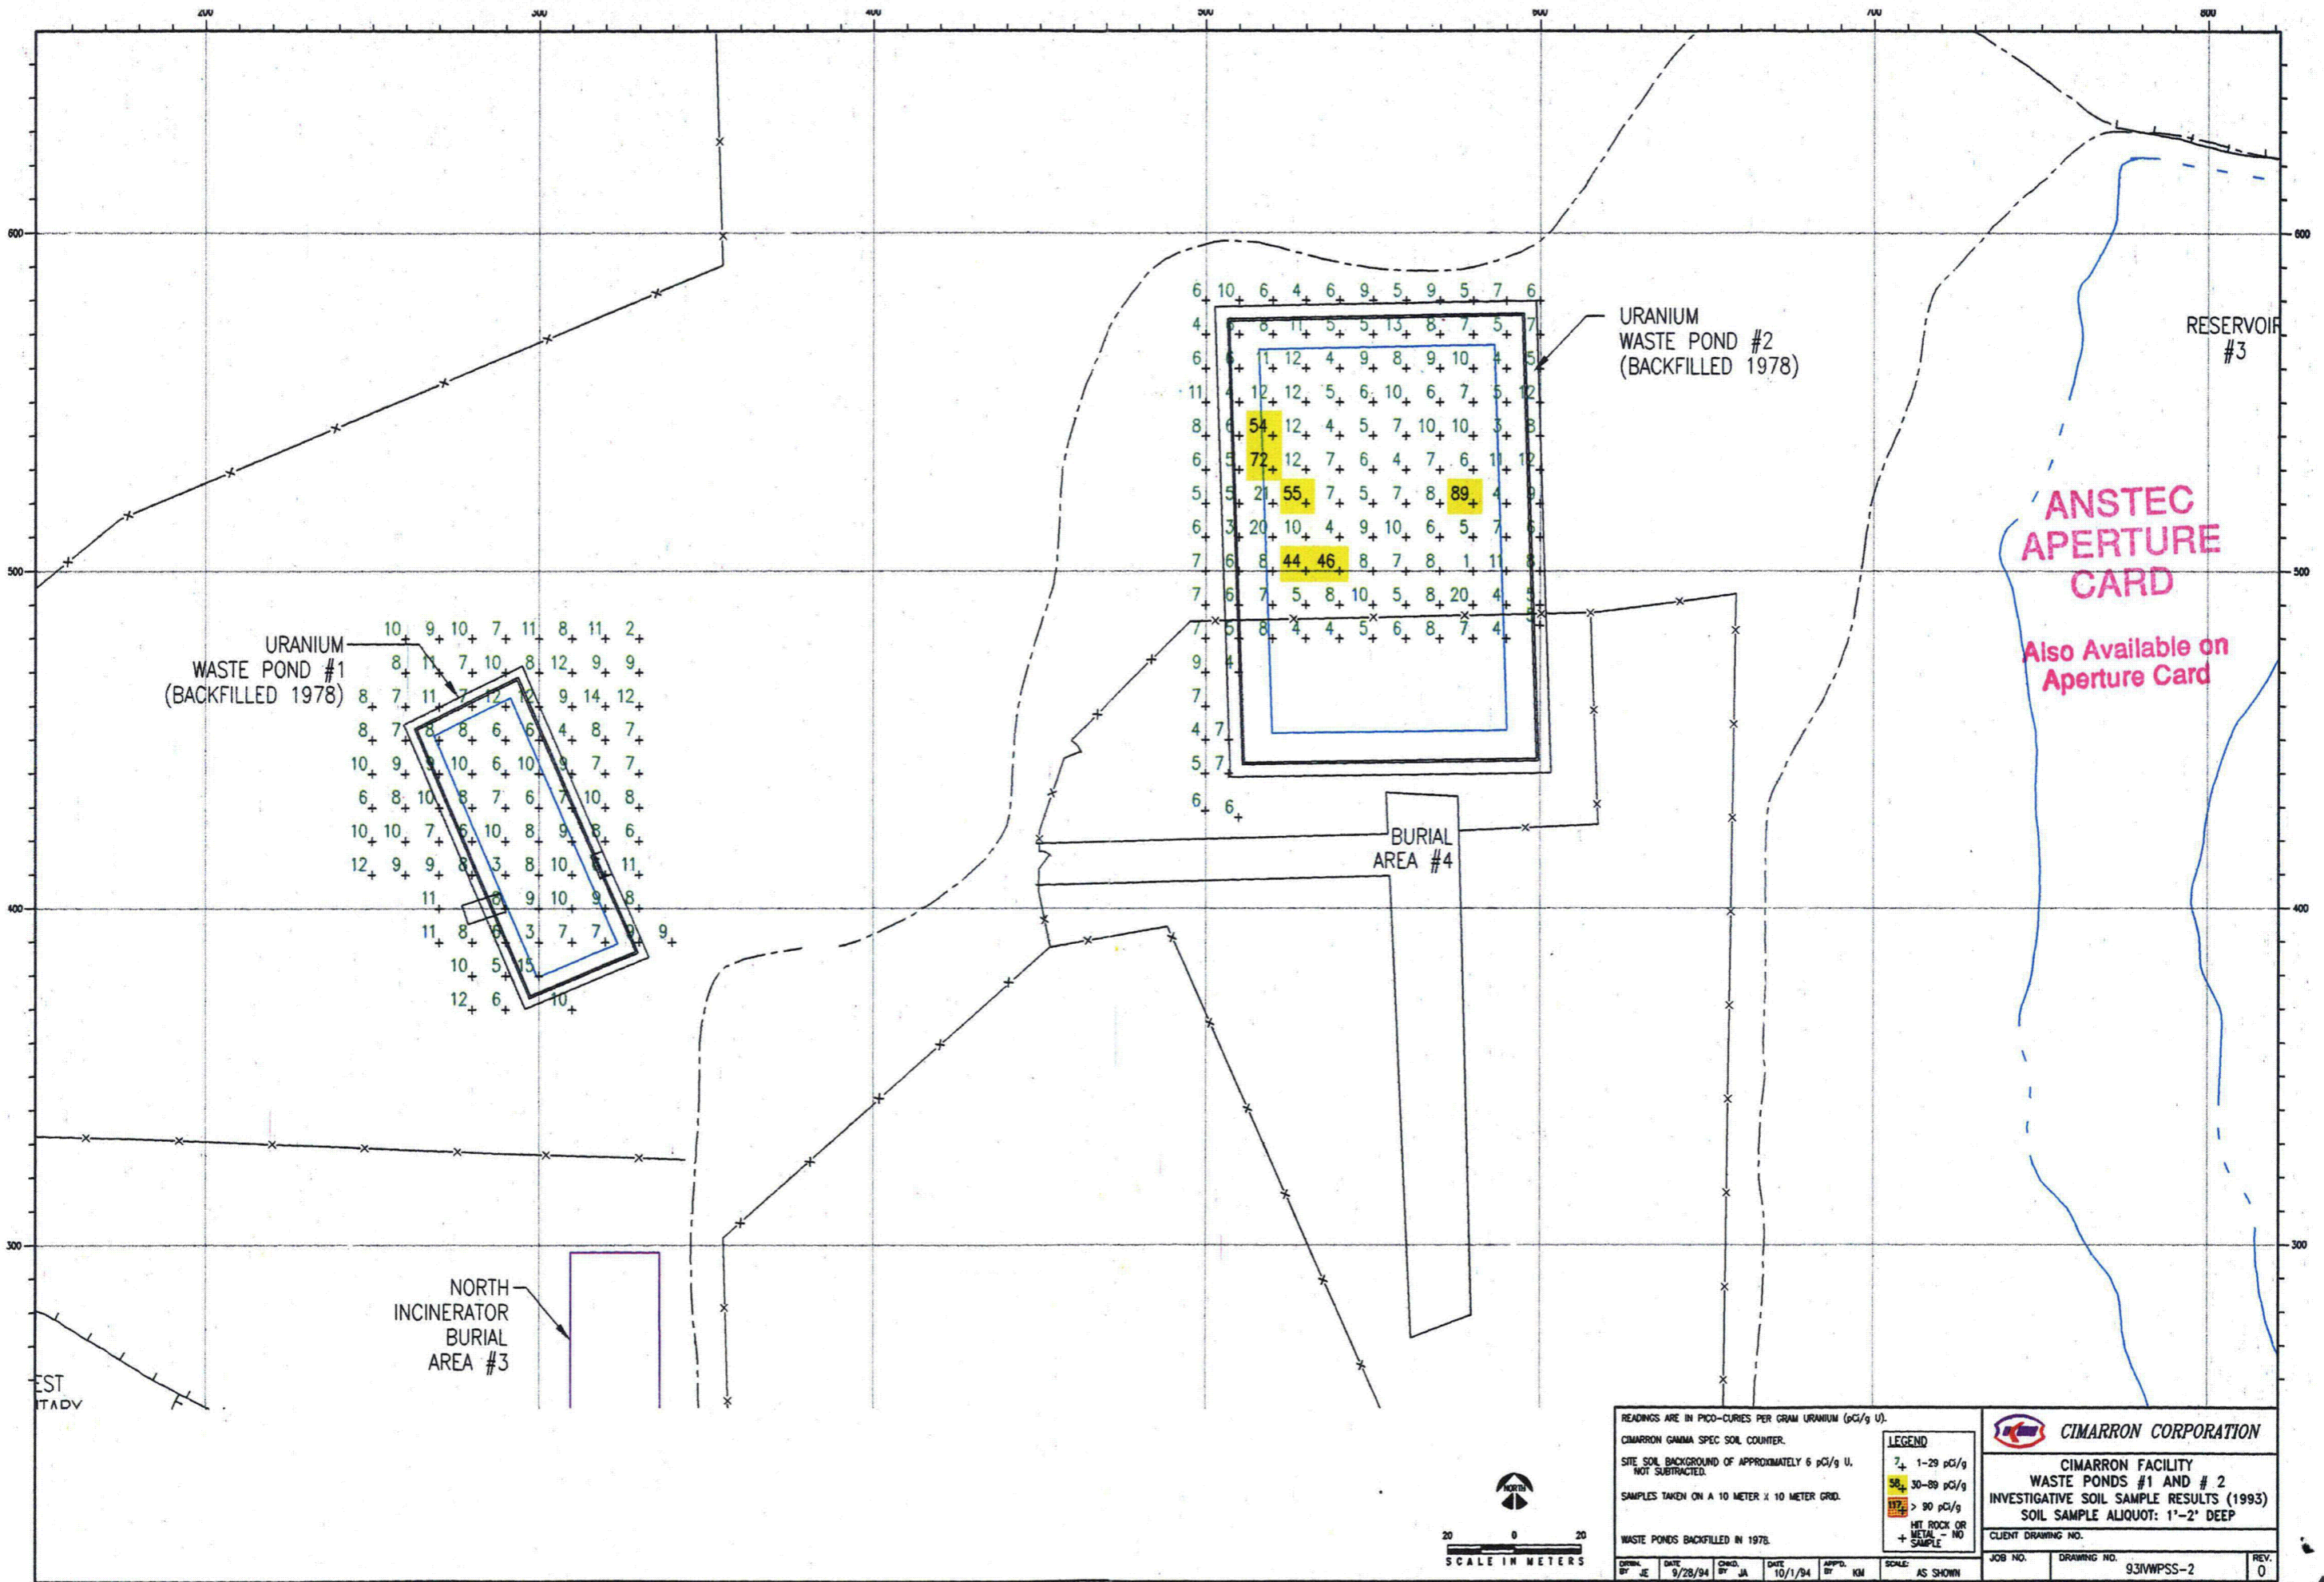
CIMARRON CORPORATION
CIMARRON FACILITY
WASTE PONDS #1 AND #2
INVESTIGATIVE SOIL SAMPLE RESULTS (1993)
SOIL SAMPLE ALIQUOT: 0-1' DEEP
CLIENT DRAWING NO.
JOB NO. DRAWING NO. 93JWVPS-1 REV. 0

URANIUM
WASTE POND #1
(BACKFILLED 1978)

URANIUM
WASTE POND #2
(BACKFILLED 1978)

READINGS ARE IN PICO-CURIES PER GRAM URANIUM (pCi/g U).
CIMARRON GAMMA SPEC SOIL COUNTER.
SITE SOIL BACKGROUND OF APPROXIMATELY 6 pCi/g U.
NOT SUBTRACTED.
SAMPLES TAKEN ON A 10 METER X 10 METER GRID.
WASTE PONDS BACKFILLED IN 1978.

The very southern tip of Waste Pond #1 was not sampled due to large pieces of equipment being stored in this area at the time of sample collection. The southern tip of Waste Pond #1 is over the original diked area and it is unlikely that elevated concentrations of uranium would be found in this area.

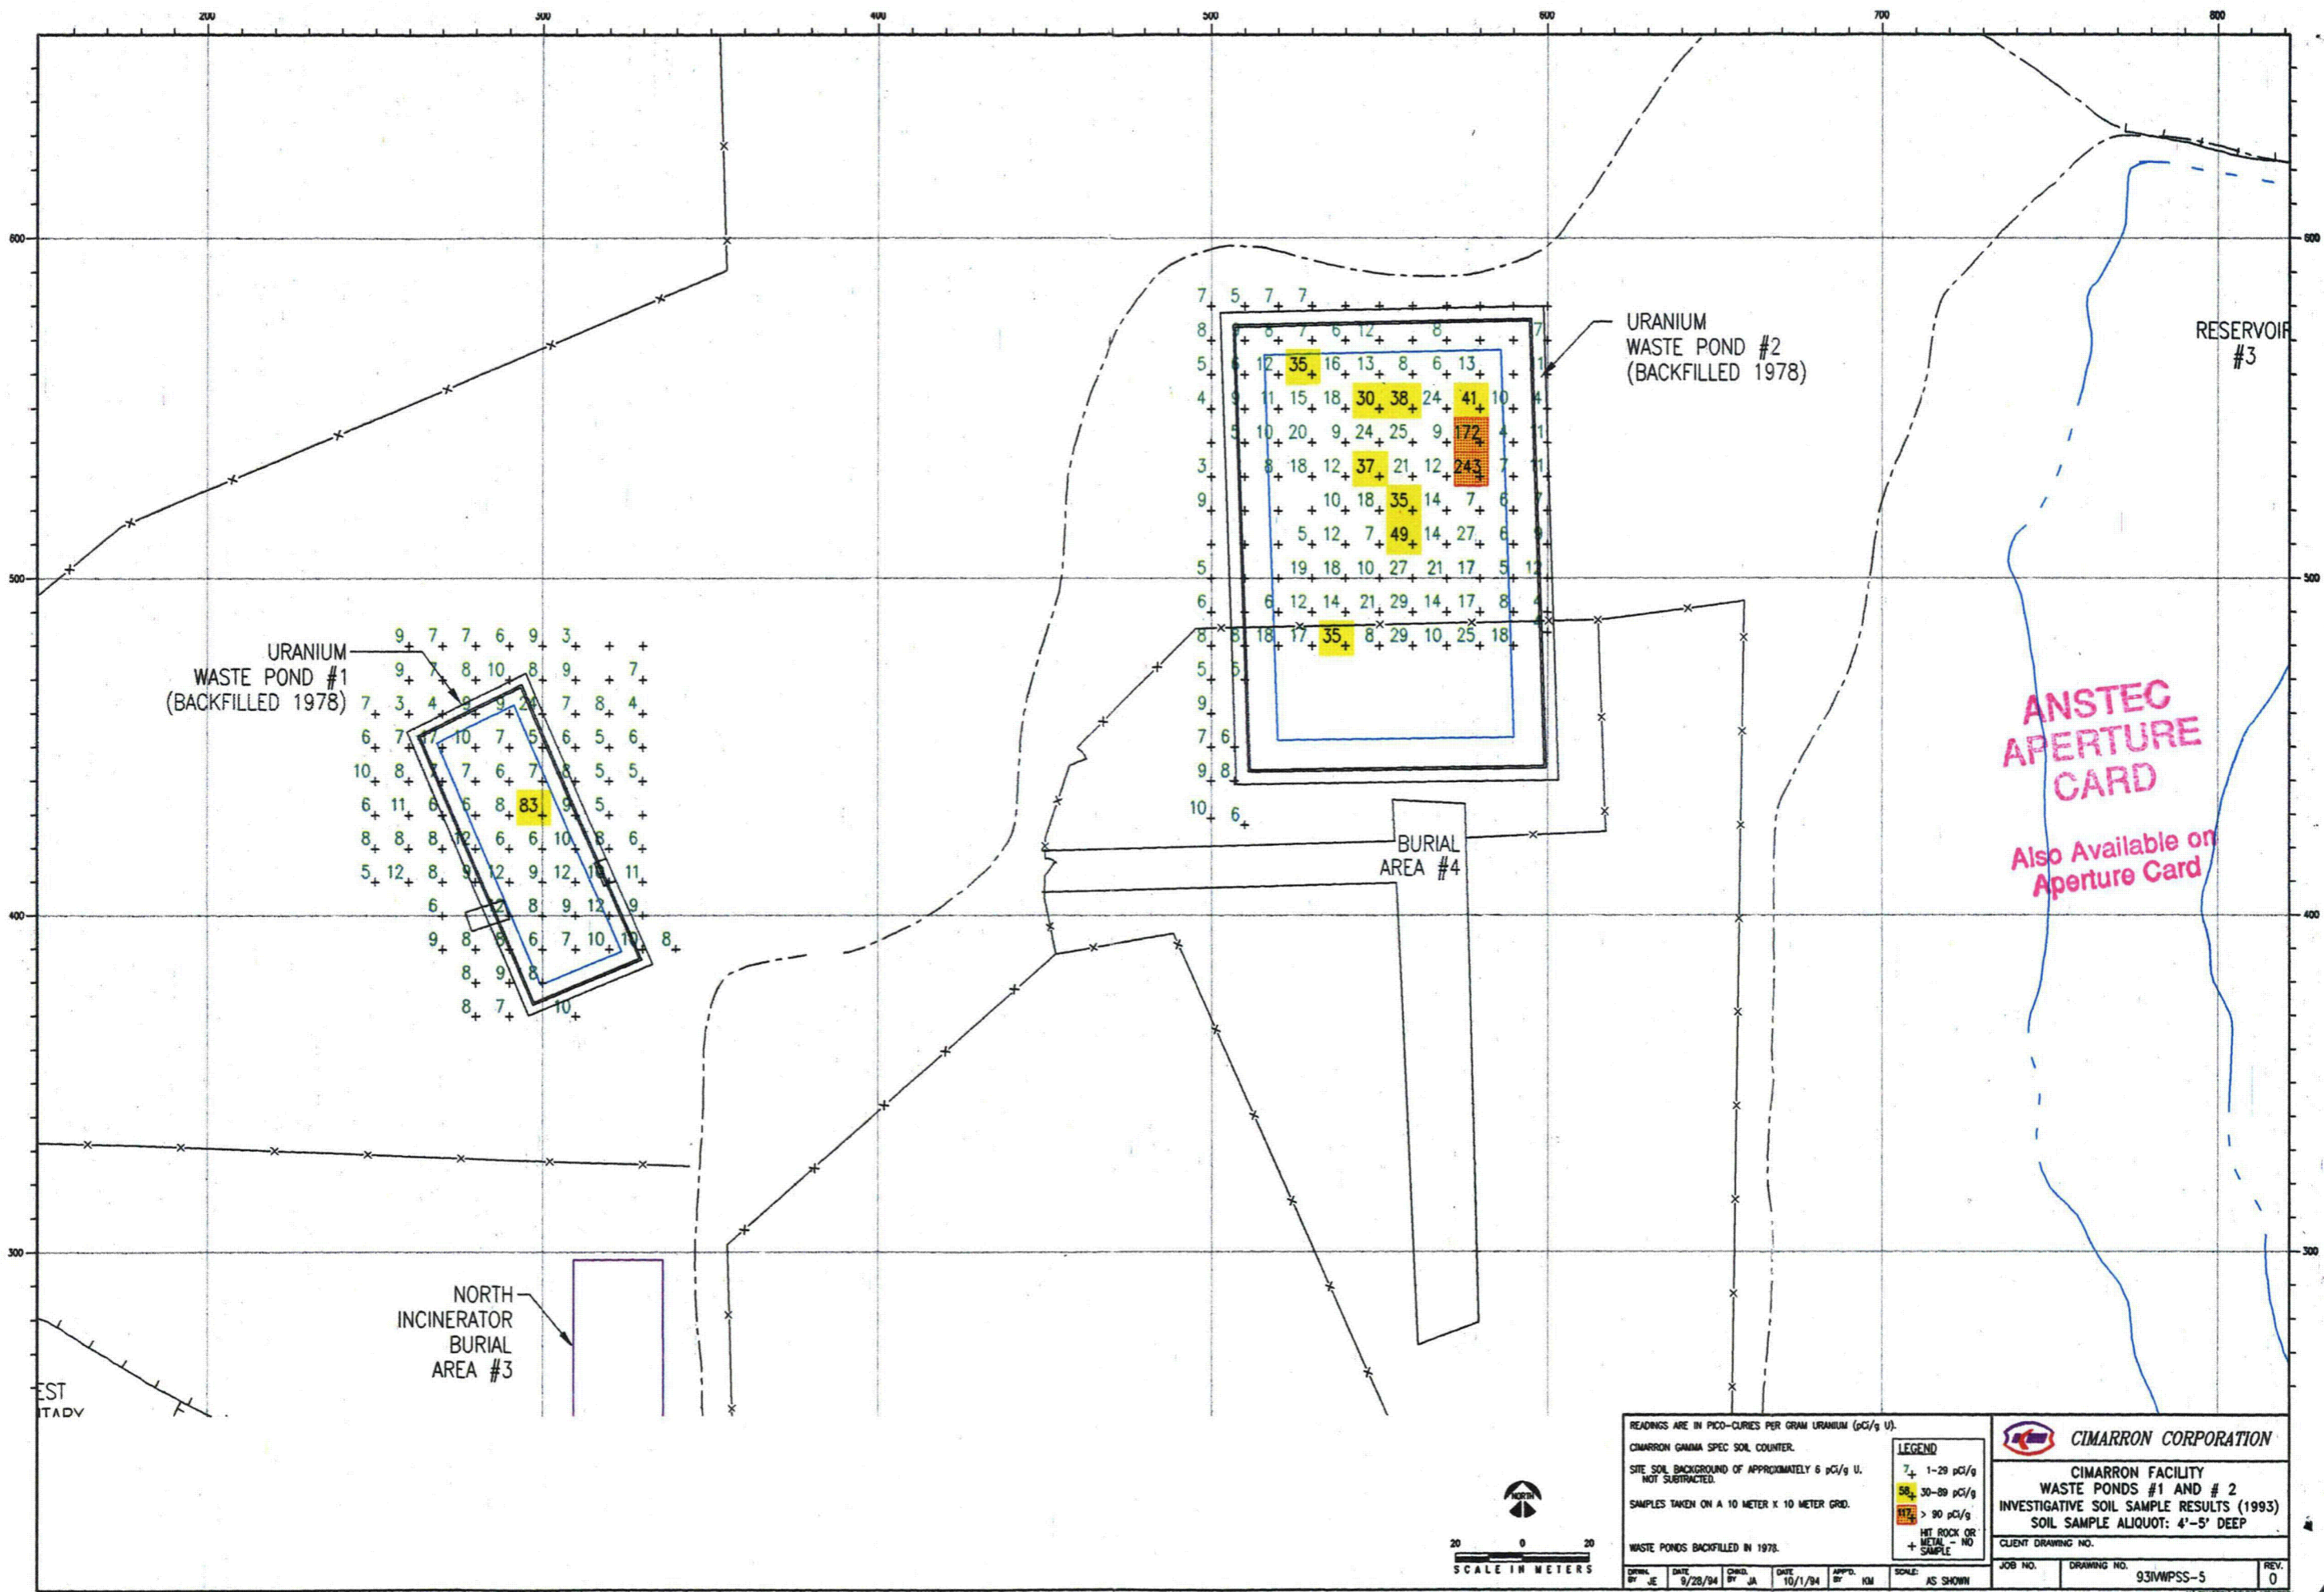
DATE	9/28/94	CHKD. BY	JA	DATE	10/1/94	APP'D. BY	KM	SCALE	AS SHOWN
DRAWN BY	JE	DATE		DATE		DATE		JOB NO.	DRAWING NO.
								93NWPS-4	REV. 0

READINGS ARE IN PICO-CURIES PER GRAM URANIUM (pCi/g U).

CIMARRON GAMMA SPEC SOIL COUNTER.

SITE SOIL BACKGROUND OF APPROXIMATELY 6 pCi/g U. NOT SUBTRACTED.

SAMPLES TAKEN ON A 10 METER X 10 METER GRID.

WASTE PONDS BACKFILLED IN 1978.

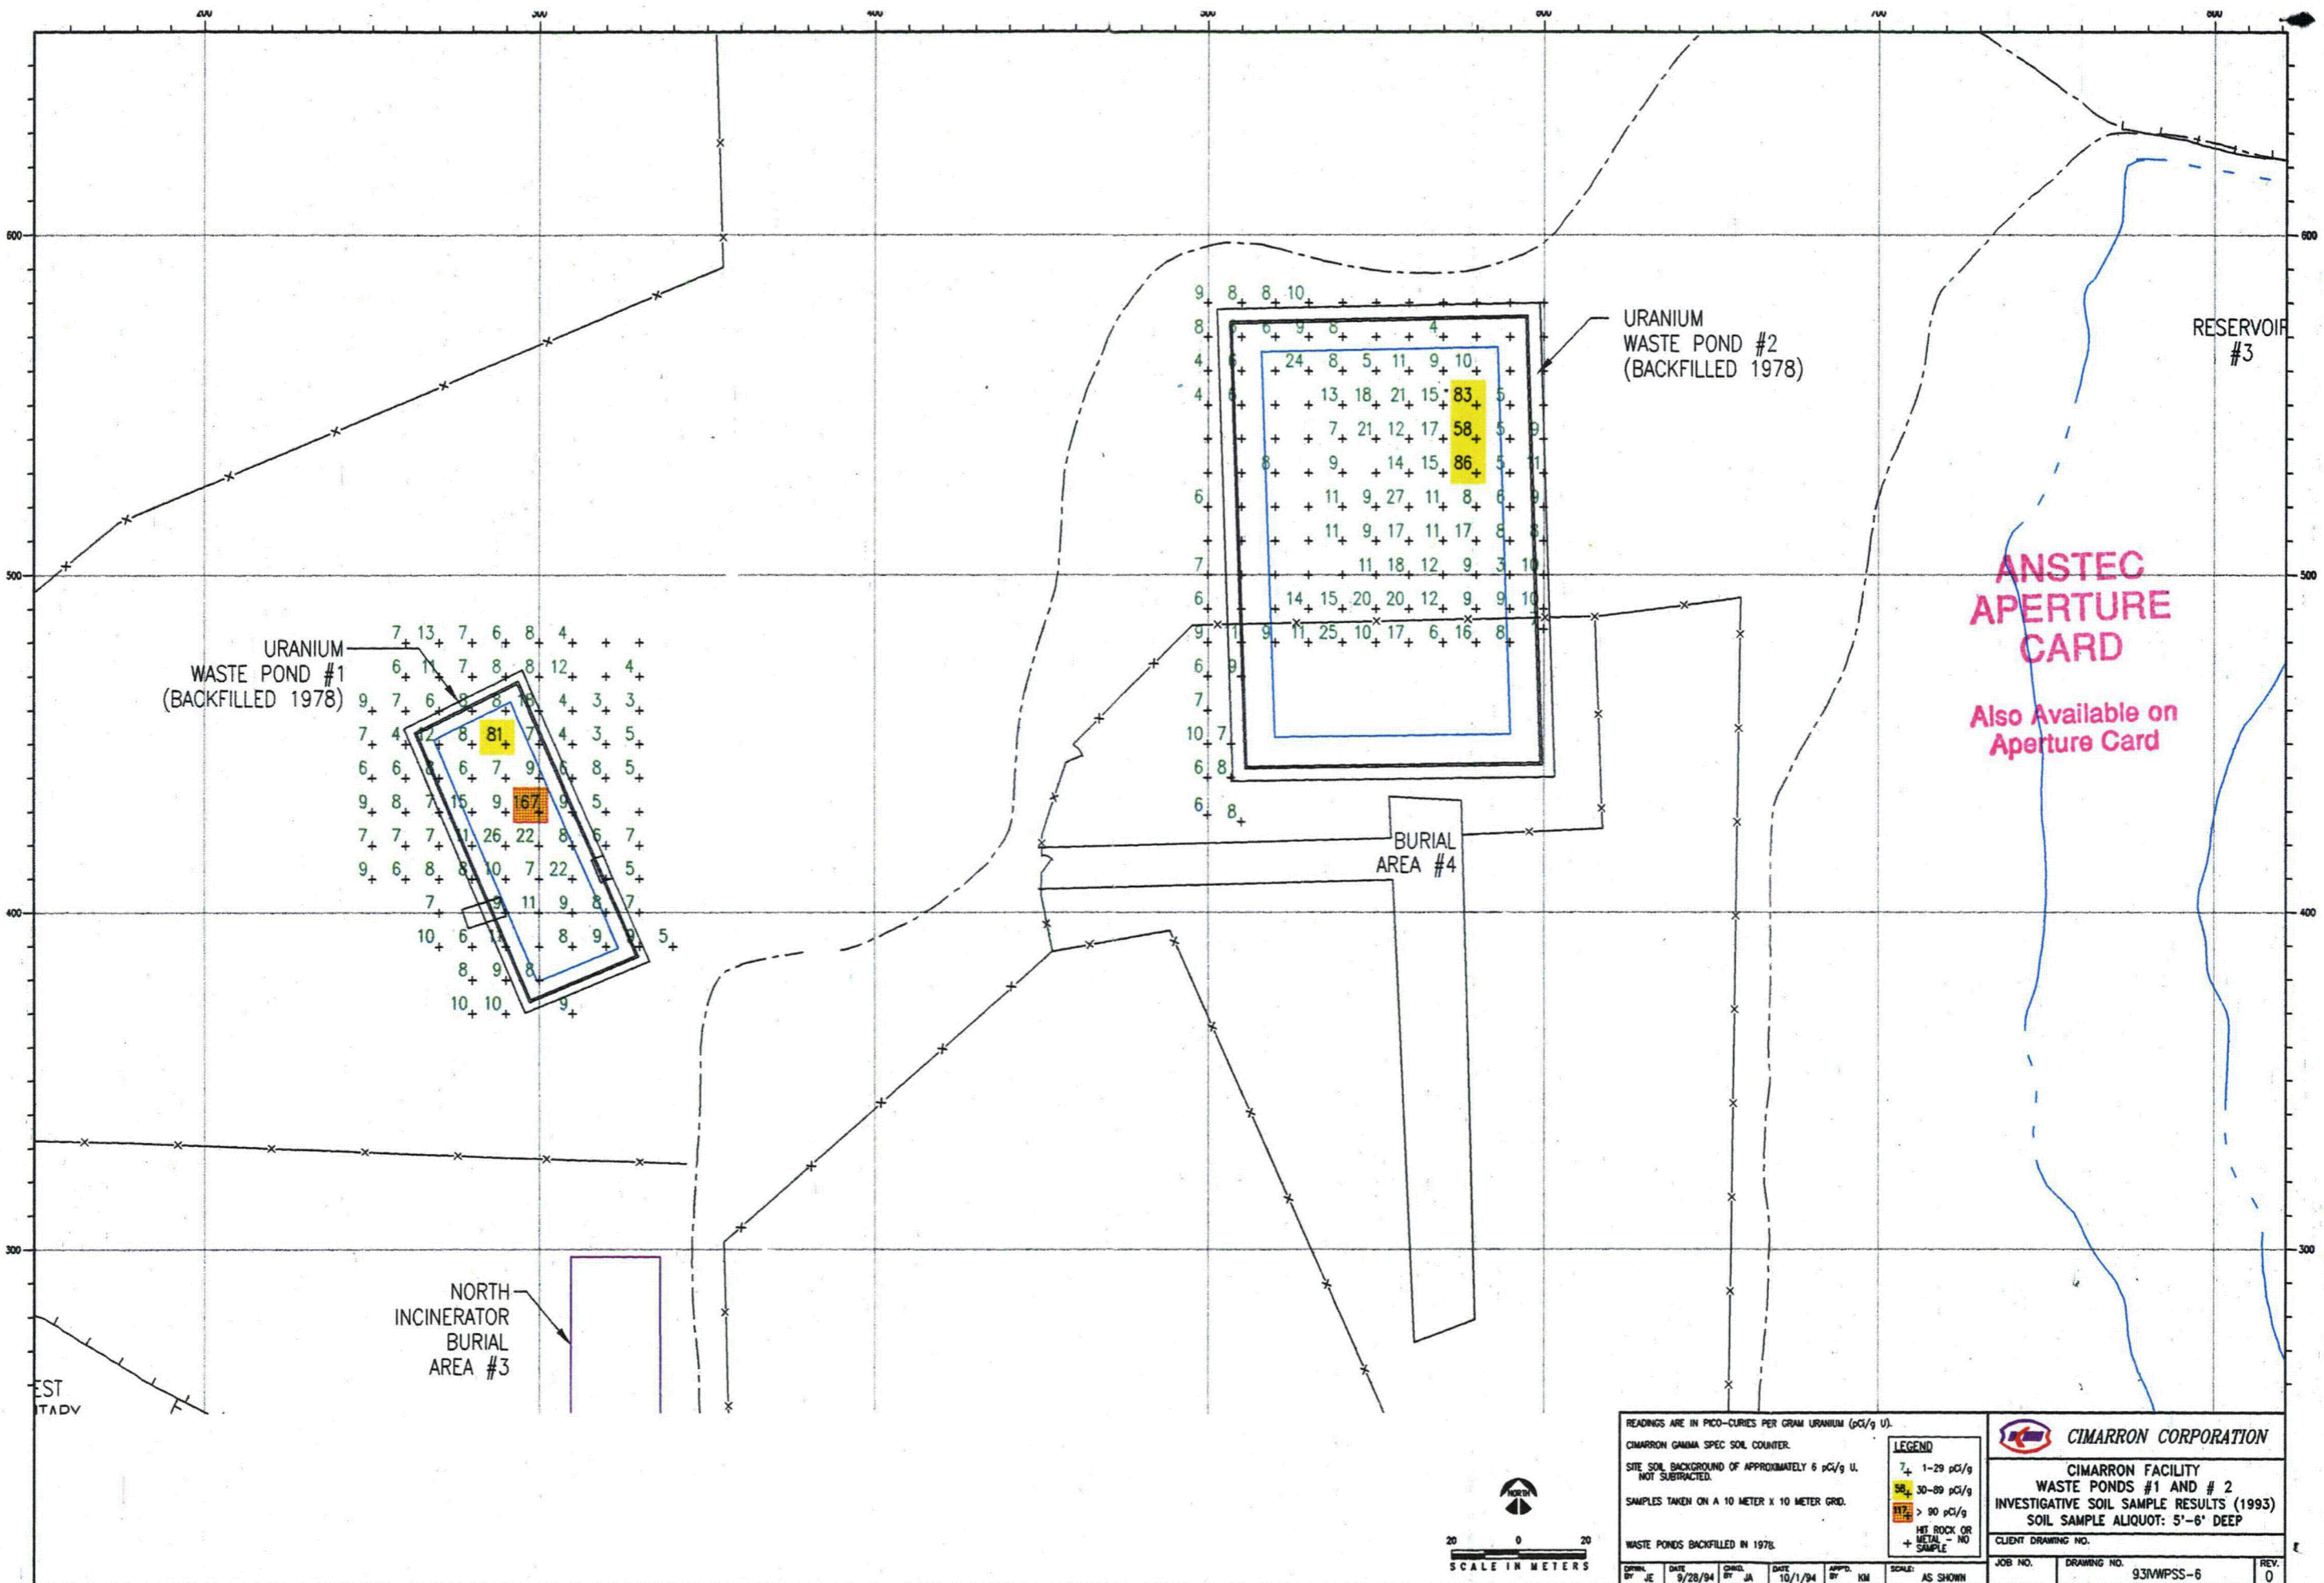
READINGS ARE IN PICO-CURIES PER GRAM URANIUM (pCi/g U).

CIMARRON GAMMA SPEC SOIL COUNTER.

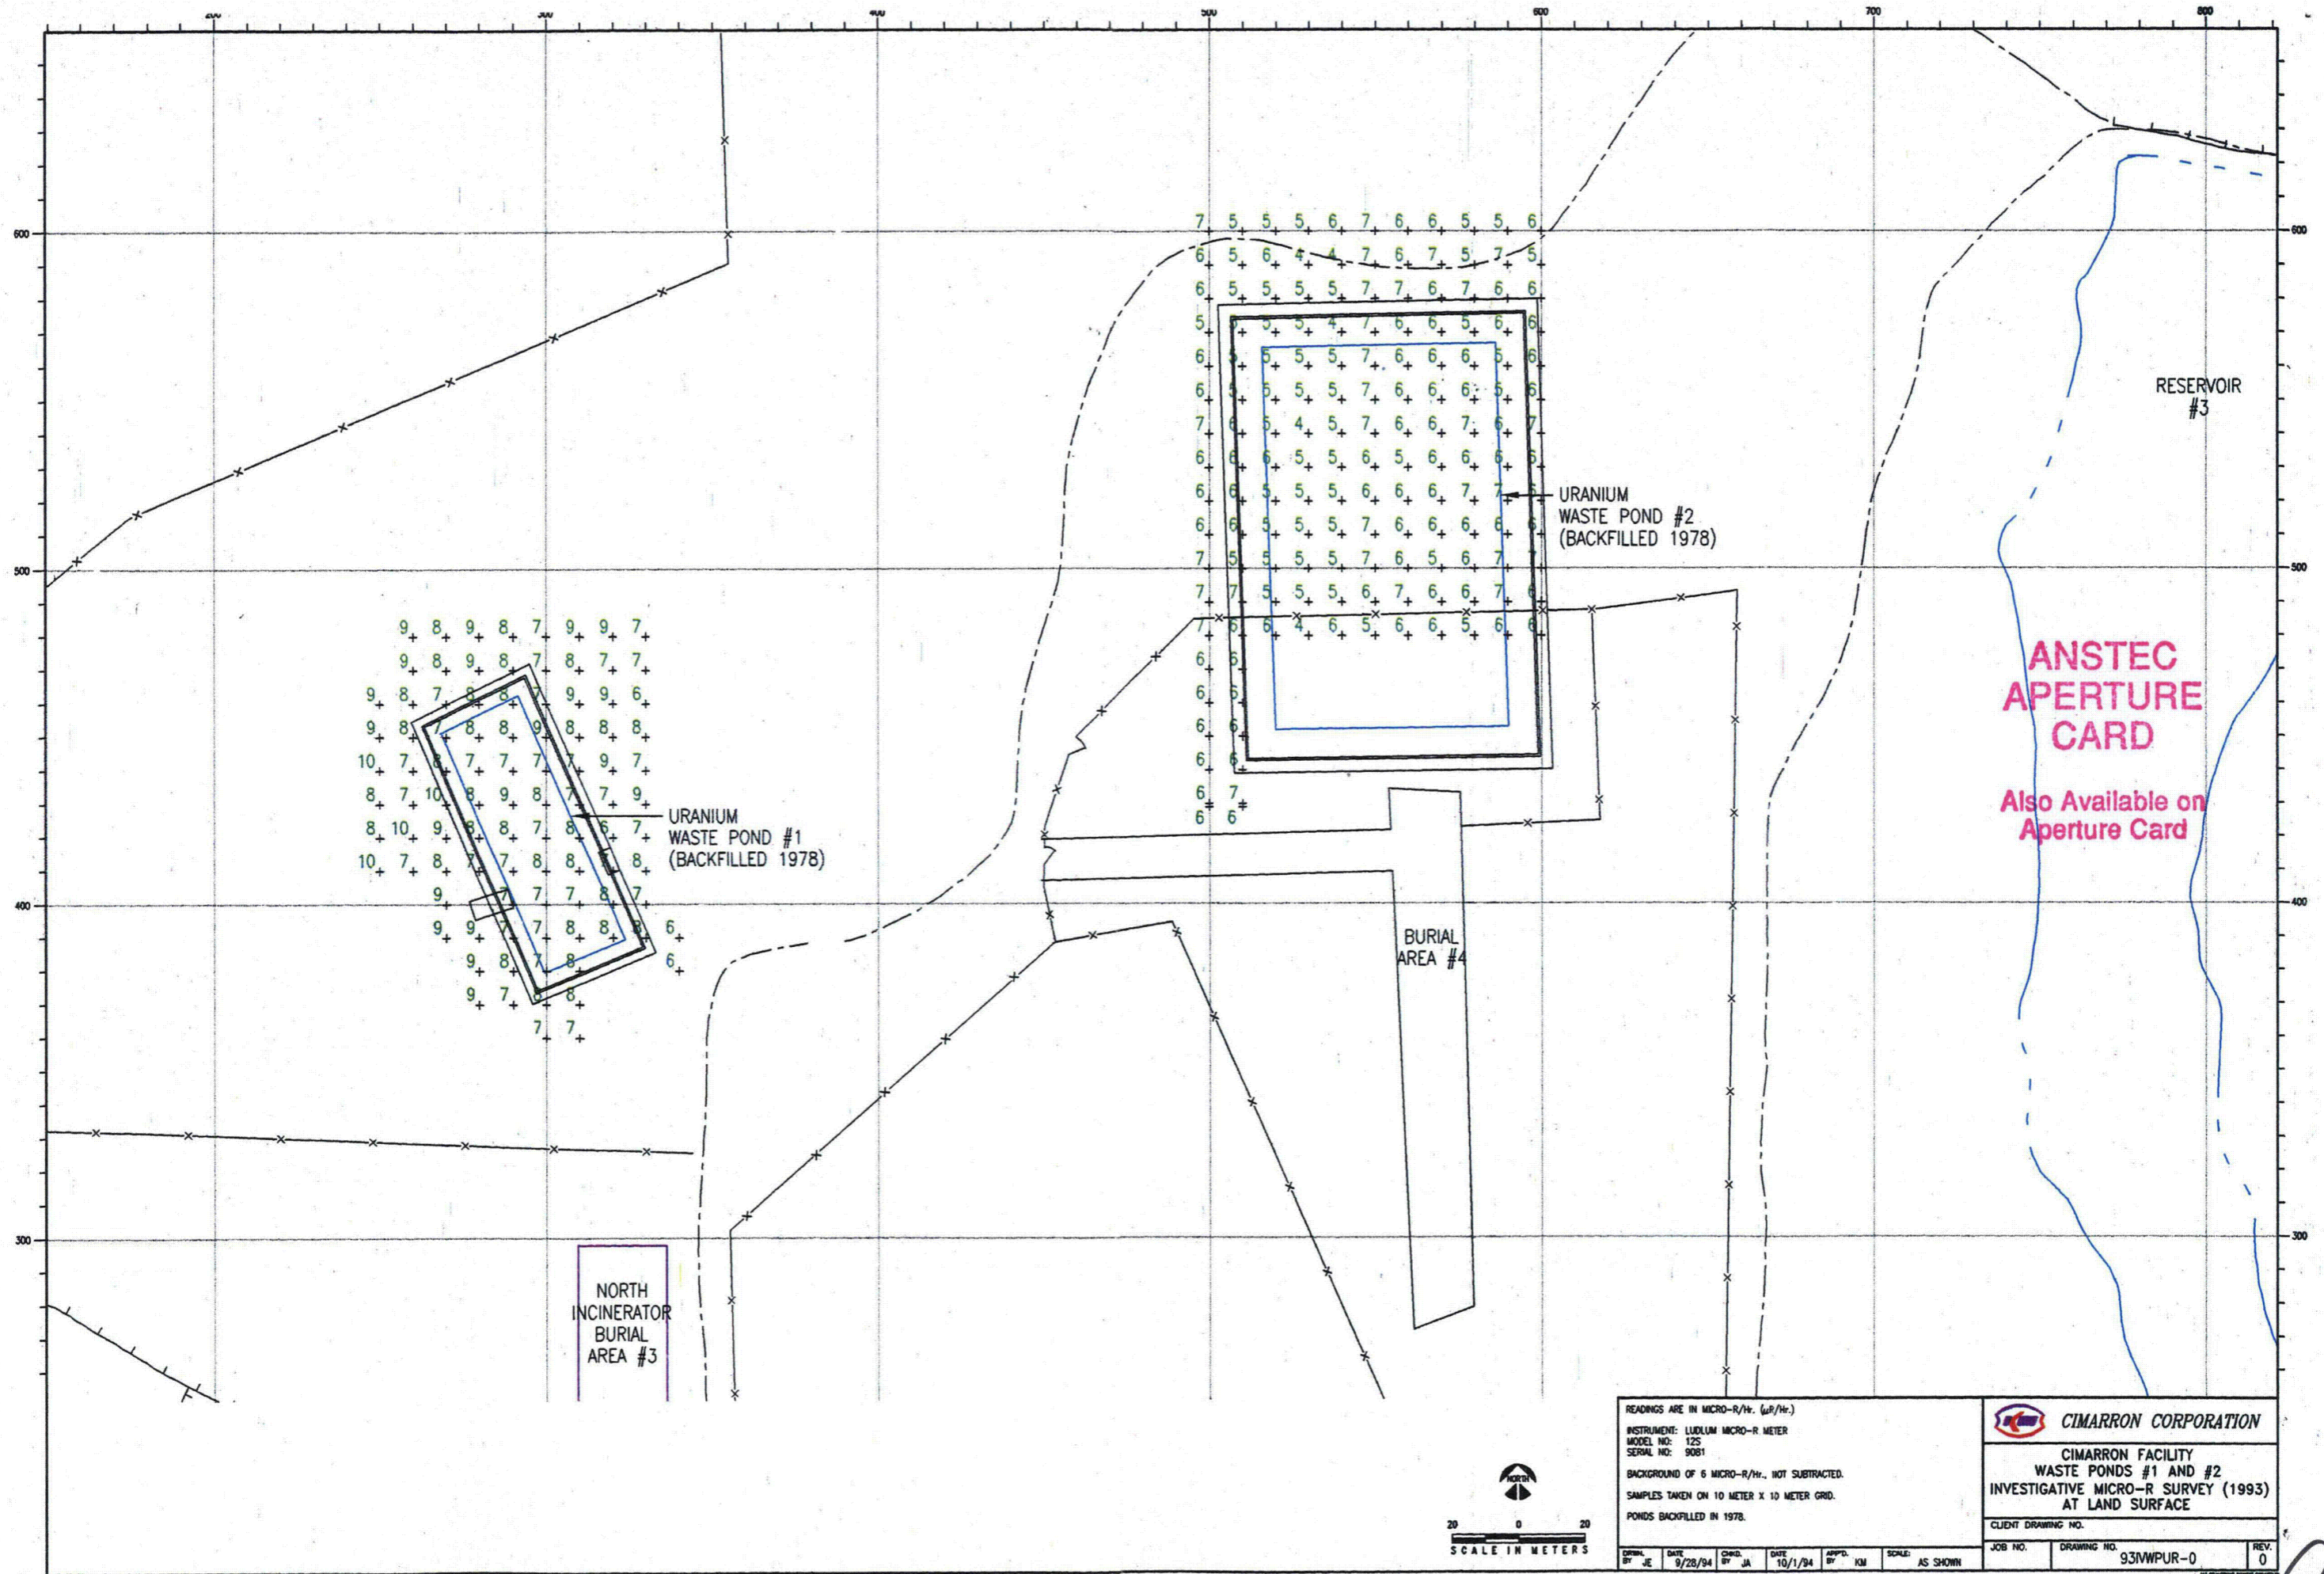
READINGS ARE IN MICRO-R/HR. ($\mu R/HR.$) INSTRUMENT: LUDLUM MICRO-R METER MODEL NO: 125 SERIAL NO: 9081 BACKGROUND OF 6 MICRO-R/HR., NOT SUBTRACTED. SAMPLES TAKEN ON 10 METER X 10 METER GRID. PONDS BACKFILLED IN 1978.			
INSTRUMENT: LUDLUM MICRO-R METER MODEL NO: 125 SERIAL NO: 9081 BACKGROUND OF 6 MICRO-R/HR., NOT SUBTRACTED. SAMPLES TAKEN ON 10 METER X 10 METER GRID. PONDS BACKFILLED IN 1978.		CIMARRON CORPORATION CIMARRON FACILITY WASTE PONDS #1 AND #2 INVESTIGATIVE MICRO-R SURVEY (1993) AT LAND SURFACE CLIENT DRAWING NO.	
DRAWN BY: JE DATE: 9/28/94 CHECKED BY: JA DATE: 10/1/94 APPROVED BY: KM SCALE: AS SHOWN	JOB NO. DRAWING NO. 93NWPUR-0 REV. 0	9412080115 -92

A Micro-R survey of this area was conducted in 1993 and the results are listed on Drawings No. 93IVWPUR-0 and 93IVWPUR-1. The survey readings were in the range of 5

to 10 uR/hr. A gamma survey also was conducted in 1993 and the results are shown on Drawing No. 93IVWP3D-0.

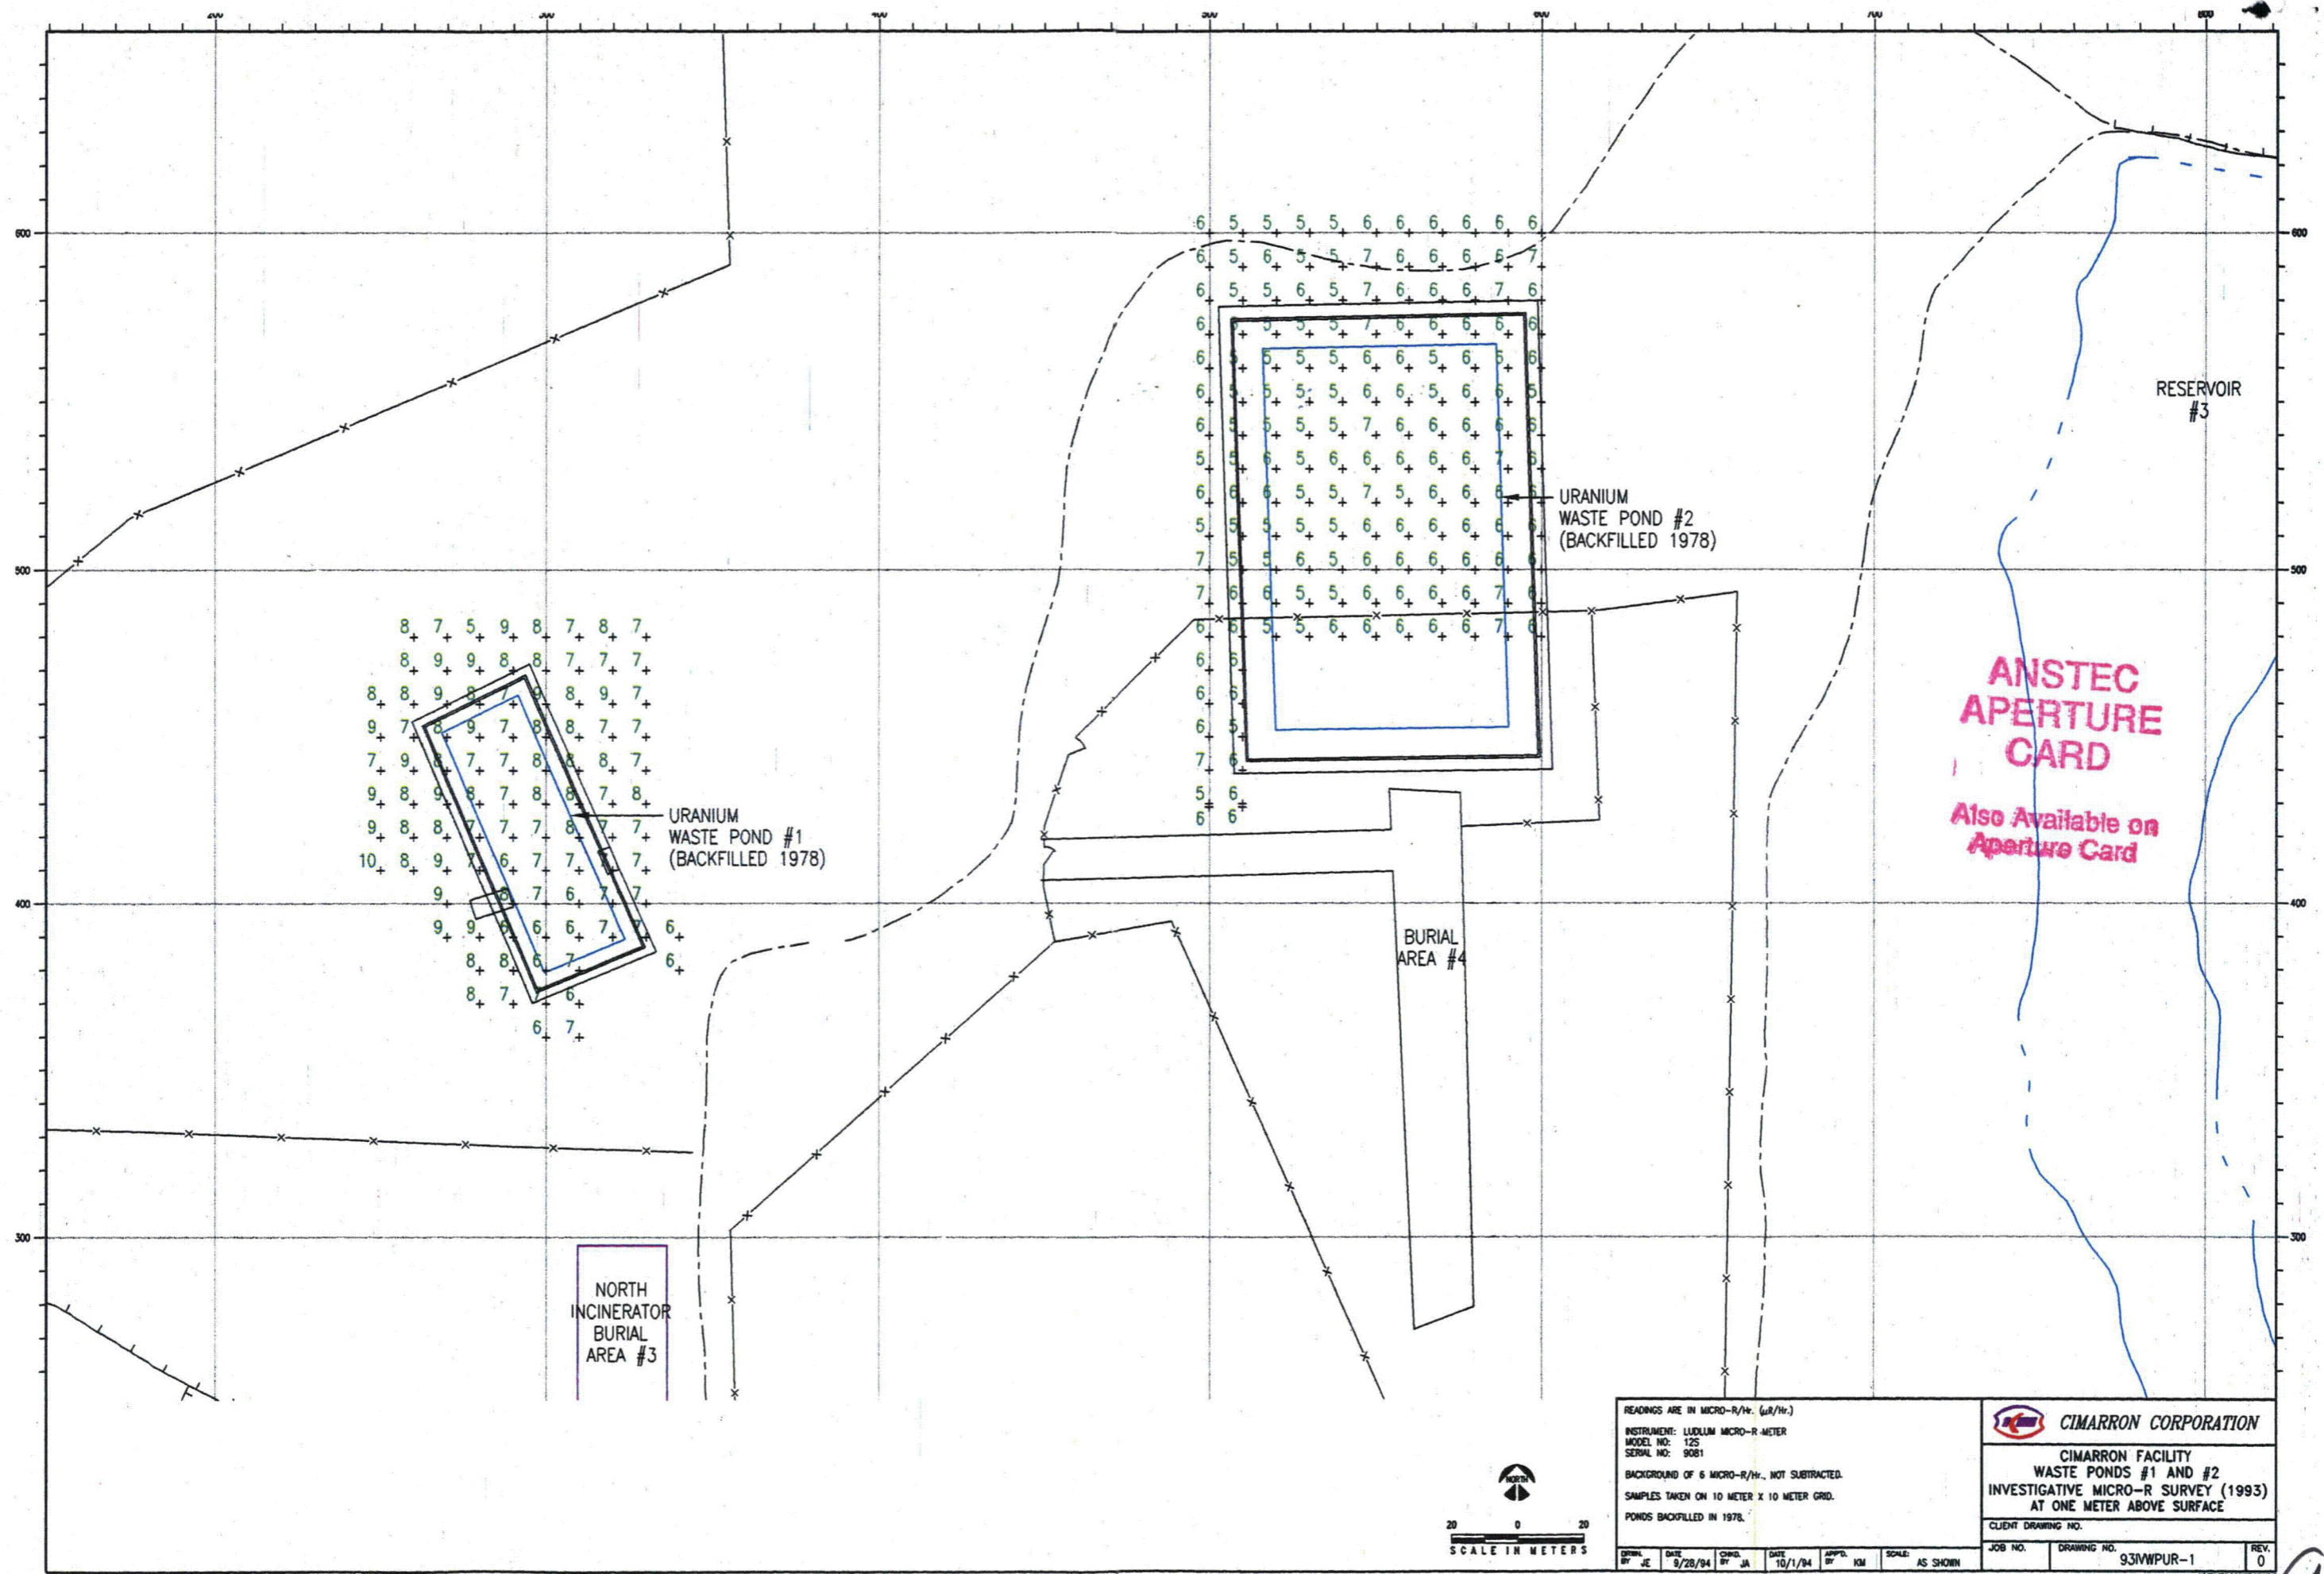
READINGS ARE IN MICRO-R/Hr. (µR/Hr.) INSTRUMENT: LUDLUM MICRO-R METER MODEL NO: 125 SERIAL NO: 9081 BACKGROUND OF 6 MICRO-R/Hr., NOT SUBTRACTED. SAMPLES TAKEN ON 10 METER X 10 METER GRID. PONDS BACKFILLED IN 1978.			
INSTRUMENT: LUDLUM MICRO-R METER MODEL NO: 125 SERIAL NO: 9081 BACKGROUND OF 6 MICRO-R/Hr., NOT SUBTRACTED. SAMPLES TAKEN ON 10 METER X 10 METER GRID. PONDS BACKFILLED IN 1978.		CIMARRON CORPORATION CIMARRON FACILITY WASTE PONDS #1 AND #2 INVESTIGATIVE MICRO-R SURVEY (1993) AT ONE METER ABOVE SURFACE CLIENT DRAWING NO.	
DRAWN BY: JE DATE: 9/28/94 CHD. BY: JA DATE: 10/1/94 APPD. BY: KM SCALE: AS SHOWN	JOB NO. DRAWING NO. 93JWPUR-1 REV. 0	SCALE IN METERS
