11.0 Sanitary Lagoons

11.1 East Sanitary Lagoon & West Sanitary Lagoon

11.2 New Sanitary Lagoon

12.0 Five Former Waste Water Ponds

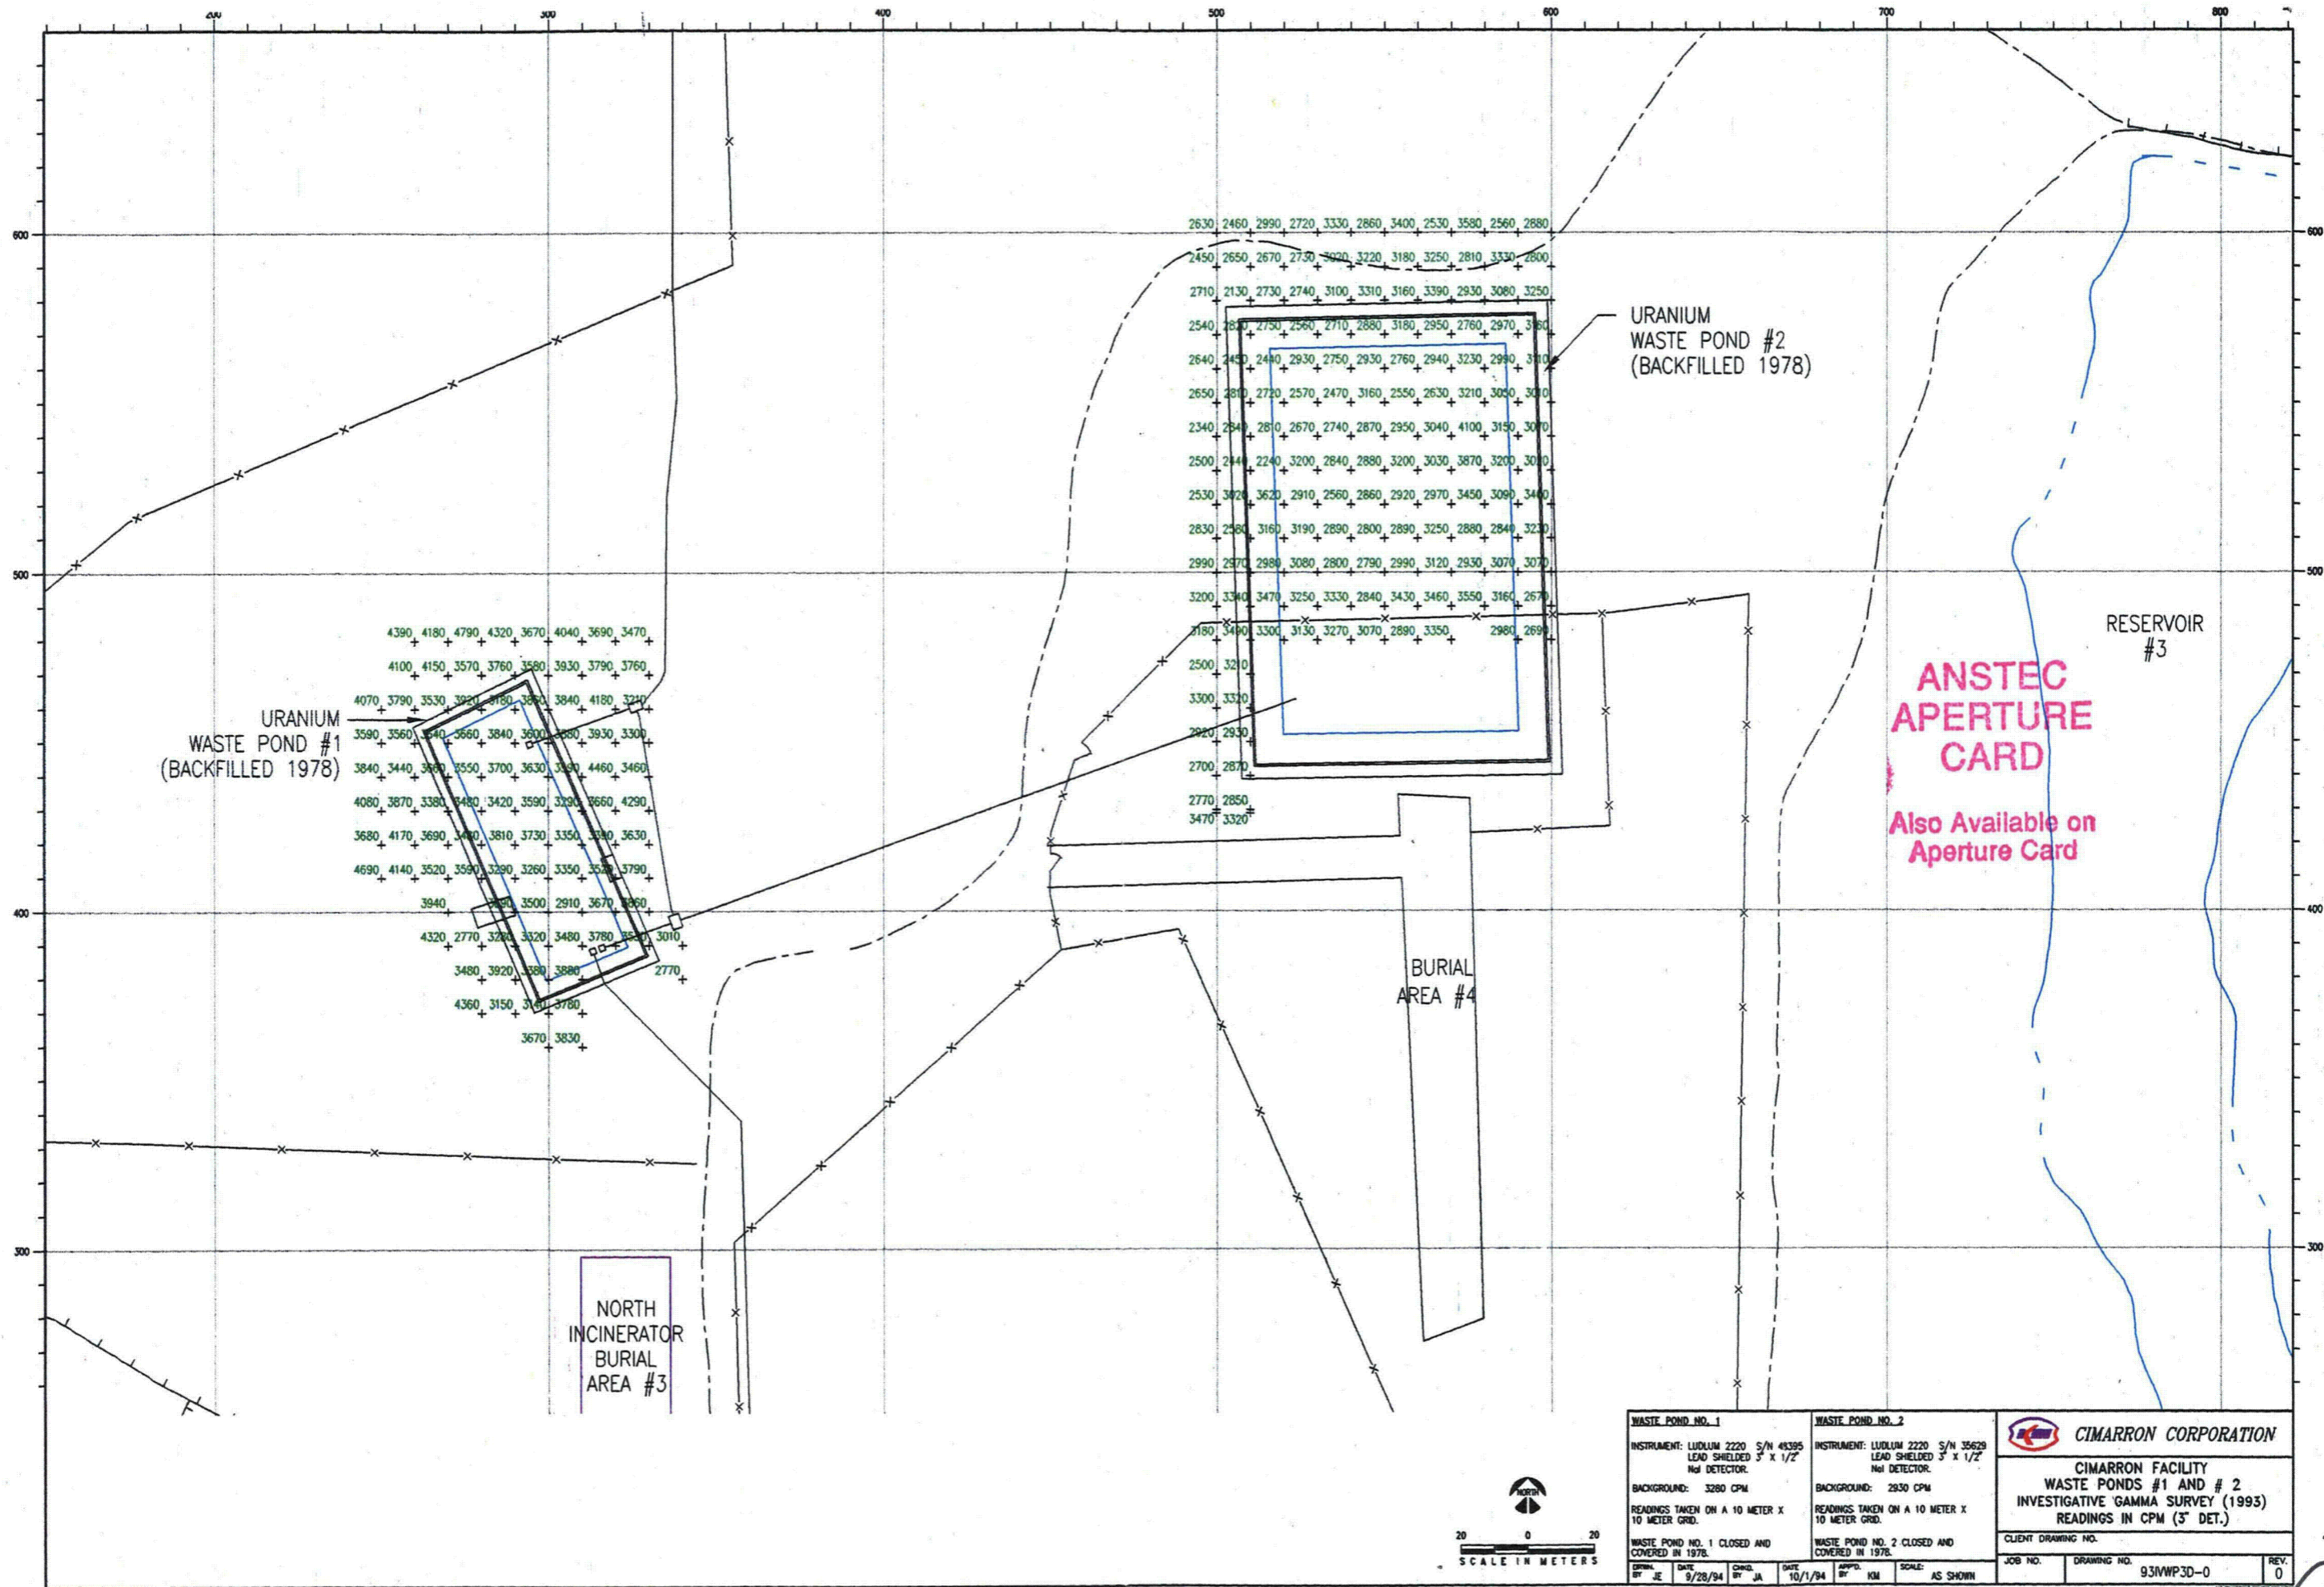
<p>WASTE POND NO. 1 INSTRUMENT: LUDLUM 2220 S/N 48395 LEAD SHIELDED 3" X 1/2" NaI DETECTOR. BACKGROUND: 3280 CPM READINGS TAKEN ON A 10 METER X 10 METER GRID. WASTE POND NO. 1 CLOSED AND COVERED IN 1978.</p>	<p>WASTE POND NO. 2 INSTRUMENT: LUDLUM 2220 S/N 35629 LEAD SHIELDED 3" X 1/2" NaI DETECTOR. BACKGROUND: 2930 CPM READINGS TAKEN ON A 10 METER X 10 METER GRID. WASTE POND NO. 2 CLOSED AND COVERED IN 1978.</p>	<p>CIMARRON CORPORATION CIMARRON FACILITY WASTE PONDS #1 AND #2 INVESTIGATIVE GAMMA SURVEY (1993) READINGS IN CPM (3" DET.) CLIENT DRAWING NO. JOB NO. DRAWING NO. 93/NWP3D-0 REV. 0</p>
<p>DATE: 9/28/94 BY: JE</p>	<p>DATE: 10/1/94 BY: KM</p>	<p>SCALE: AS SHOWN</p>

to 10 uR/hr. A gamma survey also was conducted in 1993 and the results are shown on Drawing No. 93IVWP3D-0.
