2.12.5.5.7 Run 17 - SC-2 Sample Container, Side Impact, Support Structure 0°

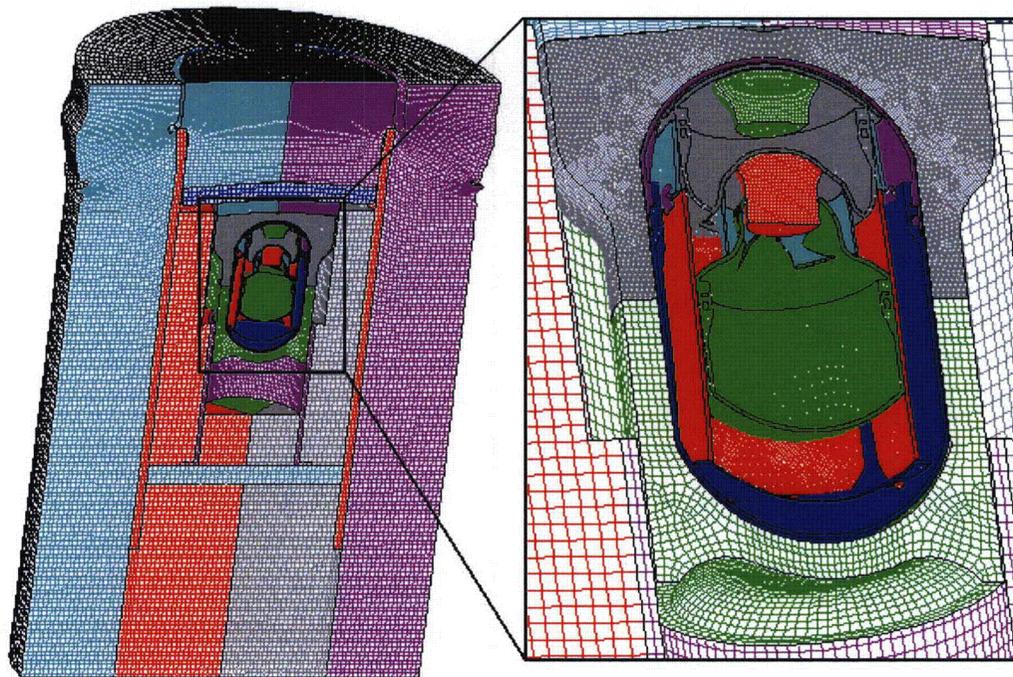
Figure 2-262. Finite Element Mesh for the SC-2, End Impact, 0° Support Structure – Final Displacement

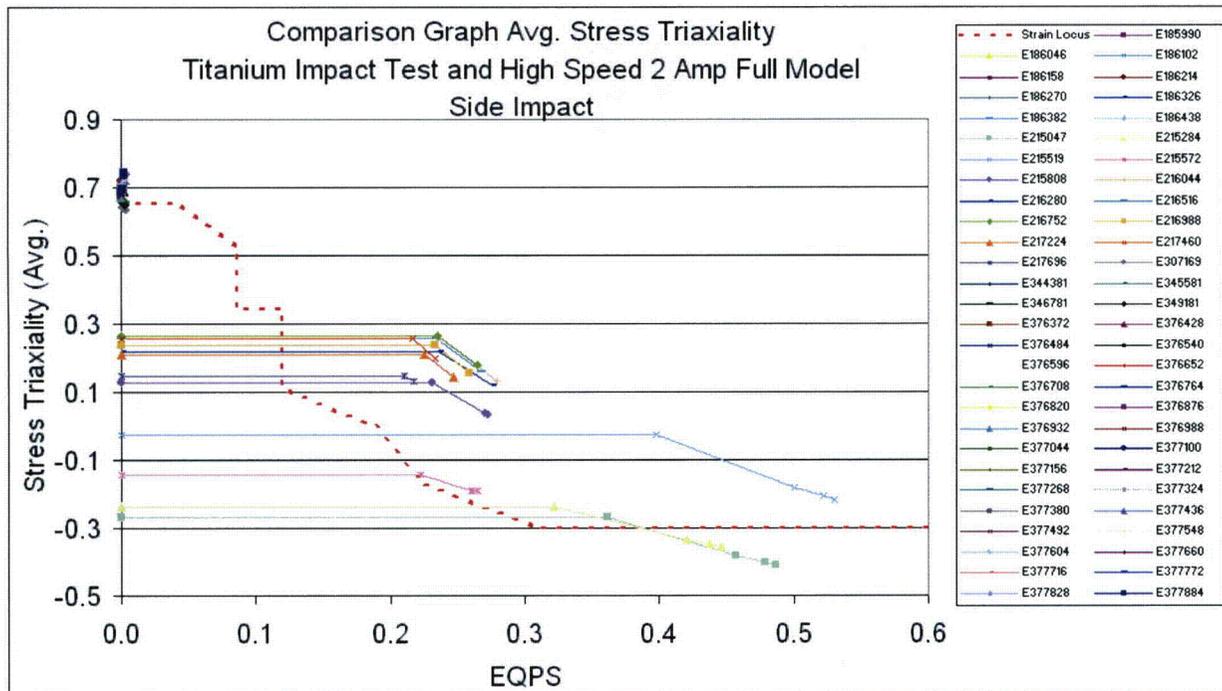
Figure 2-270. Graph of Average Stress Triaxiality versus EQPS of Elements Exceeding the Experimental Strain Locus for the SC-2, Side Impact, 0° Support Structure

Average stress-triaxiality versus EQPS is shown in Figure 2-270 for the 55 elements extending beyond the tested Bao-Wierzbicki strain locus. All of these elements are outside the B-W locus, for a variety of stress triaxialities, although most of the 580,000 T-Ampoule elements are inside the B-W locus. The Tearing Parameter values for these same 55 elements are shown in Figure 2-271 and all are below the critical Tearing Parameter value of 1.012 for Ti-6Al-4V. These elements are highlighted in red in Figures 2-272 and 2-273, but note that these elements are still below the initiation of a ductile tear and thus, T-Ampoule integrity is maintained.

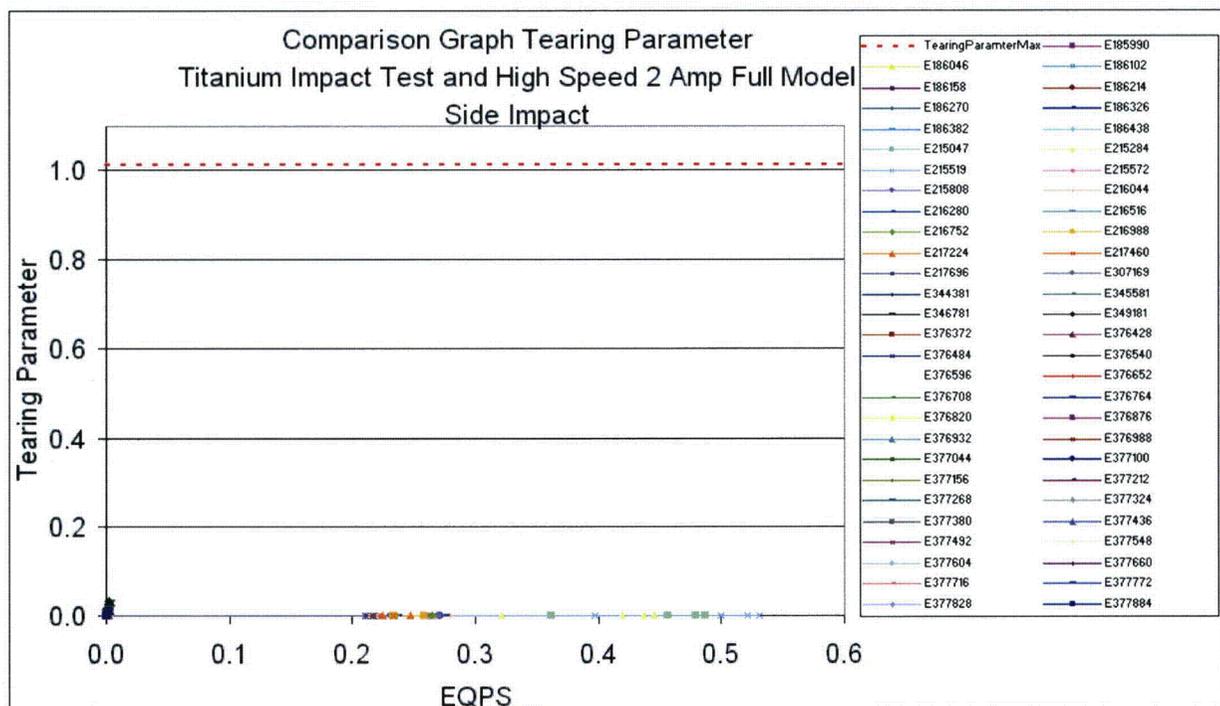
Figure 2-271. Graph of Tearing Parameter versus EQPS of Elements Exceeding the Experimental Strain Locus for the SC-2, Side Impact, 0° Support Structure

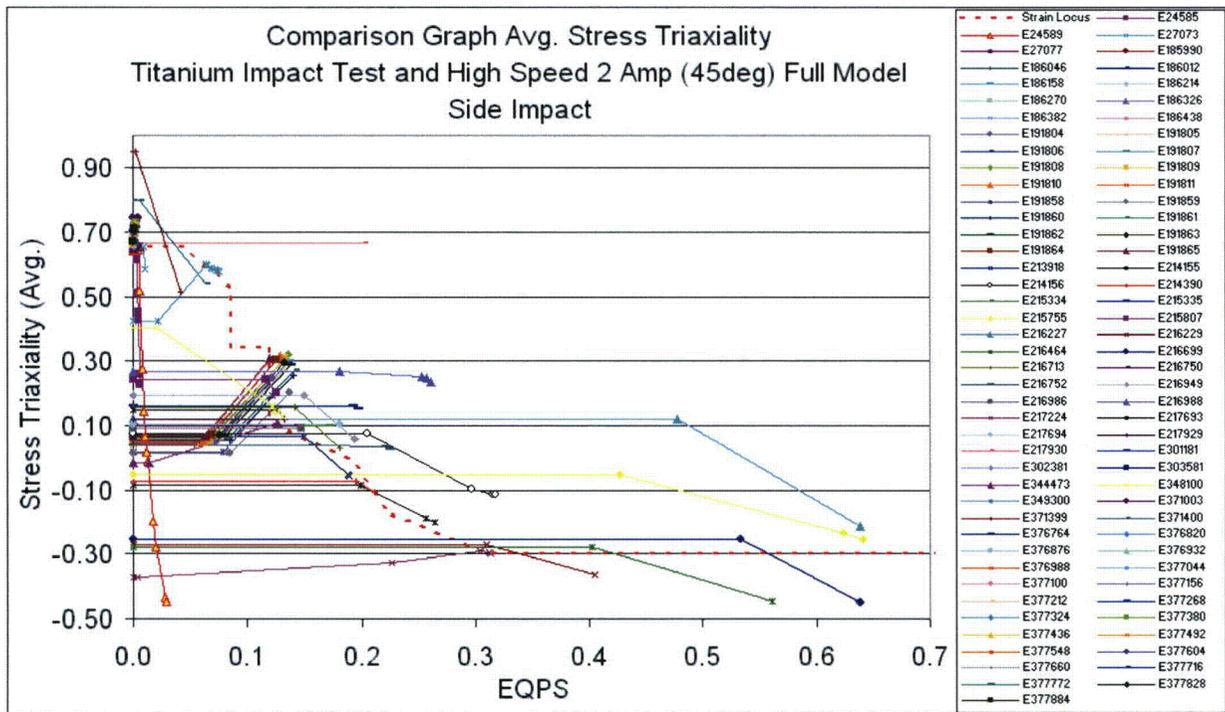
Figure 2-280. Graph of Average Stress Triaxiality versus EQPS of Elements Exceeding the Experimental Strain Locus for the SC-2, Side Impact, 45° Support Structure

Average stress-triaxiality versus EQPS is shown in Figure 2-280 for the 82 elements extending beyond the tested Bao-Wierzbicki strain locus. All of these elements are outside the B-W locus, for a variety of stress triaxialities, although most of the 580,000 T-Ampoule elements are inside the B-W locus. The Tearing Parameter values for these same 82 elements are shown in Figure 2-281 and all are below the critical Tearing Parameter value of 1.012 for Ti-6Al-4V. These elements are highlighted in red in Figures 2-282 and 2-283, but note that these elements are still below the initiation of a ductile tear and thus T-Ampoule integrity is maintained.

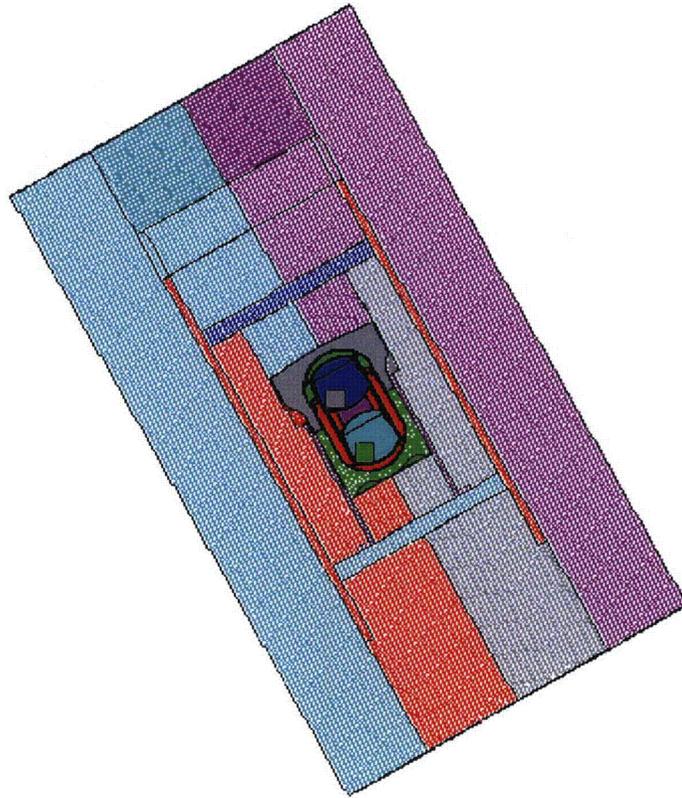
Figure 2-288. Finite Element Mesh for the SC-2, CGOC Impact, 0° Support Structure

The lid end CG-over-corner impact model for each large SC-2 with delta Pu contents (inner cradle rotated 0 degrees) is shown in Figure 2-288. Each Pu cylinder is located at the rotated bottom of each SC-2 so that its net impact velocity with the top of the T-Ampoule is maximized. The post-impact deformation is shown in Figure 2-289 and its kinetic energy history in Figure 2-290. The Pu cylinder contents remain largely confined within the SC-2's, although significant localized deformation of the SC-2's has occurred.

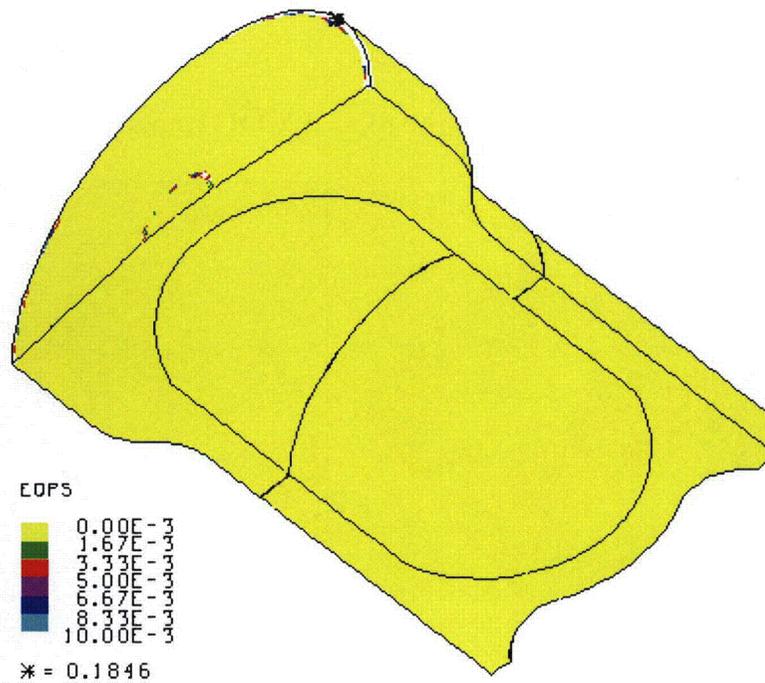
Figure 2-291. Plot of EQPS in the TB-1 for the SC-2, CGOC Impact, 0° Support Structure

Equivalent Plastic Strain (EQPS) in the TB-1 vessel is shown in Figure 2-291 to peak at about 18.5%, but only in some localized outer contact regions with the redwood overpack. The von Mises stresses (see Figure 2-292) peak at 145 ksi, just above the elevated-temperature minimum yield strength for the TB-1 of 141 ksi but more importantly, through-thickness TB-1 stress values are in the 47 ksi range, below yield. The time at which the peak value of the von Mises stress occurs coincides with the peak value of the contact force (summed over the lid area). A plot of this force as a function of time is shown in Figure 2-293. A maximum contact load of 34,253 lbs is applied to the inner surface of the TB-1 lid during the impact. No T-Ampoule elements exceeded the tested B-W strain locus, and the peak Tearing Parameter value (see Table 2-11, run #19) of 0.0953 was below the critical Tearing Parameter value of 1.012 for Ti-6Al-4V.

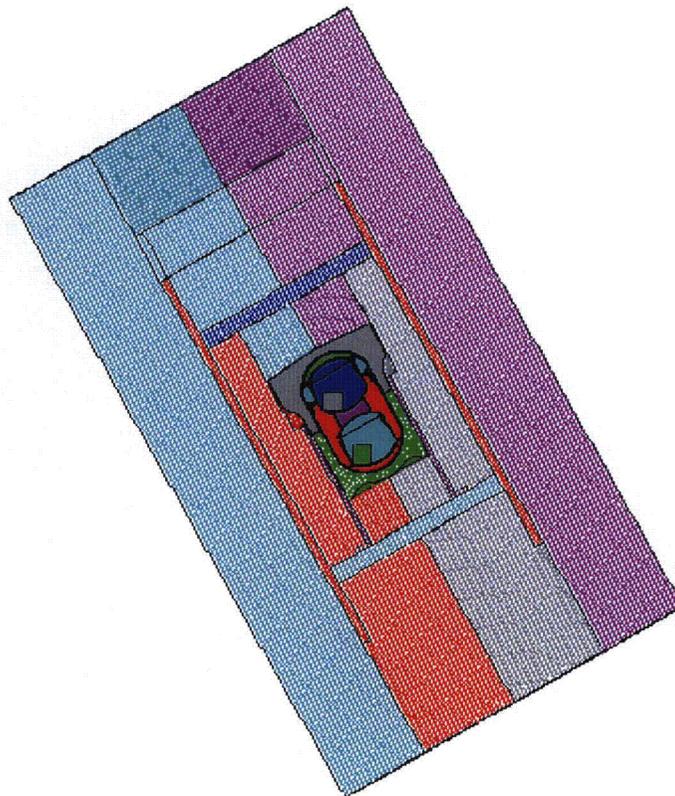
Figure 2-294. Finite Element Mesh for the SC-2, CGOC Impact, 45° Support Structure

The lid end CG-over-corner impact model for each large SC-2 with delta Pu contents (inner cradle rotated 45 degrees) is shown in Figure 2-294. Each Pu cylinder is located at the rotated bottom of each SC-2 so that its net impact velocity with the top of the T-Ampoule is maximized. The post-impact deformation is shown in Figure 2-295 and its kinetic energy history in Figure 2-296. The Pu cylinder contents remain largely confined within each SC-2, although localized deformation of the SC-2 has occurred.

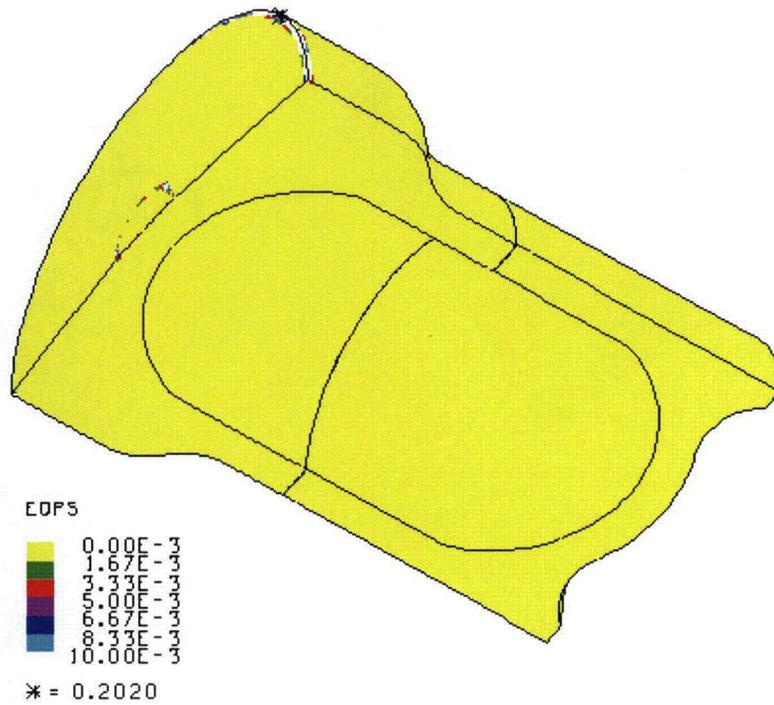
Figure 2-297. Plot of EQPS in the TB-1 for the SC-2, CGOC Impact, 45° Support Structure

Equivalent Plastic Strain (EQPS) in the TB-1 vessel is shown in Figure 2-297 to peak at about 20%, but only in some localized outer contact regions with the redwood overpack. The von Mises stresses (see Figure 2-298) peak at 143 ksi, just above the elevated-temperature minimum yield strength for the TB-1 of 141 ksi but more importantly, through-thickness TB-1 stress values are in the 37.5 ksi range, below yield. The time at which the peak value of the von Mises stress occurs coincides with the peak value of the contact force (summed over the lid area). A plot of this force as a function of time is shown in Figure 2-299. A maximum contact load of 31,307 lbs is applied to the inner surface of the TB-1 lid during the impact. No T-Ampoule elements exceeded the tested B-W strain locus, and the peak Tearing Parameter value (see Table 2-11, run #20) of 0.054 was below the critical Tearing Parameter value of 1.012 for Ti-6Al-4V.

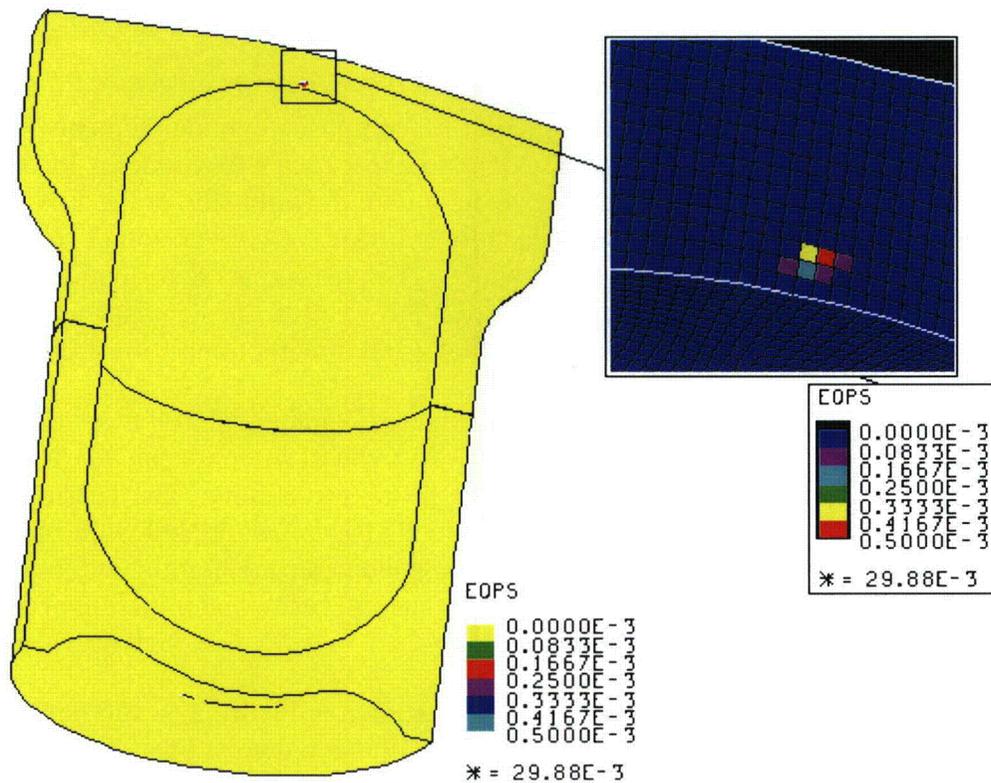
Figure 2-303. Plot of EQPS in the TB-1 for the SC-1, End Impact, 0° Support Structure, Be Contents

Equivalent Plastic Strain (EQPS) in the TB-1 vessel is shown in Figure 2-303 to be less than 3%, and only in some localized outer contact regions with the redwood overpack. A very small area of localized internal denting occurs, with plasticity less than 0.05%. The von Mises stresses (see Figure 2-304) peak at 143 ksi, just above the elevated-temperature minimum yield strength for the TB-1 of 141 ksi, but more importantly, through-thickness TB-1 stress values are in the less-than-75 ksi range, below yield. No T-Ampoule elements exceeded the tested B-W strain locus, and the peak Tearing Parameter value (see, Table 2-11 run #21) of 0.0155 was below the critical Tearing Parameter value of 1.012 for Ti-6Al-4V.

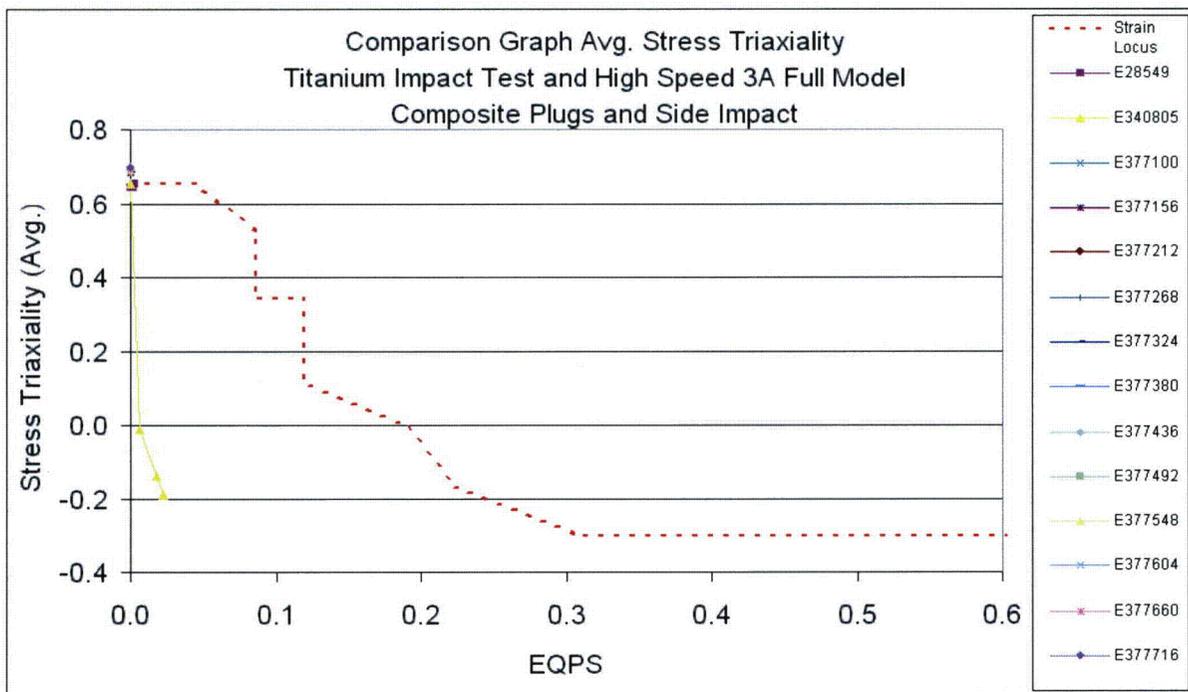
Figure 2-308. Graph of Average Stress Triaxiality versus EQPS of the Elements Exceeding the Experimental Strain Locus for the SC-1, Side Impact, 0° Support Structure, Be Contents

Average stress-triaxiality versus EQPS is shown in Figures 2-308 and 2-309 (zoomed in view) for the 14 elements extending beyond the tested Bao-Wierzbicki strain locus. All of these elements are outside the B-W locus, in a region of high stress triaxiality. The Tearing Parameter values for these same 14 elements are shown in Figure 2-310, and all are below the critical Tearing Parameter value of 1.012 for Ti-6Al-4V. These elements are highlighted in red in Figures 2-311 and 2-312, but note that these elements are still below the initiation of a ductile tear and thus T-Ampoule integrity is maintained.

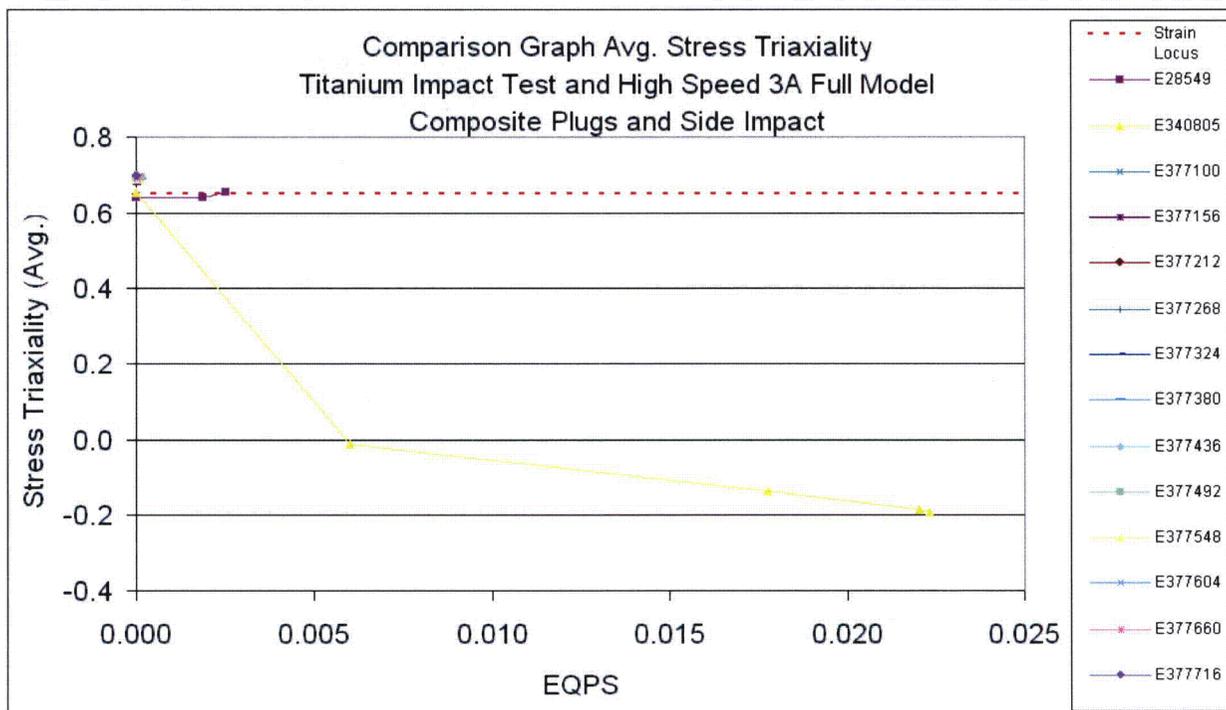
Figure 2-309. Graph of Average Stress Triaxiality versus EQPS of the Elements Exceeding the Experimental Strain Locus (Zoomed In) for the SC-1, Side Impact, 0° Support Structure, Be Contents

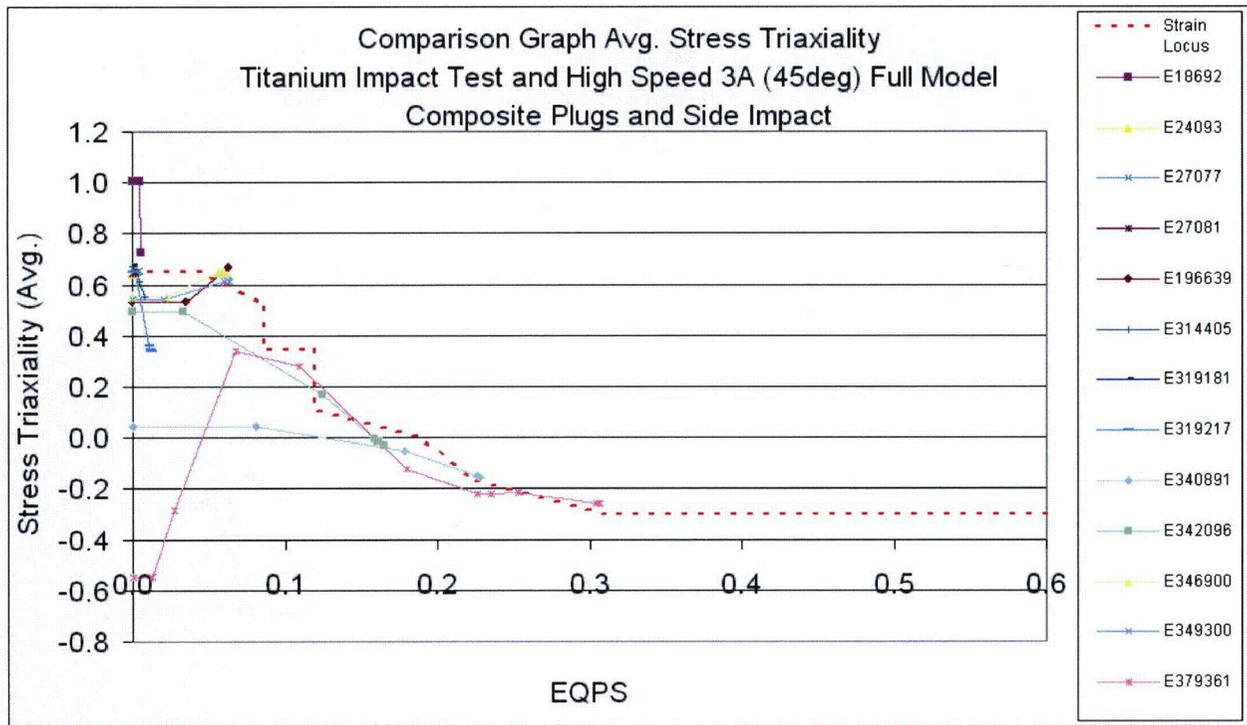
Figure 2-318. Graph of Average Stress Triaxiality versus EQPS of Elements Exceeding the Experimental Strain Locus for the SC-1, Side Impact, 45° Support Structure, Be Contents

Average stress-triaxiality versus EQPS is shown in Figure 2-318 for the 13 elements extending beyond the tested Bao-Wierzbicki strain locus. All of these elements are outside the B-W locus, in a region of high stress triaxiality. The Tearing Parameter values for these same 13 elements are shown in Figure 2-319, and all are below the critical Tearing Parameter value of 1.012 for Ti-6Al-4V. These elements are highlighted in red in Figures 2-320 and 2-321, but note that these elements are still below the initiation of a ductile tear and thus T-Ampoule integrity is maintained.

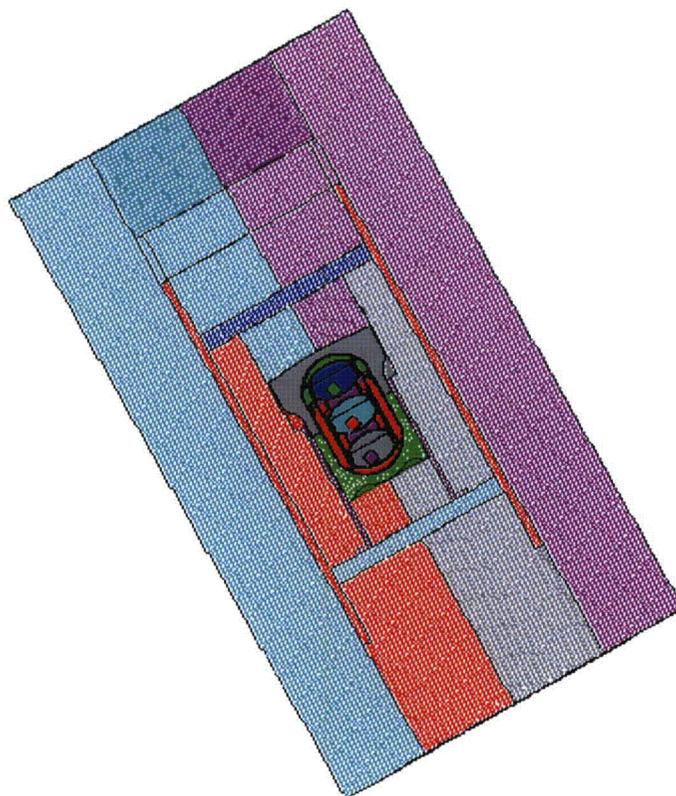
Figure 2-324. Finite Element Mesh for the SC-1, CGOC Impact, 0° Support Structure, Be Contents

The lid end CG-over-corner impact model for each SC-1 with Be composite contents (inner cradle rotated 0 degrees) is shown in Figure 2-324. Each Be cylinder is located at the rotated bottom of each SC-1 so that its net impact velocity with the top of the T-Ampoule is maximized. The post-impact deformation is shown in Figure 2-325 and its kinetic energy history in Figure 2-326. The Be cylinder contents remain largely confined within the SC-1's, although localized deformation of the SC-1's has occurred.

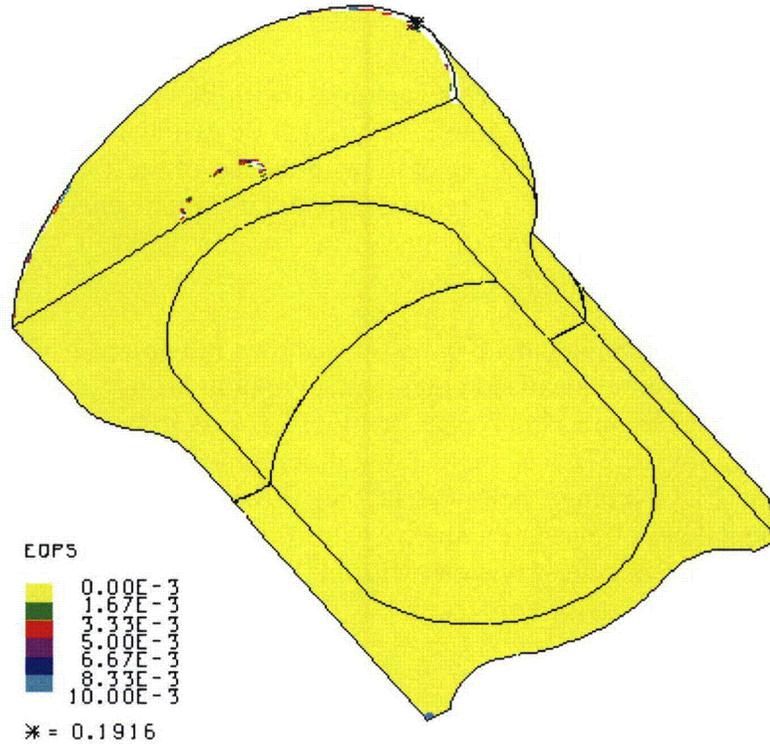
Figure 2-327. Plot of EQPS in the TB-1 for the SC-1, CGOC Impact, 0° Support Structure, Be Contents

Equivalent Plastic Strain (EQPS) in the TB-1 vessel is shown in Figure 2-327 to peak at about 19%, but only in some localized outer contact regions with the redwood overpack. The von Mises stresses (see Figure 2-328) peak at 181 ksi, just above the elevated-temperature minimum yield strength for the TB-1 of 141 ksi, but more importantly, through-thickness TB-1 stress values are in the 23 ksi range, below yield. No T-Ampoule elements exceeded the tested B-W strain locus, and the peak Tearing Parameter value (see Table 2-11, run #24) of 0.0597 was below the critical Tearing Parameter value of 1.012 for Ti-6Al-4V.

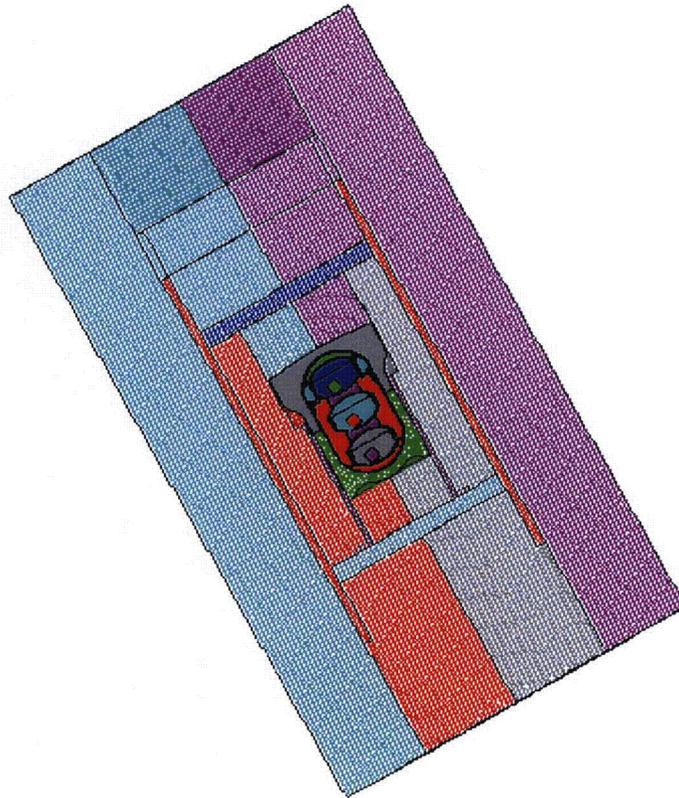
Figure 2-329. Finite Element Mesh for the SC-1, CGOC Impact, 45° Support Structure, Be Contents

The lid end CG-over-corner impact model for each SC-1 with Be composite contents (inner cradle rotated 45 degrees) is shown in Figure 2-329. Each Be cylinder is located at the rotated bottom of each SC-1 so that its net impact velocity with the top of the T-Ampoule is maximized. The post-impact deformation is shown in Figure 2-330 and its kinetic energy history in Figure 2-331. The Be cylinder contents remain largely confined within the SC-1's, although localized deformation of the SC-1's has occurred.

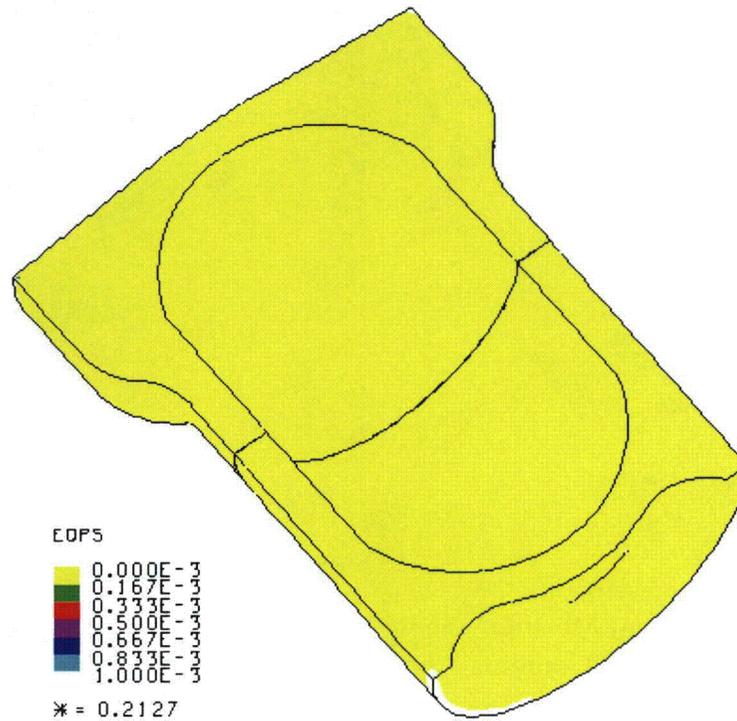
Figure 2-332. Plot of EQPS in the TB-1 for the SC-1, CGOC Impact, 45° Support Structure, Be Contents

Equivalent Plastic Strain (EQPS) in the TB-1 vessel is shown in Figures 2-332 and 2-333 to peak at about 21.3%, but only in some localized outer contact regions with the redwood overpack. The von Mises stresses (see Figure 2-334) peak at 143.3 ksi, just above the elevated-temperature minimum yield strength for the TB-1 of 141 ksi, but more importantly, through-thickness TB-1 stress values are in the 23.3 ksi range, below yield. No T-Ampoule elements exceeded the tested B-W strain locus, and the peak Tearing Parameter value (see Table 2-11, run #25) of 0.1197 was below the critical Tearing Parameter value of 1.012 for Ti-6Al-4V.

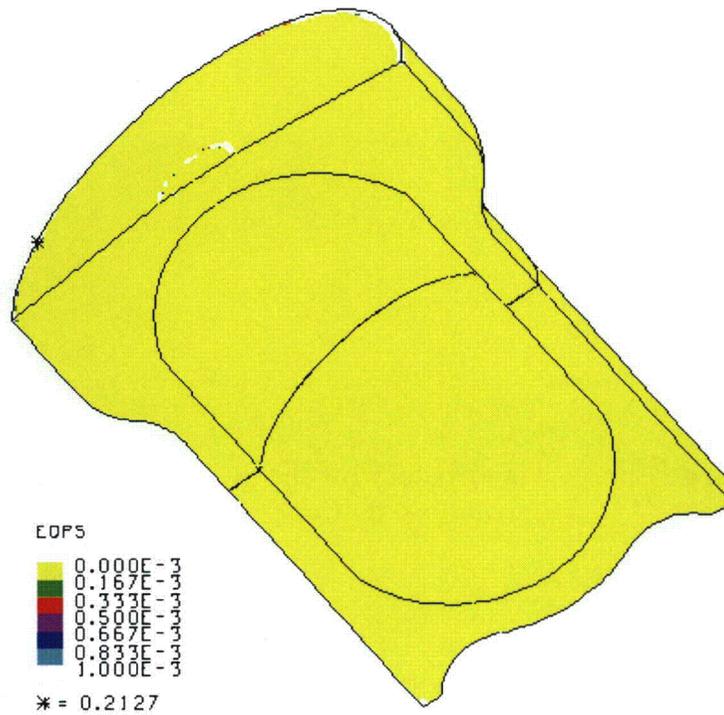
Figure 2-333. Plot of EQPS in the TB-1 for the SC-1, CGOC Impact, 45° Support Structure, Be Contents

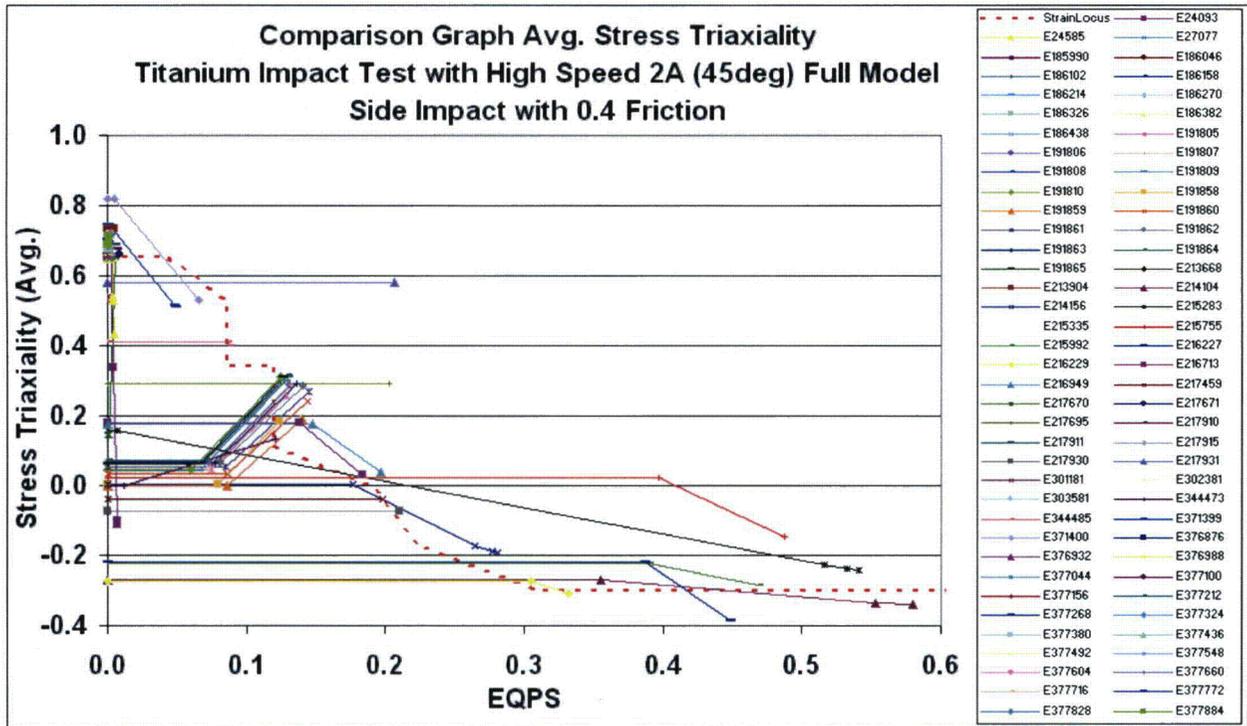
Figure 2-338. Graph of Average Stress Triaxiality versus EQPS of Elements Exceeding the Experimental Strain Locus for the SC-2, Side Impact, 45° Support Structure, Friction 0.4

Average stress-triaxiality versus EQPS is shown in Figure 2-338 for the 73 elements extending beyond the tested Bao-Wierzbicki strain locus (similar to the 82 elements for the 0.3 friction case). All of these elements are outside the B-W locus, for a variety of stress triaxialities, although most of the 580,000 T-Ampoule elements are inside the B-W locus. The Tearing

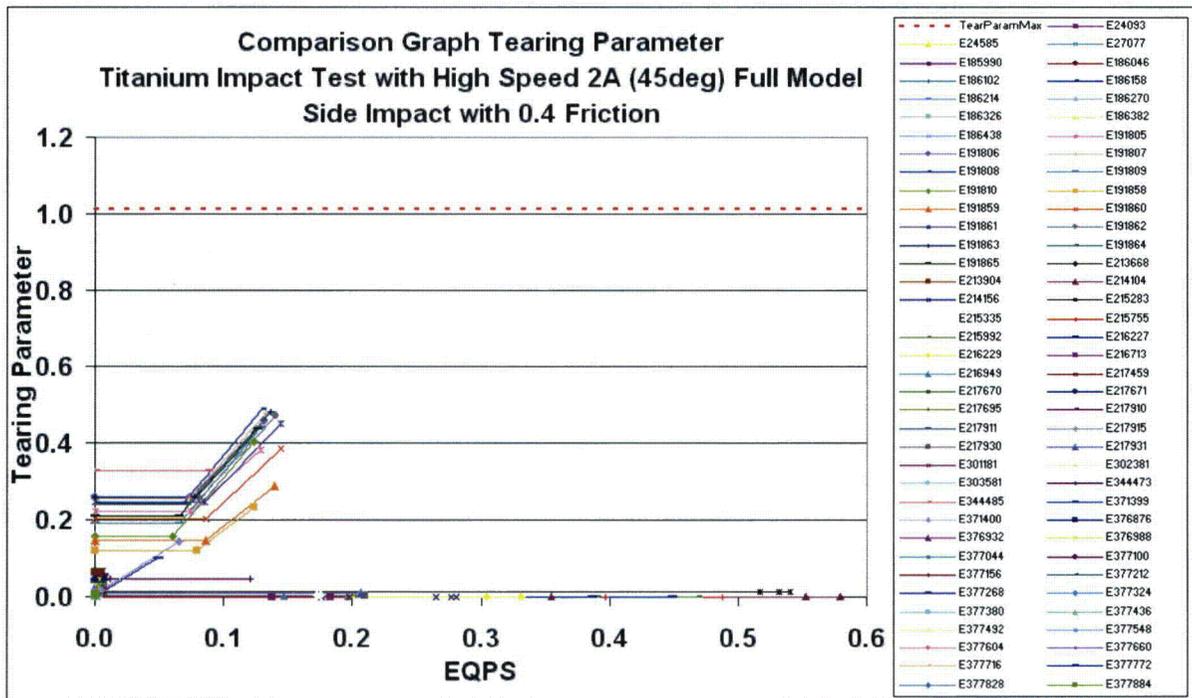
Figure 2-339. Graph of Tearing Parameter versus EQPS of Elements Exceeding the Experimental Strain Locus for the SC-2, Side Impact, 45° Support Structure, Friction 0.4

Parameter values for these same 73 elements are shown in Figure 2-339, and all are below the critical Tearing Parameter value of 1.012 for Ti-6Al-4V. These elements are highlighted in red in Figures 2-340, 2-341, and 2-342, but note that these elements are still below the initiation of a ductile tear and thus T-Ampoule integrity is maintained. The higher friction coefficients produced only slightly fewer elements exceeding the B-W strain locus, and essentially the same peak Tearing Parameter values (~0.5), indicating lower T-Ampoule “deformation” dependence on the friction coefficient at higher friction values.

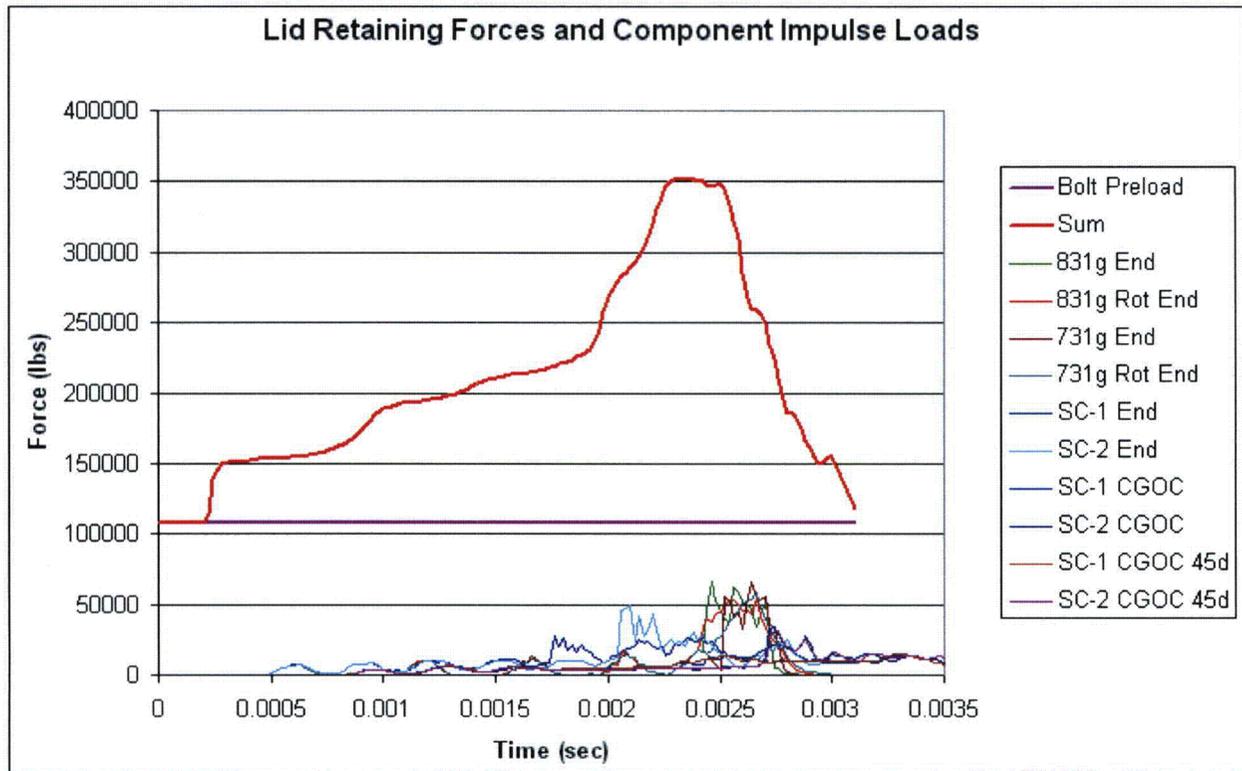
Figure 2-356. Summary Plot of Lid Retaining Forces and Component Impulse Loads

Analyses presented in the high velocity impact section have demonstrated that the PAT-1 package maintains its structural integrity under regulatory 422 ft/sec impacts. Bolt loads, as shown in Figure 2-356 comparing the sum of redwood compression and bolt preload against the under-lid forces from impacting solid metal contents, are minimal and thus lid closure is maintained. Through-thickness stresses in the primary containment vessel, the TB-1, are shown to be below yield values for the S13800 high strength stainless steel material (see Section 2.12.4.9). Only localized minor "denting" occurs in the TB-1, and it would be invisible to the naked eye. And deformations in the T-Ampoule eutectic barrier are shown to be below levels that could initiate a ductile tear, and are largely within the tested locus of stress-triaxiality and plastic strain that precludes failure. Many of the elements with the highest Tearing Parameter values are plotted in stress-triaxiality versus EQPS space in Figure 2-357, demonstrating how close they are to the tested locus, which is not a failure boundary: it is a tested locus of non-failure.

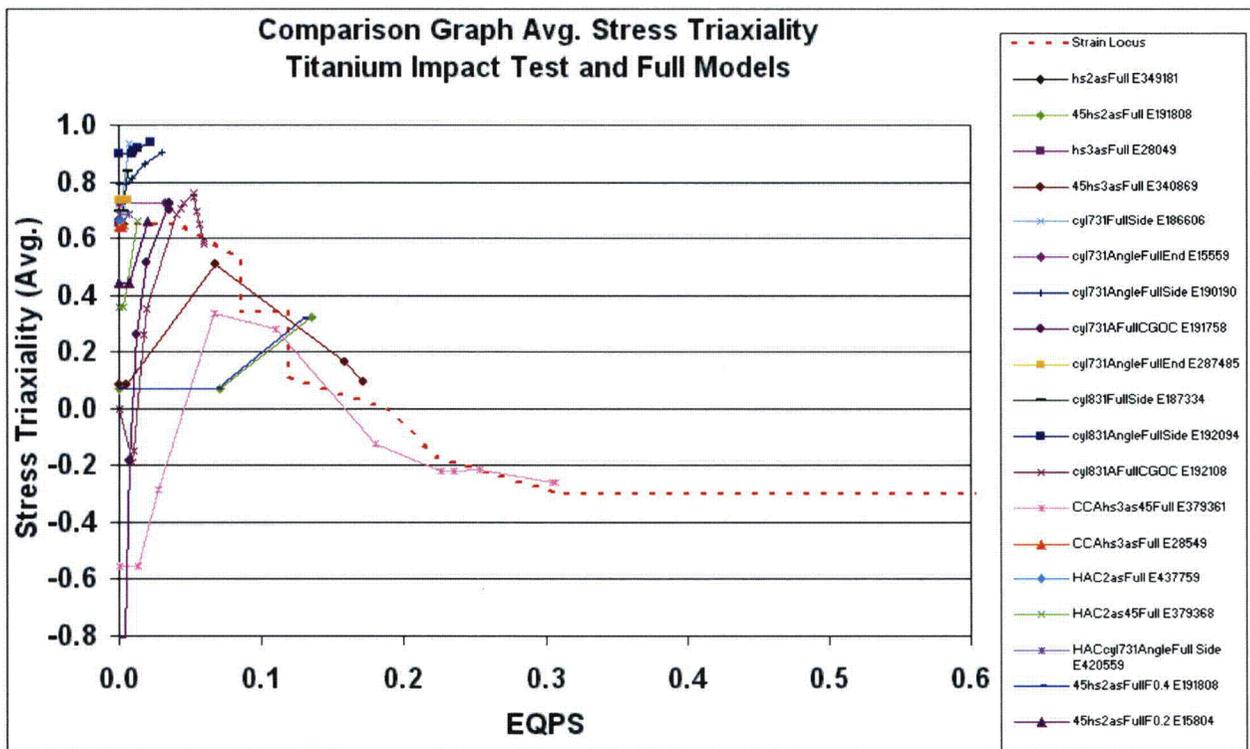
Figure 2-357. Summary Plot of Plastic Stress Triaxiality for Selected Runs

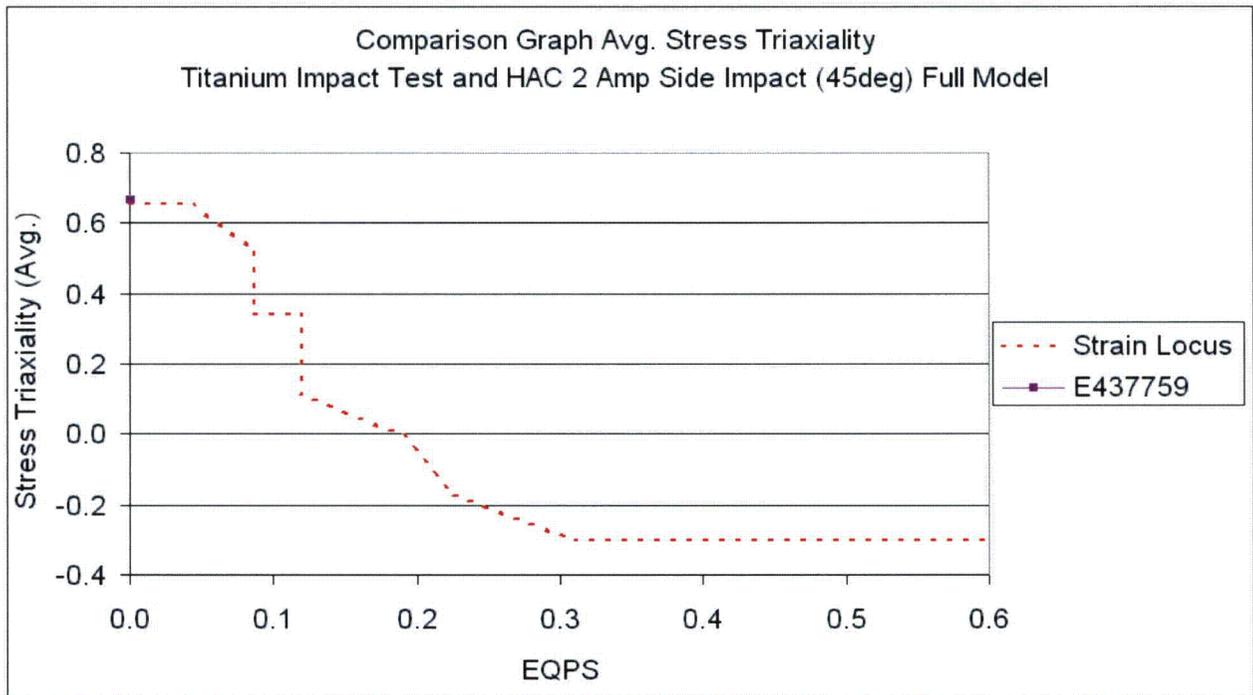
Figure 2-367. Graph of Average Stress Triaxiality versus EQPS for Element Exceeding Experimental Strain Locus for HAC Run 2, SC-2, Side Impact, Support Structure 0°
