**GEOLOGY OF THE SOUTH RAMP - STATION 55+00 TO 78+77,
EXPLORATORY STUDIES FACILITY, YUCCA MOUNTAIN PROJECT,
YUCCA MOUNTAIN, NEVADA**

**by G.L.W. Eatman, W.L. Singleton, T.C. Moyer, D.L. Barr, A.L. Albin,
R.C. Lung, and S.C. Beason**

Bureau of Reclamation and U.S. Geological Survey

**Denver, Colorado
1997**

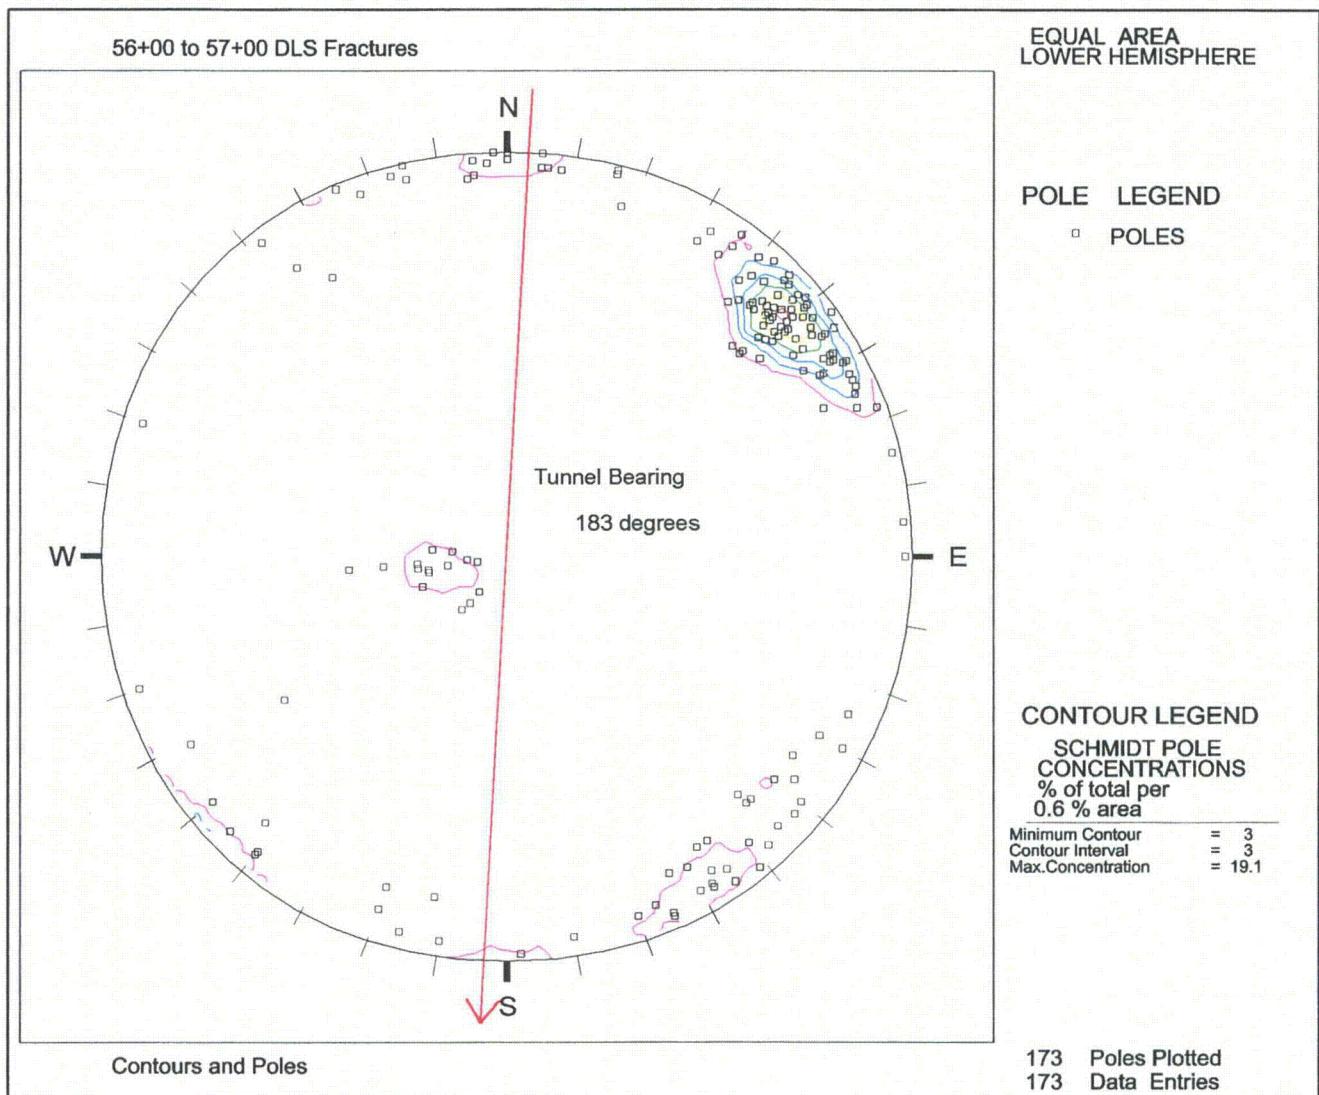
Figure 6: Stereonet plot of contours, poles, and Main Drift tunnel bearing of 183 degrees. This represents DLS fractures collected between Sta. 56+00 and 57+00, as an example of the bias in the Main Drift against the collection of fractures with strike azimuths parallel or subparallel to 183 degrees. Consequently few poles are plotted on the East or West of the stereonet.

easily dismissed. DLS's show that there is a trend for fractures with strike azimuths that are parallel or subparallel to the tunnel bearing to be under represented in any given section of tunnel. This trend can be easily seen by examining stereonet plots and scatter plots of strike azimuth vs. stationing (of DLS fractures). The trend, or bias, is present only for fractures recorded on the DLS, and does not affect fractures mapped on the FPGMs.

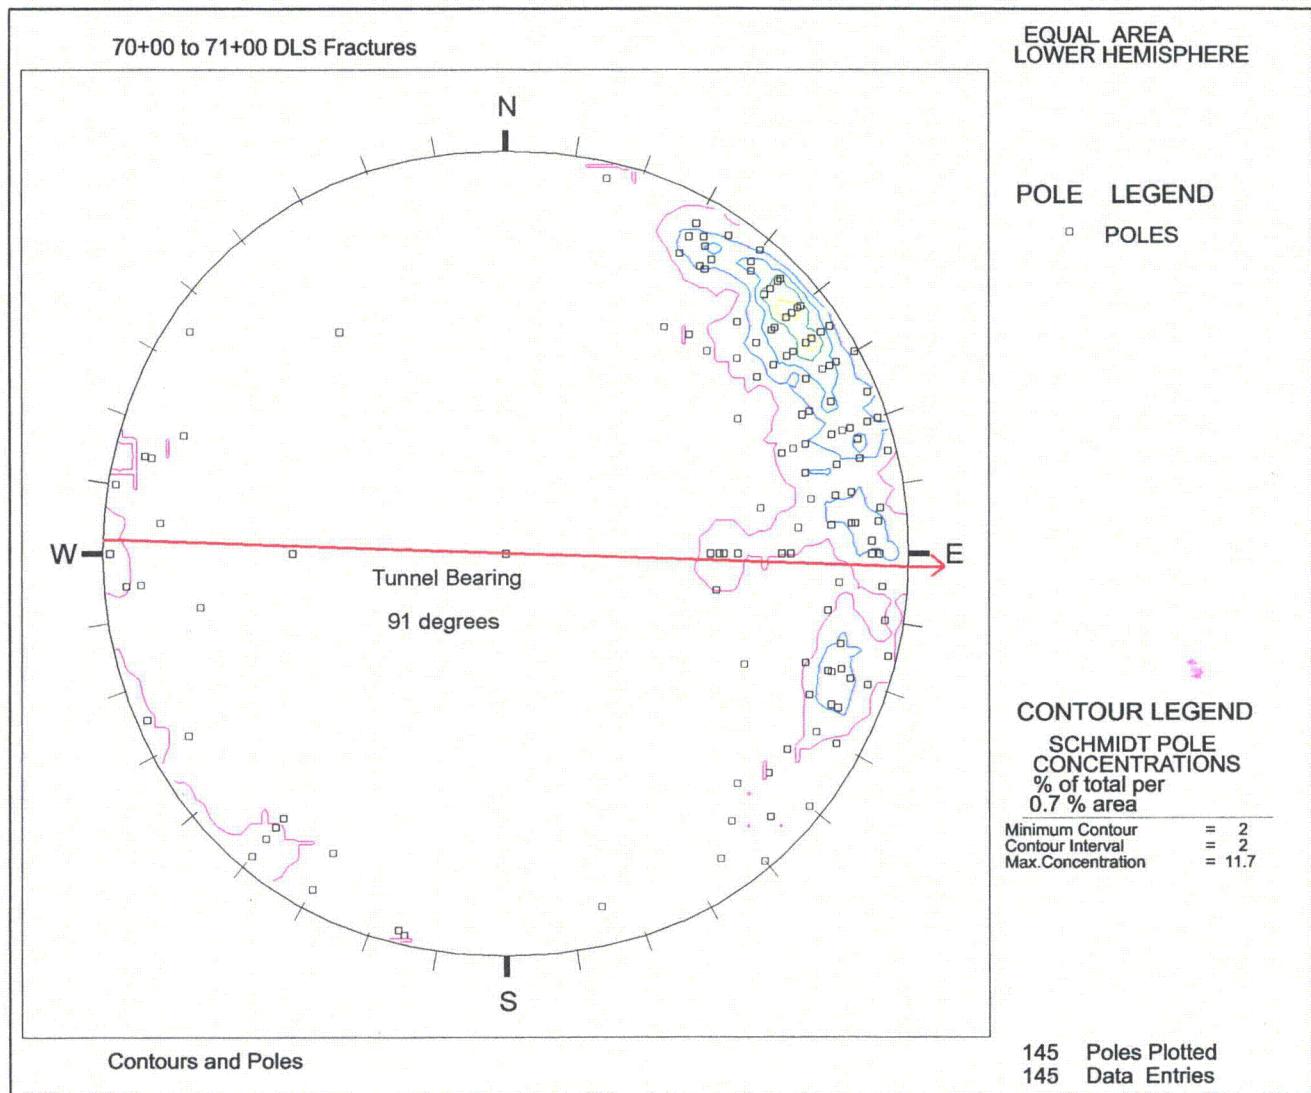
Figure 7: Stereonet plot of contours, poles, and South Ramp tunnel bearing of 91 degrees. This represents DLS fractures collected between Sta. 70+00 and 71+00, as an example of the bias in the South Ramp against the collection of fractures with strike azimuths parallel or subparallel to 91 degrees. Consequently few poles are plotted on the North or South of the stereonet.

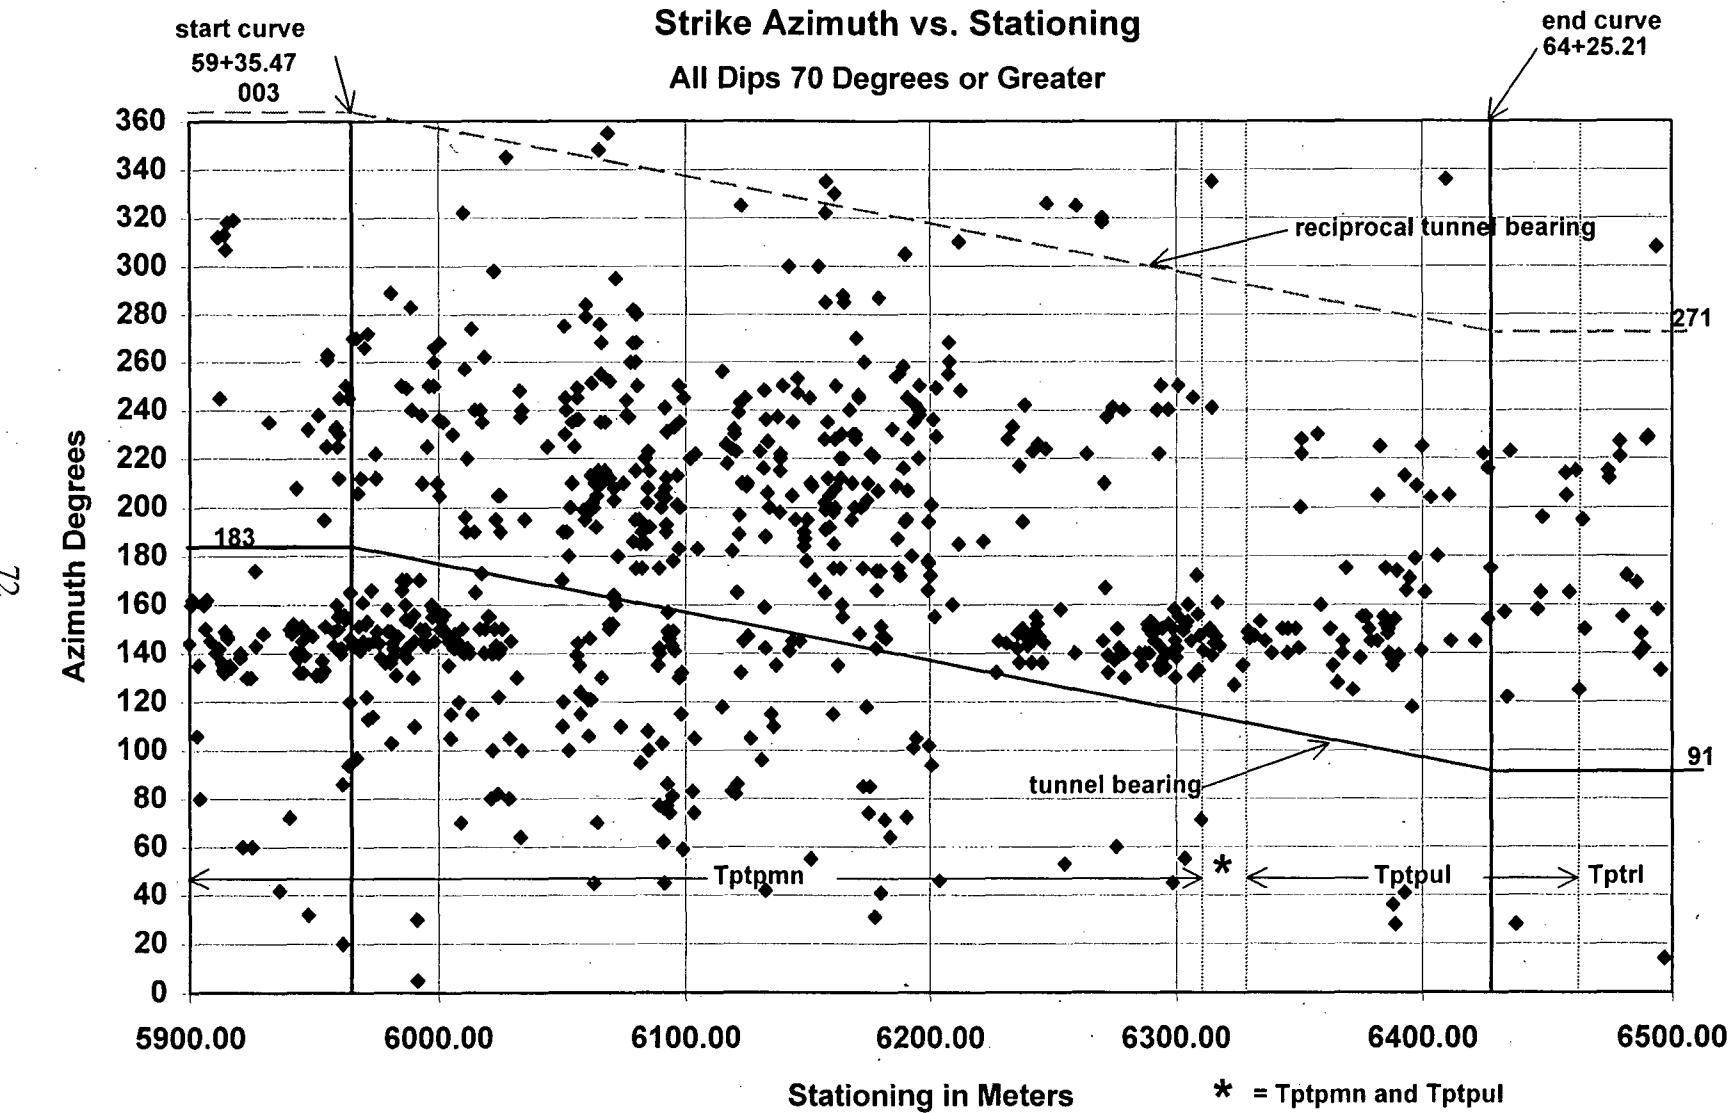
Figure 8: Scatter plot of strike azimuth vs. stationing. DLS fractures collected from Sta. 59+00 to 65+00 excluding those with dips less than 70°. Tunnel bearing is plotted, illustrating the "blind zone".

As illustrated on Fig. 8, fractures approaching 091° can be found up to approximate Sta. 62+00, which is near the midpoint of the curve. After Sta. 62+00, fractures approaching 091° are absent. From the last half of the curve and beyond, the tunnel orientation is biased against fractures near 091° azimuth. The reciprocal tunnel bearing is also plotted on Fig. 8, showing only a few fractures plotted anywhere near the reciprocal bearing. The few that come near this bearing are reciprocals of the dominant fracture set (130° - 160°).

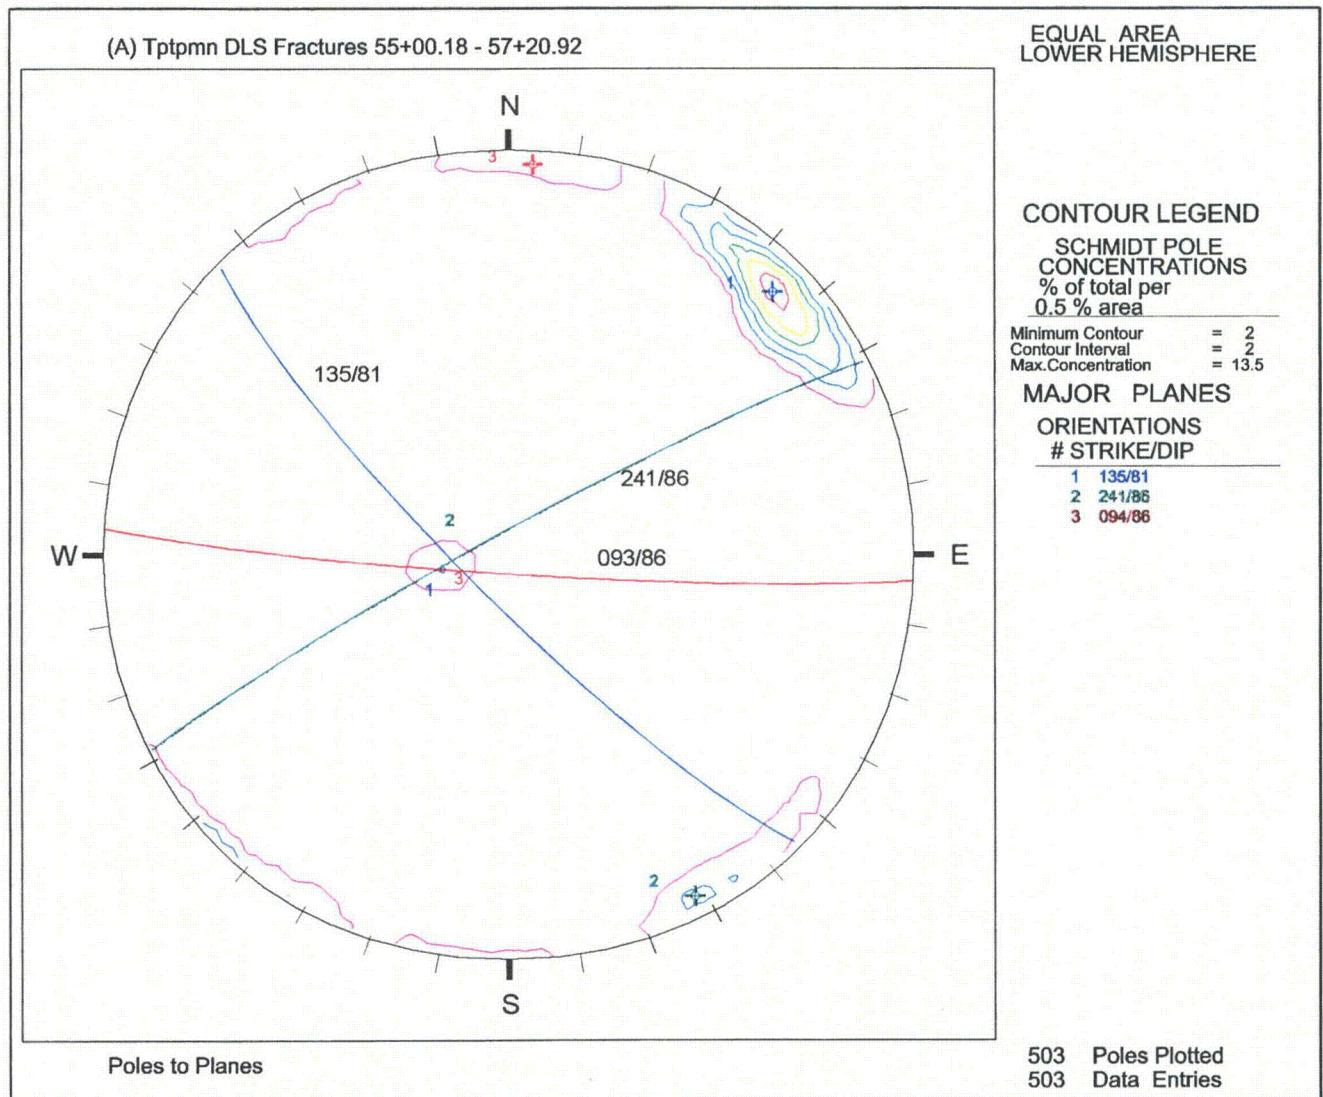
Figure 9: Stereonet A. Contour plot of DLS fractures in the first of three Tptpmn intervals. This section from Sta. 55+00 to 57+20.92 is located in the Main Drift of the ESF (bearing 183 degrees).

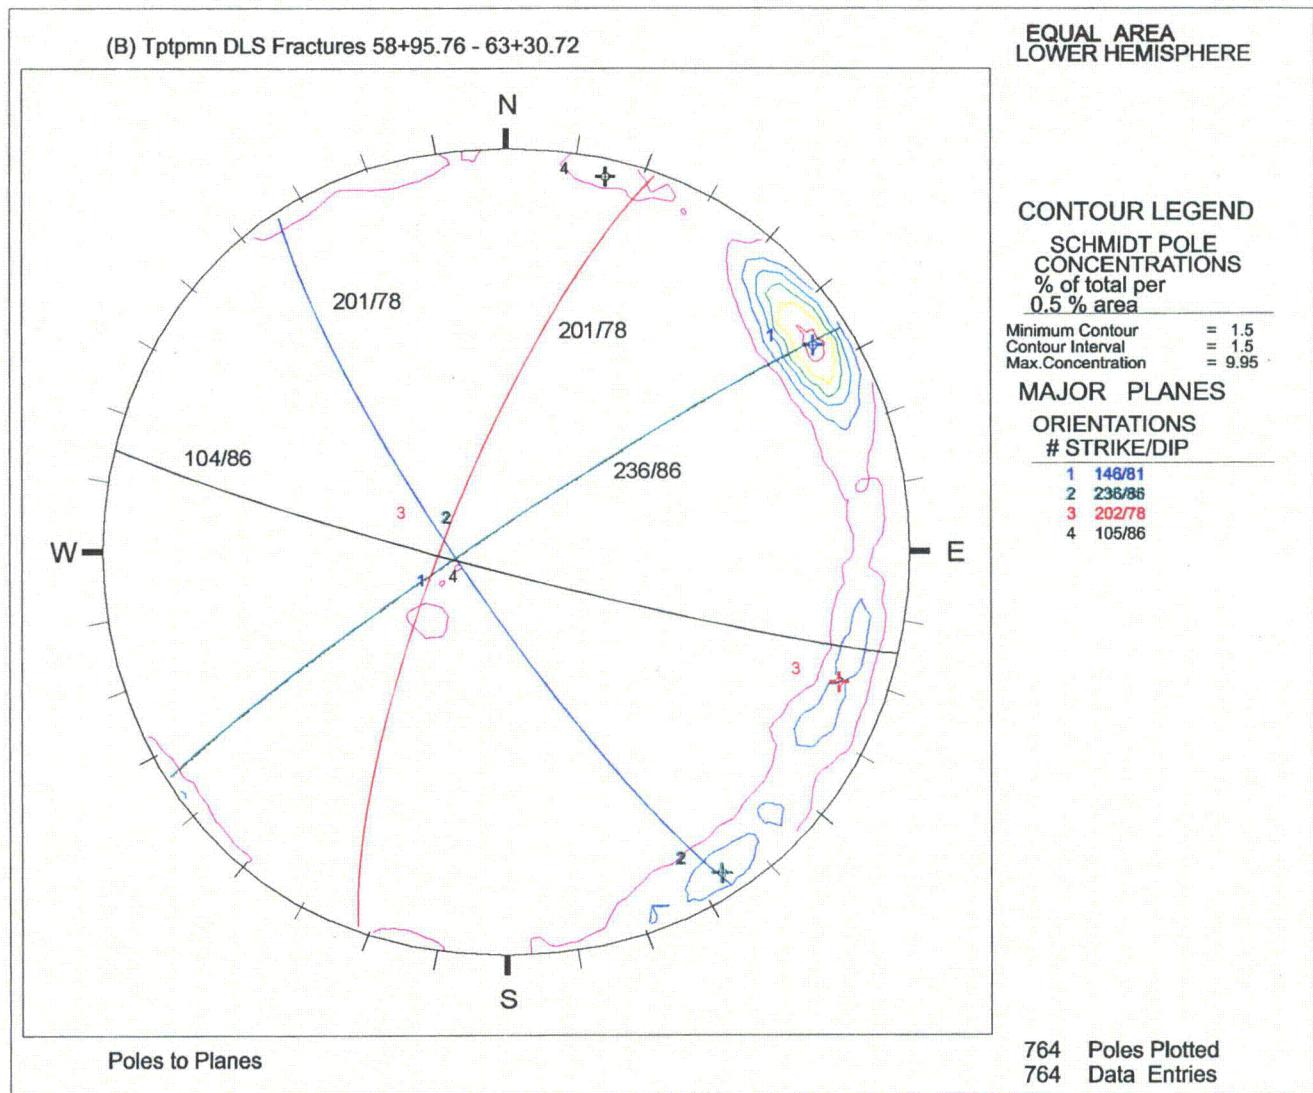
Figure 10: Stereonet B. Contour plot of DLS fractures in the second of three Tptpmn intervals. This section from Sta. 58+95.76 to 63+30.72 is located partly in the Main Drift (bearing 183 degrees) and mostly in the curved section.

The new concentration of poles seen in Stereonet B can also be seen when comparing the 100 meter stereonets (refer to Drawings OA-46-257 through -282, and OA-46-293 through -294). This concentration (201°) is either a distinct fracture set, or a shift of the set represented by poles in the 230° - 245° range. The stereonets for Sta. 60+00-61+00 and Sta. 61+00-62+00 each have a

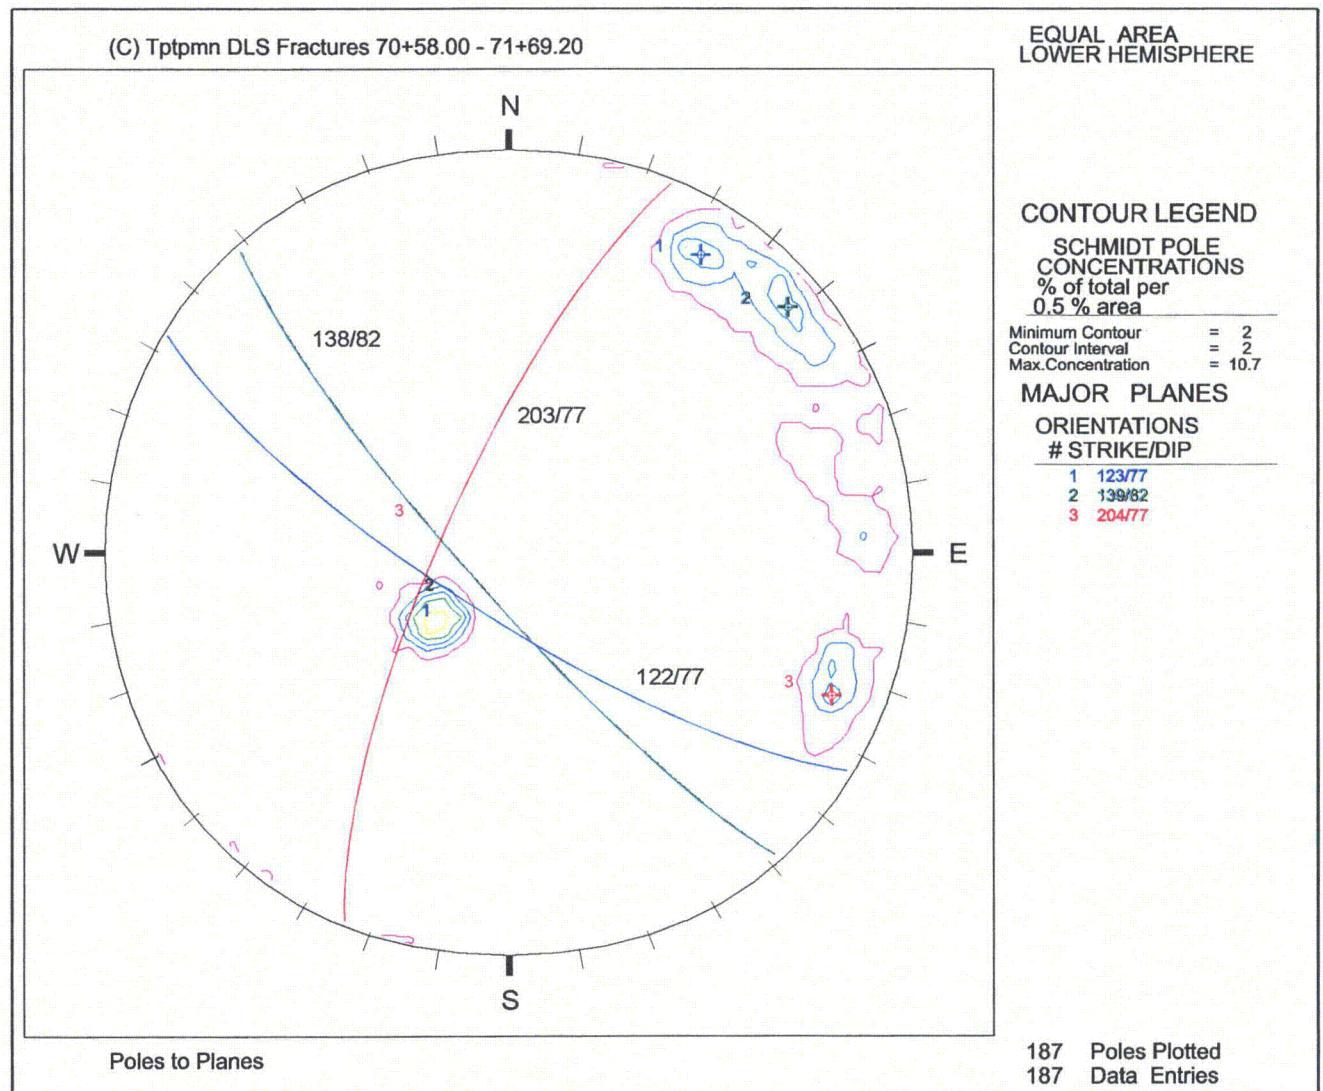
Figure 11: Stereonet C. Contour plot of DLS fractures in the third of three Tptpmn intervals. This section from Sta. 70+58 to 71+69.20 is located in the South Ramp (bearing 91 degrees).

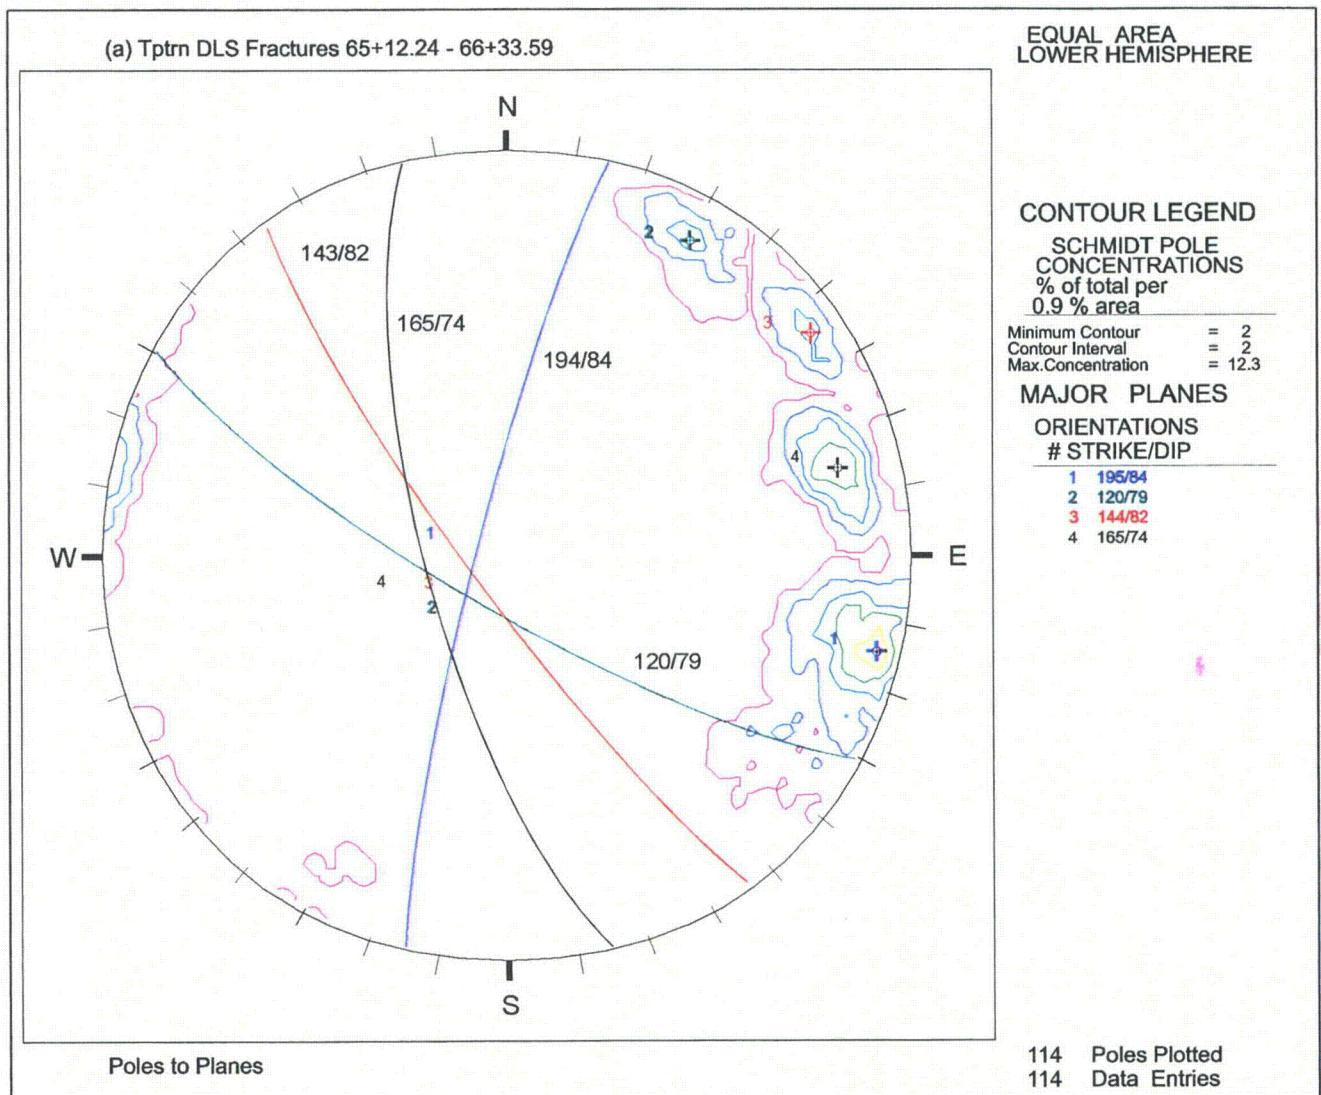
Figure 12: Stereonet a. Contour plot of DLS fractures in the first of three Tptrn intervals in the South Ramp.

The dominant set falls in the azimuth range 180° - 210° . In Stereonet a the peak concentration is at 194° , in b the peak is 203° , and in c the peak is 198° , indicating minor shifts.

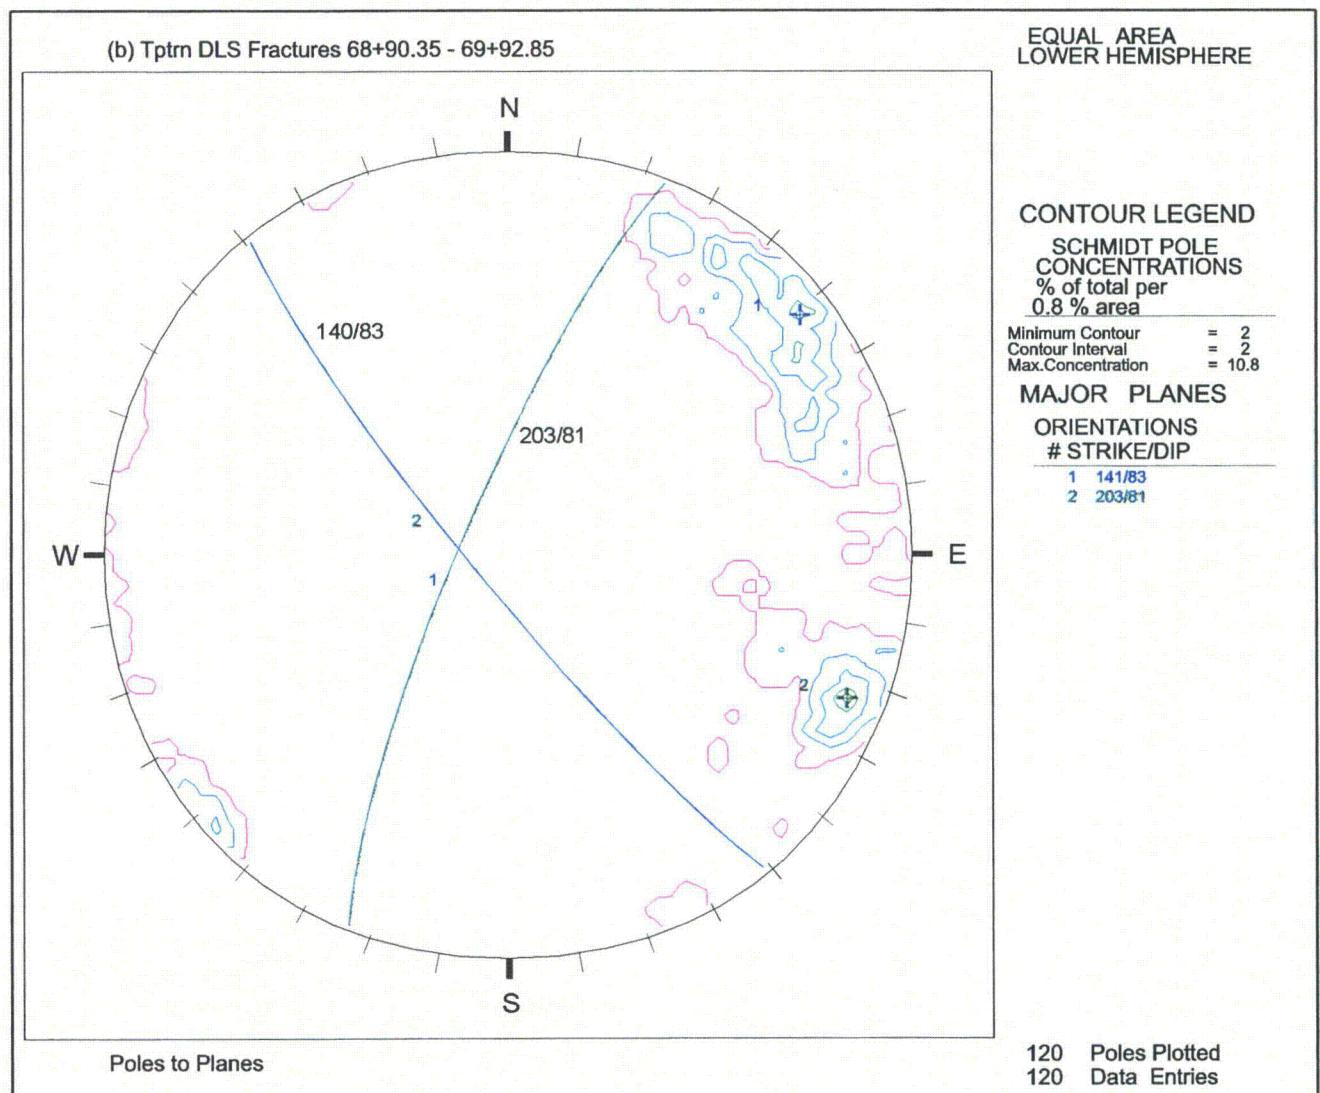
Figure 13: Stereonet b. Contour plot of DLS fractures in the second of three Tptrn intervals in the South Ramp.

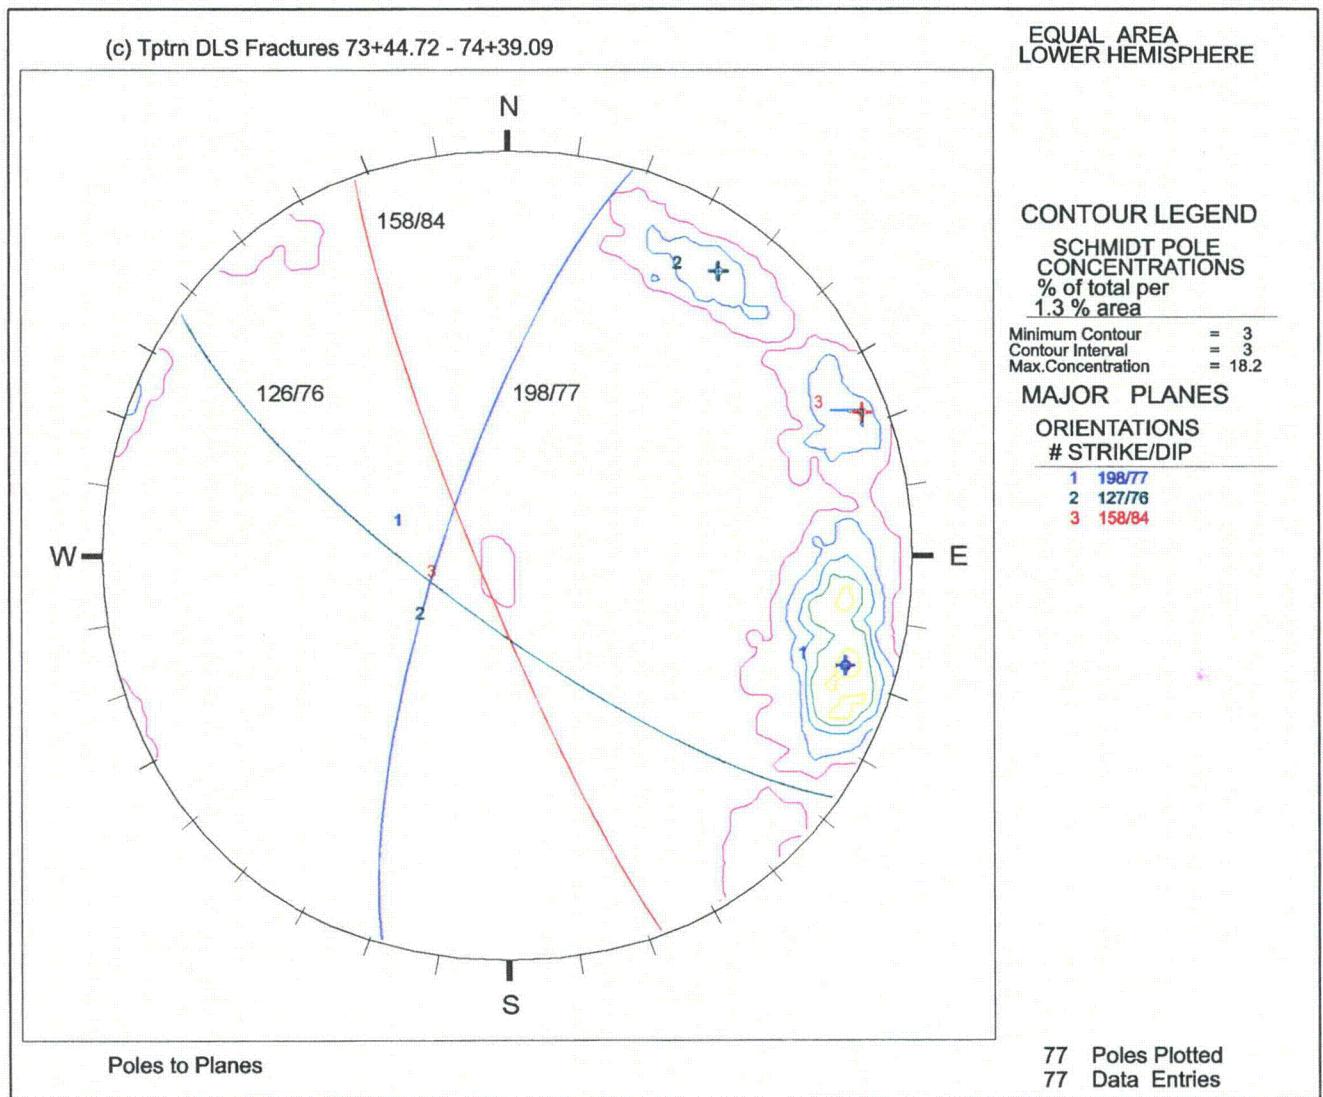
Figure 14: Stereonet c. Contour plot of DLS fractures in the third of three Tptrn intervals in the South Ramp.

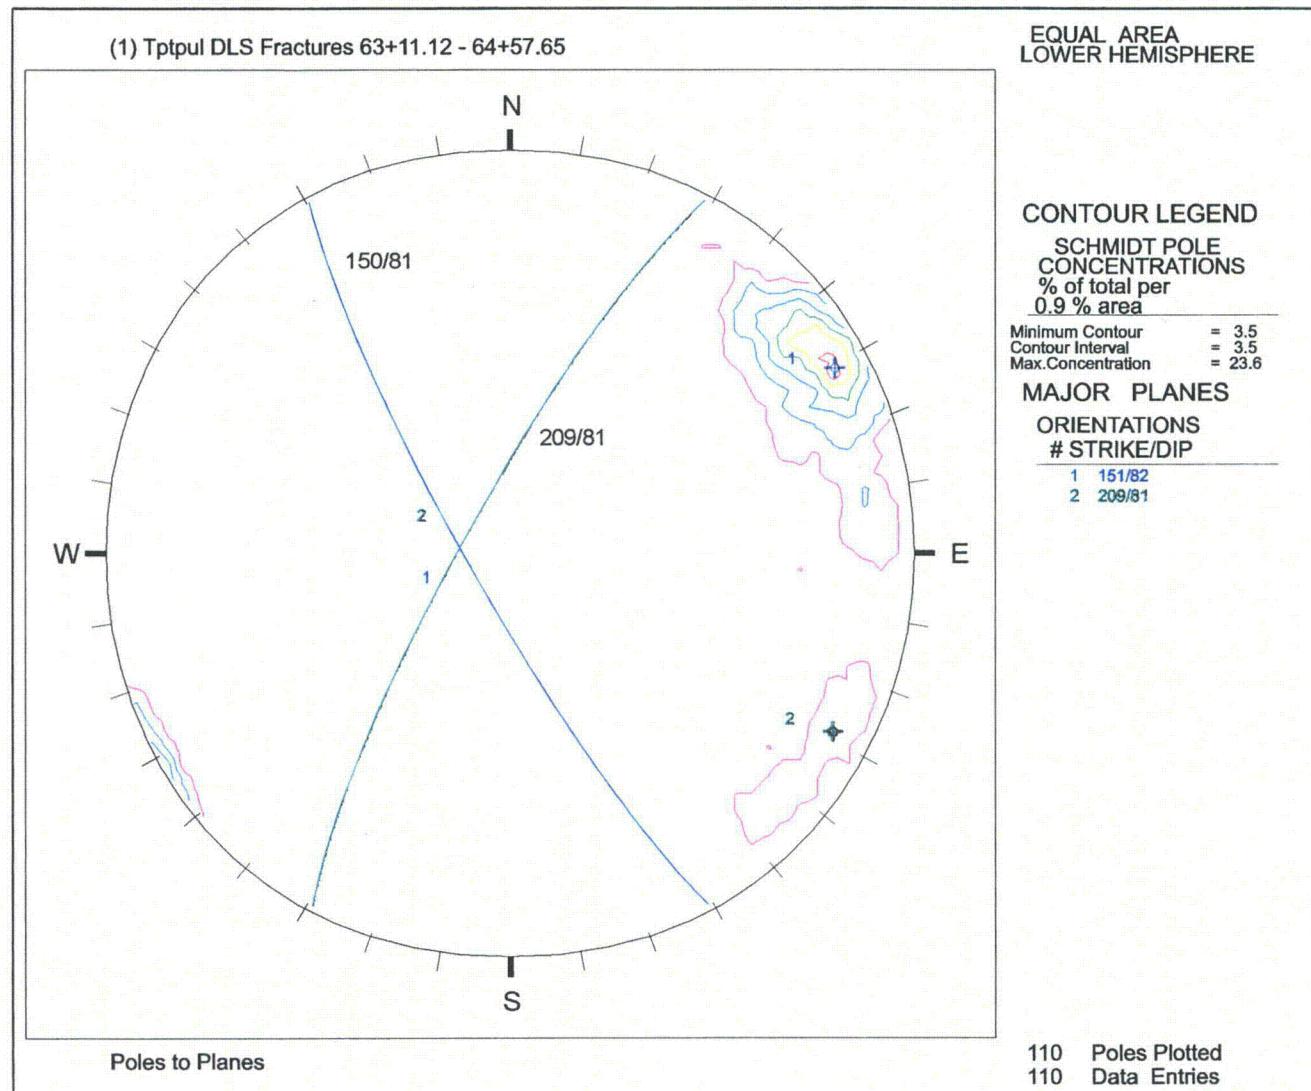
Figure 15: Stereonet 1. Contour plot of DLS fractures in the first of two composite intervals of Tptpul. This composite interval combines the section from Sta. 63+11.12 to 63+18.50 (within the curve) with the section from Sta. 63+32.18 to 64+57.65 (partly in the curve, and partly in the South Ramp - bearing 91 degrees).

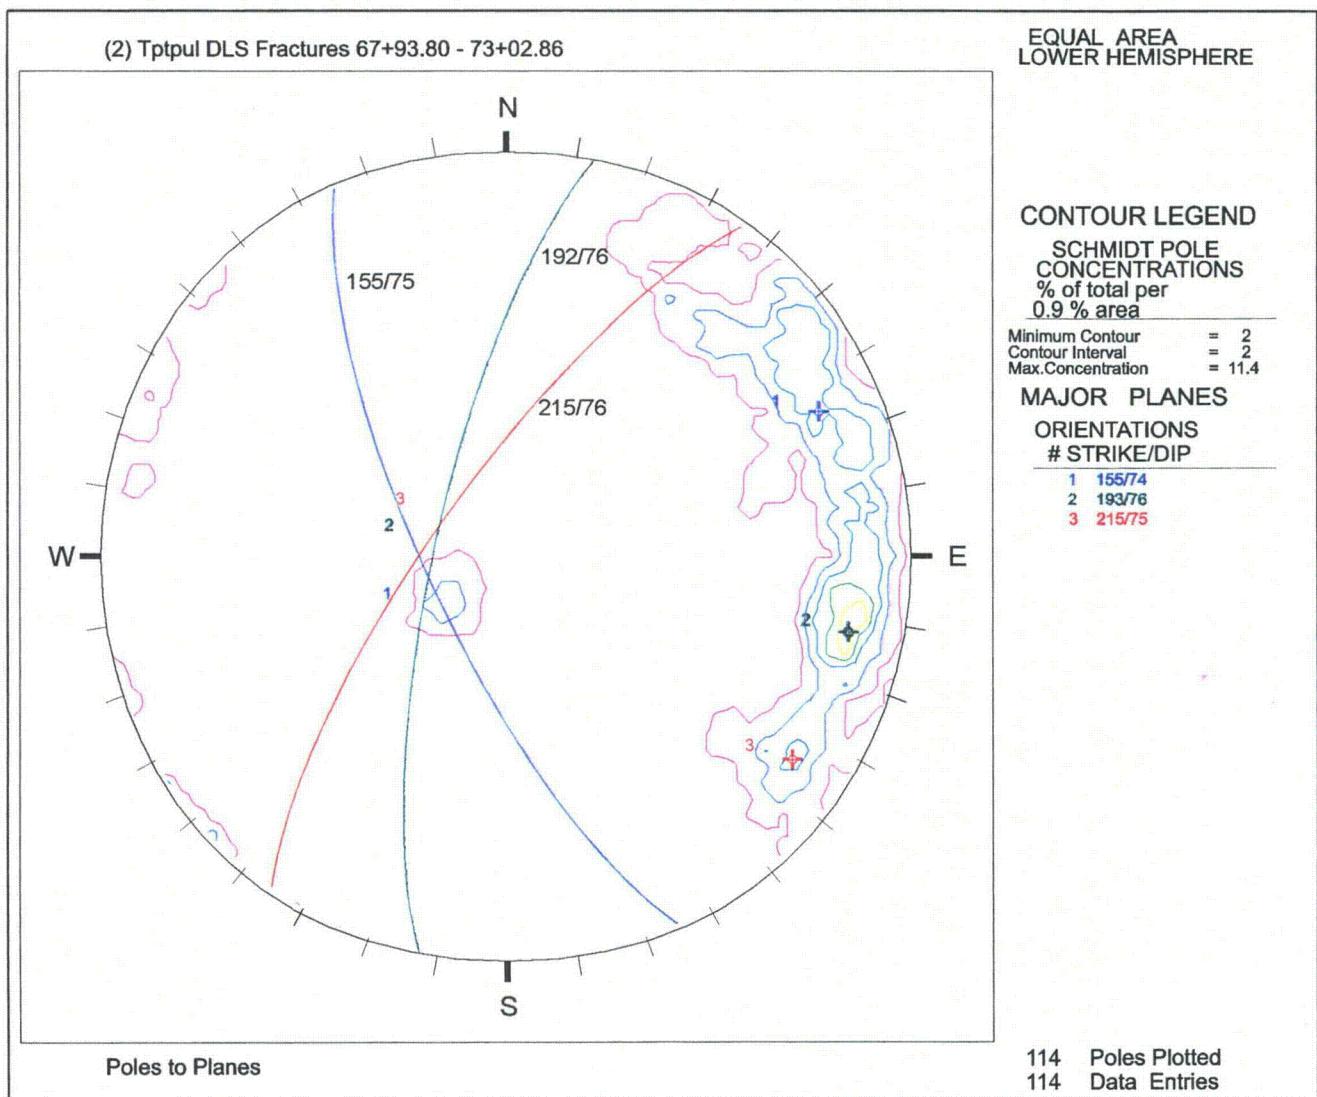
Figure 16: Stereonet 2 Contour plot of DLS fractures in the second of two composite intervals of Tptpul. This composite interval combines the section from Sta. 67+93.80 to 68+47.38 with the section from Sta. 71+70.29 to 73+02.86 (both sections in the South Ramp - bearing 92 degrees).

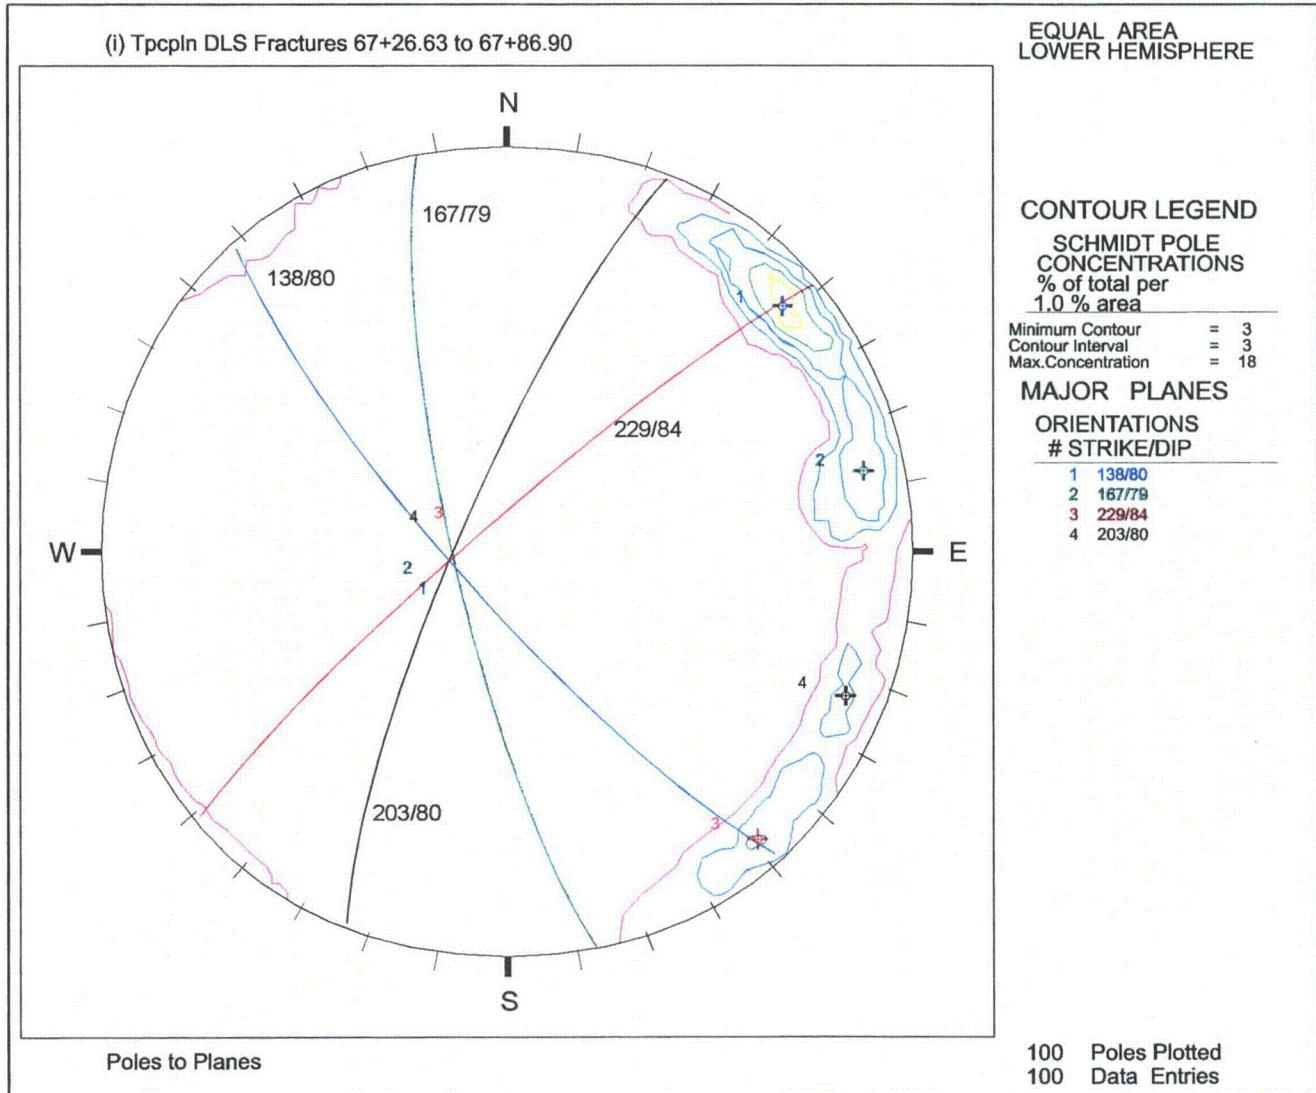
Figure 17: Stereonet i. Contour plot of DLS fractures in the first of two intervals of Tpcpln in the South Ramp. This section is from Sta. 67+26.63 to 67+86.90.

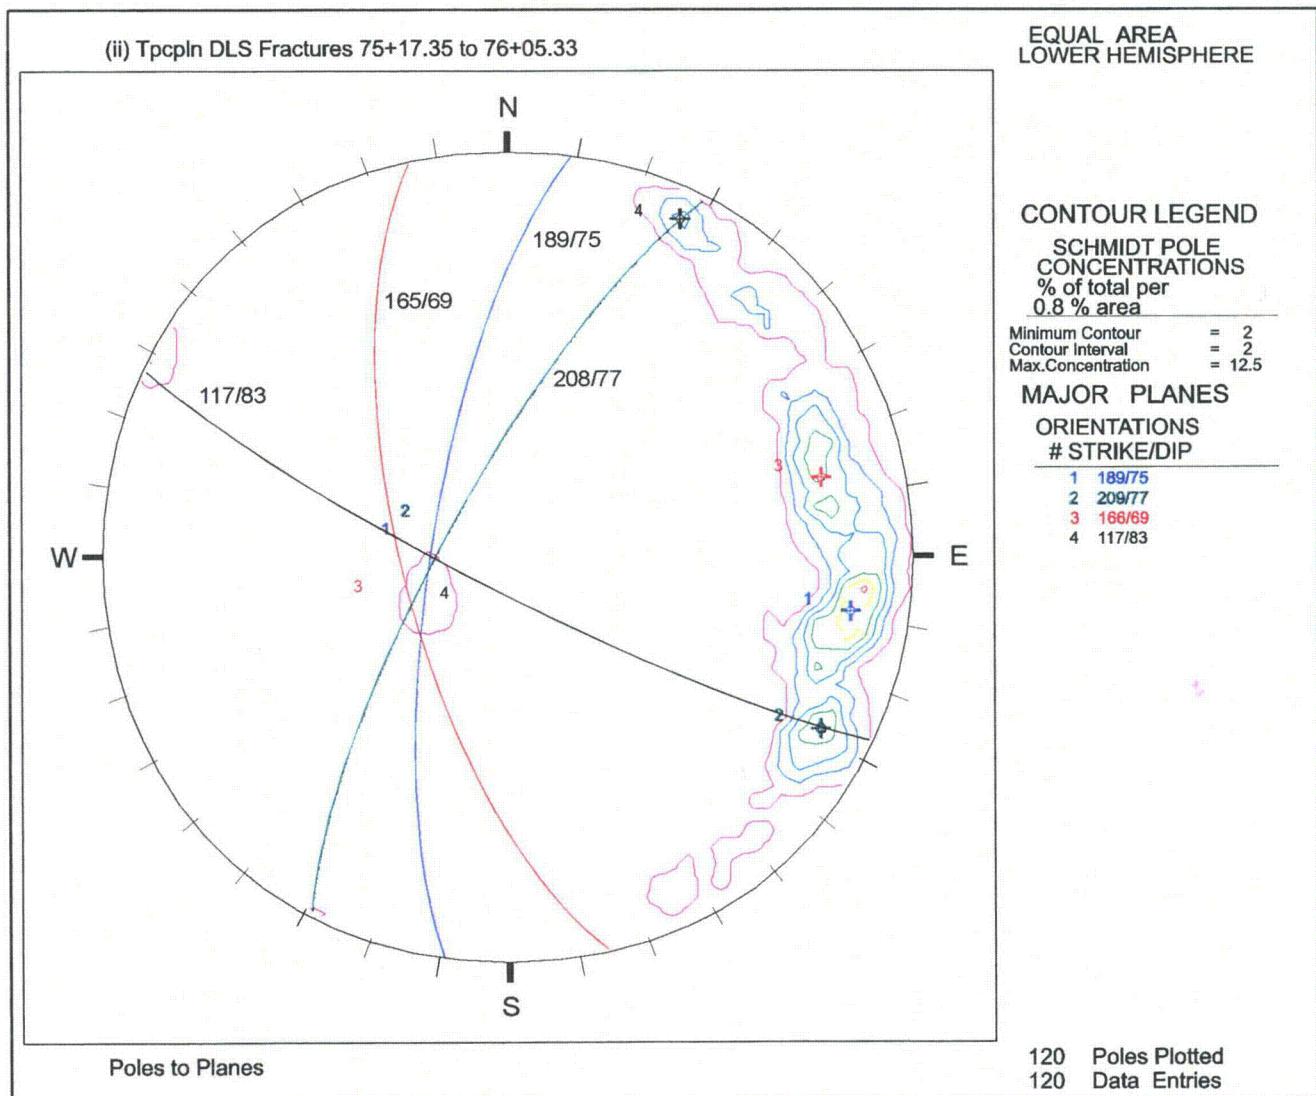
Figure 18: Stereonet ii. Contour plot of DLS fractures in the second of two intervals of Tpcpln in the South Ramp. This section is from Sta. 75+17.35 to 76+05.33.

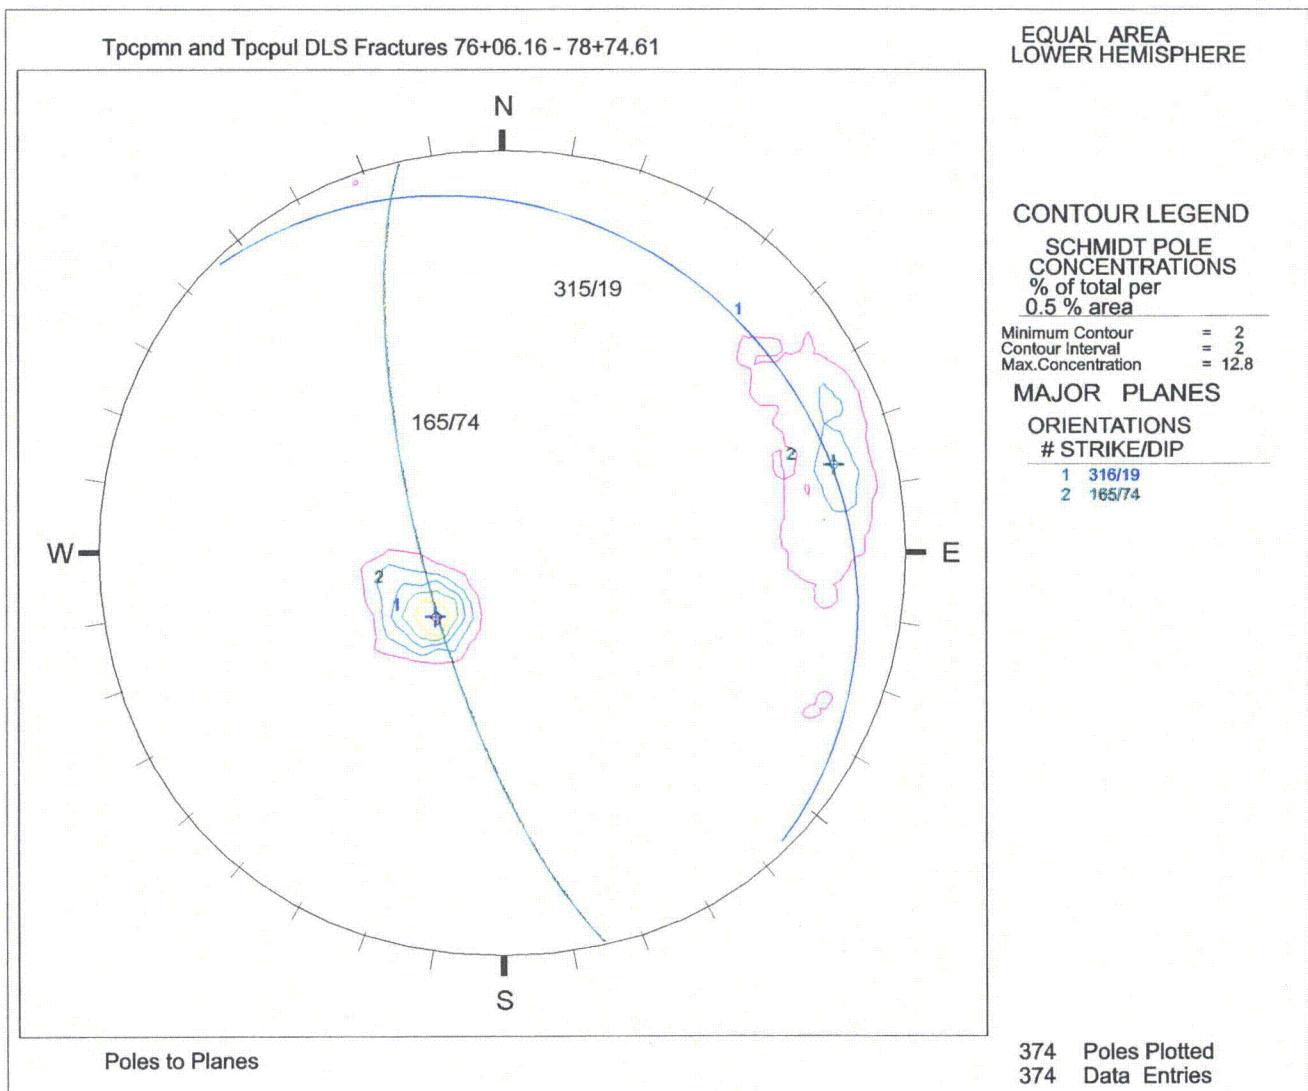
Figure 19: Stereonet Contour plot of DLS fractures from Sta. 76+06.16 to the end of the South Ramp at Sta. 78+77. The lithology of this interval is mostly Tpcpmn, with some Tpcpul.
