**GEOLOGY OF THE SOUTH RAMP - STATION 55+00 TO 78+77,
EXPLORATORY STUDIES FACILITY, YUCCA MOUNTAIN PROJECT,
YUCCA MOUNTAIN, NEVADA**

**by G.L.W. Eatman, W.L. Singleton, T.C. Moyer, D.L. Barr, A.L. Albin,
R.C. Lung, and S.C. Beason**

Bureau of Reclamation and U.S. Geological Survey

**Denver, Colorado
1997**

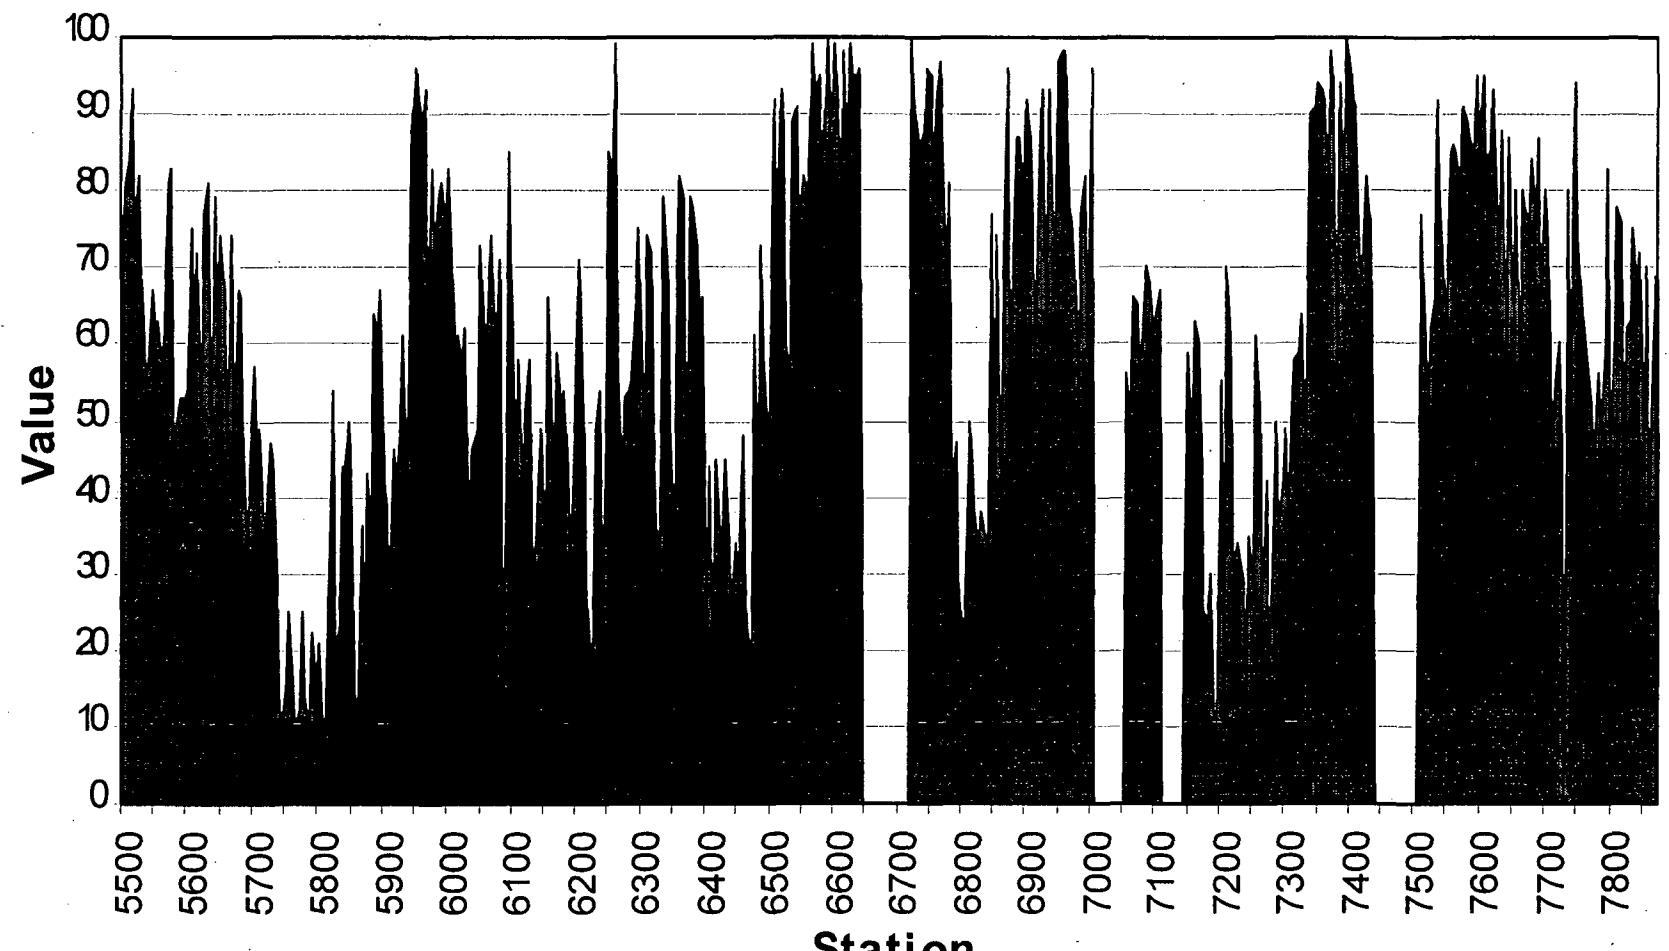
Figure 20: South Ramp RQD

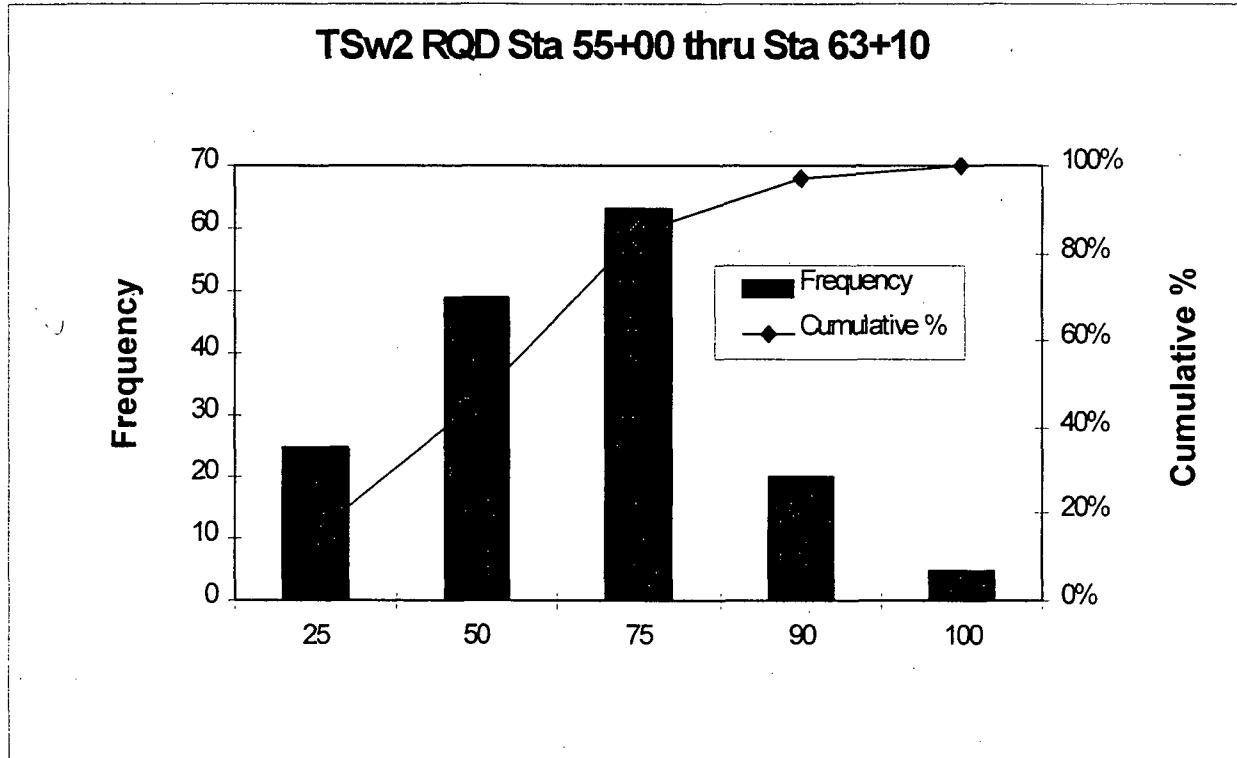
Figure 21a: Distribution of RQD in TSw2 (Sta 55+00 - 63+10)

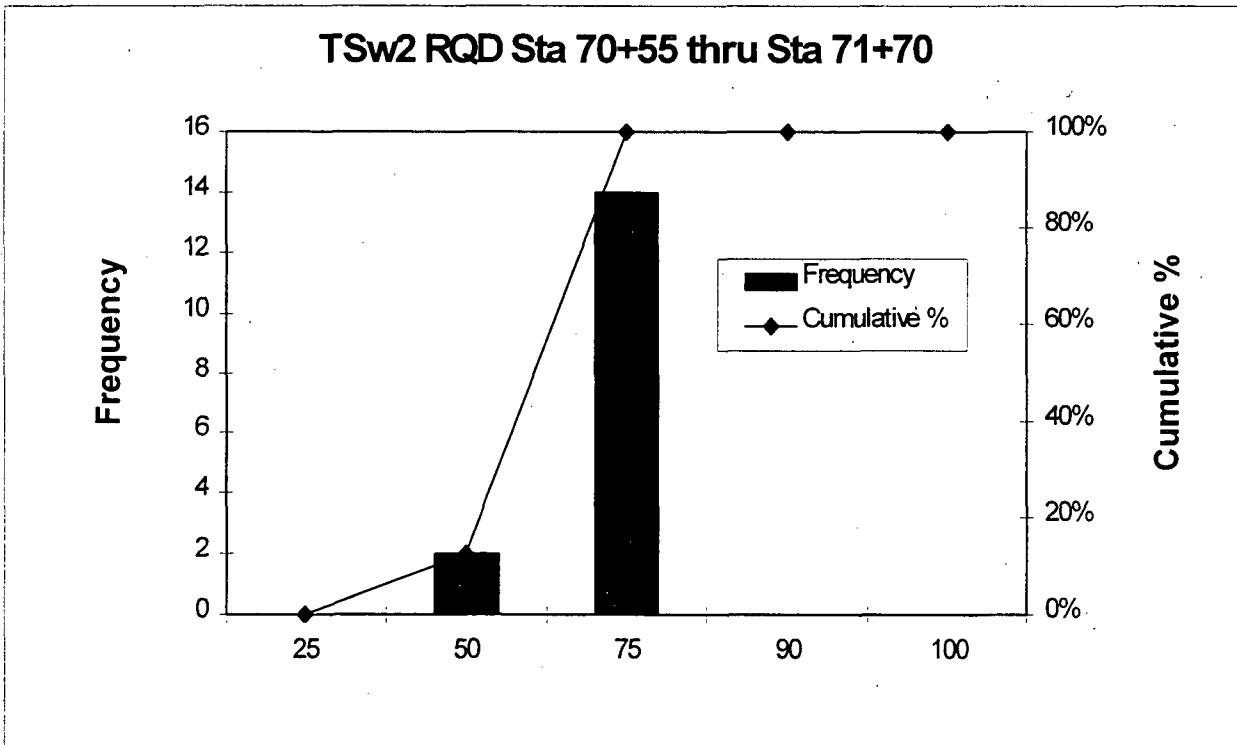
Figure 21b: Distribution of RQD in TSw2 (Sta 70+55 - 71+70)

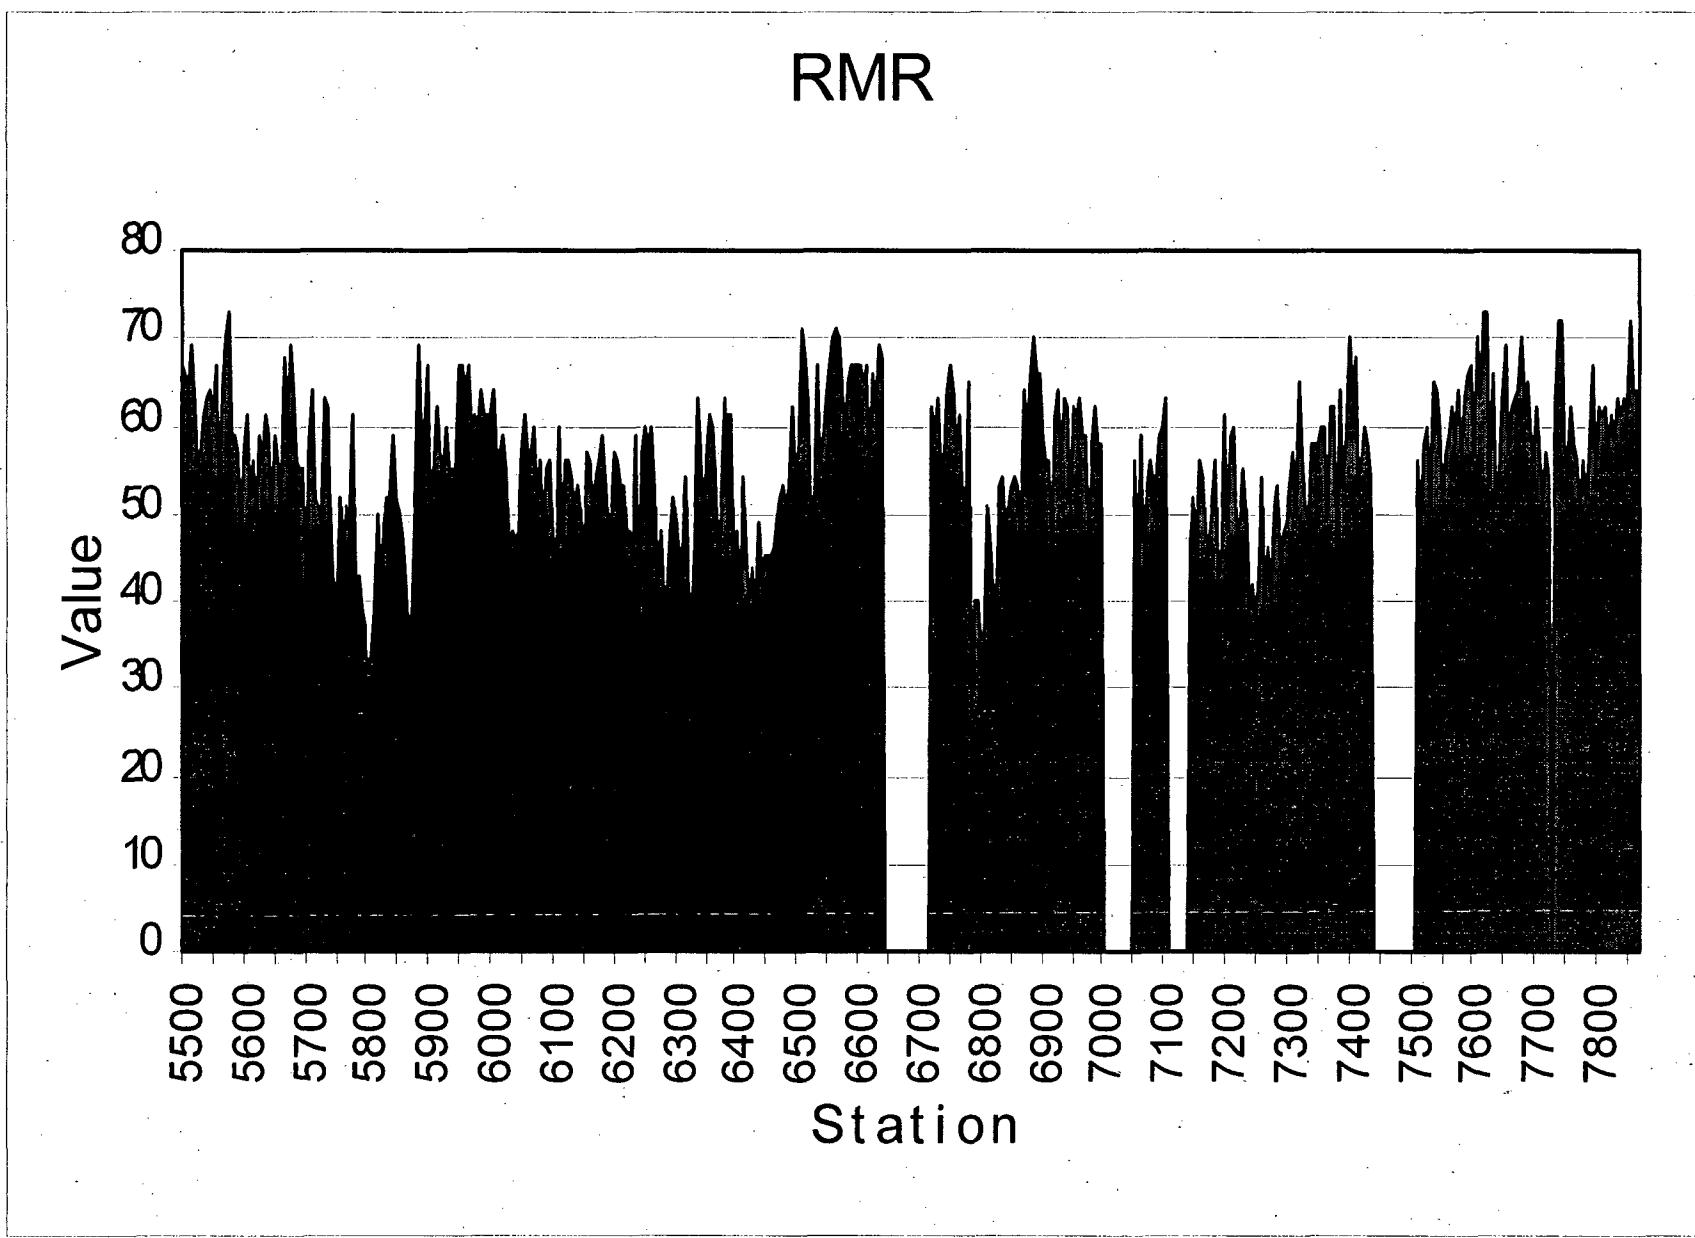
Figure 25: South Ramp RMR

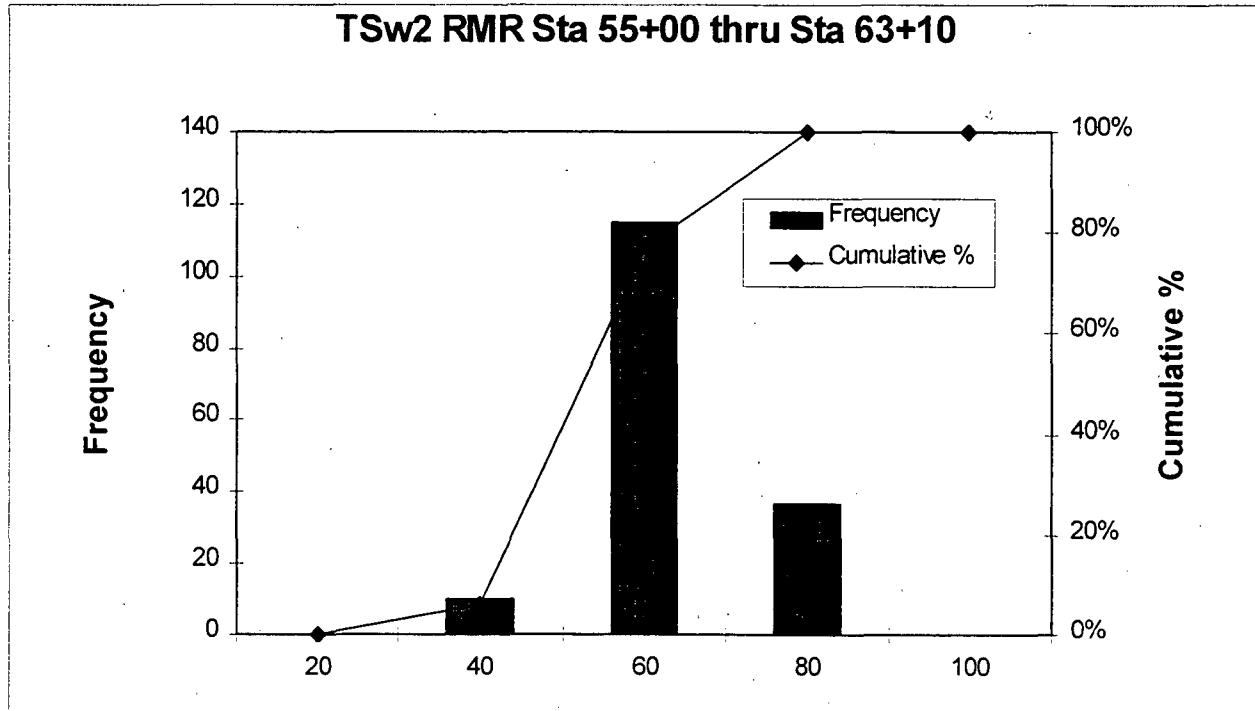
Figure 26a: Distribution of RMR in TSw2 (Sta 55+00 - 63+10)

Figures 26 through 29 depict the distribution of RMR ratings for each of the four thermal-mechanical units in the South Ramp.

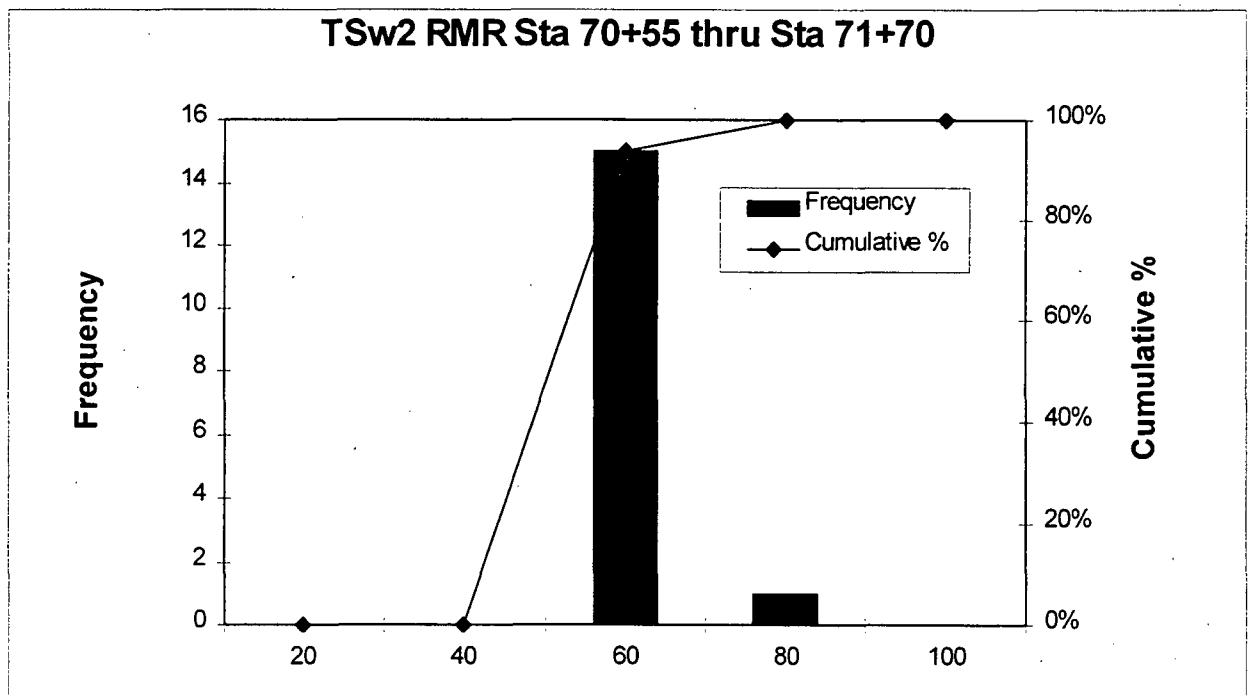
Figure 26b: Distribution of RMR in TSw2 (Sta 70+55 - 71+70)

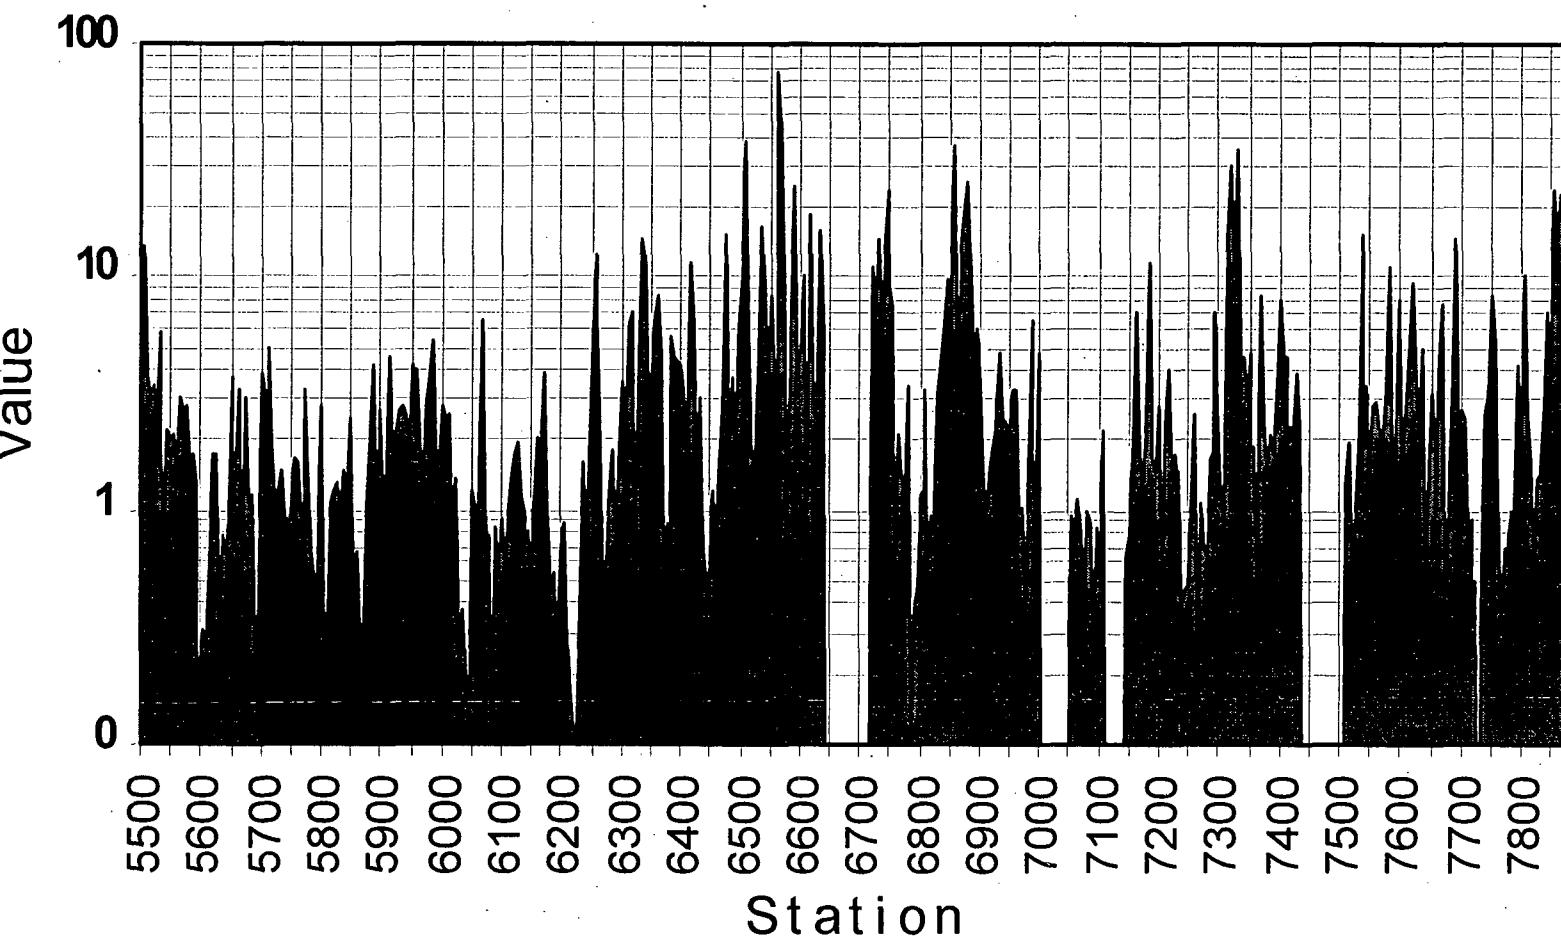
Figure 30: South Ramp Rated Q

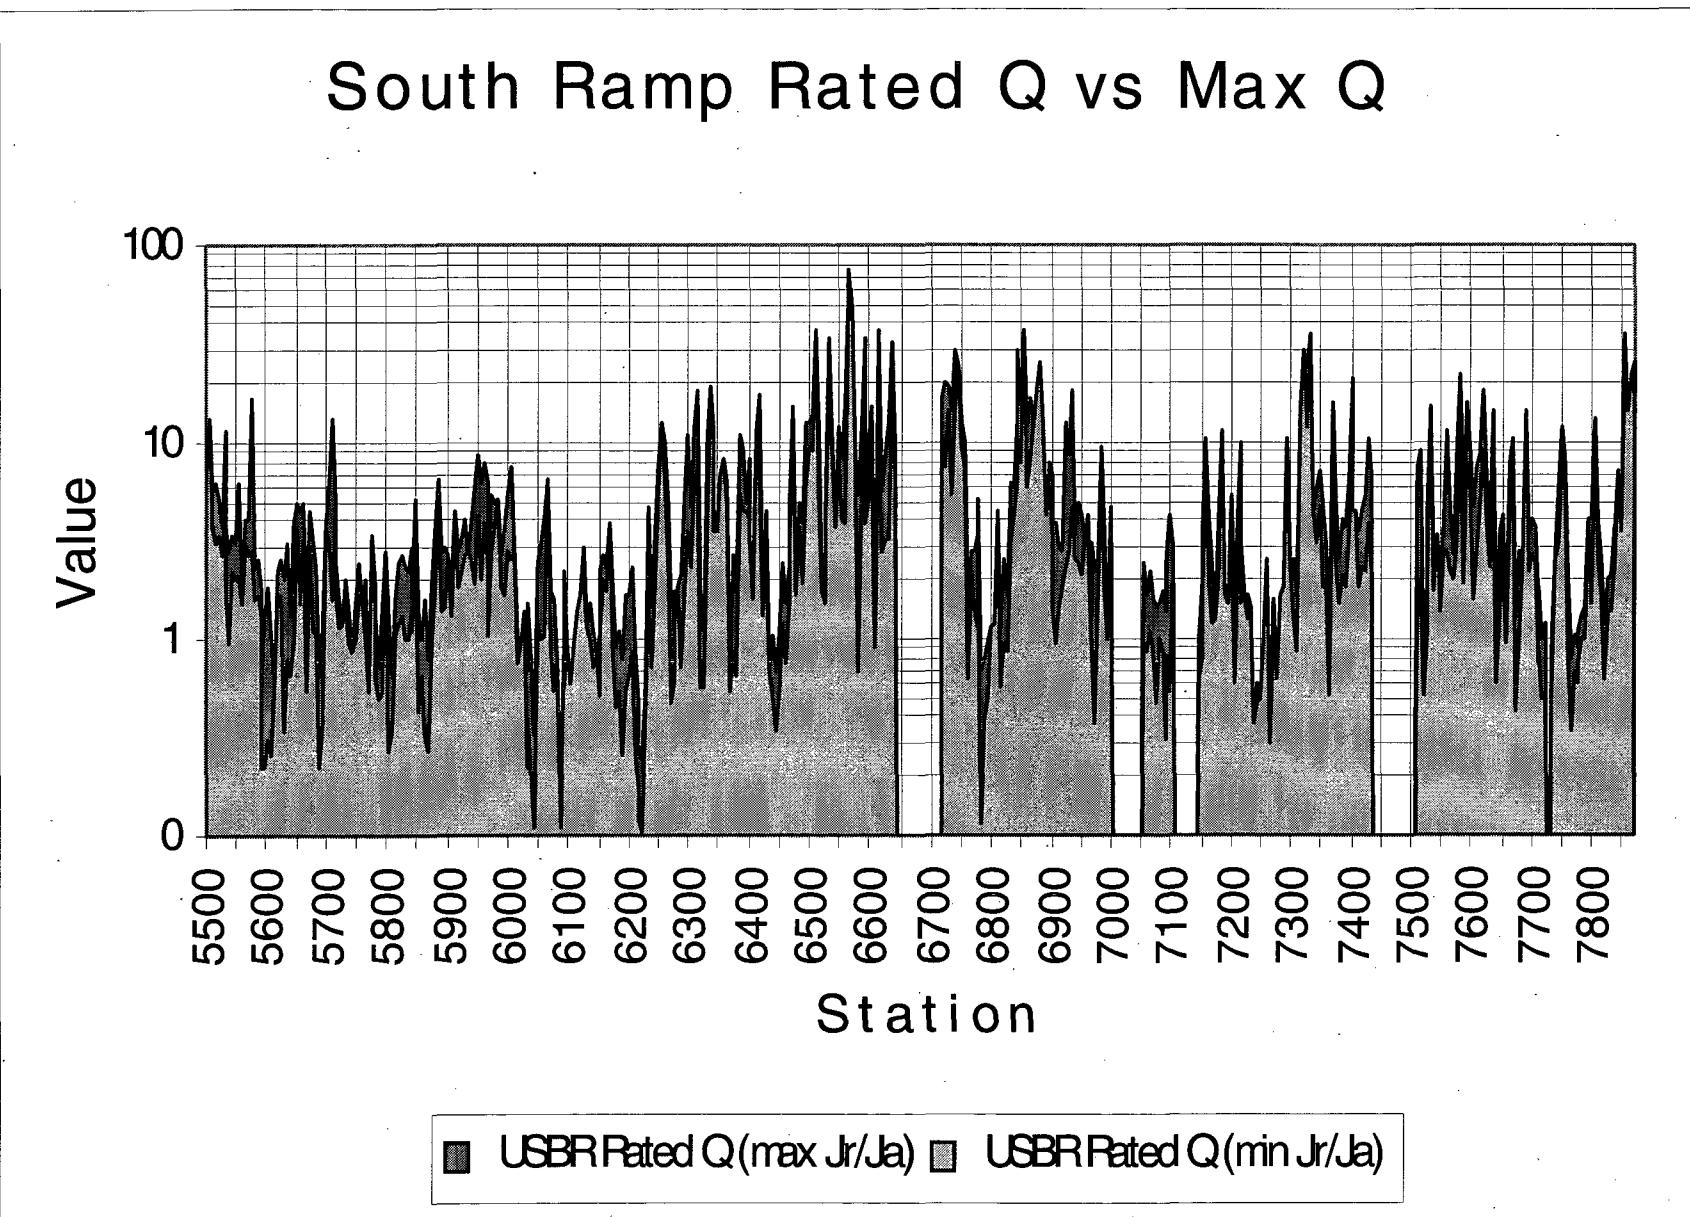
Figure 31: South Ramp Rated Q and Max Q

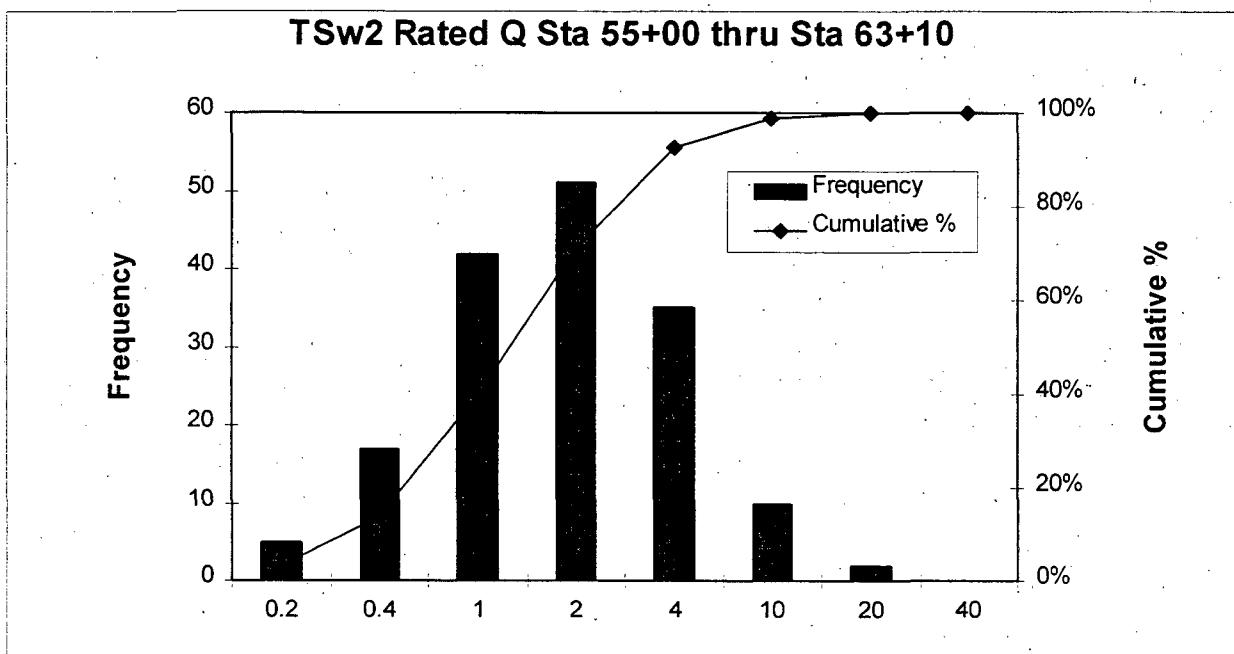
Figure 32a: Distribution of Q in TSw2 (Sta 55+00 - 63+10)

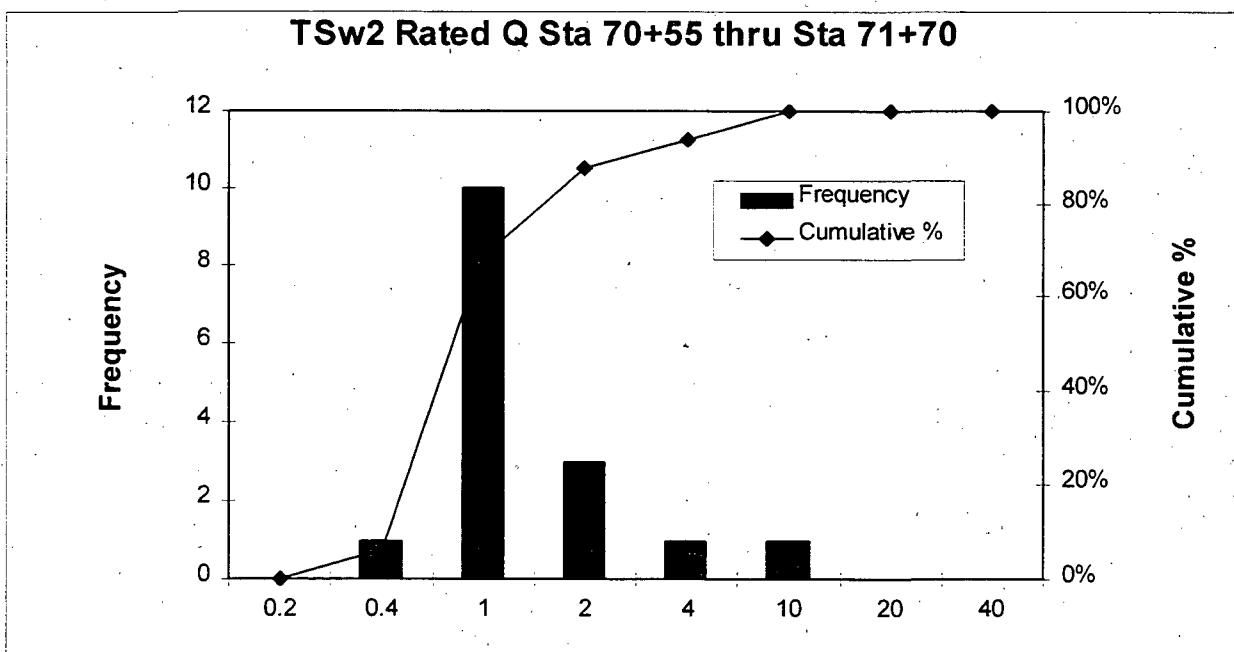
Figure 32b: Distribution of Q in TSw2 (Sta 70+55 - 71+70)

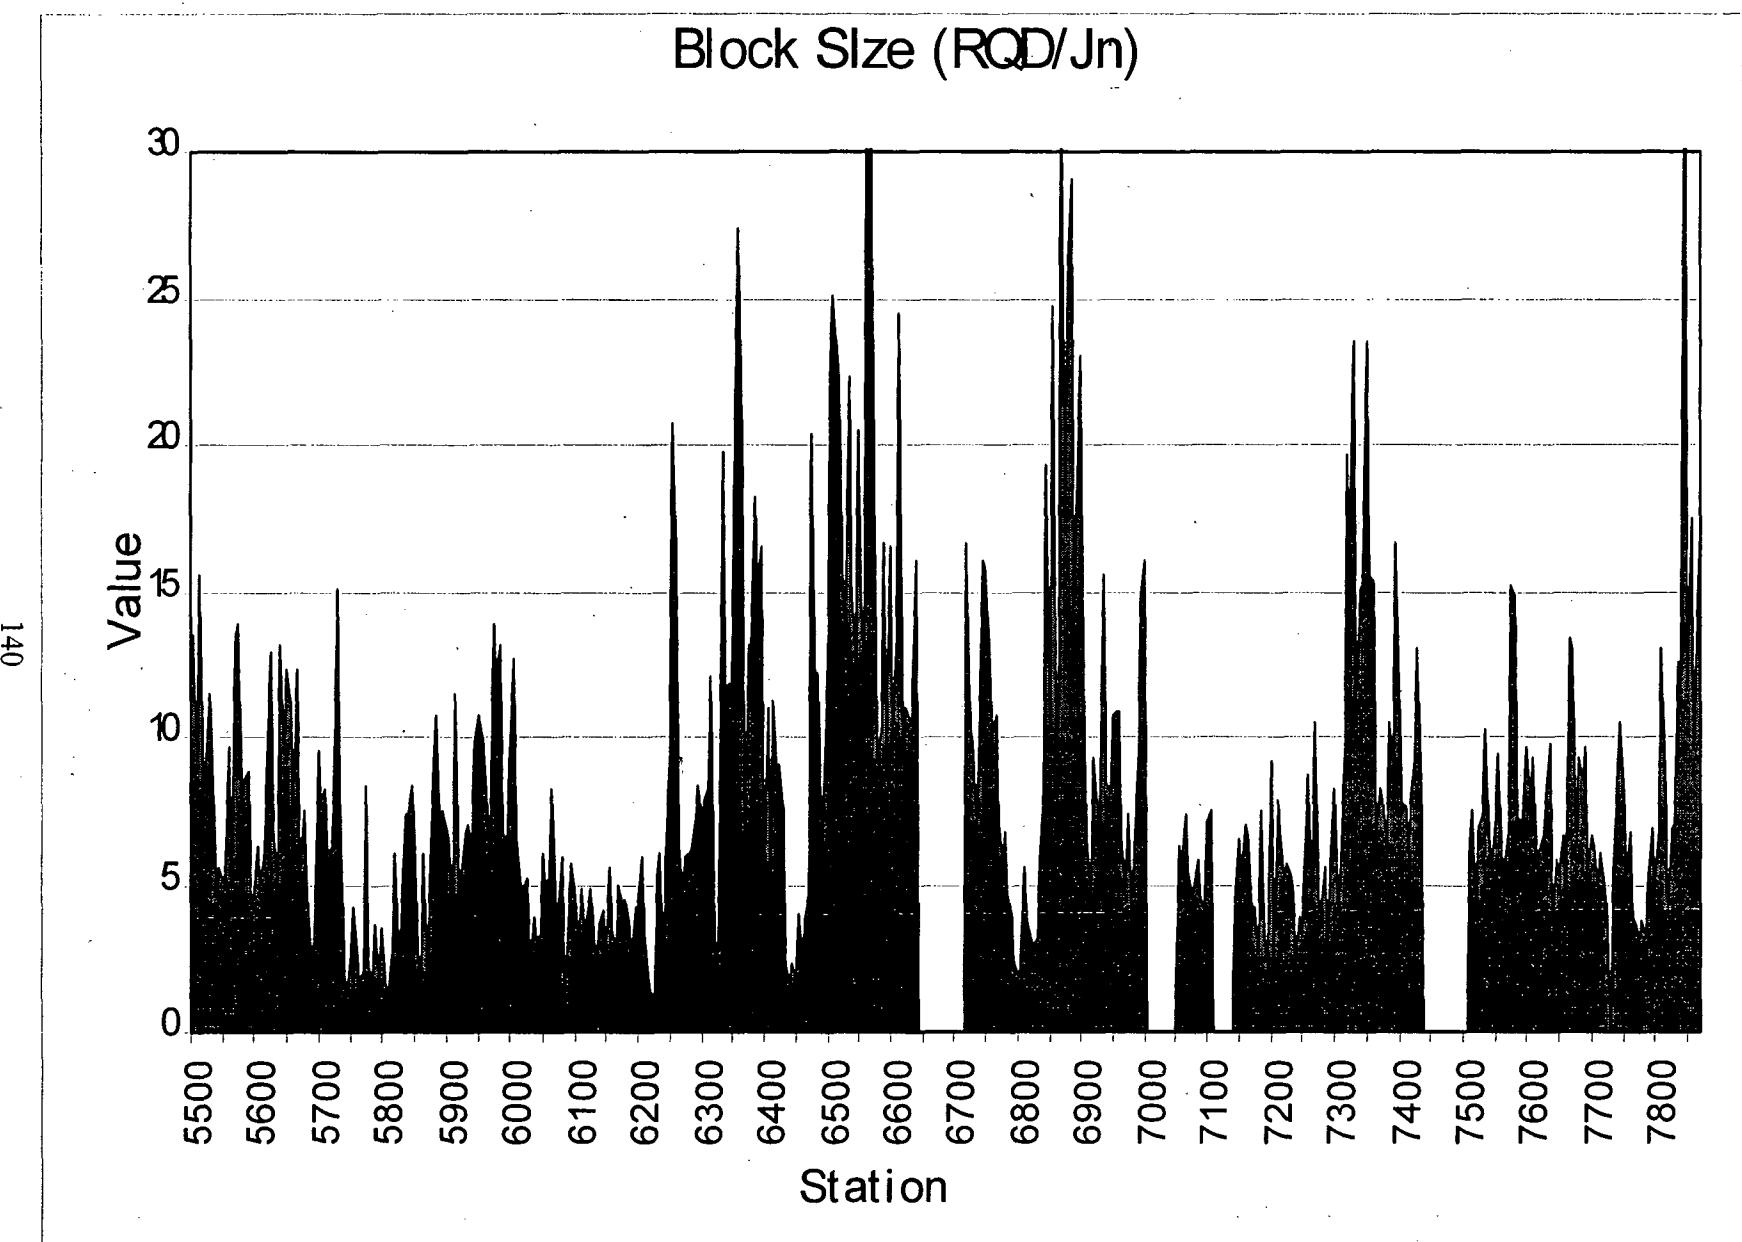
Figure 36: Q System RQD/Jn

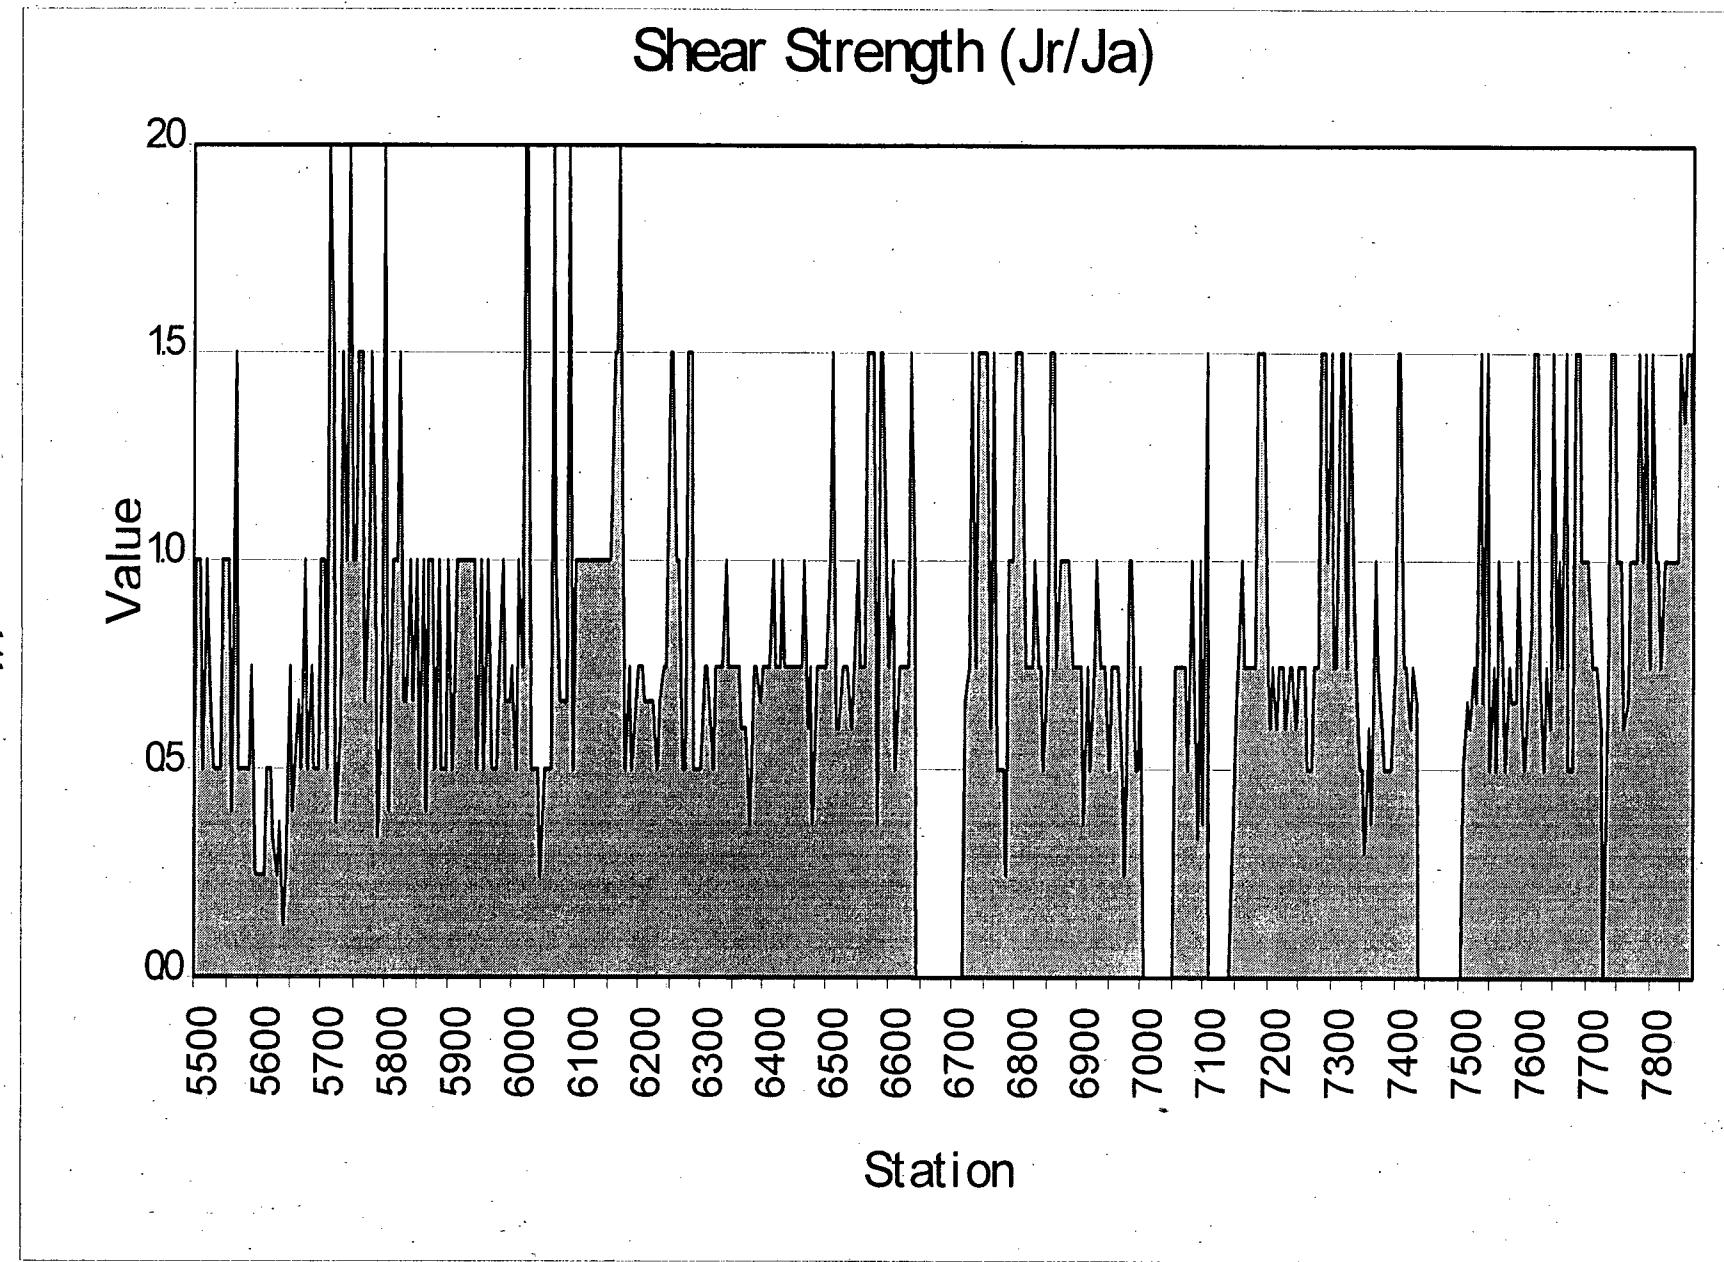
Figure 37: Q System Jr/Ja

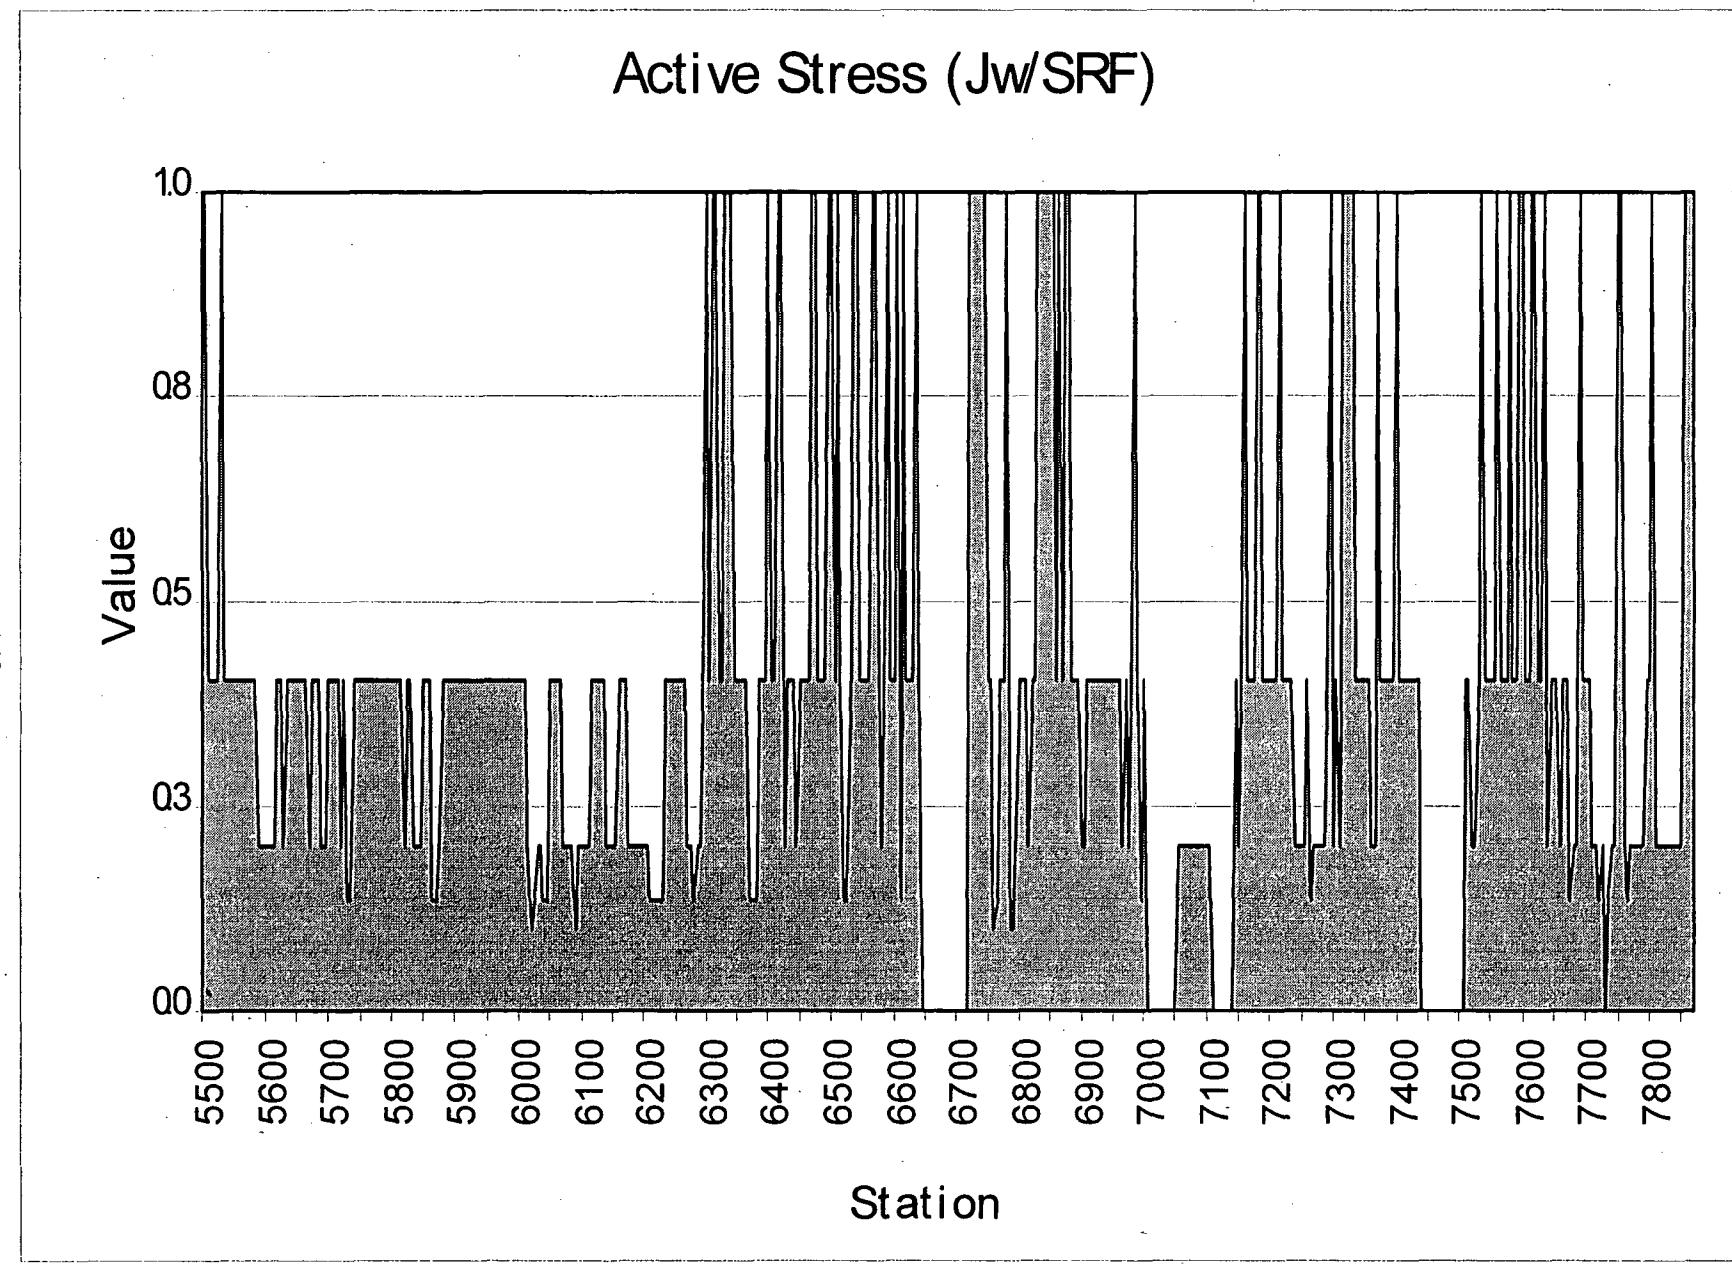
Figure 38: Q System Jw/SRF

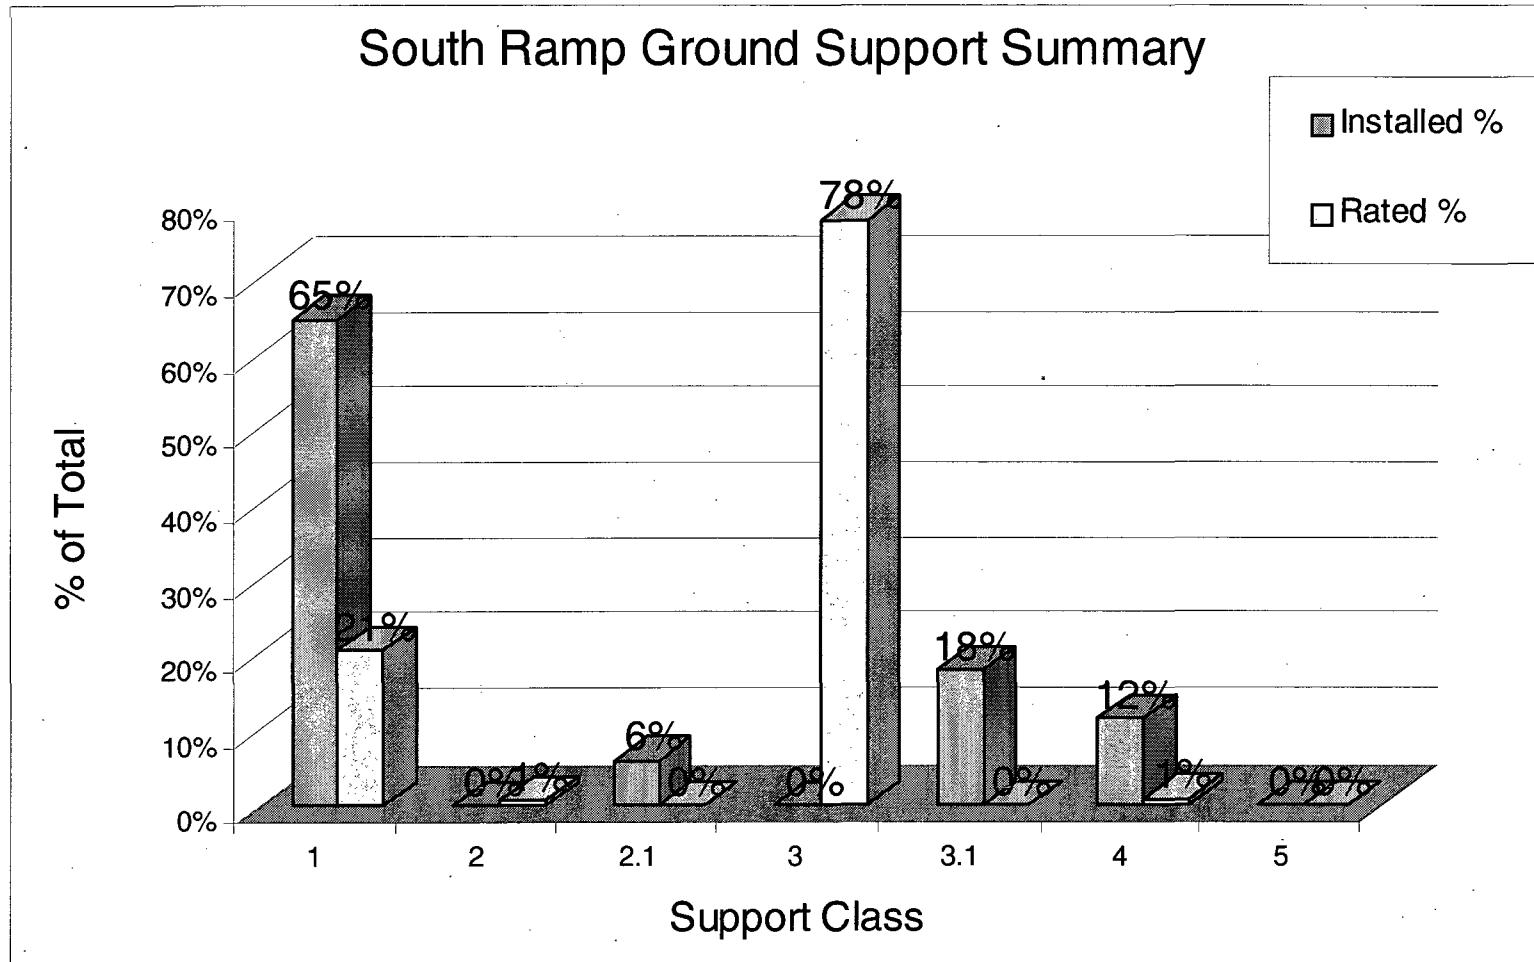
Figure 39: South Ramp Summary of Ground Support

The ground support actually installed in the South Ramp is determined by the excavation contractor. The heading crew selects rock reinforcement or steel sets and lagging for support based on their experience in similar conditions and their estimate of loosening loads. Table 16 gives the percentage of various classes of support shown in Figure 39. The table shows that in the South Ramp the theoretical requirement for class 2, 3, or 4 ground support is 80 percent. Actual installation of the classes was 36 percent. Figures 40 thru 46 show rated and installed support in each thermal-mechanical unit.

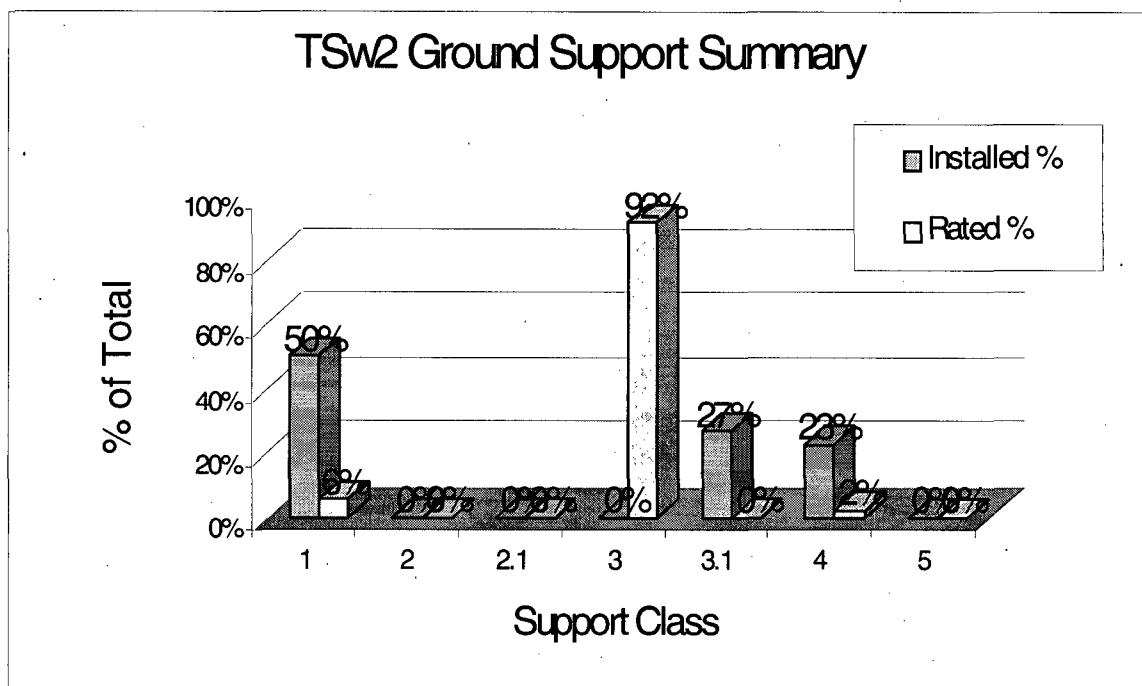
Figure 40a: Summary of Ground Support in TSw2

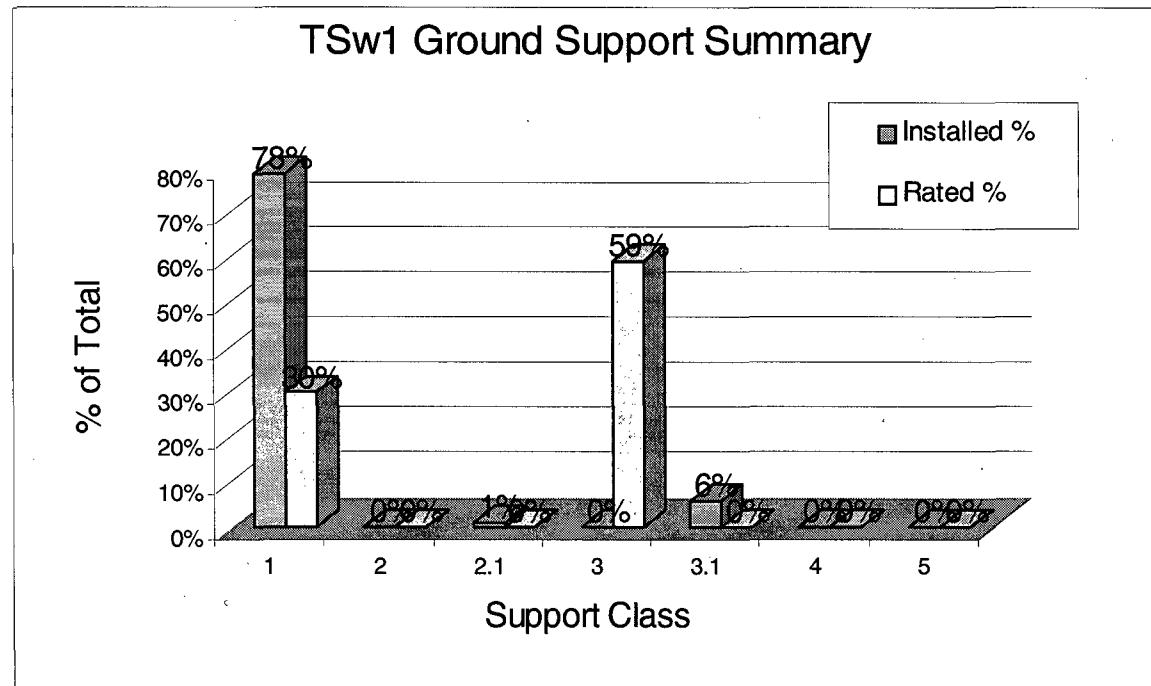
Figure 40b: Summary of Ground Support in TSw1

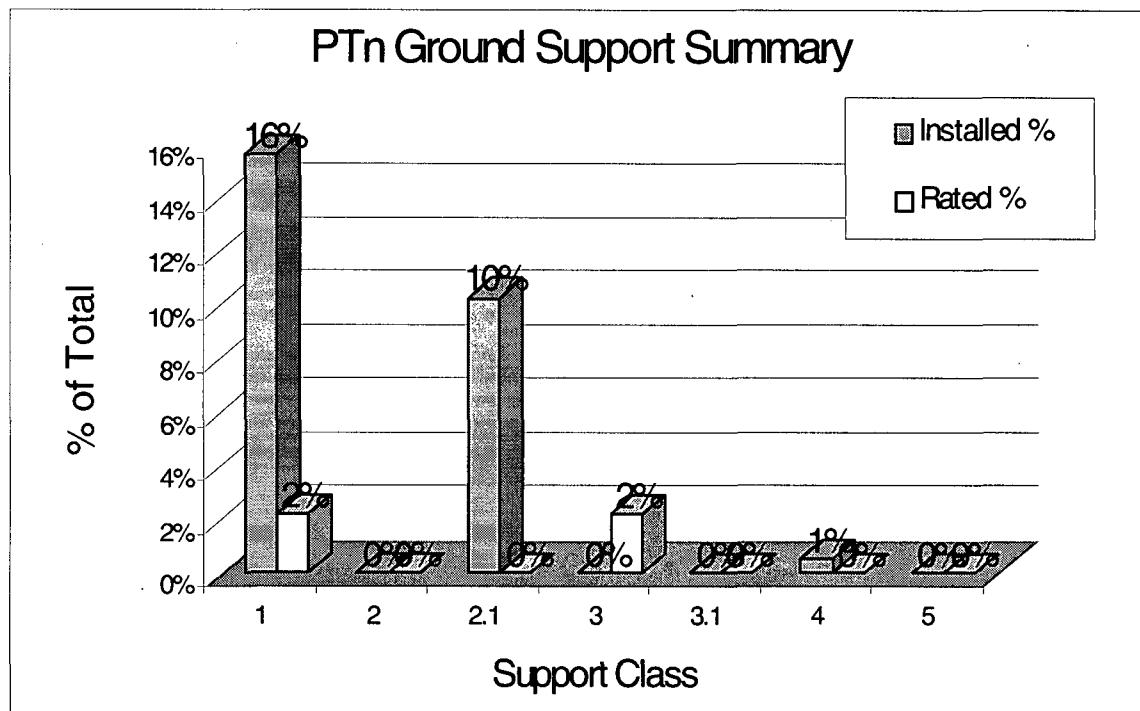
Figure 41a: Summary of Ground Support in PTn
