**GEOLOGY OF THE SOUTH RAMP - STATION 55+00 TO 78+77,
EXPLORATORY STUDIES FACILITY, YUCCA MOUNTAIN PROJECT,
YUCCA MOUNTAIN, NEVADA**

**by G.L.W. Eatman, W.L. Singleton, T.C. Moyer, D.L. Barr, A.L. Albin,
R.C. Lung, and S.C. Beason**

Bureau of Reclamation and U.S. Geological Survey

**Denver, Colorado
1997**

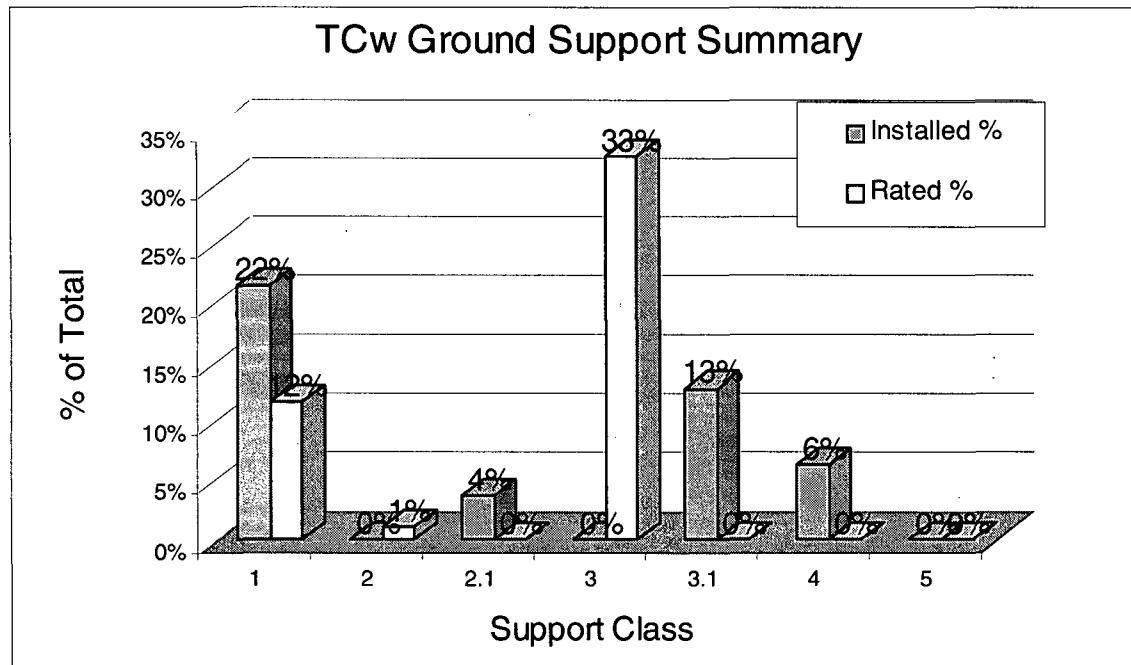
Figure 41b: Summary of Ground Support in TCw

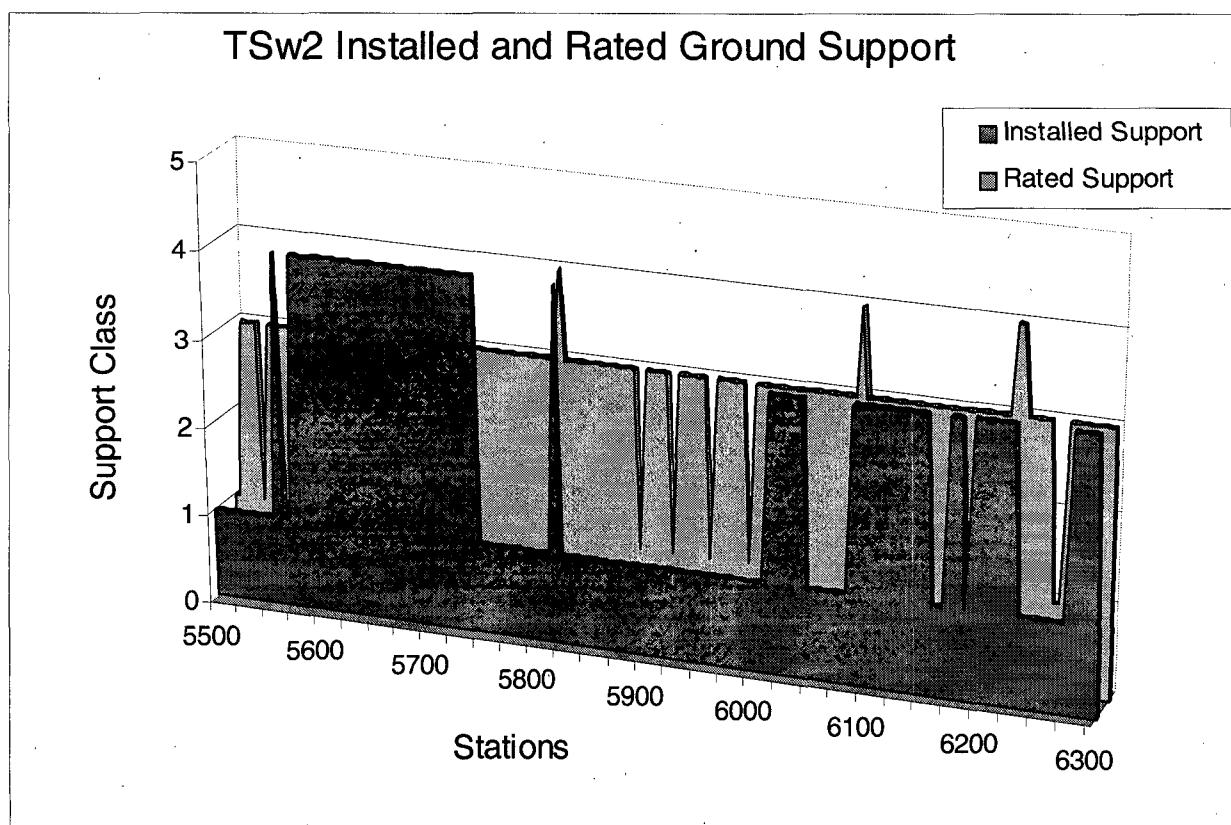
Figure 42a: TSw2 Installed and Rated Ground Support

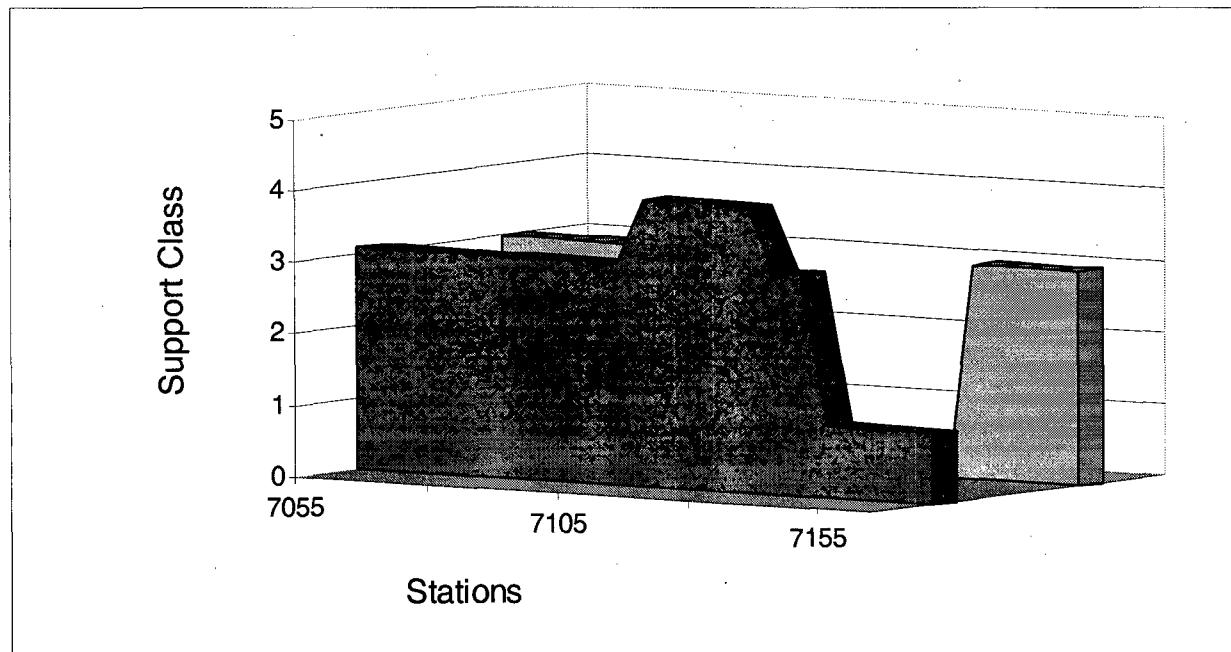
Figure 42b: TSw2 Installed and Rated Ground Support Continued

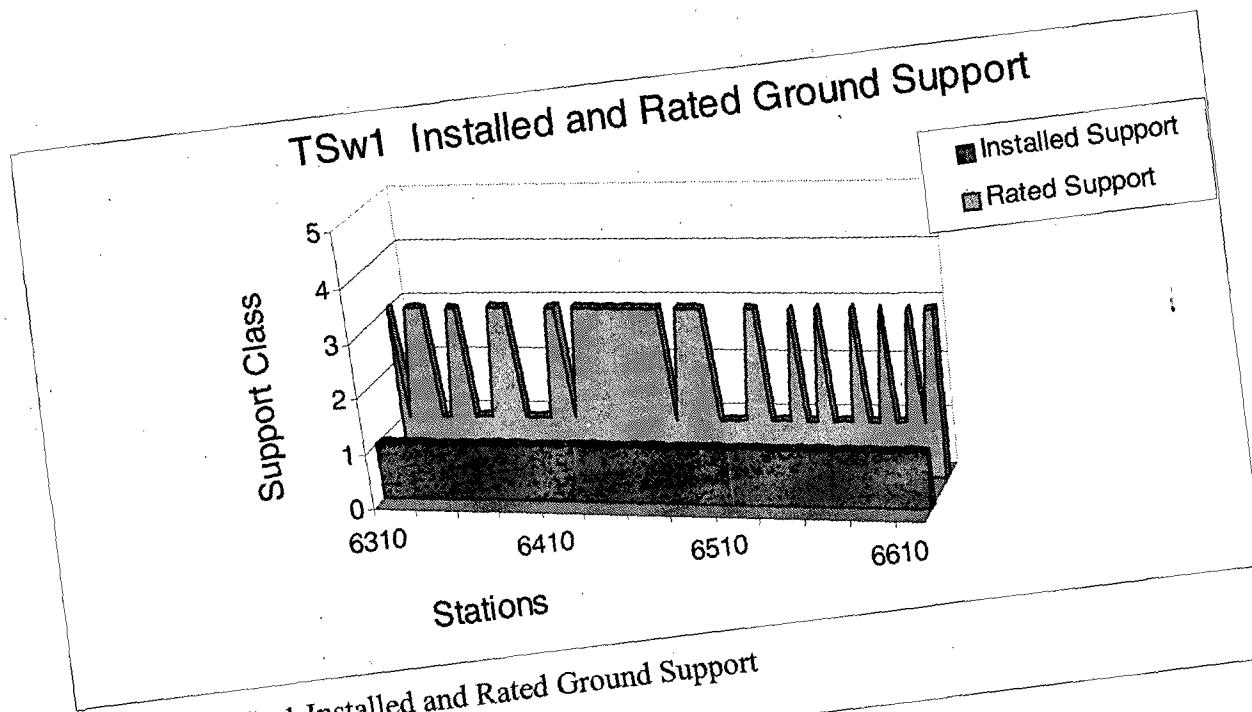
Figure 43a: TSw1 Installed and Rated Ground Support

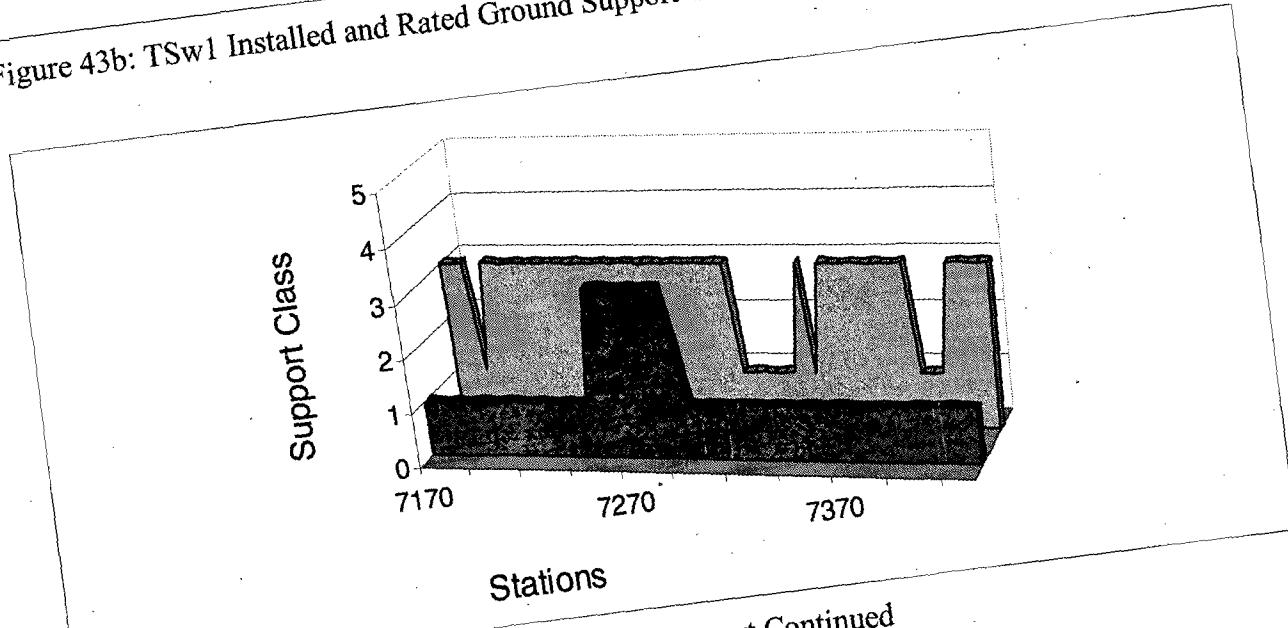
Figure 43c: TSw1 Installed and Rated Ground Support Continued

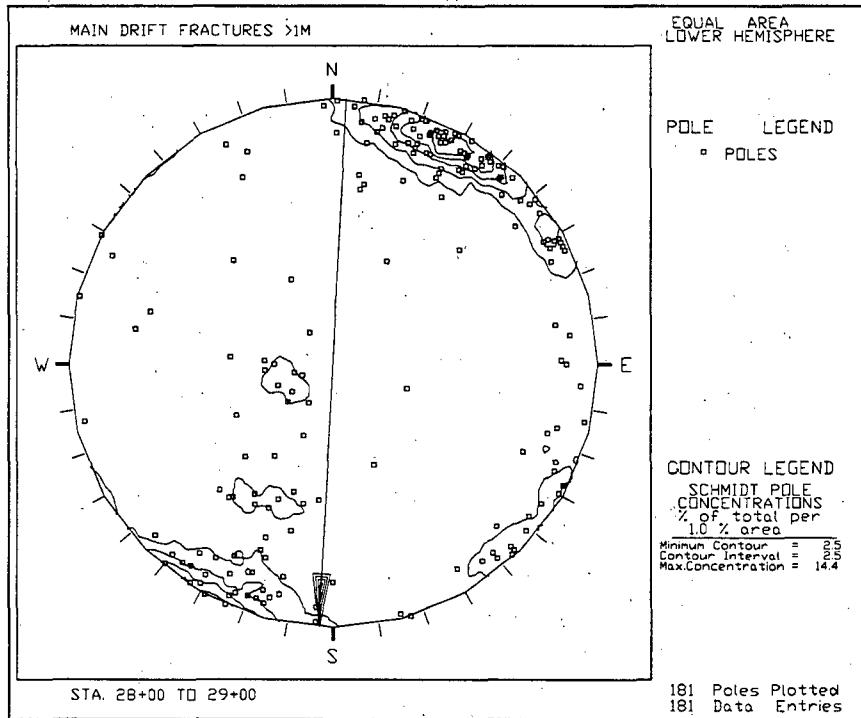
48b

Figure 48. Stereonet plots of DLS data from the Main Drift between Sta. 28+00 and 29+00 (48a) and Alcove 5 (48b). The Alcove 5 data shown was collected in the Access-Observation Drift and the Heated Drift. The two drifts are parallel to each other and at a 75° angle to the Main Drift. The arrows indicate the bearing of the Main Drift and the drifts in the alcove. A comparison of the two stereonets shows a general similarity in the distribution of poles. The differences in the two plots can largely be attributed to a sampling bias. The effect of the bias can be seen by comparing the two plots. In each stereonet, more poles plot near the arrow than in the same location on the accompanying plot. Conversely, there are fewer poles plotting approximately 90° from the arrow than in the accompanying plot.

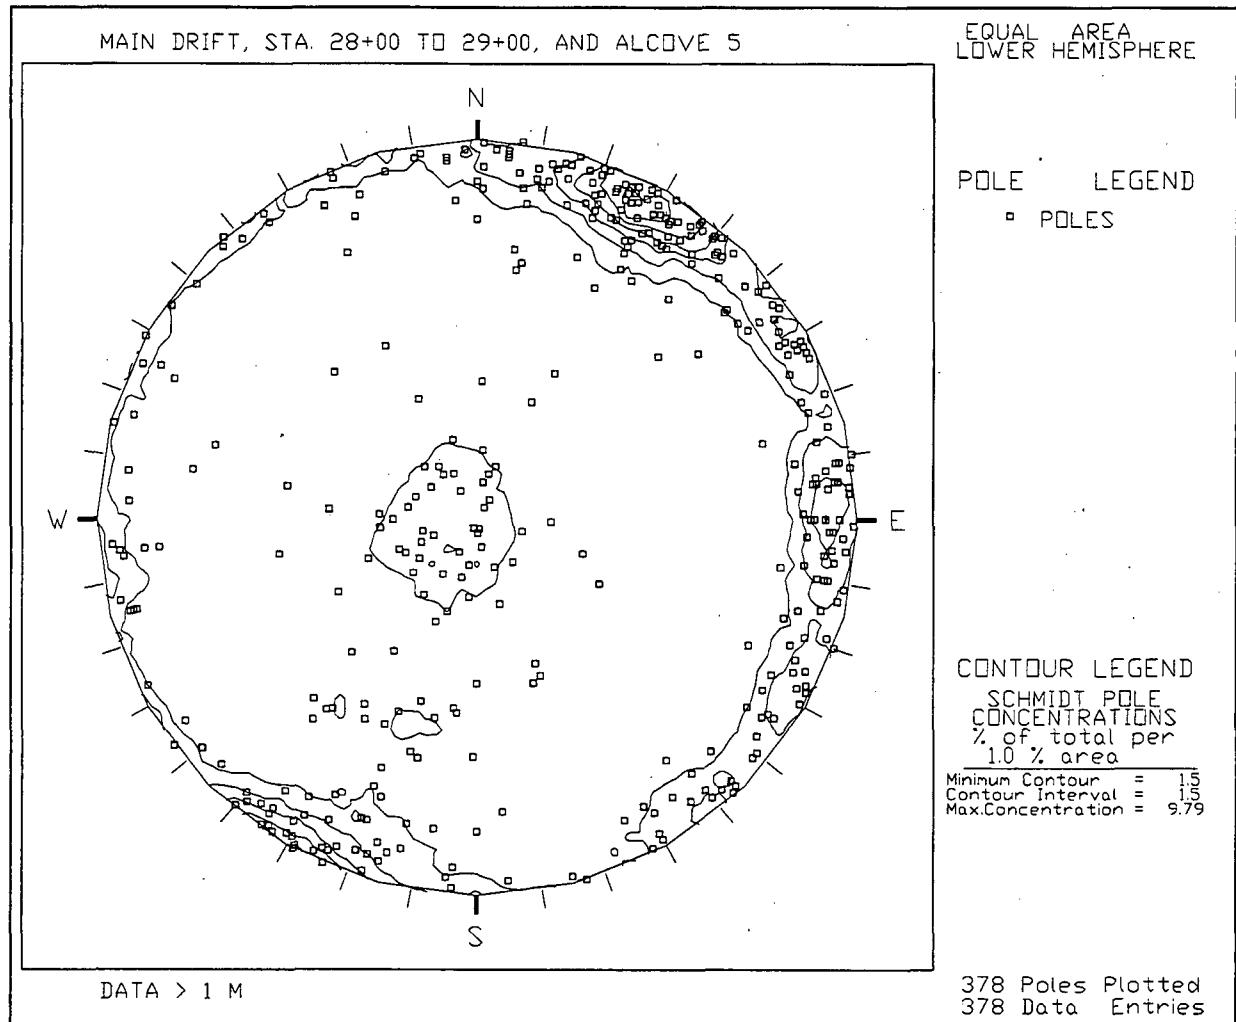
Figure 49. The stereonet showing data from the Main Drift between Sta. 28+00 and 29+00 combined with data from all of the drifts in Alcove 5 has a distribution that more closely represents the actual distribution of fractures in that area. The sampling bias has largely been nullified by combining several orthogonal or nearly orthogonal transects from Alcove 5 and the adjacent Main Drift.

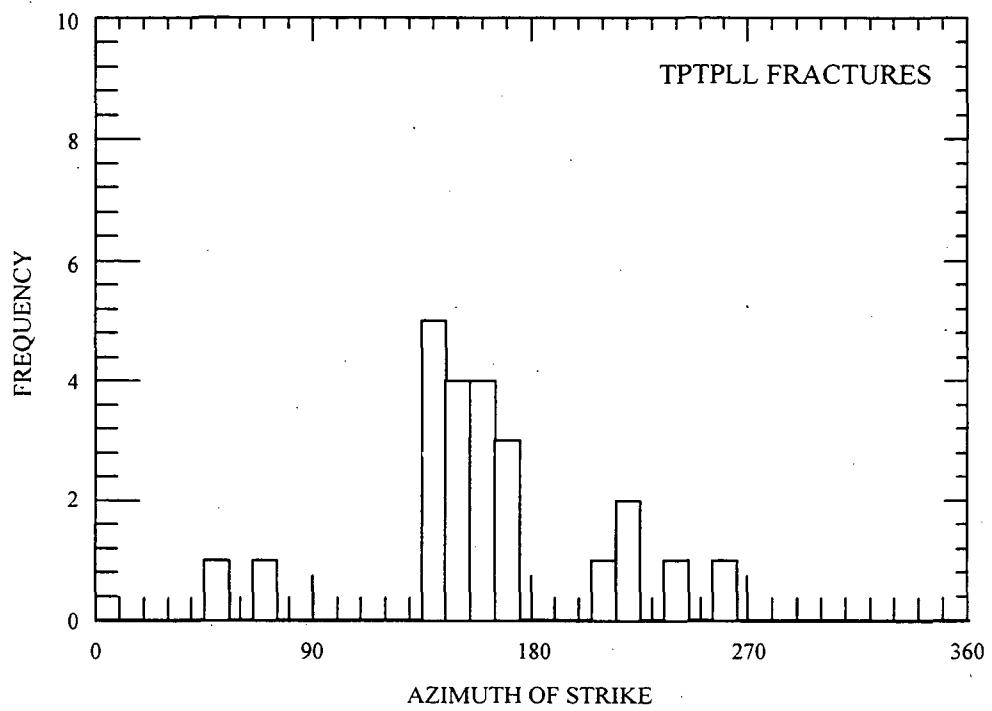
FIGURE A4.1: HISTOGRAM OF FRACTURE STRIKE: Tptpll

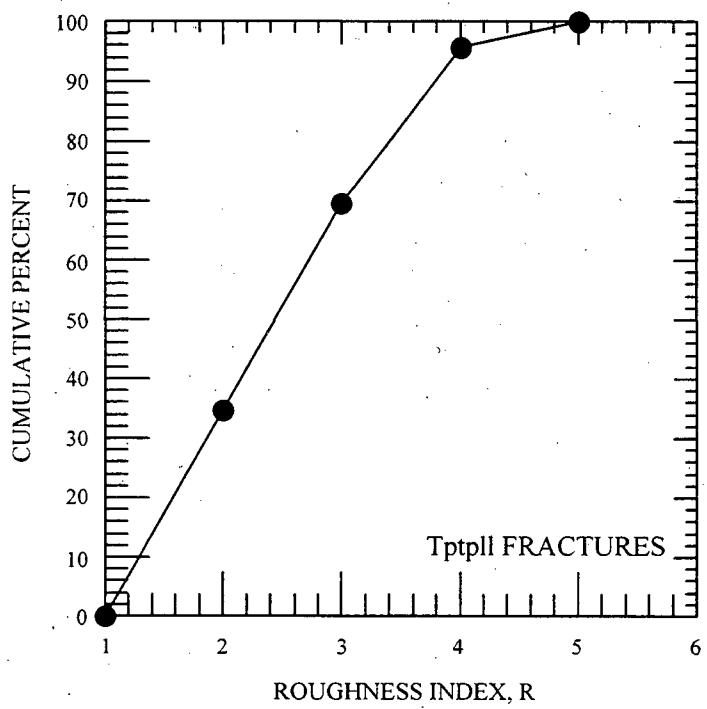
FIGURE A4.1.1: CUMULATIVE PERCENT OF ROUGHNESS: Tptpl

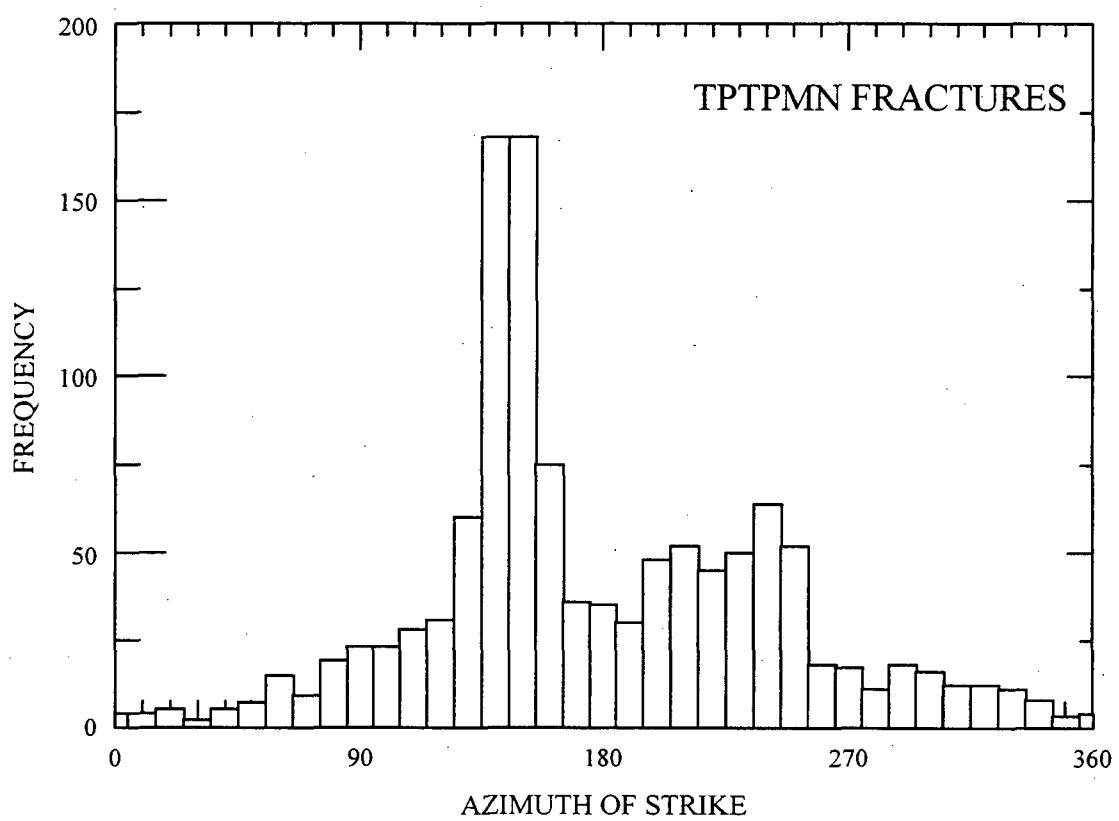
FIGURE A4.2: HISTOGRAM OF FRACTURE STRIKE: Tptpmn

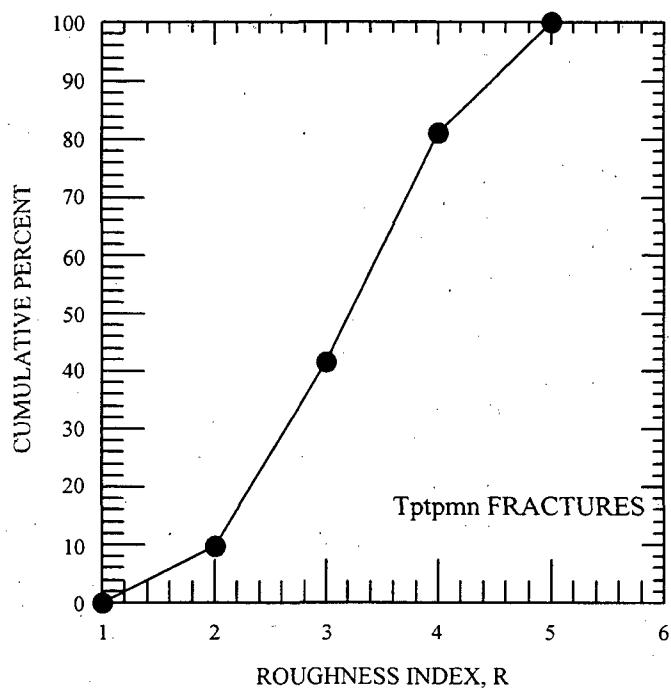
FIGURE A4.2.1: CUMULATIVE PERCENT OF ROUGHNESS: Tptpmn

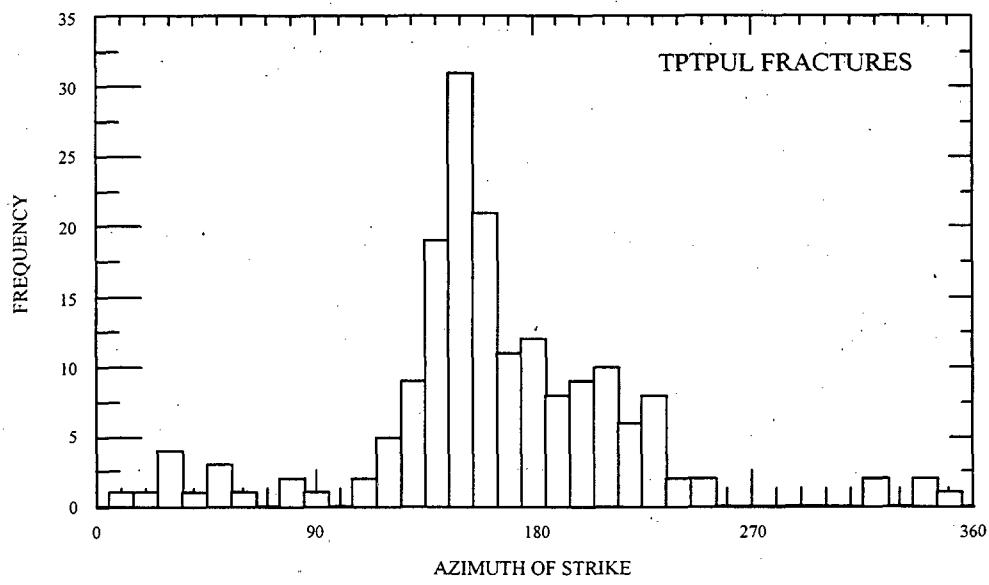
FIGURE A4.3: HISTOGRAM OF FRACTURE STRIKE: Tptpul

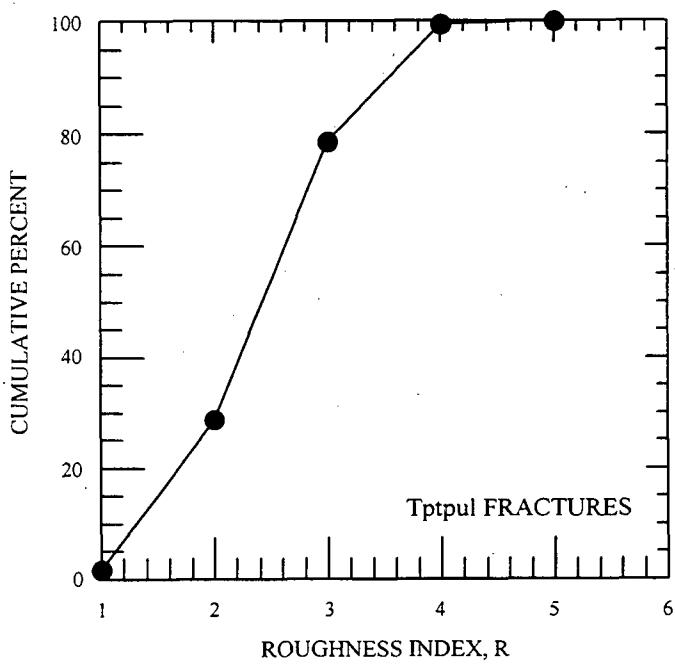
FIGURE A4.3.1: CUMULATIVE PERCENT OF ROUGHNESS: T_{ptpul}

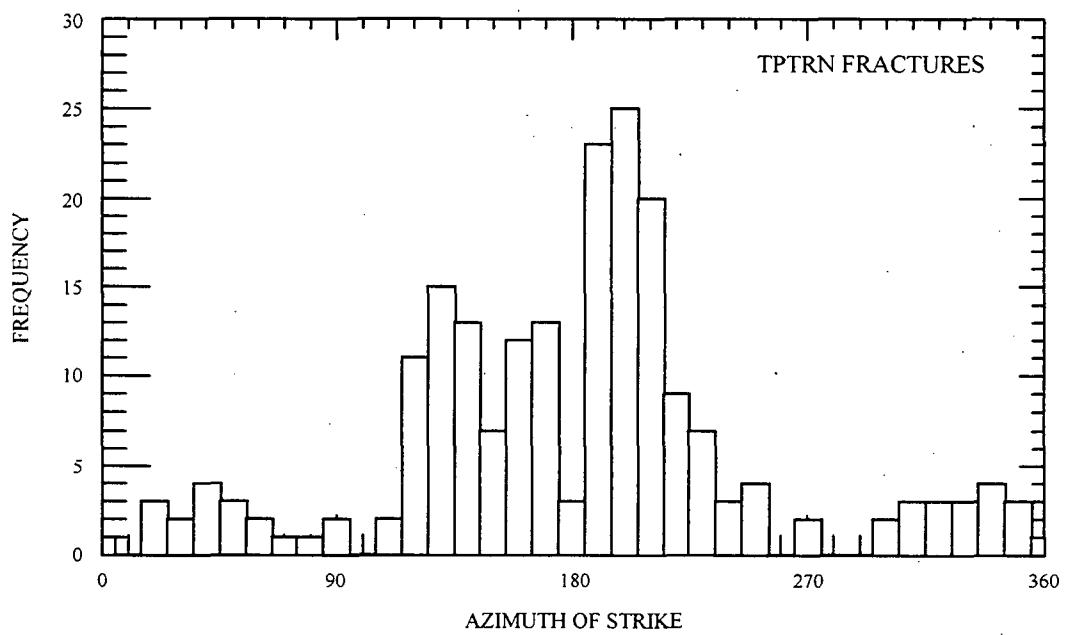
FIGURE A4.5: HISTOGRAM OF FRACTURE STRIKE: Tptrn

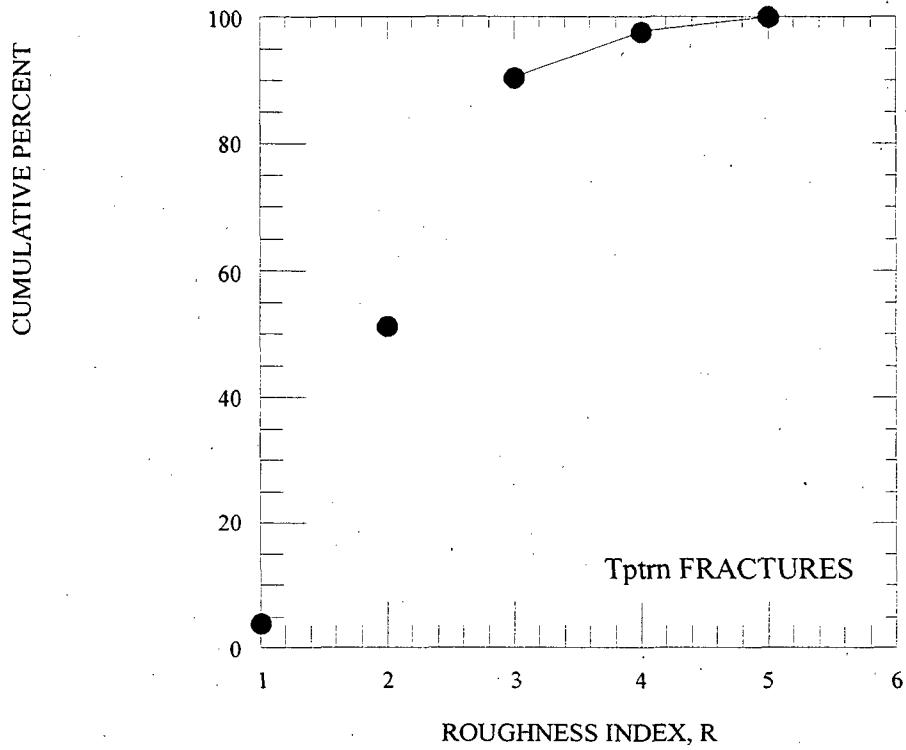
FIGURE A4.5.1: CUMULATIVE PERCENT OF ROUGHNESS: T_{ptrn}

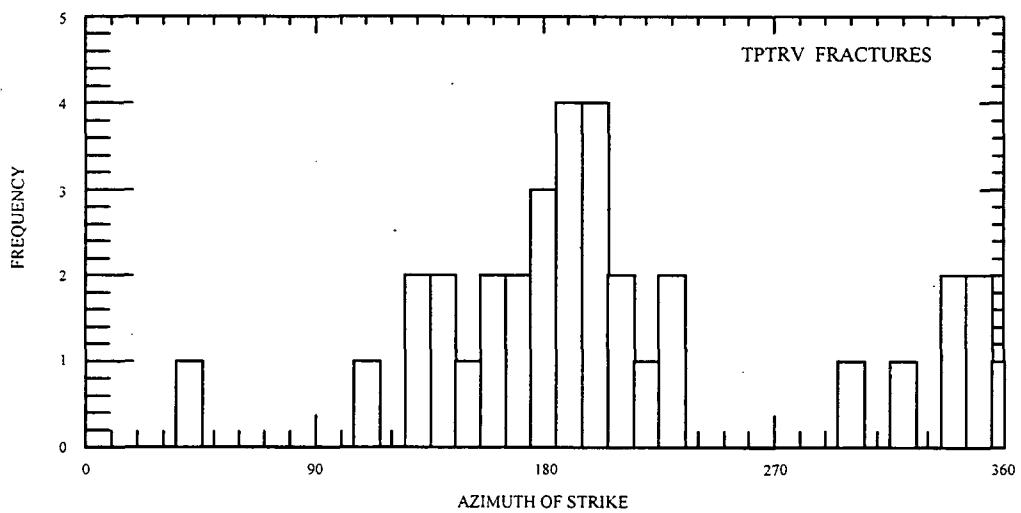
FIGURE A4.6: HISTOGRAM OF FRACTURE STRIKE: Tptrv

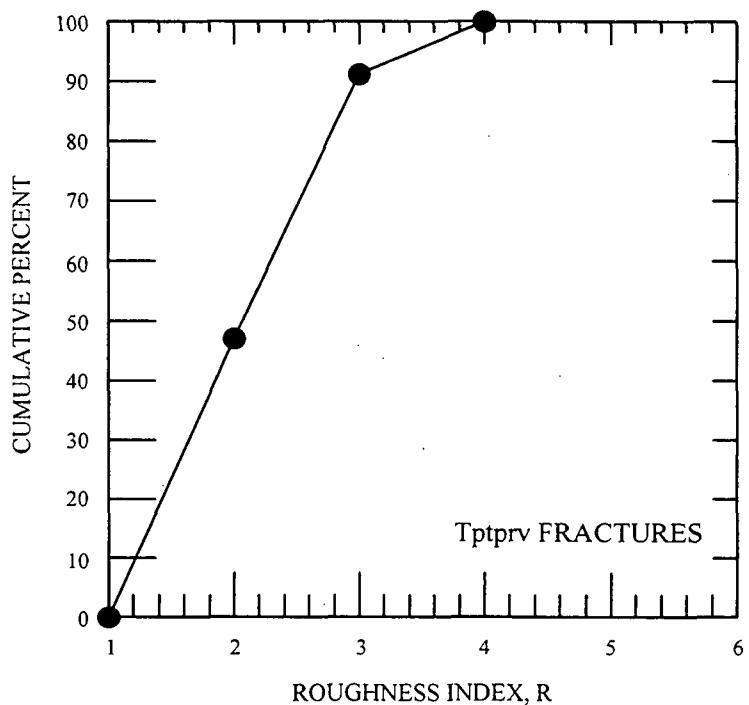
FIGURE A4.6.1: CUMULATIVE PERCENT OF ROUGHNESS: Tptrv

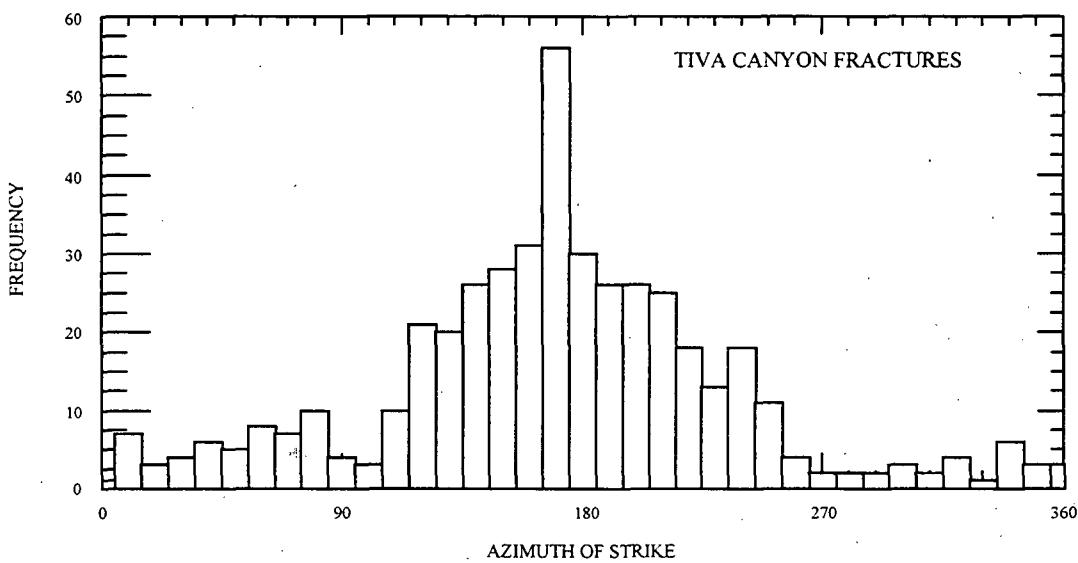
FIGURE A4.7: HISTOGRAM OF FRACTURE STRIKE: TIVA CANYON

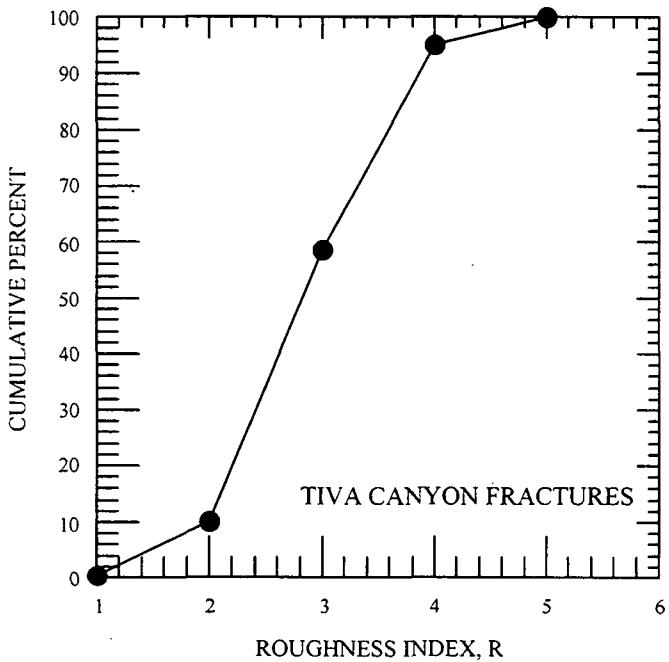
FIGURE A4.7.1: CUMULATIVE PERCENT ROUGHNESS: TIVA CANYON

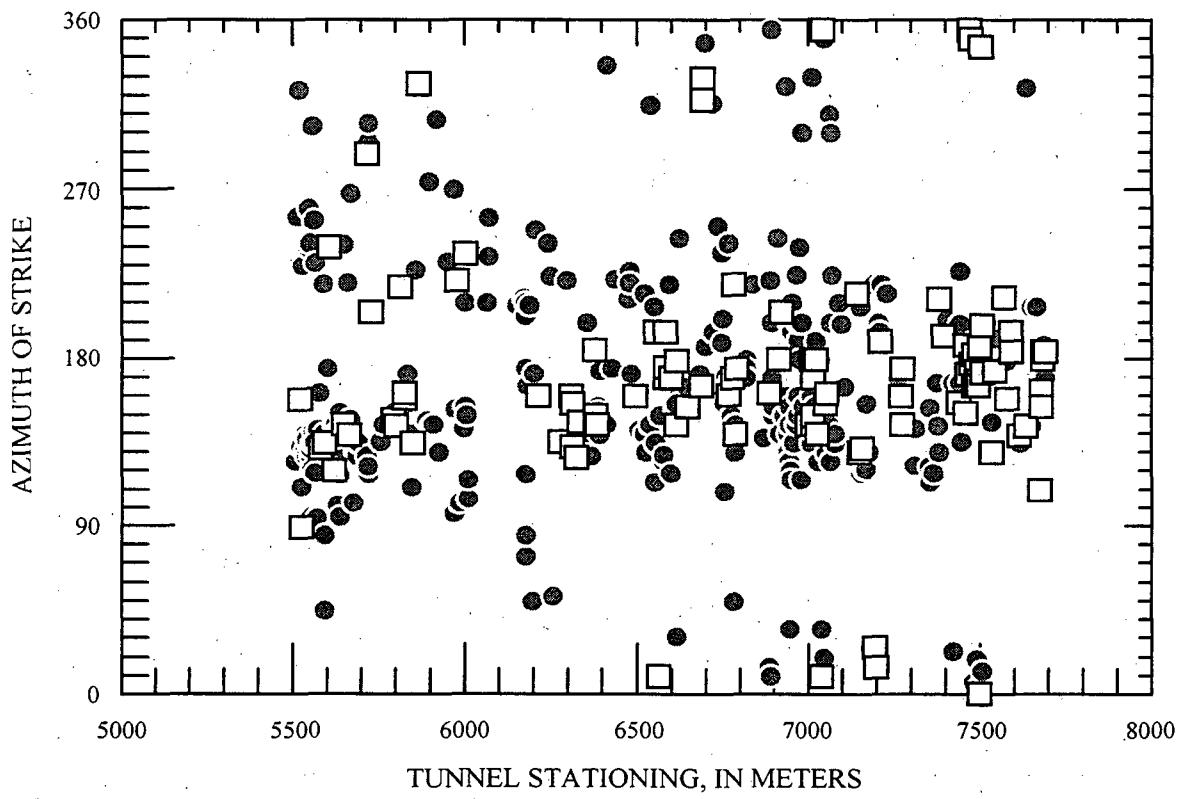
FIGURE A4.8: FAULTS AND SHEARS: AZIMUTH OF STRIKE AND STATIONING
FILLED CIRCLES:SHEARS
OPEN SQUARES:FAULTS

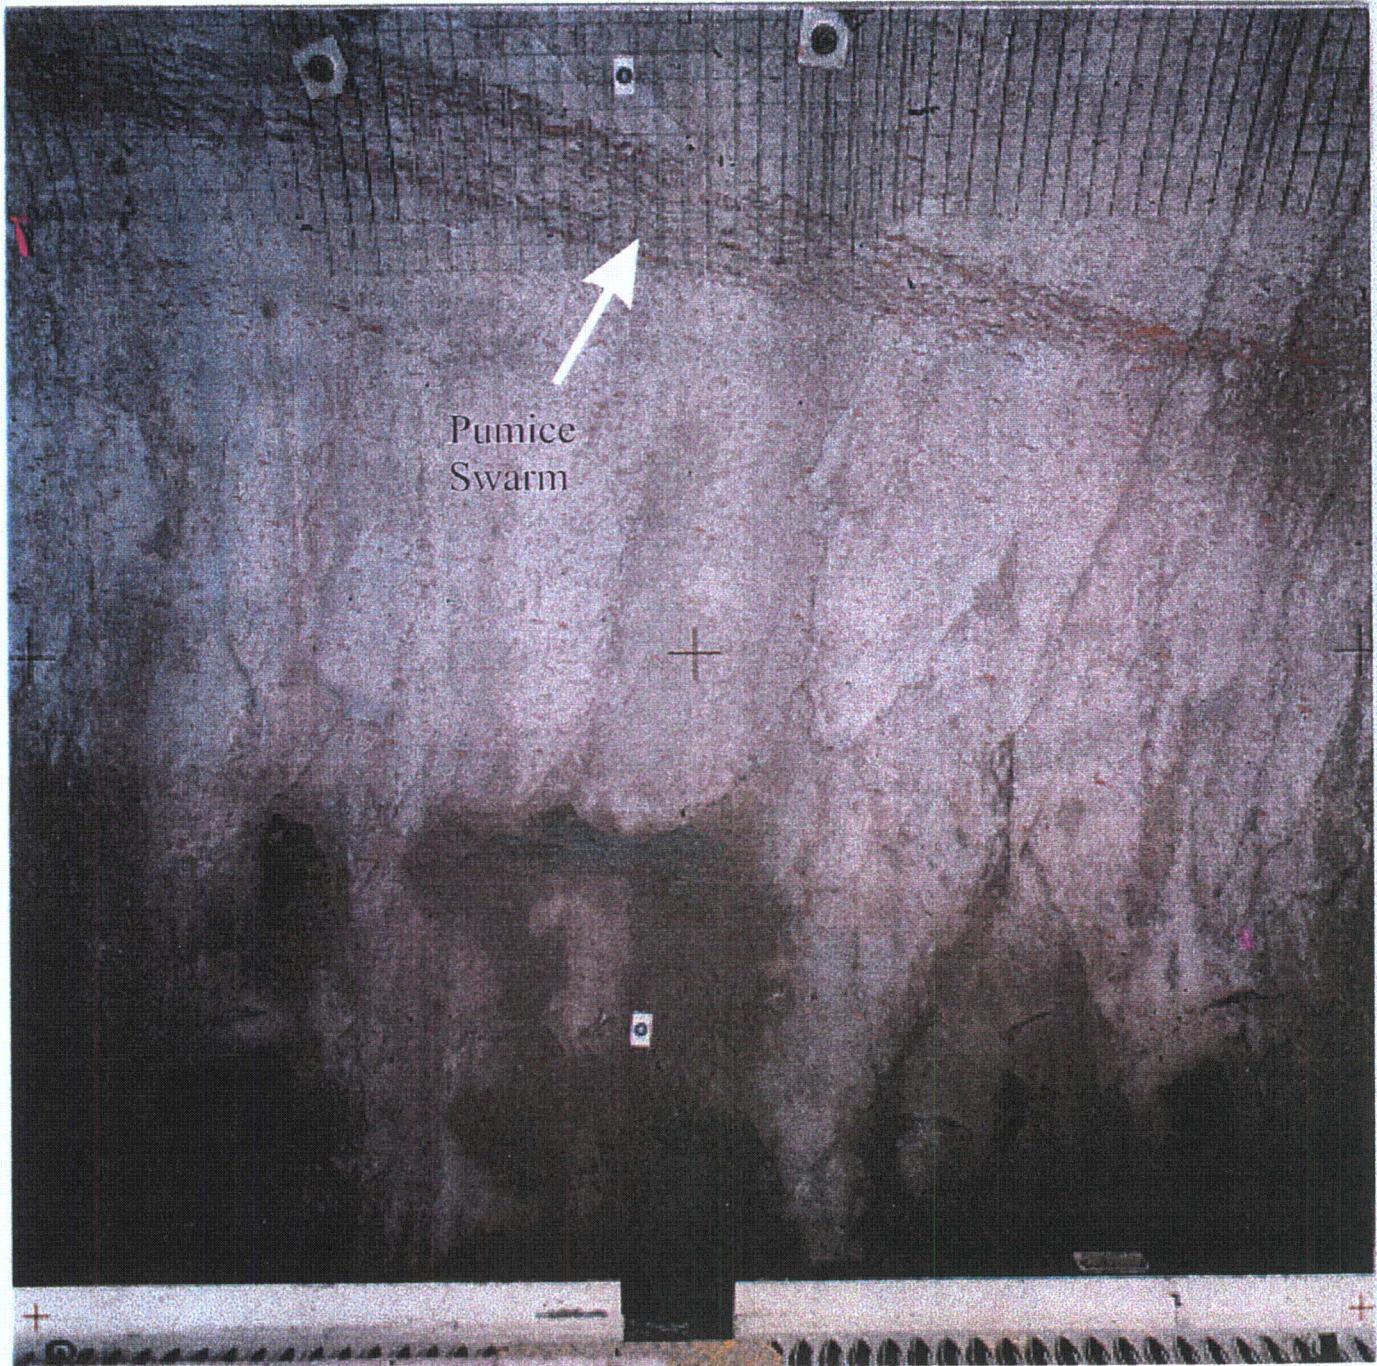
Photo 1. View of the crystal-poor lower nonlithophysal zone of the Tiva Canyon Tuff near Sta. 67+42, left rib, showing the higher of two pumice swarms observed in this location. Pumice clasts are argillically altered. Field of view is approximately 4.5 m; rock bolt bearing plates are 15 cm across. Photo PG021882.

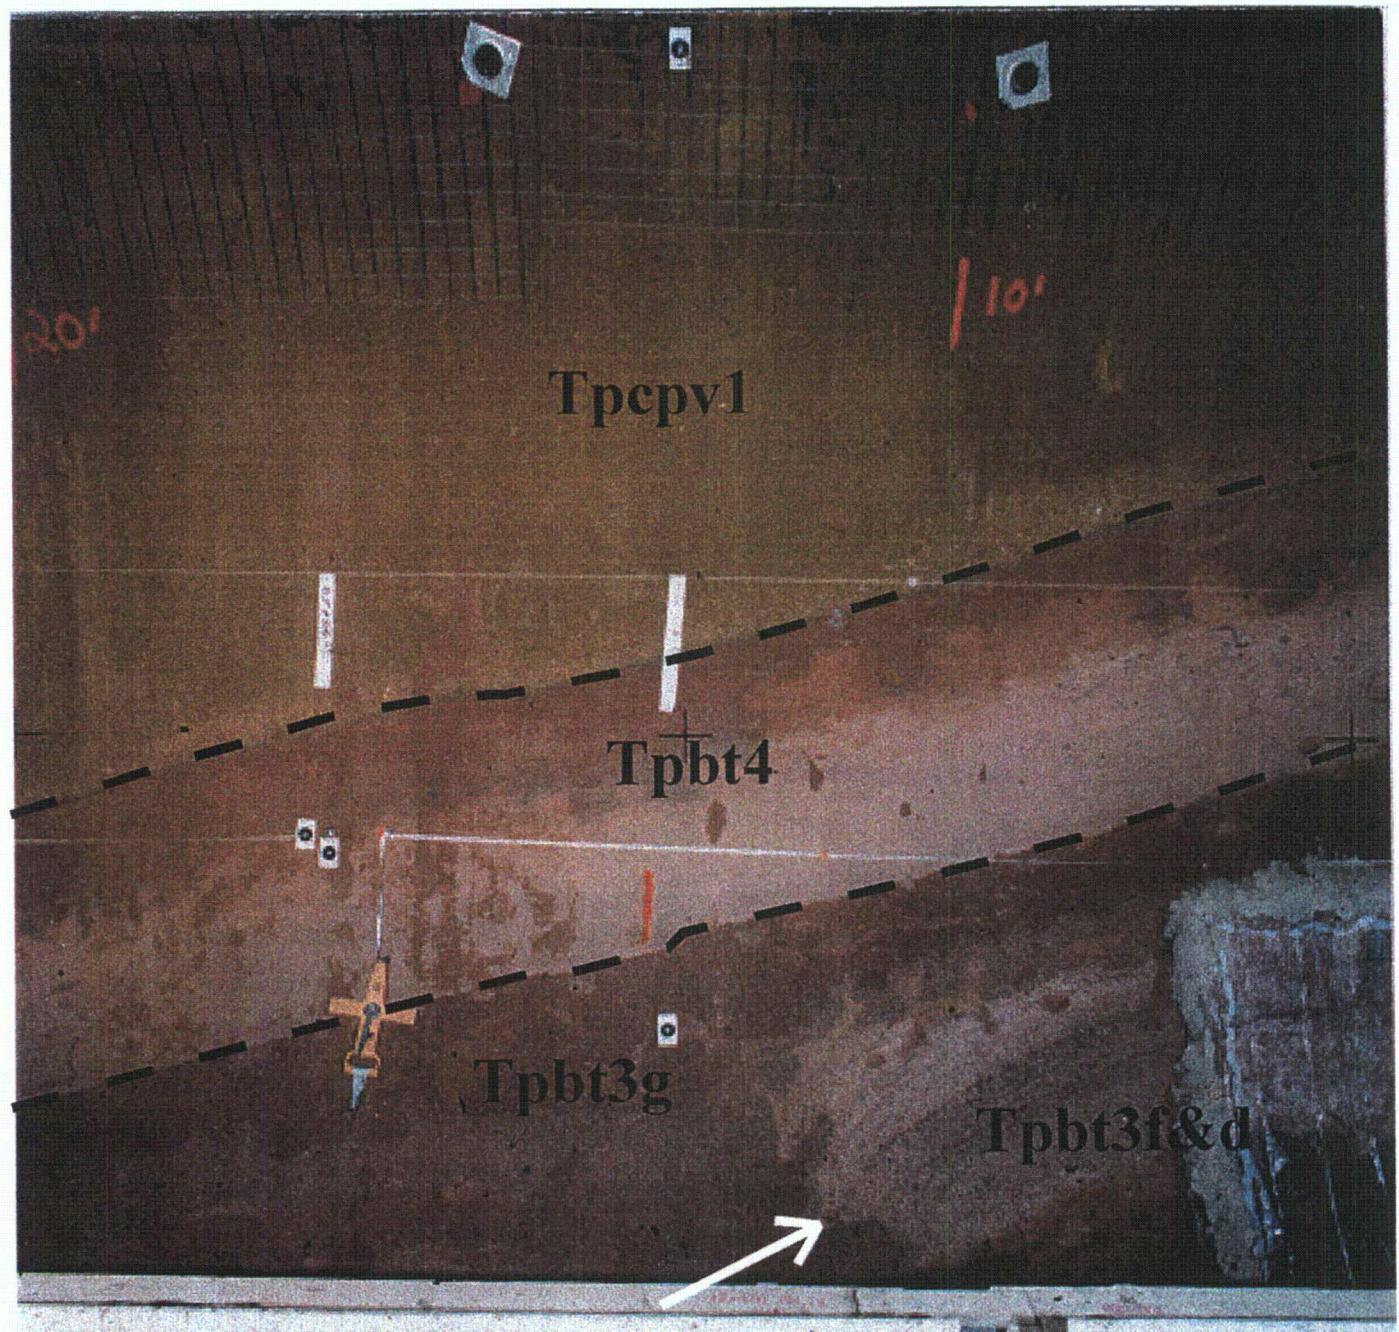
Photo 2. The contact between the Tiva Canyon Tuff and underlying pre-Tiva Canyon Tuff bedded tuffs (Tpbt4) at Sta. 67+00, right rib. Units d and f of the underlying pre-Yucca Mountain Tuff bedded tuffs (Tpbt3) are eroded and incorporated into unit g near the base of the photo (arrow). Field of view is approximately 4.5 m; rock bolt bearing plates are 15 cm across. Photo PG021748.

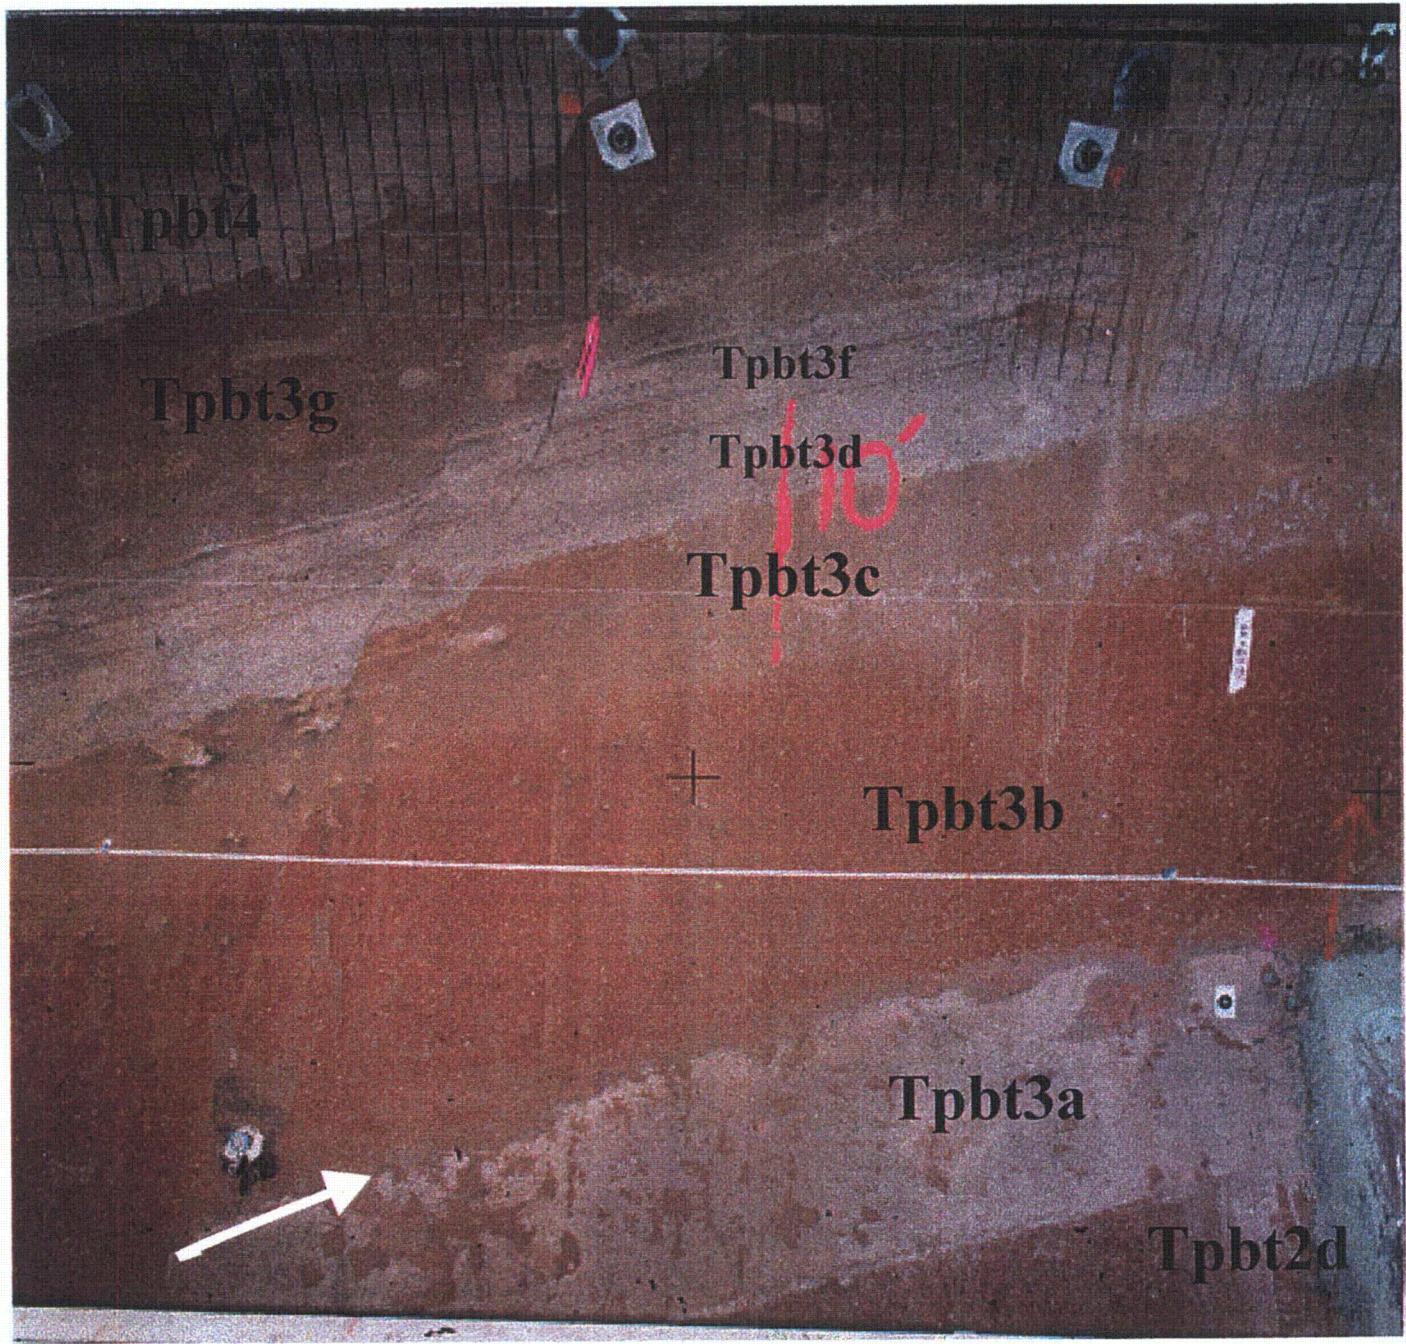
Photo 3. The pre-Yucca Mountain Tuff bedded tuffs (Tpbt3) exposed near Sta. 66+88, right rib. Arrow points to disturbed upper surface of unit a. Infilled burrow structures can be found in Tpbt3g and 3c. Field of view is approximately 4.5 m; rock bolt bearing plates are 15 cm across. Photo PG021723.

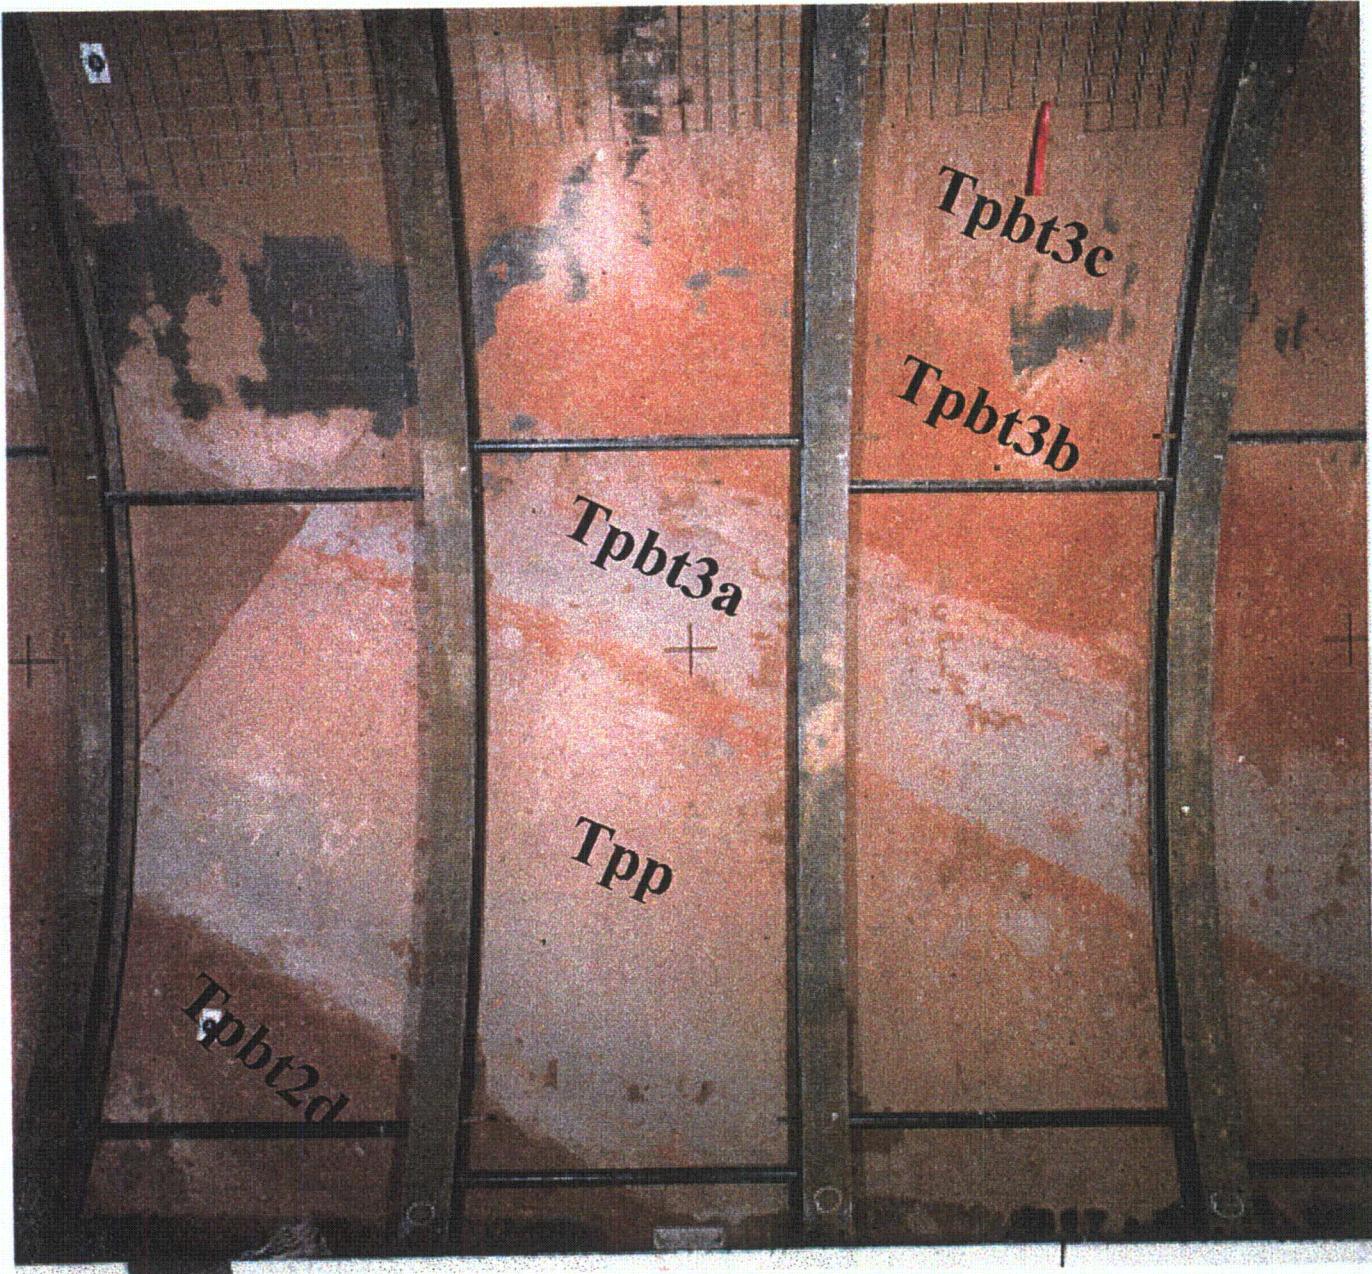
Photo 4. Pah Canyon Tuff showing reverse grading of pumice fragments along the left rib near Sta. 74+91. A small fault truncates the unit on the left side of the photo. Field of view is approximately 4.5 m. Photo PG024572.
