**GEOLOGY OF THE SOUTH RAMP - STATION 55+00 TO 78+77,
EXPLORATORY STUDIES FACILITY, YUCCA MOUNTAIN PROJECT,
YUCCA MOUNTAIN, NEVADA**

**by G.L.W. Eatman, W.L. Singleton, T.C. Moyer, D.L. Barr, A.L. Albin,
R.C. Lung, and S.C. Beason**

Bureau of Reclamation and U.S. Geological Survey

**Denver, Colorado
1997**

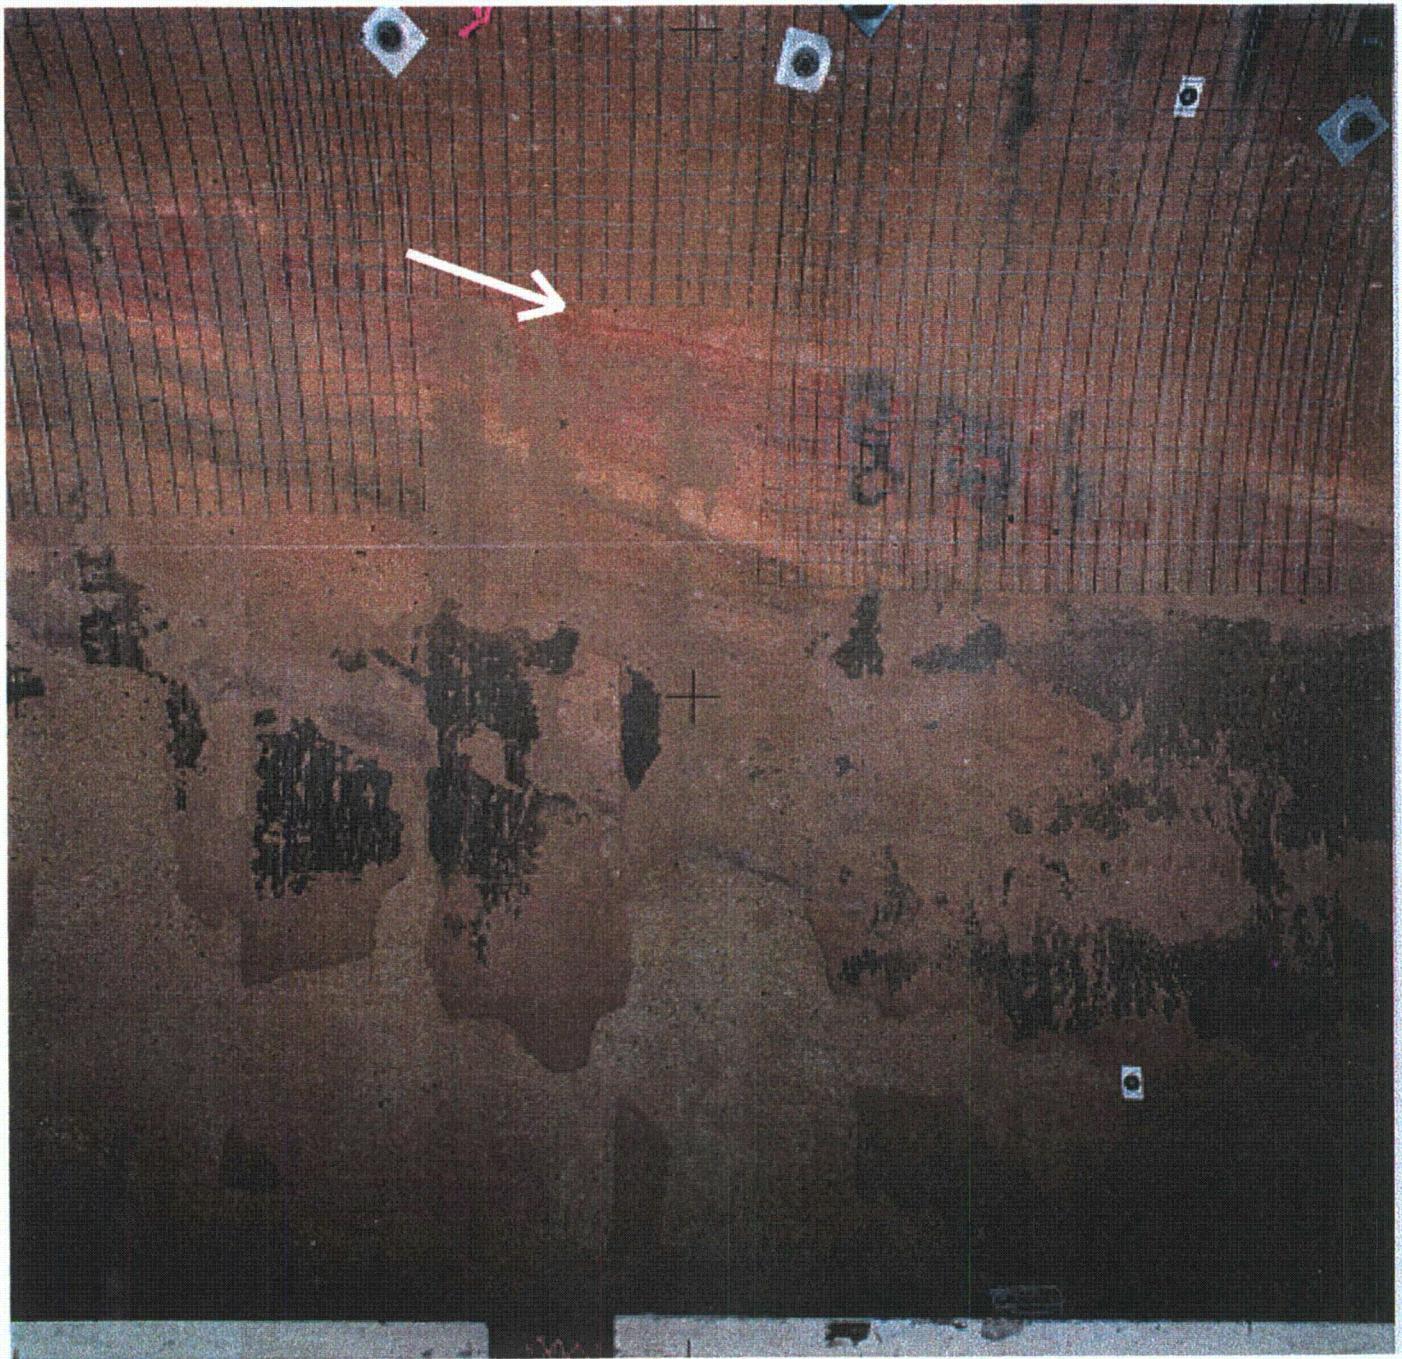
Photo 5. The upper part of the post-Topopah Spring Tuff pumice-fall deposits, showing crude stratification near the top of the deposit, the “red clay layer”, and the base of the overlying reworked tephra deposit, Tpbt2D (arrow). Field of view is approximately 4.5 m; rock bolt bearing plates are 15 cm across. Photo PG021682.

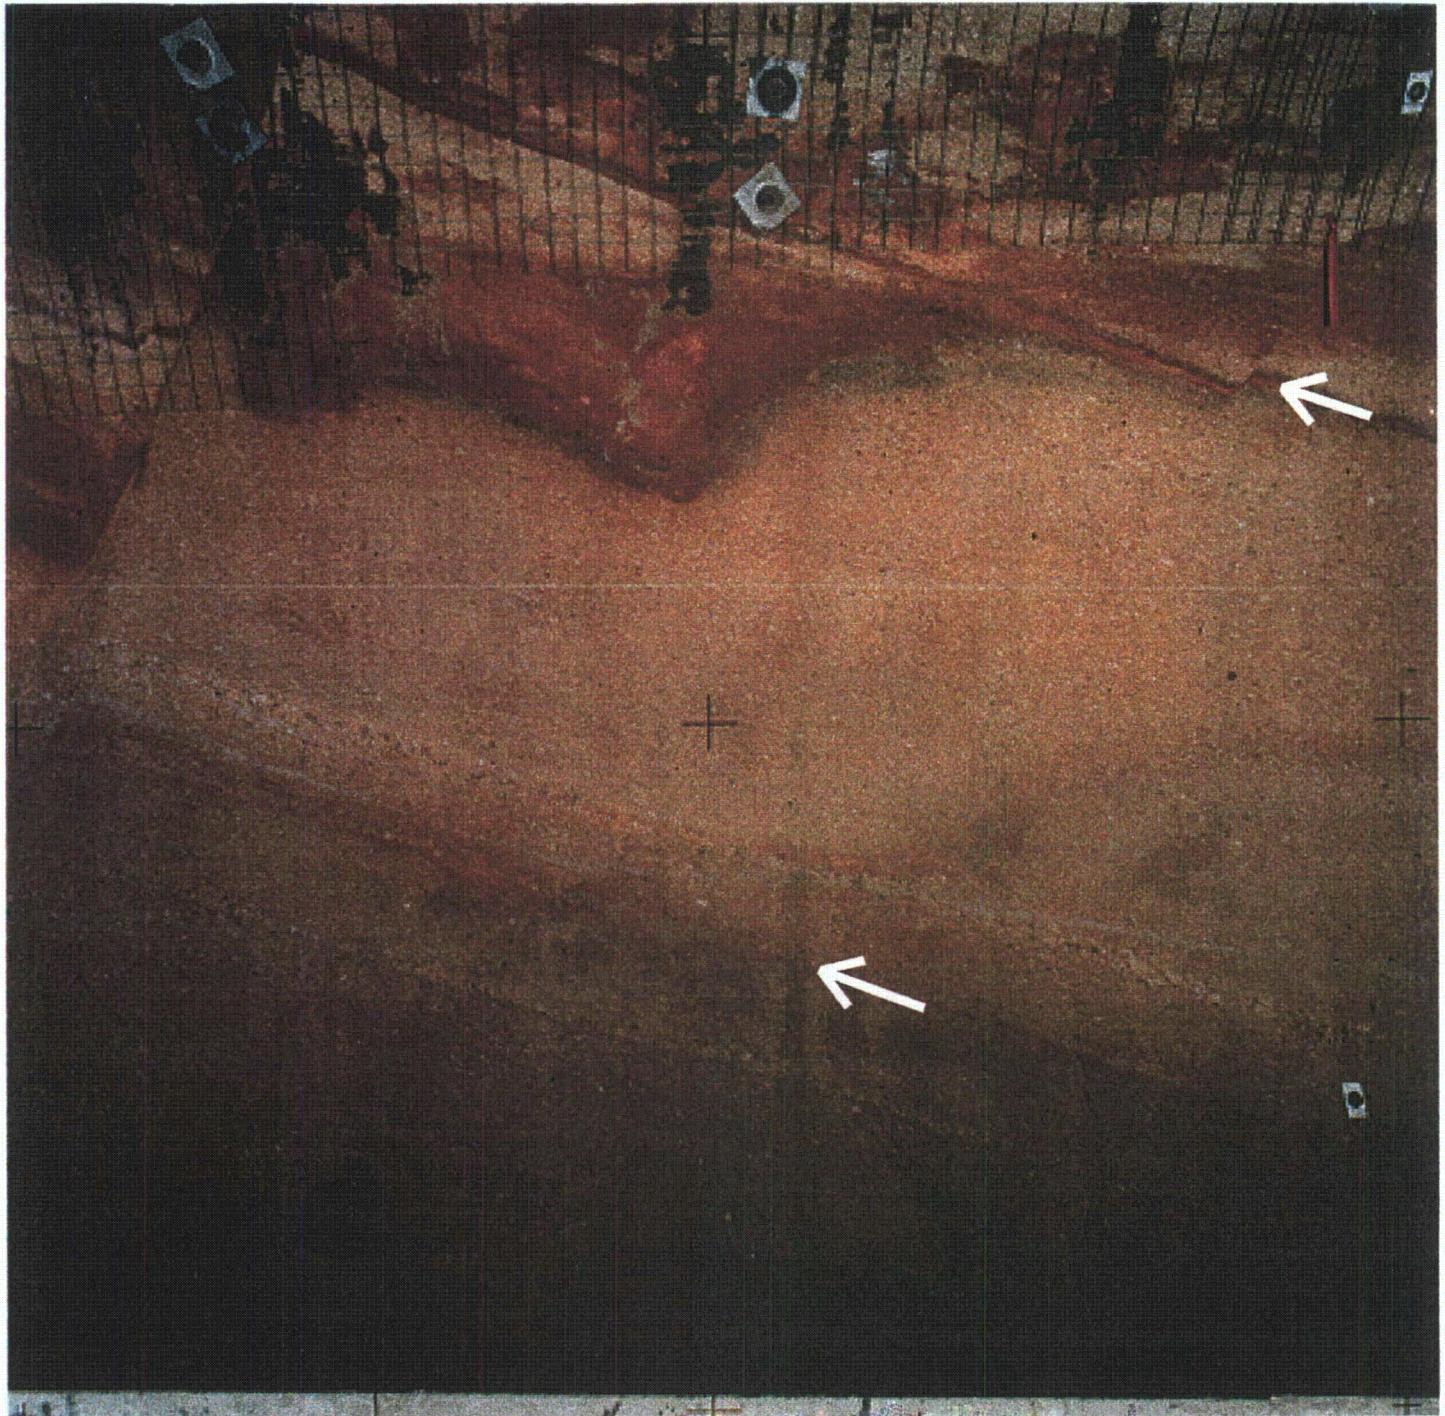
Photo 6. View of the post-Topopah Spring Tuff pumice-fall deposits near Sta. 74+00, left rib, showing ash layer 2 and ash layer 1 (arrows) truncated by a small fault on the right side of the image. Argillic alteration associated with fumarolic degassing of the underlying pyroclastic-flow deposits creates discoloration of the pumice-fall material in the upper part of the photo. Field of view is approximately 4.5 m; rock bolt bearing plates are 15 cm across. Photo PG024437.

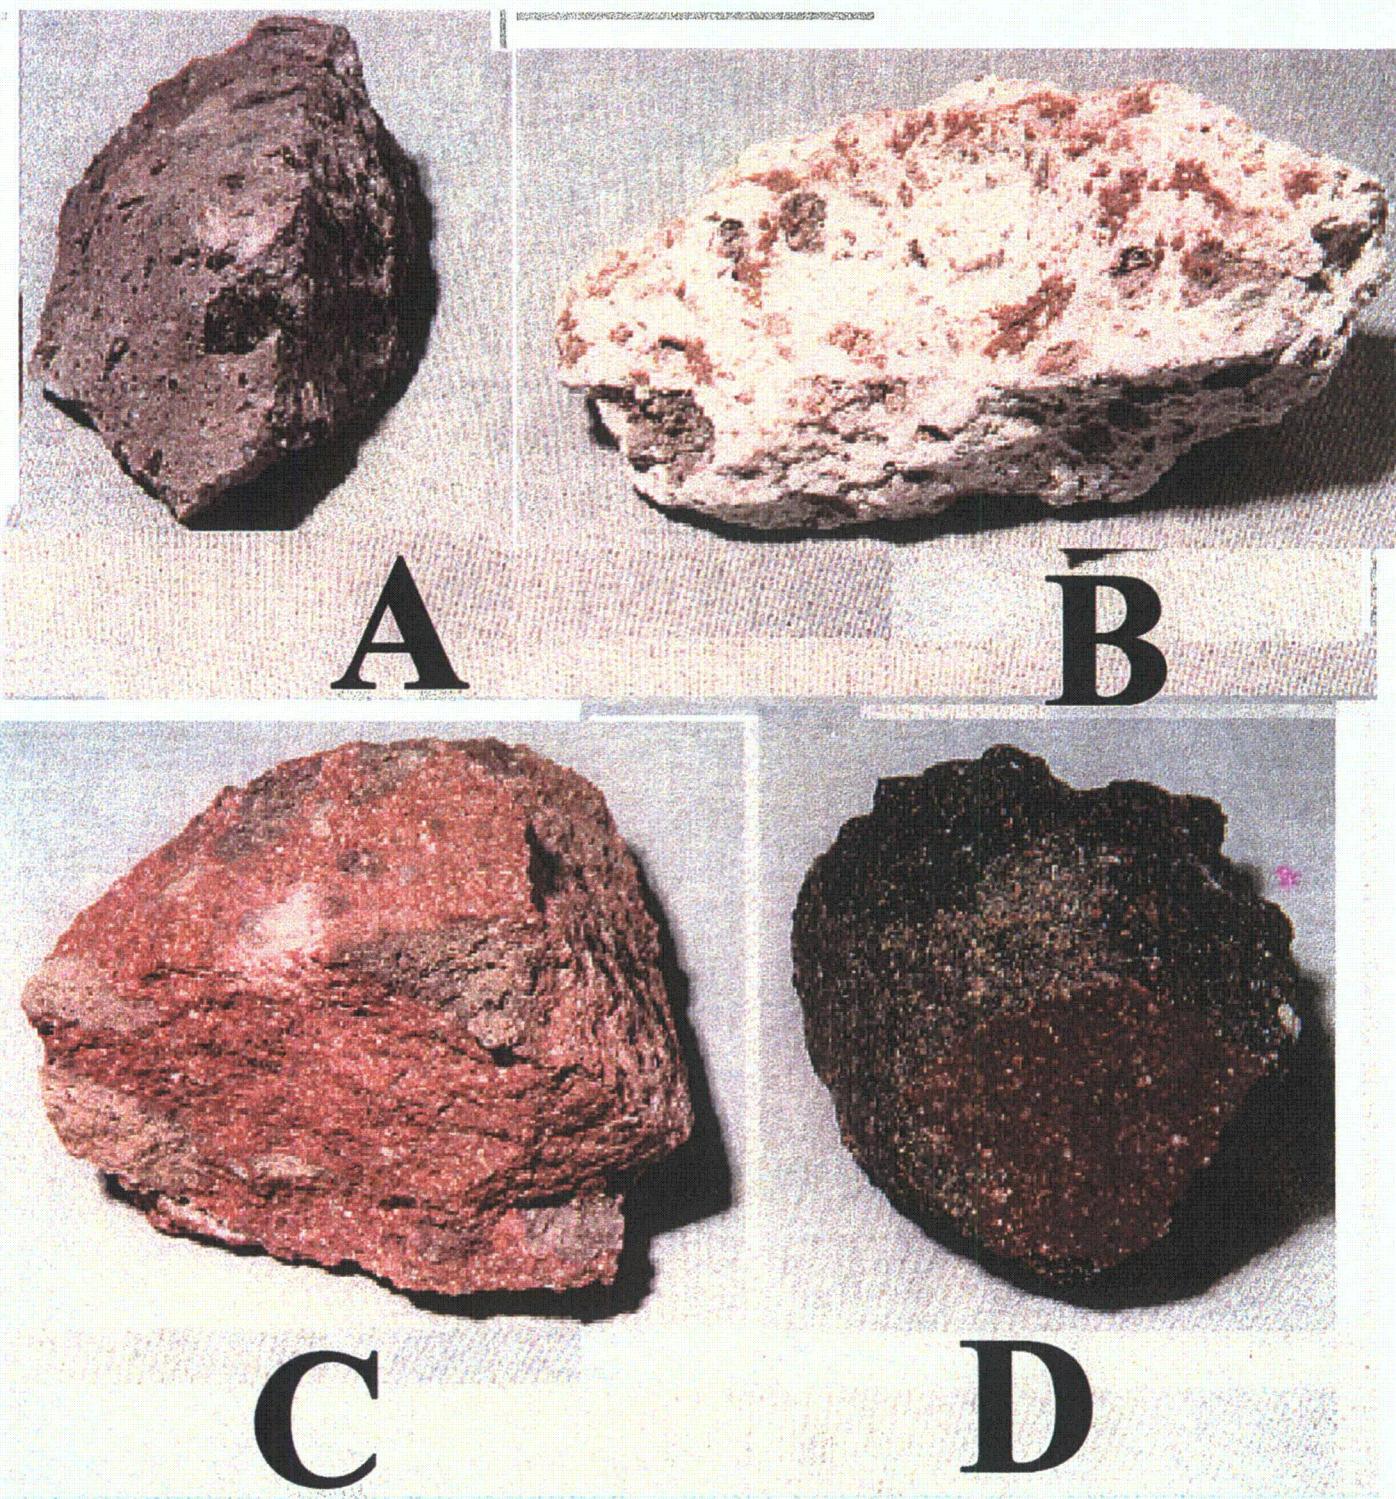
Photo 7. A series of hand samples collected from the South Ramp showing variations in the character of the upper part of the Topopah Spring Tuff pyroclastic-flow deposits. A. Moderately welded, vapor-phase altered tuff from Sta. 70+00. B. Moderately welded, bleached and vapor-phase altered tuff from Sta. 74+48. C. Moderately welded, devitrified and vapor-phase altered tuff of the crystal-rich nonlithophysal zone (Tptrn2) from Sta. 69+68. D. Densely welded, crystal-rich vitrophyre (Tptrv1) from Sta. 69+96. All samples collected from approximately 1 m above the right invert. Photo YM15609

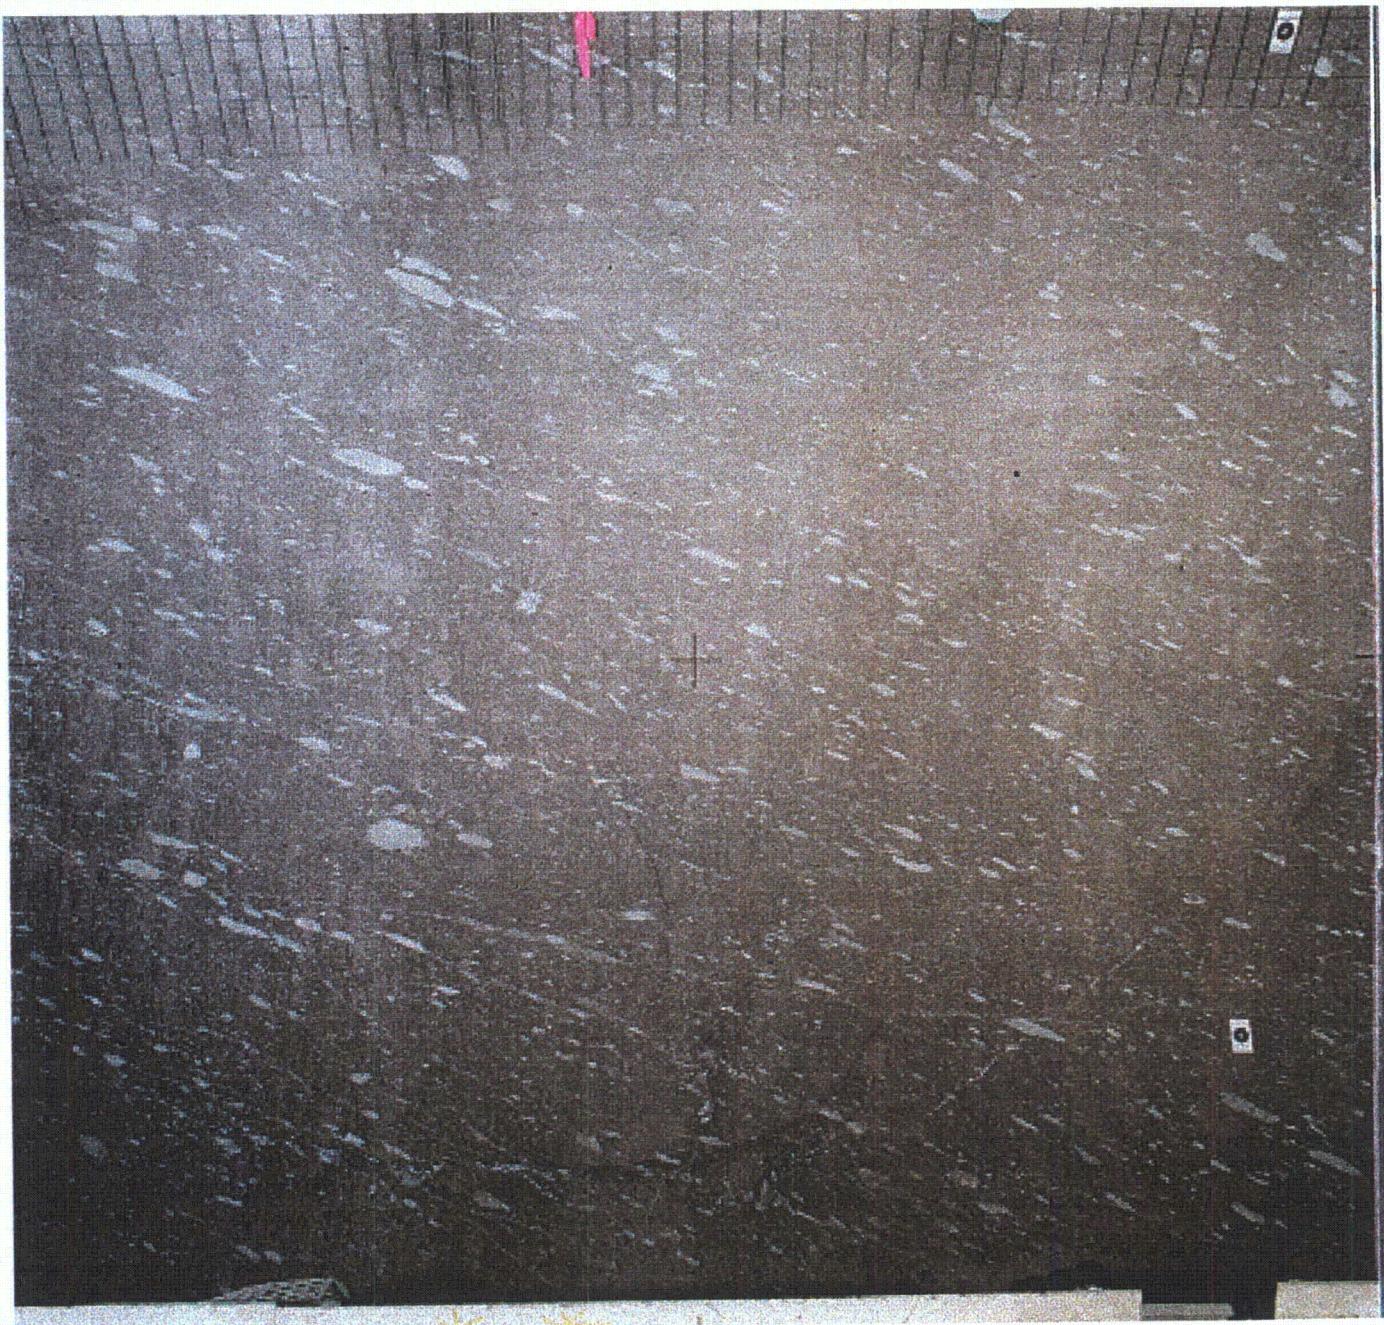
Photo 8. View of the crystal-rich nonlithophysal zone of the Topopah Spring Tuff at Sta. 66+07, left rib. Field of view is approximately 4.5 m. Photo PG021477.

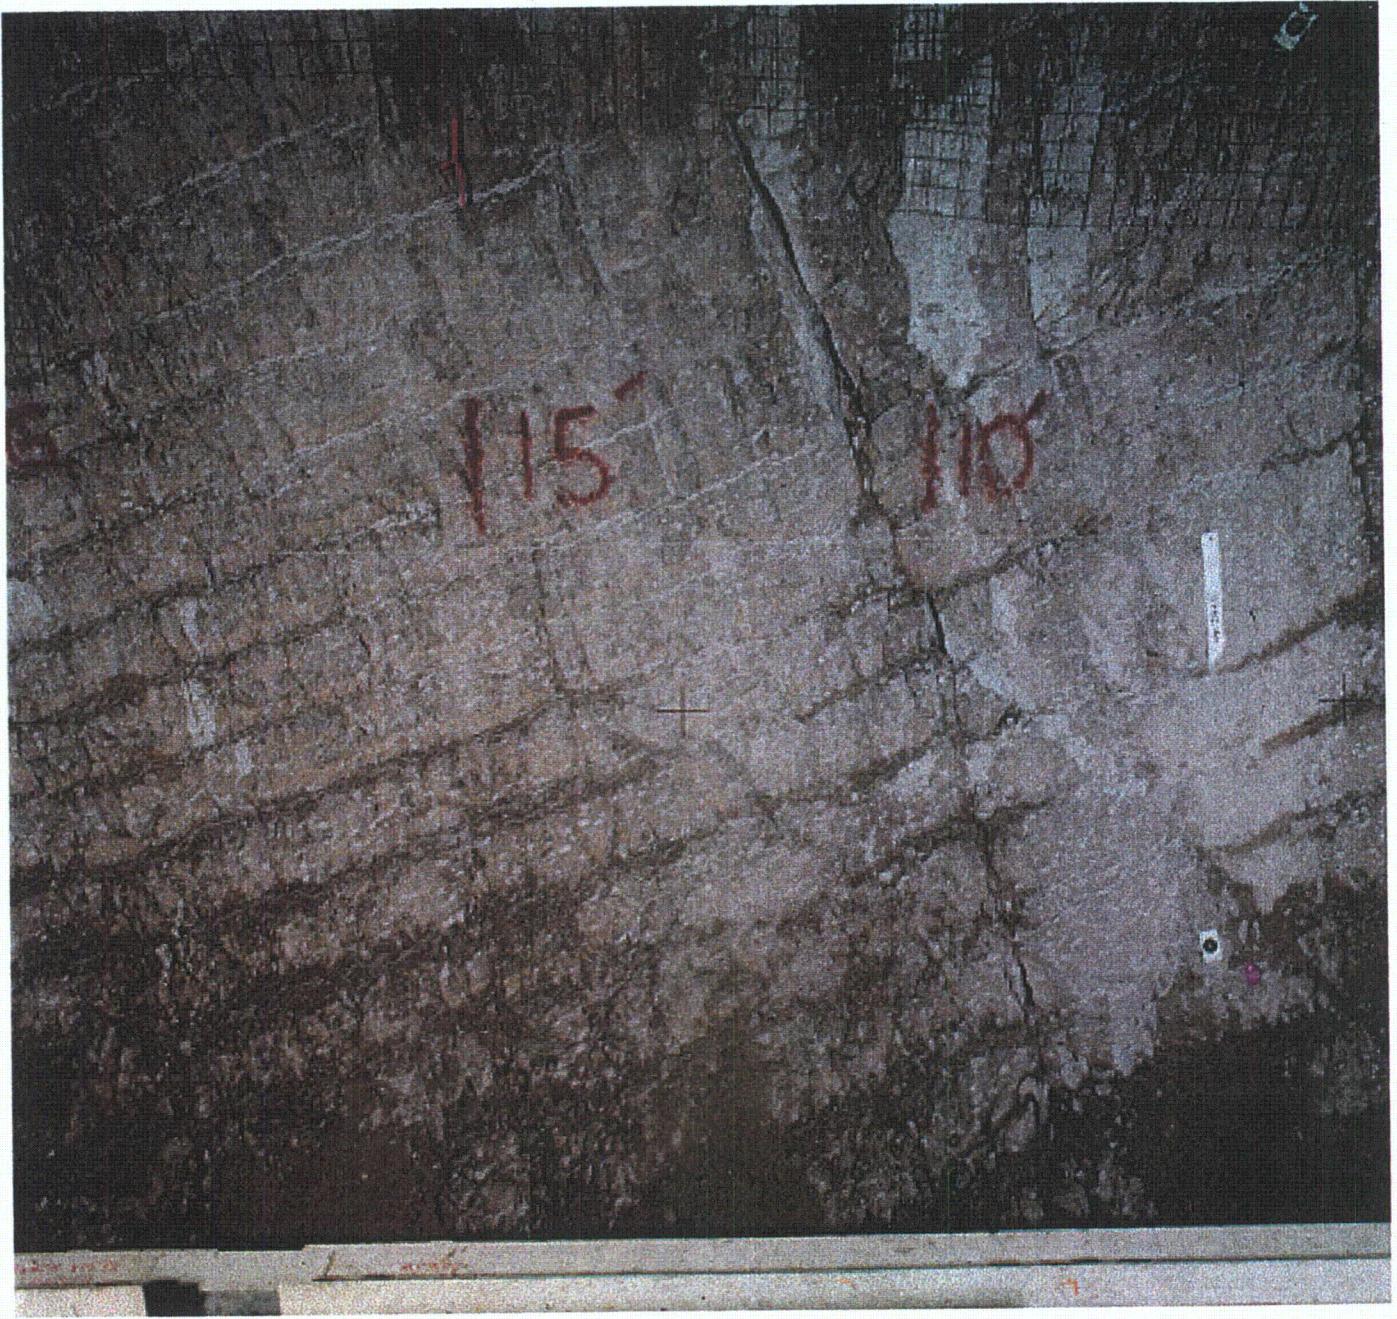
Photo 9. View of the upper portion of the crystal-poor middle nonlithophysal zone of the Topopah Spring Tuff along the right rib near Sta. 71+52. This interval is characterized by a series of laterally continuous vapor-phase partings spaced on vertical intervals of 25 to 40 cm. Field of view is approximately 4.5 m; rock bolt bearing plates are 15 cm across. Photo PG023343.

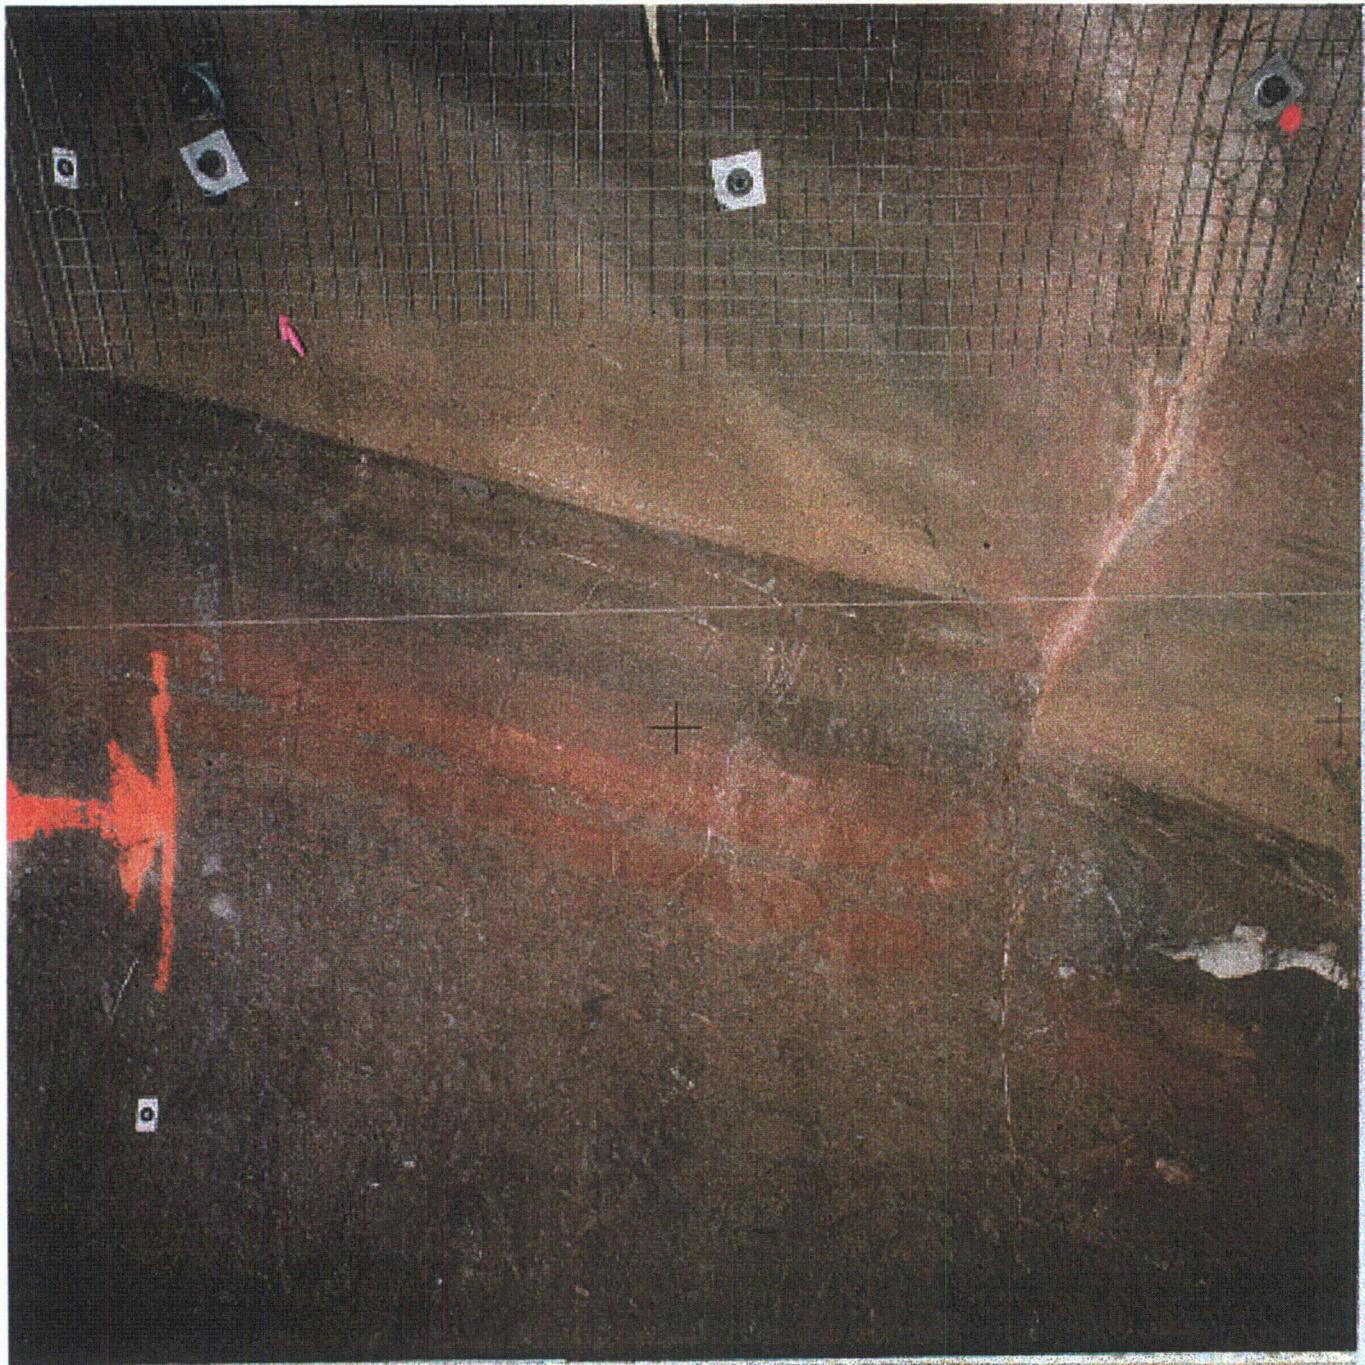
Photo 10. View of the contact between the pyroclastic-flow deposits of the Topopah Spring Tuff and the overlying pumice-fall deposits exposed along the left rib near Sta. 66+45. Alteration of the pumice-fall material is along a small fault that offsets the flow-fall contact. The fault can be traced downward through the pyroclastic-flow deposits which were not altered. Field of view is approximately 4.5 m; rock bolt bearing plates are 15 cm across. Photo PG021582.

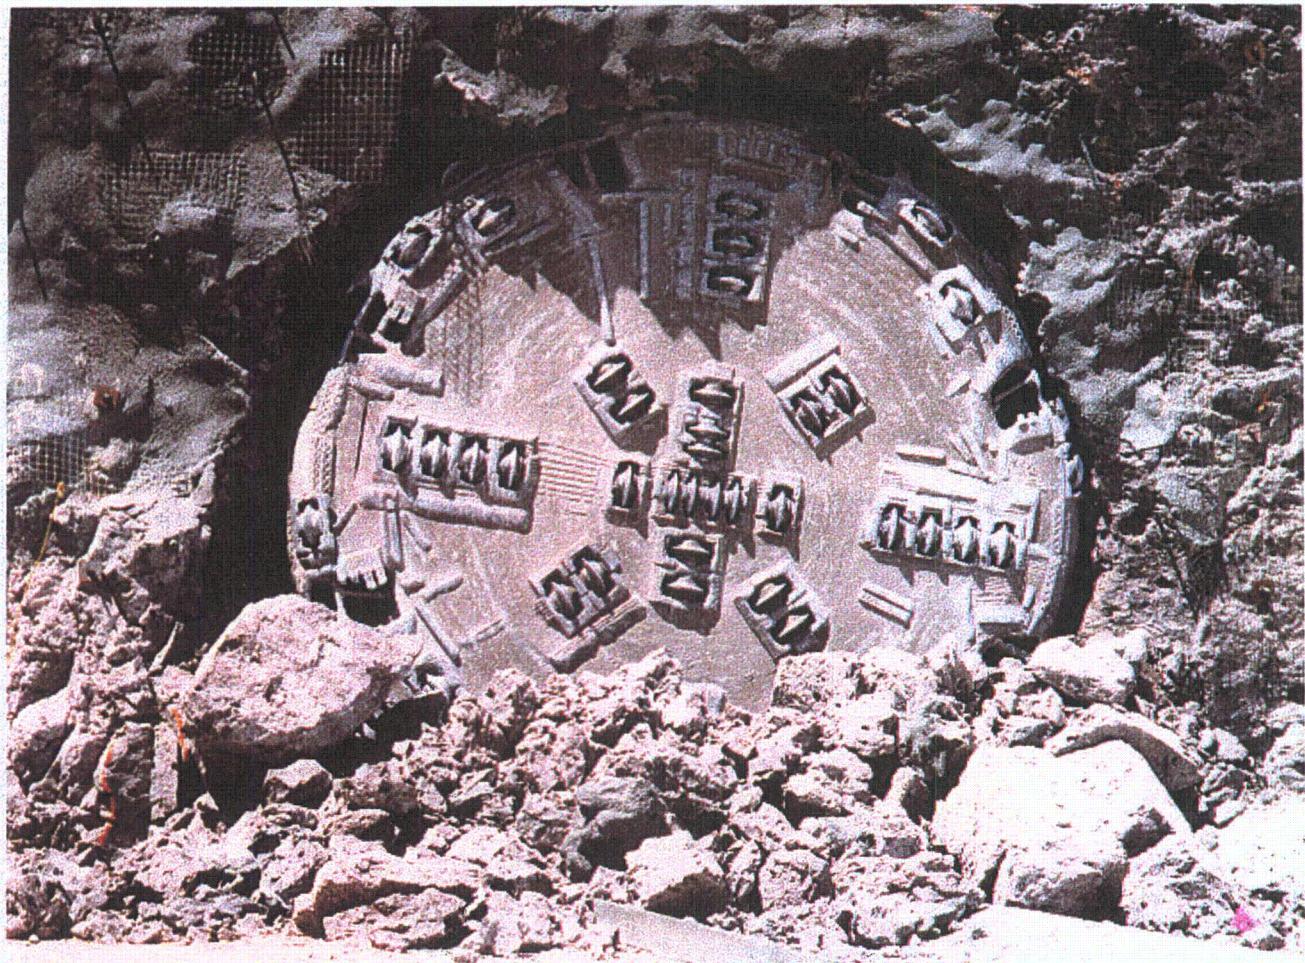
Photo 11. Photograph of tunnel boring machine after breaking through at the South Portal. Photo YM1434!

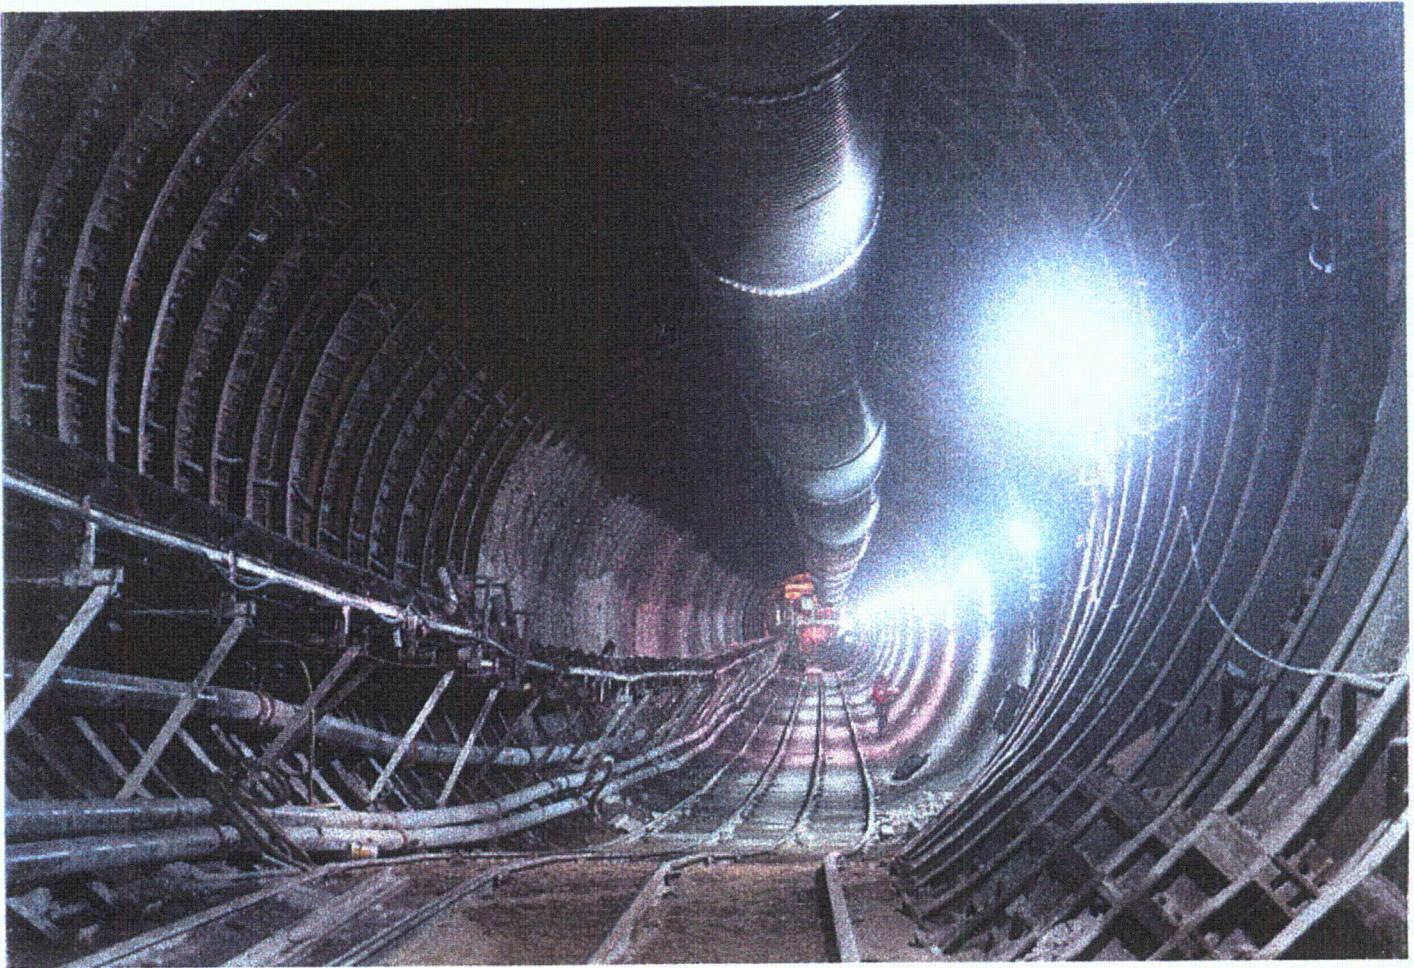
Photo 12. Photograph of South Ramp showing fault zone at Sta. 71+31. Photo shows heavy ground support with steel sets and lagging, and the loss of grade of more than 1 meter where the TBM dropped while excavating through this zone. Photo YM13876.
