NUREG/CR-6989

Methodology for Estimating Fabrication Flaw Density and Distribution – Reactor Pressure Vessel Welds

Pacific Northwest National Laboratory

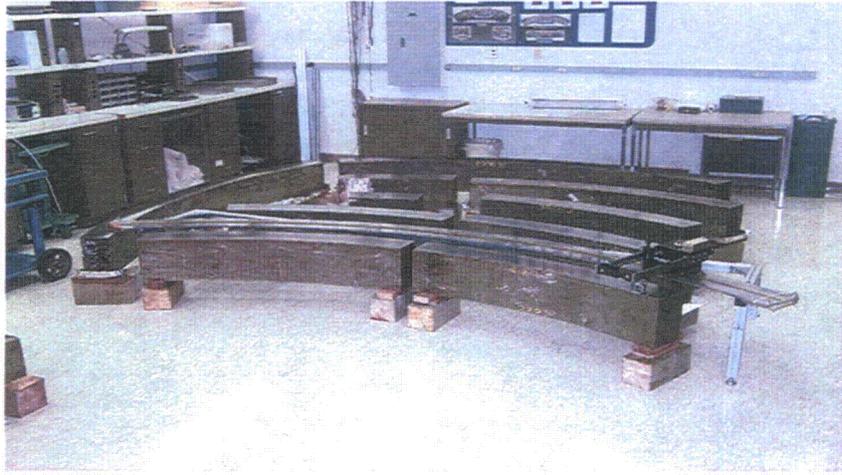
Figure 2.3 Large Weld Segments from the Shoreham Vessel

The second stage in developing validated flaw rates for RPVs used weld-normal SAFT-UT inspections with cut and machined inspection surfaces. Figure 2.3 shows large weld segments weighing up to 2000 Kg (4400 lb) prepared for inspection in the laboratory. The process for preparing the specimens is fully described in Schuster et al. (1999). Using weld-normal inspections, planar flaws in the weld's fusion zones and in the weld repairs can easily be detected and sized. Then, using these detection and sizing results, the flawed material is prioritized for additional validation testing.

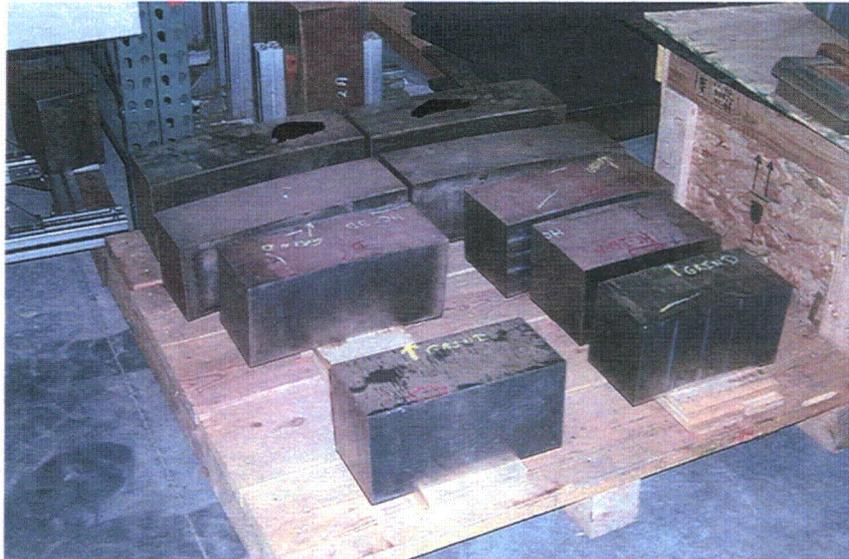
Figure 2.4 Photo of Small Weld Segments from Hope Creek Unit 2 and River Bend Unit 2 Vessels for Immersion Testing

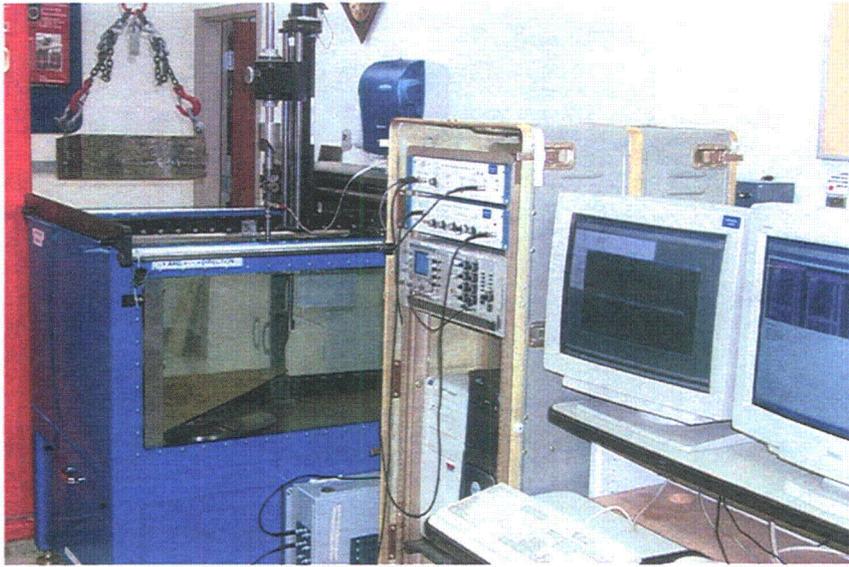
Figure 2.5 SAFT-UT Immersion Inspection of Small Weld Segments

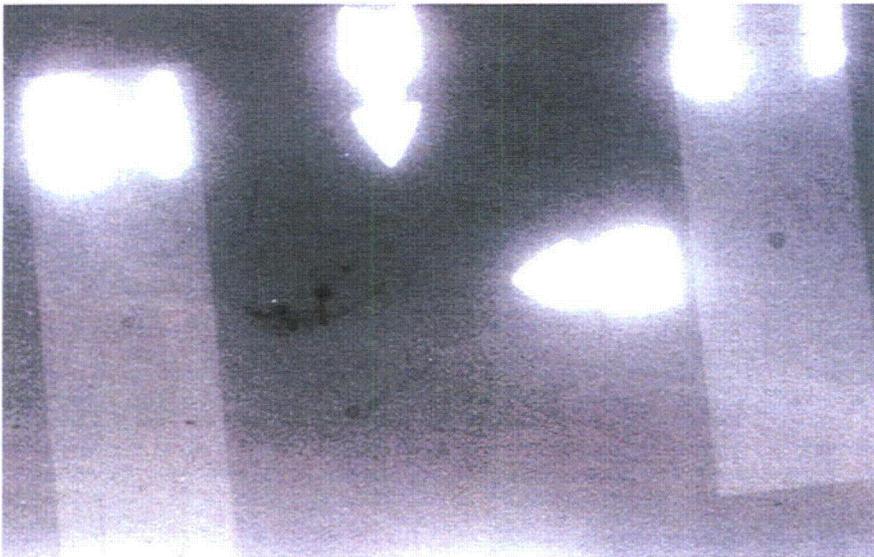
Figure 2.10 Image of Fabrication Flaw Using Film Radiography

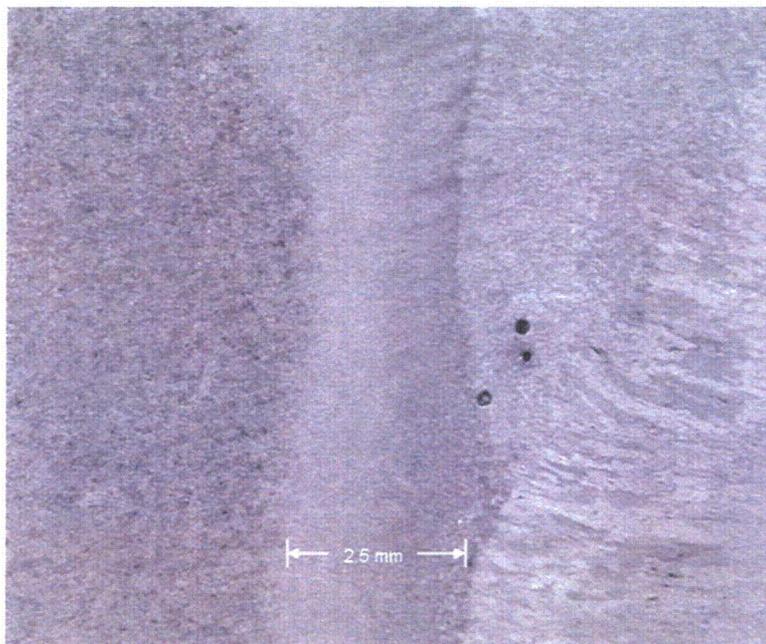
Figure B.3 Metallograph of Flaw HC5B at 10x
