# WOLF CREEK

Subject: Docket No. 50-482: Supplemental Information Regarding NRC Request for Additional Information for Responses to Generic Letter (GL) 2004-02, "Potential Impact of Debris Blockage on Emergency Recirculation during Design Basis Accidents at Pressurized-Water Reactors"

Enclosures: I Alden Video Description of the Fiber Debris Transport Testing  
II Video of Flume Transport Test #1, Latent Fiber Transport Test  
III Video of Flume Transport Test #2, Smalls Transport Test

## Fiber debris transport testing for the Wolf Creek and Callaway power plants

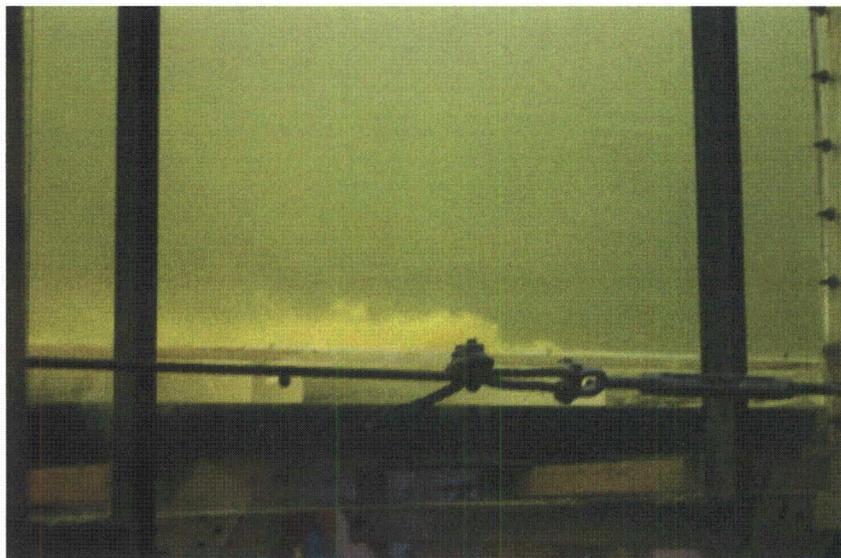
**Figure 6. Latent fiber leading edge being pulled downstream**

- 2:25 – 8:43 (14:35:24 – 14:41:42): The fiber has all been placed into the flume, and the five minute settling period has begun. All of the fiber will have settled onto the flume floor by the end of this five minute period.
- 8:43 – 10:05 (14:41:42- 14:42:04): The pump has just been started and the flow rate of 439.4 gpm or slightly higher has been established in the flume. The fiber can be observed moving downstream. A cloud of fiber is lifted off of the flume floor and transports downstream.

- 10:05 – 16:40 (14:42:04 – 14:49:39): More than half the fiber has moved downstream and little fiber remains to be transported. The movement of the fiber downstream is still occurring but at a reduced rate (Figure 6).
- 16:40 – 37:18 (14:49:39 – 15:10:17): More than  $\frac{3}{4}$  of the fiber has transported to the strainer by this time. The last small tufts of fiber are being transported to the strainer.

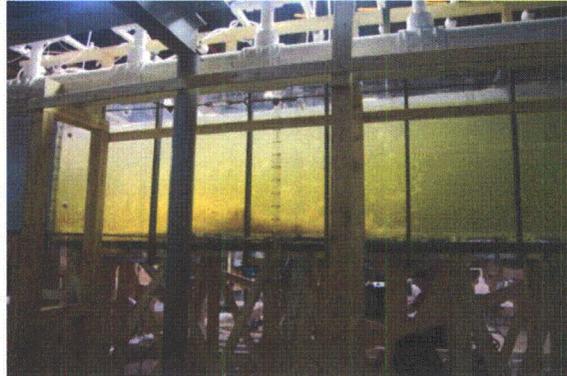
**Figure 10. Fibers settling in flume downstream of introduction**

- 2:51 – 5:00 (15:37:45 – 15:39:54): The lighter smaller fiber and individual fiber is transporting to the strainer at this time, while the heavier fiber material is starting to accumulate on the floor (Figure 10). It should be noted that small agglomerations of fiber or “clumps” can be seen entering the water column on introduction. These small clumps form very quickly in the introduction vessel. The water used to wet and prepare the debris is hot (approximately 120°F, similar to the conditions for head loss testing) to remove entrapped air. This also leads to rapid settling of the fiber to the bottom of the introduction vessel (fiber settles very quickly in hot water) once mixing has ceased. The clumps are thus not formed by inadequate mixing but by rapid settling of the fiber in the preparation bucket. As such, the clumps that are formed from fiber loosely settling in the introduction vessel can be seen to break up readily in the water column and release entrapped fines and disintegrate into even smaller clumps of fiber. The video shows what appear to be several additions of fiber. However, the additions represent the rinsing of the fiber from the bottom of the bucket which is also performed during head loss testing.

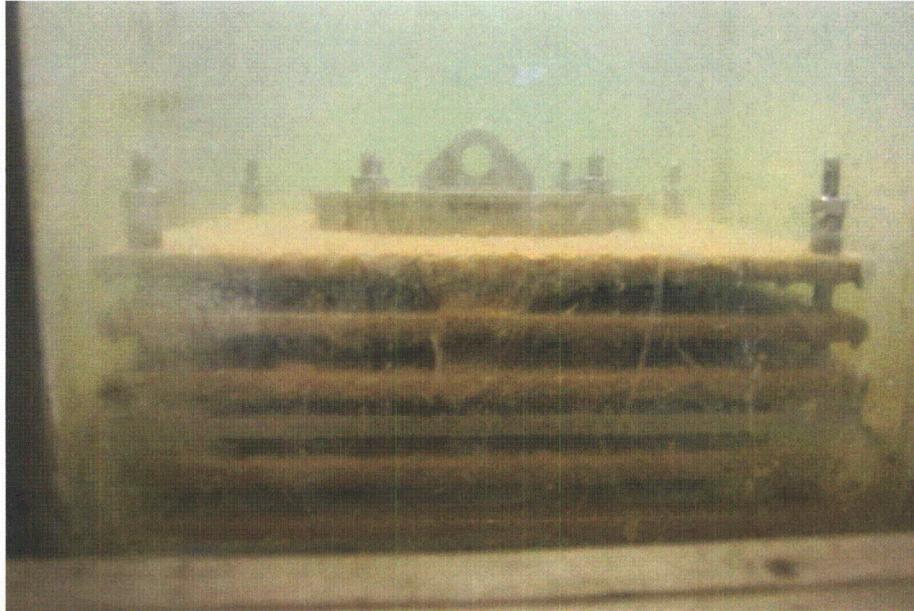
Figure 11 shows a picture of the strainer near the end of testing. It is clear from this picture that a significant amount of fines were released from the smalls and traveled to the strainer. Given that Figure 7 shows the picture of 0.25 lb of latent fine fiber on the screen, it is possible to

conservatively conclude that at least twice this amount separated from the introduced small fiber and made it to the strainer in the smalls introduction test.

**Figure 11. Fine fiber on strainer after smalls introduction**
