**YUCCA MOUNTAIN – REQUEST FOR ADDITIONAL INFORMATION – VOLUME 2,
CHAPTER 2.1.1.4, SET 2 AND SET 9; CHAPTER 2.1.1.5, SET 1 – REFERENCES**

EDF Title: FY1999 DROP TESTING REPORT FOR THE 18-INCH STANDARDIZED DOE SNF CANISTER			
Summary:			
EDF-NSNF-007 Revision 0 originally released this report. This Revision 1 supplements the original release by making minor corrections to 4 pages (identified by a vertical bar in the right-side column of a modified page):			
-Part I, page 28, modified one paragraph to satisfy Deficiency Report 00-NSNF-AU-011-DR-002			
-Part II, page 12, replaced an incorrect coefficient of friction value of 0.05 with the correct value of 0.10			
-Part II, page 33, added a sentence to clarify the post-drop coefficient of friction value used for canister 04			
-Appendix B, page B-47, corrected a measurement value.			
Only the above modified pages are attached to this EDF-NSNF-007 Revision 1.			
Total Attachments:	Attachment Nos.:	No. of pages in each:	Total Pages:
4	Part I, page 28 Part II, pages 12 and 33 Appendix B, page B-47	1 2 1	4 total pages

1. PROGRAM OBJECTIVES

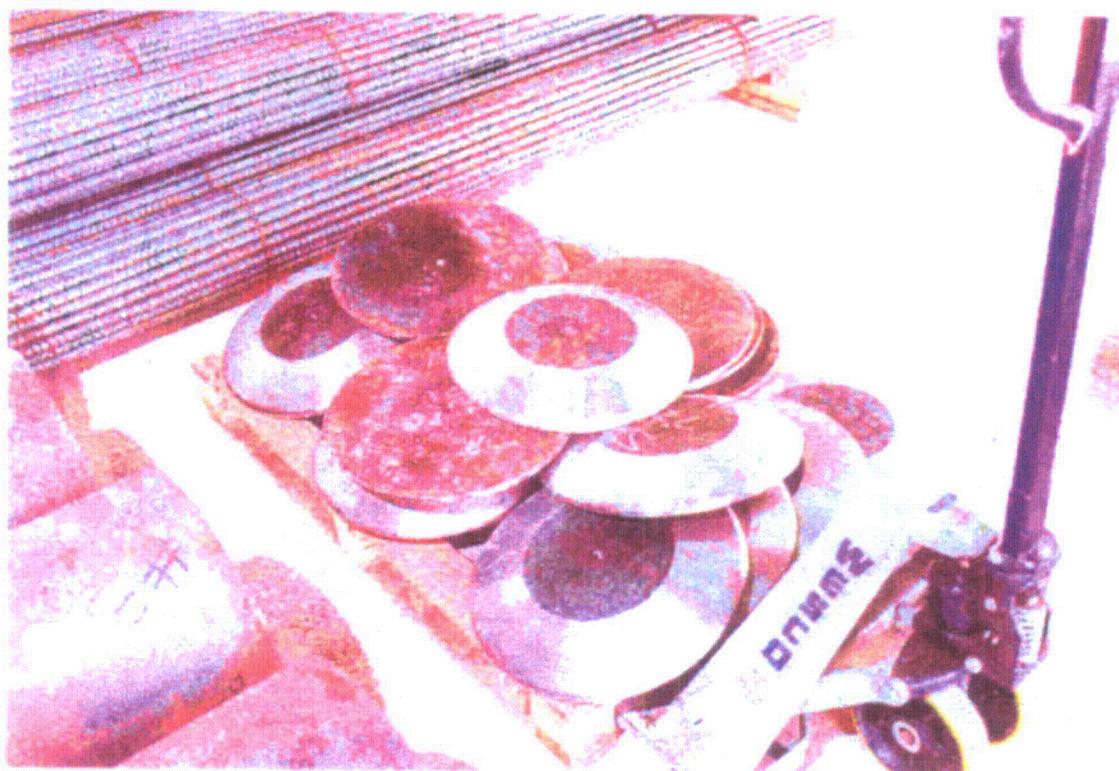
Figure 3. Impact Plates

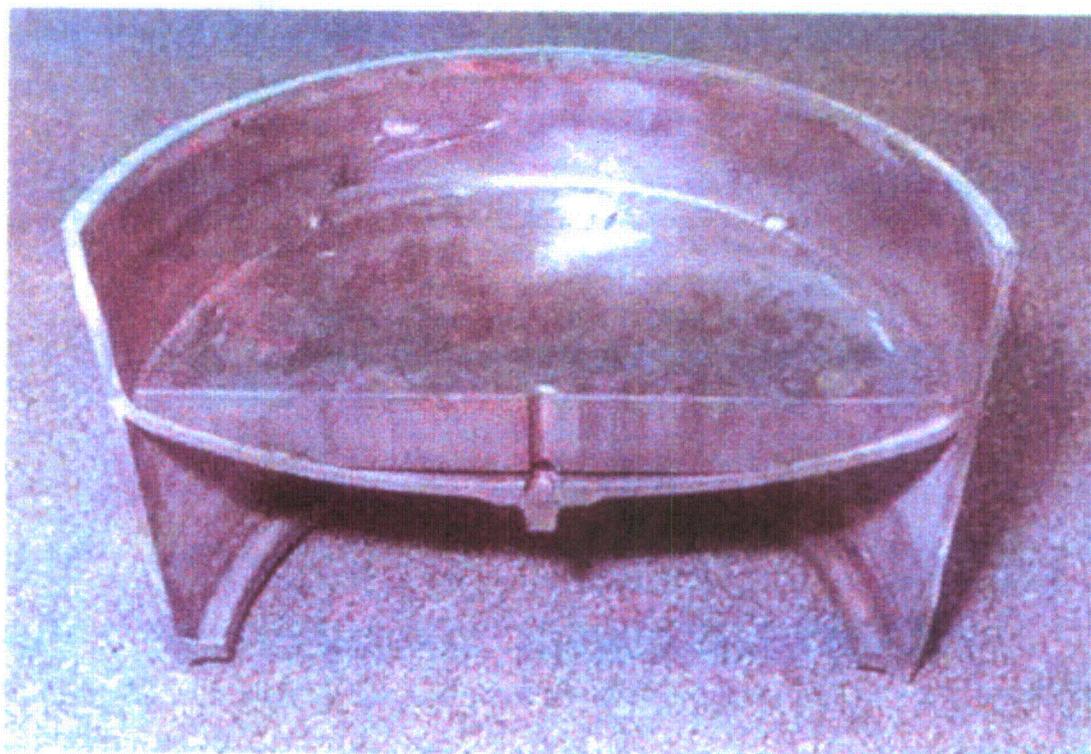
Figure 4. Cut-Away View of Canister End

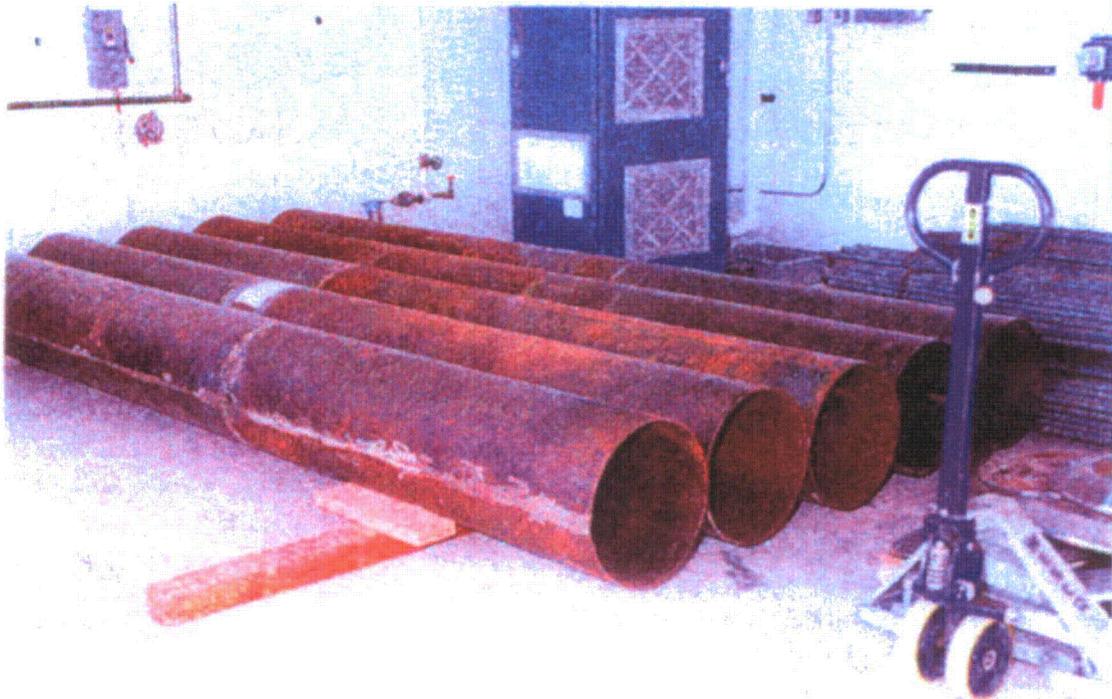
Figure 6. Sleeves

Next the 3/16-inch thick sleeve (Figure 6) was lowered into the canister. It rested on the top flat surface of the lower impact plate. At this time, when required, positioning lugs were welded to the canister inside wall, through the sleeve (Figure 7). By holding the sleeve in position, the other internals, namely the spoked-wheel basket could also be held in the desired position for the drop test. Then the spoked-wheel basket was lowered into the canister bottom assembly (inside the sleeve) and also rested on the top flat surface of the lower impact plate. Although the pipe material used for the canisters was not perfectly round (as one would expect during actual usage), the impact plates, sleeves, and spoked-wheel baskets all loaded with exceptional ease and did not require any force to position them. The dimensions specified on the engineering sketches were correctly specified to allow easy loading yet still provide adequate space for the SNF. The remote loading of these internals can indeed be performed with ease. The only recommended change would be to shorten the sleeve so that it doesn't overlap with the top head assembly backing ring (see Appendix A drawings). In this way, the backing ring would still protect the canister inside wall from impacting internals and there would not be any interference between the backing ring and the sleeve while the top head assembly is being positioned for final welding.

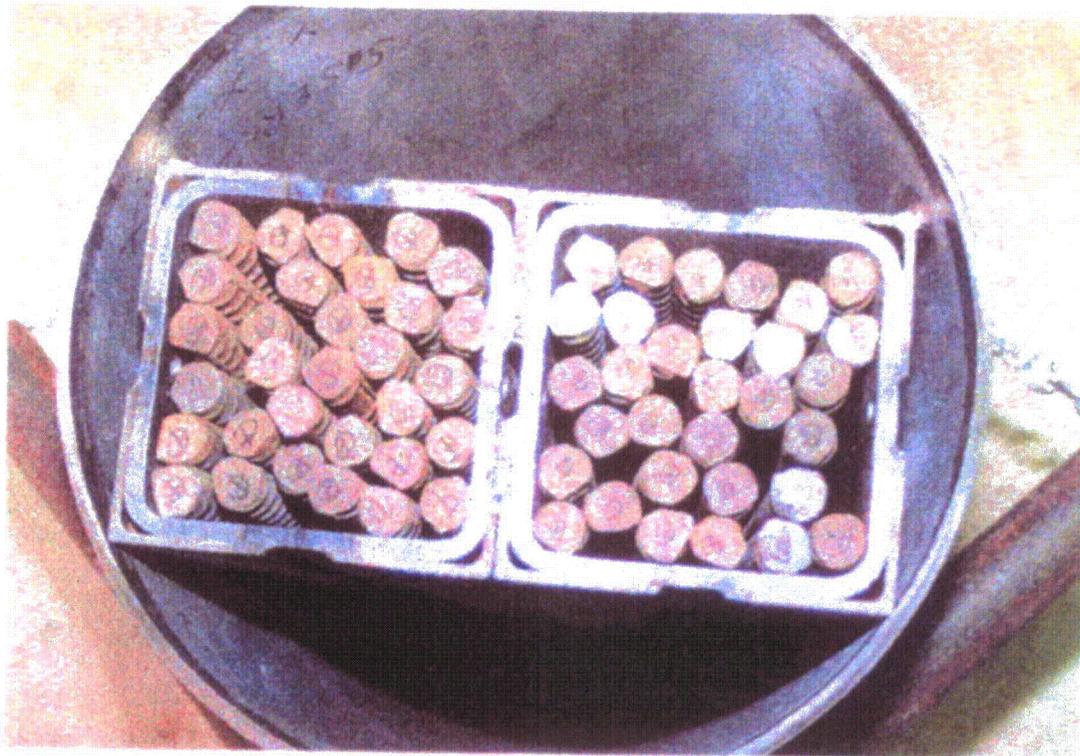
Figure 8. Simulated Shippingport Fuel Bundles (Canister 18-10-90-07)

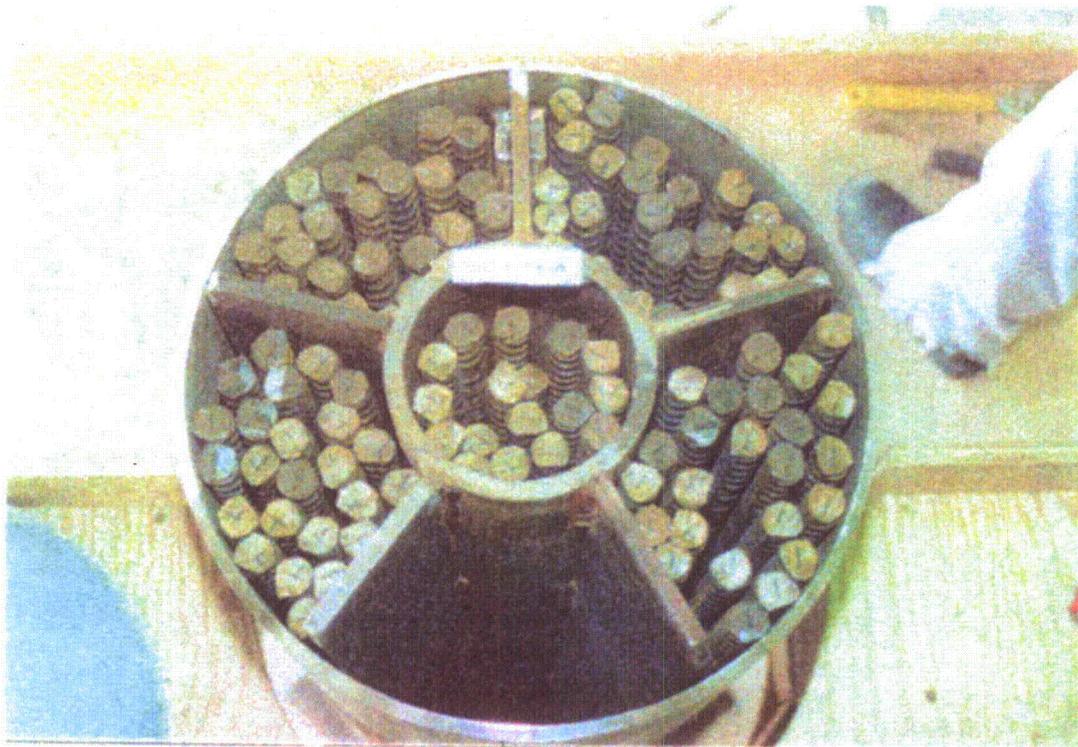
Figure 11. Empty Slot in Spoked Assembly (Canister 18-15-PP-09)

After the fabricated internals were loaded into the test canisters, the rebar was loaded. Care was taken to properly orient the internals and rebar with respect to where the test canisters were designated to impact during the drop tests. Figures 9 and 10 identify the internals configuration for each test canister and how the rebar was positioned. Whenever the most significant impact occurred on a canister skirt, the canister internals were positioned to cause the most potential damage to the canister containment, and the canister was marked so that the initial impact occurred on the longitudinal weld seam of the skirt. Whenever the most significant impact occurred on the canister pressure boundary, the canister internals were positioned to cause the most potential damage to the canister, and the canister was marked so that the initial impact occurred on the longitudinal weld seam of the canister pressure boundary. For the two test canisters being subjected to puncture tests (18-15-PW-08 and 18-15-PP-09), rebar was omitted from that local puncture region in order to permit as much canister deformation as possible. This is clearly illustrated in Figure 11.

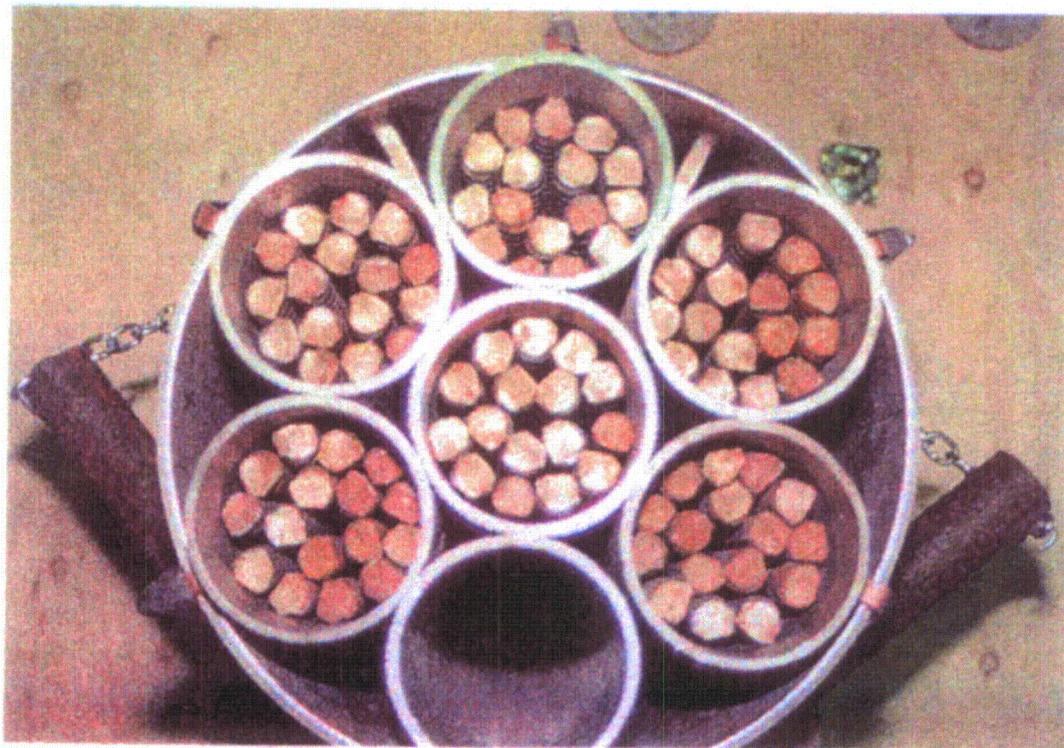
Figure 12. Six Loaded HICs and One Empty HIC (Canister 18-10-90-06)

For canister 18-10-90-06 with the simulated HICs, the bottom simulated HIC (aligned with the canister longitudinal weld seam) was left empty while all of the other simulated HICs were filled with rebar (Figure 12). This would produce more damage in the bottom simulated HIC. Finite element predictions were also made for these specific internals in order to ascertain how to best determine accurate internals deformations. After loading the rebar into the simulated HICs, ½-inch-thick endplates were welded into all seven of the simulated HICs, including the empty one (Figure 13). Except for the two canisters subjected to puncture testing and the canister with the simulated HICs, the goal was to always uniformly distribute the rebar placement across the canister (Figure 14).

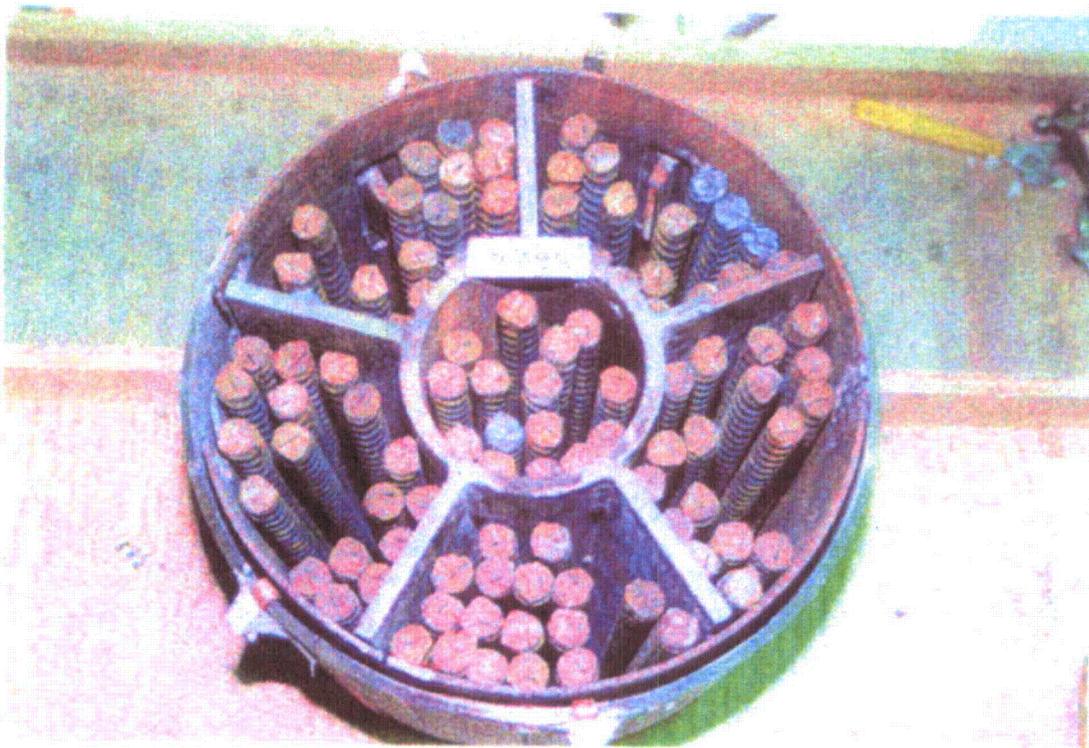
Figure 14. Uniform Rebar Distribution (Canister 18-15-80-05)

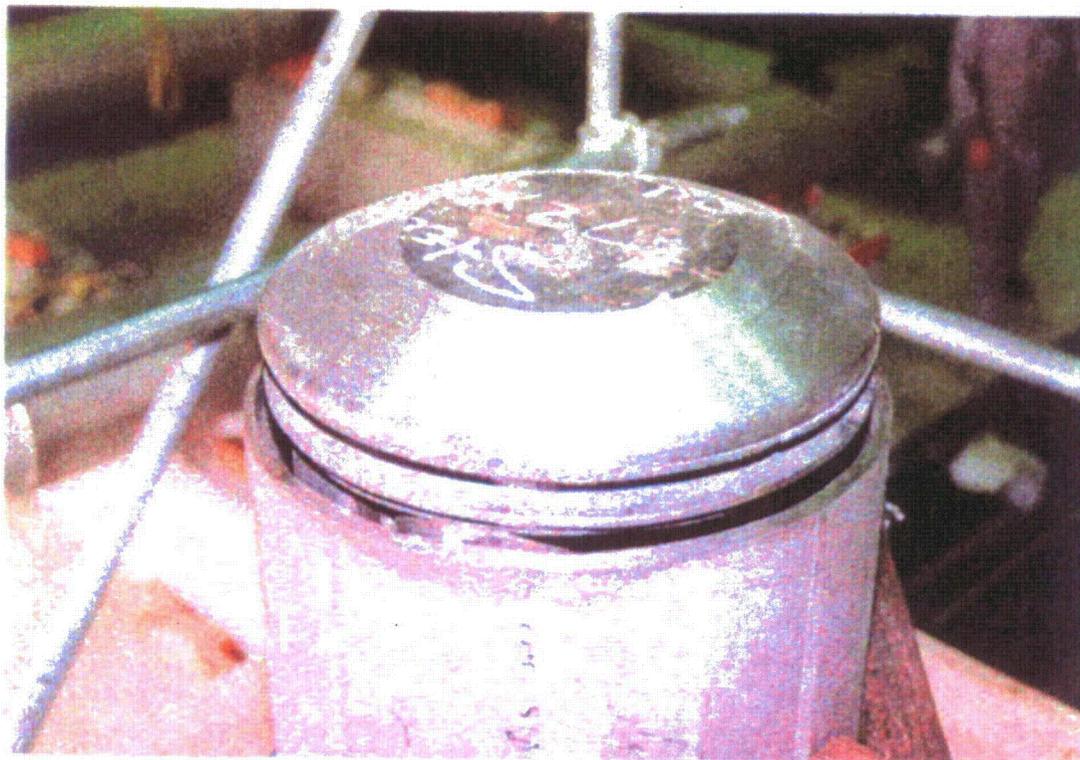
Figure 15. Impact Plate and Spacer Plates (Canister 18-10-90-07)

After each test canister was loaded, the top impact plate and spacer plates (where necessary) were positioned. Figure 15 shows an example of the impact plate and spacer plates properly positioned. Next, the top head assembly was positioned onto the bottom canister assembly. After a quality examination checked for proper alignment, TAN personnel then completed the final closure weld that sealed each test canister. Manual TIG welding using INEEL weld procedure S2.0 was utilized for the final closure welds.

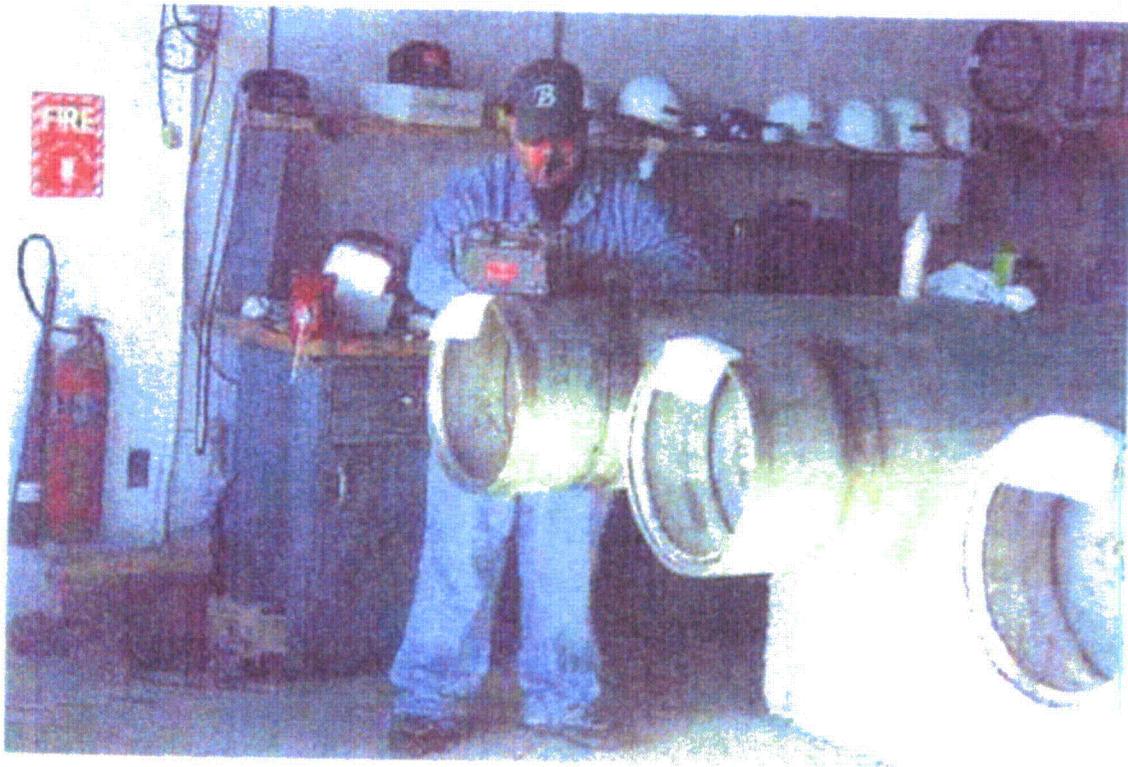
Figure 18. UT Inspection in Progress

Volumetric examinations of the final closure welds were planned using ultrasonic testing (UT) methods (Figure 18). After a substantial number of indications [per LMITCO examination procedure TPR-4974 (Reference 18)] were recorded by the UT examiner, a significant portion of the closure welds were ground out on the first five test canisters (18-15-00-01 through 18-15-80-05). However, during this laborious grinding process, few if any actual defects were noticed. After re-welding these canisters, the UT examiner indicated problems in the exact same locations as before. This result was truly surprising and the validity of the examination process being utilized was questioned. Additional efforts to determine the validity of the UT indications were made; however, no clear assurances were provided that the apparent UT indications were actually valid or significant. There was speculation that the backing ring was causing some sort of misinterpretation of the UT readings, especially since the calibration standard used did not include a backing ring. In addition, all of the initial UT examinations used just a 45°-beam transducer. After consultations with another inspector with higher qualifications (Level III), both 45° and 60°-beam transducers were tried to clarify the interpretations of the UT examinations.

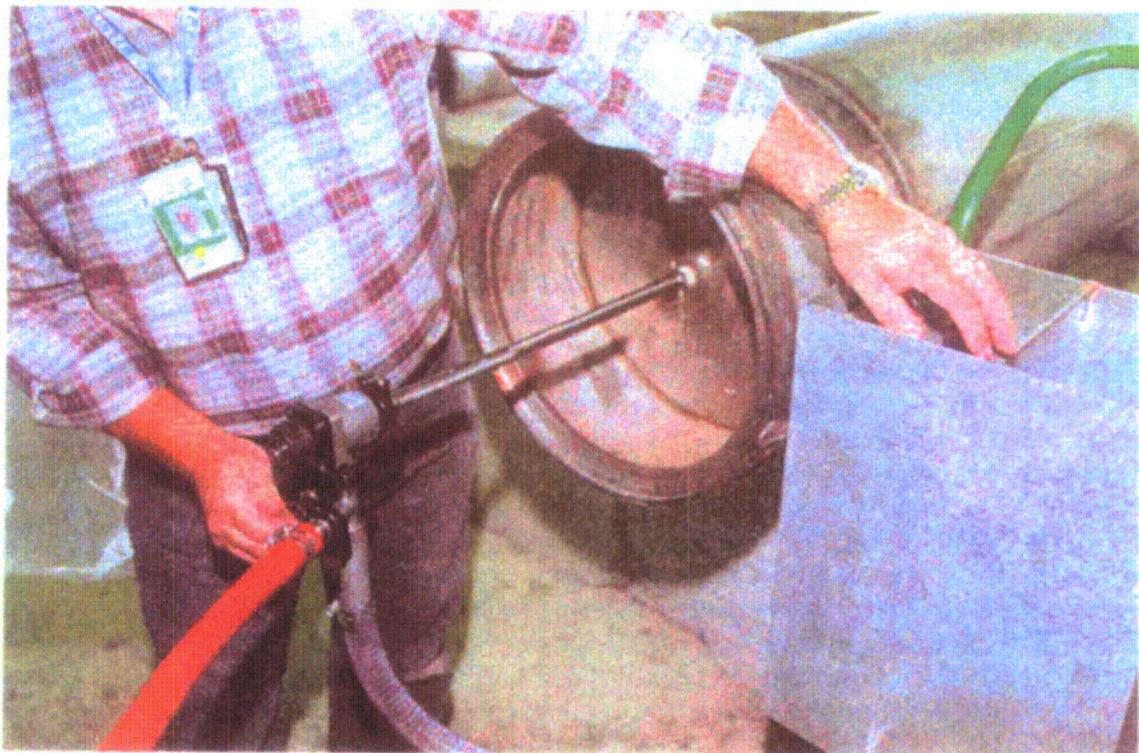
Figure 25. Pulling a Vacuum on a Test Canister During Helium Leak Test Activities

The canisters that had the most significant damage were chosen to be helium leak tested. At first, two canisters were thought to have been adequately damaged to undergo helium leak testing. However, after second consideration, it was decided to test the four most damaged test canisters. This would not only minimize concerns over a very limited number of canisters being leak tested, but more canisters would cover a wider range of canister impact angles. The canisters chosen for helium leak testing were 18-15-00-01, 18-15-45-04, 18-15-80-05, and 18-15-PP-09. The leak testing effort (Figures 25 and 26) utilized procedure TPR-4976 (Reference 25) which ties back to the ASME B&PV Code, Section V, Article 10 (Reference 26). A full vacuum was pulled inside the test canister and the outside surface was "bagged" in order to permit a 99% pure helium environment to exist on the outside surface of the test canister. The acceptance criteria of leaktight or 10^{-7} std cc/sec leak rate are discussed in the ANSI N14.5 standard (Reference 27). The results of the leak testing (Appendix E) indicated that a helium leak rate of less than 10^{-7} std cc/sec was achieved. Note that the U.S. NRC recognizes leak rates of this magnitude to reflect a leaktight containment system.

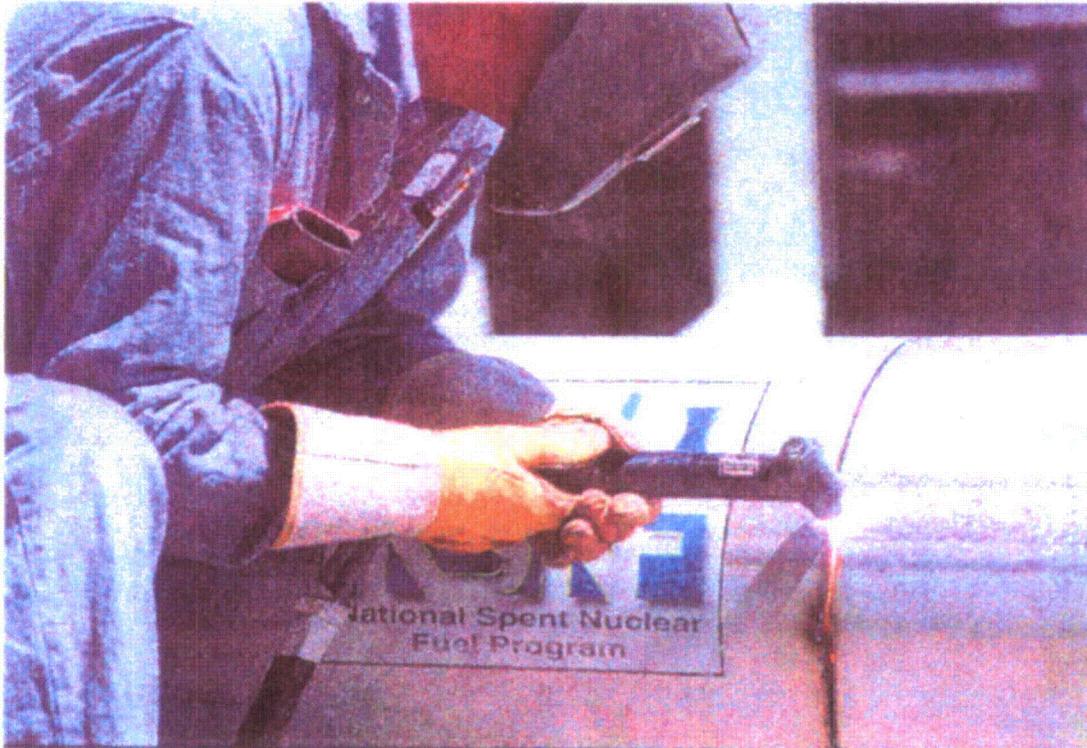
Figure 27. Cutting Apart A Test Canister

After the post-drop measurements and the helium leak testing were completed, the test canisters were cut open (Figure 27) in order to examine the condition of the internals, the rebar, and the interior surfaces of the test canisters.

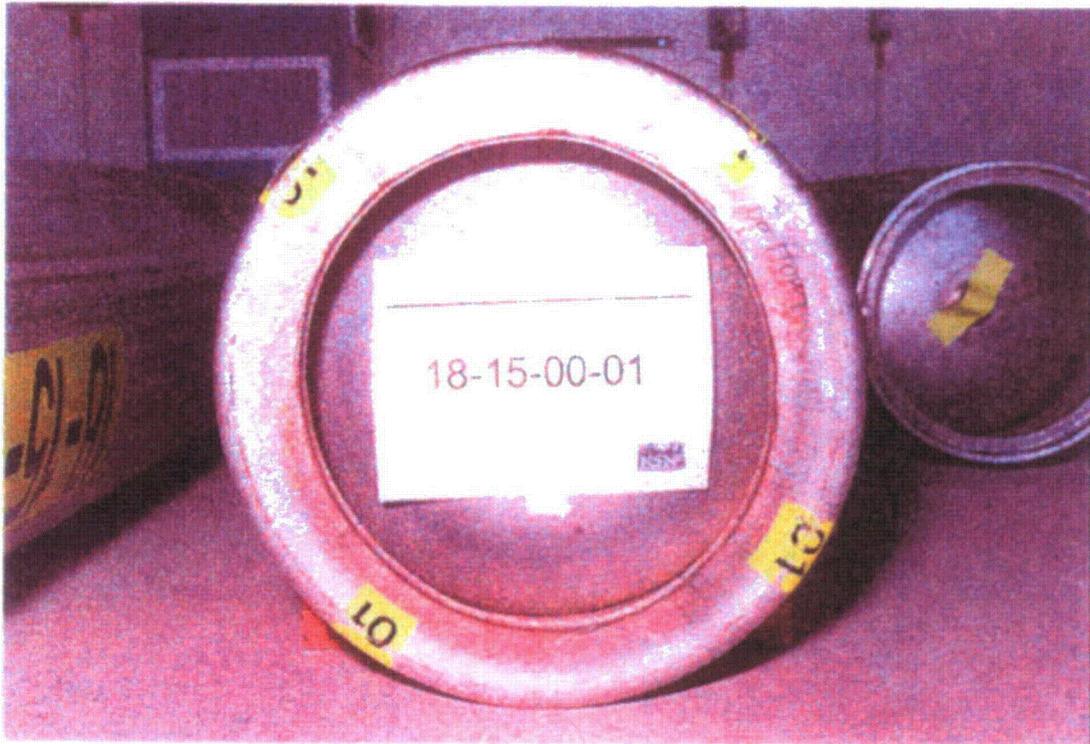
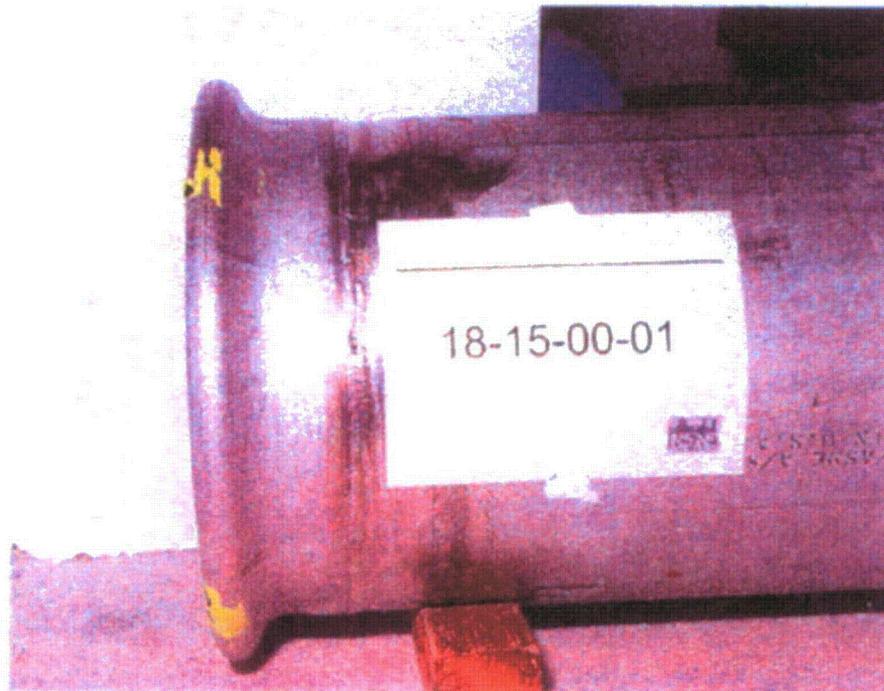
Figure 28. Bottom End View of Canister 18-15-00-01

Figure 29. Bottom Side View of Canister 18-15-00-01

This test canister was dropped from a vertical orientation 30 feet onto the essentially unyielding surface. Figures 28 and 29 show the bottom portion of the canister, especially the deformed skirt. The skirt protected the canister pressure boundary as expected. The top portion of this canister was not damaged since the test

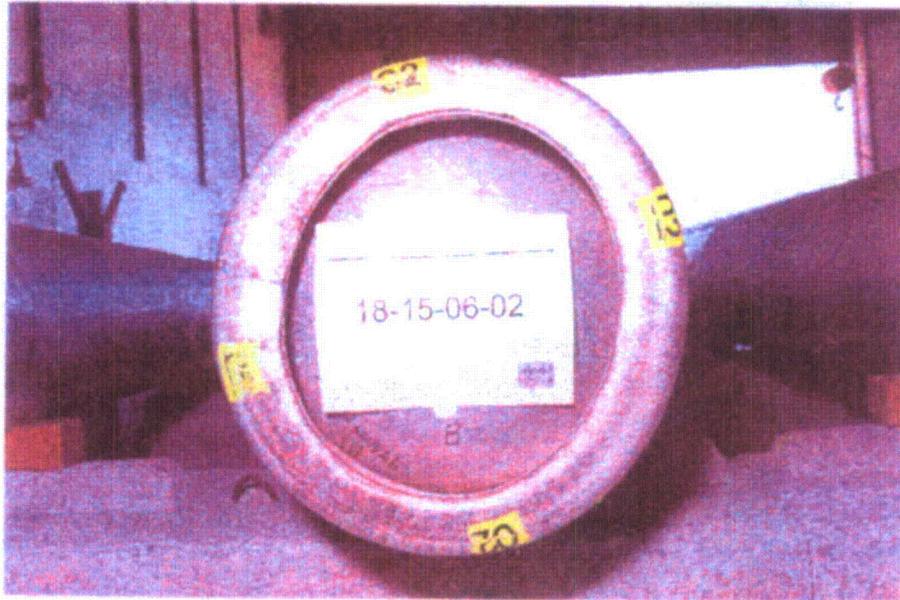
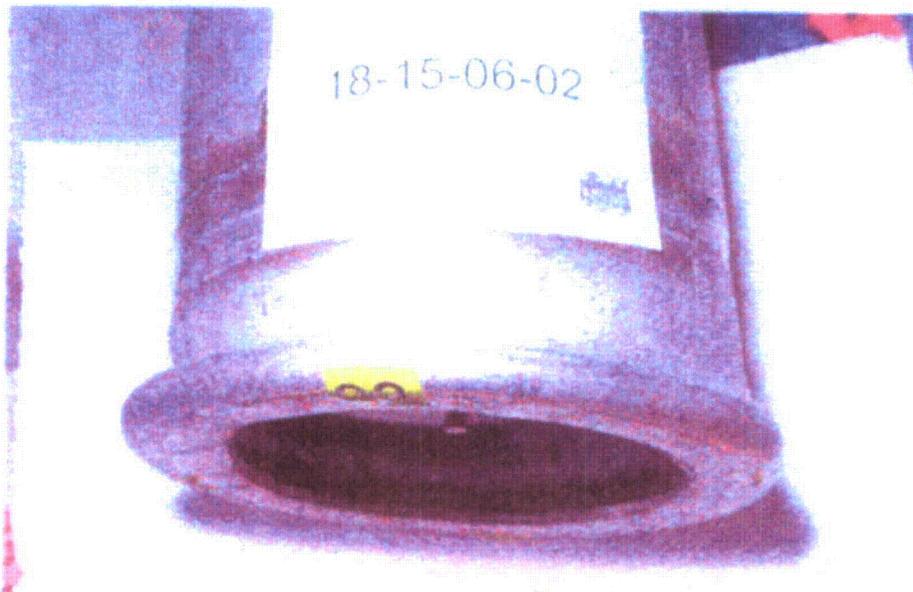
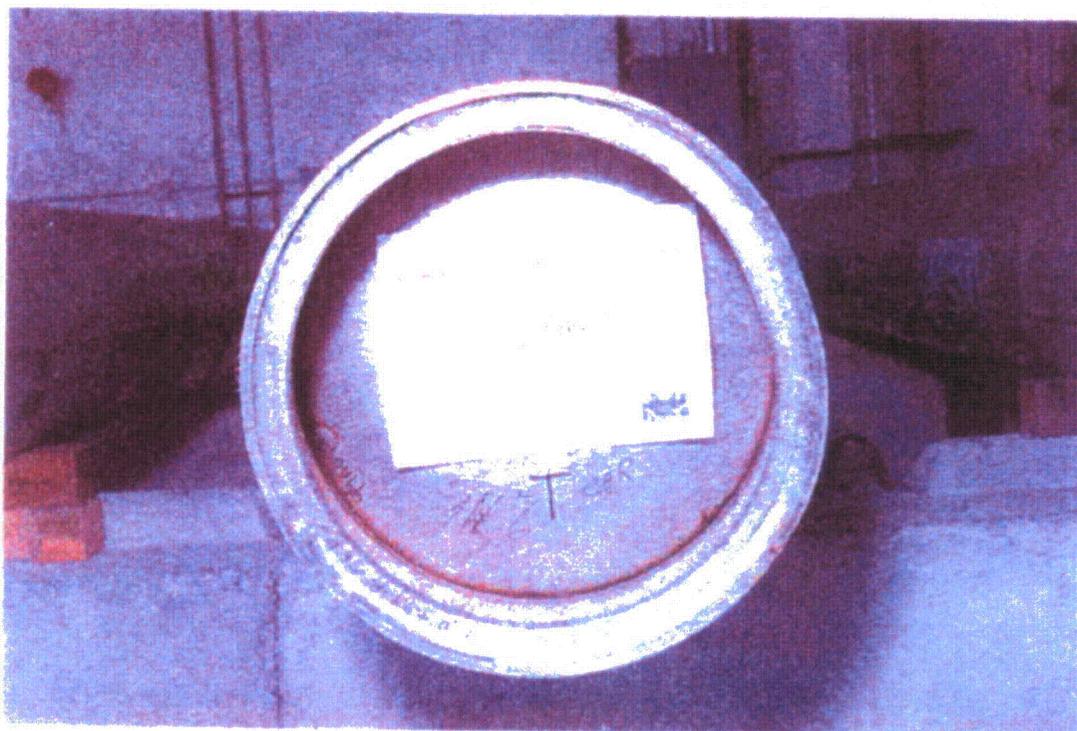
Figure 30. Bottom End View of Canister 18-15-06-02

Figure 31. Side View of Canister Bottom 18-15-06-02

Figure 32. Top End View of Canister 18-15-06-02

This test canister was dropped from a "center-of-gravity-over-the-corner" orientation (approximately 6 degrees from vertical) 30 feet onto the essentially unyielding surface. Figures 30 and 31 show the bottom portion of the canister, especially the deformed skirt. The skirt protected the pressure boundary of the test canister as expected. The top portion of the canister was only slightly deformed (Figure 32) as it fell over after the initial impact. The internals showed no recognizable damage.

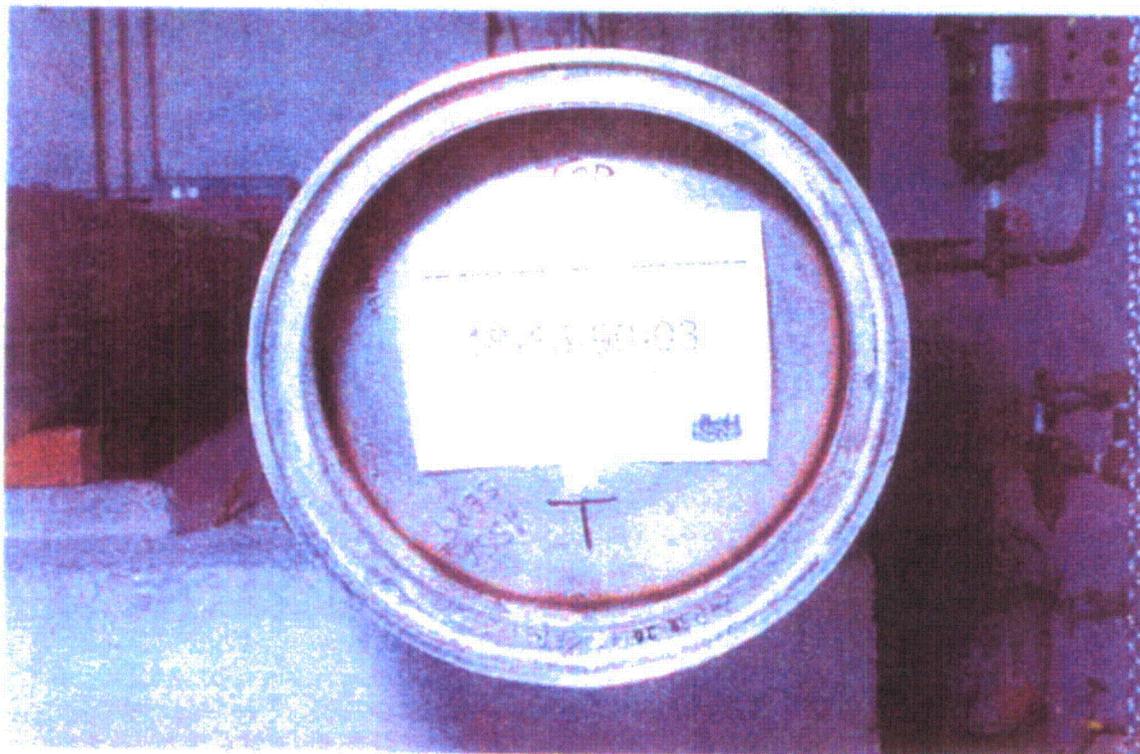
Figure 34. Top End View of Canister 18-15-90-03

This test canister was dropped from a horizontal orientation 30 feet onto the essentially unyielding surface. Figure 33 shows the bottom portion of the canister end while Figure 34 shows the top end portion of the test canister. The skirt ends deformed very little. Most of the deformation occurred in the mid-section where the canister body flattened along the point of impact and the body ovalized to a maximum diameter of slightly less than 19 inches. The internals were somewhat deformed but could easily still carry out their intended function of separating the SNF and keeping it adequately positioned. Figure 35 is a cut-away view of the internals without the rebar. The drop test missed impacting the longitudinal weld seam on the test canister body.

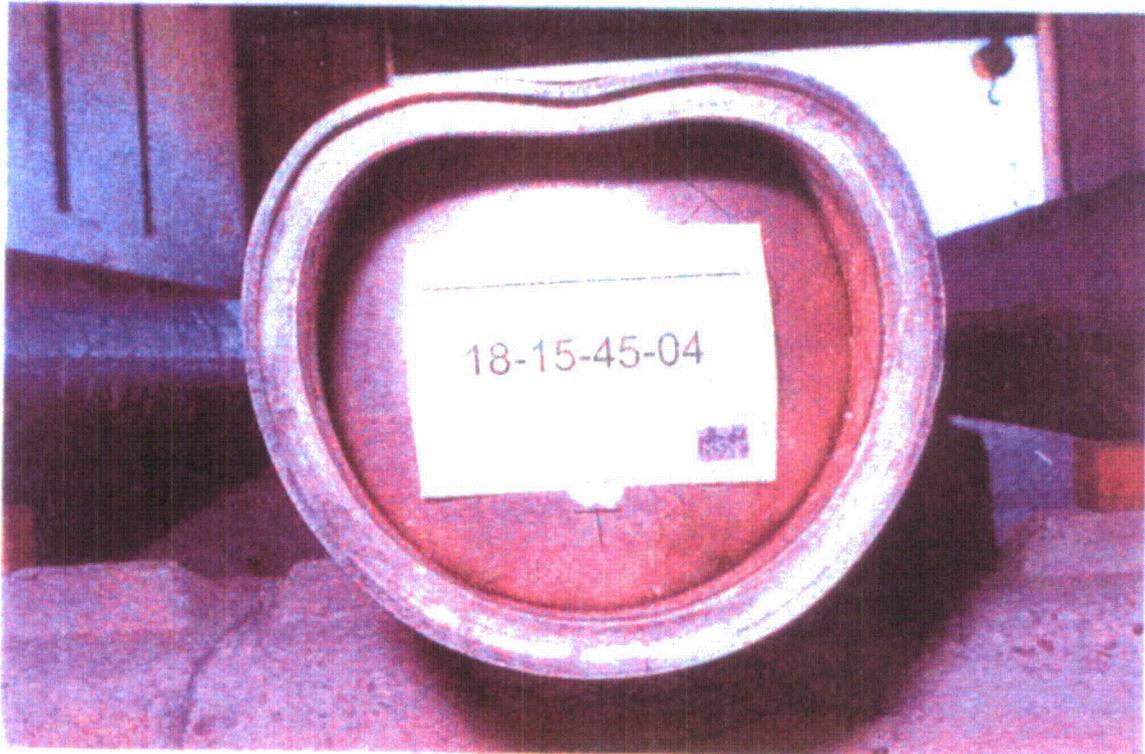
Figure 36. Bottom of Canister 18-15-45-04

Figure 37. Bottom End View of Canister 18-15-45-04

Figure 38. Top End View of Canister 18-15-45-04

Figure 39. Top Side View of Canister 18-15-45-04

This test canister was dropped from a 45-degree orientation 30 feet onto the essentially unyielding surface. Figures 36 and 37 show the bottom portion of the canister while Figures 38 and 39 show the top portion of the canister. Both the top and bottom skirts deformed, especially the bottom skirt. However, the skirt still absorbed much of the impact energy and significantly reduced the damage that could have potentially occurred to the canister pressure boundary. The test canister had a noticeable bow over the entire canister length after the drop test. The internals showed no recognizable damage with the exception of the 2-inch thick impact plates that were slightly deformed (Figure 40) in the local area of the impact point. However, they could still perform their intended function.

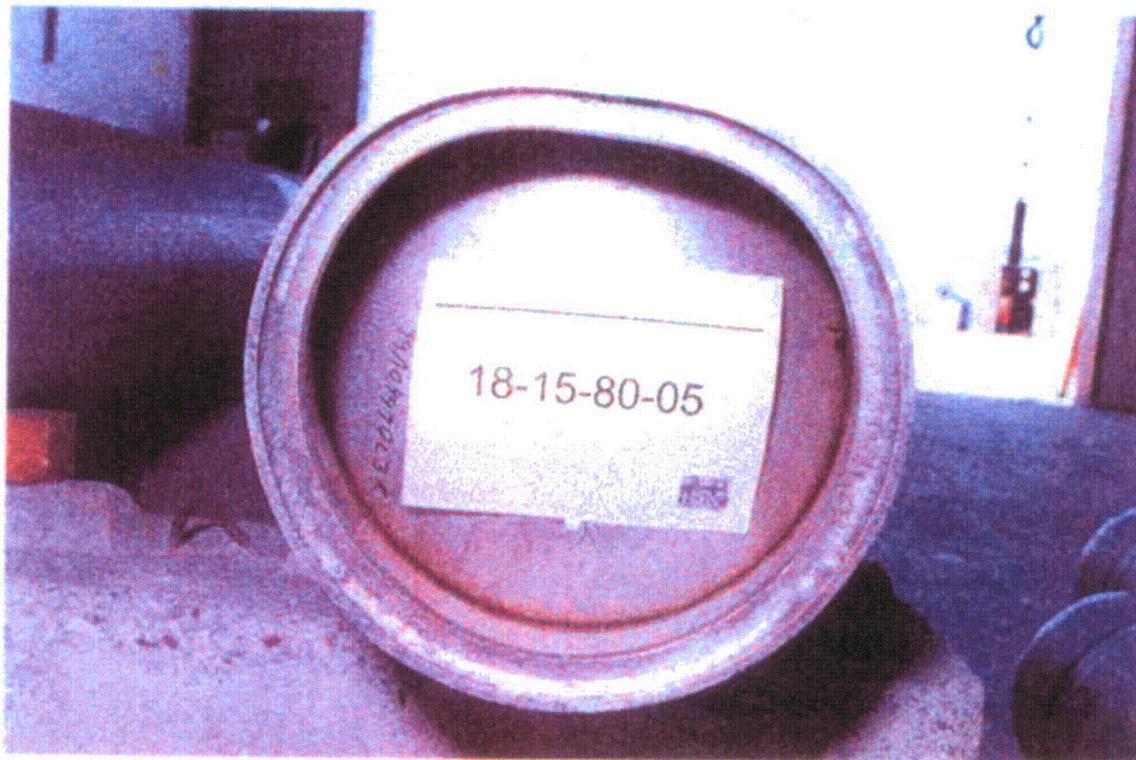
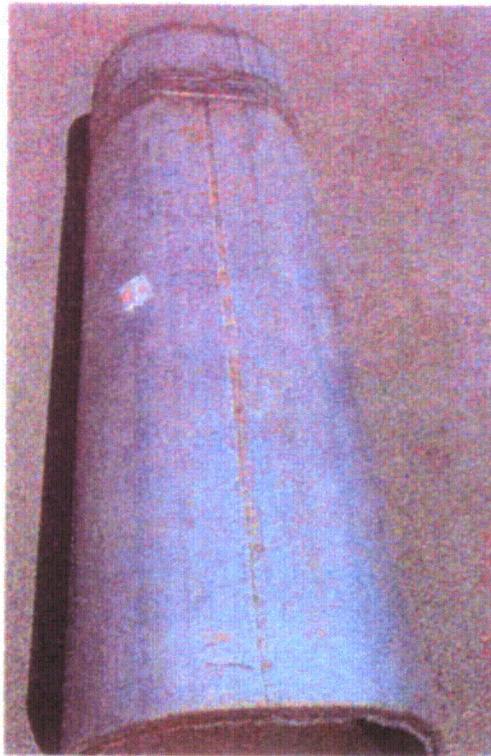
Figure 41. Bottom End View of Canister 18-15-80-05

Figure 42. Bottom Side View of Canister 18-15-80-05

Figure 43. Top End View of Canister 18-15-80-05

Figure 44. Top Side View of Canister 18-15-80-05

Figure 45. Cross-Section of Canister 18-15-80-05 at Flattened Region

Figure 46. Top Third of Canister 18-15-80-05

This test canister was dropped from an 80-degree (near horizontal) orientation 30 feet onto the essentially unyielding surface. Figures 41 and 42 show the bottom portion of the canister while Figures 43 and 44 show the top portion of the test canister. Since the slapdown effect was achieved, the top portion of the canister pressure boundary was more damaged than the bottom. This test canister experienced the most damage to the canister pressure boundary, especially for the welds made at the INEEL. The top head to canister body weld was significantly flattened during slapdown (Figures 45 and 46) and the dished portion of the head had a noticeable bulge at the slapdown impact location near where the skirt was welded onto the head. The spoked-wheel basket internal for this test canister showed the most significant damage of all of the test canisters. However, that damage was not that significant. Three of the spokes showed some deformation due to the rebar impacting the spokes. Figure 47 shows the spoke most damaged. Some slight deformation of the spoke is noticeable. Along that same spoke, two of the intermittent welds (near the top end) cracked. Figure 48 shows those two welds and Figure 49 shows a close-up of one of the cracked welds. The 2-inch thick impact plates were slightly deformed at the point of impact but were still able to perform their intended function.

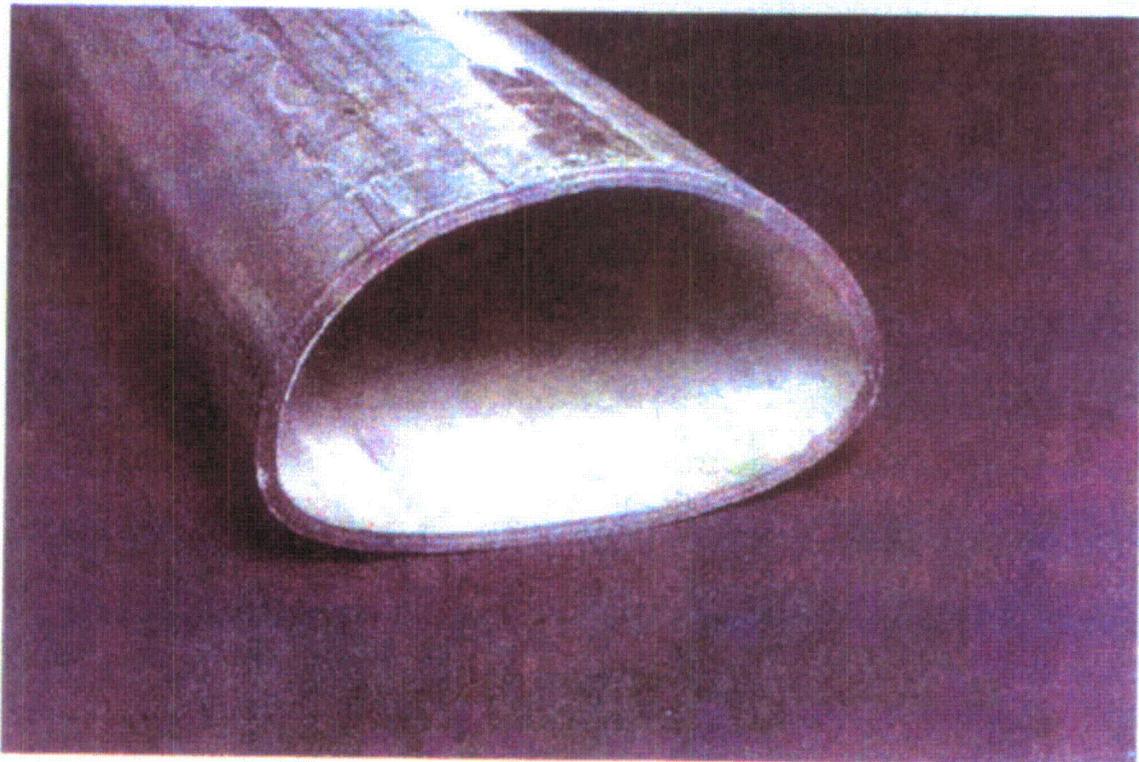
Figure 50. End View of Canister 18-10-90-06

Figure 51. Flattened Empty HIC

This test canister was dropped from a horizontal orientation 30 feet onto the essentially unyielding surface. Figure 50 shows a representative end view of the canister, highlighting the slightly deformed skirt. The most damage occurred in the middle section of the canister where the canister body flattened along the point of impact and the body ovalized to a maximum diameter of approximately 18-5/8 inches. The drop test missed impacting the longitudinal weld seam on the test canister body. The simulated HICs were inside this test canister. All of the simulated HICs had a slight bow over their entire length due to the 90-degree impact. The one simulated HIC that was left empty was indeed flattened and is shown in Figure 51. The mid-section maximum measured diameter on this empty simulated HIC was 6-11/16 inches and the minimum diameter was measured as 3-15/16 inches.

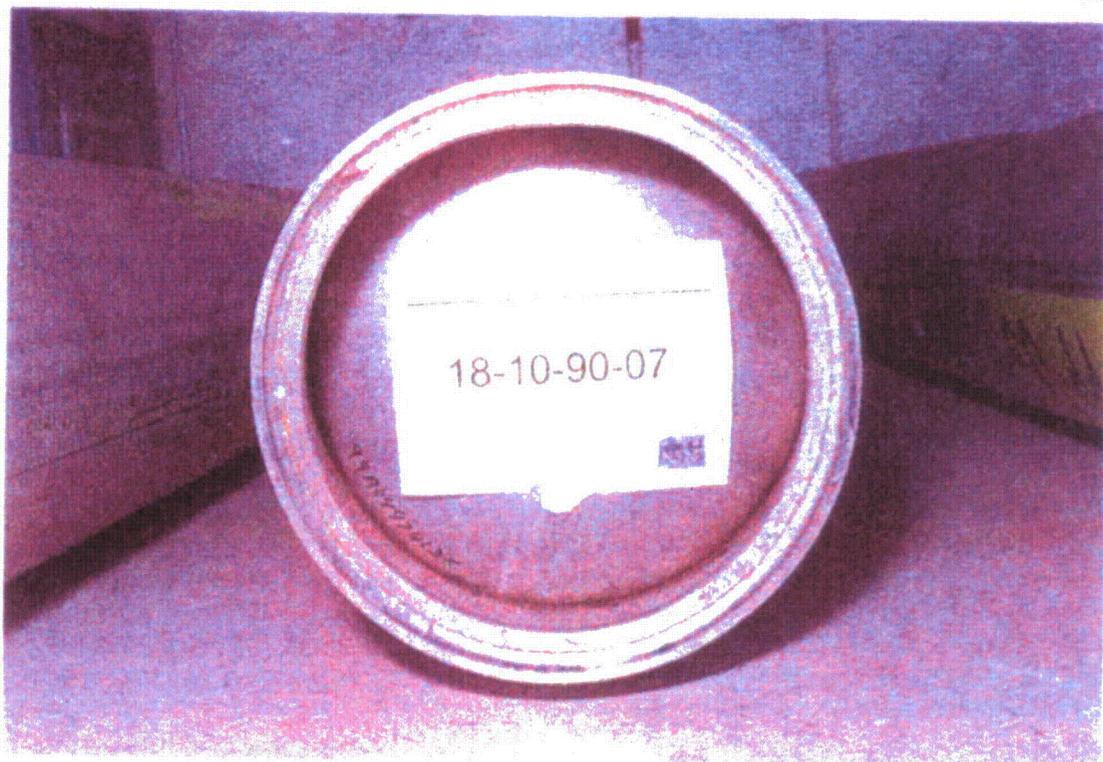
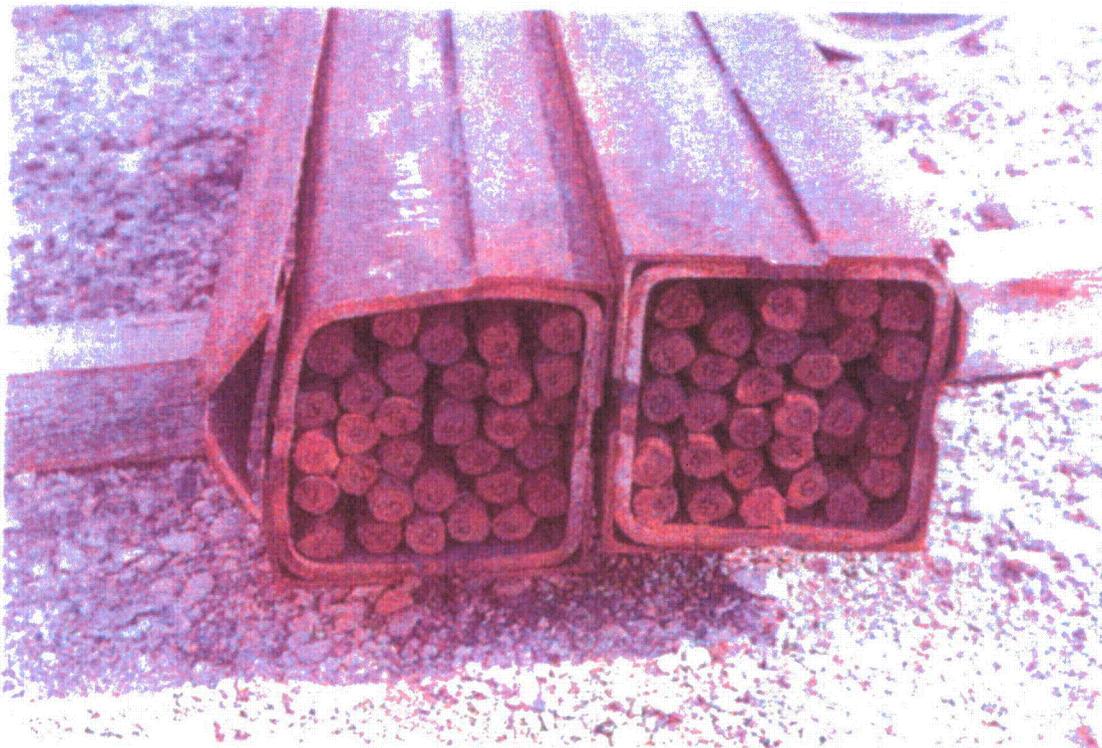
Figure 52. End View of Canister 18-10-90-07

Figure 53. Simulated Shippingport Fuel Bundles After Drop

This test canister was dropped from a horizontal orientation 30 feet onto the essentially unyielding surface. Figure 52 shows a representative end view of the canister, highlighting the slightly deformed skirt. This test canister experienced even less apparent damage than 18-10-90-06. The most damage occurred in the middle section of the canister where the canister body flattened along the point of impact and the body ovalized to a maximum diameter of approximately 18-1/2 inches. This canister deformed a smaller amount than 18-10-90-06 due to the different internals configuration and the lighter total weight of the test canister. The drop test missed impacting the longitudinal weld seam on the test canister body. The internals for this test canister were the simulated Shippingport fuel bundles. Figure 53 shows the resulting deformation of these pieces. Note that the corners were ground down during canister loading to allow the backing ring on the top head assembly to properly fit. Since these internals represented a specific fuel bundle and not a basket design, the deformations were not a major concern to this drop test effort.
