**YUCCA MOUNTAIN – REQUEST FOR ADDITIONAL INFORMATION – VOLUME 2,
CHAPTER 2.1.1.4, SET 2 AND SET 9; CHAPTER 2.1.1.5, SET 1 – REFERENCES**

EDF Title: FY1999 DROP TESTING REPORT FOR THE 18-INCH STANDARDIZED DOE SNF CANISTER			
Summary:			
EDF-NSNF-007 Revision 0 originally released this report. This Revision 1 supplements the original release by making minor corrections to 4 pages (identified by a vertical bar in the right-side column of a modified page):			
-Part I, page 28, modified one paragraph to satisfy Deficiency Report 00-NSNF-AU-011-DR-002			
-Part II, page 12, replaced an incorrect coefficient of friction value of 0.05 with the correct value of 0.10			
-Part II, page 33, added a sentence to clarify the post-drop coefficient of friction value used for canister 04			
-Appendix B, page B-47, corrected a measurement value.			
Only the above modified pages are attached to this EDF-NSNF-007 Revision 1.			
Total Attachments:	Attachment Nos.:	No. of pages in each:	Total Pages:
4	Part I, page 28 Part II, pages 12 and 33 Appendix B, page B-47	1 2 1	4 total pages

1. PROGRAM OBJECTIVES

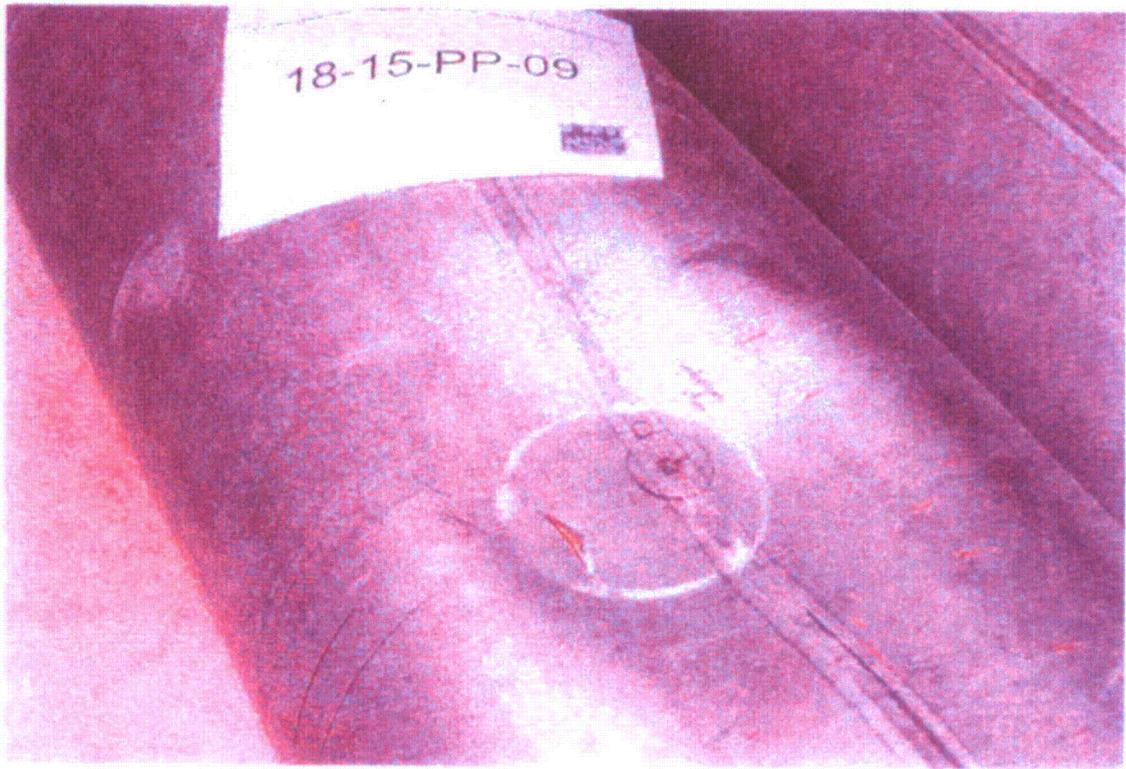
Figure 58. Damage at Point of Impact on Canister 18-15-PP-09

Figure 59. Side View of Damaged Canister 18-15-PP-09

This test canister was dropped from 40 inches onto a six-inch diameter puncture bar. This test duplicated that specified in 10 CFR 71.73 (c) (3). The impact target was the center-of-gravity of the test canister. This orientation would produce the most deformation to the canister body. However, the drop test actually impacted about 1/2-inch more toward the lower head and about 1-1/4-inch off of the longitudinal weld seam. Figures 58 and 59 show the results of this puncture test. Damage to the test canister body was significant. The post-drop measurements indicated that the resulting puncture deformation was approximately 2-3/4 inches into the canister. Both the top and bottom portions of the canister were virtually undamaged due to the short fall to the essentially flat unyielding surface of the drop pad. However, after impact, the test canister rolled off the puncture bar, impacting an eye bolt used to lift the puncture bar assembly. As indicated earlier in Section 6, this test canister was loaded with a spoked-wheel basket only (no sleeve) and with no rebar adjacent to the impact point (Figure 60). The resulting damage to the spoked-wheel basket was very minimal. The edge of the one spoke in the vicinity of the puncture impact had a slight mark that resembled a rub mark. The damage was so slight that it was very hard to see. The interior surface of the canister where the puncture occurred also shows little if any noticeable damage, except in the immediate area of the puncture bar deformation.
