NRC – Callaway / Wolf Creek Public Meeting

GL 2004-02 Response RAIs
November 20
2009

- The purpose of this presentation is to address GL 2004-02 RAIs for Union Electric Company (Callaway) and Wolf Creek Nuclear Operating Corporation (Wolf Creek).

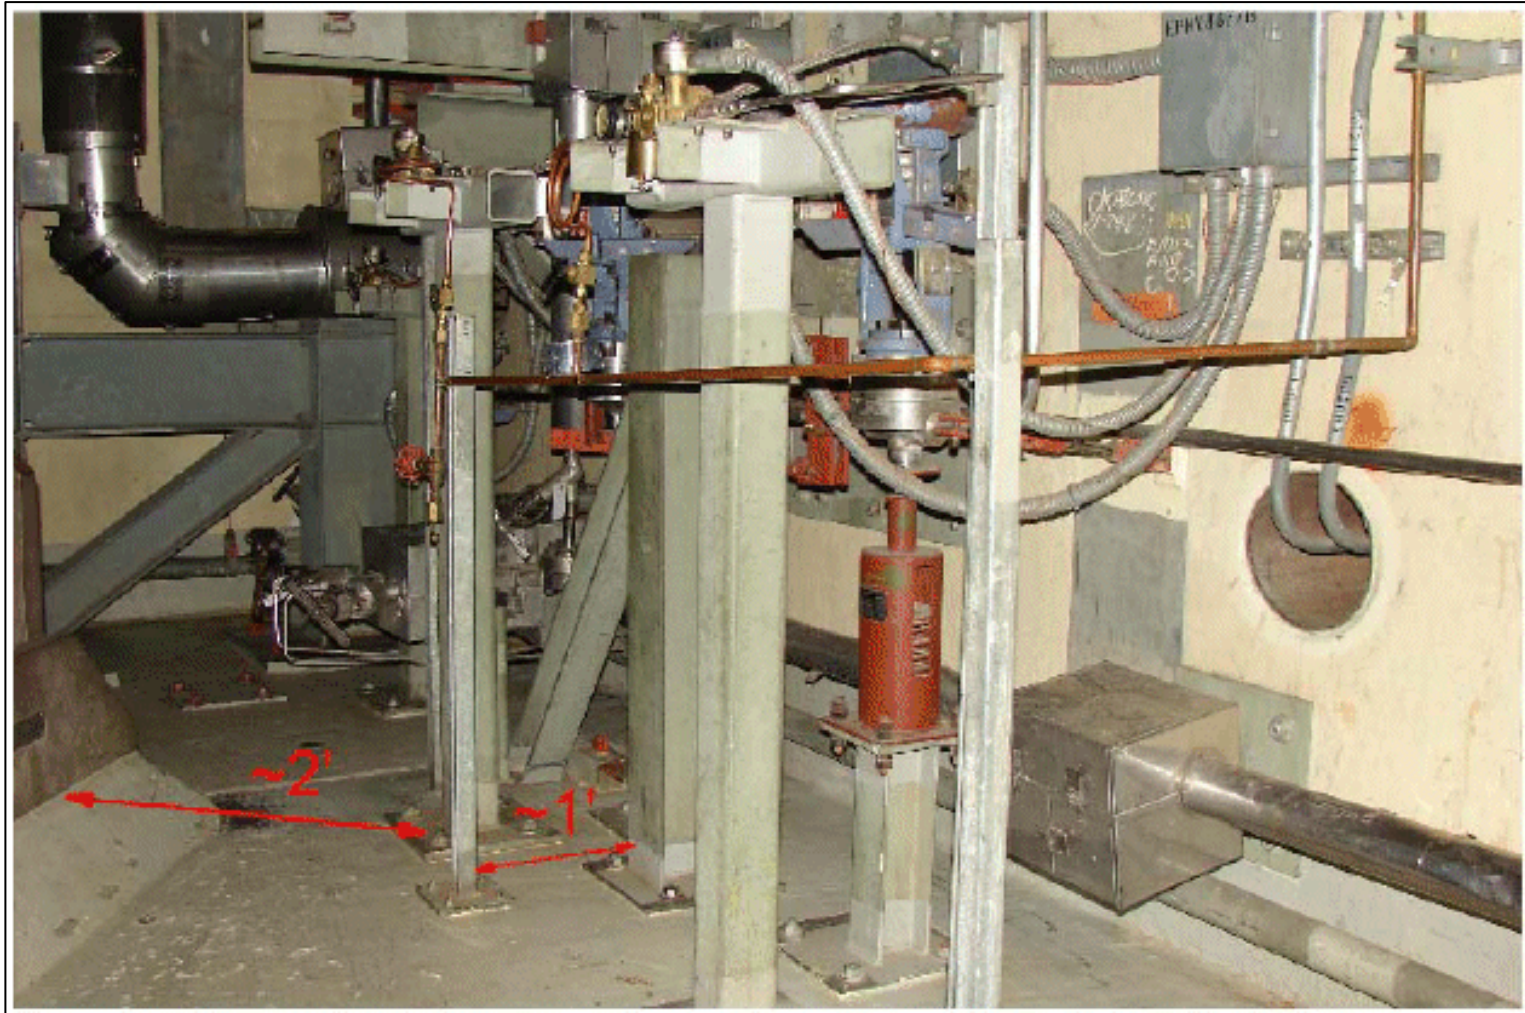
Figure 26-1

- 95% of the miscellaneous debris (313.8 ft² of 330.2 ft²), all non-porous is initially located inside the secondary shield wall, would be subjected to pipe break conditions (100% humidity)
- Pre-soaking the debris is prototypical since the miscellaneous debris will be wetted (surface air bubbles removed) by direct exposure to the LOCA break and long transport time due to tortuous path to the strainers

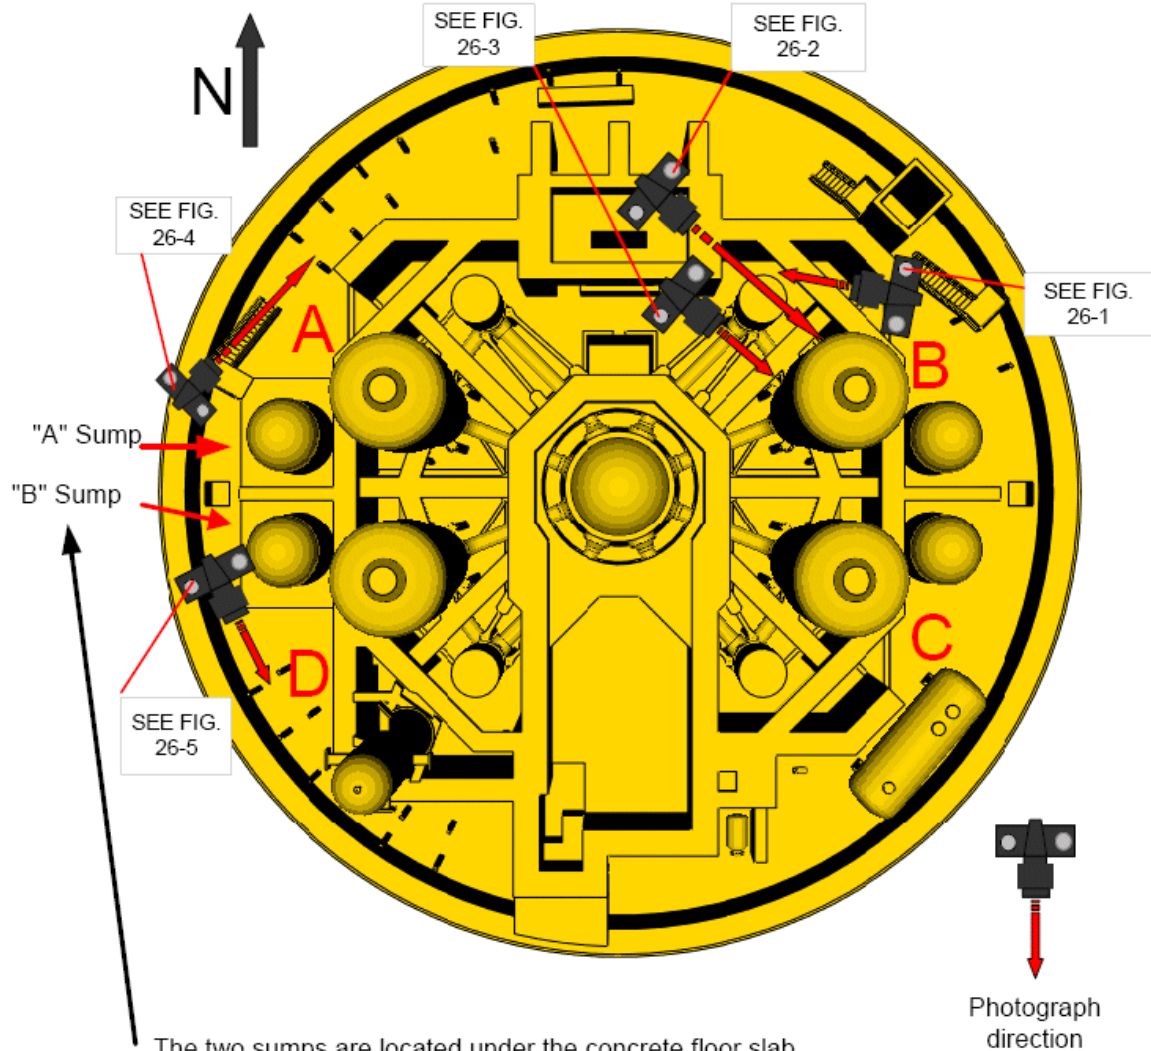
- The barrier doors, made from 1/8" perforated plate, installed in Loops A and D would stop pieces of debris from transporting directly to the ECCS sump cavities during pool fill
 - Large debris would have to travel out of the SG compartments through the Loop B and C entrances and around the torturous length of the annulus during the short amount of time it would take to fill these cavities.

- There are numerous obstructions within the bioshield and the containment annulus that would serve to capture large debris during pool-fill phase of a LOCA.
 - Refer to RAI #26

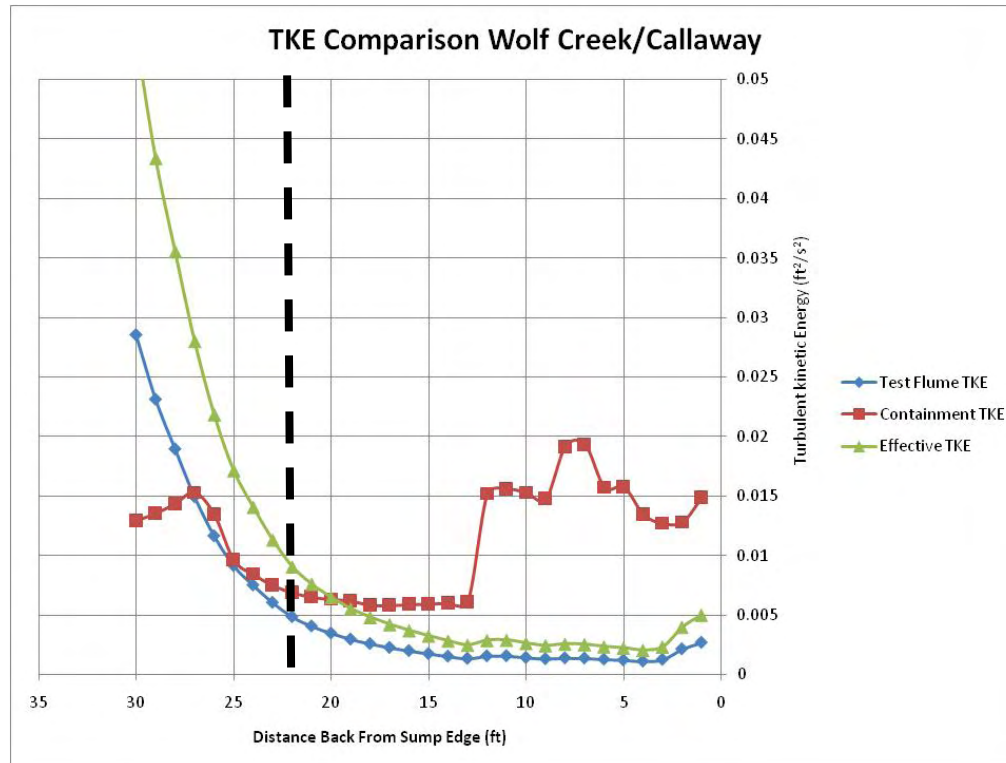
- Effective turbulence level takes into account the differential in flume and containment water temperatures and is a correction of the flume TKE to containment temperatures.
- ***Higher turbulence predicted by the debris transport containment CFD simulations within 20 ft of the sump pit did not affect the flume test results since no debris deposition was observed in the test flume within 23 ft of the test strainer modules.***

- Drainage sources from Containment Spray near the sump strainers enters in the form of droplets through grating and as run-off from concrete floors
- Turbulence was not modeled in the test flume from either direct spray or from run-off quantities because the impact of these quantities is small in areas near the strainer
- Flume testing showed that there was sufficient kinetic energy and turbulence to transport all debris within 23 ft of the sump
- See graphics on next few slides

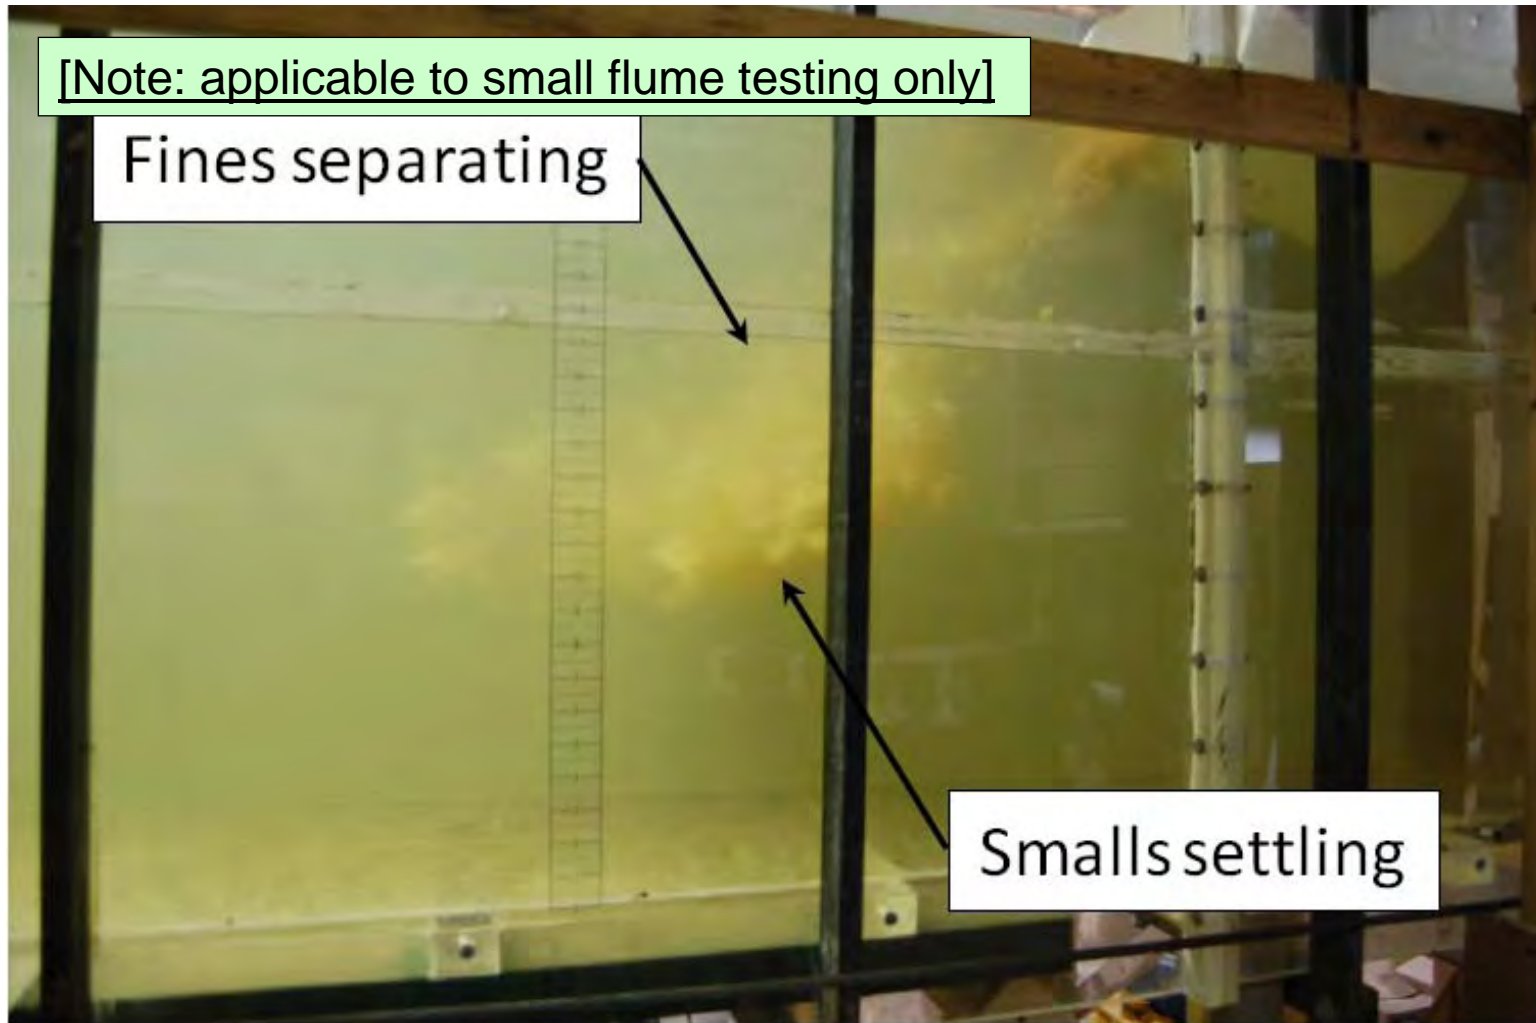
Figure 9. Smalls fiber addition

- Small flume testing was conducted
 - Video documentation and test descriptions were submitted to the Staff on November 4, 2009
 - Velocity during the small flume test was equal to the minimum velocity sections of the large flume strainer head loss testing
- The video of the small flume test has confirmed separation of the fine fibrous debris upon introduction of small fines mixture did occur in a manner that did not affect transport to the strainers

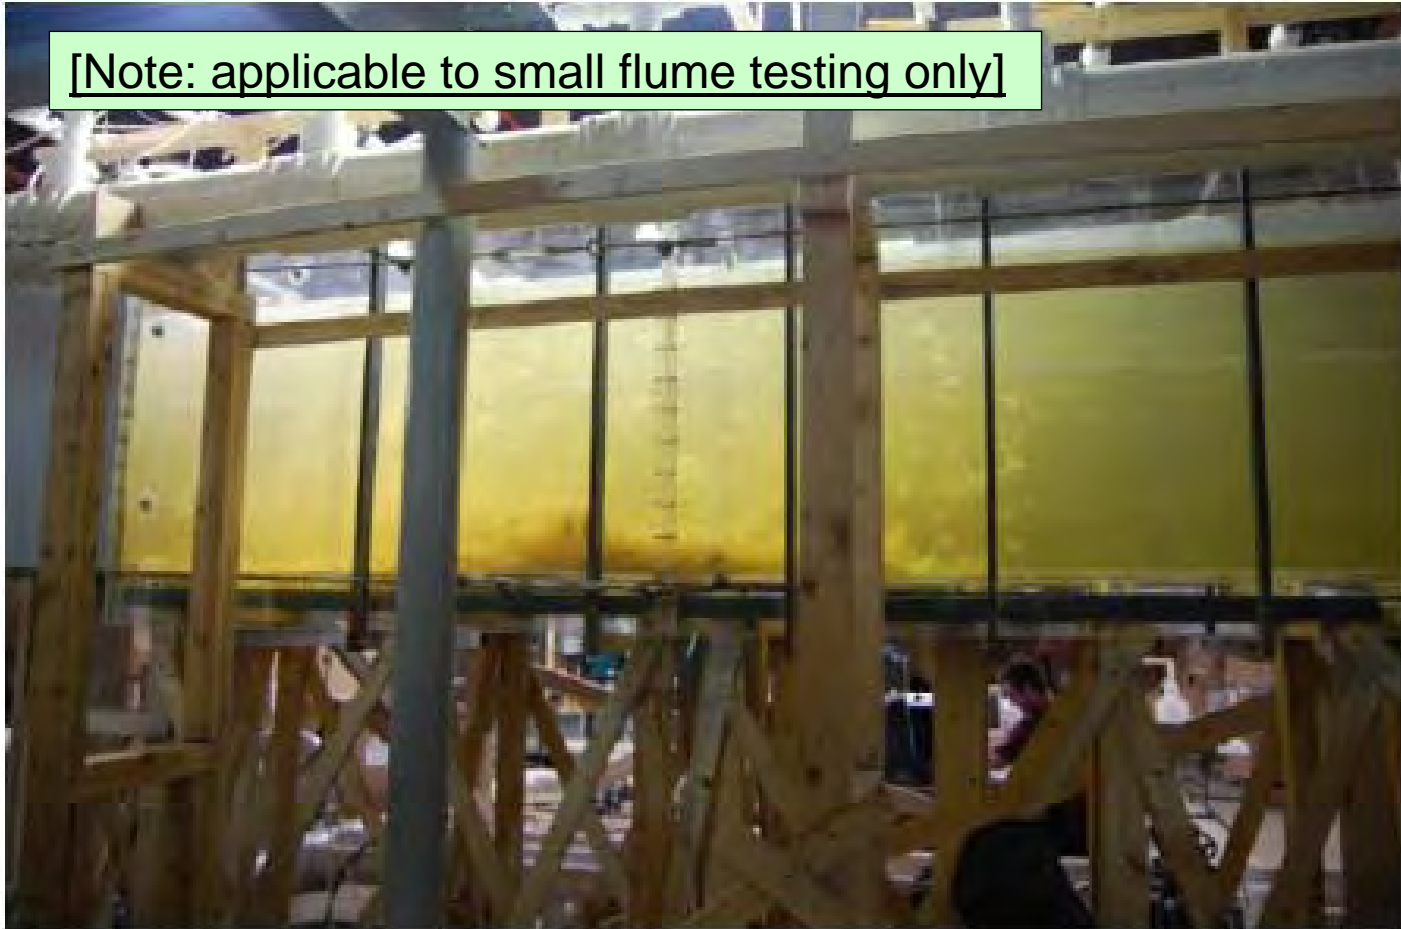
Figure 10. Fibers settling in flume downstream of introduction

[Note: applicable to small flume testing only]

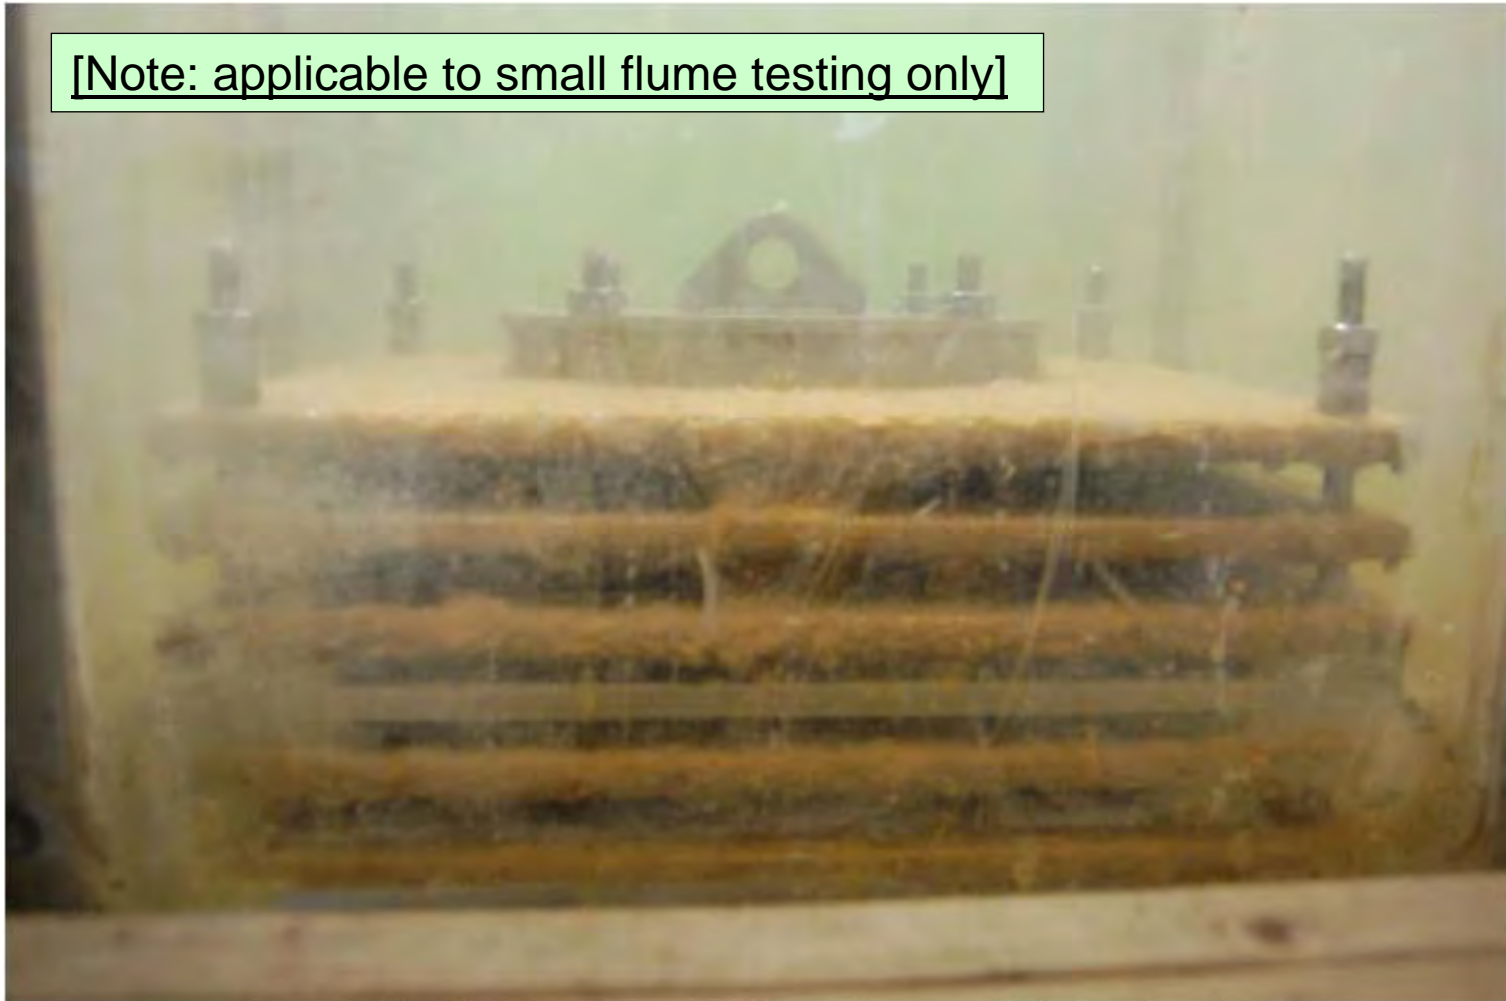
Figure 11. Fine fiber on strainer after smalls introduction

[Note: applicable to small flume testing only]

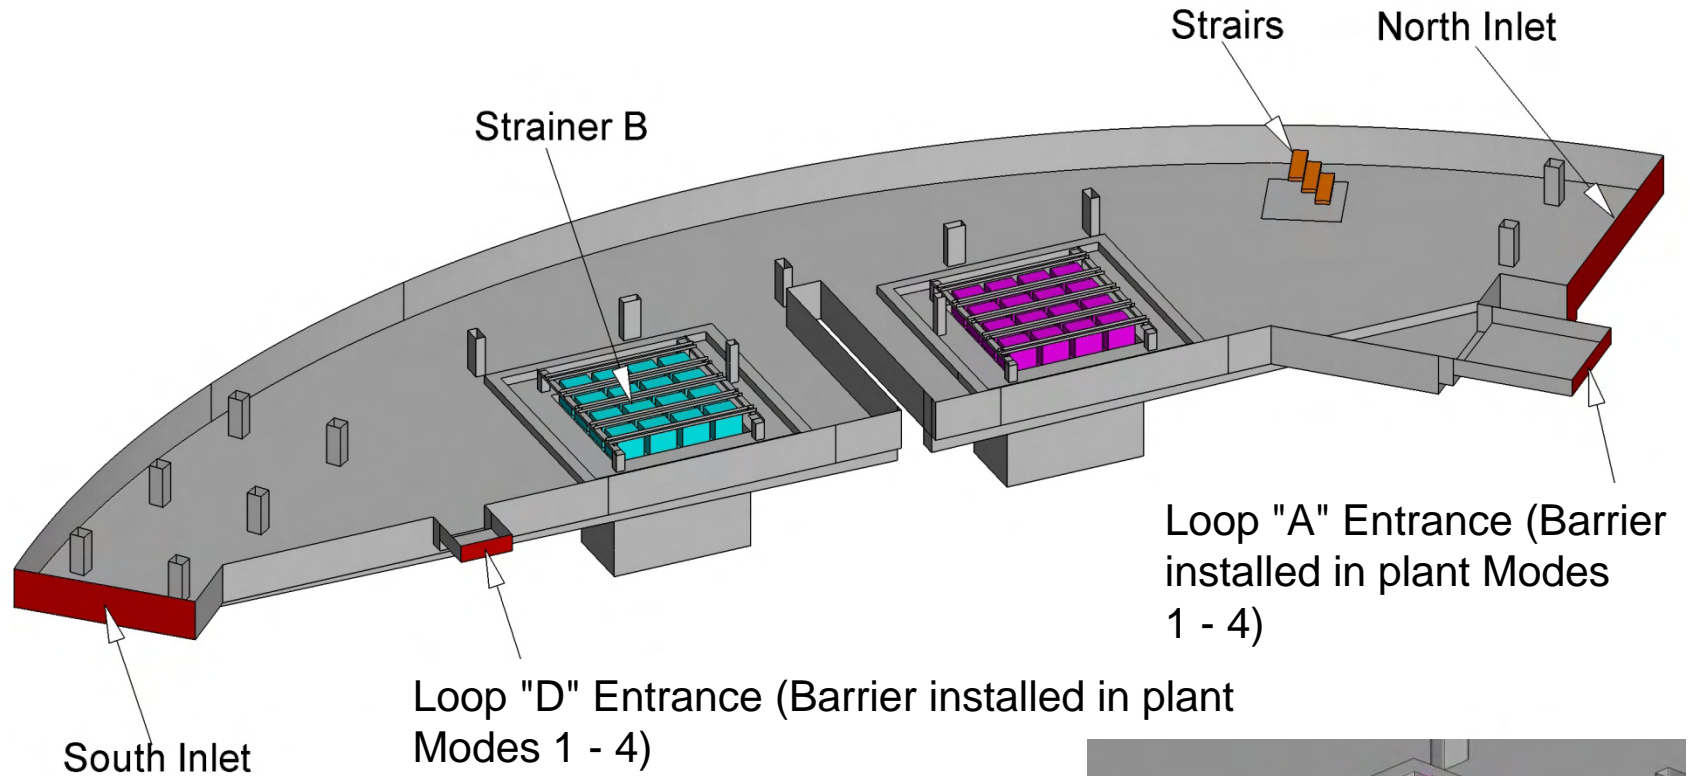
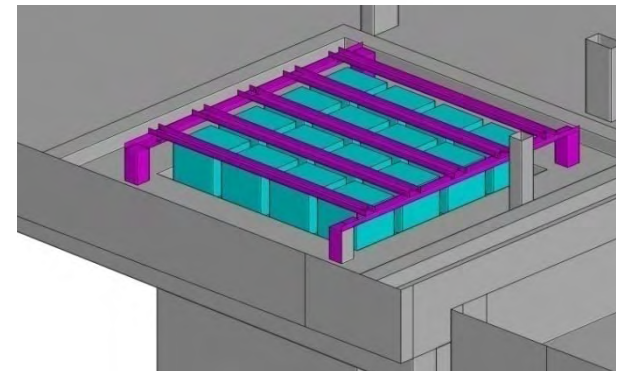
Wolf Creek Refined CFD Model Configuration

- Current computational capabilities allowed for more detailed refinement of flow patterns near sump pit in response to RAI 27.
- Flow patterns and velocities near sump sensitive to representation of strainer boundary condition.
 - Test flume CFD assumed equal velocity along the vertical planes defining the sides of the sump pit (no specific representation of modules).
- Subsequent CFD simulations conducted in response to RAI #27 further detailed strainer configuration and obstacles near sump pit.
 - Modeled each individual strainer module in sump
 - Modeled strainer module support structures
 - Wolf Creek – Modeled additional instrument support stand
 - Callaway – Modeled TSP baskets and additional instrument support stand

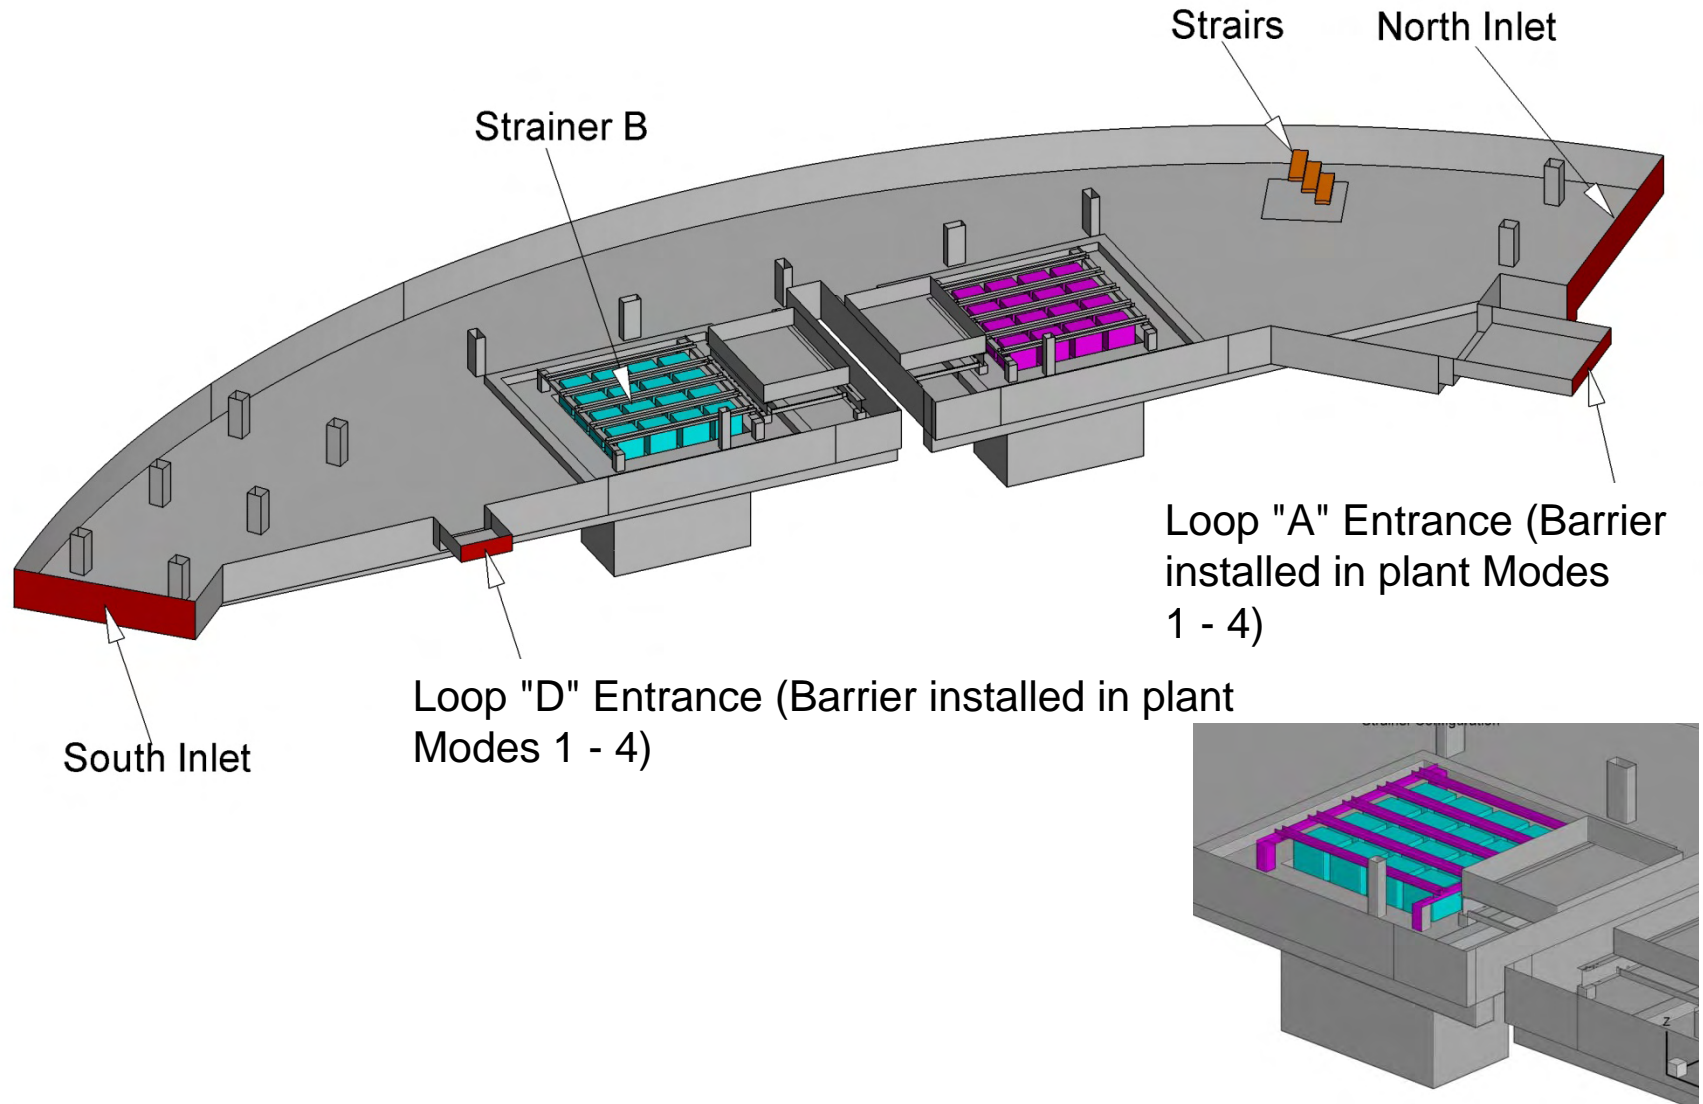
Callaway Refined CFD Model Configuration

- Current computational capabilities allowed for more detailed refinement of flow patterns near sump pit in response to RAI 27.
- Flow patterns and velocities near sump sensitive to representation of strainer boundary condition.
 - Test flume CFD assumed equal velocity along the vertical planes defining the sides of the sump pit (no specific representation of modules).
- Subsequent CFD simulations conducted in response to RAI #27 further detailed strainer configuration and obstacles near sump pit.
 - Modeled each individual strainer module in sump
 - Modeled strainer module support structures
 - Wolf Creek – Modeled additional instrument support stand
 - Callaway – Modeled TSP baskets and additional instrument support stand

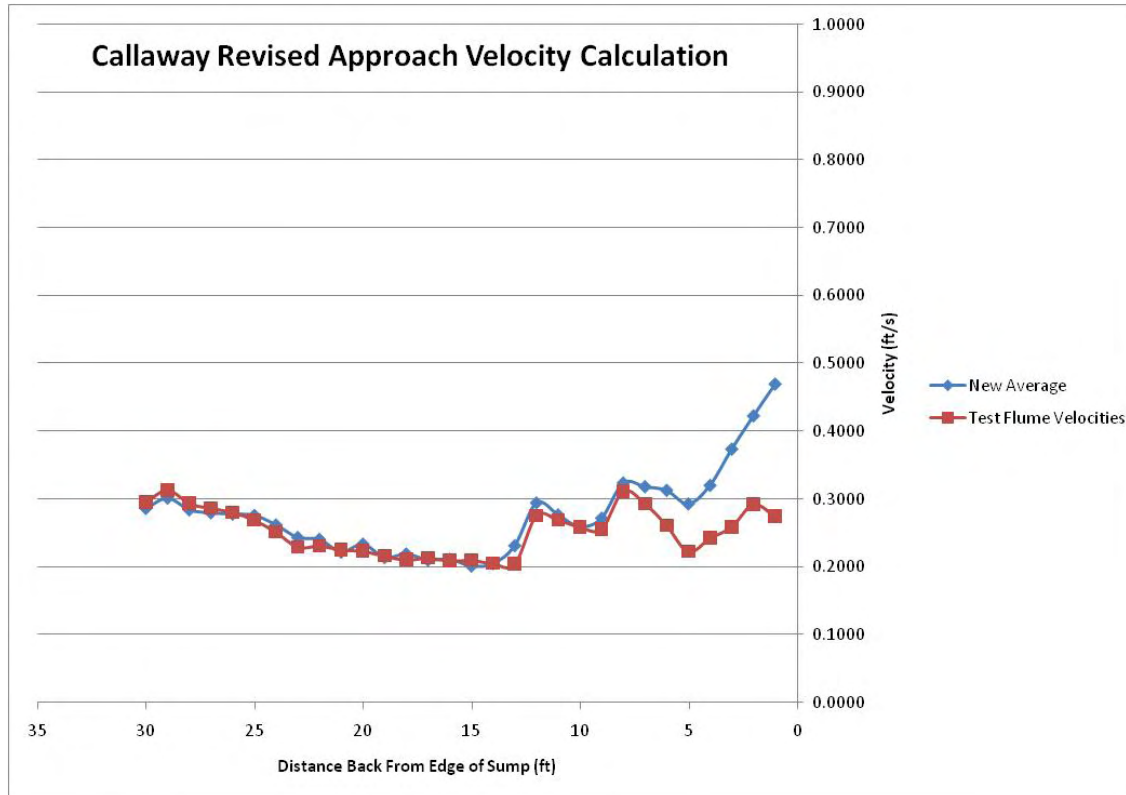
Approach Velocity Calculation with TSP Basket and Instrument Support

- Velocities in Drop Zone and up to 14 ft back from sump equivalent
- Velocities from 8 ft to 14 ft very similar
- Velocities from 1 ft to 8 ft higher based on refined CFD

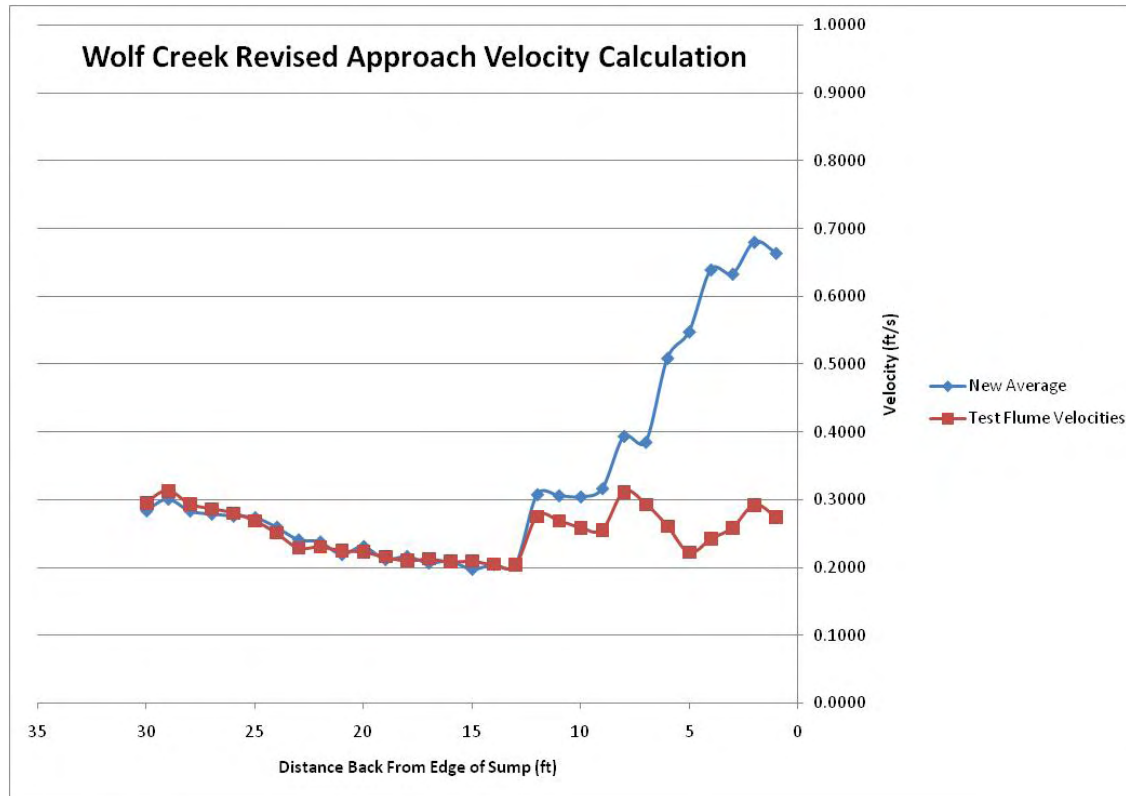
Approach Velocity Calculation with Instrument Support

- Velocities in Drop Zone and up to 13 ft back from sump equivalent
- Velocities from 1 ft to 13 ft higher based on recent CFD

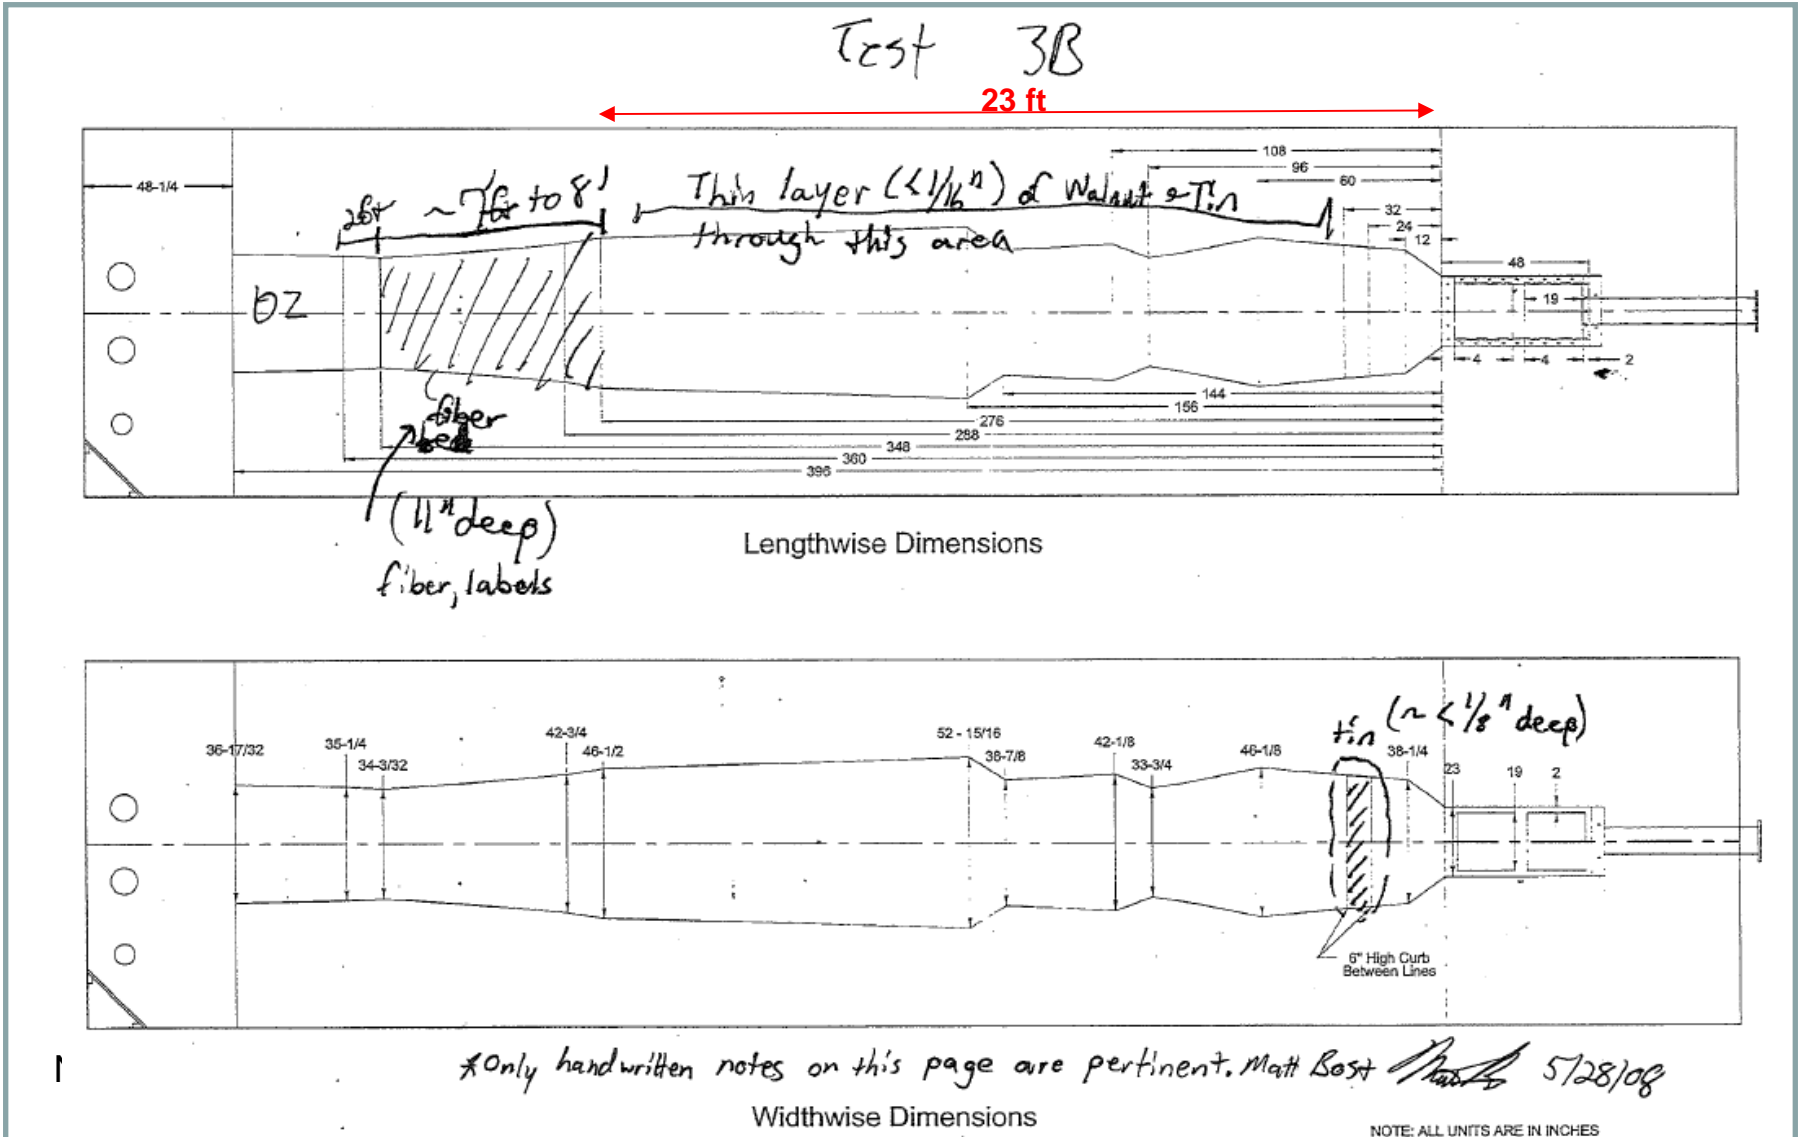
Material Deposition Observations Test 3B – Wolf Creek Design Basis Test

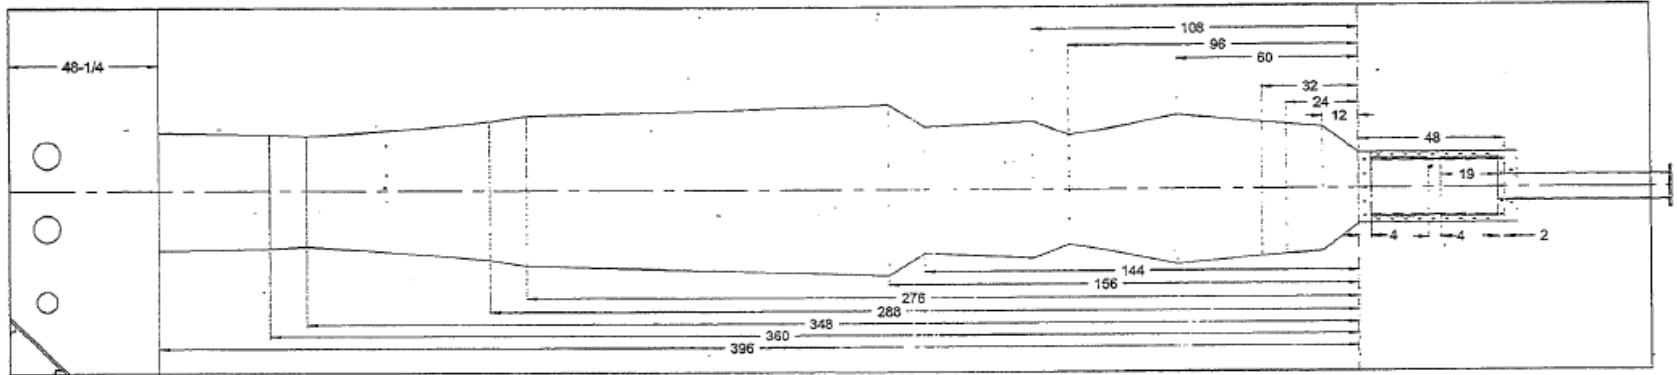
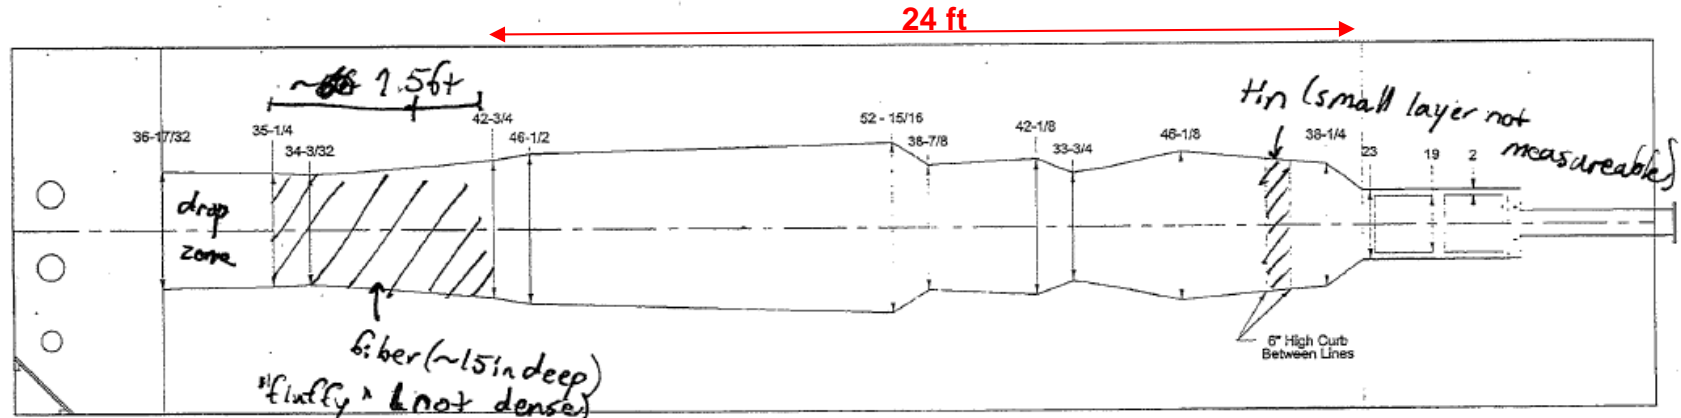
Material Deposition Observations Test 3C – Callaway Design Basis Test

Lengthwise Dimensions

Widthwise Dimensions

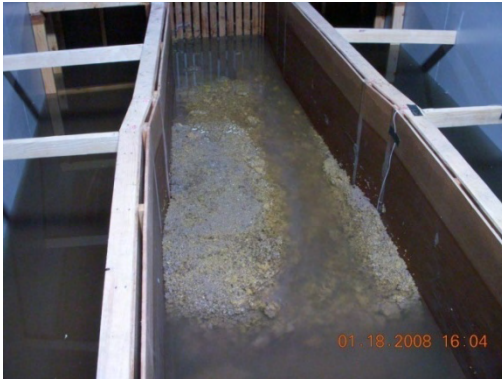
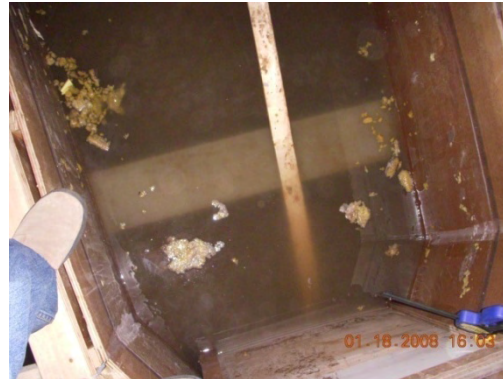
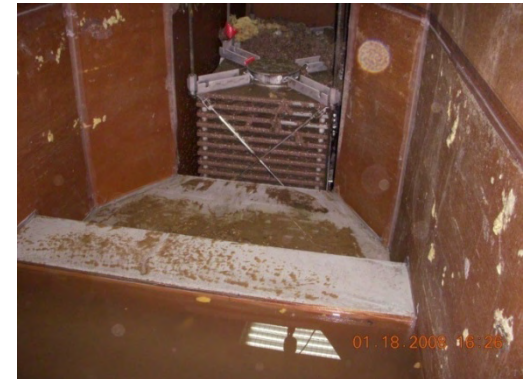
Photos from Wolf Creek Design Basis Test – Test 3B

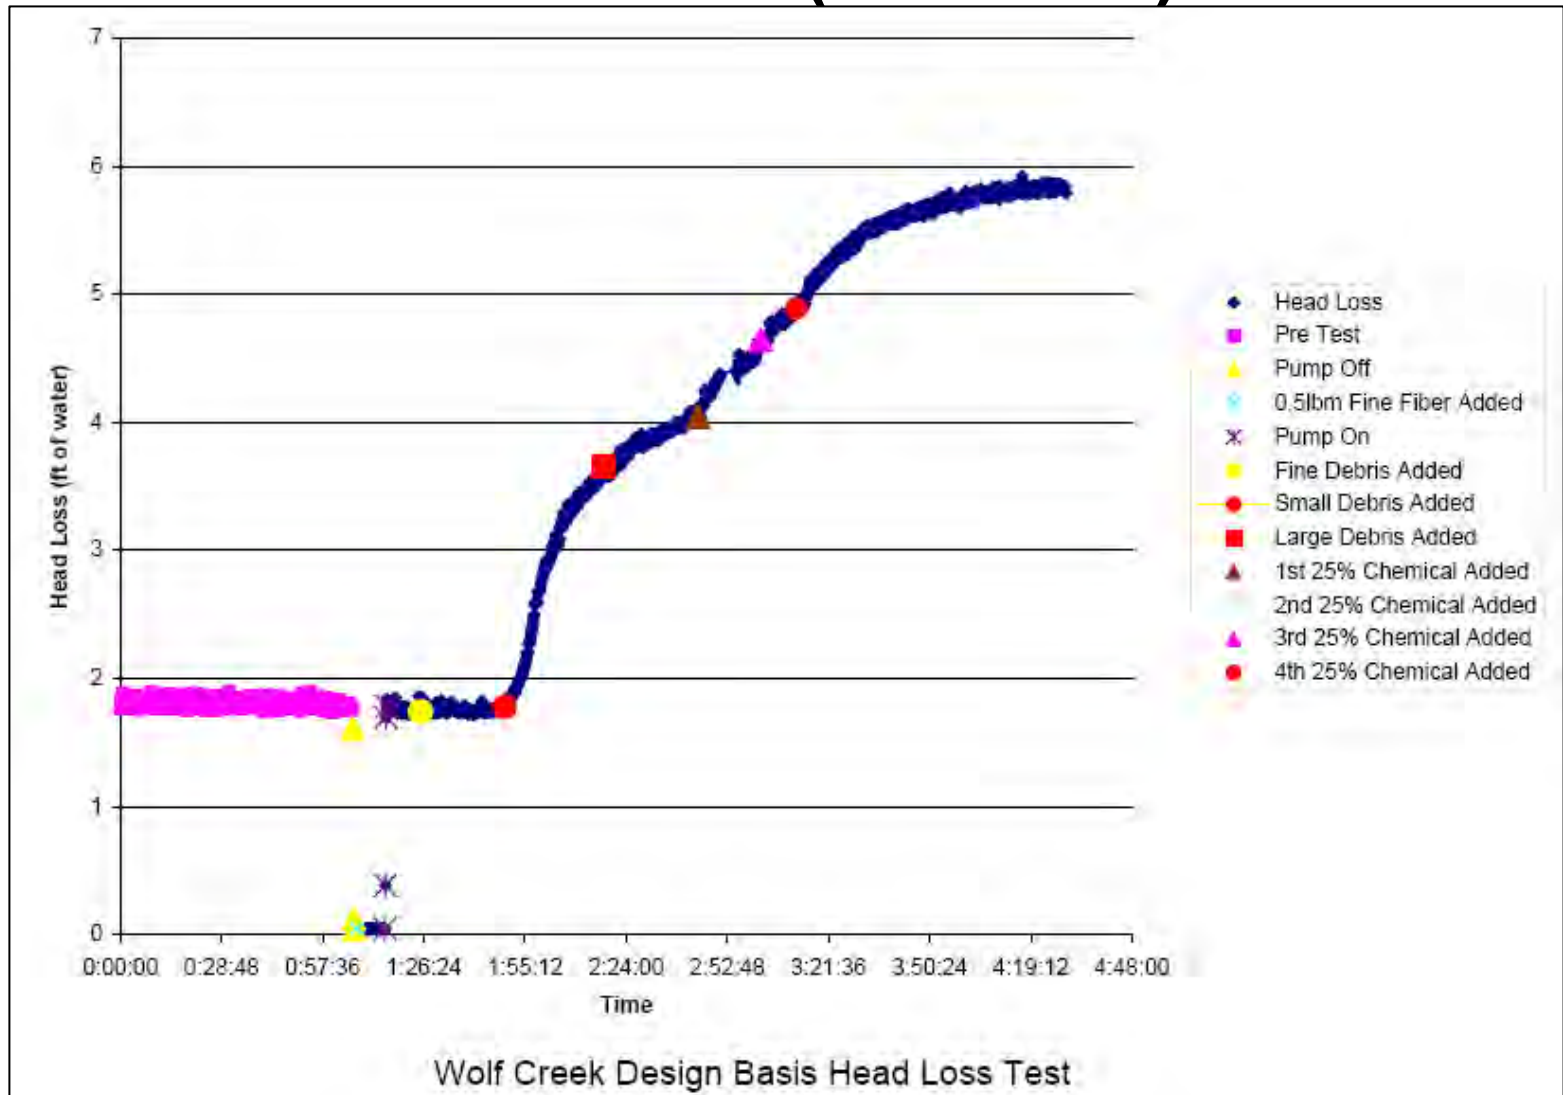
- The head loss testing for WC/CNP did account for erosion of this debris due to
 - Increased velocities from the decreased flow area over the settled debris
 - Fibers separated upon introduction into the flume, as shown in the video
 - The head loss curves shows large increase in head loss which we believe is related to fine fibrous debris being transported to the screen, which would include any erosion – see figure below
- No fiber was observed to settle within 23 ft. downstream of the debris accumulation

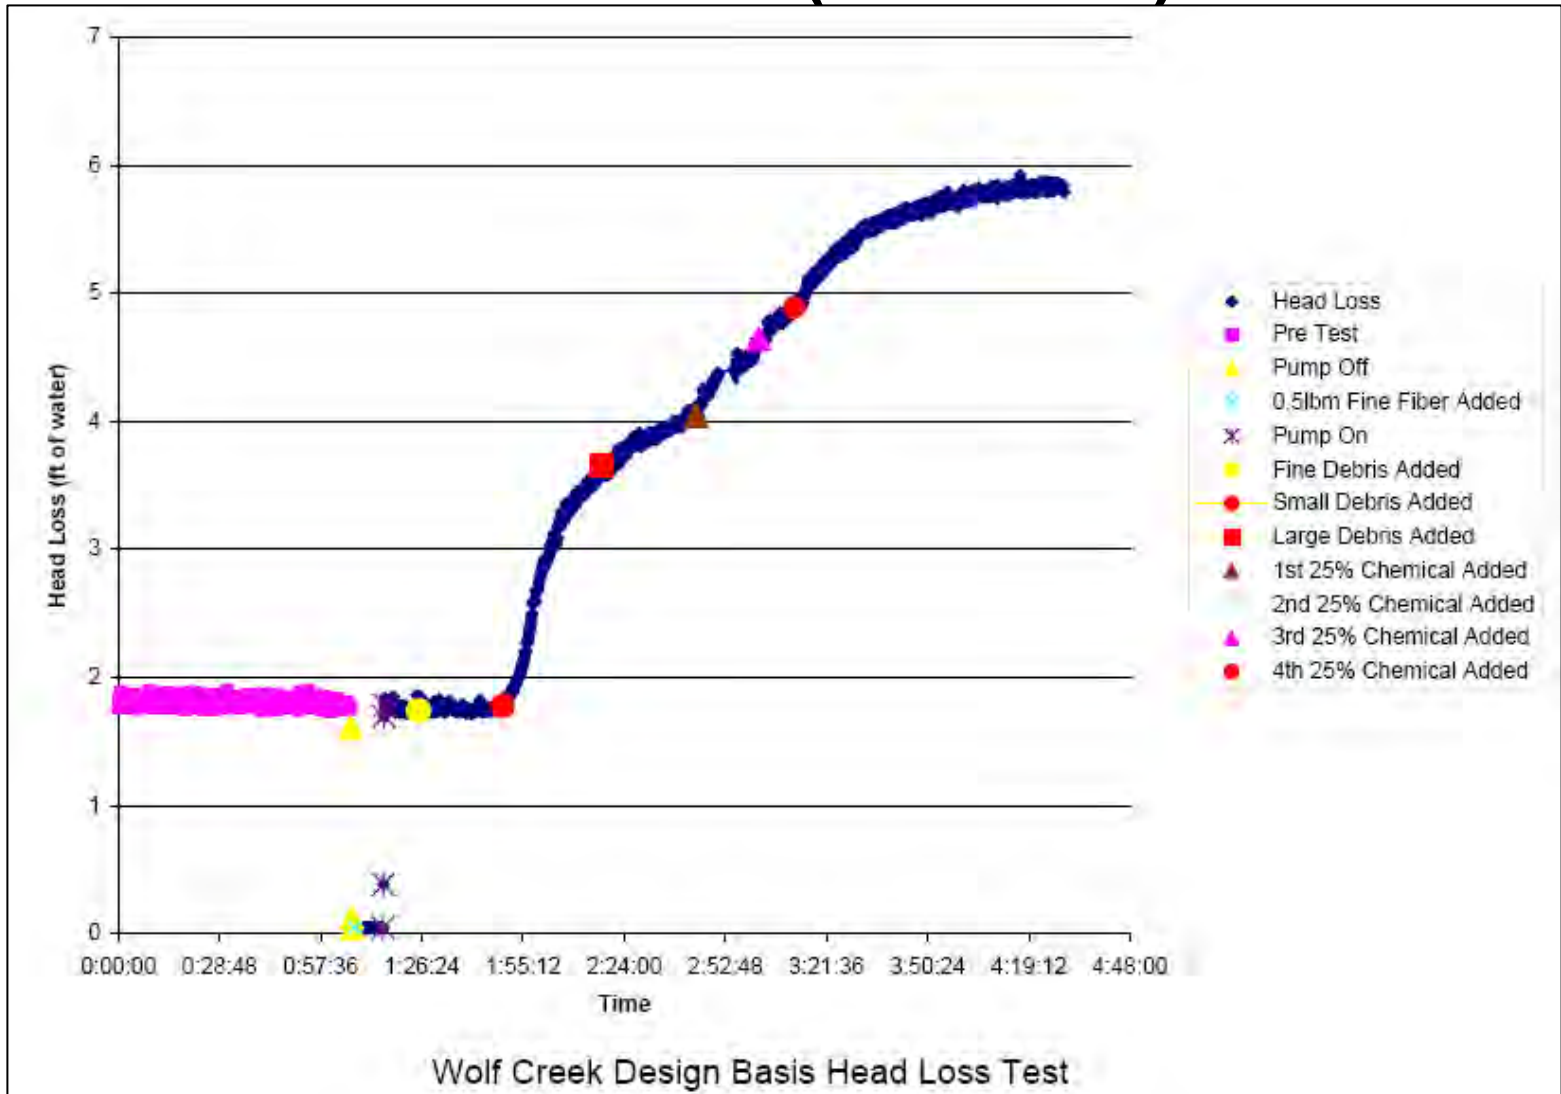
- Two pool turnovers between addition of next debris types – so adequate time (7 min) available to transport material.
- The introduction sequence did not affect the test results, since subsequent head loss testing shows a significant jump in head loss when the small fines mixture was added. See figure below from RAI #22.
