NRC – Callaway / Wolf Creek Public Meeting

GL 2004-02 Response RAIs
November 20
2009

- The purpose of this presentation is to address GL 2004-02 RAIs for Union Electric Company (Callaway) and Wolf Creek Nuclear Operating Corporation (Wolf Creek).

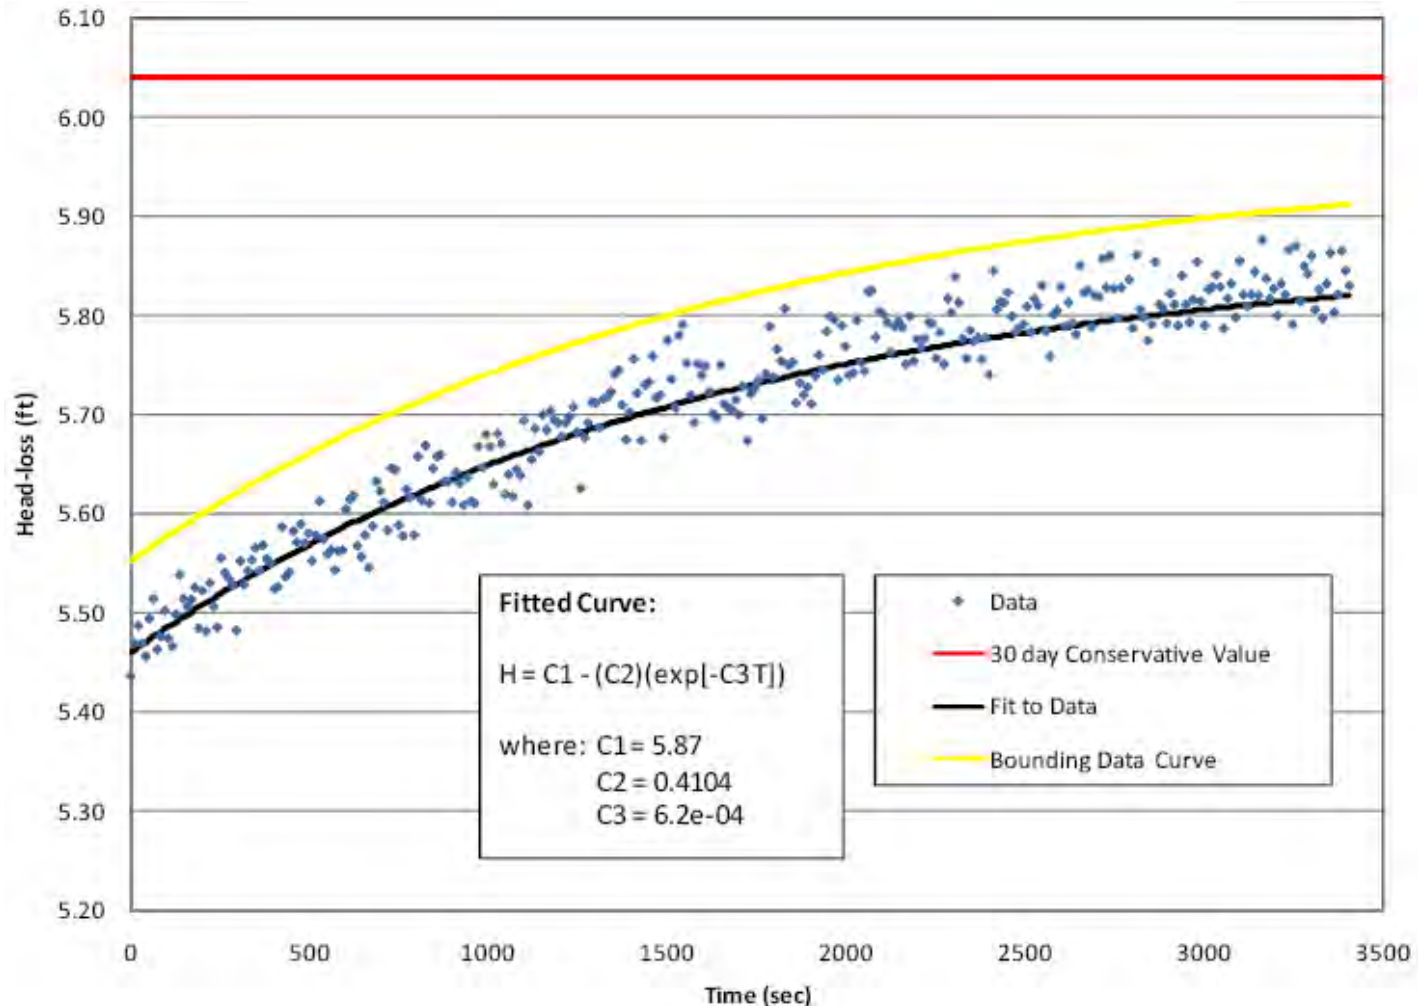
Wolf Creek 30-day head loss curve

- A more detailed look at the data fit is given in the following graphs
 - The data is shown along with the mean fit and a statistically meaningful bounding curve to all collected data points
 - The 30 day head loss value used in further analysis is based on the extrapolated head loss determined from the data-bounding curve
- For conservatism, additional margin was added
 - The maximum difference between the mean curve fit and any data point is added to the bounding curve value (yellow line)
- The resultant 30 day head loss value is shown as a red horizontal line at 6.04 ft for Wolf Creek and 3.00 ft for Callaway
