ATTACHMENT INTERTEK 1

Analysis of wedge block and debris

Excerpts from the Intertek study on the wedge block and debris

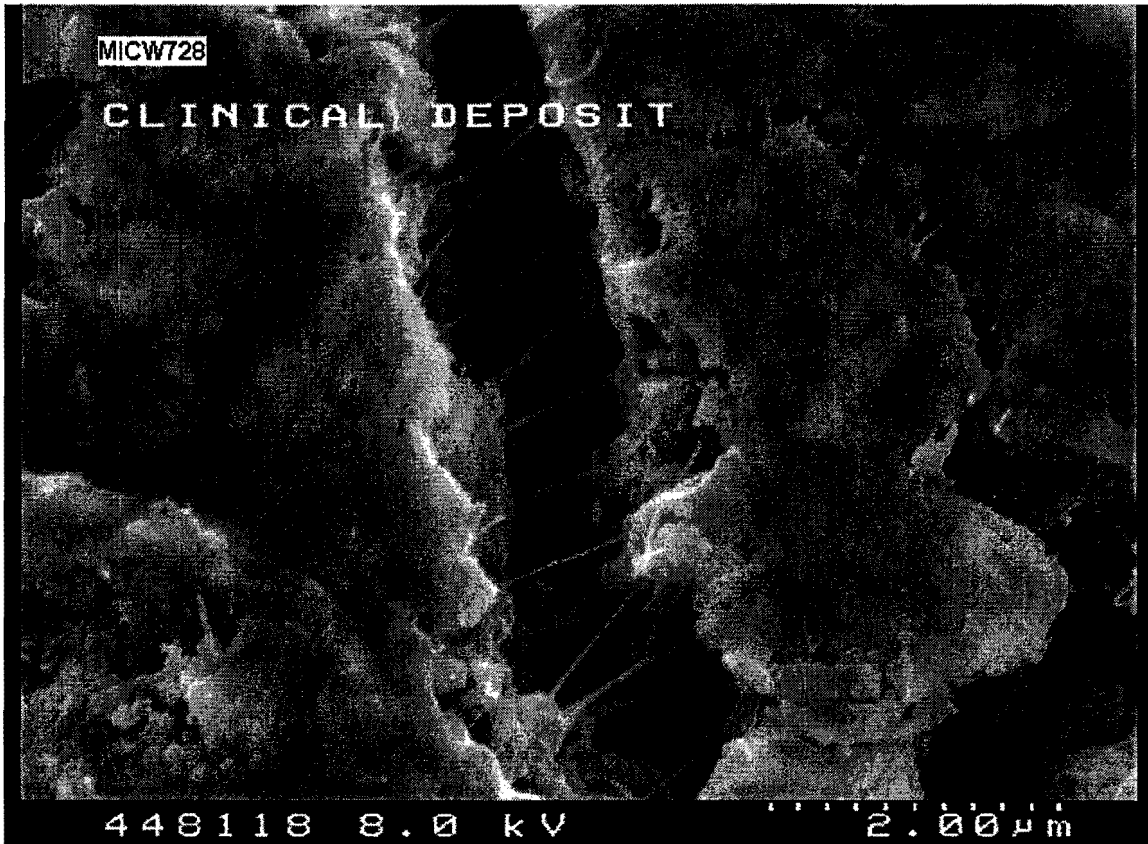
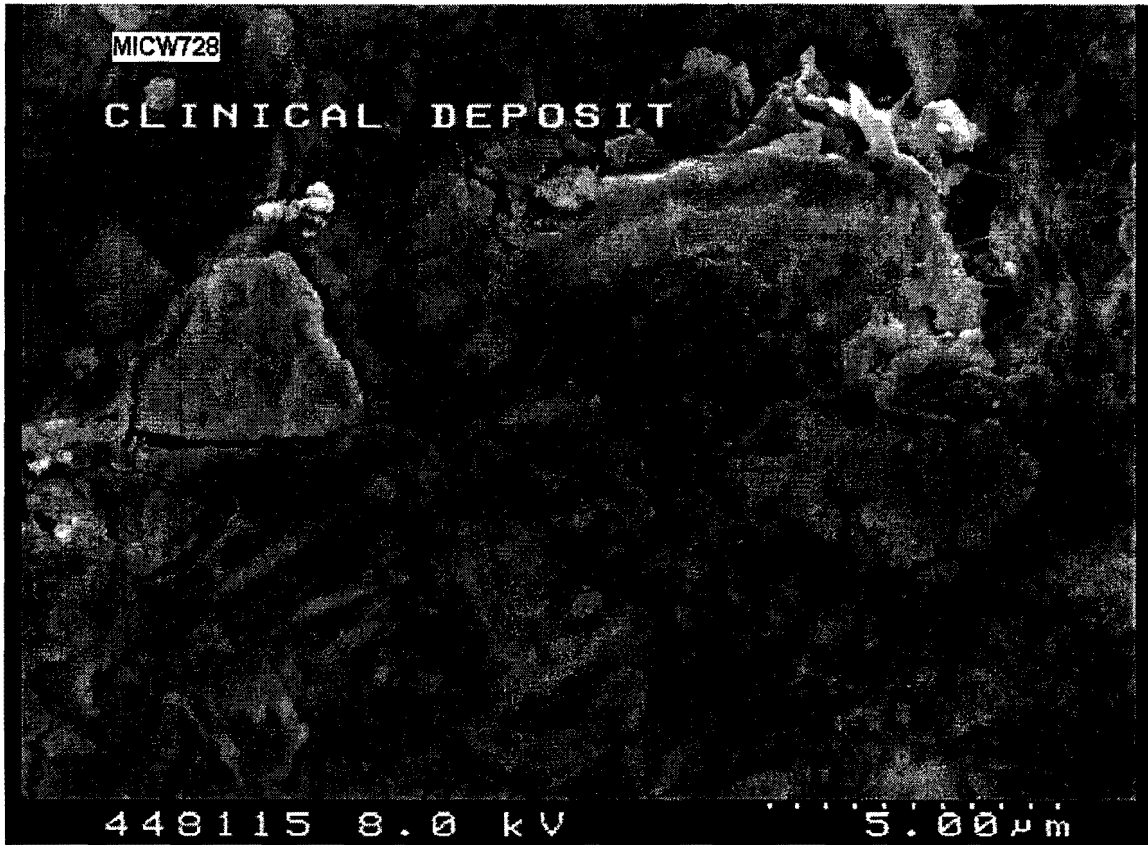
What follows is a sequence of SEM / EDX spectra that gives a “fingerprint” of the inorganic material comprising the particles illustrated above. Characteristically, the particles contain Fluorine (probably the Fluoropolymer matrix). Titanium and Nickel are also detected and this appears to be due to fine particles entrained in the continuous phase. [REDACTED] the black debris in the light micrographs are representative of this material which is likely to be wear debris. Traces of Iron were noted in many of the particles examined and on searching individual particles we noted small particles of Iron / Chrome / Nickel containing material – probably stainless steel. Occasionally we noted small Sulphur and Silicon peaks.

We therefore postulated that the clinical deposit was a soft fluoropolymer that has acted as a binding agent for wear debris from [REDACTED] and other parts of the machine.

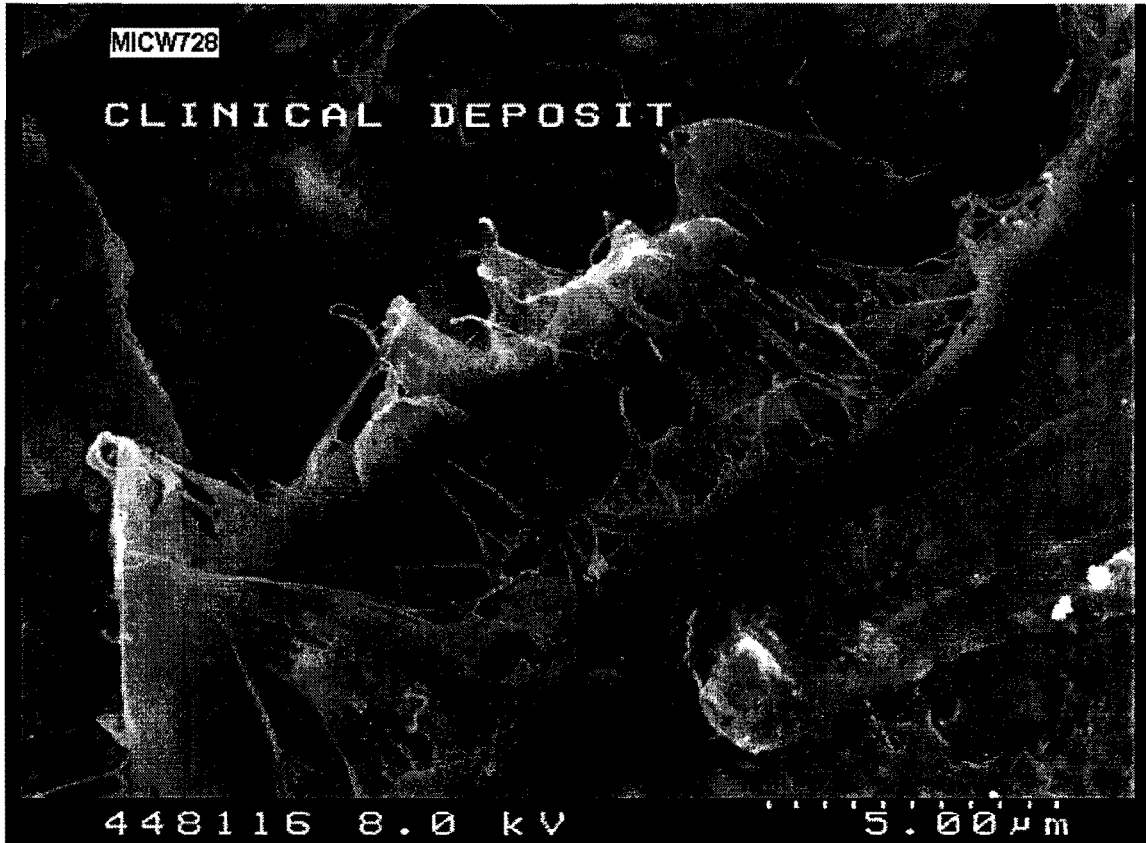
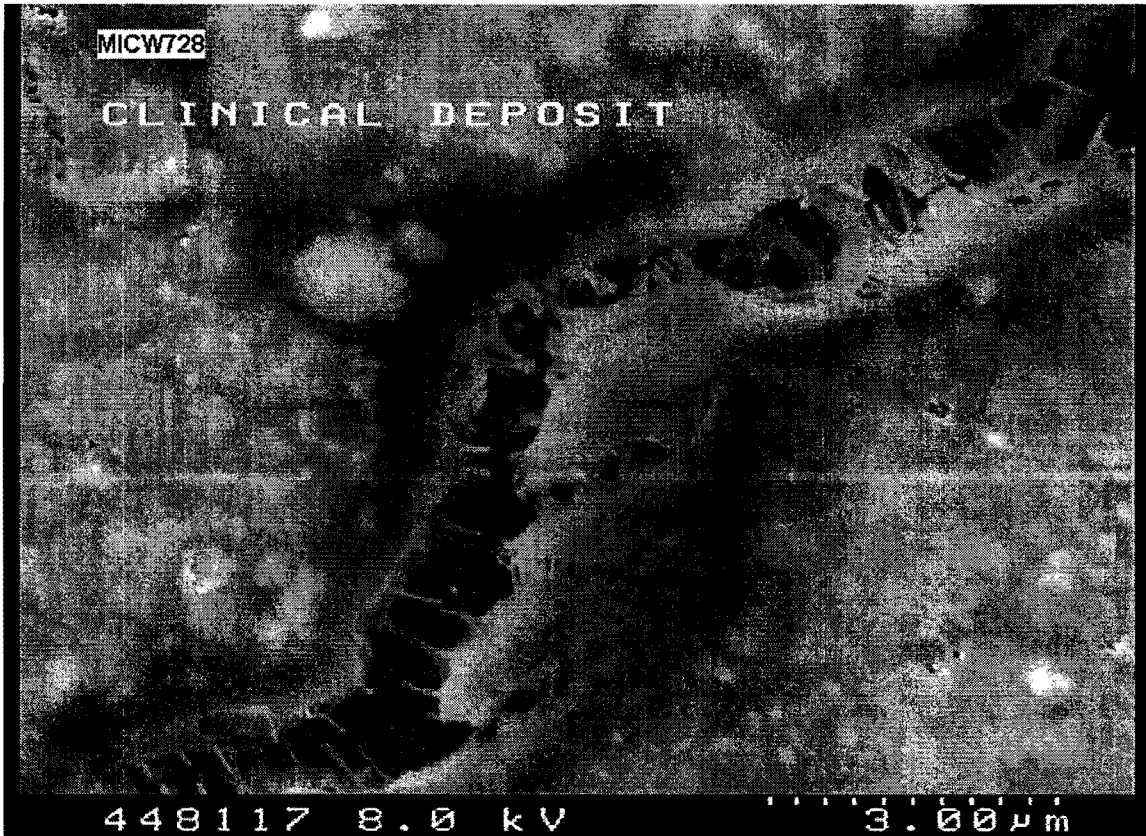
The black and white images above are high resolution FESEM images and characterise the clinical deposit well.

The “soft” transparent continuous phase is prone to fibrillation – it is basically a “sticky” material that deforms under shear – similar to PTFE. The particles visible in this continuous phase are the wear debris identified as largely being [REDACTED] the previous EDX spectra.
