REPORT
ON
CONSOLIDATED EDISON'S
INDIAN POINT UNIT NO. 2

CONTAINMENT VESSEL
STRUCTURAL INTEGRITY TEST
FOR
WESTINGHOUSE ELECTRIC CORPORATION

PREPARED BY
UNITED ENGINEERS & CONSTRUCTORS INC.
PHILADELPHIA, PENNSYLVANIA 19105

MAY 28, 1971

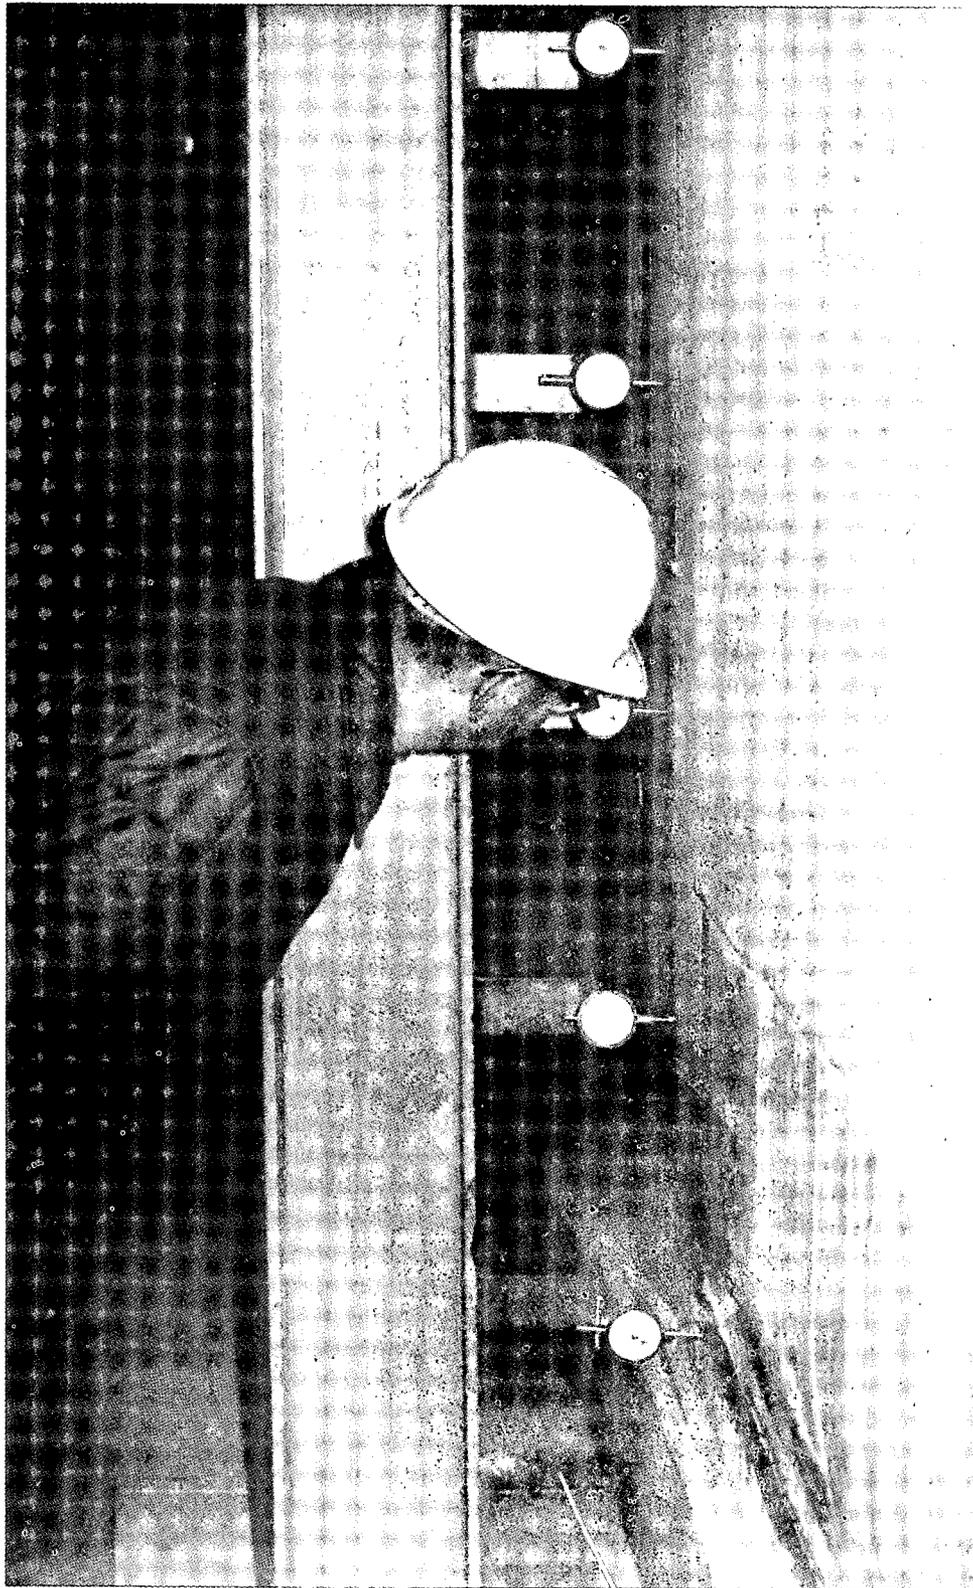
Fig. 1

Gross deformation measurements at the electrical penetration and the 290° meridian below Elev. 62 ft were obtained using dial gages having one inch of travel and an accuracy of 0.001 in. The dial gages were attached to a temporary support system at both locations (see Fig. 1).

DIAL GAGE INSTALLATION
IN ELECTRICAL TUNNEL
