***Seagrass Quantification Report
for the Area Adjacent to the Crystal River
Power Generation Facility, Florida***

Data collected: Nov-Dec, 2007

Report: Apr 24, 2008

**Prepared for:
Progress Energy Florida, Inc.
515 Independence Highway
Inverness, FL 34453**

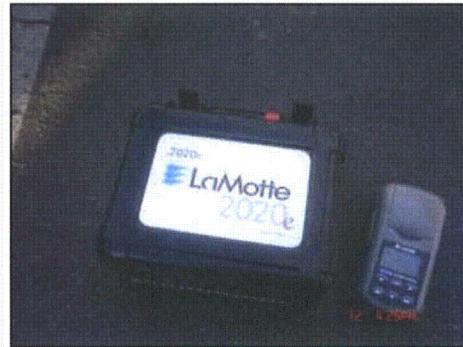
Figure 2b. LaMotte 2020c turbidity meter.

Water temperature and salinity were measured using a YSI 556 multi-probe system (www.ysilifesciences.com, Figure 2a), turbidity was measured using a LaMotte 2020e portable turbidity meter (www.lamotte.com, Figure 2b); all three measurements were taken 1 foot below the water surface. Light transmittance was measured using a Secchi disk (Figure 2c) and water depth was measured by using a graduated lead line (Figure 2d). Table 1 below shows the breakout of water quality monitoring sites by depth. The full dataset of water quality information can be found in the Appendix.

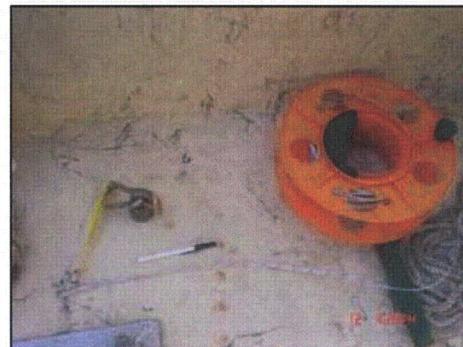
Figure 2d. Graduated lead line

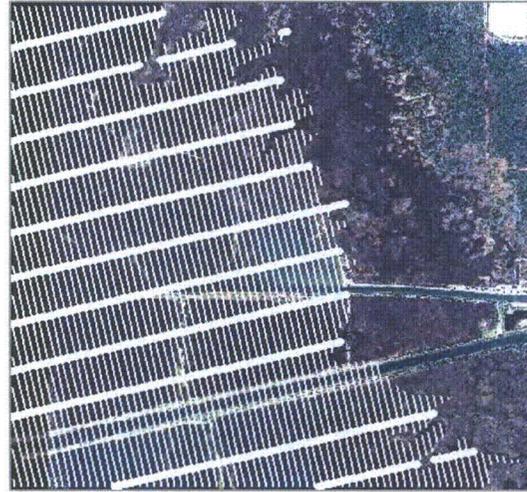
Figure 4. Crossing transects planned for hydroacoustic data collection totaled approximately 140-miles within the 2,842-acre study area. Closely spaced transects (oriented roughly north-south) were 60-meters apart, and widely spaced transects (oriented roughly east-west) were 400-meters apart.

ReMetrix collected data from crossing transects oriented WSW to ENE spaced 400-meters apart and SSE to NNW spaced 60-meters apart. This totaled approximately 140 miles of transects collected over the 2,842-acre site. Figure 4 represents the proposed crossing transects used for hydroacoustic sampling of this site.

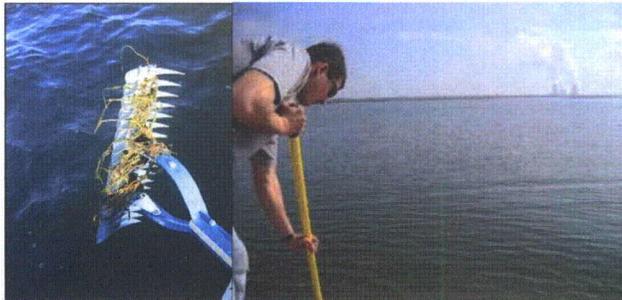
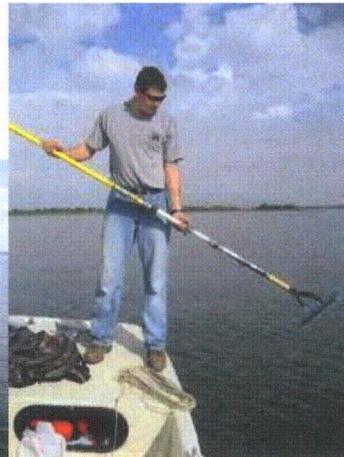
Figures 5a-c. A double-sided thatch rake was used to sample submerged vegetation at 109 sample points.

In areas deeper than three feet, a physical plant sample was collected by throwing a double-sided thatch rake toward the shoreline at each sampling site. A rake tethered to a 25-foot rope was tossed into the water and allowed to sink until it made contact with the bottom. The rake was then slowly dragged along the bottom back toward the boat, (Figure 5a).

In areas shallower than three feet, a rake with a handle was dipped into the water until it made contact with the bottom. Steady pressure was put on the rake handle as it was scraped along the bottom (Figure 5b,c).

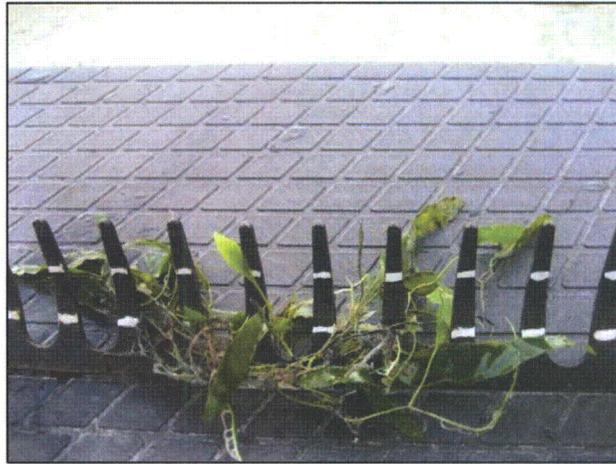
Figure 7. Species density was estimated by gently compressing the sample onto a one-sided garden rake with graduated tines. The white stripes on the tines mark 20% and 60% of the total tine length.

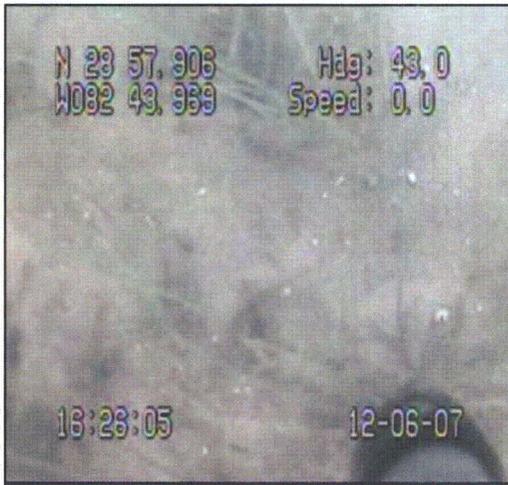
Figure 8a. When vegetation was found, the video camera was maneuvered to a range where plant identification was possible.

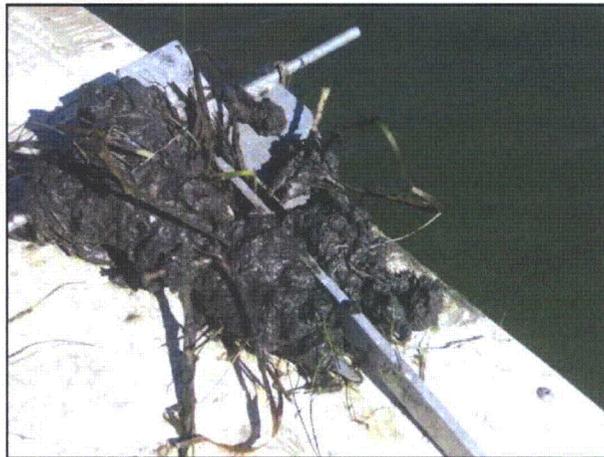
Figure 11. The anchor would occasionally capture vegetation samples in seagrass beds when rake sampling did not.

The rake sample method could successfully capture the species type, relative density, and estimate relative abundance. Additionally, this method could be employed while collecting the hydroacoustics making this the least time consuming of all the methods. Another advantage was photos could be taken to document the species and abundance, which could be linked back to a precise spatial location. The primary challenge involved while sampling with the rake method was retrieving a plant sample from the sediment. The only way to verify if the rake sample was missing vegetation was to check the hydroacoustics. If the hydroacoustics indicated plant while rake samples showed no plant, additional rake samples were attempted. Certain seagrass species were missed by rake sampling simply due to plant physiology. Long narrow leaf blades, dense root mats and un-branched structure allowed the rake to “comb” through sparsely populated seagrass stands rather than hooking or snagging the vegetation. For sites where this was true, vegetation was typically pulled up by the anchor, which dug into the soil like a shovel (Figure 11). Anchor samples were recorded as rake samples when these situations arose.

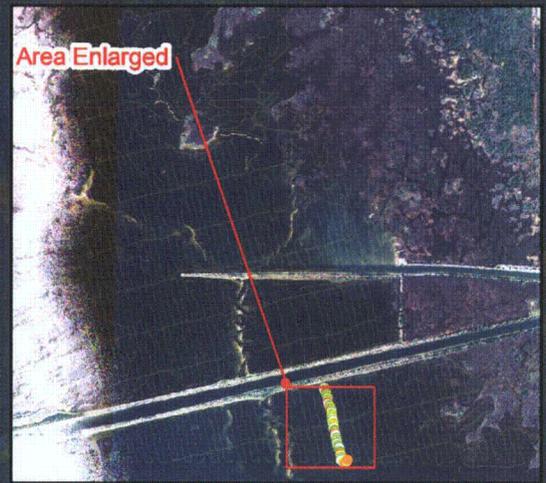
Transect Line 20071202_145701

0% - 100% Cover
BioCover Estimates

Start of Transect

A patented software algorithm is used to interpret the amount of submerged vegetation along each hydroacoustic transect. Examples of this process can be seen in the figures labeled “Transect Line 2007x” found in Appendix (these show the raw transect data with corresponding interpretations). Noise threshold settings influence how conservatively the algorithm filters noise within the hydroacoustic signal responses. The noise threshold settings are based on established ranges and can be adjusted by the data analyst during data processing. As processing proceeds, the data analyst compares the amount of submerged vegetation interpreted by the algorithm with visual inspection of raw transect data and other field data types. Noise threshold settings are considered acceptable when the data types are in agreement.

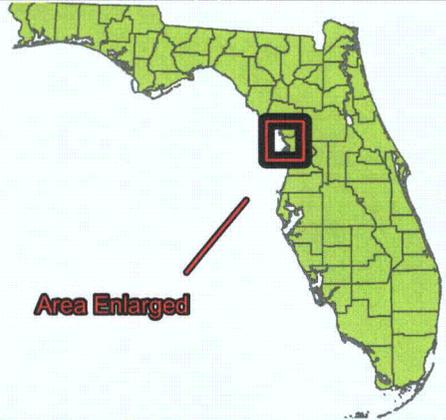
Monitoring Sites

11/27/2007 - 12/6/2007

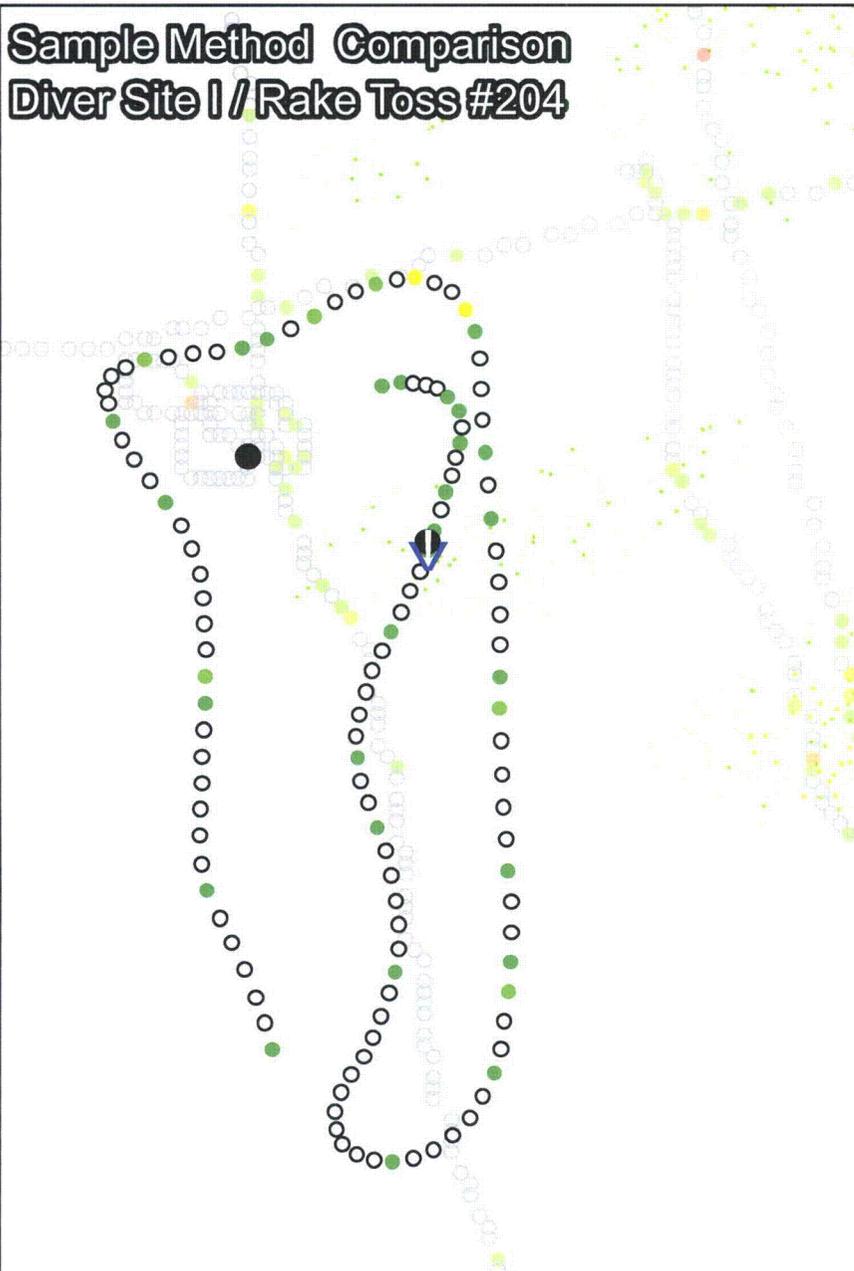
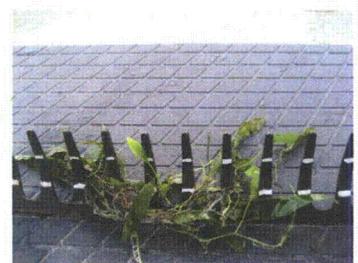
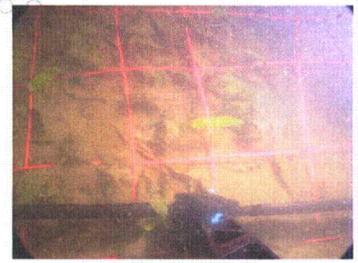
Sample Method Comparison Diver Site I / Rake Toss #204

Water Quality Information	
NAME	DS0001
Water Temp (deg C)	22.9
Sample Date	11/15/2007
Sample Time	12:25PM
Turbidity (ntu)	5.09
Salinity (ppt)	25.9
Secchi Depth (ft)	5
Physical Depth (ft)	5
Tide Level	L2:25PM
Water Depth (m)	1.5-2m

Bed Characteristics	
Size	Not defined; scattered
Plant Height	6 inches
Bottom Coverage	23%
Bed Density	Sparse

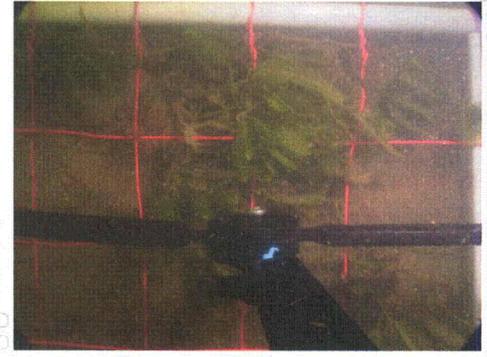
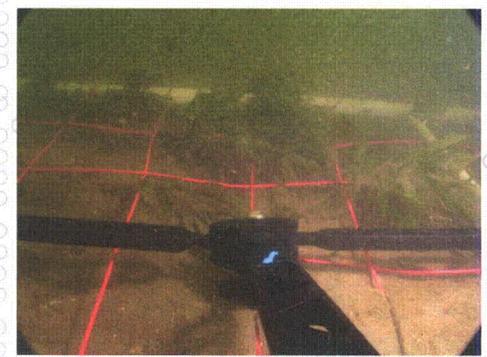
Diver Site II / Rake Toss #146

Water Quality Information	
NAME	DS0002
Water Temp (deg C)	22.9
Sample Date	11/15/2007
Sample Time	1:40PM
Turbidity (ntu)	3.94
Salinity (ppt)	29.1
Secchi Depth (ft)	3.6
Physical Depth (ft)	3.9
Tide Level	L2:25PM
Water Depth (m)	1-1.5m

Bed Characteristics	
Size	Not defined; scattered
Plant Height	1 foot
Bottom Coverage	22%
Bed Density	Sparse

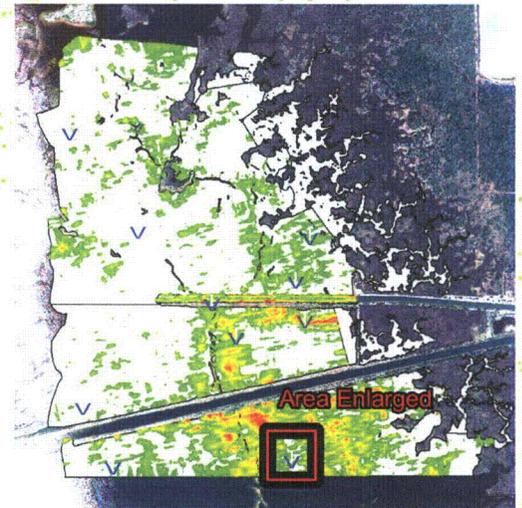
Sample Method Comparison Diver Site V / No Rake Toss

NAME	DS0005
Water Temp (deg C)	16.2
Sample Date	11/16/2007
Sample Time	12:05PM
Turbidity (ntu)	3.62
Salinity (ppt)	27.6
Secchi Depth (ft)	0.9
Physical Depth (ft)	0.9
Tide Level	L3:20PM
Water Depth (m)	0.5-1m

Bed Characteristics	
Size	Not defined; scattered
Plant Height	1 foot
Bottom Coverage	95%
Bed Density	Medium

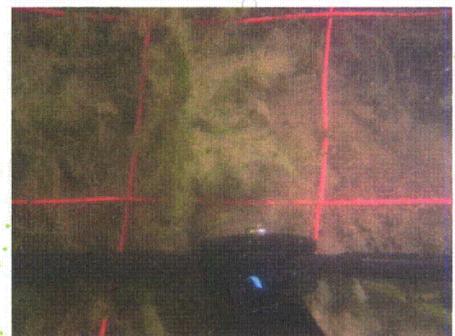
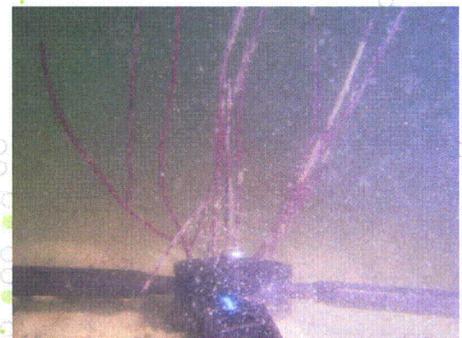
Sample Method Comparison Diver Site VI / No Rake Toss

NAME	DS0006
Water Temp (deg C)	16.9
Sample Date	11/16/2007
Sample Time	1:22PM
Turbidity (ntu)	2.55
Salinity (ppt)	30.9
Secchi Depth (ft)	3.6
Physical Depth (ft)	3.6
Tide Level	L3:20PM
Water Depth (m)	1-1.5m

Bed Characteristics	
Size	Not defined; scattered
Plant Height	1 foot
Bottom Coverage	100%
Bed Density	Medium

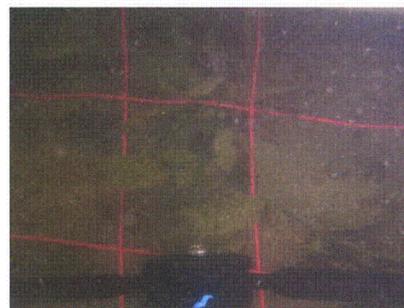
Diver Site VII / Rake Toss #62

NAME	DS0007
Water Temp (deg C)	19.3
Sample Date	11/16/2007
Sample Time	2:55PM
Turbidity (ntu)	4.09
Salinity (ppt)	29.8
Secchi Depth (ft)	3.9
Physical Depth (ft)	5.5
Tide Level	L3:20PM
Water Depth (m)	1.5-2m

Bed Characteristics	
Size	No defined; scattered
Plant Height	6 inches
Bottom Coverage	65%
Bed Density	Medium

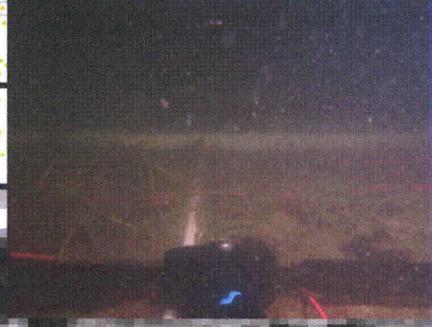
Diver Site VIII / Rake Toss #9996

NAME	DS0008
Water Temp (deg C)	18.3
Sample Date	11/16/2007
Sample Time	3:38PM
Turbidity (ntu)	5.42
Salinity (ppt)	27.6
Secchi Depth (ft)	3.9
Physical Depth (ft)	11.7
Tide Level	L3:20PM
Water Depth (m)	3-4m

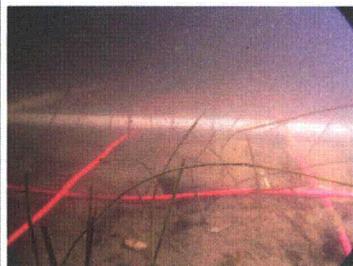
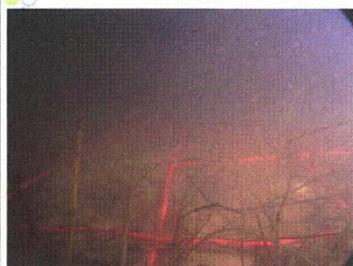
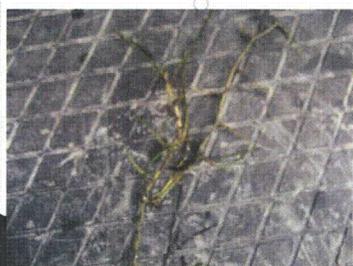
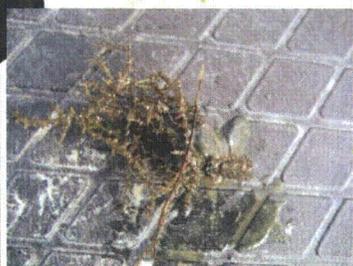
Diver Site X / Rake Toss #133

NAME	DS0010
Water Temp (deg C)	26.5
Sample Date	11/16/2007
Sample Time	5:00PM
Turbidity (ntu)	13.6
Salinity (ppt)	31.9
Secchi Depth (ft)	1.7
Physical Depth (ft)	1.7
Tide Level	L3:20PM
Water Depth (m)	0.5-1m

Bed Characteristics		
Size		Large
Plant Height		1 foot
Bottom Coverage		100%
Bed Density		Dense
