PNNL-19119

Preliminary Examination of Cracks in Alloy 152, 52, and 52M Weld Metals

January 2010

Prepared for
U.S. Nuclear Regulatory Commission
under a Related Services Agreement
with the U.S. Department of Energy
Contract DE-AC05-76RL01830
NRC Project JCN N6547

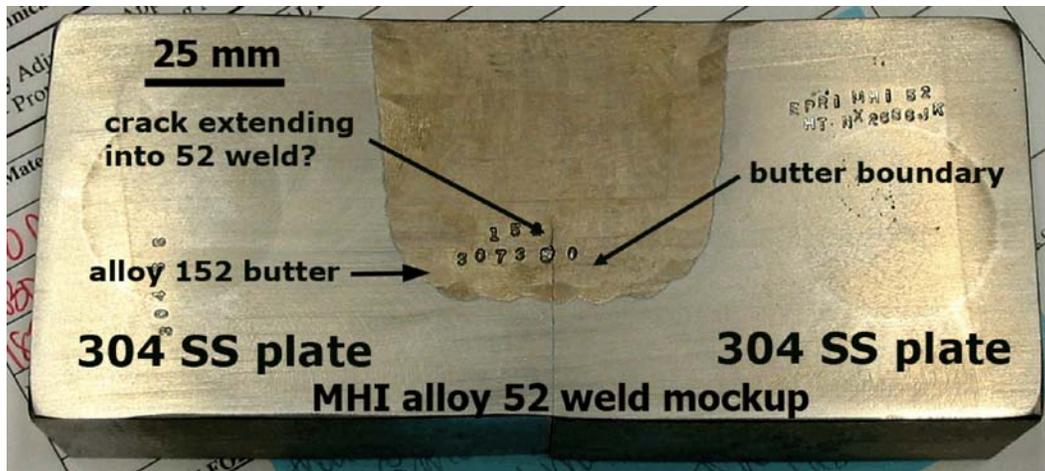
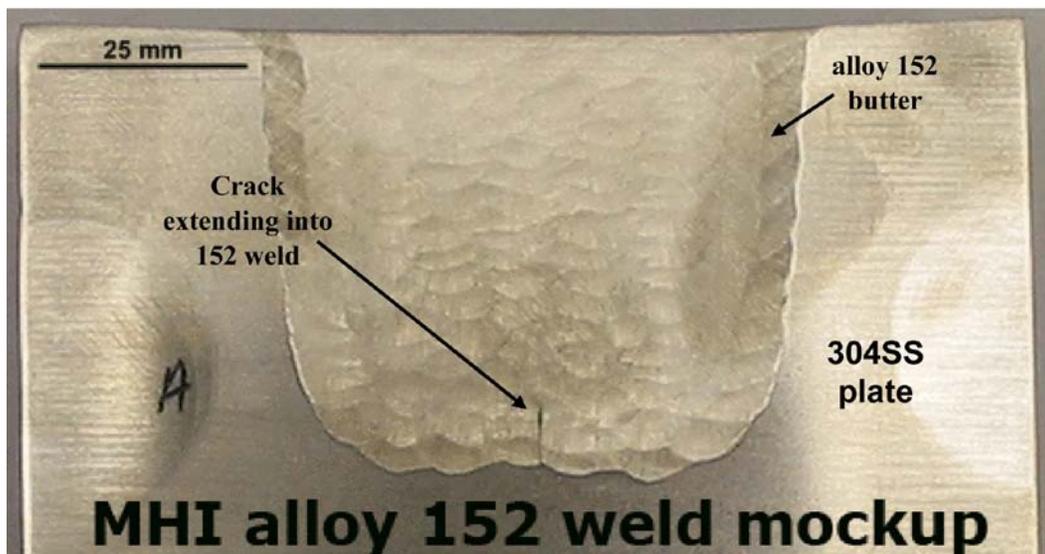
Figure 2.1. Optical Images of MHI Alloy 52 and Alloy 152 Weld Mockups Showing U-groove Weld in Cross Section. Both welds were made to 304SS plate using an Alloy 152 butter layer.

One prominent feature in these mockup welds is the presence of a crack starting at the 304SS butt joint at the bottom of the U-groove and extending up into the weld. It appears that the 304SS plate on either side of the butt joint acted as an anchor for the weld, resulting in a stress riser across the slit that drove crack formation and extension into the fill weld. As will be shown in the next section, the extent of the cracking around this stress riser was much greater in the MHI 52 weld mockup.

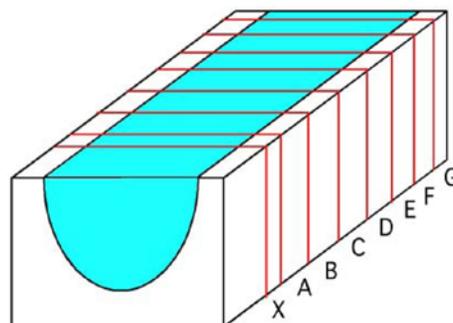
Figure 2.2. Sketch Showing the Relative Location of Slices Taken from the MHI Alloy 152 Mockup

A relatively long piece of the MHI Alloy 152 mockup was obtained from the Electric Power Research Institute (EPRI) NDE Center, which provided sufficient material to take three slices, X, B, and F, from the mockup for weld crack characterization as described in Figure 2.2. Only a small length of the MHI Alloy 52 mockup was acquired from the General Electric Global Research Center limiting weld defect analysis to a single slice (remaining material was needed for crack-growth specimens).

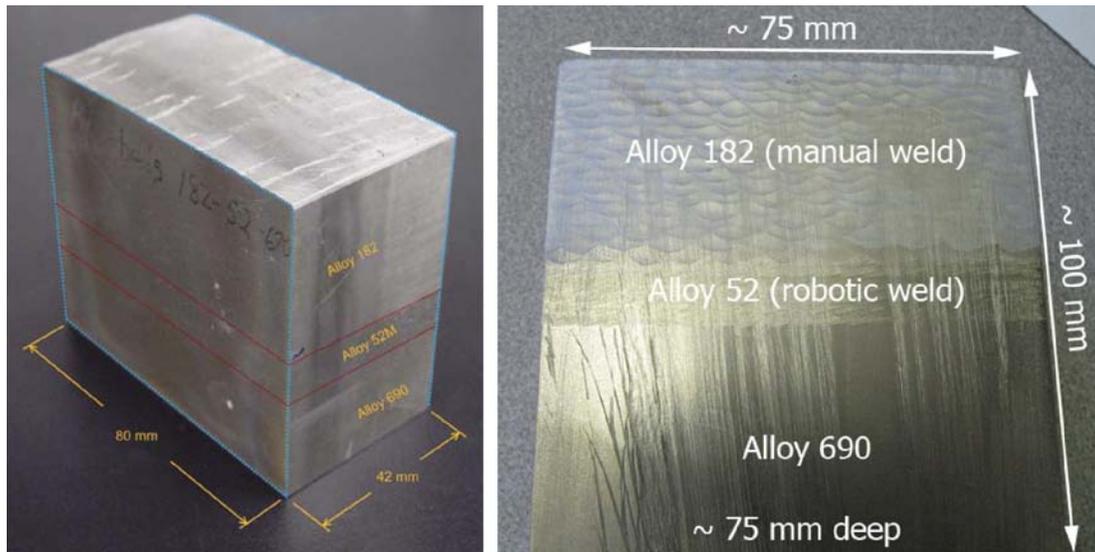
Figure 2.3. Overview of the Ringhals Alloy 52M Overlay Mockup where Alloy 52M was Robotically Welded to an Alloy 690 Plate Followed by Alloy 182 Manually Welded onto the Alloy 52M. The Alloy 52M layer is 10-mm thick.

Two slices were taken from the Ringhals overlay for weld defect characterization, one near the front of the piece (slice A) shown in Figure 2.3 and one near the back of the piece (slice C). A cut plan for the Ringhals Alloy 52M inlay, shown in Figure 2.5, indicates the positioning of the slices used for the weld defect examinations.

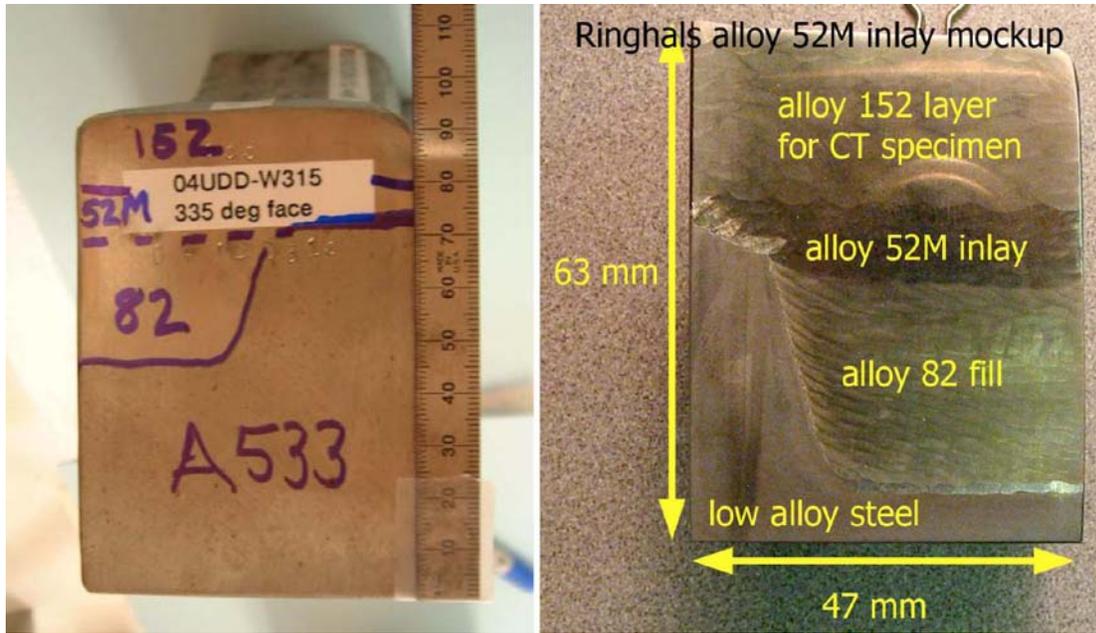
Figure 2.4. Overview of the Ringhals Alloy 52M Inlay Mockup. This was a full-scale, service mockup with Alloy 82 fill followed by an Alloy 52M inlay. Alloy 152 was welded onto the Alloy 52M by Westinghouse to allow fabrication of CT specimens from the inlay region.

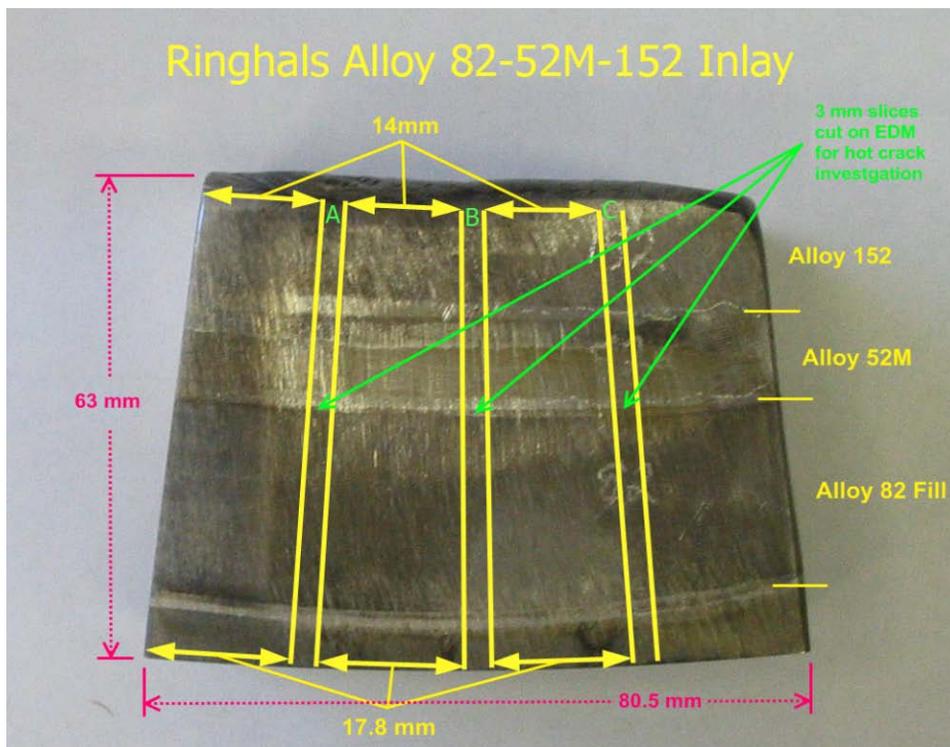
Figure 2.5. Side View of Ringhals Alloy 52M Mockup Showing Cut Lines for CT Specimen Blanks and Metallography Slices

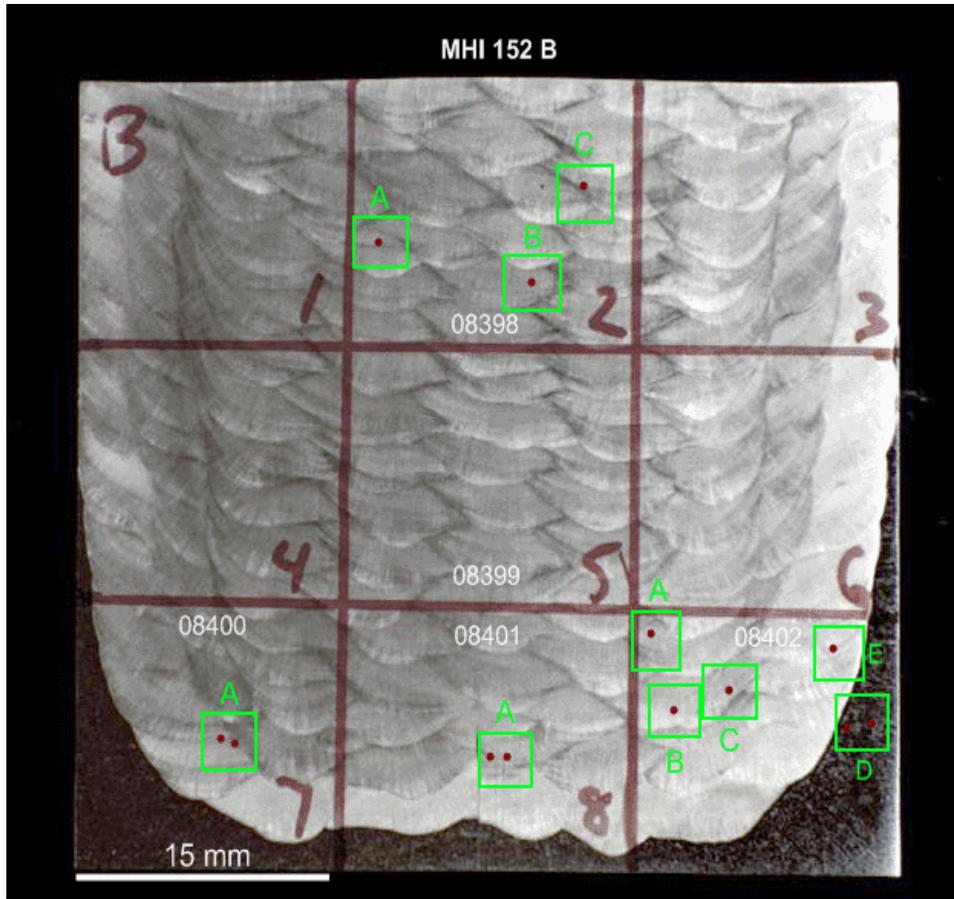
Figure 3.1. Overview Image of the Alloy 152 Weld Slice B with areas Showing Possible Weld Defects Highlighted by the Green Boxes

Three slices of the MHI Alloy 152 material were examined for weld defects. The first slice (B) is shown in Figure 3.1. For this slice and all the other MHI weld slices, only those pieces with ID codes in white lettering were examined as these were the expected areas of highest weld residual stress. The small green boxes indicate areas that appeared to contain weld defects in our overview examinations. However, detailed metallography determined that few of these features were cracks. Most were small pits probably resulting from inclusion or precipitate pullout during polishing as shown in Figure 3.2. Only a few cracks were found in the lower right region of the Alloy 152 weld (#08402) and typical small cracks are presented in Figure 3.3. The largest crack was found near the 304SS – Alloy 152 interface, possibly in a region of altered composition. The overview of Alloy 152 slice F in Figure 3.4 shows several locations where cracks were thought to be present in the initial examination. As with slice B, detailed metallographic examination revealed that the majority of small indications were only pits created by pullout of second-phase particles during polishing. An example of this damage and a crack are shown in Figure 3.5. Examination of slice X, shown in Figure 3.6, revealed no cracks except the crack that extended from the butt joint at the bottom of the U-groove weld.

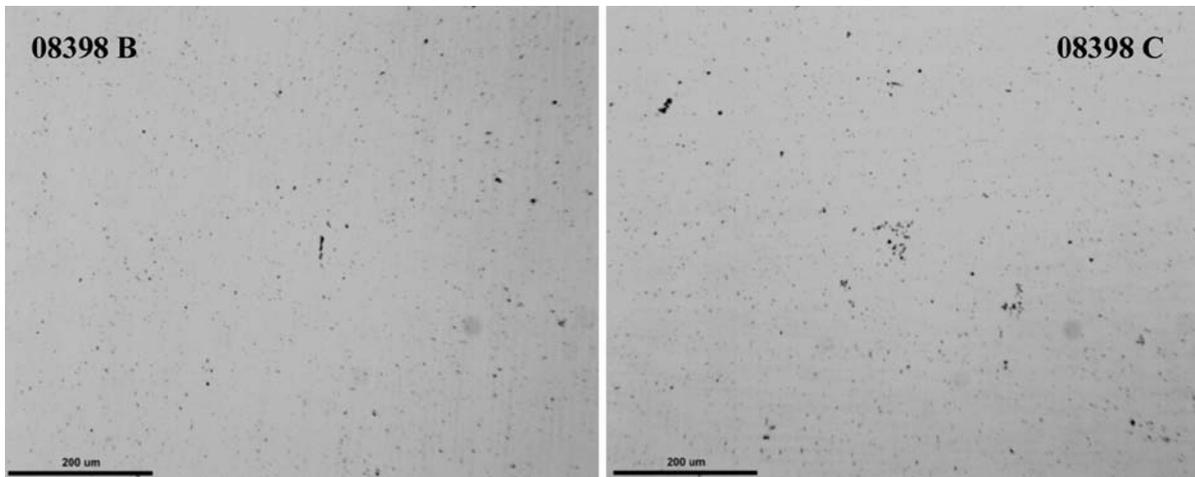
Figure 3.2. Optical Metallographs Illustrating Regions in the Alloy 152 Weld Metal Slice B. Most areas only reveal fine pits due to particle pullout. Scale markers in lower left of each micrograph represent 200 μm .

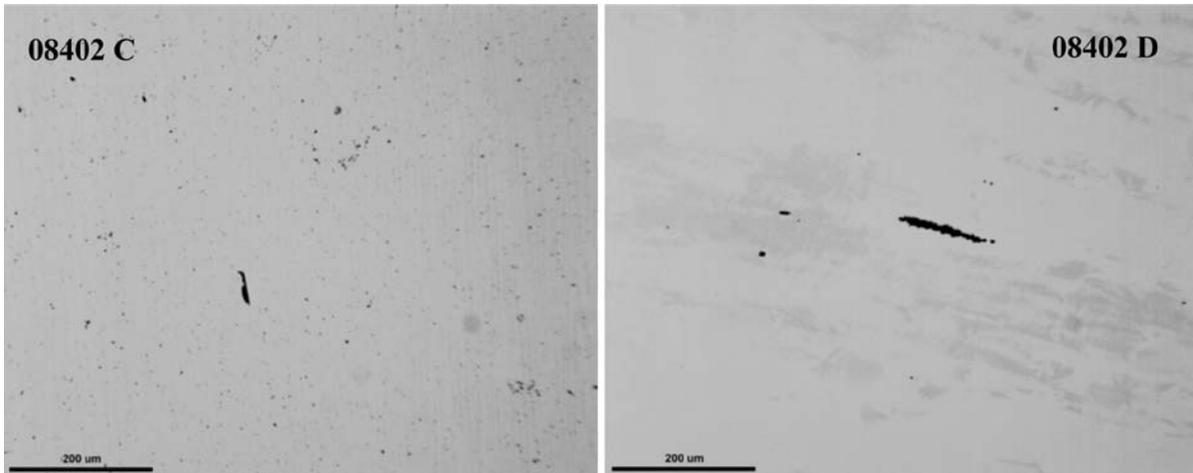
Figure 3.3. Optical Metallographs Illustrating Regions in the Alloy 152 Weld Metal Slice B. The images show small weld cracks, 08402C is in the Alloy 152 weld metal while 08402D is near the 304SS – Alloy 152 interface. Scale markers in lower left of each micrograph represent 200 μm .

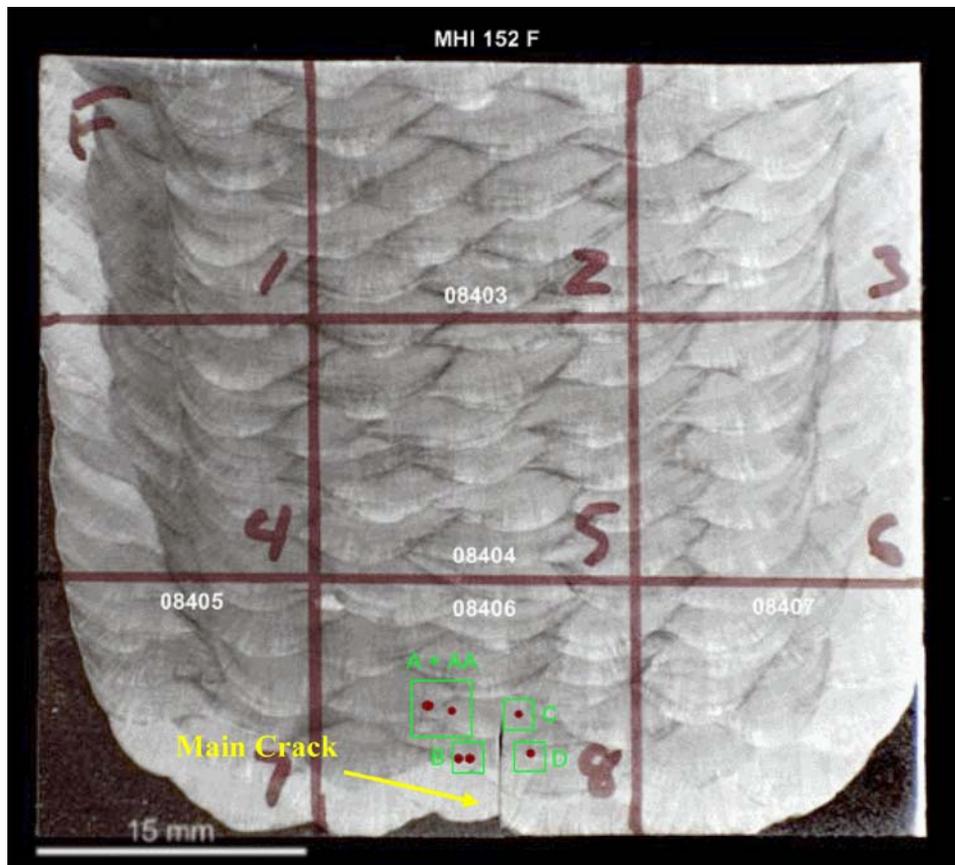
Figure 3.4. Overview Image of the Alloy 152 Weld Slice F with Areas Showing Possible Weld Defects Highlighted by the Green Boxes

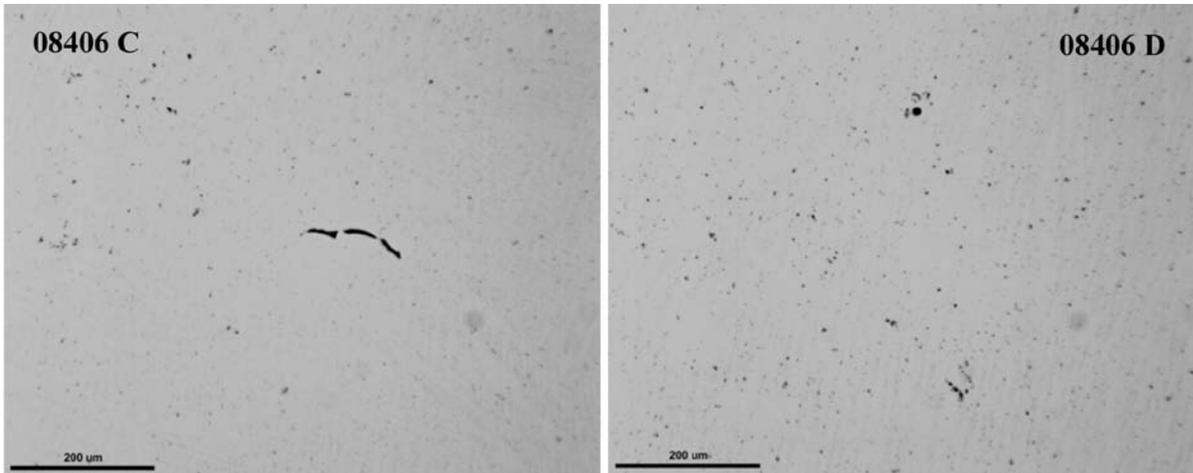
Figure 3.5. Optical Metallographs Illustrating Regions in the Alloy 152 Weld Metal Slice F. Most areas only reveal fine pits due to particle pullout. A small weld crack is seen in 08406C near the main crack. Scale markers in lower left of each micrograph represent 200 μm .

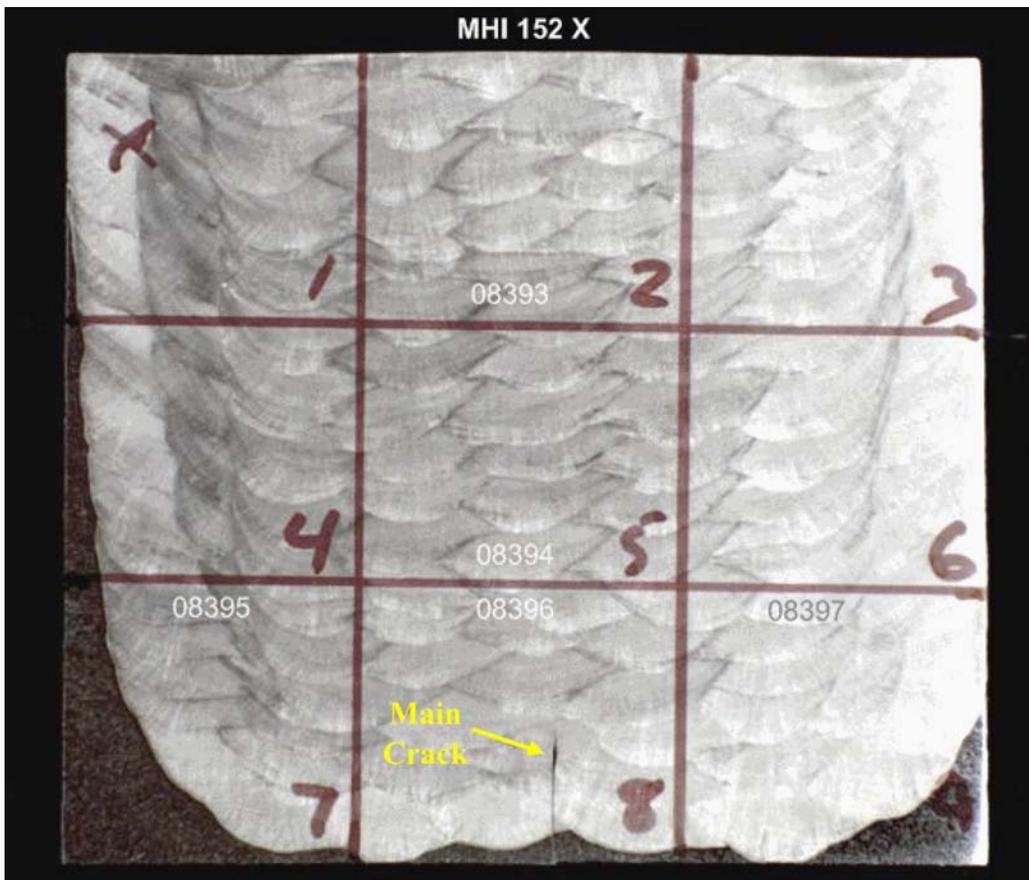
Figure 3.6. Overview Image of the Alloy 152 Weld Slice X. No areas containing weld cracks were identified except for the crack extending from the 304SS joint.

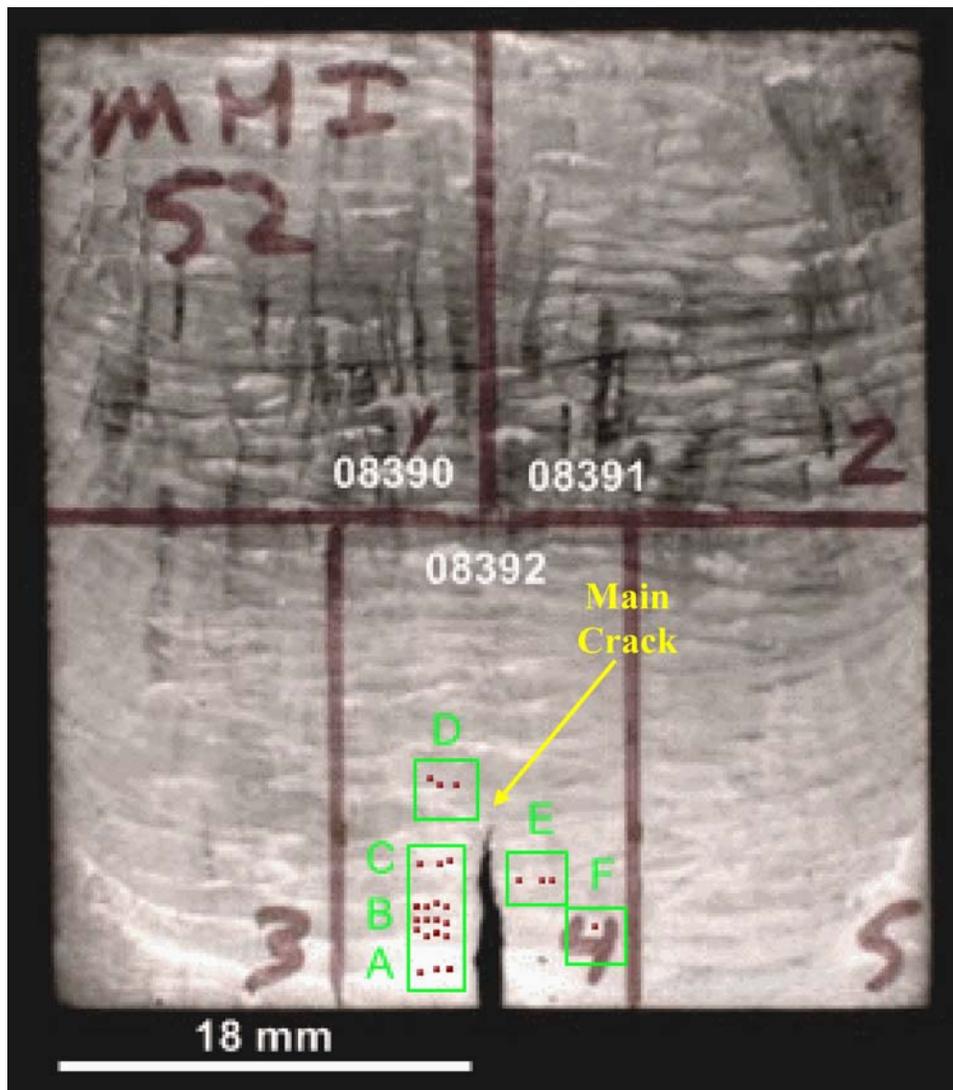
Figure 3.7. Overview Image of the Alloy 52 Slice Showing Large Separation and Cracking Extending Up from the Butt Joint at the Bottom of the U-groove. Large amounts of weld cracks were found in the region around this large crack but nowhere else in the slice.

The Alloy 52 weld, which was fabricated by GTAW instead of SMAW, has a large degree of weld-induced separation at the base of the U-groove where the two plate pieces meet. A long macroscopic crack can be seen extending up through the Alloy 152 butter passes and into the Alloy 52 fill weld as shown in Figure 3.7. Many cracks were identified in the Alloy 52 weld metal around this macroscopic crack with examples shown in Figure 3.8. These cracks are roughly parallel to the large main crack in most instances and span from 300–500 μm in length. Etching of selected cracks, as shown in Figure 3.9, reveals that the cracks are located on grain boundaries as expected. No obvious features can be seen on the cracks that explain their location on these particular grain boundaries. The remainder of the slice was free of any weld defects.

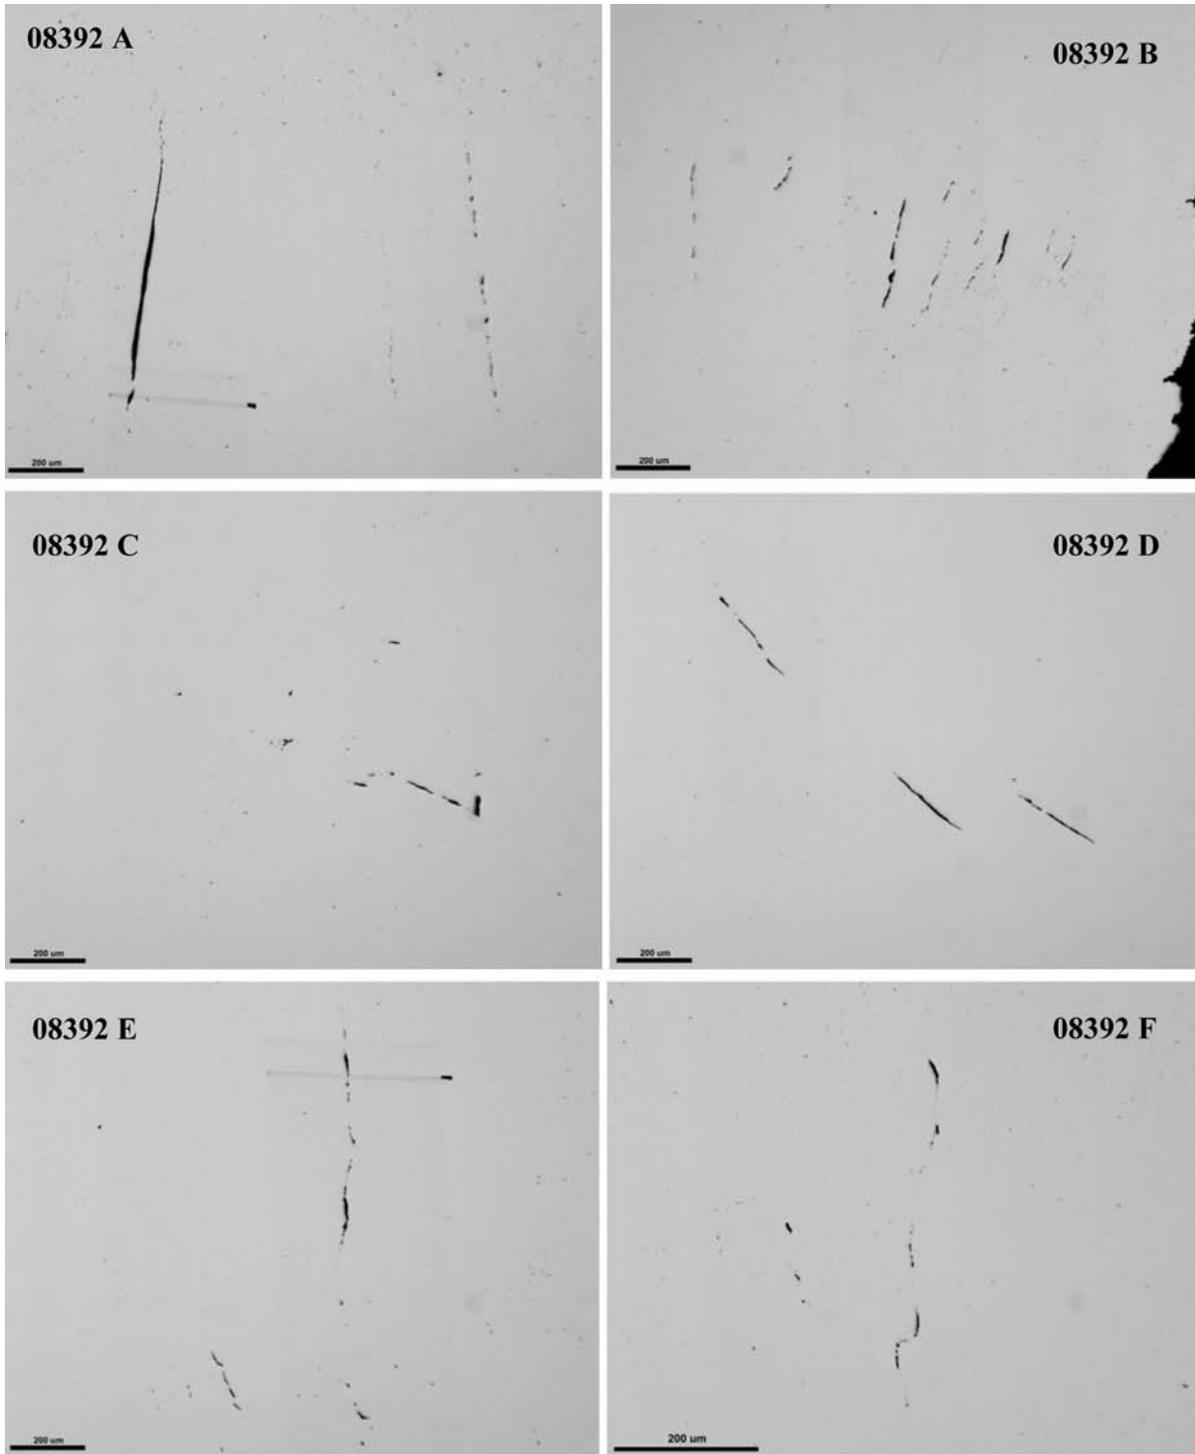
Figure 3.8. Weld Cracks in Alloy 52 Weld Metal Adjacent to Main Crack as Illustrated in Figure 3.7. Scale markers in lower left of each micrograph represent 200 μm .

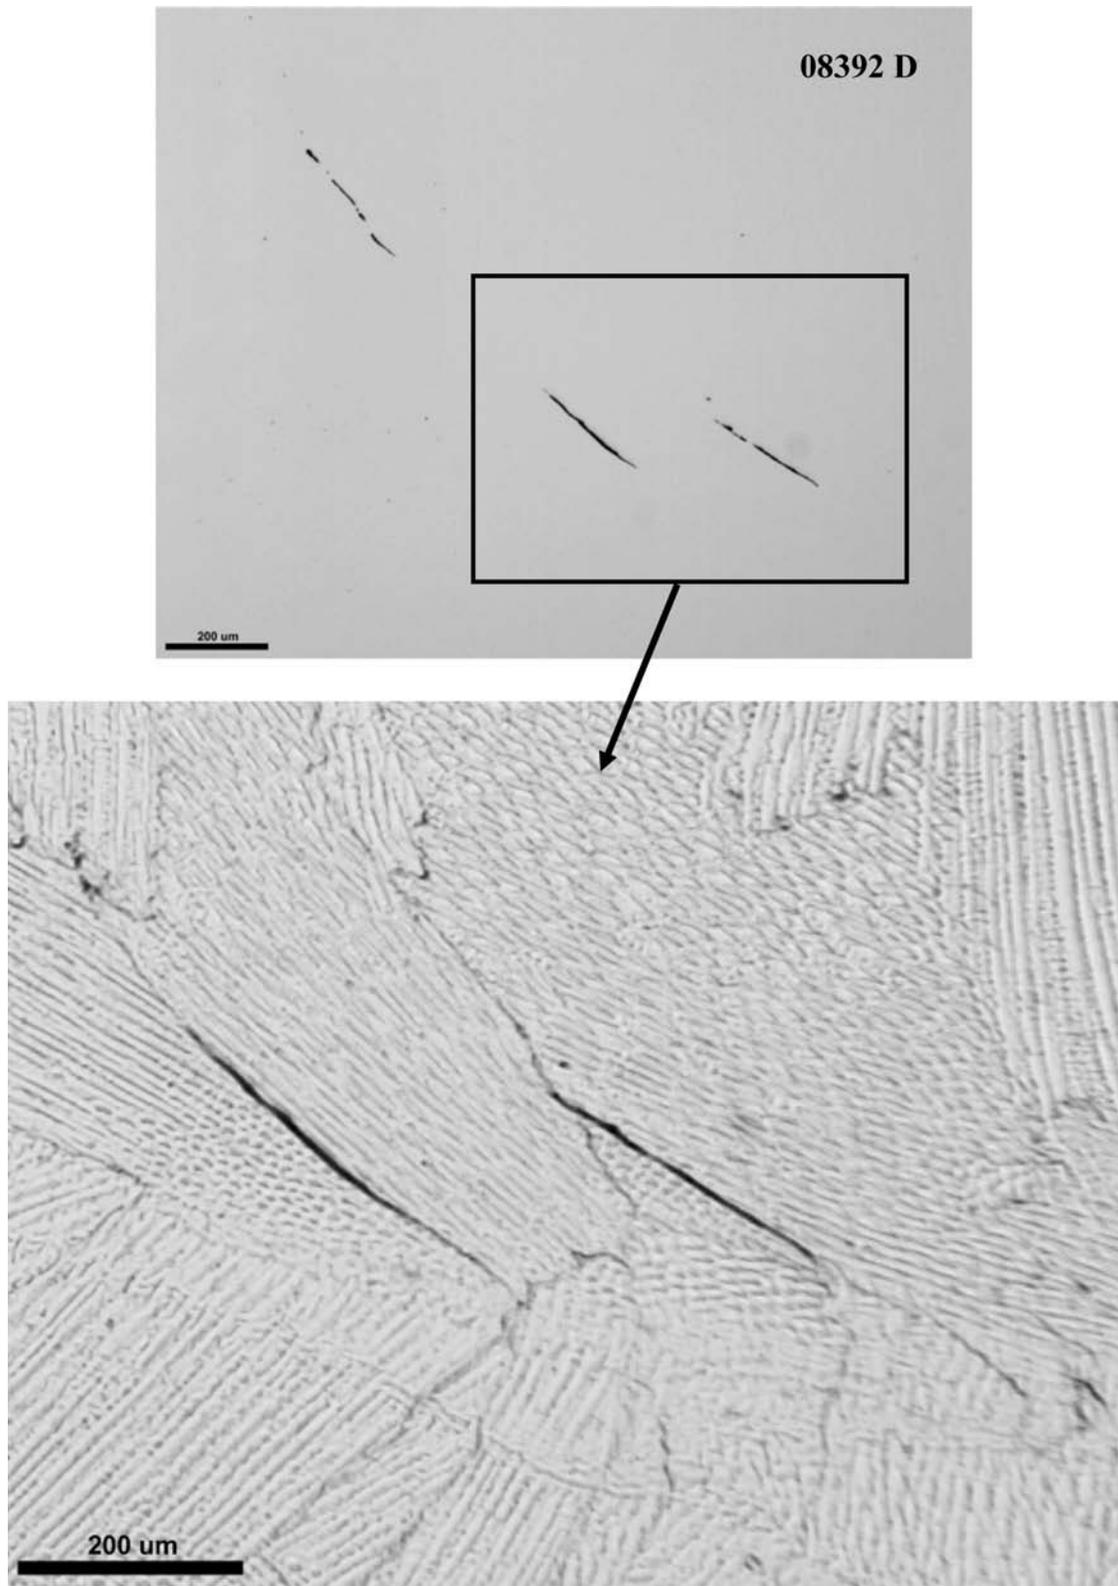
Figure 3.9. Etched Weld Microstructure is Shown to Illustrate the Typical Morphology of the Cracks in the MHI Alloy 52 Weld Metal

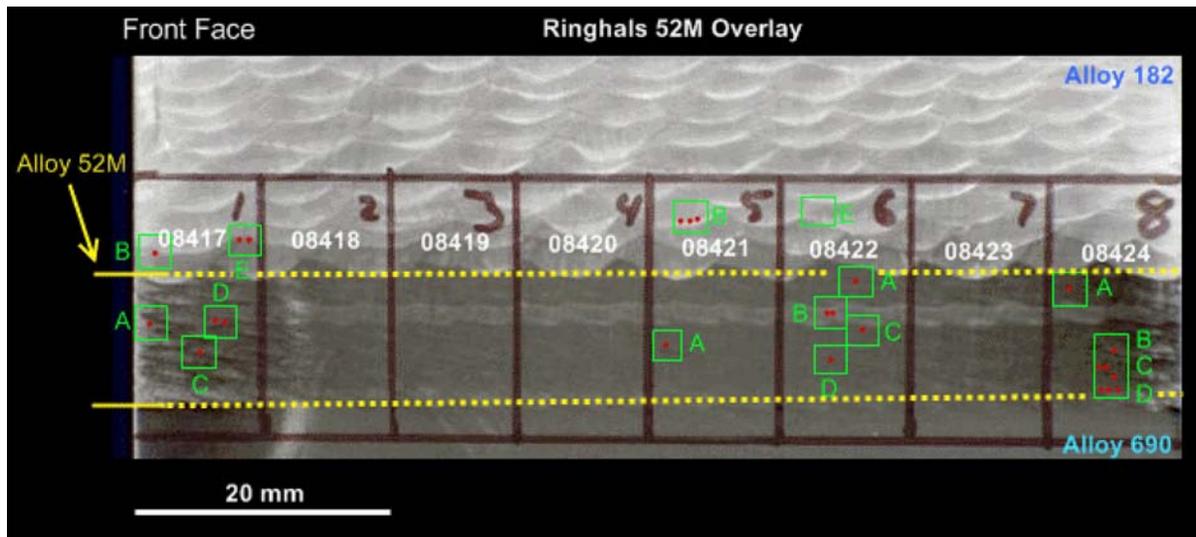
Figure 3.10. Overview Image of the Alloy 52M – Alloy 182 Overlay Slice A (front face) Showing the Alloy 690, Alloy 52M, and Alloy 182 Layers Along with Selected Regions of Analysis

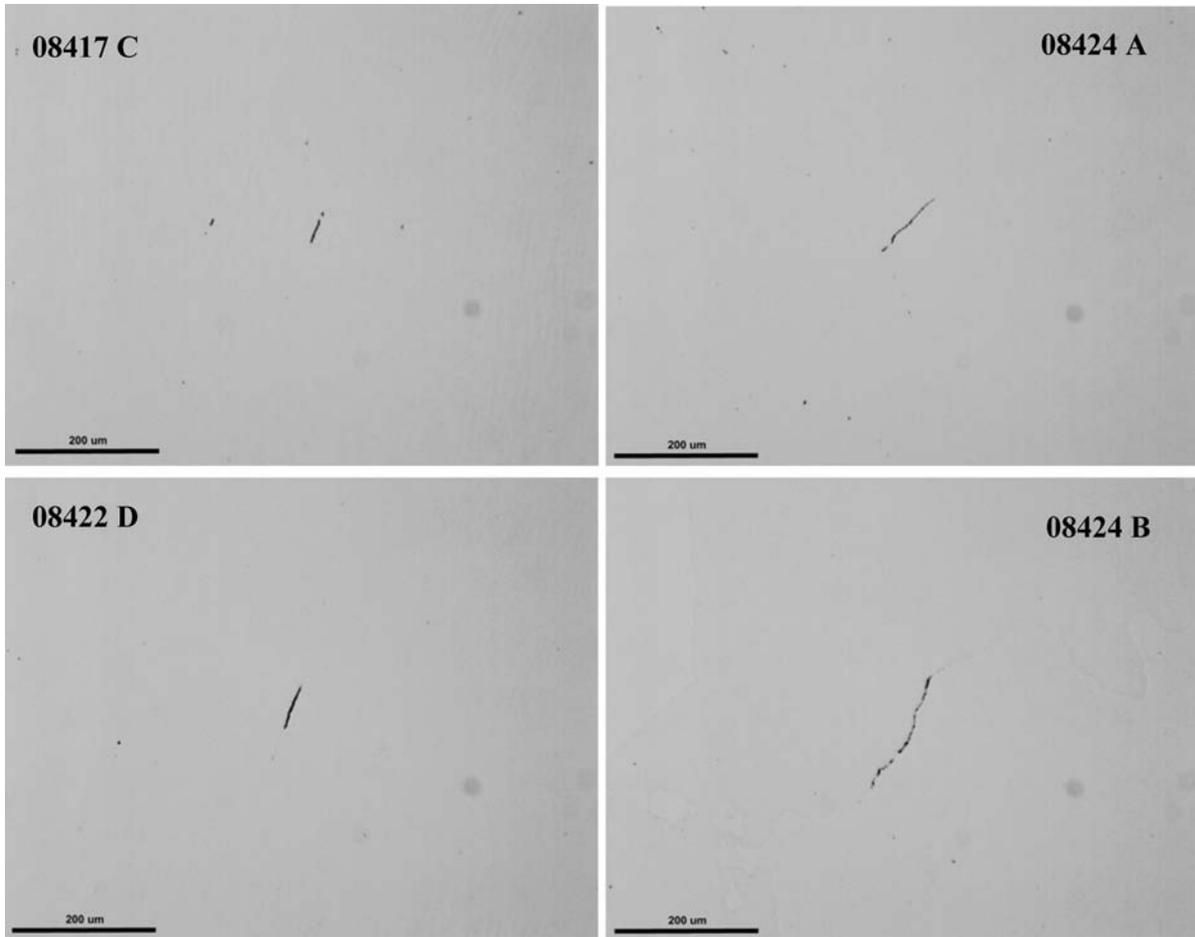
Figure 3.11. Optical Metallographs Illustrating Regions in the Alloy 52M Overlay Slice A (front face) Containing Weld Cracks. Scale markers in lower left of each micrograph represent 200 μm.

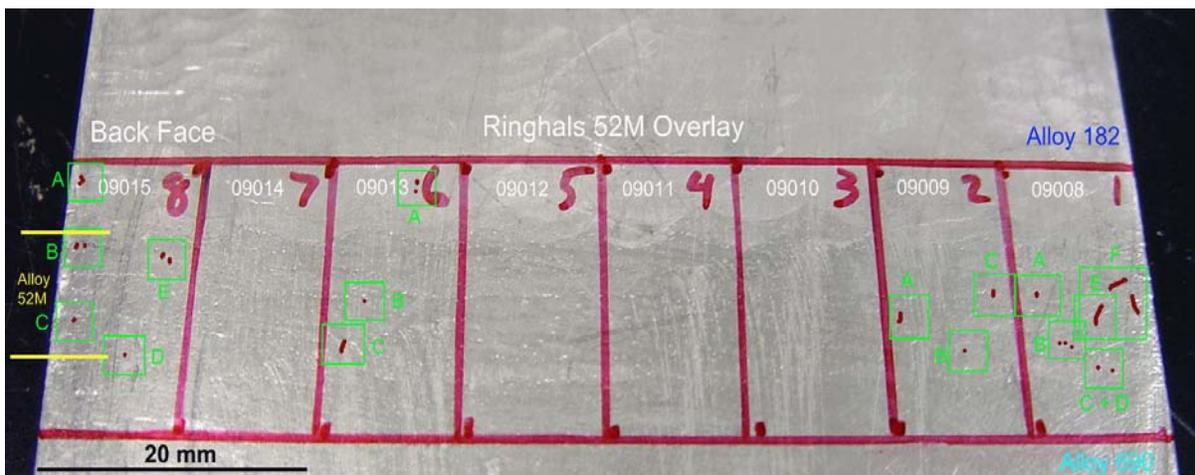
Figure 3.12. Overview Image of the Alloy 52M – Alloy 182 Overlay Slice B (back face) Showing Selected Regions of Analysis

Clusters of weld cracks were also found in the back face slice of the Ringhals Alloy 52M overlay mockup as shown in Figure 3.12 with the location of the clusters matching the location found in the front face slice. The clustering of the cracks suggests some characteristic difference in the weld material or welding parameters in these regions on the overlay mockup. Examples of weld cracks found in this back face slice are shown in Figure 3.13. Several of the metallographic specimens were subsequently etched to reveal the location of the weld cracks relative to the grain structure as shown in Figure 3.14 and Figure 3.15. As with the MHI Alloy 52 U-groove mockup, the weld cracks are located on grain boundaries with no outstanding features explaining their presence on these particular interfaces.

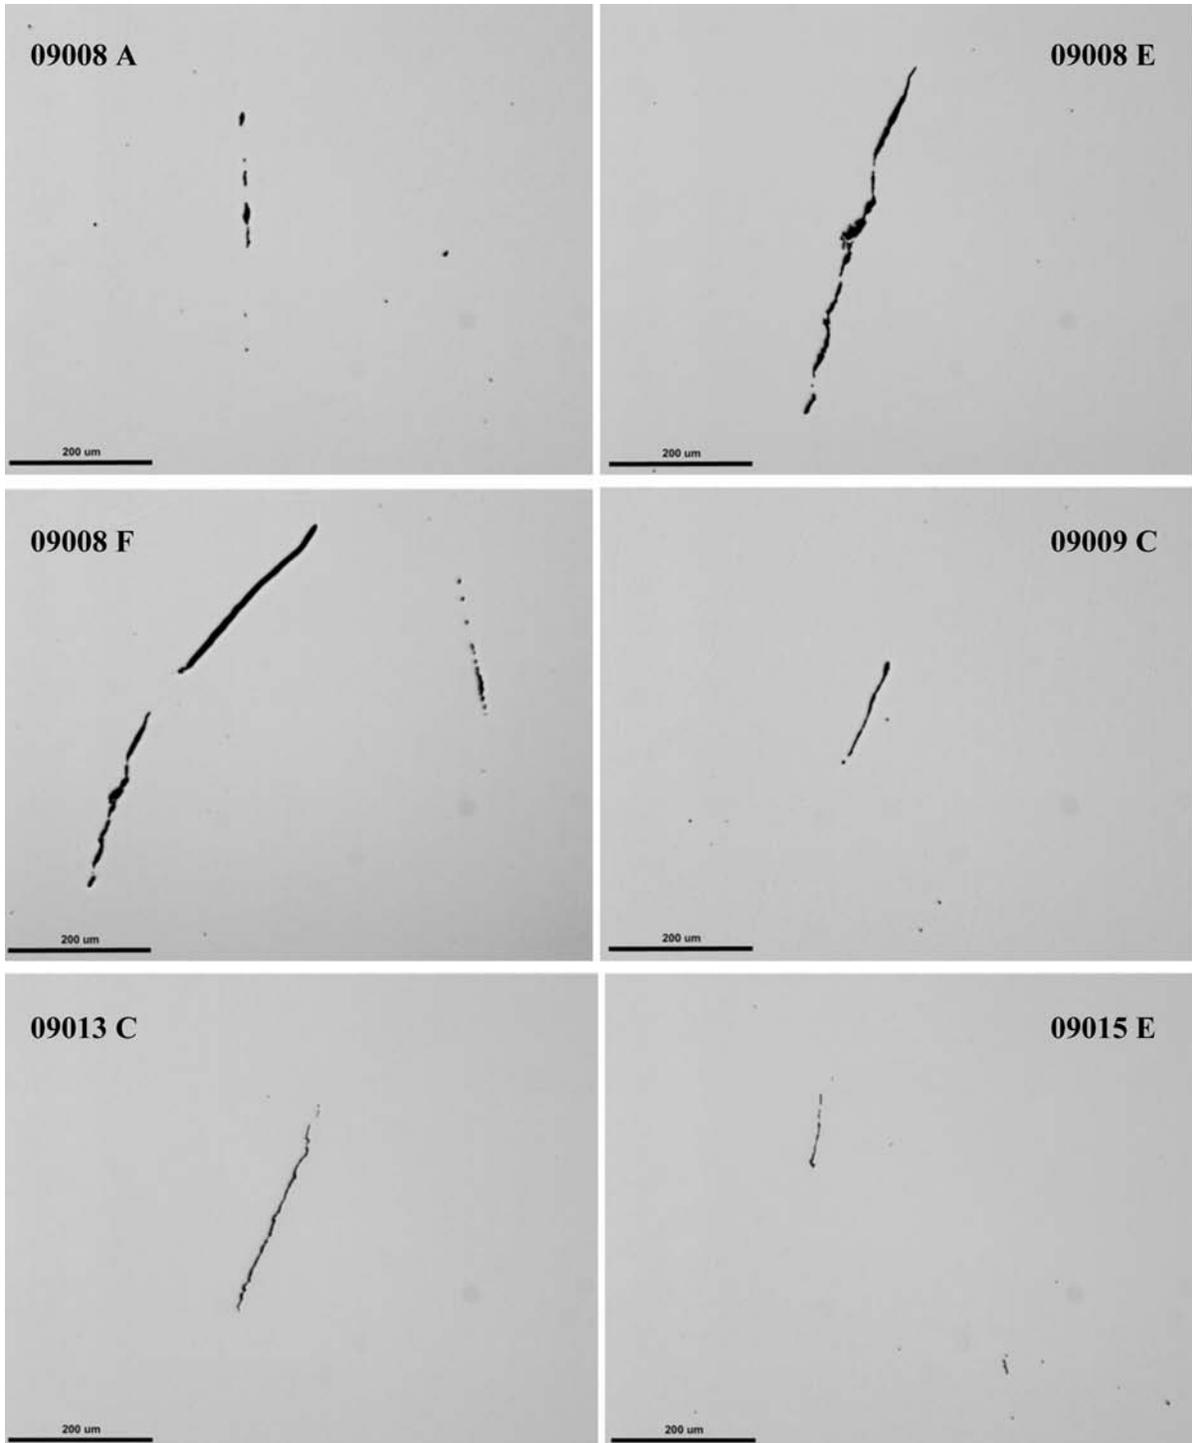
Figure 3.13. Optical Metallographs Illustrating Regions in the Alloy 52M Overlay Slice B (back face) Containing Weld Cracks. Scale markers in lower left of each micrograph represent 200 μm .

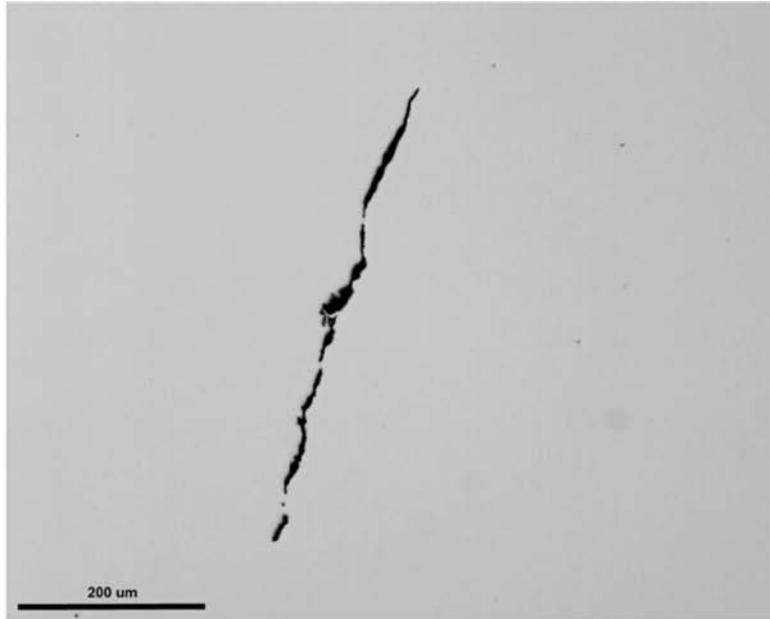
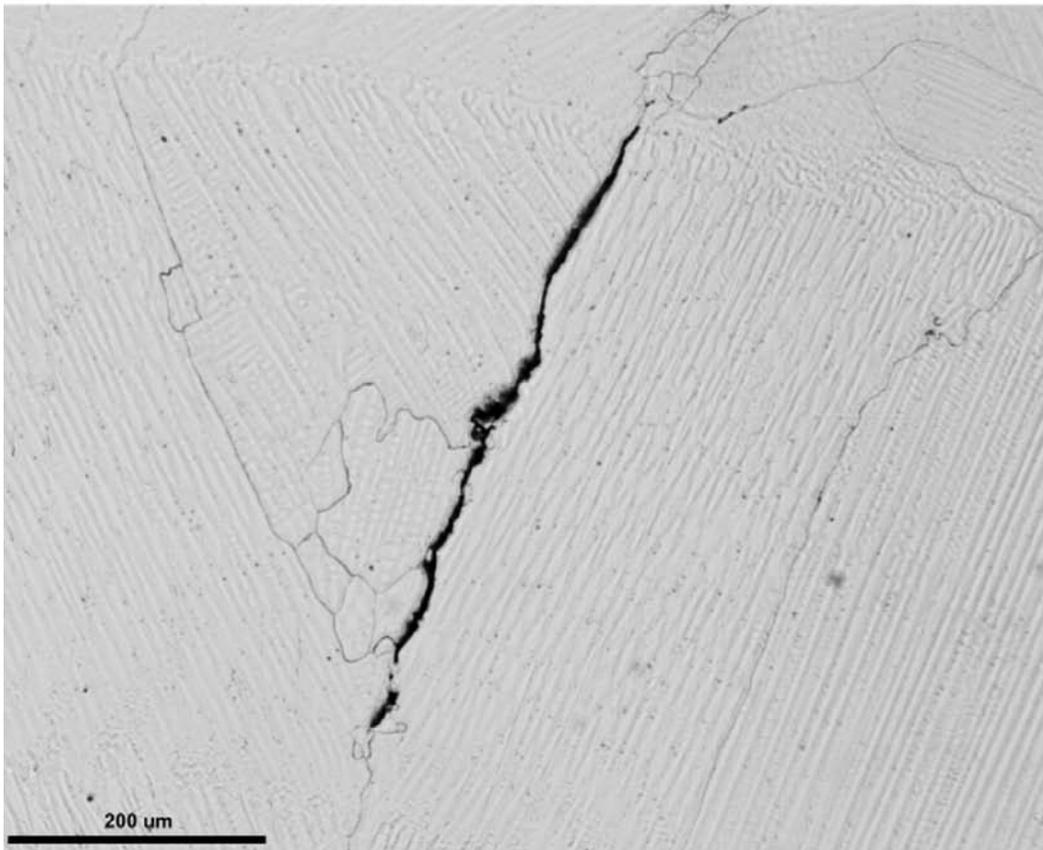
Figure 3.14. Etched Weld Microstructure is Shown to Illustrate the Typical Morphology of the Cracks in the Alloy 52M Overlay

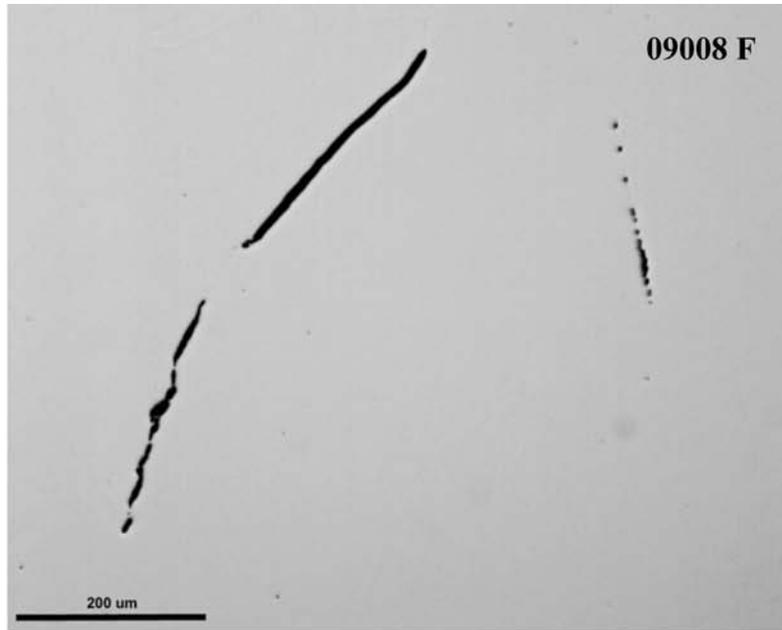
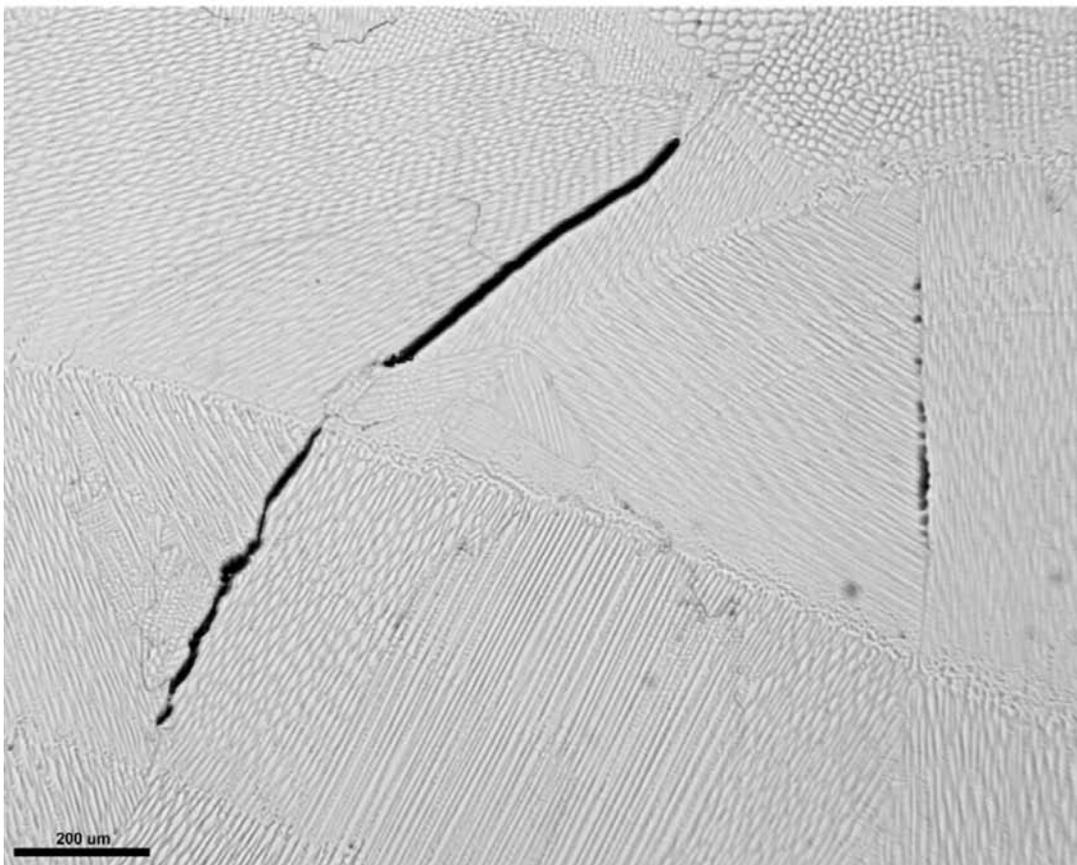
Figure 3.15. Etched Weld Microstructure is Shown to Illustrate the Typical Morphology of the Cracks in the Alloy 52M Overlay

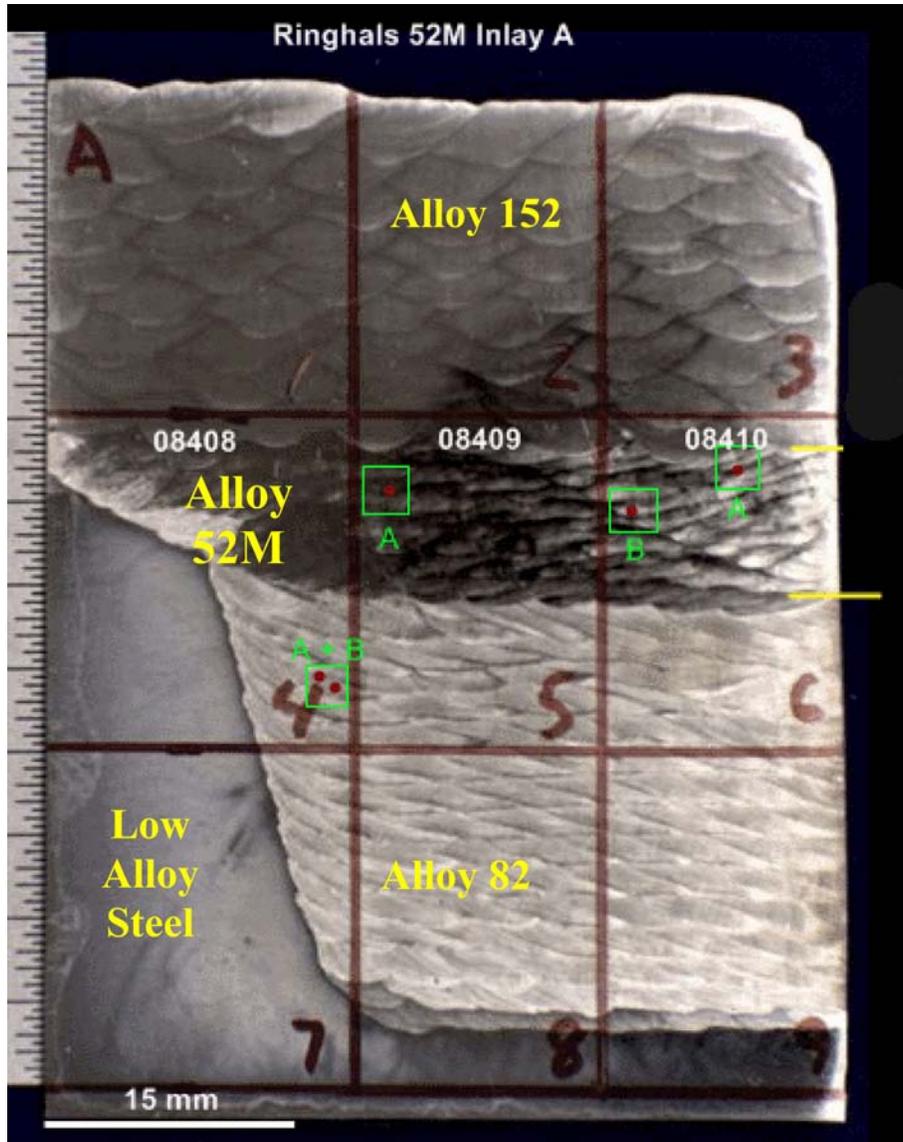
Figure 3.16. Overview Image of the Alloy 52M Inlay Mockup Slice A Showing the Low-Alloy Steel, Alloy 82, Alloy 52M and Alloy 152 Layers Along with Selected Regions of Analysis

An overview of the Ringhals Alloy 52M inlay slice “A” with the cut plan is shown in Figure 3.16. The small green boxes again identify sections that were examined in detail. Several indications of cracking in the upper region of the Alloy 52M weld were observed during preliminary examination, but only one indication was determined to be a weld crack as shown in Figure 3.17. Some small cracks were also found in the Alloy 82 weld metal in one region.
