PNNL-19119

Preliminary Examination of Cracks in Alloy 152, 52, and 52M Weld Metals

January 2010

Prepared for
U.S. Nuclear Regulatory Commission
under a Related Services Agreement
with the U.S. Department of Energy
Contract DE-AC05-76RL01830
NRC Project JCN N6547

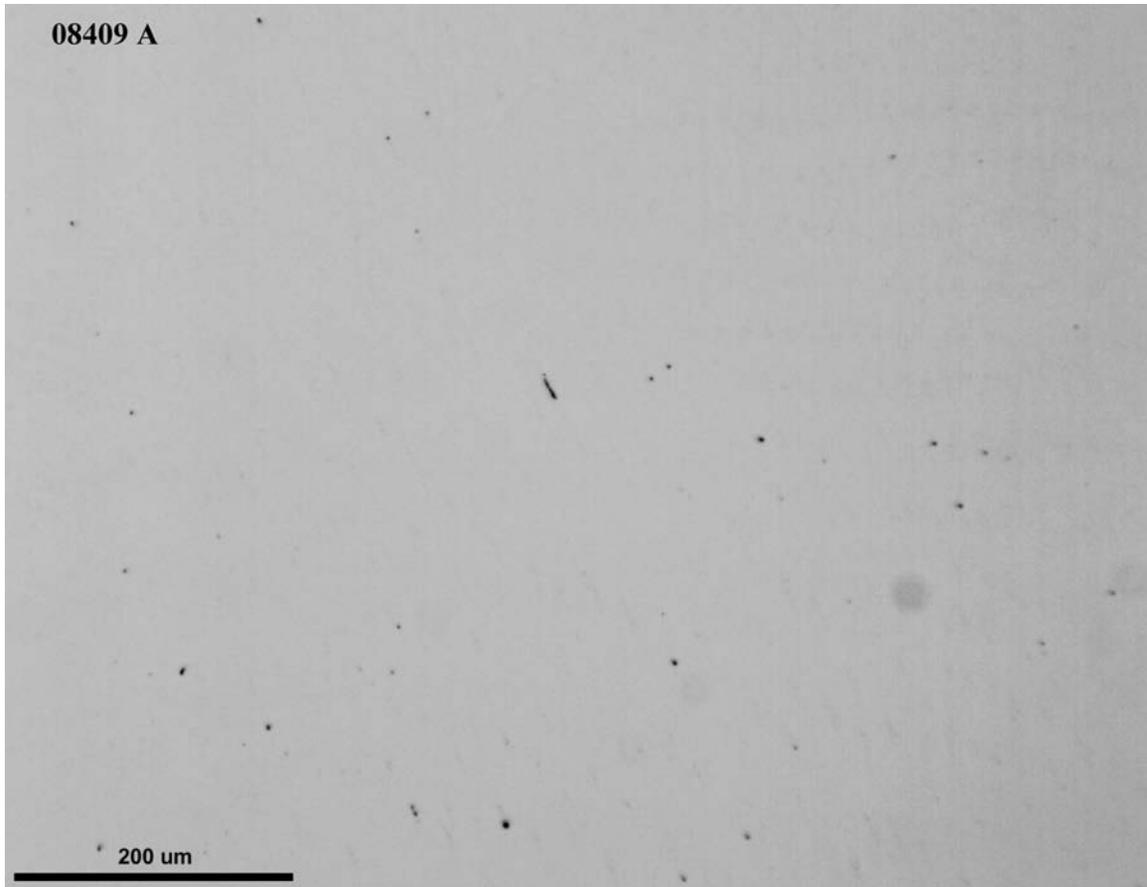
Figure 3.17. Optical Metallograph Illustrating a Region in the Alloy 52M Inlay Slice A Containing Small Pits Probably Resulting from Particle Pullout during Polishing. The only evidence for a weld crack in this slice is shown.

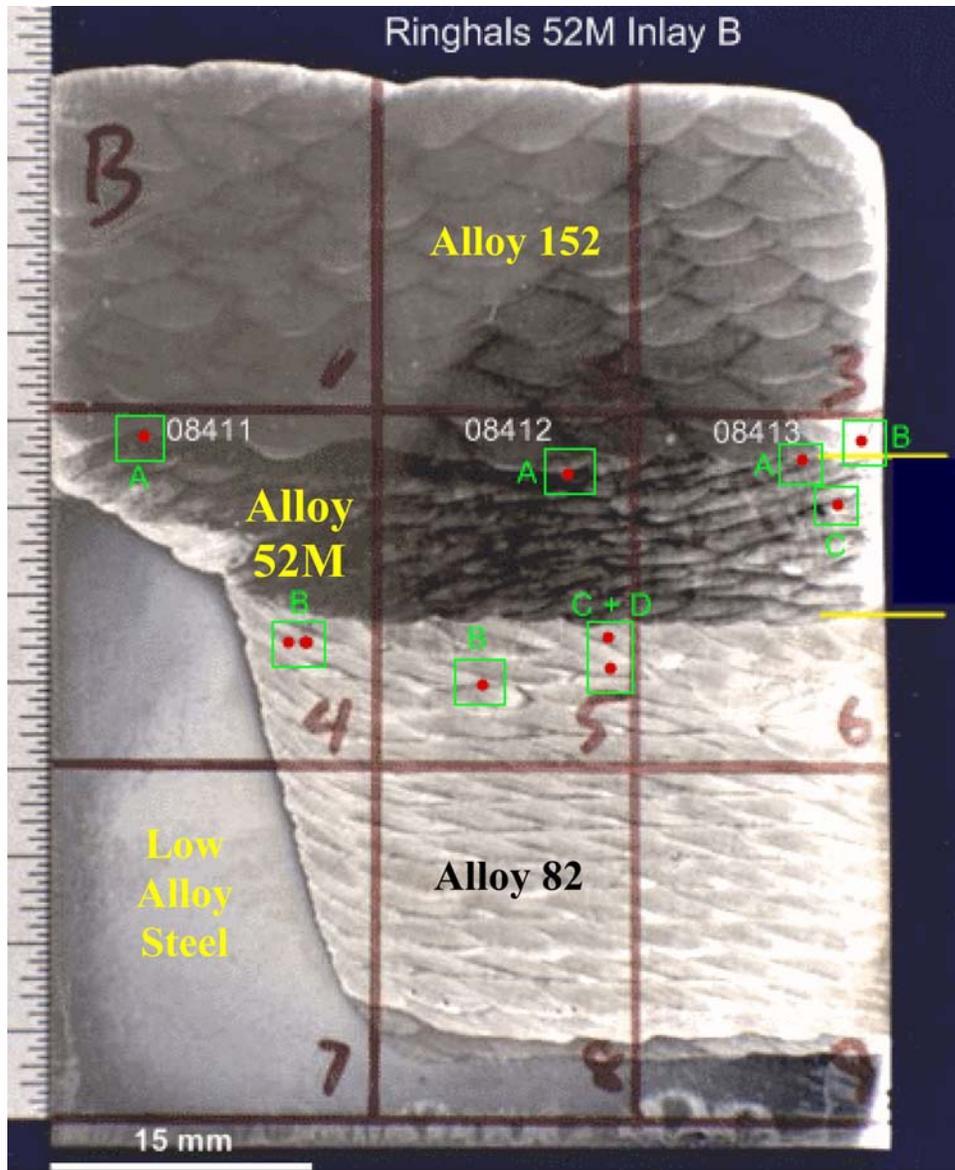
Figure 3.18. Overview Image of the Alloy 52M Inlay Mockup Slice B Showing the Low-Alloy Steel, Alloy 82, Alloy 52M and Alloy 152 Layers Along with Selected Regions of Analysis

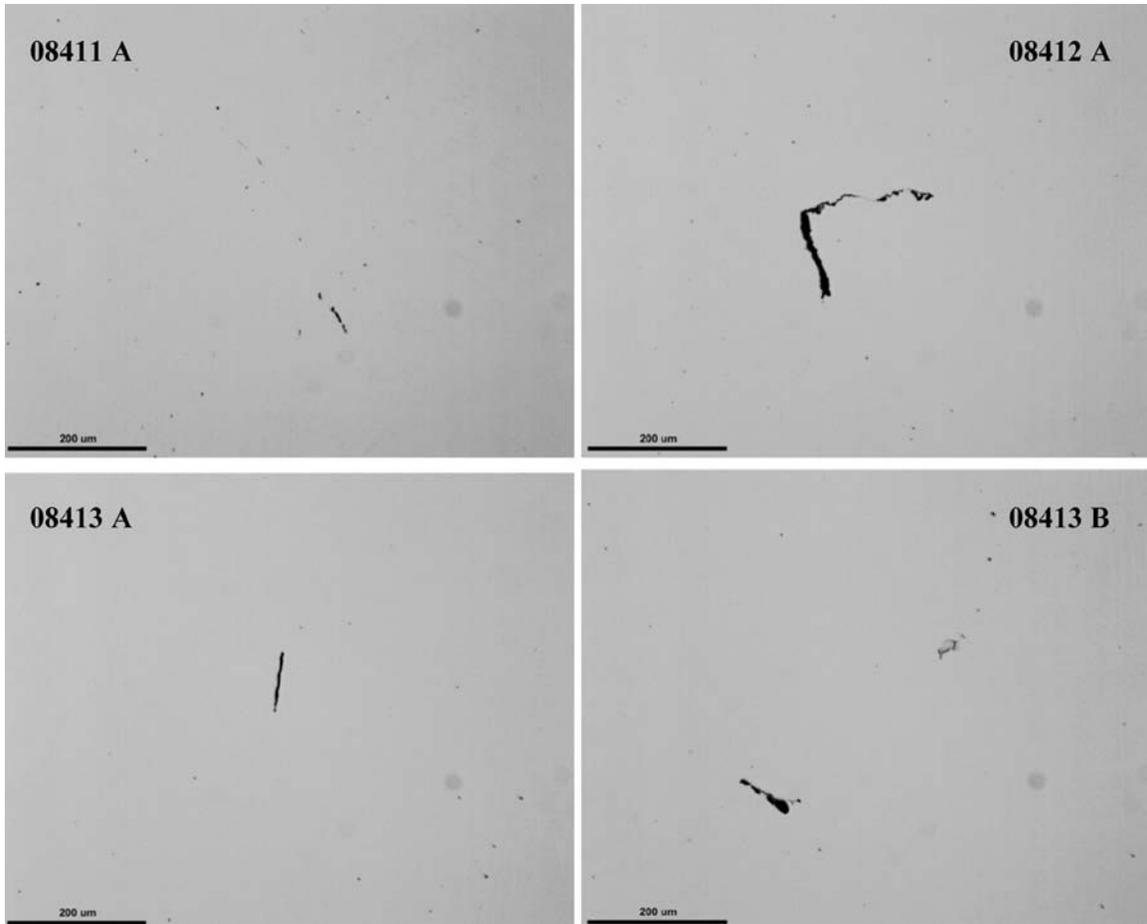
Figure 3.19. Optical Metallographs Illustrating Regions in the Ringhals Alloy 52M inlay Mockup Slice B Containing Small Weld Cracks in the Alloy 52M Weld Metal. Scale markers in lower left of each micrograph represent 200 μm .

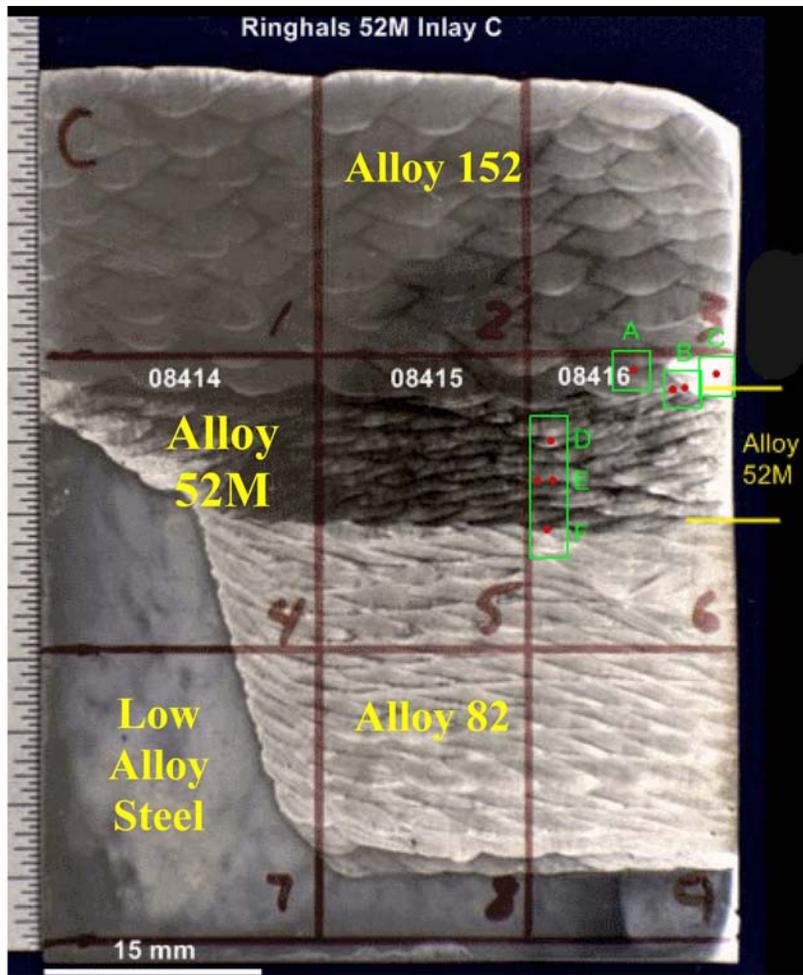
Figure 3.20. Overview Image of the Ringhals Inlay Mockup Slice C Showing Regions Where Indications of Weld Cracks were Observed and Analyzed

An overview image of the Ringhals Alloy 52M inlay mockup, slice C, is shown in Figure 3.20. Several short and long cracks were observed in the Alloy 52M inlay with two examples of longer weld cracks shown in Figure 3.21. The weld cracks were clustered in one region slightly to the right of center of the slice.

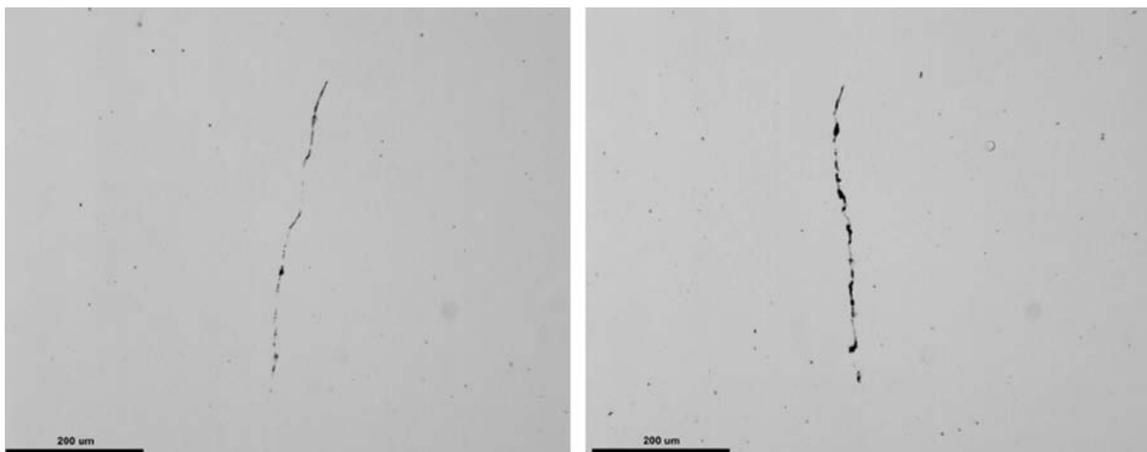
Figure 3.21. Two Examples of Weld Cracks Found in Ringhals Inlay Mockup Slice C. The scale markers on the images represent 200 μm.

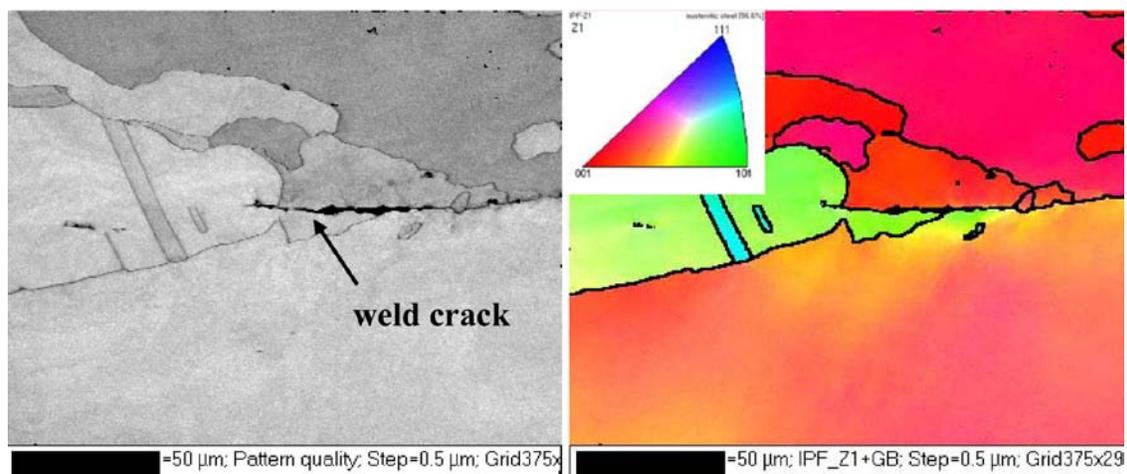
Figure 4.1. EBSD Pattern Quality and IPF-Z Images of a Weld Crack in the Ringhals Alloy 52M Inlay (C-6) Showing Weld Metal Microstructure, Crack Morphology, and Areas of Deformation

Just as with the optical metallography results, all the weld cracks that were examined in detail were found to be on grain boundaries. An EBSD pattern quality image and an EBSD inverse pole figure image about the Z axis (IPF-Z) of a Ringhals Alloy 52M inlay specimen (slice C-6) with a short IG crack are shown in Figure 4.1. Color variation in the EBSD IPF-Z image represents variation in crystal orientation with red representing the 001 zone axis pointing out of the image, green representing the 011 zone axis

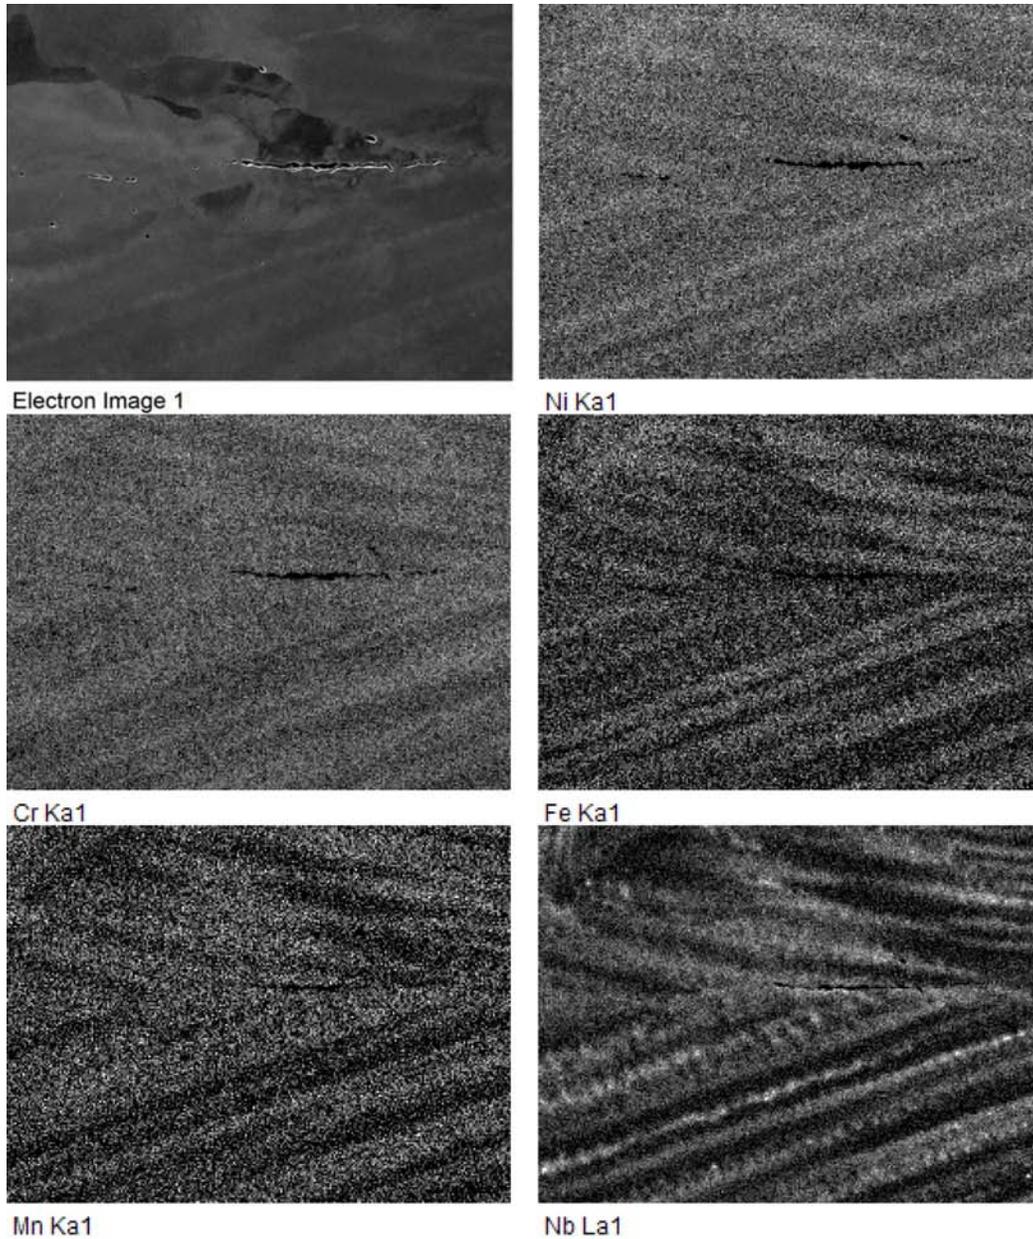
Figure 4.2. SEM-BSE Image and EDS Maps of the Ringhals Alloy 52M Inlay Weld (C-6) Revealing Significant Compositional Variations within Grains Particularly for Nb

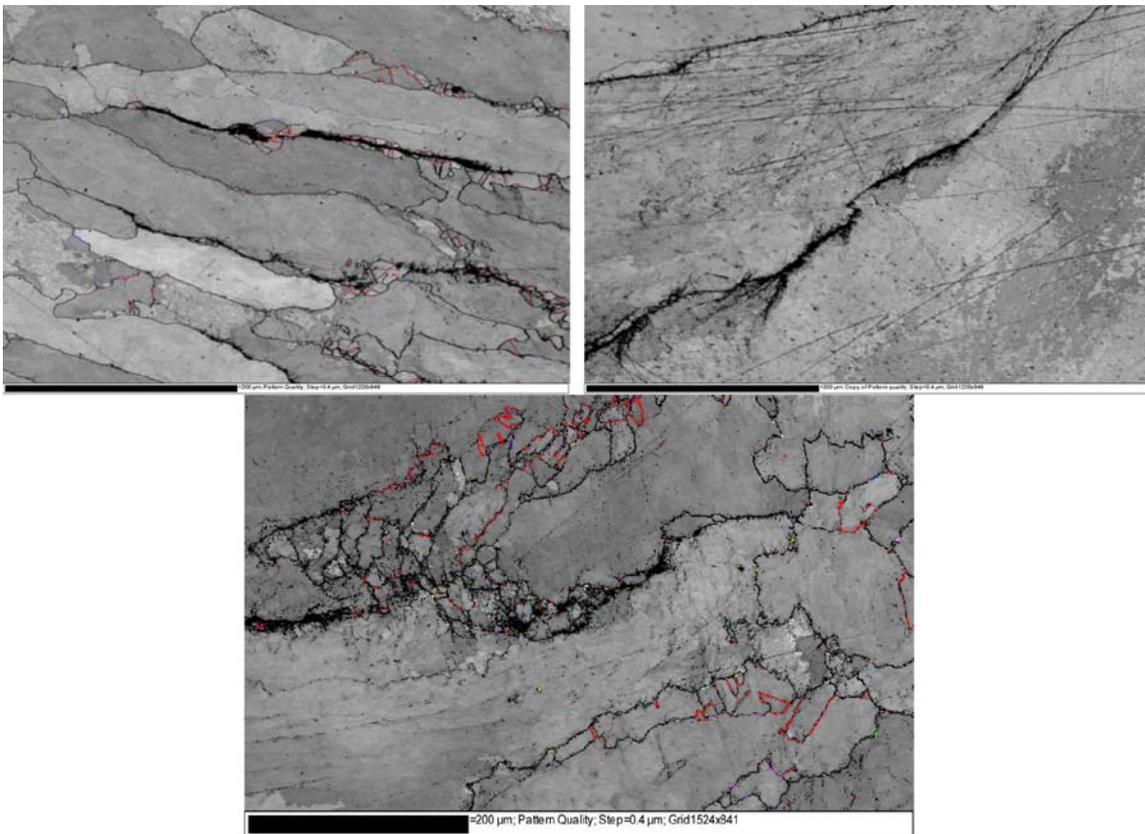
Figure 4.3. EBSD Pattern Quality Images of Three Regions of Cracks in the MHI Alloy 52 U-Groove Weld Where EBSD Characterization was Performed. Each region is near the main center crack shown in Figure 3.7 and these cracks are represented by the optical images in Figure 3.8.

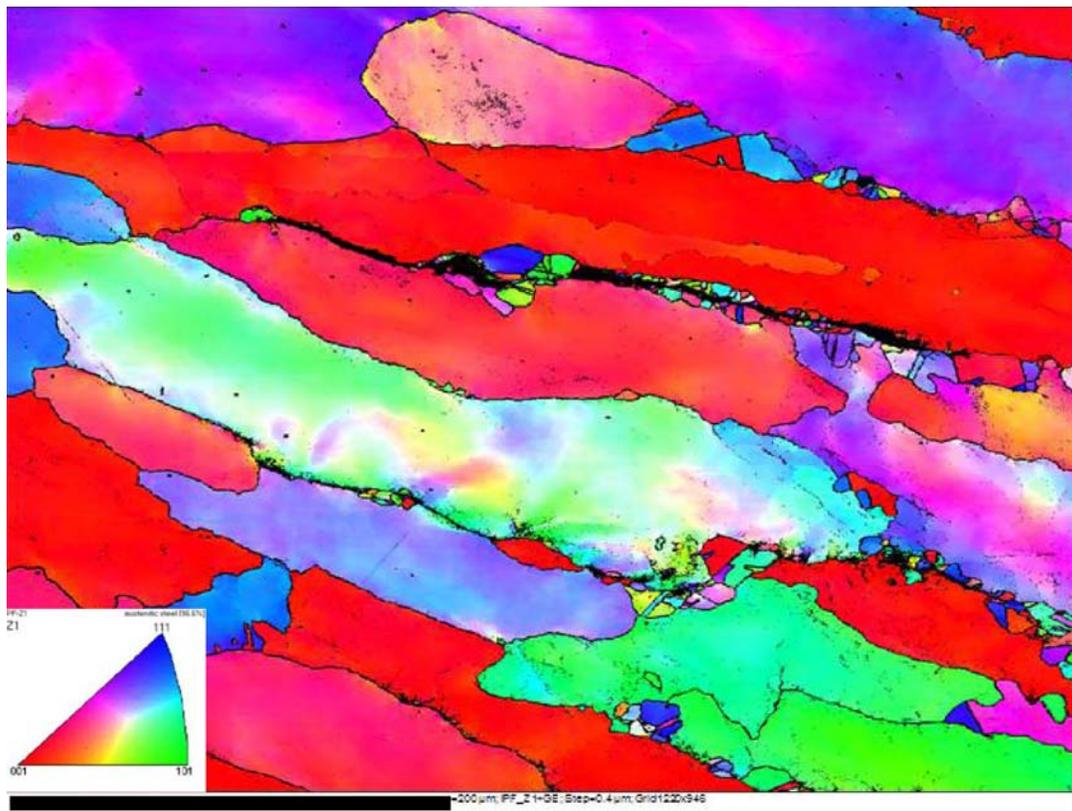
Figure 4.4. EBSD IPF-Z Illustrating the Differences in Grain Orientations and Deformation in the Vicinity of the MHI Alloy 52 U-groove Weld Cracks

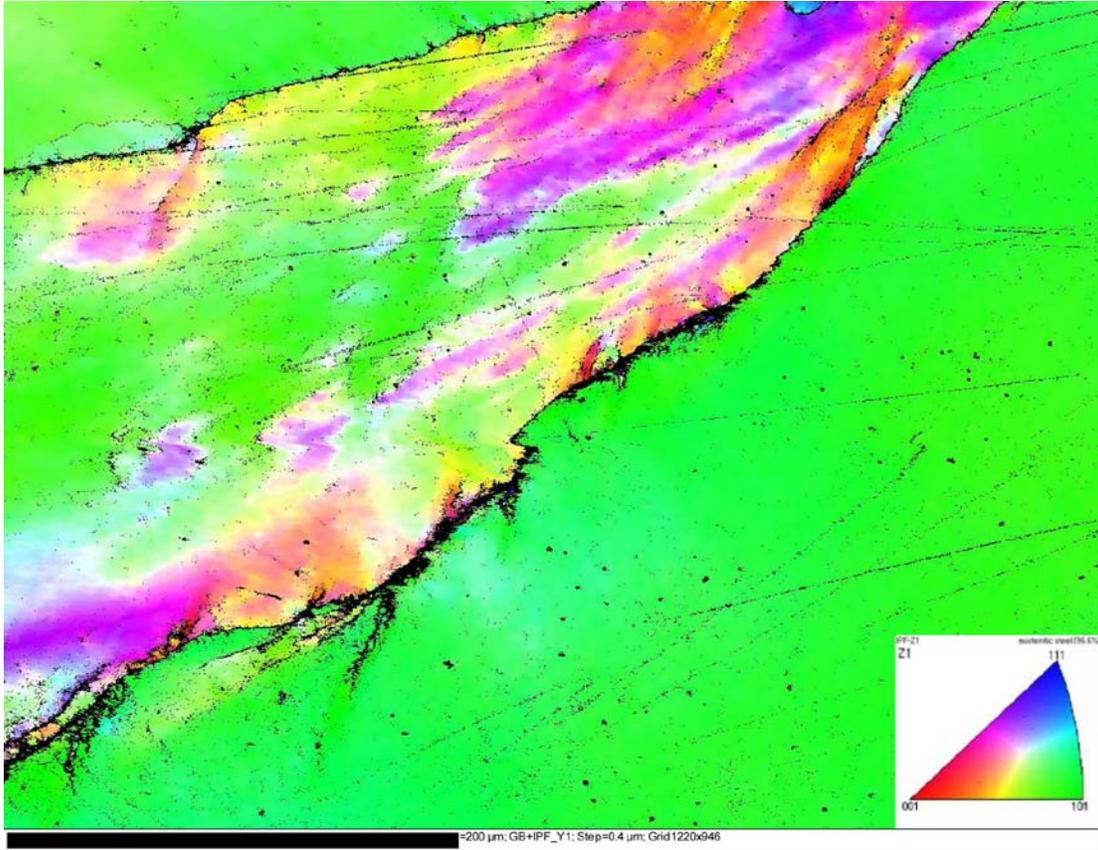
Figure 4.5. EBSD IPF-Y Image Illustrating Differences in Grain Orientation and Rotation Around Weld Cracks that Formed Along High-Energy Grain Boundaries in the MHI Alloy 52 U-groove Weld

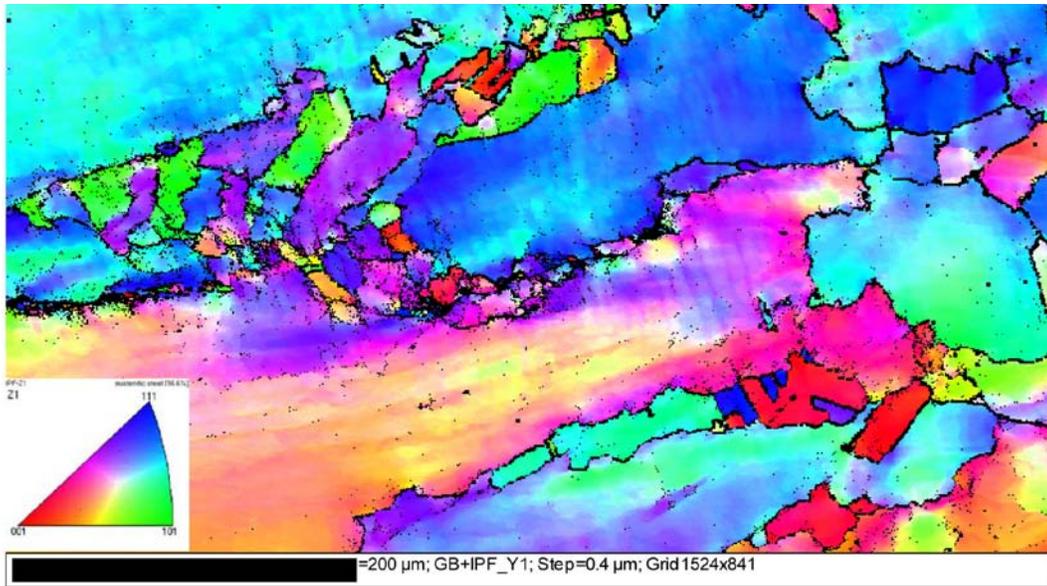
Figure 4.6. EBSD IPF-Y Image of the MHI Alloy 52 U-groove Weld Illustrating Differences in Grain Orientation and Deformation Near Weld Cracks Situated Along High-Energy Grain Boundaries and Regions of Fine Grains

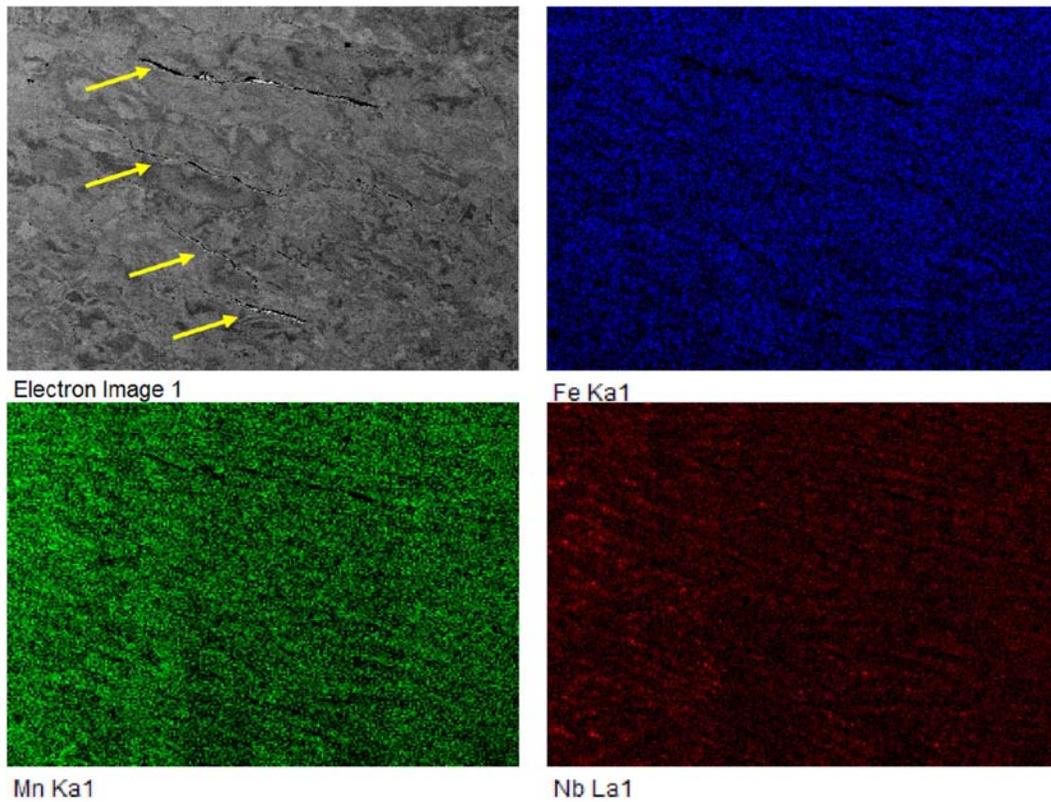
Figure 4.7. SEM-EDS Maps of the MHI Alloy 52 U-groove Mockup Show Very Little Variation in Elemental Composition with the Weld Cracks

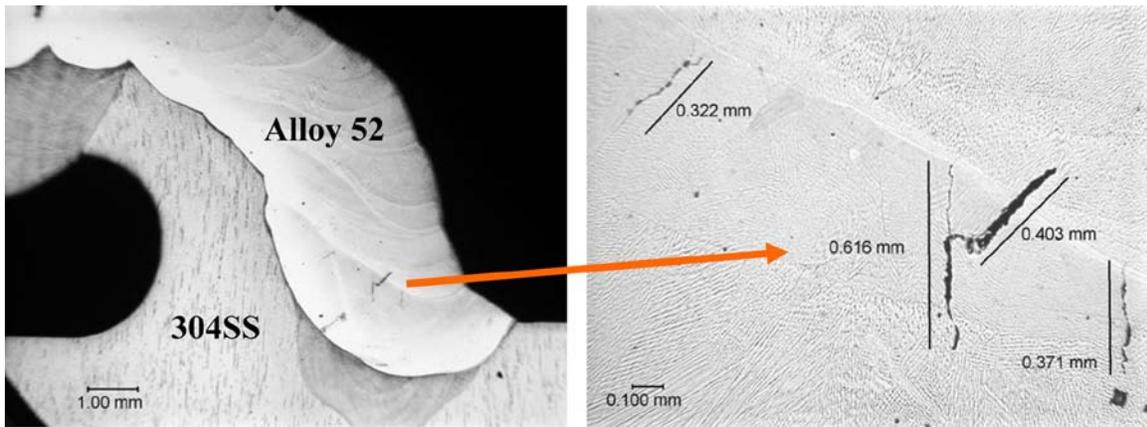
Figure 4.8. Optical Micrographs Provided by Ringhals Showing an Alloy 52 Weld Metal Overlay on a 304SS Housing. An example of a large crack is shown.

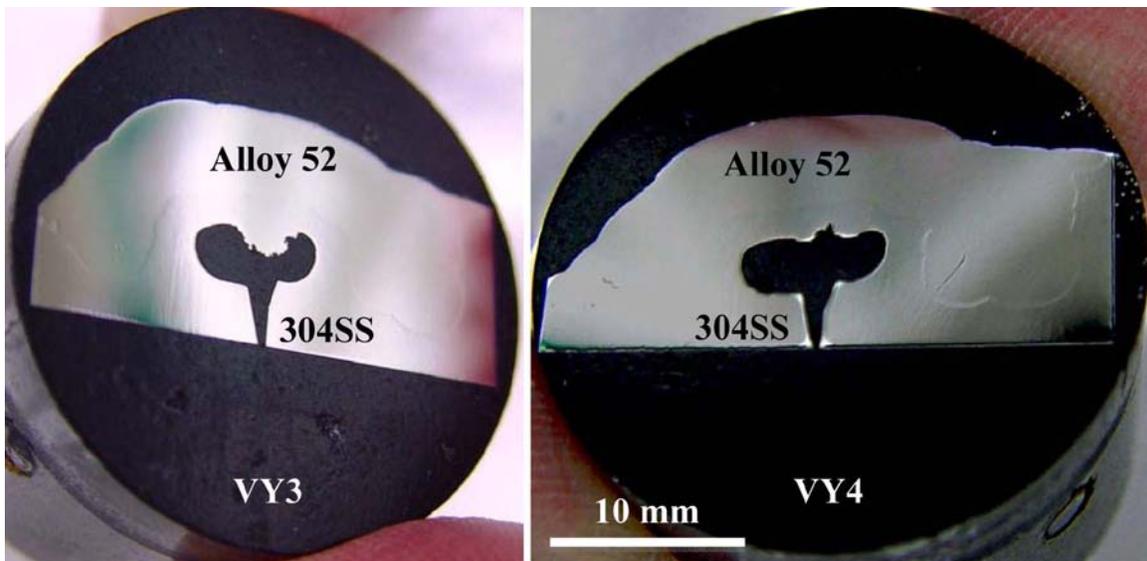
Figure 4.9. Optical Images of As-Received Ringhals Weld Overlays Mounted in Epoxy

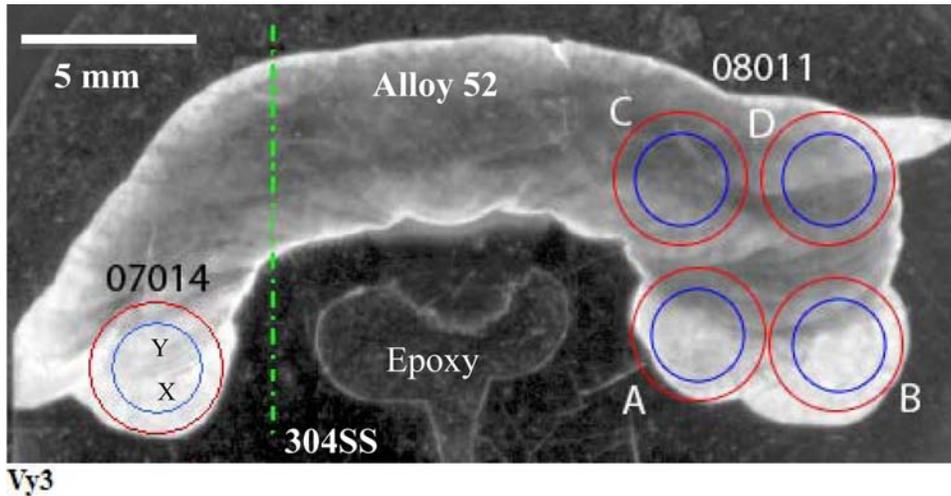
Figure 4.10. Optical Image Providing Overview of the Ringhals Alloy 52 Weld Overlay Sample VY3 After Light Etching and Identifying Various Regions Where TEM Samples were Prepared

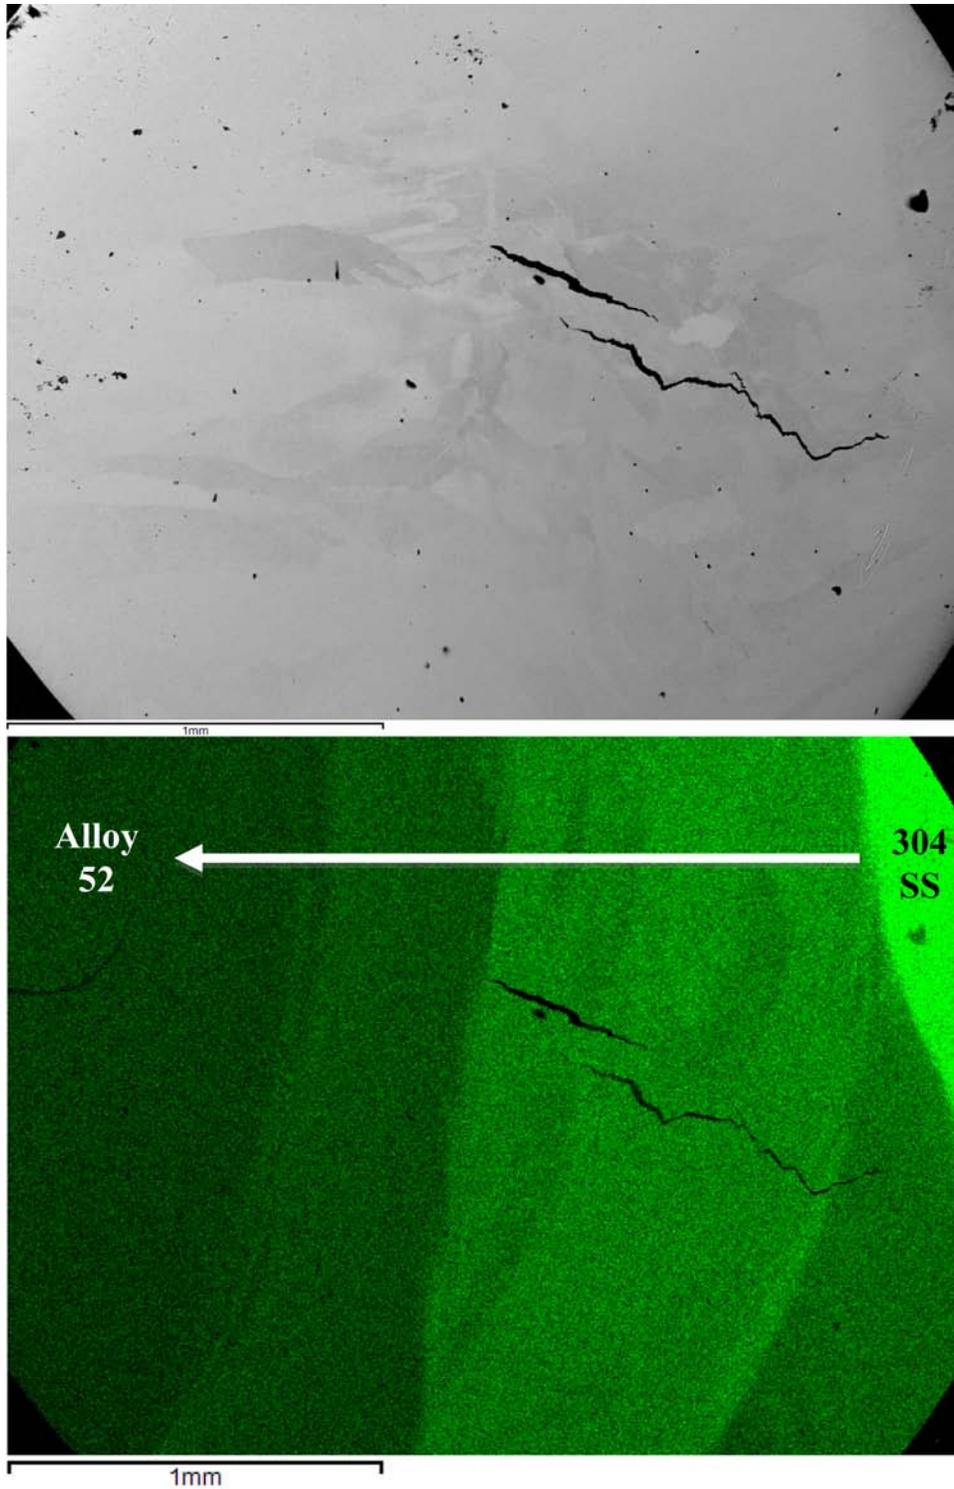
Figure 4.11. SEM and EDS Compositional Map for Fe Illustrating Location of Hot Cracks in the Dilution Layer Between Alloy 52 and 304SS for Overlay Sample VY3

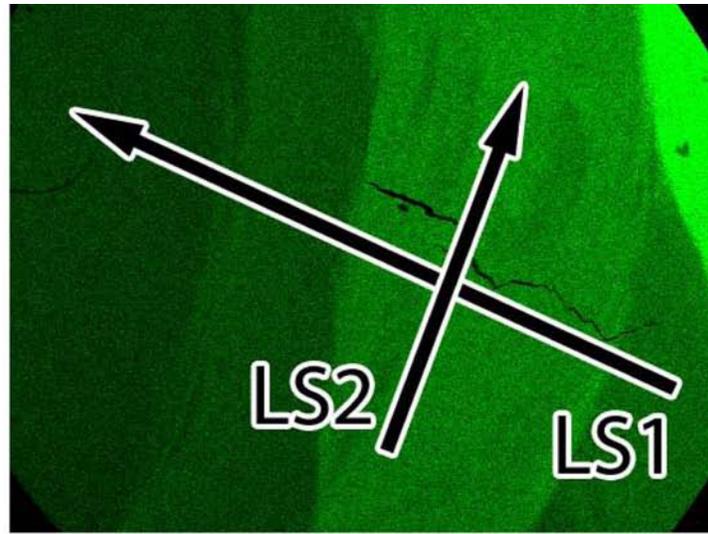
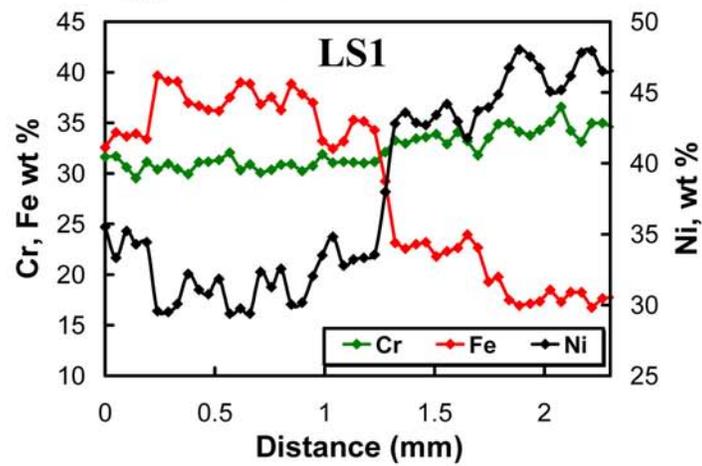
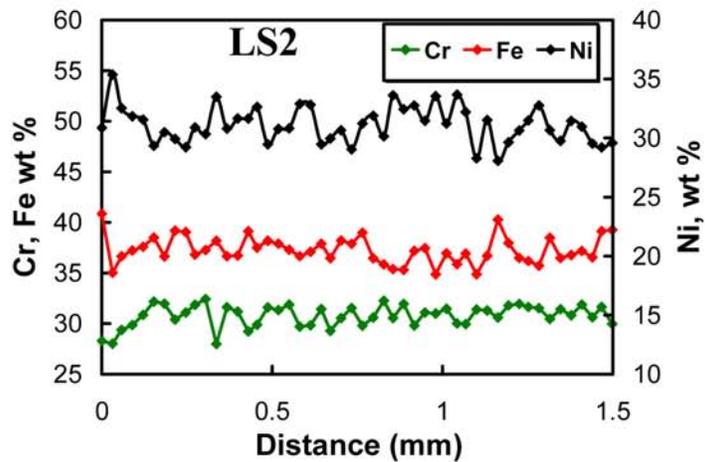
Figure 4.12. Compositional Variation as Measured by SEM-EDS Along the Length and Across a Weld Crack in the Extensive Dilution Zone of the Alloy 52 Overlay

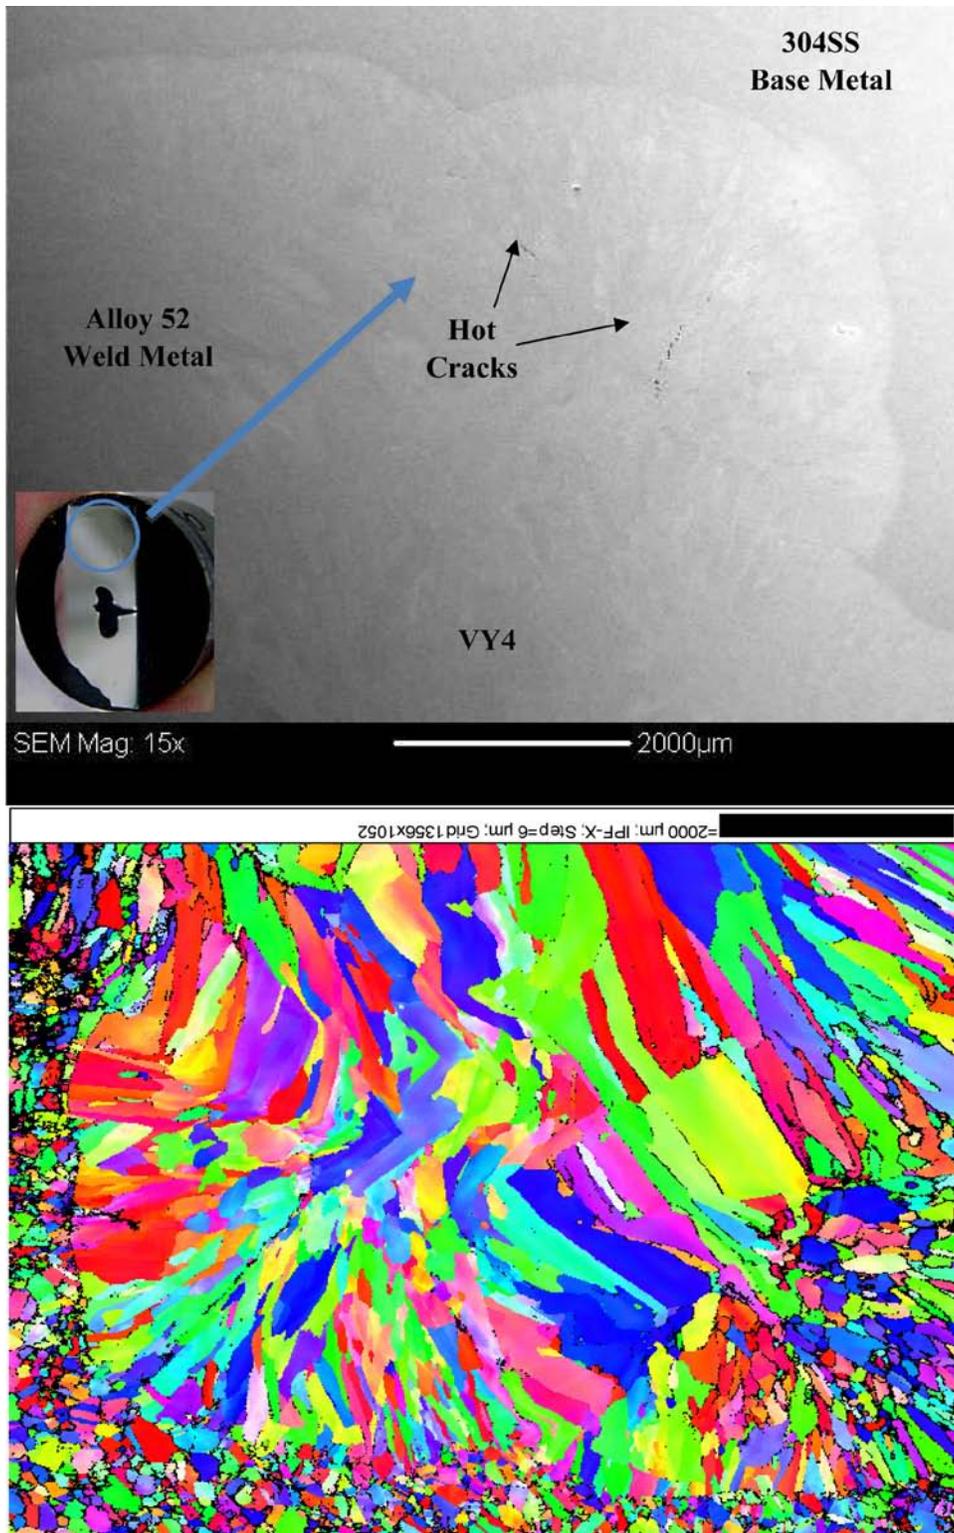
Figure 4.13. SEM and EBSD IPF-X Images Illustrating the Microstructure Across the 304SS Base Metal and Weld Metal Interface Region in Overlay Sample VY4

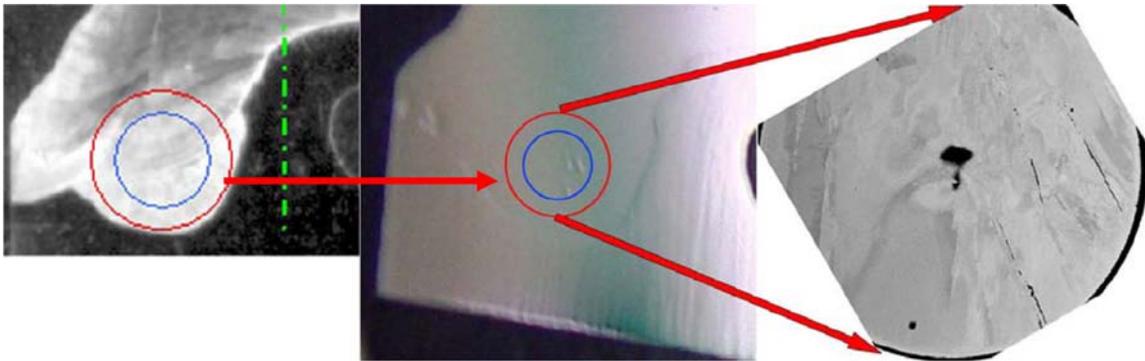
Figure 4.14. Optical and SEM Micrographs Illustrating Region where TEM Sample VY3 Originated in the Original Weld Overlay. The two optical micrographs on the left were obtained using different polishing/etch preparations shown in Figure 4.9 and Figure 4.10.

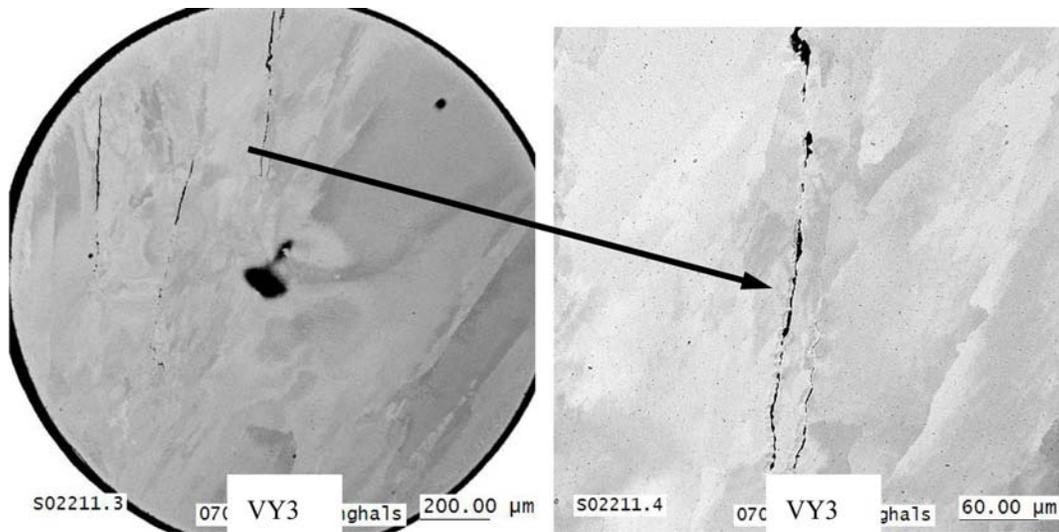
Figure 4.15. Backscatter SEM Images Showing Weld Cracks in Alloy 52 Overlay Sample VY3 and Identifying Region for ATEM Examinations

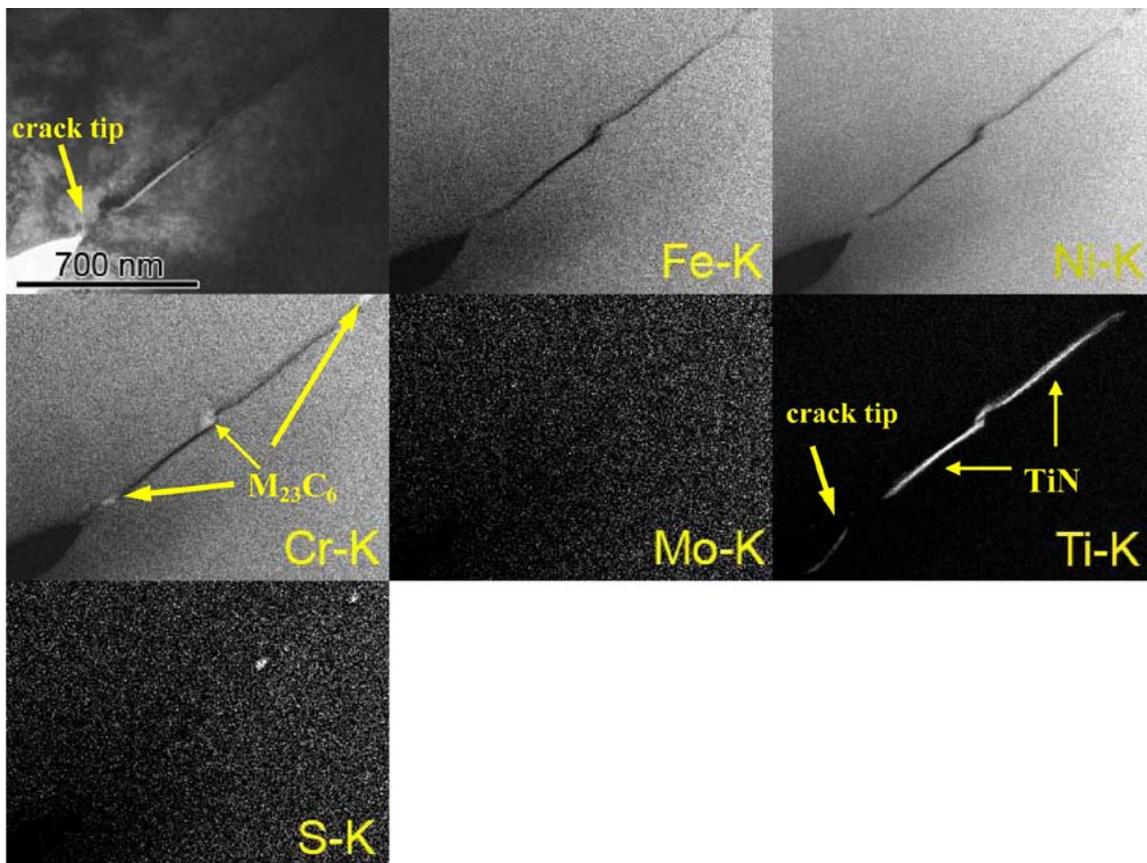
Figure 4.16. TEM Micrograph and Elemental Maps of an IG Crack in Sample VY3. A continuous TiN phase is observed along the grain boundary in front of the crack.

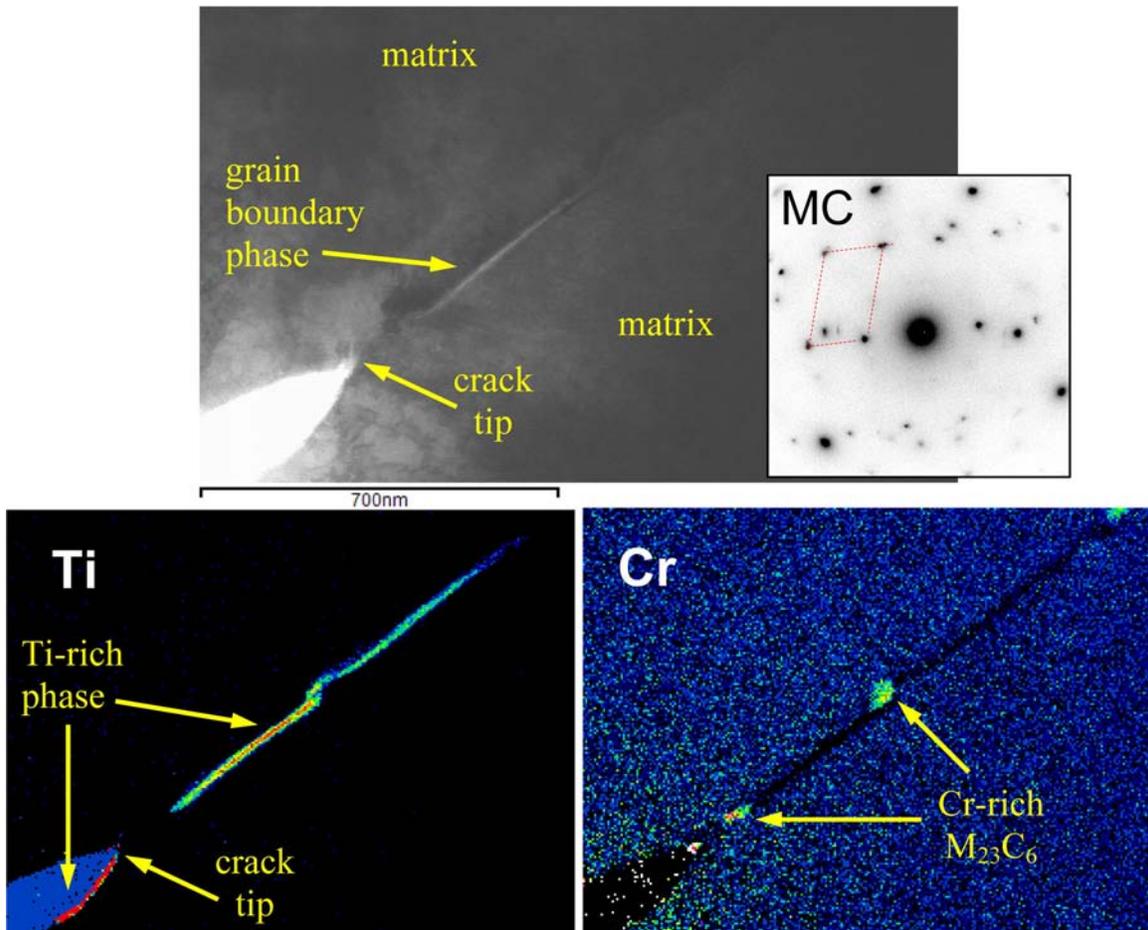
Figure 4.17. Higher Magnification Examination of the Crack-Tip Region Shown in Figure 4.16: (a) TEM bright-field image and selected area diffraction identifying a thin MC-structure second phase; (b) EDS map for Ti demonstrating that the thin phase is highly Ti rich and is located on one side of the crack wall and elongated along the grain boundary; and (c) EDS map for Cr highlighting several IG Cr-rich carbides.

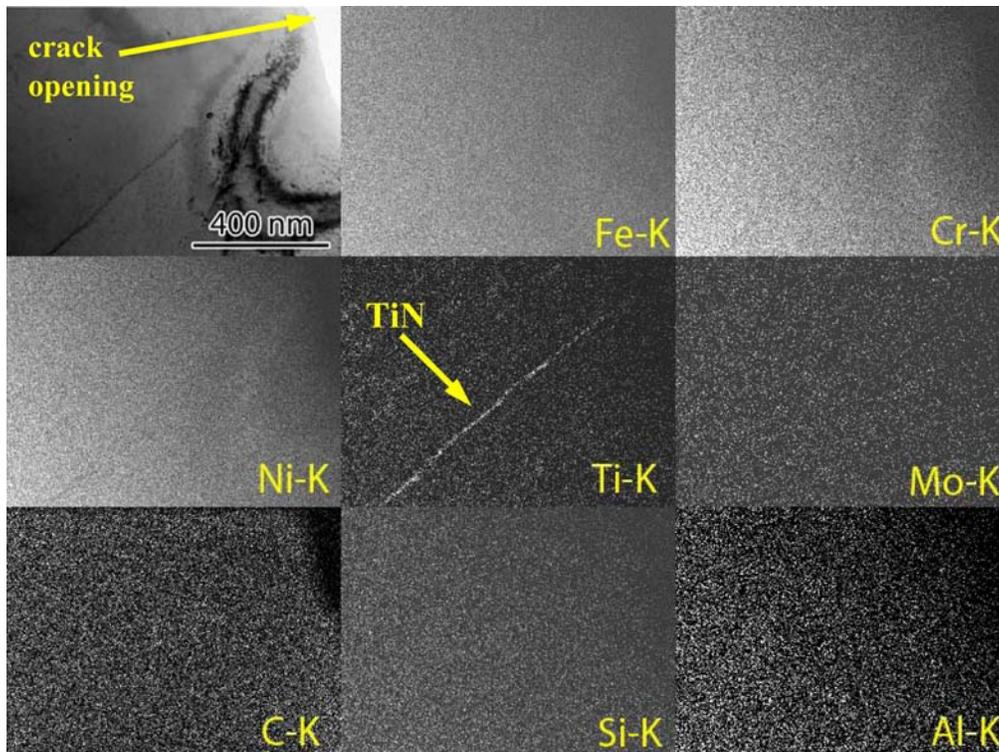
Figure 4.18. Scanning TEM Micrograph and Elemental Maps of a Grain Boundary Leading a Weld Crack in Sample VY3. A nearly continuous TiN phase is observed along the grain boundary in front of the crack. The crack opening appears large and rounded due to repetitive ion milling to thin the grain boundary region in front of the crack.

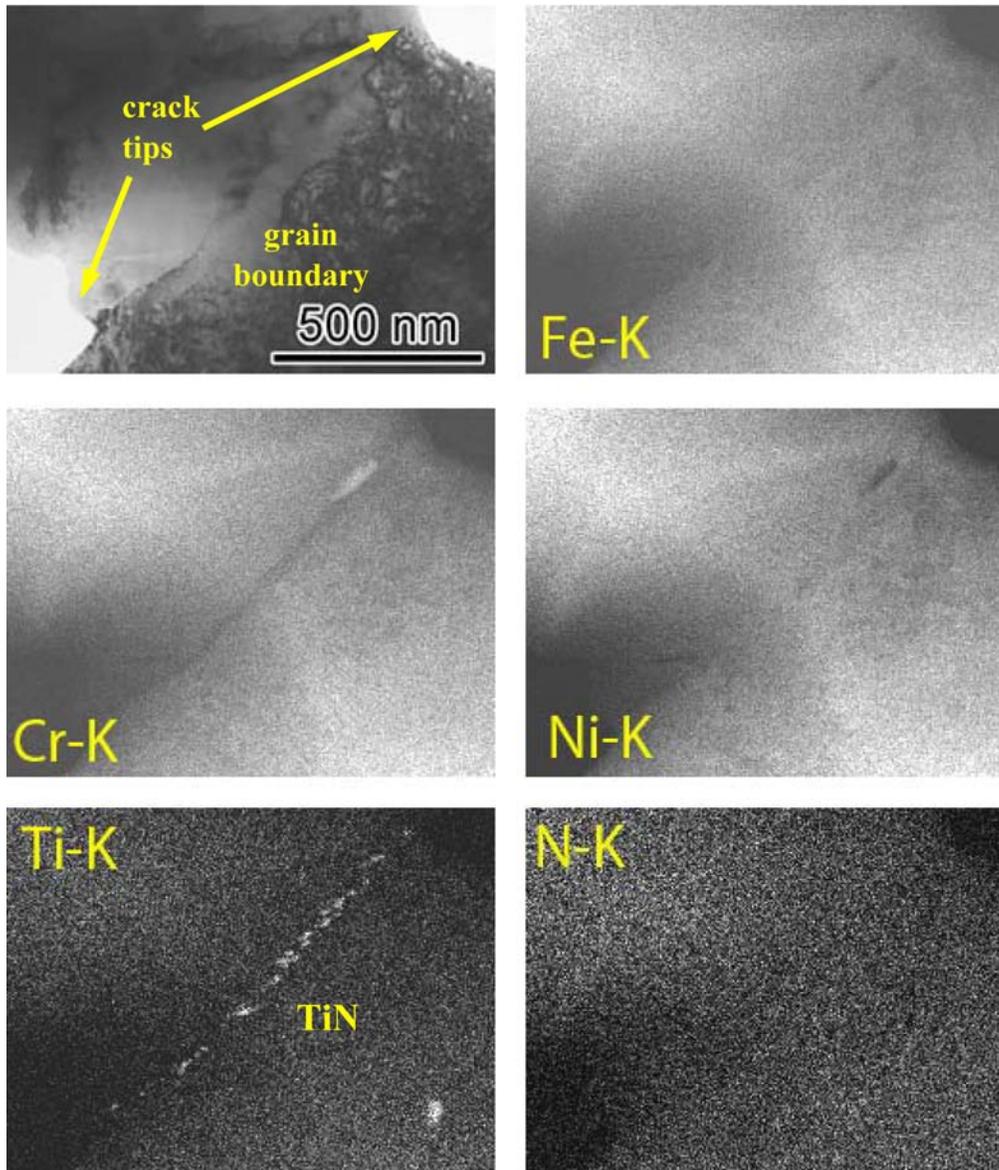
Figure 4.19. EDS Elemental Maps Illustrating Small TiN_2 Particles and One Large M_{23}C_6 Carbide Along a Grain Boundary Along the Path of a Hot Crack. Nitrogen cannot be detected in the TiN particles by EDS mapping because of the weak N-K signal.
