PNNL-19119

Preliminary Examination of Cracks in Alloy 152, 52, and 52M Weld Metals

January 2010

Prepared for
U.S. Nuclear Regulatory Commission
under a Related Services Agreement
with the U.S. Department of Energy
Contract DE-AC05-76RL01830
NRC Project JCN N6547

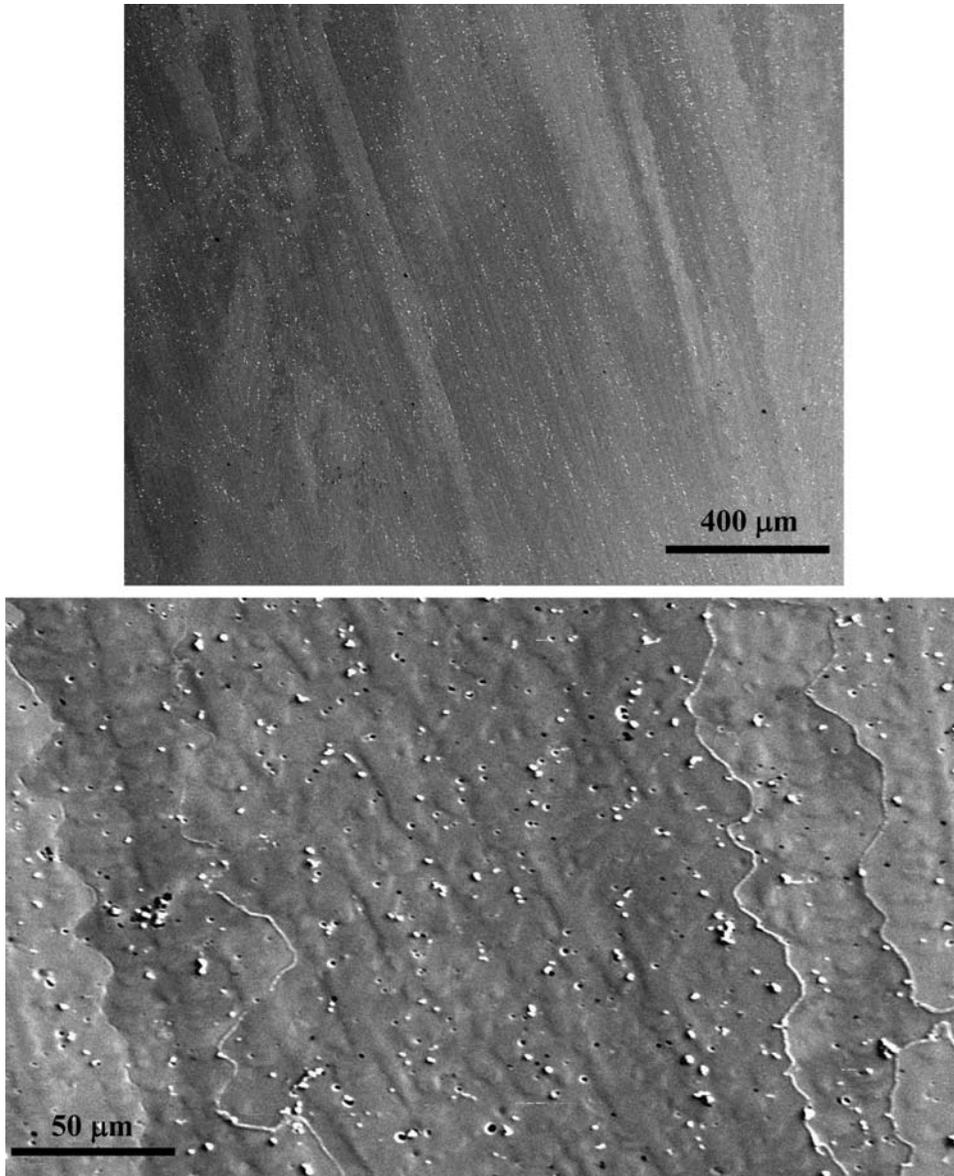
Figure 4.20. SEM-SE Images Illustrating Dendritic Large Grain Microstructure in the MHI Alloy 152 Weld Metal. Higher magnification (lower image) shows high density of second phase particles.

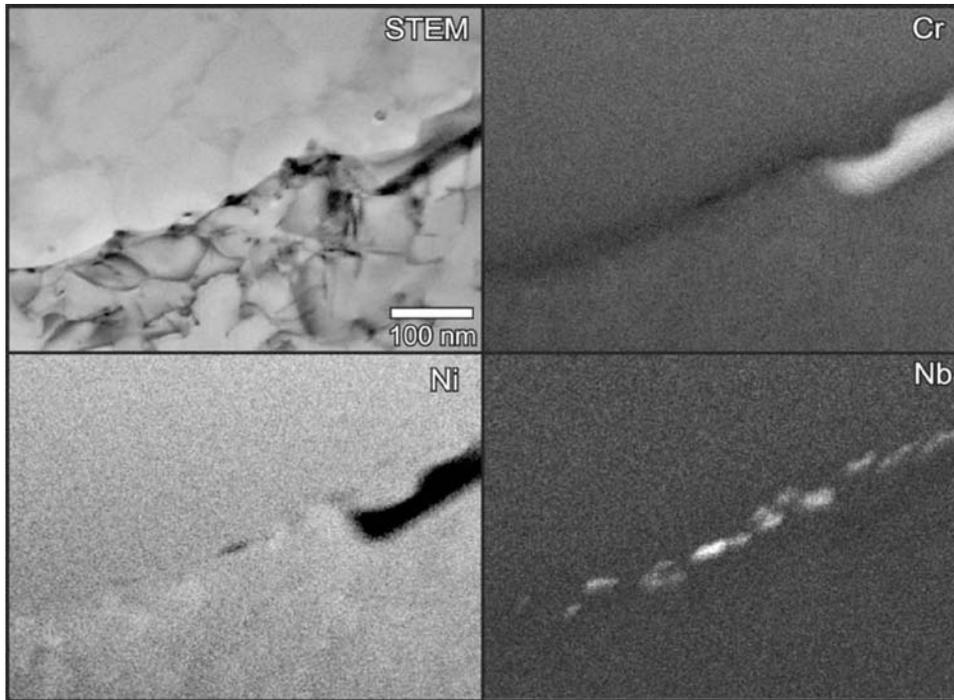
Figure 4.21. Grain Boundary Showing a Single Large Cr-carbide with Numerous Smaller Nb-Ti Carbides. In this case, no Ti was found associated with the Nb MC carbides.

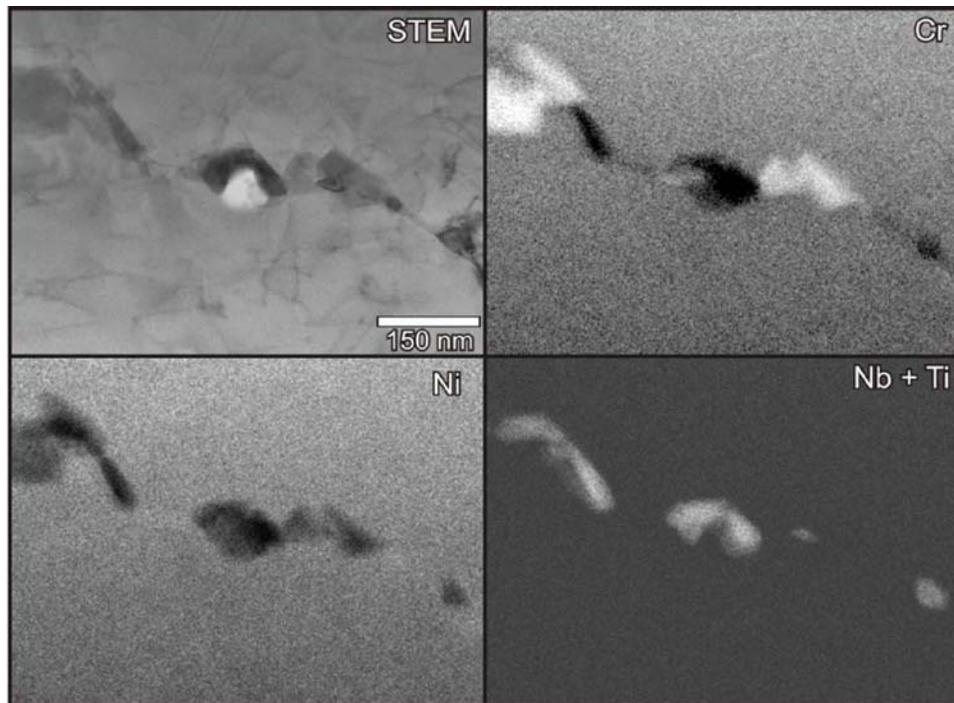
Figure 4.22. Compositional Maps Taken in STEM Mode Revealed that Both Cr-rich and Nb-rich Carbides are Present on the Boundary Between Two Dendrites. The MC carbides contained both Nb and Ti.

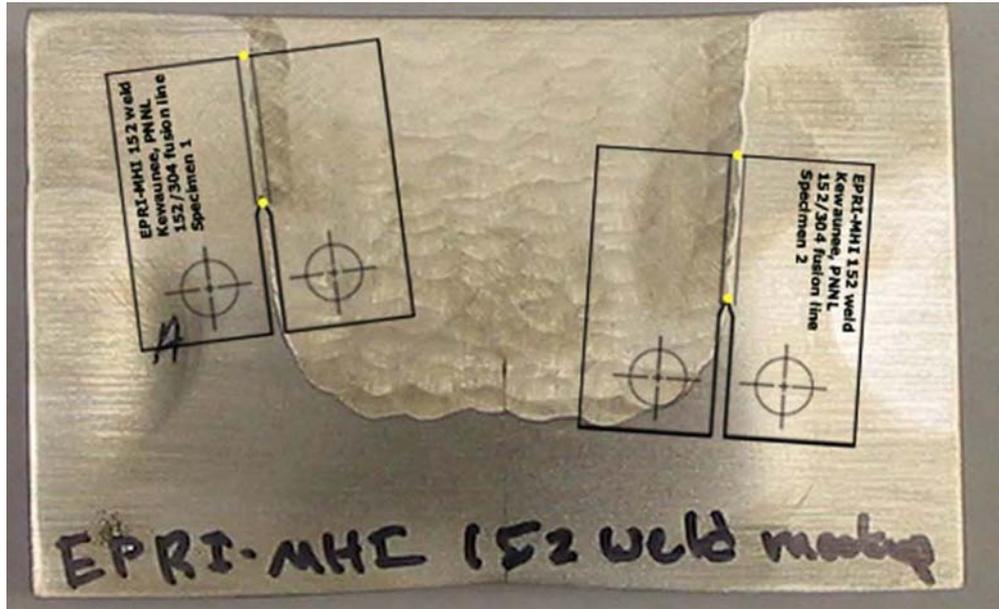
Figure 4.23. Photograph Illustrating the Location of Two CT Specimens that were Machined with the Crack Plane Coincident with the 304SS – Alloy 152 Weld Fusion Line

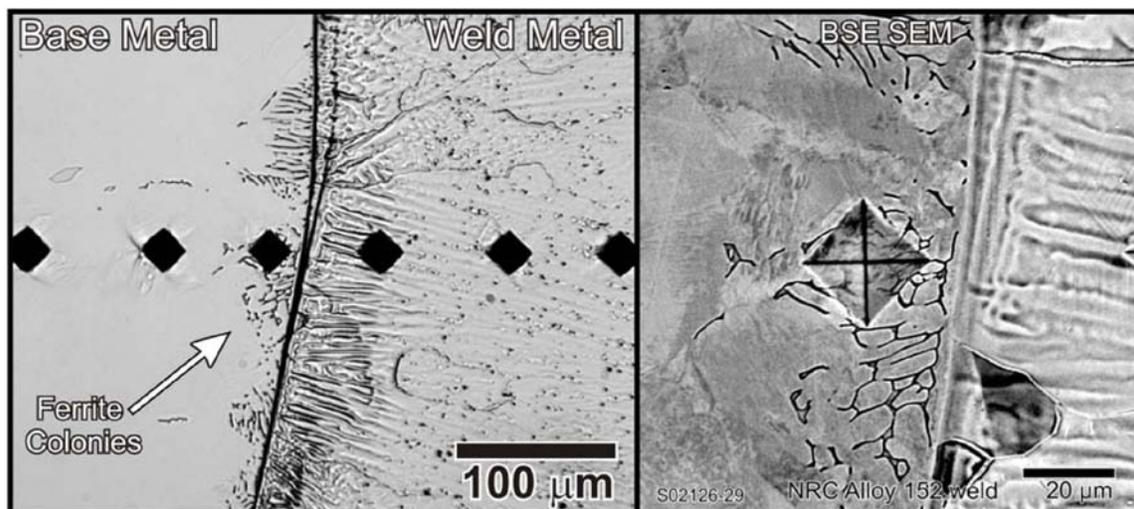
Figure 4.24. Left Image Shows an Optical Micrograph of the Transition Region with the Hardness Indentation Measurements. The hardness changed very little over the entire region despite the significant differences in microstructure.

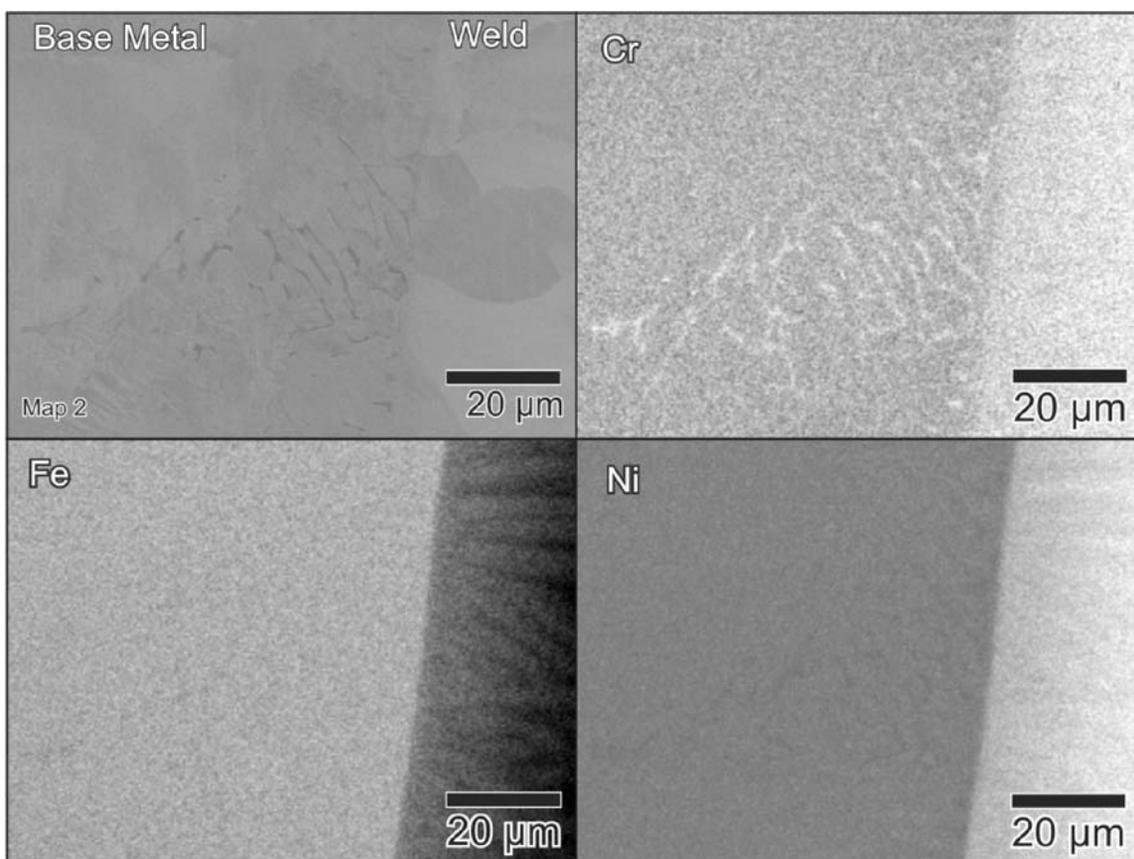
Figure 4.25. Compositional Map Taken Over the Alloy 152 – 304SS Interface

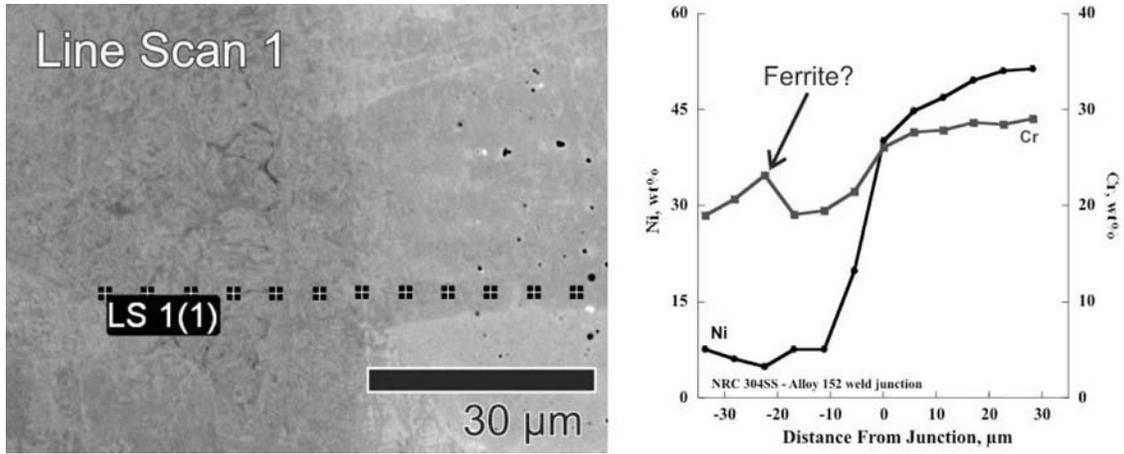
Figure 4.26. The Line Profile Across the Transition Region Shows that the Ni Changes from ~8 wt% in the Base Metal to ~50% in the Nearby Weld Region. The Cr change is smaller, decreasing from ~29% in the weld to ~19% in the 304SS austenite phase. The small spike in Cr concentration on the base metal side may be due to a ferrite colony.

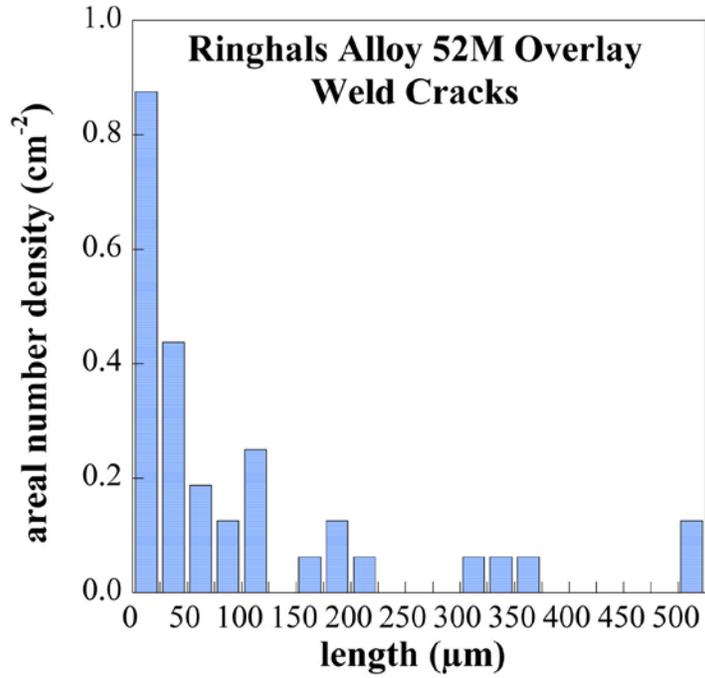
Figure 5.1. Areal Number Density Versus Crack Length for the Weld Cracks Observed in the Ringhals Alloy 52M Overlay Mockup

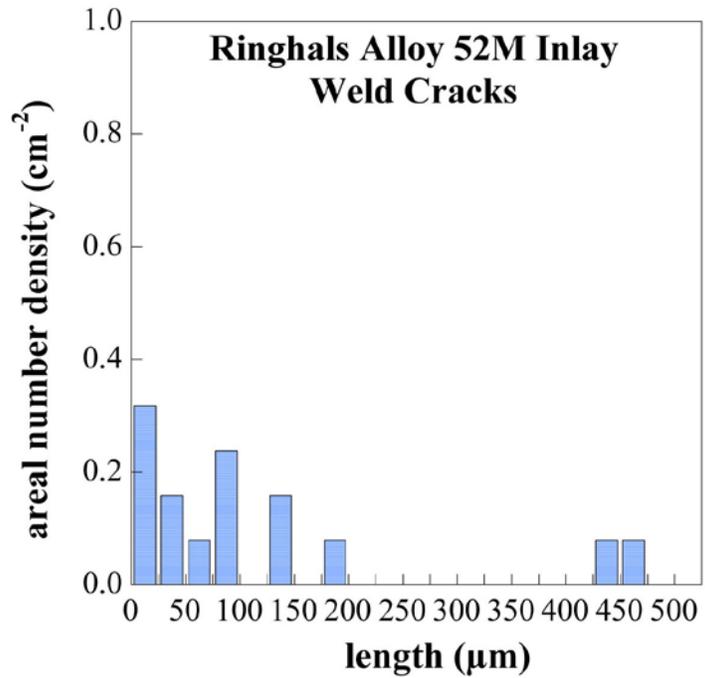
Figure 5.2. Areal Number Density Versus Crack Length for the Weld Cracks Observed in the Ringhals Alloy 52M Inlay Mockup

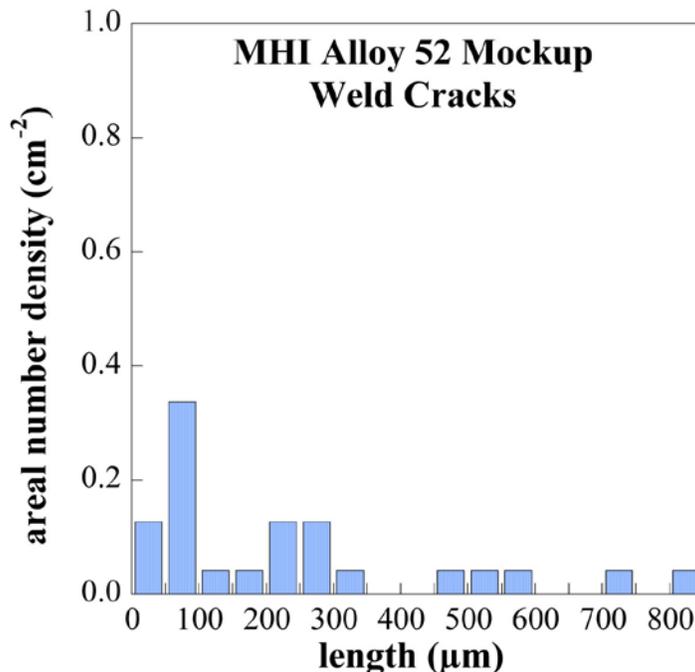
Figure 5.3. Weld Crack Areal Number Density Versus Length Observed in the MHI Alloy 52 U-groove Mockup. Although the weld cracks were isolated to the region around the large macroscopic weld crack, the entire area of the slice was used to calculate the areal number density.
