2.12.2 Elastomer O-ring Seal Performance Tests

This appendix presents the results of normal conditions of transport (NCT) and hypothetical accident condition (HAC) tests that address the free drop and puncture test performance requirements of 10 CFR 71¹. This appendix summarizes the information presented in the test report² for the first TRUPACT–III certification test unit (CTU-1). Wherever the acronym "CTU" is used in this section, it is to be understood as meaning CTU-1.

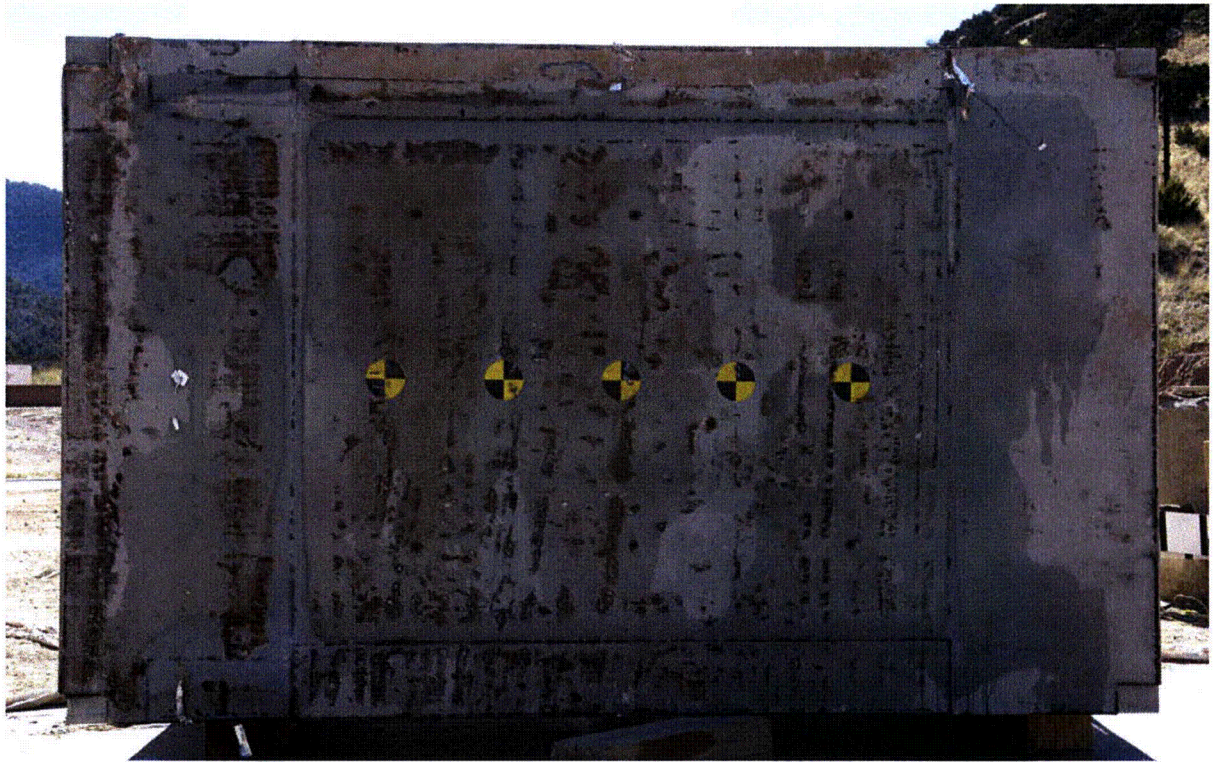
Figure 2.12.3-14 – Test LD3, Impact Side

compared to measurements after test LD3, and show the magnitude of any “inside-out” deformations of the CSA relative to the outside of the CTU. The average decrease in the four measurements (i.e., the amount that the CSA approached the impact surface from inside of the body overpack) was 7 mm. A hard vacuum was obtained between the closure lid seals after the test. Photos of the damage are shown in Figure 2.12.3-13 through Figure 2.12.3-15.

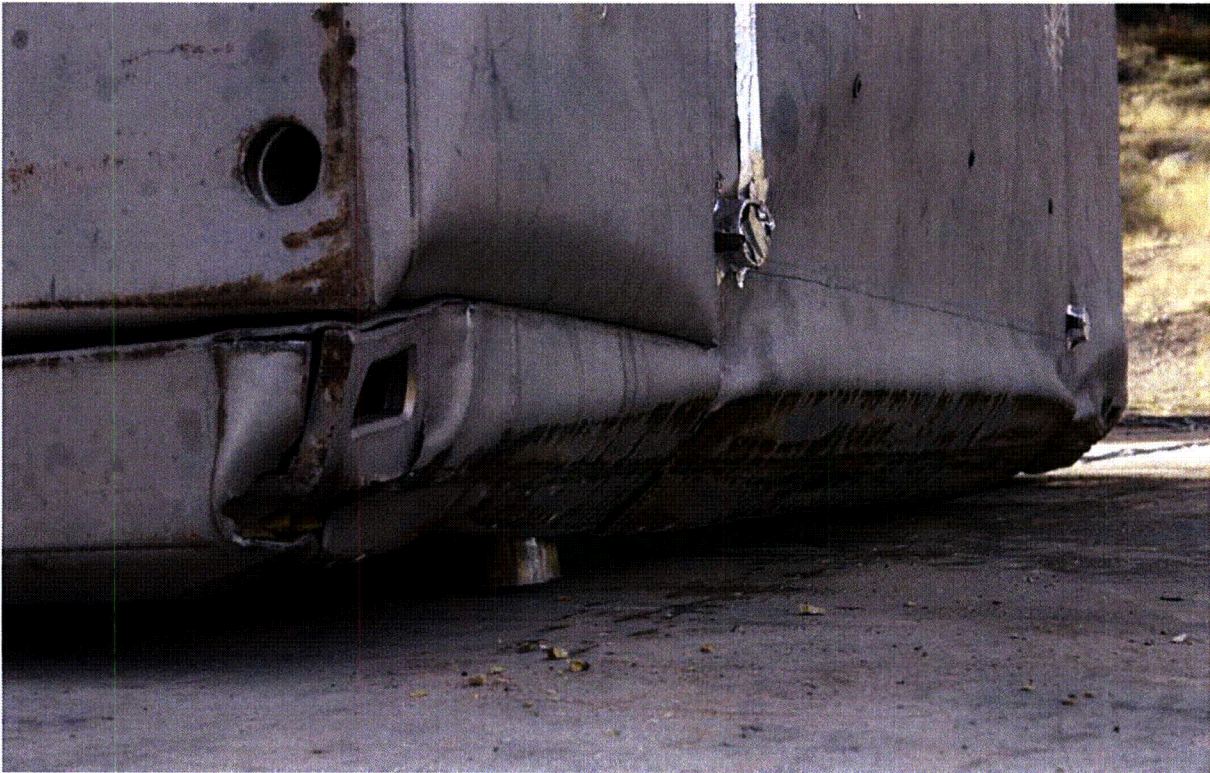
Figure 2.12.3-16 – Test LD5, Typical Deformation

The impact caused a flat region along the central side-edge approximately 305 mm wide. This tapered down to approximately 178 mm toward each end. During post-test disassembly, it was noted that the minimum perpendicular distance between the inside surface of the outer skin and the corner of the relatively rigid weldment which protects the calcium silicate insulation was 95 mm. A gap opened up between the front cheek and the steel plate encasing the 0.29 kg/dm³ foam equal to approximately 16 mm across the crush width. Additionally, the weld between the side outer skin and the front cheek unzipped for a distance of approximately 914 mm, and was a maximum of 51 mm wide, exposing the balsa wood in the side panel. It was subsequently determined that this weld was substandard. A vacuum test on the closure lid seals was not performed. Photos of the damage are shown in Figure 2.12.3-16 through Figure 2.12.3-18.

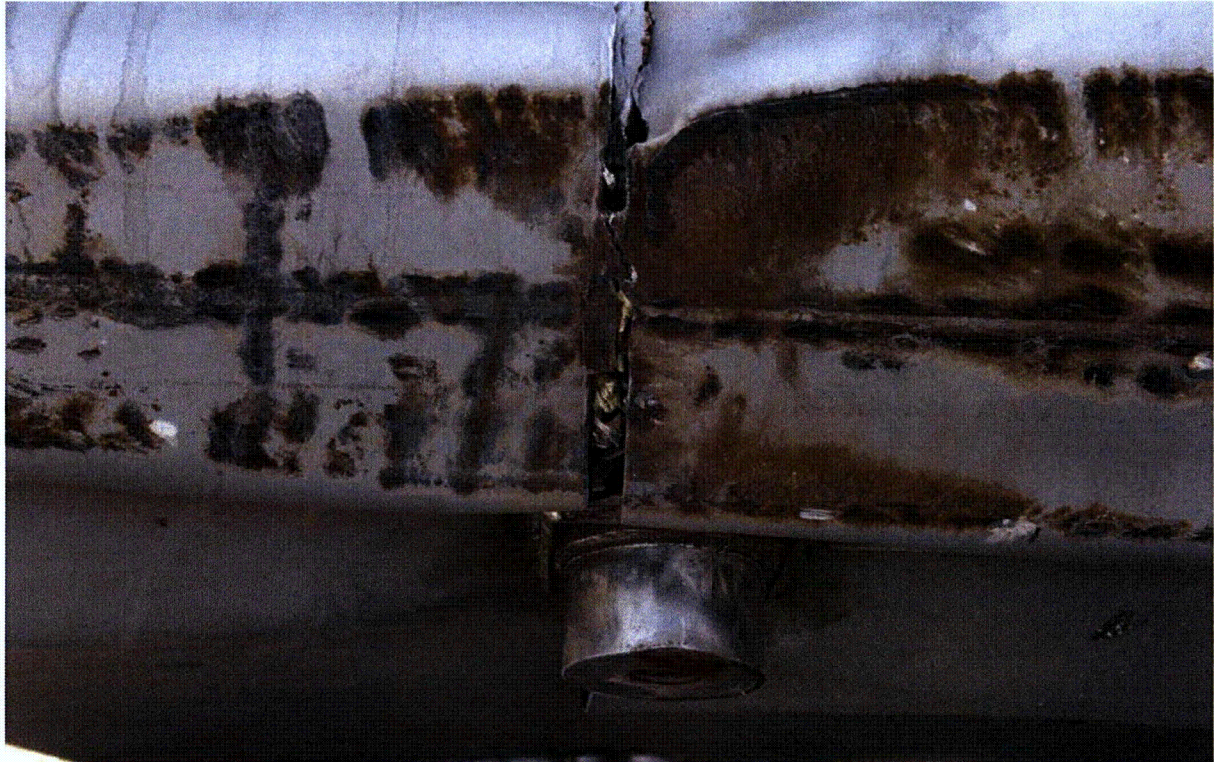
Figure 2.12.3-18 – Test LD5, Weld Tear Between Cheek (left half) and Body Edge (right half)

- The weld connecting the front edge of the right side outer skin sheet to the CTU had poor penetration. This caused an excessively long weld tear during a free drop. This is further discussed in Section 2.12.3.7.4, *Free Drop, Side-Edge, HAC (Test LD5)*.

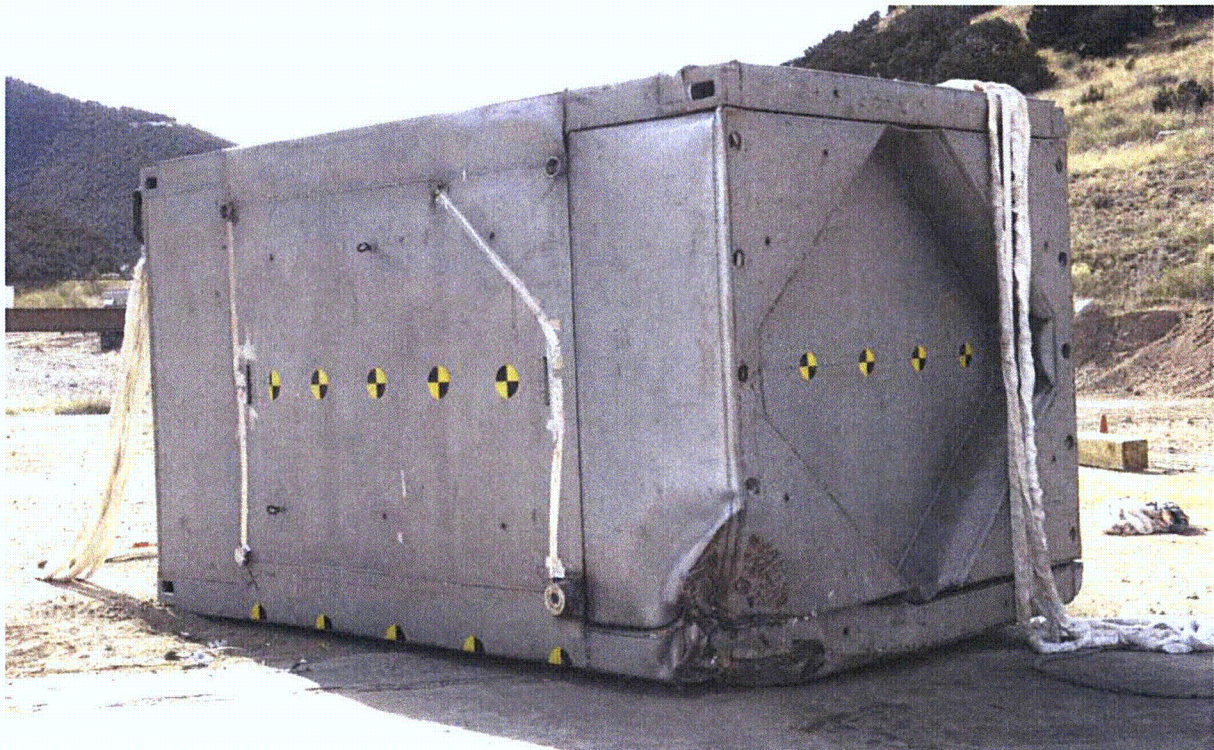
Figure 2.12.3-19 – Test LD4, Typical Deformations

The impact caused a triangular flat region having dimensions of 1,054 mm along the overpack cover, 838 mm along the bottom, and 800 mm along the right side of the CTU. The combined damage from all of the free drops caused a slight bowing of the right cheek, and a gap of up to 76 mm at the center between the cheek and the overpack cover right edge. The gap was however blocked with buckled material starting about 89 mm deep into the gap, and the gap reduced to zero width at the top and bottom of the cheek-to-cover joint. No significant weld seam failures were noted from this test. A hard vacuum could not be obtained between the closure lid seals, but the leak was not significant enough to have a measureable effect on the internal cavity pressure. Photos of the damage are shown in Figure 2.12.3-19 and Figure 2.12.3-20.

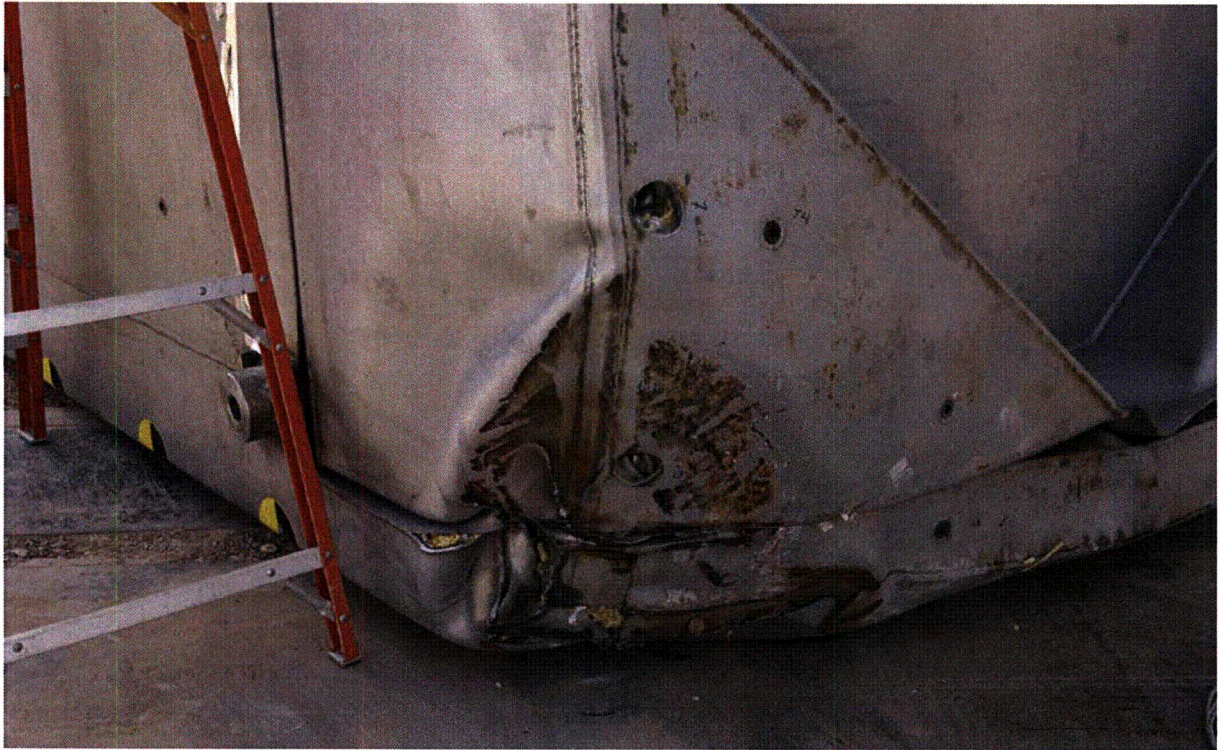
Figure 2.12.3-20 – Test LD4, Close-up of Deformations

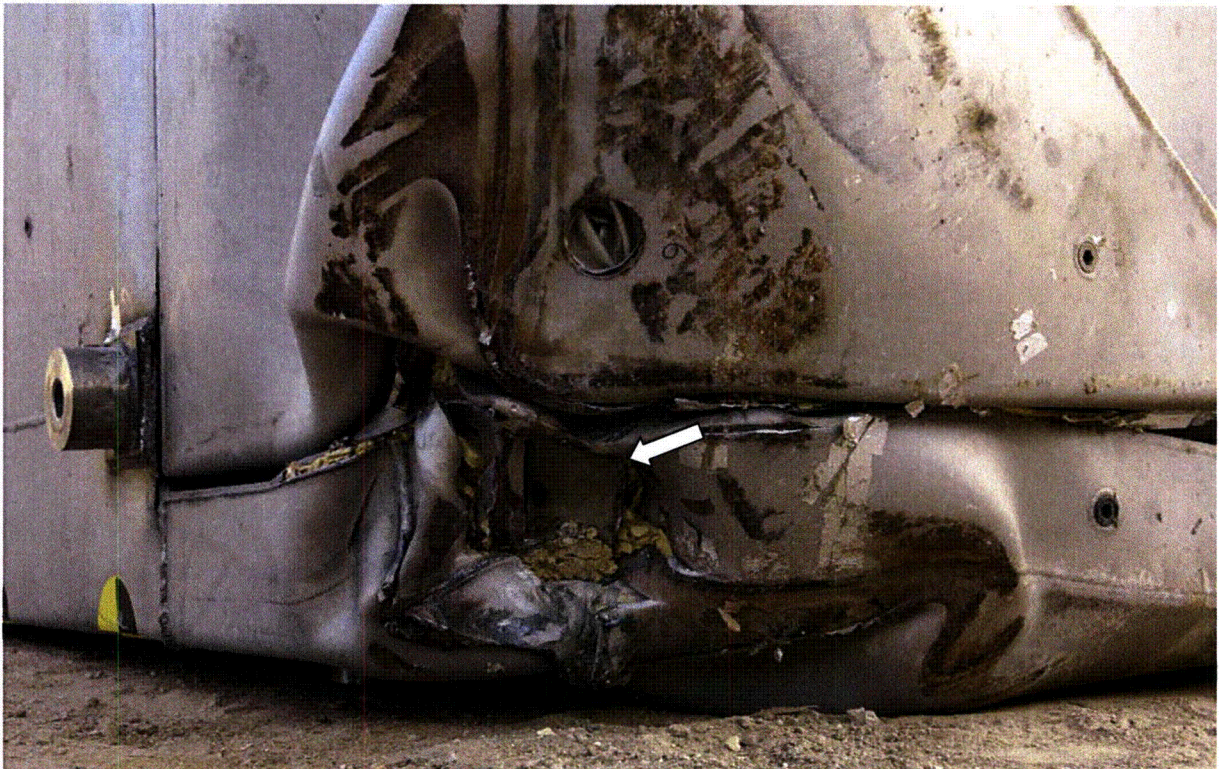
Figure 2.12.3-21 – Test LP3. Puncture Bar Damage Indicated by Arrow

The ambient temperature for this test was 17°C . The puncture bar struck at essentially the center of the prior c.g.-over-corner free drop (LD4) damage and created a further deformation of approximately 178 mm in diameter and 102 mm deep. The effect of the impact was to further locally compress the deformed materials in the damaged zone. Small amounts of foam were visible from the free drop test damage, and the puncture test did not significantly alter this. After cutting away the damaged material, a minimum distance of 51 mm was measured between the deformed steel resulting from the puncture drop and the nearest part of the calcium silicate protection box. This distance was filled with compressed, 0.48 kg/dm^3 foam. A photograph of the damage is shown in Figure 2.12.3-21.

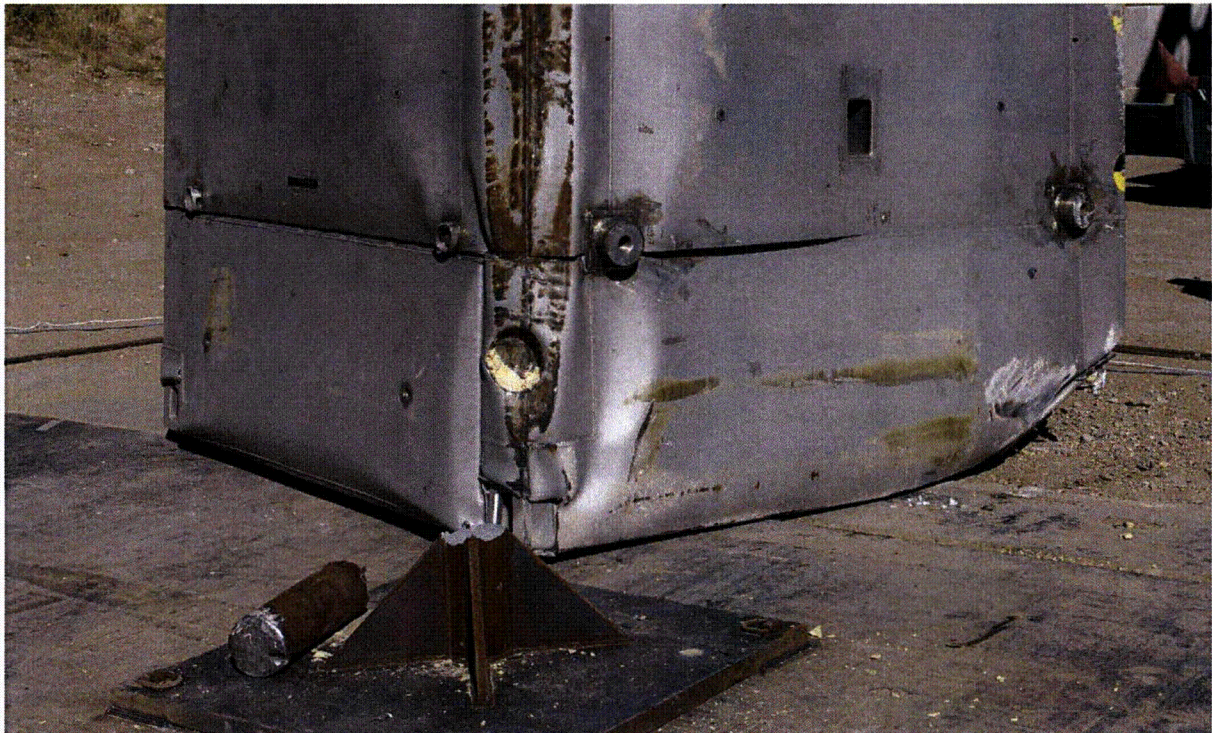
Figure 2.12.3-22 – Test LP4 Puncture Damage. Note Broken Puncture Bar

The ambient temperature for this test was 16°C . The puncture bar struck on the prior damage from free drop test LD5, with the center of the bar placed approximately 584 mm from the cover end of the package, with the package inclined 30° from the horizontal. The bar penetrated the outer skin (creating an approx. 178 mm diameter disk), and struck the top corner of the heavy structural box which protects the calcium silicate insulation in the cheek. This box is only 52 mm across, and is made from 16 mm thick material, and is therefore very rigid. Later disassembly showed relatively minor weld cracks in this region and only approximately 3 mm of deformation of the protective box. There was no damage to the calcium silicate insulating board, which maintained full integrity without crumbling or breaking. Note: the puncture bar fractured completely at a plane just above the reinforcement gussets as the package tipped off of the bar

following impact. However, all puncture bar welds, including those to the drop pad, remained intact. Photos of the damage are shown in Figure 2.12.3-22 and Figure 2.12.3-23.

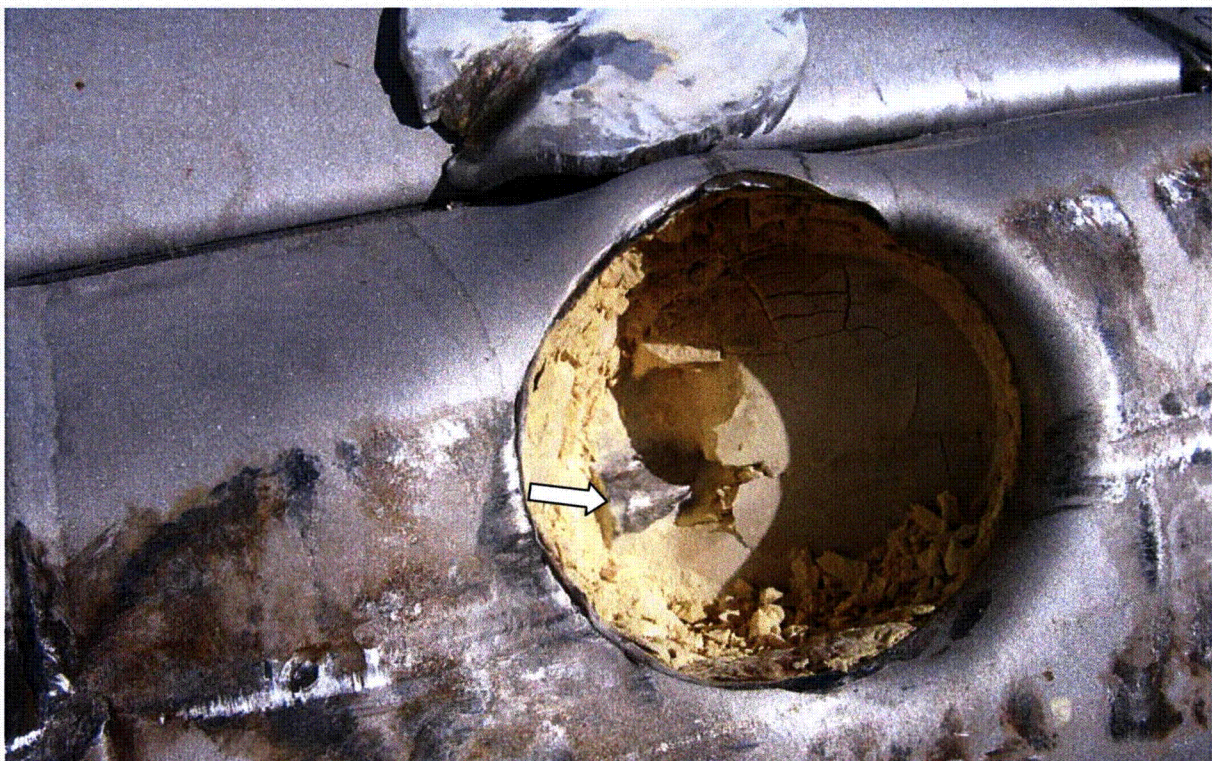
Figure 2.12.3-23 – Test LP4, Close-up of Damage. Note Corner of 16-mm Thick Insulation Protection Box Inside Hole

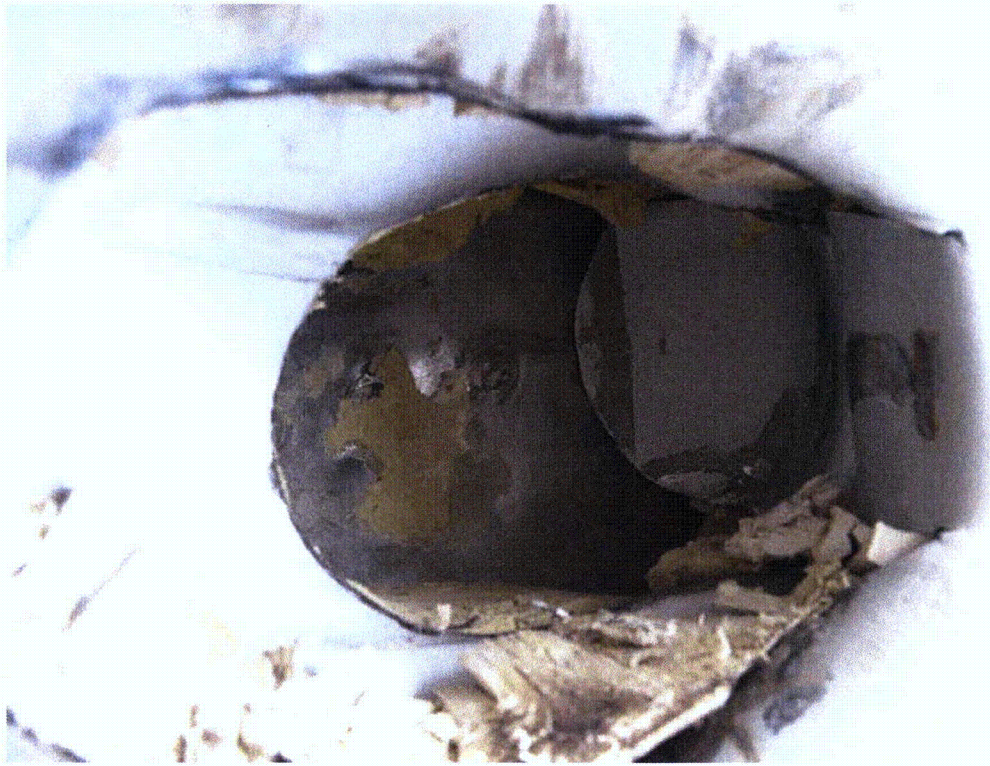
Figure 2.12.3-26 – Test LP1, Close-up of Damage. Bottom of Hole is CSA Outer Structural Sheet

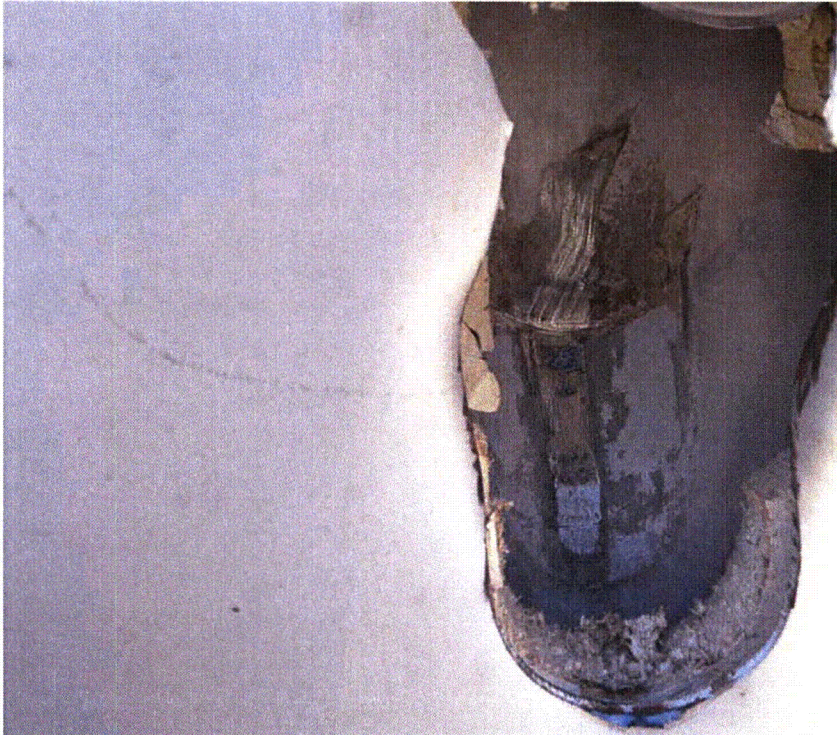
Figure 2.12.3-28 – Test LP2, Close-up of Damage. Bottom of Hole is Puncture-Resistant Plate

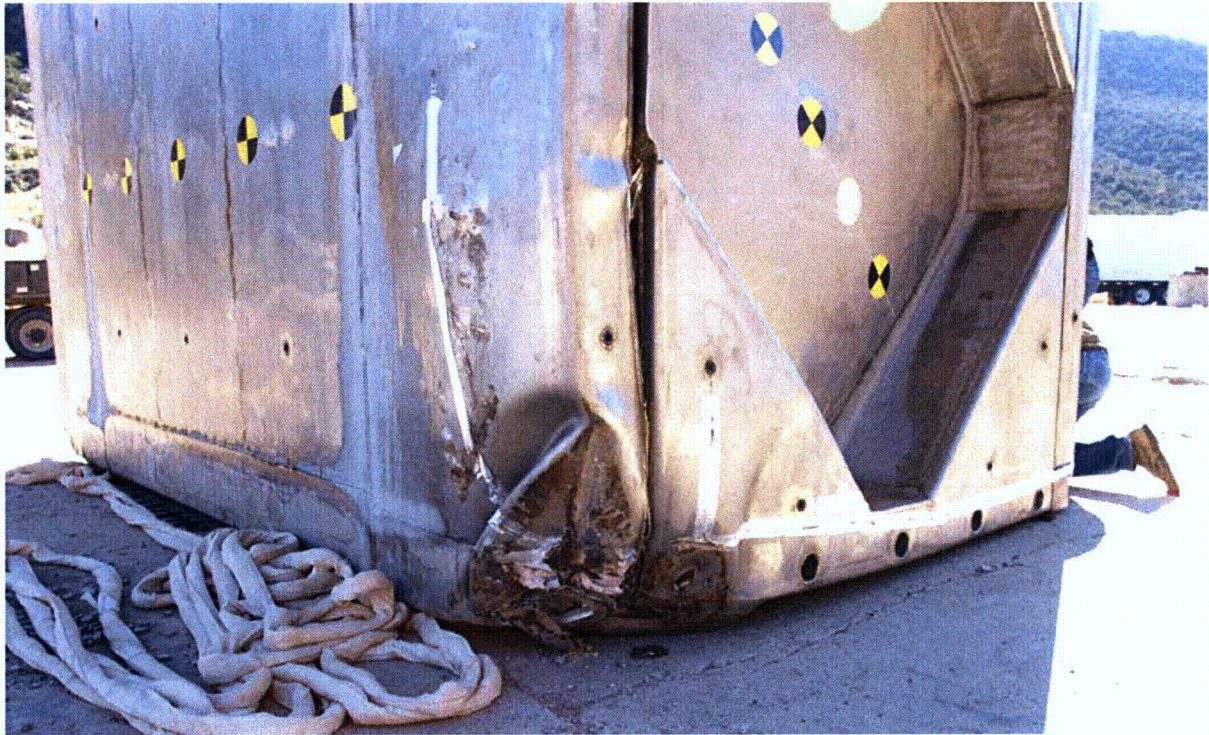
Figure 2.12.6-11 – Test LD91, CG-Over-Corner Free Drop Damage
