ATTACHMENT OP-5a

**Order 1 Soil Survey
Lost Creek Project - Plant Site
September 2008**

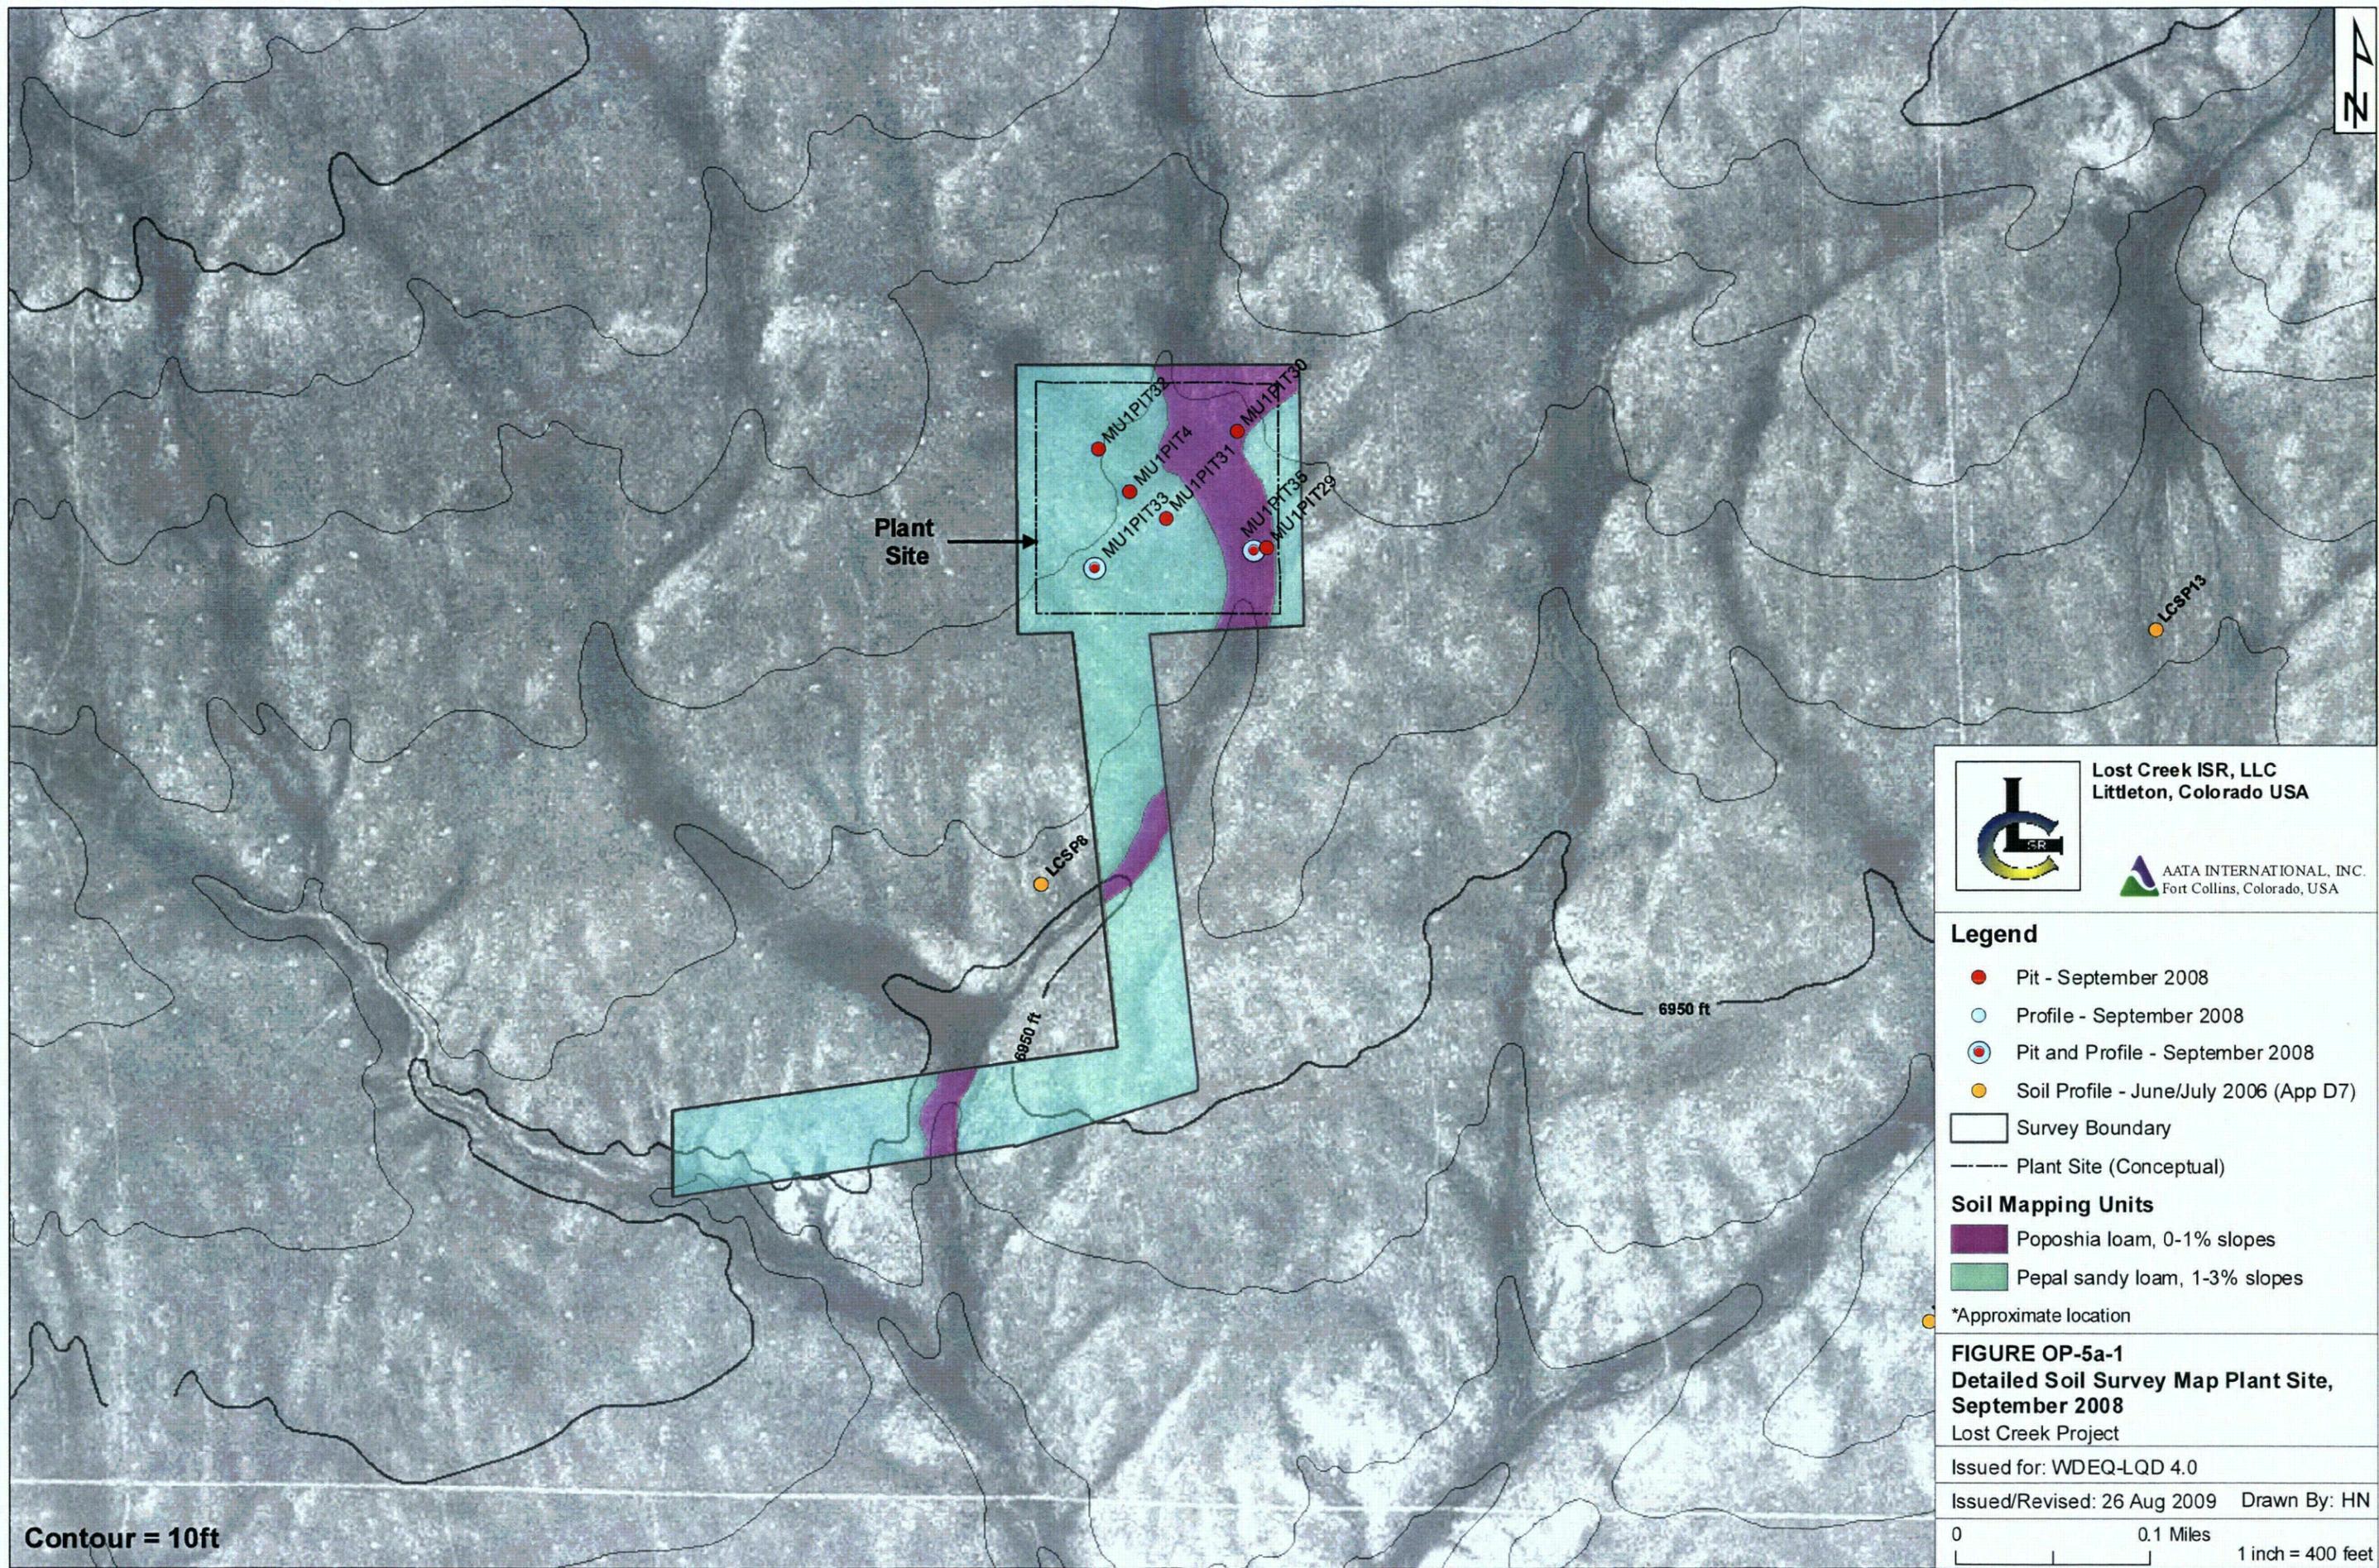
FIGURE OP-5a-1
Detailed Soil Survey Map Plant Site,
September 2008
 Lost Creek Project
 Issued for: WDEQ-LQD 4.0
 Issued/Revised: 26 Aug 2009 Drawn By: HN
 0 0.1 Miles 1 inch = 400 feet

The Plant study area includes the Plant site and connecting roadways (**Figure OP-5a-1**). The Plant site has an anticipated disturbance area of about 14 acres. The total Plant study area, including the roads, is approximately 25 acres. The Plant study area is larger than the anticipated disturbance area to ensure adequate coverage.

Two SMUs were identified in the Plant study area: the Pepal Sandy Loam and the Poposhia Loam as described in more detail below. The SMUs were identified based on comparable soils near the Permit Area that were officially surveyed and described by the National Resource Conservation Service (NRCS). The color of the SMUs is described as moist, crushed and broken.

The Lost Creek Project (Project), a proposed in-situ uranium mine, is located in Sweetwater County, on the northeastern edge of the Great Divide Basin of south-central Wyoming, approximately 38 miles northwest of Rawlins. This report describes the soils at the Plant site of the Lost Creek Permit Area (Permit Area; **Figure OP-5a-1**).

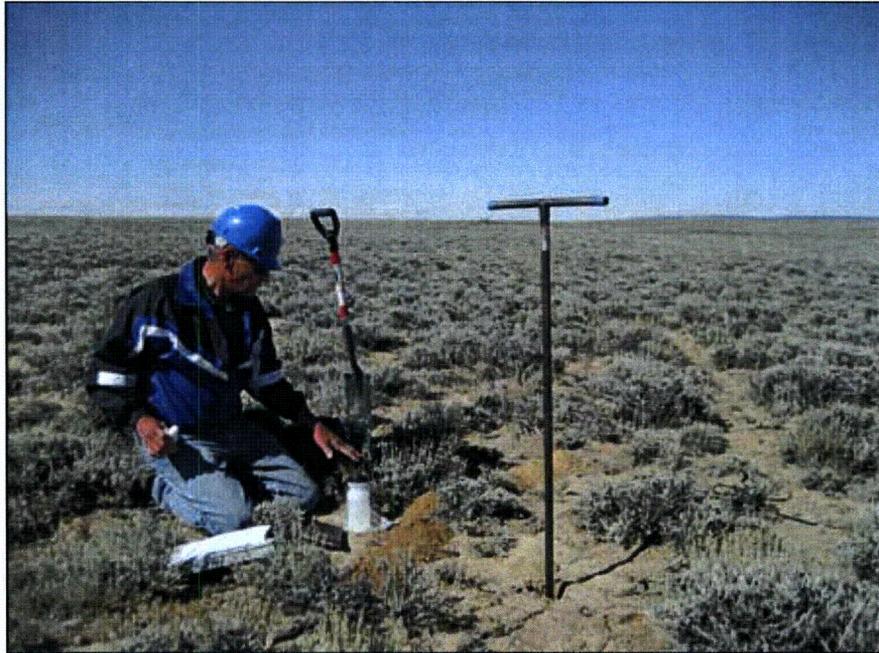
Mine Unit 1 Pit 4. West side of the Plant site, approximately 165 ft in from the edge. Vegetation on site had 60% ground cover, including 40% sage, 10% grass & 10% litter. Drilled to depth of 33 in.

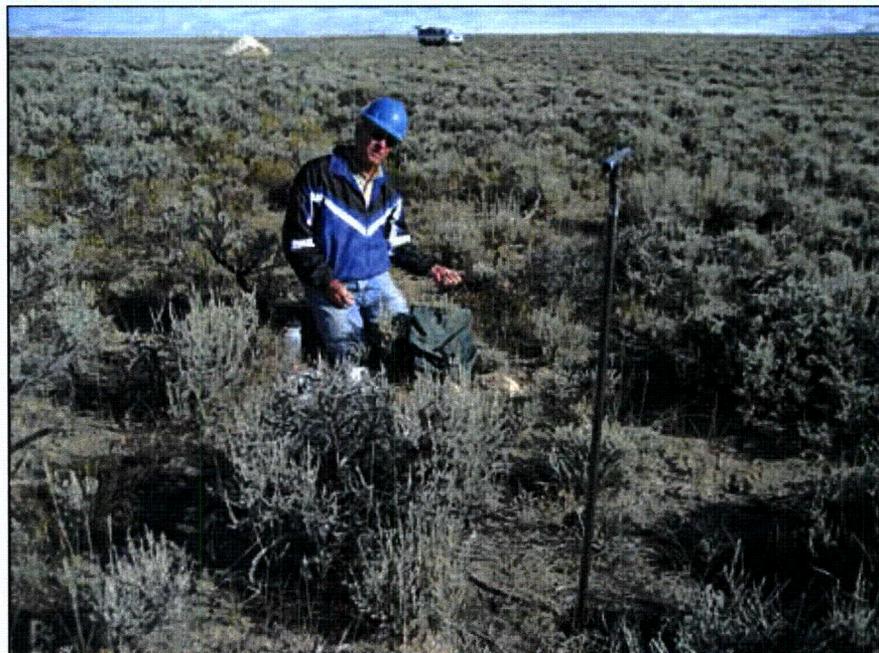
Mine Unit 1 Pit 29. Plant Site. Elevation 6985 ft. Vegetation on site had 80% ground cover, including 60 % sage to 2 ft high, 15% grasses & 5% litter. Site was undisturbed. Drilled to depth of 30 in.

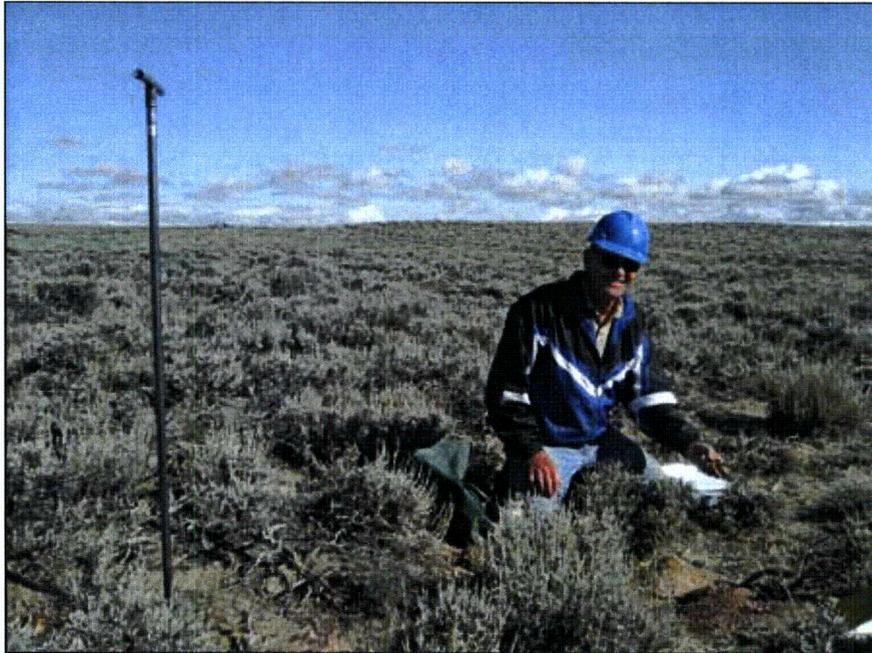
Mine Unit 1 Pit 30. Plant Site. Elevation 6988 ft. Vegetation on site had 70% ground cover, including 60% sage to 1 ft high, 5% grasses & 5% other. Site was undisturbed. Drilled to depth of 24 in.

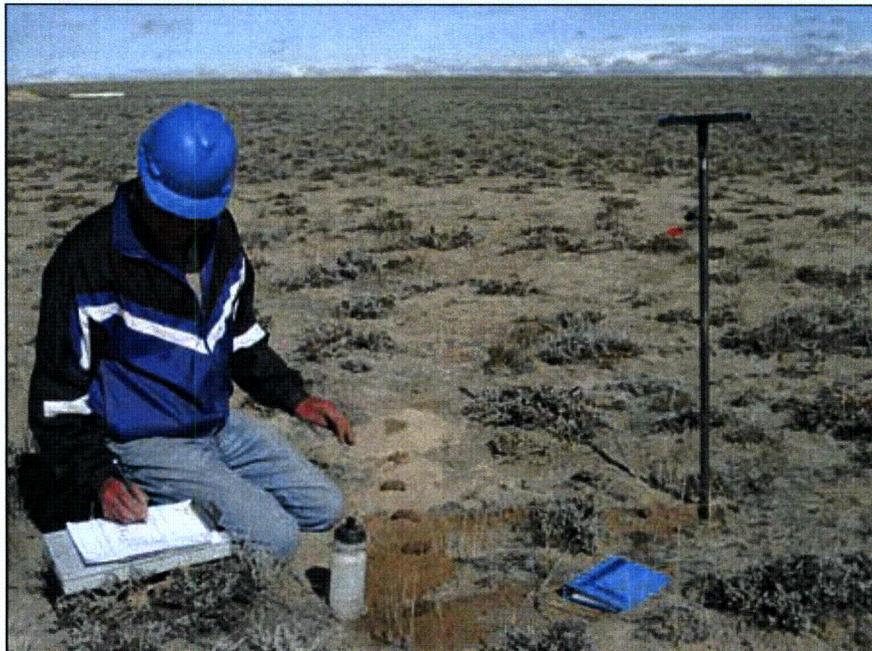
Mine Unit 1 Pit 31. Plant Site. Elevation 6992 ft. Vegetation on site had 25% ground cover, including 20% sage & 5% other cover. The site was disturbed by passenger vehicles. Drilled to depth of 36 in.

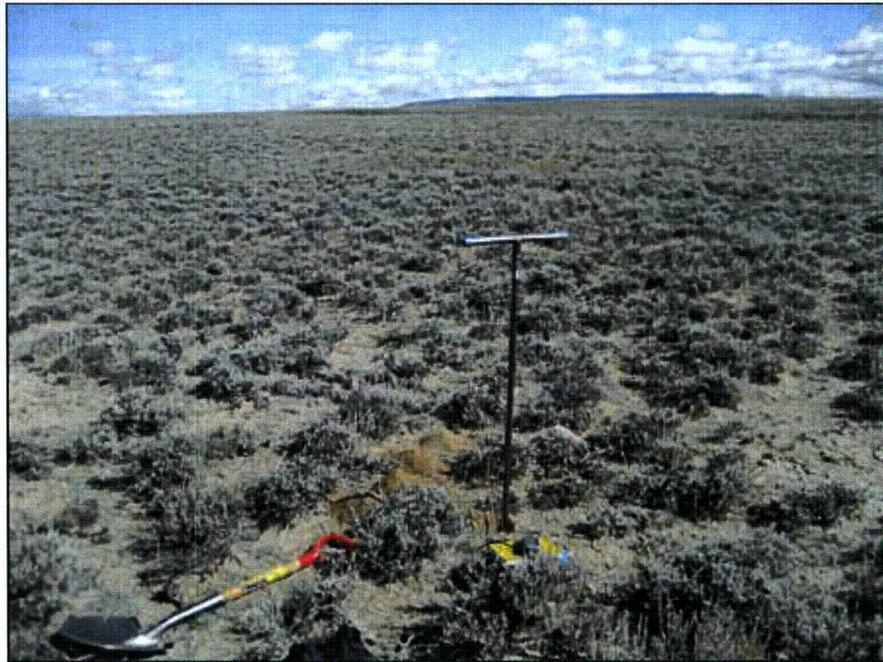
Mine Unit 1 Pit 32. Plant Site. Elevation 6992 ft. Vegetation on site had 45% ground cover, including 35% sage to 1 ft high, 5% grasses & prickly pear cactus, & 5% other vegetation. Drilled to depth of 36 in.

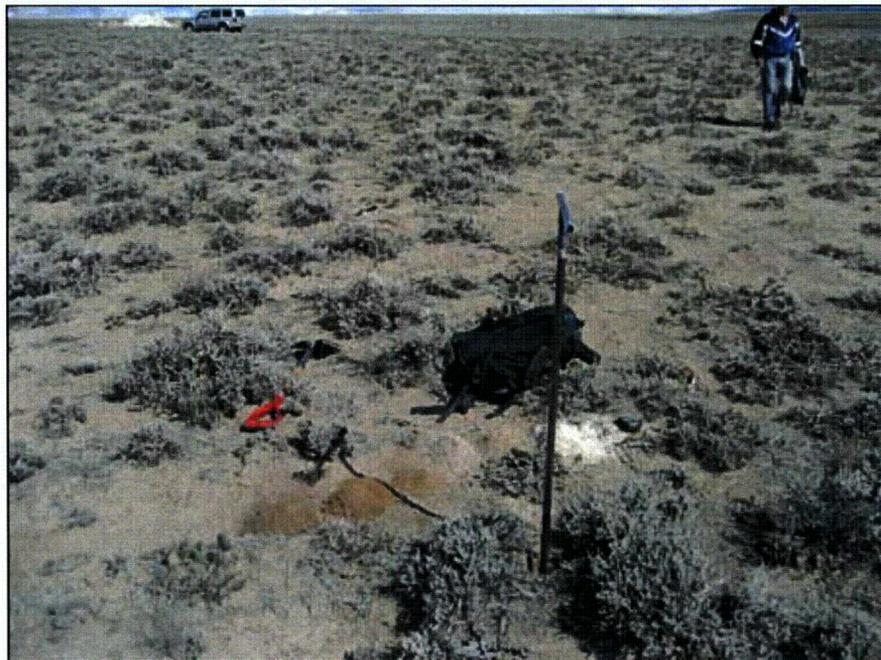
Mine Unit 1 Pit 33 (Expanded to soil profile & sampled). Plant Site. Elevation 6985 ft. Vegetation on site had 50% ground cover, including 40% sage, 5% grasses & 5% litter. Site was relatively undisturbed. Drilled to depth of 36 in.

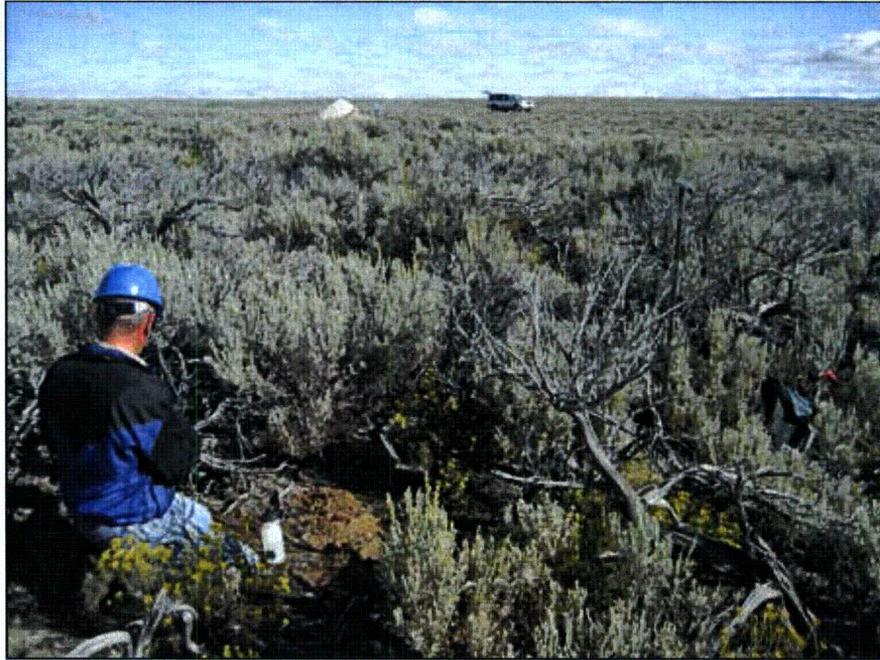
Mine Unit 1 Pit 35 (Expanded to soil profile & sampled.) Plant Site. Elevation 6978 ft. Vegetation on site had 85% ground cover, including 80% large sage to 4 ft high & 5% other vegetation. Picture was taken in the undisturbed terrain west of Mine Unit 1 Pit 29 in the swale. Site was undisturbed. Drilled to depth of 24 in.

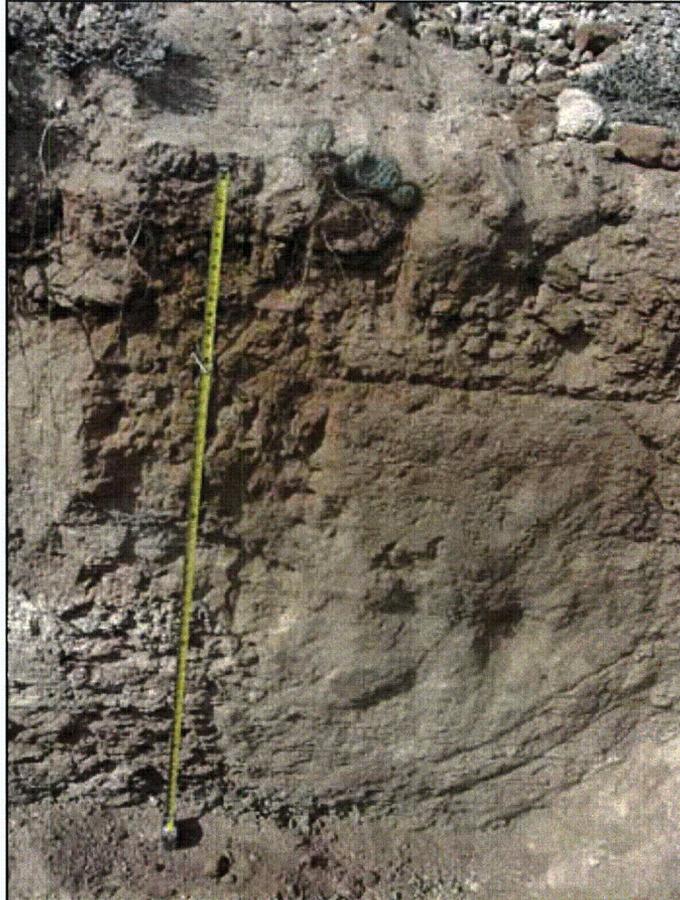
Mine Unit 1 Profile 33
Plant Site (Sampled for laboratory analyses.)

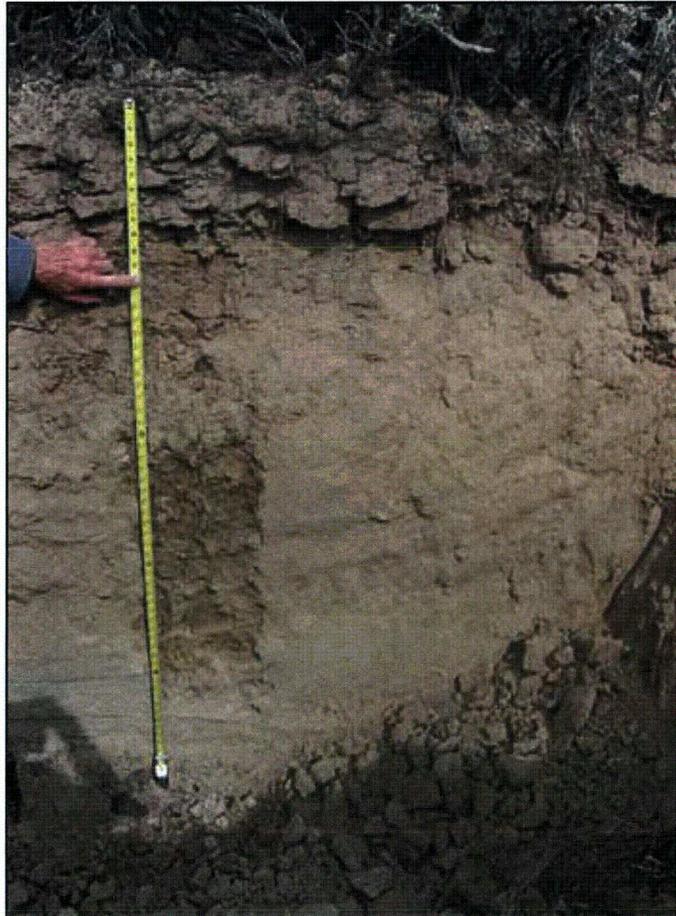
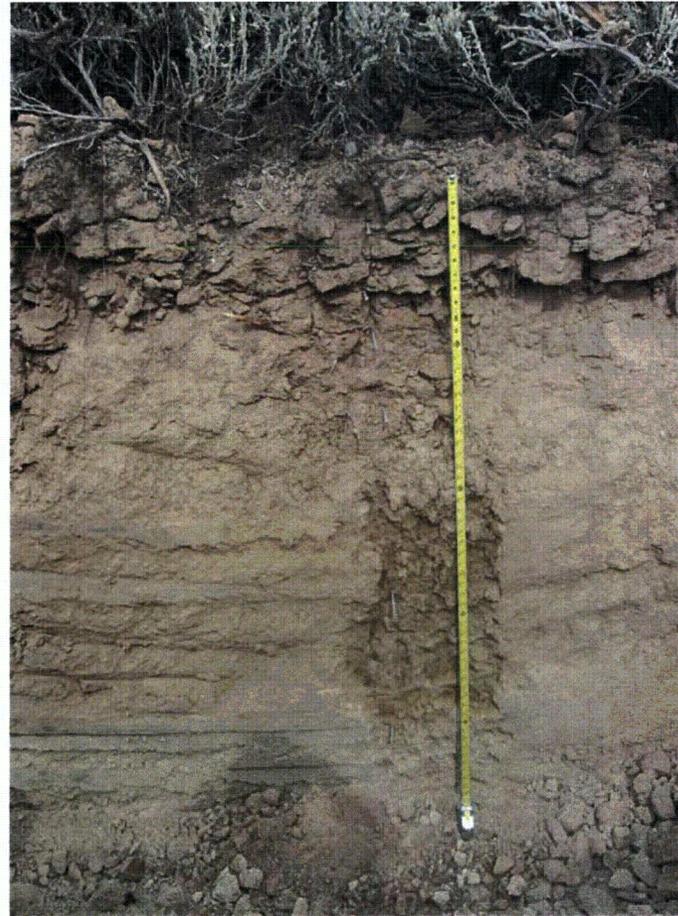
Mine Unit 1 Profile 35 (Sampled for laboratory analyses.) Plant Site

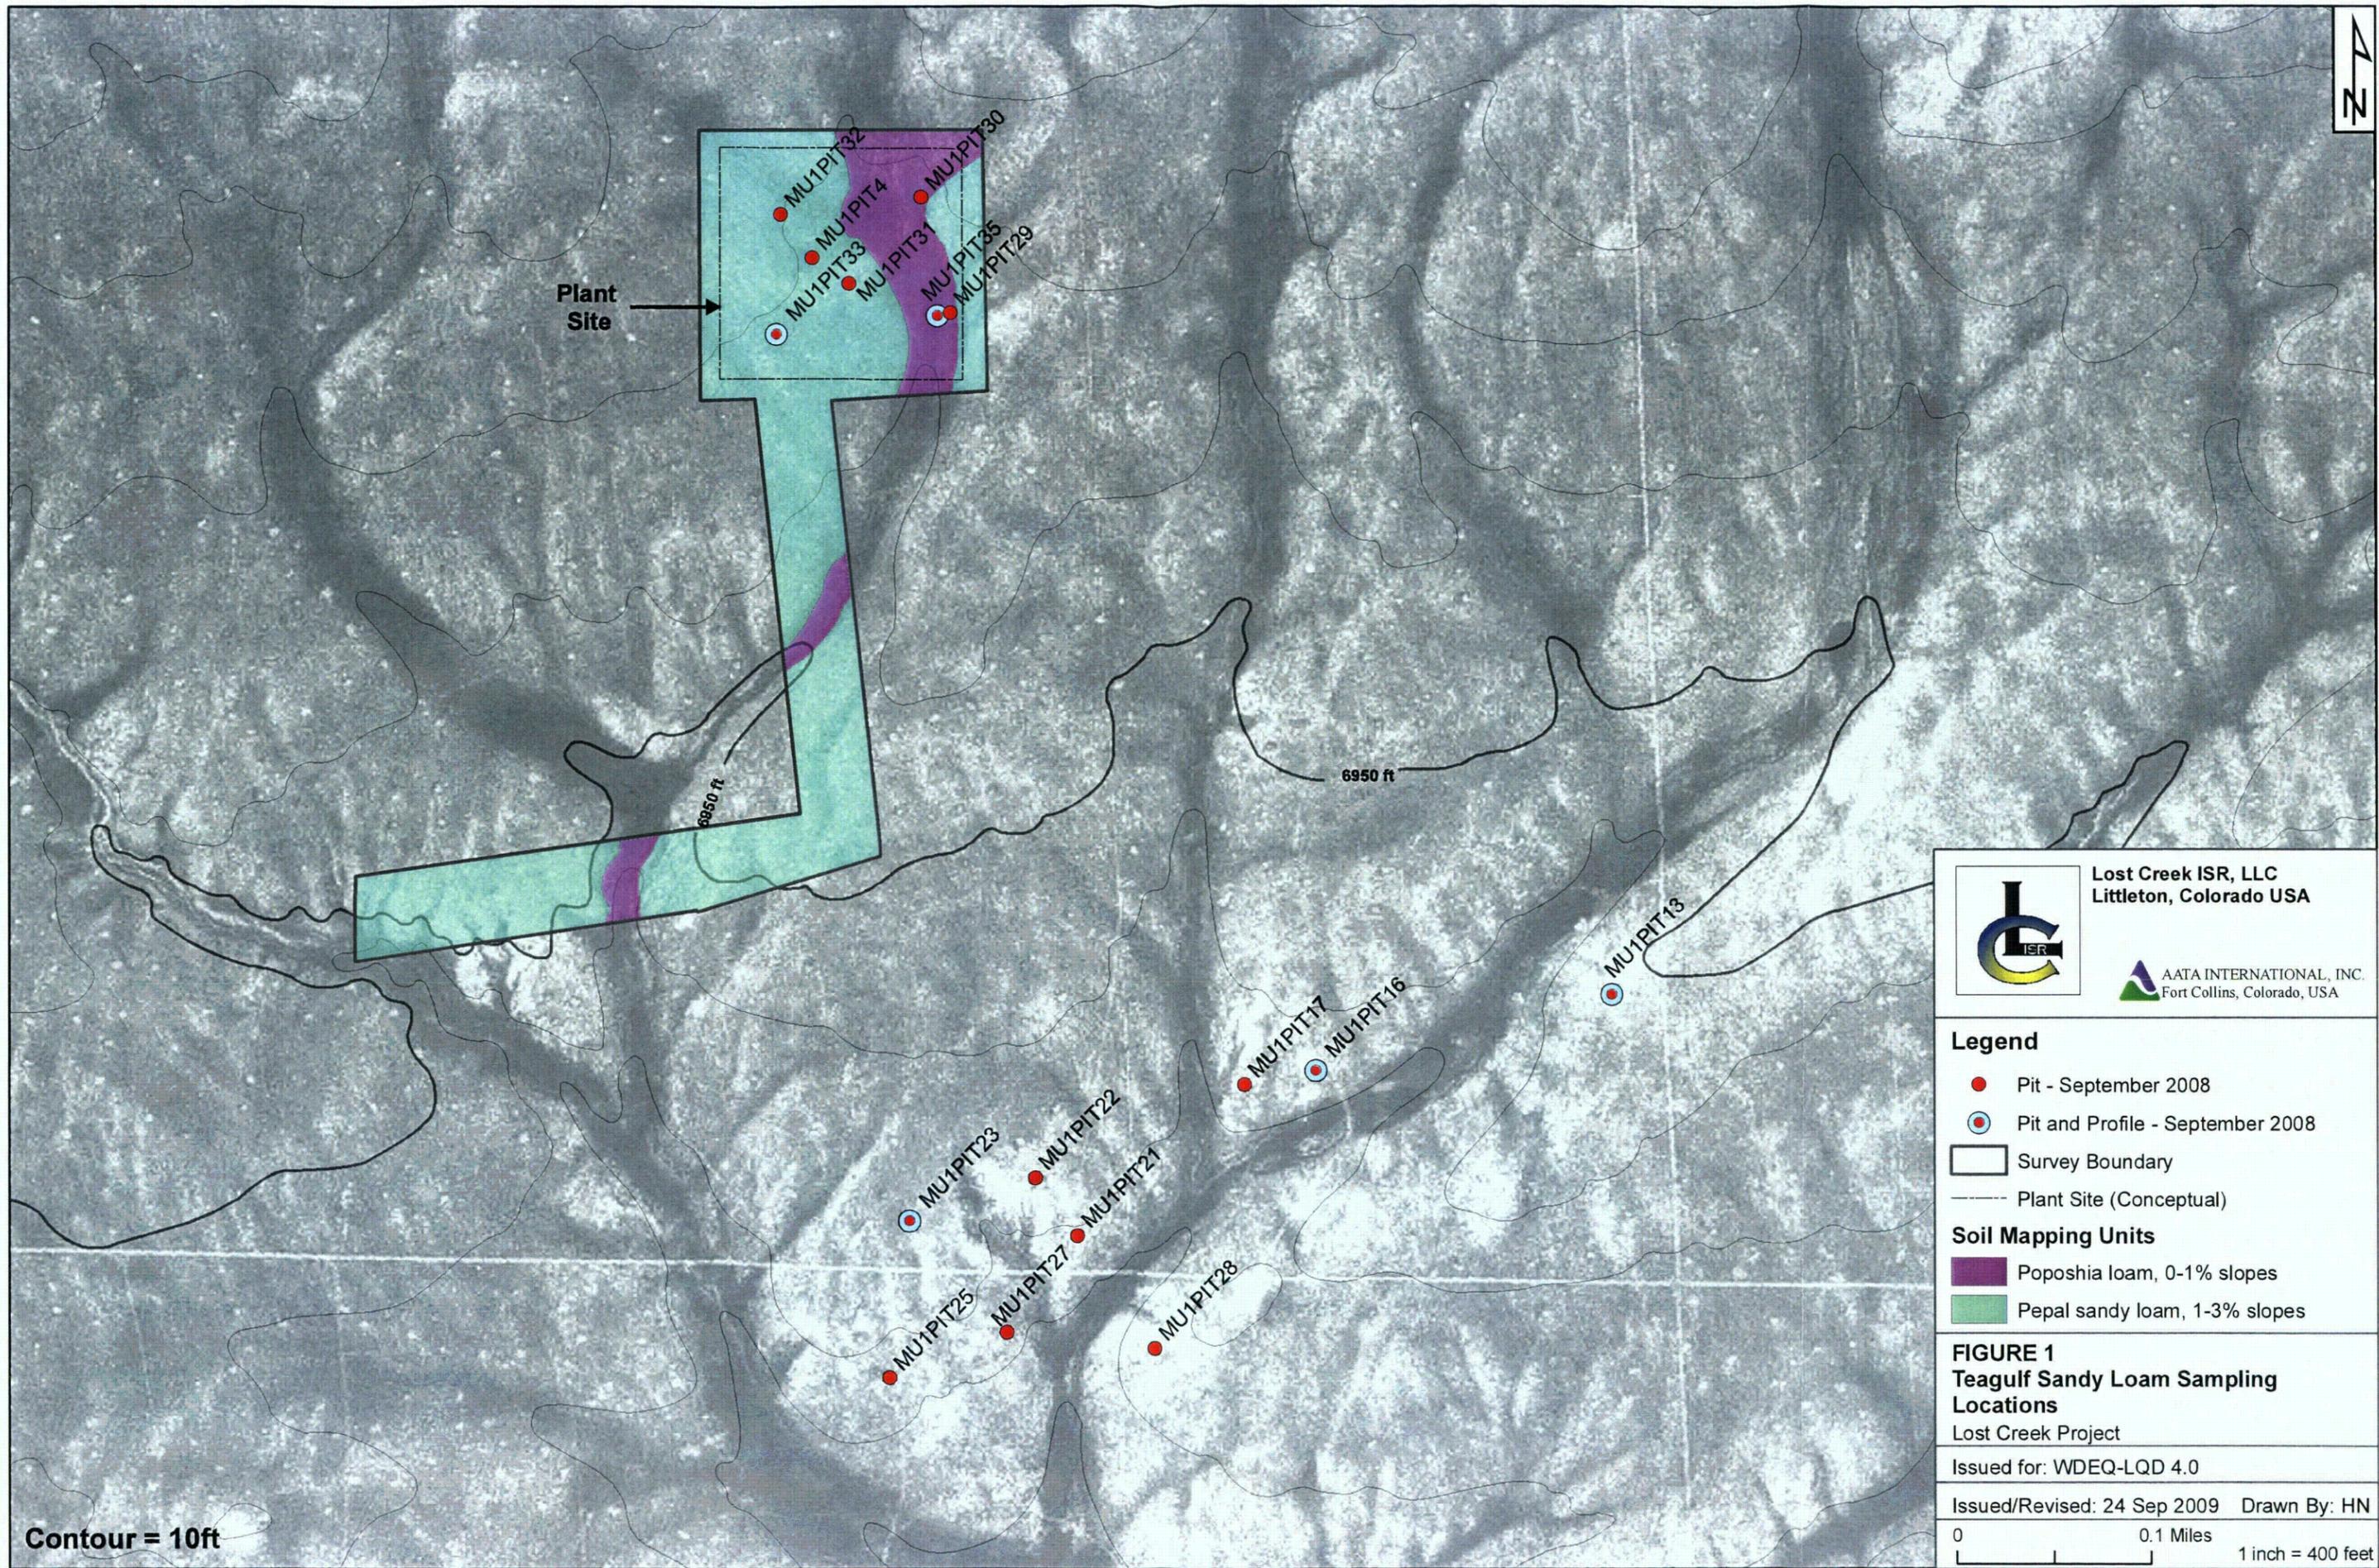
Figure 1 shows pit and profile locations within the Teagulf Sandy Loam SMU from September 2008. The Teagulf Sandy Loam is described below. The SMU was identified based on comparable soils near the Permit Area that were officially surveyed and described by the National Resource Conservation Service (NRCS). The color of the SMU is described as moist, crushed and broken.

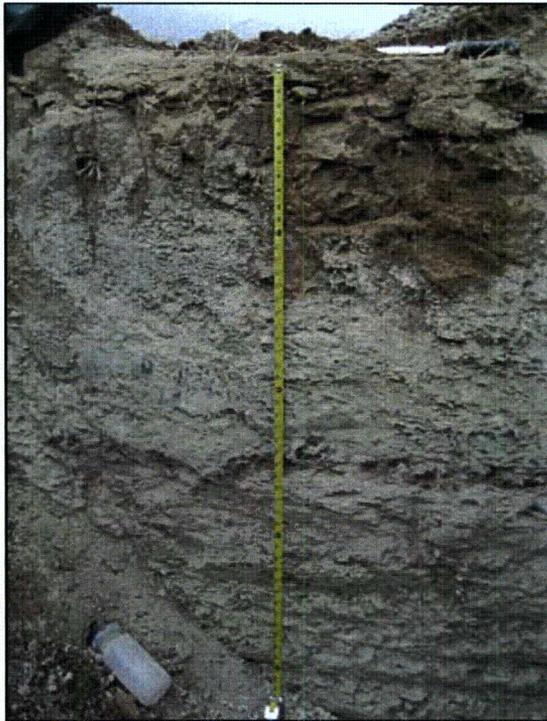
Figure 2a Soil Profile of MU1PR13

Figures 2a, 2b, and 2c are photographs of the three profiles excavated in the Teagulf Sandy Loam.
