FSAR UPDATE
DIABLO CANYON ISFSI
FIGURE 2.6-24 CLAY BEDS AND DOLOMITE IN TRENCH T-11C

Revision 0 June 2004

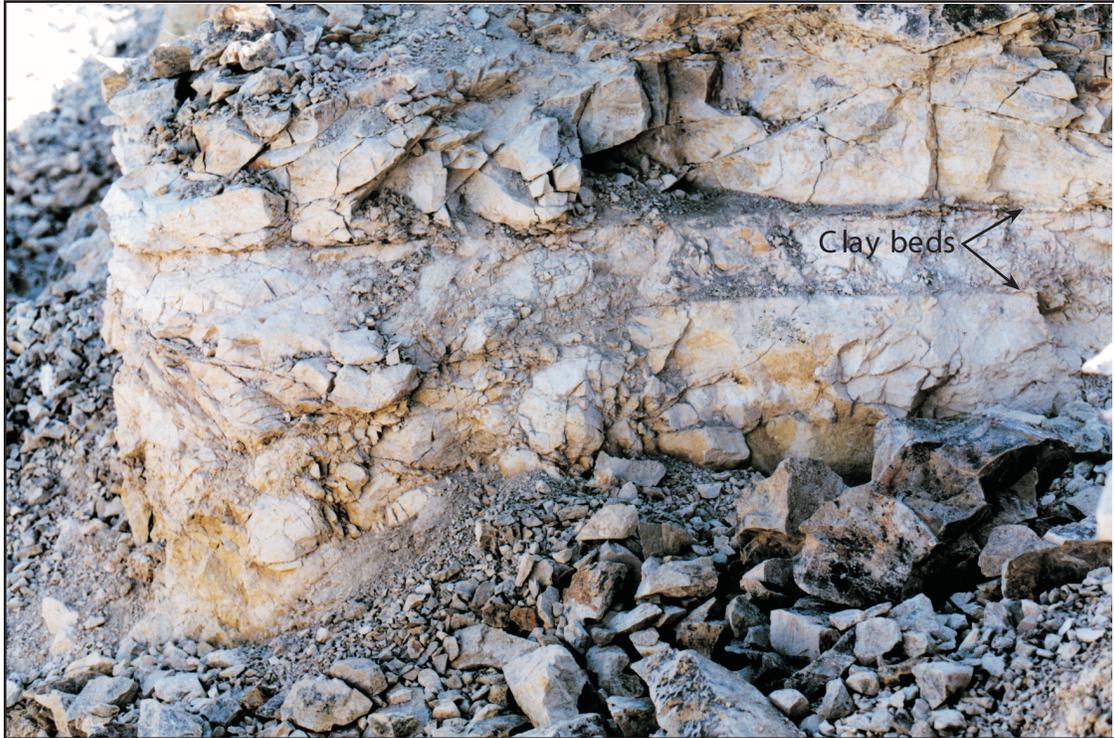
Typical dolomite Tof_{b-1} and thin clay beds exposed in trench T-11C. Clay beds are subhorizontal and define bedding. Photo roll 01JLB-1.
