FSAR UPDATE
DIABLO CANYON ISFSI
FIGURE 2.6-28 MINOR FAULT IN TRENCH T-1

**FIGURE 2.6-30
MINOR FAULTS ALONG DIABLO CREEK ROAD**

**FIGURE 2.6-32
GEOLOGY OF ISFSI AND CTF SITES AT
PROPOSED FINAL GRADES**

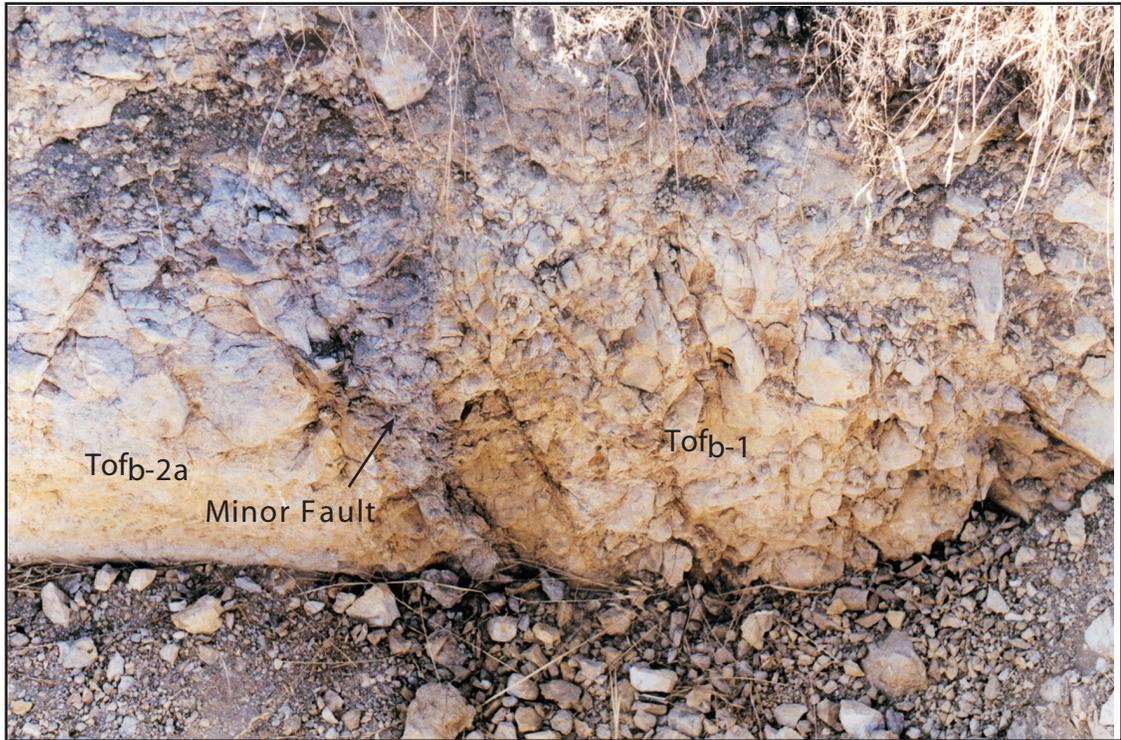
Minor fault in trench T-1 juxtaposing friable sandstone (Tof_{b-2a}) on left against dolomite (Tof_{b-1}). Photo roll JLB-2.

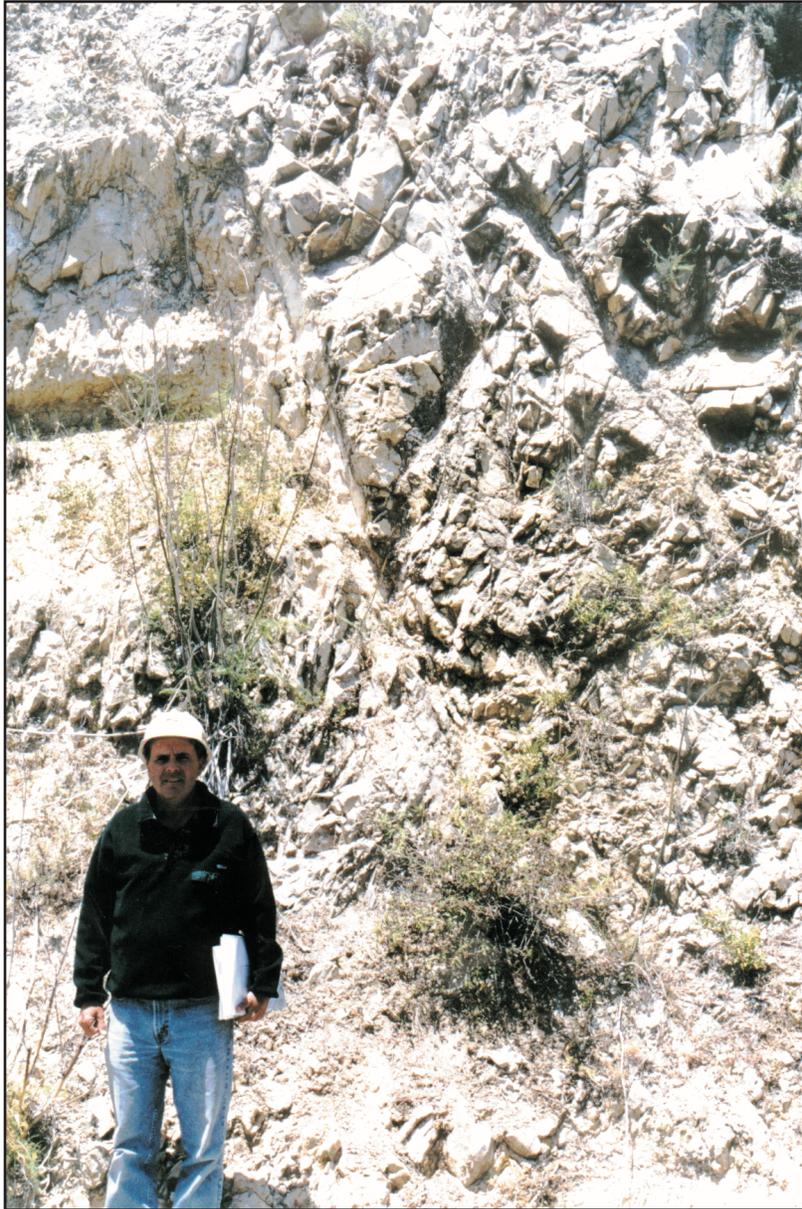
Northward view of Diablo Creek Road cut showing steeply dipping minor faults in dolomite of unit Tof_{b-1} . Slickensides and mullions on the fault plane indicate primarily strike-slip displacement, but bedding also suggests a component of down-to-the-east vertical separation of approximately 3 to 6 feet. These faults are located along projection of faults exposed in trenches at the ISFSI, approximately 800 feet to the southeast, that have similar strike and slickenside/mullion rakes. Photo roll JLB5/16-1.

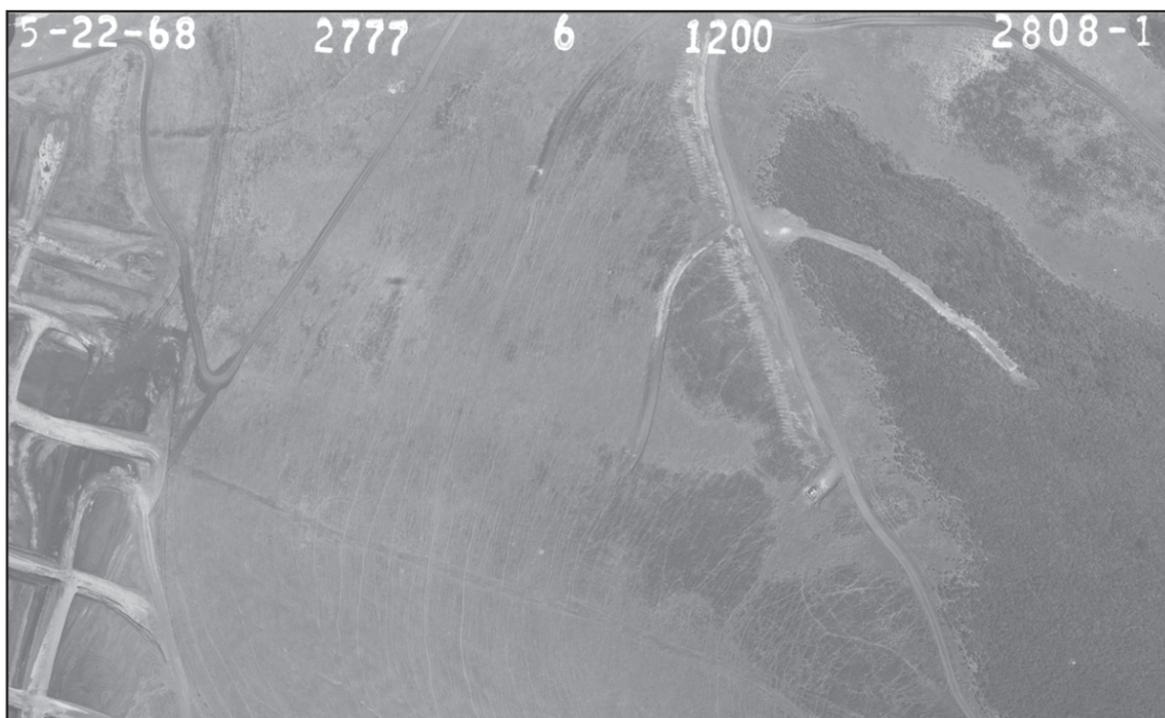
1968 stereo air photos (2777; 2808-1 and 2808-2) of ISFSI study area prior to the 1971 excavation of the borrow site. Diablo Creek traverses the upper (northern) part of the photo. Trenches for the power block are evident in the lower left. The road that follows the ridge crest in center of photo was removed during 1971 excavation of the borrow area. No features indicating deep seated landslides are present at the site; large landslides are evident to the east, however. The small landslide south of the word "swale" is shallow and was removed in the 1971 excavations. See Figure 2.6-7 for unit descriptions. To view with a stereoscope, fold and adjust the photos as necessary.

FSAR UPDATE
DIABLO CANYON ISFSI
FIGURE 2.6-31 1968 AERIAL STEREO PHOTOGRAPHY OF ISFSI STUDY AREA

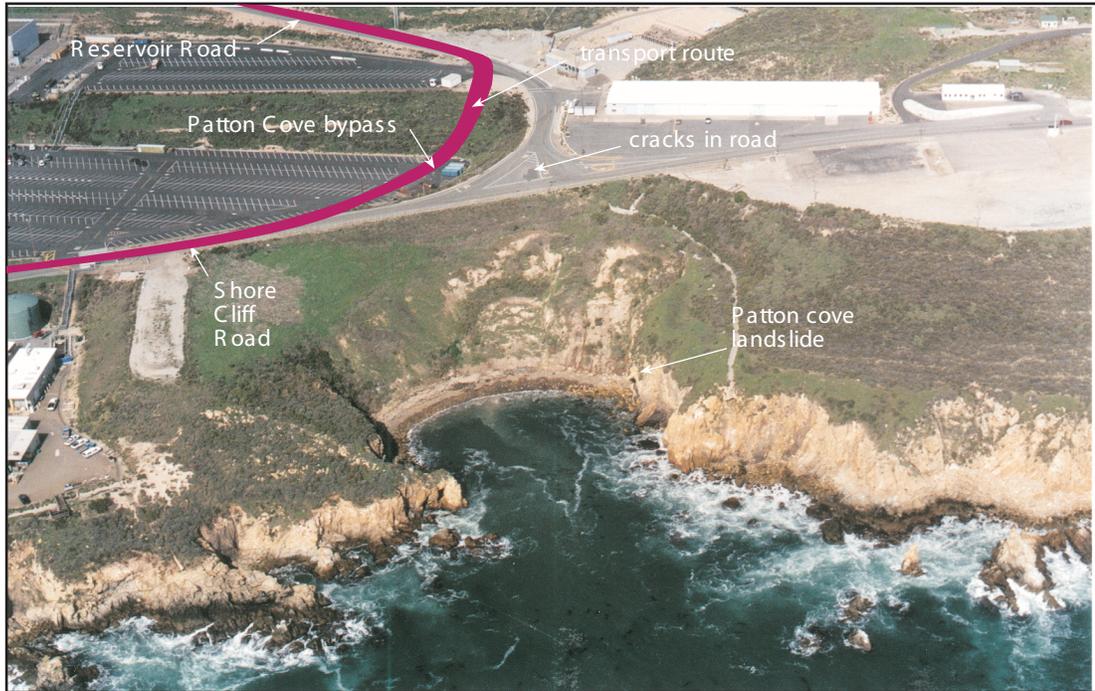
Northeast view of the horseshoe curve along the transport route and the Patton Cove landslide. The Patton Cove landslide crosses the width of the cove in the center, and its headscarp encroaches on the existing roadway. The transport route is aligned north of the existing road to avoid the landslide. Photo roll JLB-AR-3.

FSAR UPDATE
DIABLO CANYON ISFSI
FIGURE 2.6-36 TRANSPORT ROUTE NEAR PATTON COVE LANDSLIDE
