ESH-WPG-2006-00132

### **Z-Area Industrial Solid Waste Landfill Vault Cracking (U)**

**Attachment 6**  
**Savannah River Site**  
**Saltstone Disposal Facility**  
**Vaults 1 and 4 Overview**

LWO-CES-2006-00010  
Rev. 0  
October 19, 2006

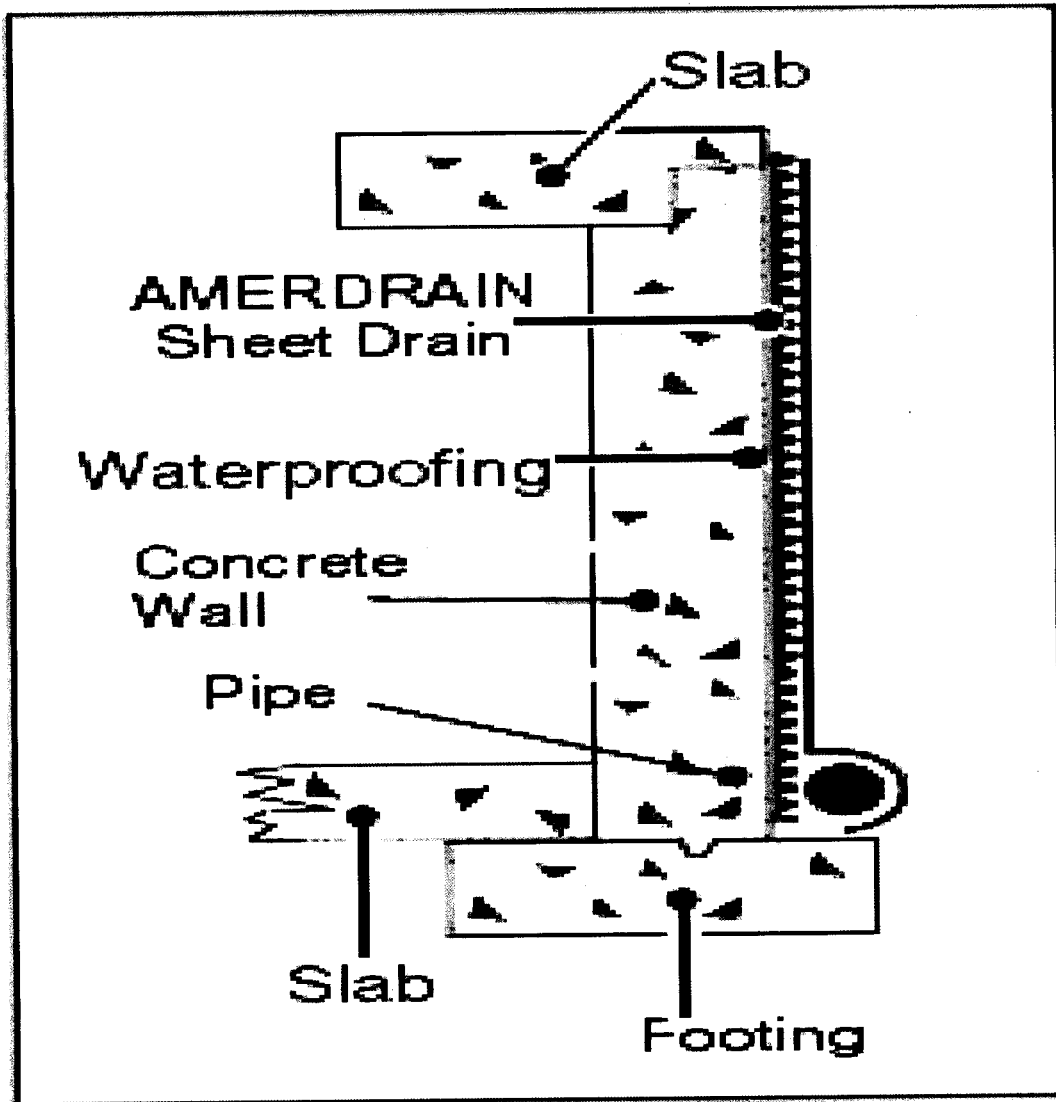
Attachment 2  
Vault Water Collection System

In order to prevent weeping from vault cracks in the future the Vault Water Collection System has been installed in Vault 4 Cells B, D, E, F, H, J, K, and L. (See Attachments # 1, 2 and 3) This system is used for the collection and pumping of the excess liquid such as rainwater intrusion and bleed/process water from the Vault 4 cells back to the Salt Feed Tank in the SPF. A geotextile fabric membrane with an impervious backing is attached to the vault walls. Free liquid passes through the fabric where it is captured in the gap between the fabric and the backing. The water drains into a

PVC pipe system around the base perimeter of each vault cell. A drain line is connected to the PVC pipe through the Vault 4 wall which allows periodic draining of the liquid. The drain lines on each side of the vault are connected to a common header which is connected to a pump to transfer the excess water back to the Salt Feed Tank in the SPF. The interior surfaces of the outside walls are also coated with a waterproof coating up to a height of five feet, due to the fact that the vault walls are designed for gravity loads plus the hydrostatic pressure associated with the saltstone grout.

Extensive pilot testing of the Vault Water Collection System materials was conducted by the Savannah River National Laboratory to ensure that the System is adequate to remove the excess liquid from the vault cells. The test concluded that the Vault Water Collection System is adequately sized and will perform to remove excess liquid from the vault cells.

In addition to the pilot testing, during start-up testing of the Saltstone Facility, clean grout was added to one of the Vault 4 cells. The Vault Water Collection System was shown to operate as designed. Bleed and process water was collected in the pipe system around the base of the vault and pumped back to the Salt Feed Tank in the SPF.

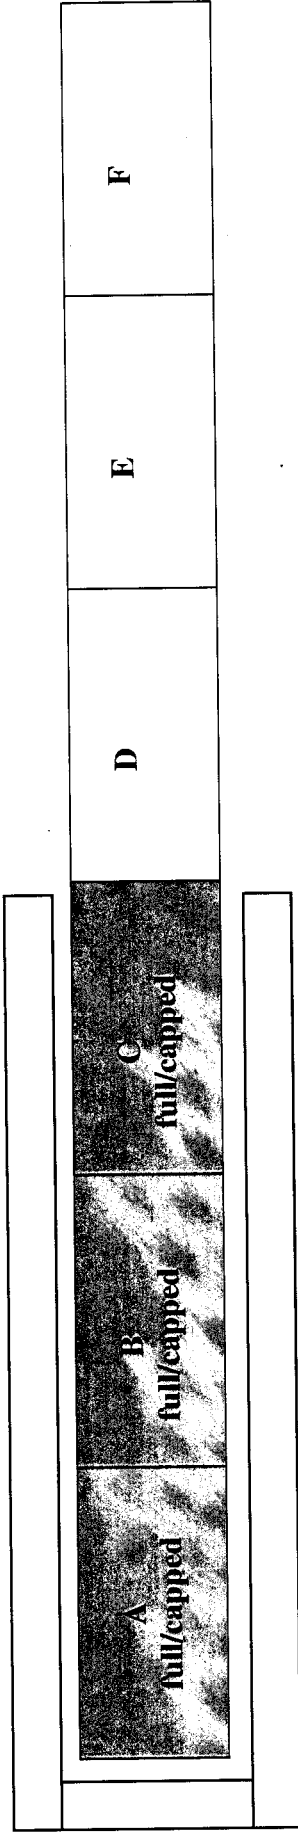
**Vault 1**

A diagram of Saltstone Vaults 1 and 4 is included in Attachment #5. Attachment #5 shows the cells which are full or partially full with grout and the empty cells.

As is shown in Attachment #5 the areas adjacent to Vault 1, Cells A, B, and C are posted as ICAs due to past operations. Periodic surveys are taken around the ICAs to confirm that there is no spread of contamination outside the posted area. Recent surveys outside the ICAs have found no spread of contamination. Plans are underway to survey inside the ICAs adjacent to Vault 1 to determine current radioactive contamination and radiation levels.

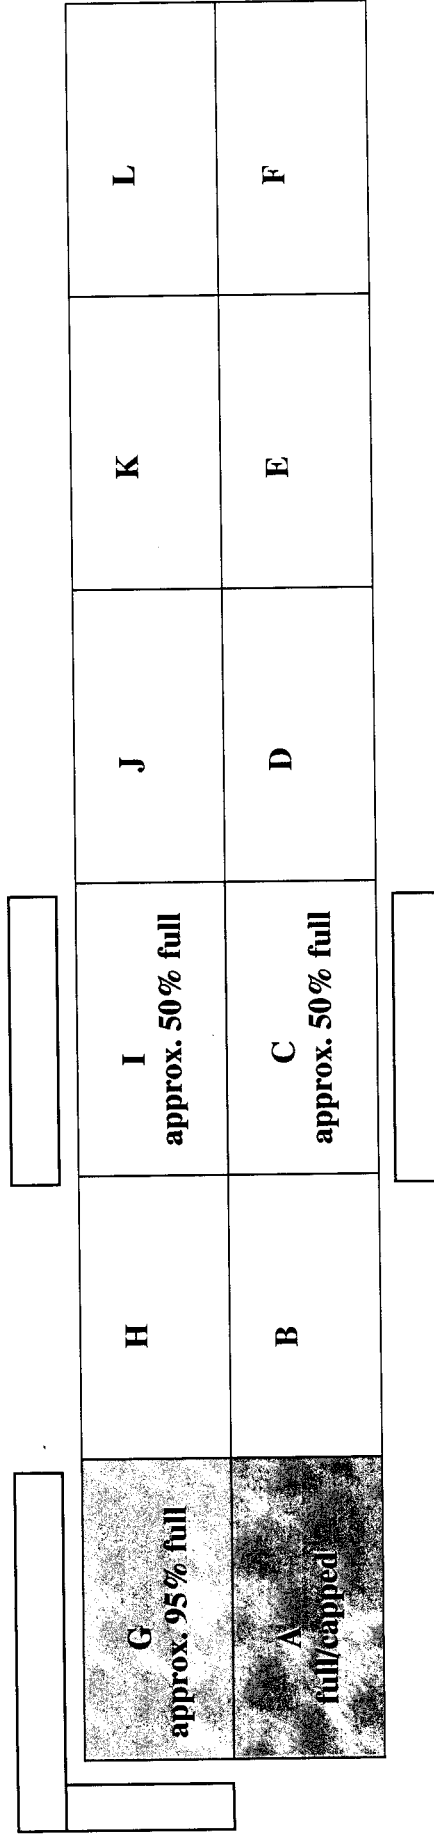
**Vault 4**

The area adjacent to Vault 4, Cell G is posted as an ICA. Periodic surveys are taken around the ICA to confirm no spread of contamination outside the posted area. Recent surveys outside the ICA have found no spread of contamination. (See Attachment #5) Plans are underway to survey inside the ICA adjacent to Vault 4, Cell G to determine current radioactive contamination and radiation levels.

The areas adjacent to Cells C and I are posted as ICAs due to previous operations and detection of contamination. Recent surveys outside the ICAs have found no spread of contamination. (See Attachment #5) Plans are underway to survey inside the ICAs adjacent to Vault 4, Cells C & I to determine current radioactive contamination and radiation levels.

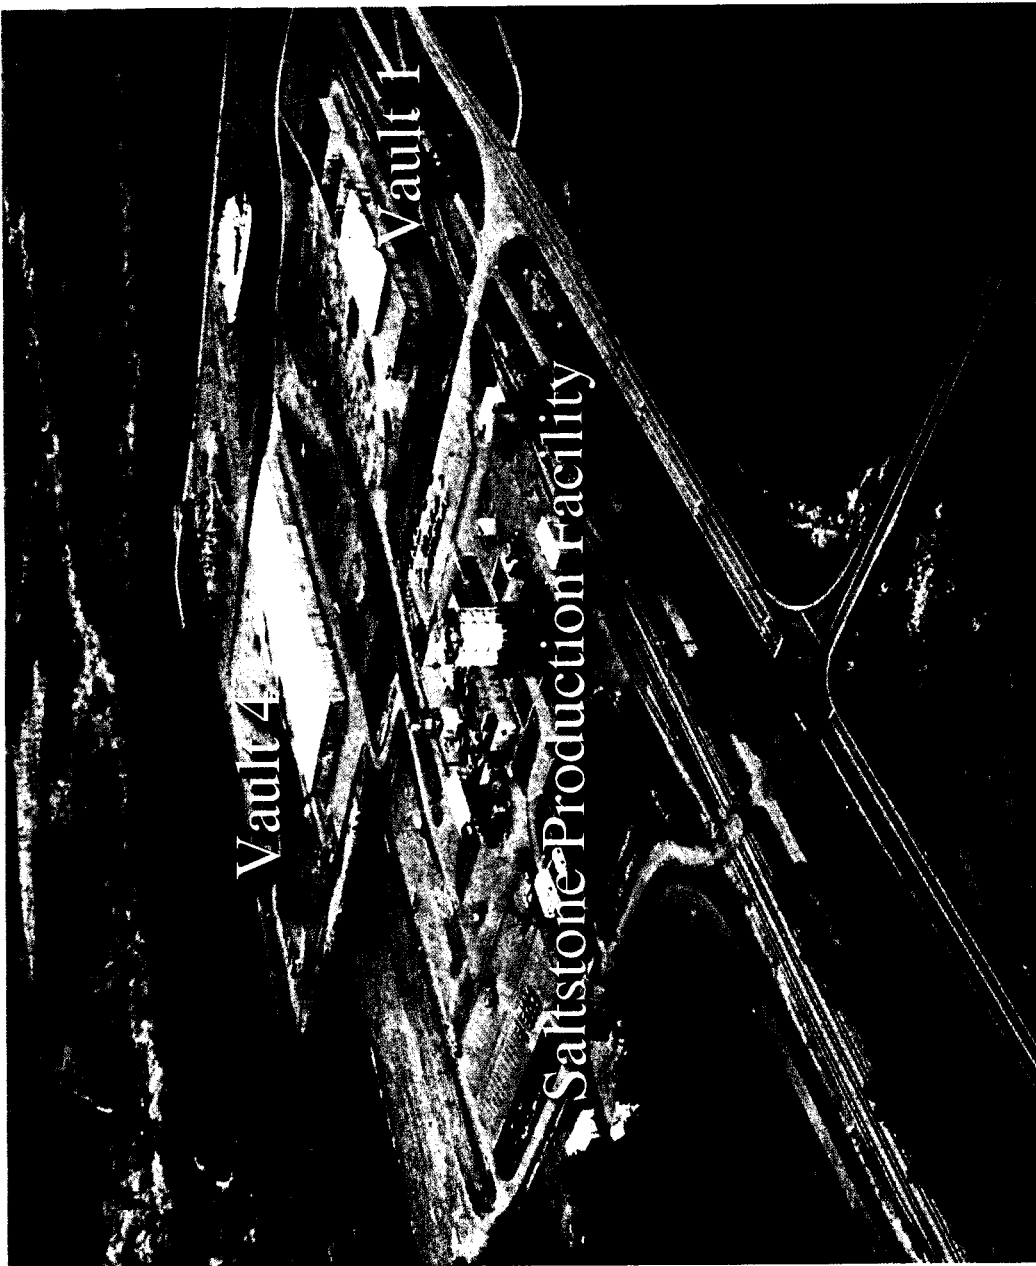
**Attachment 6.1**  
**Saltstone Facility After Installation of Permanent Roof to Eliminate Rainwater Intrusion**

Vault 4 was modified with a permanent roof prior to introduction of grout to provide operational flexibility (allows more than two partially filled cells at any time) and eliminate rainwater intrusion. The roof joints, however, allowed small amounts of rainwater to enter the vault cells and condensation associated with operation continued to occur. This resulted in wall cracking similar to that experienced in Vault 1. Therefore, joint sealing and cell draining was instituted to remediate the liquid accumulation.

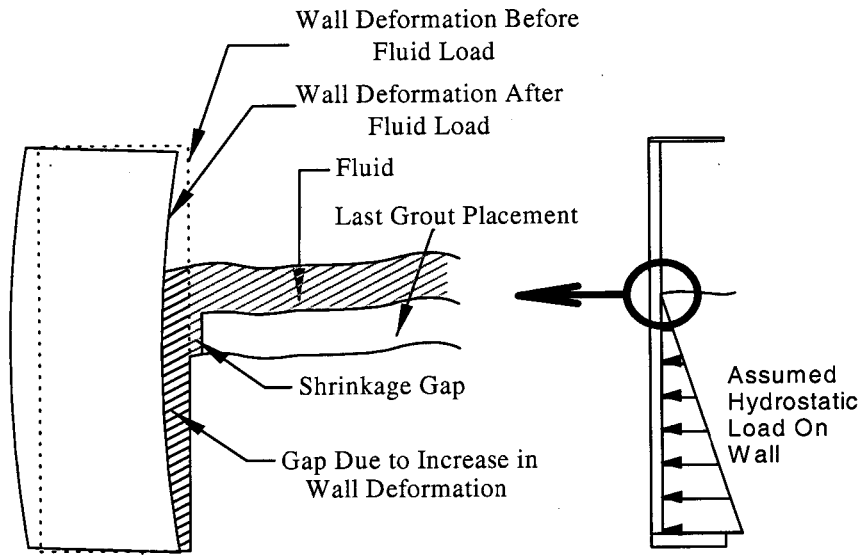
### Attachment 6.3 Vault Cracking Mechanism

Saltstone operations have been successful in producing and disposing of saltstone grout in accordance with design requirements. However, minor cracks have been observed in some of the vault walls. Some of the cracks are attributable to vault construction in Vault 1. Another phenomenon that can initiate cracks stems from the fact that grout shrinks slightly as it solidifies.

Therefore, a tiny gap can form between the grout and the vault wall. Bleed/process water resulting from the grout curing process, flush water used to clean portions of the transfer lines after grout runs, condensation from temperature changes, along with small amounts of rainwater intrusion can then fill the gap. The water column can create enough hydrostatic pressure to cause small cracks through which the condensate and rainwater can slowly weep. (Attachment 6.3)
