**BELL BEND NUCLEAR POWER PLANT
UNISTAR NUCLEAR DEVELOPMENT, LLC.**

GAI conducted Phase Ib cultural resources investigations at the Bell Bend Nuclear Power Plant (BBNPP), Luzerne County, Pennsylvania, for UniStar Nuclear, under a contract to Areva NP, Inc. Phase Ib archaeological survey and supplemental architectural and historical survey of the project area were performed between May and August, 2008. Phase Ib archaeological survey was conducted of approximately 350 acres (142 hectares) of moderate to high archaeological potential within the 630-acre (255-hectare) project area. Phase Ib fieldwork included pedestrian ground survey of cultivated fields, the excavation of 3,789 shovel test pits, and a program of deep testing (11 mechanical trenches, soil corings, and 8 1x1-meter hand-excavated test unit column samples) in one low terrace adjacent to the Susquehanna River. The supplemental architectural field survey included examination of 22 of the 52 resources initially identified within the project viewshed to conclusively evaluate their NRHP eligibility and to define the boundaries of NRHP-eligible resources.

GAI Consultants Inc.
385 East Waterfront Drive
Homestead, Pennsylvania

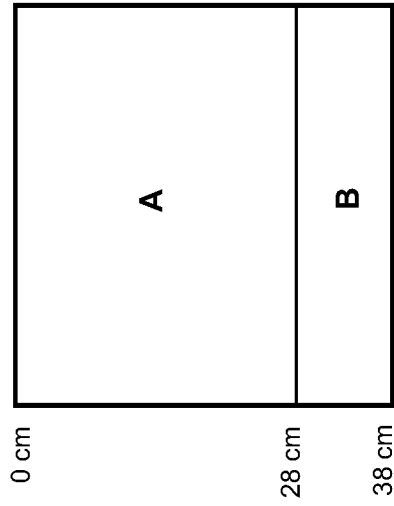
FIGURE 29. SITE 11: REPRESENTATIVE SOIL PROFILE (STP J3)

**SITE 11
STP J3**

- A – BROWN (10YR 4/3) SILT LOAM
- B – YELLOWISH BROWN (10YR 5/4) SANDY LOAM

Site 11 represents a small, low-density, mid 19th century artifact scatter. The integrity of this site is good. Because of its small size, low density, and lack of associated features or structures GAI concludes that the potential for Site 11 to contribute important information on the historic utilization of this area is low. GAI recommends that Site 11 is Not Eligible to the National Register under Criterion D. No further archaeological investigations are recommended for this site.

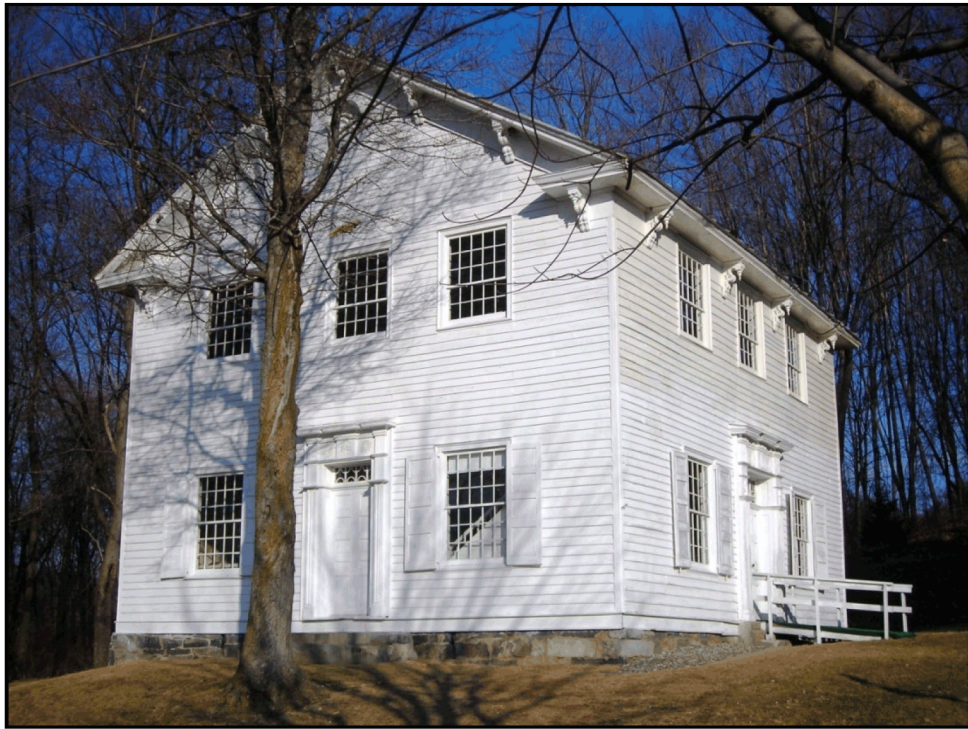
1. Photograph 1
2. Old River Church
3. Conyngham Township, Luzerne County
4. Facade and Southwest Elevation, Facing Northeast

Built in 1833, this Greek Revival church building stands two stories tall on a stone foundation. The exterior of this building is clad in weatherboard, and the gable roof is topped by V-crimp metal sheathing. The roofline is marked by a plain frieze with ornately carved corbels and brackets with drop pendants, and the gable ends have plain rakeboards with cornice returns. The building features detailed wood moulding throughout, including cornerboards, window surrounds, and ornate door surrounds on the east, west, and south elevations. The fenestration consists of 15/15, 15/10, and 30/25 double-hung wood sash windows, trimmed by shutters on the first story. Additionally, decorative gable end attic story windows are present on the east and west elevations, and each entrance is marked by elaborate transom windows and frontispiece with raised panel doors. Stone steps mark the entrances, with a modern wood access ramp on the south elevation. According to a historical marker at the site, the church building was restored in 1952. A one-story, concrete block privy is also located on the property. This privy has a gable roof with composition shingles and no window apertures.

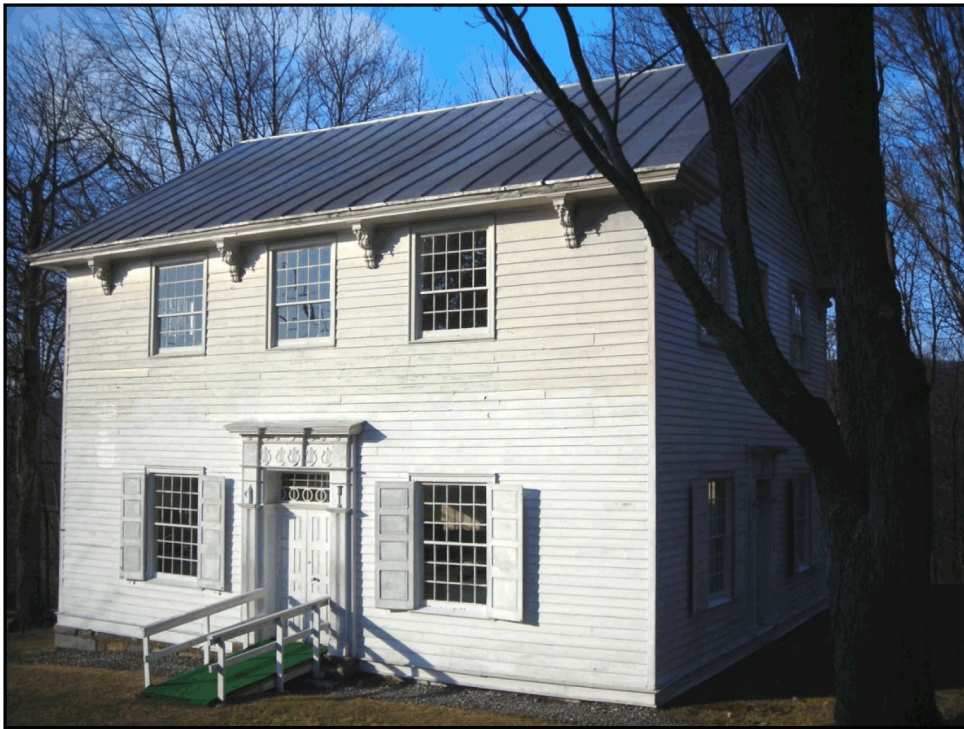
1. Photograph 2
2. Old River Church
3. Conyngham Township, Luzerne County
4. East and South Elevations, Facing Northwest

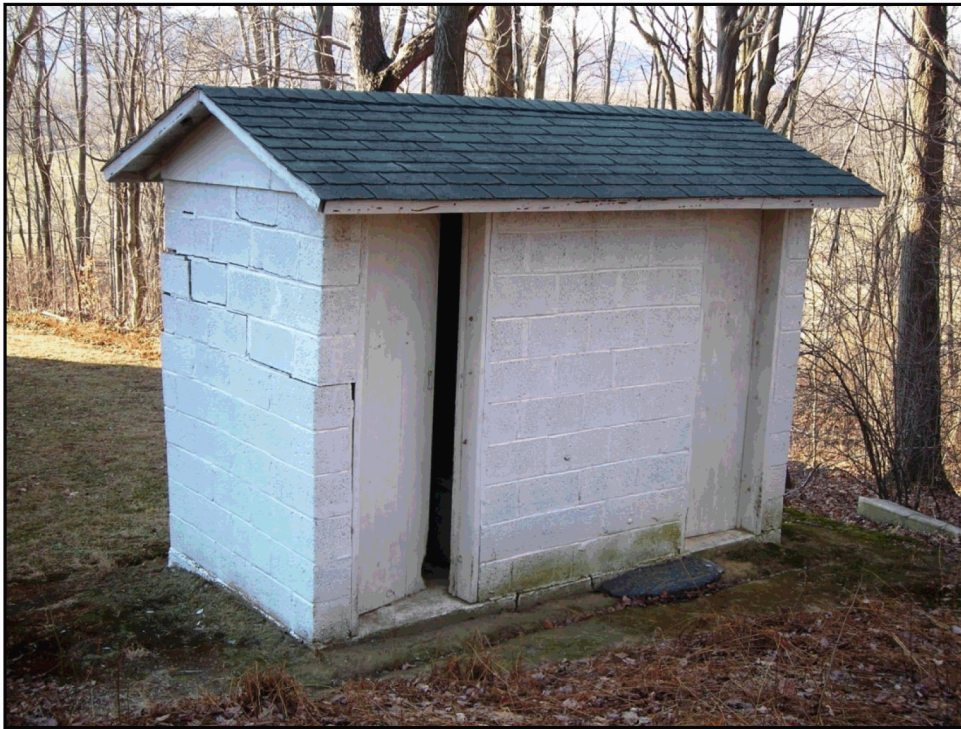
1. Photograph 3
2. Old River Church
3. Conyngham Township, Luzerne County
4. Privy-East and South Elevations, Facing Northwest

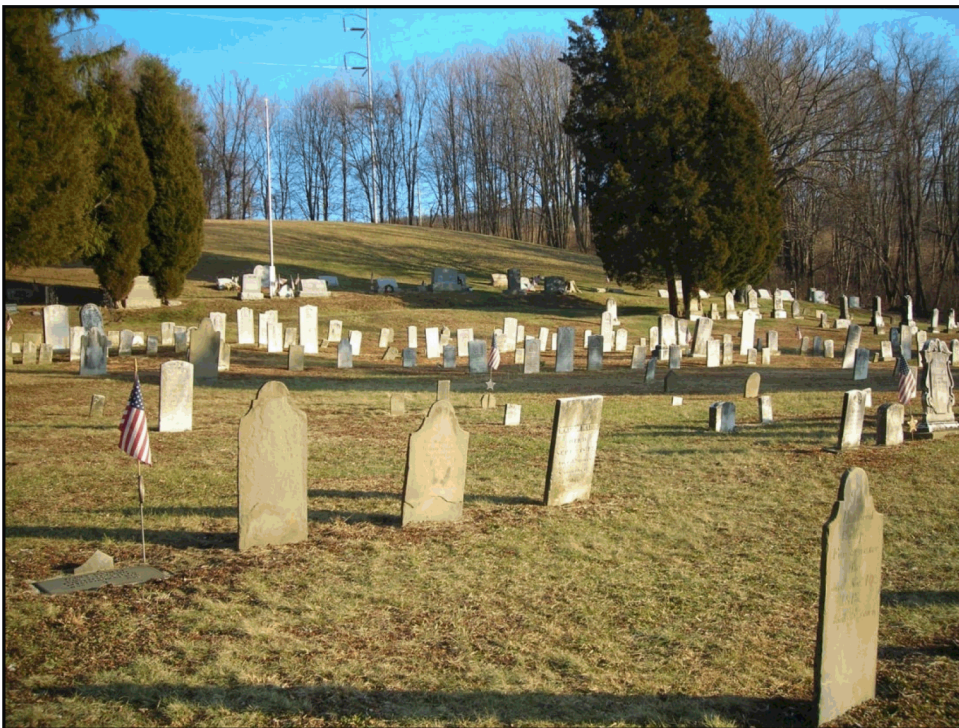
1. Photograph 4
2. Old River Church
3. Conyngham Township, Luzerne County
4. Cemetery Overview, Facing Southeast

Associated with the church is a cemetery, which is located to the south of the building. This cemetery is generally rectilinear and is surrounded by a wrought iron decorative fence. The cemetery contains several hundred burials, with the earliest noted date being 1805. The most recent burial dates from 1975. The cemetery contains the burials of some of the earliest settlers in the Wapwallopen area, including some of its more prominent pioneer residents.

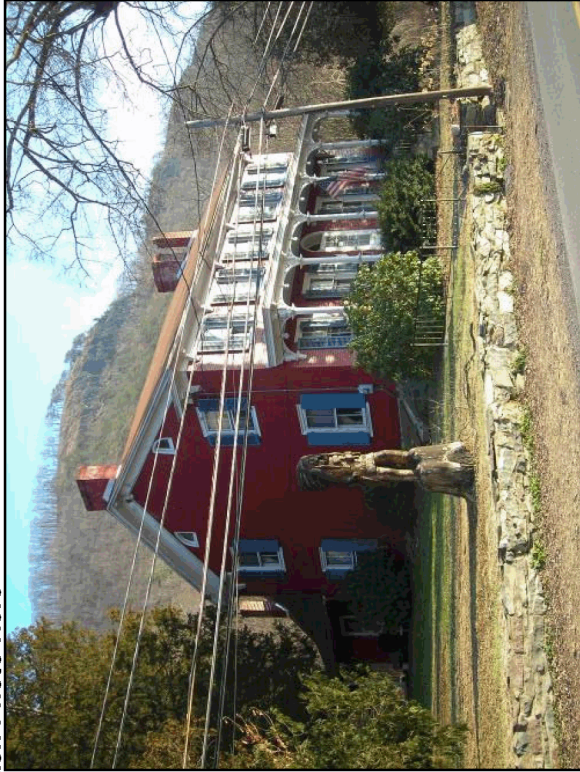
Number	Description of View	Direction of Camera
_____	Facade and NW Elevation	<u>SE</u>
_____	_____	_____
_____	_____	_____
_____	_____	_____
_____	_____	_____

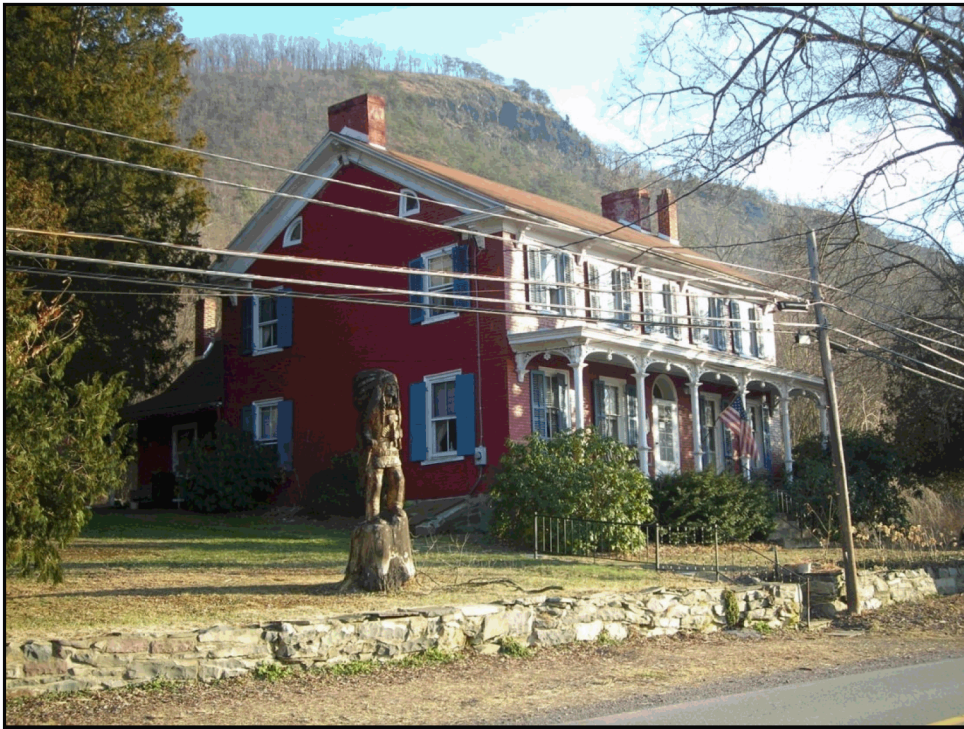
1. Photograph 1
2. Woodcrest
3. Conyngham Township, Luzerne County
4. Main House, Facade and North Elevation, Facing Southeast

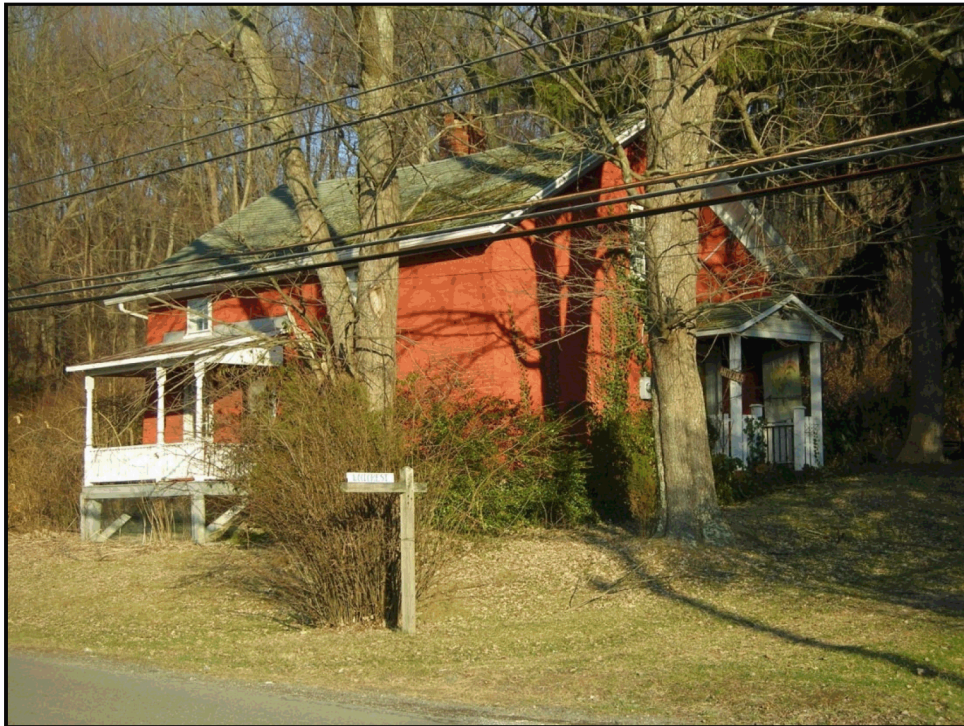
1. Photograph 2
2. Woodcrest
3. Conyngham Township, Luzerne County
4. Second House-Facade and South Elevation, Facing Northeast

Also associated with the main house is a 1.5-story, gable roofed, brick secondary living quarters. Built on a stone foundation, this building is constructed of brick laid in common bond and has a gable roof clad in asphalt shingles. There are entrances on the south and west elevations, marked by a gable-roofed porch and shed-roofed porch, respectively. The fenestration consists of 2/2 double-hung, wood sash windows, with shorter windows on the second story. A single brick interior chimney pierces the roofline.

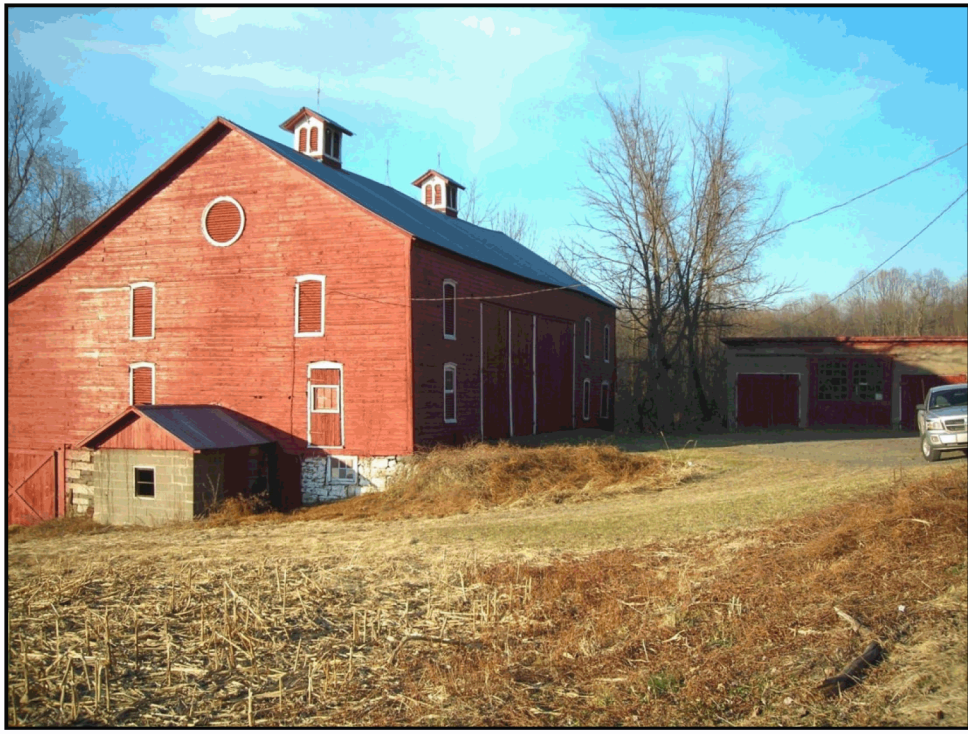
1. Photograph 3
2. Woodcrest
3. Conyngham Township, Luzerne County
4. Barn and Garage, Facing North

Located opposite the residential buildings is a large, gable-roofed, heavy timber-framed bank barn. This large barn is built on a stone foundation and is clad in horizontal wood siding. The roof is clad in V-crimp metal, and two gable-roofed cupola vents are located along the ridge line. The fenestration throughout consists of louvered vent openings with molded wood drip caps and surrounds. A sliding double door marks the entrance from the earthen embankment approach. A small, one-room concrete block addition is located on the south elevation.

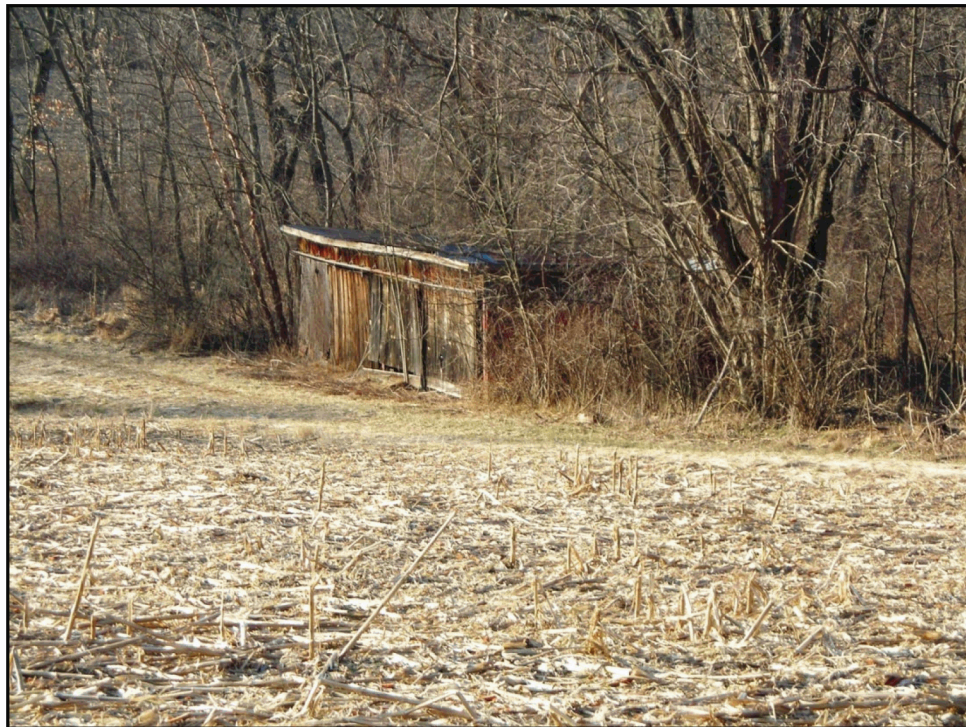
1. Photograph 4
2. Woodcrest
3. Conyngham Township, Luzerne County
4. Shed-Facade and South Elevation, Facing Northwest

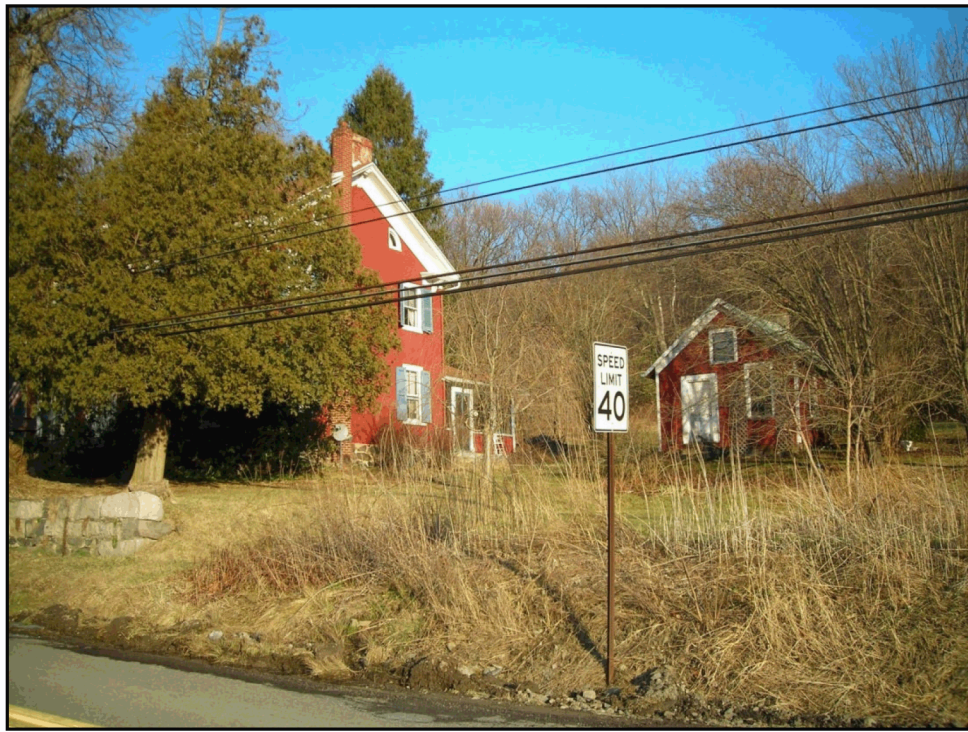
1. Photograph 5
2. Woodcrest
3. Conyngham Township, Luzerne County
4. Main House and Summer Kitchen, Facing Northeast

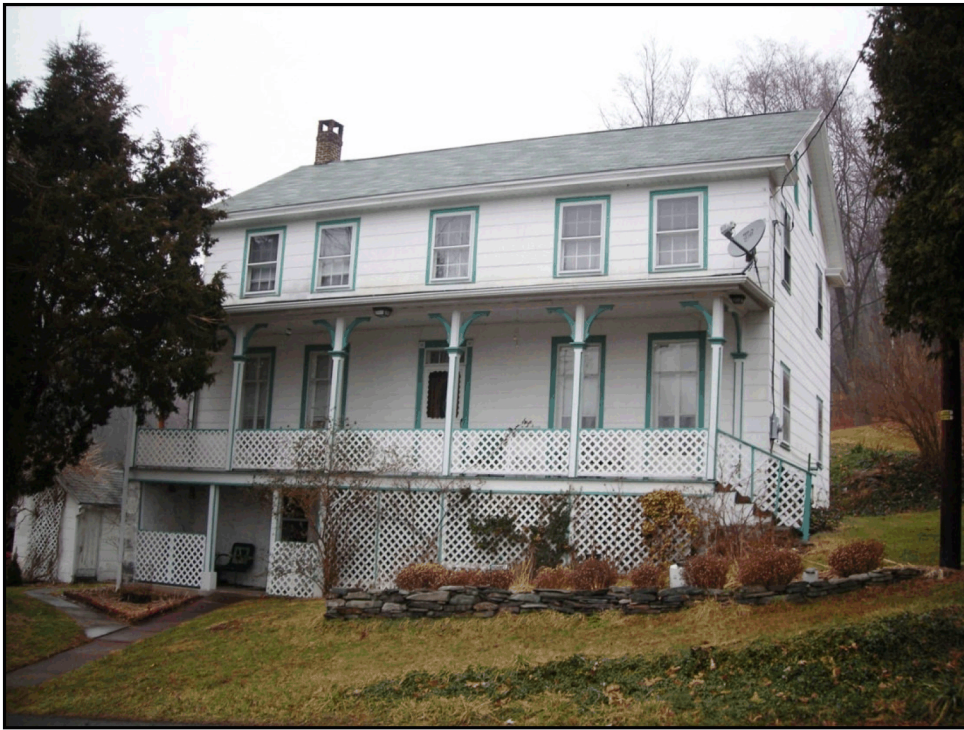
1. Photograph 1
2. Hummel Farmstead
3. Salem Township, Luzerne County
4. Main House-Facade and East Elevation, Facing Northwest

Built circa 1890, this resource is a 2-story, gable-roofed, Victorian vernacular frame house built on a raised stone foundation. The exterior of the house is clad in asbestos shingles, and the gable roof is clad in asphalt shingles. The gable ends of the house are marked by cornice returns. The full-width, hip-roofed front porch is supported by chamfered posts with decorative brackets. Modern lattice has been applied to the porch, as well as to the area along the raised basement. The fenestration includes both 2/4, double-hung, wood sash windows as well as modern 6/6 vinyl sashes. Additionally, the door opening is topped by a transom.

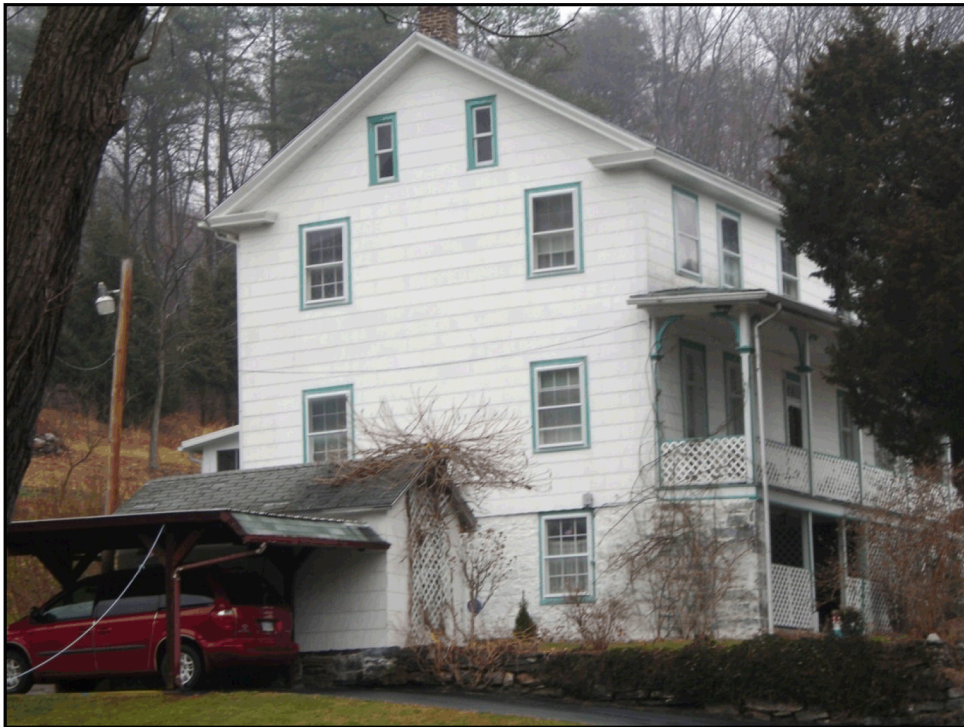
1. Photograph 2
2. Hummel Farmstead
3. Salem Township, Luzerne County
4. Main House and Springhouse, Facing Northeast

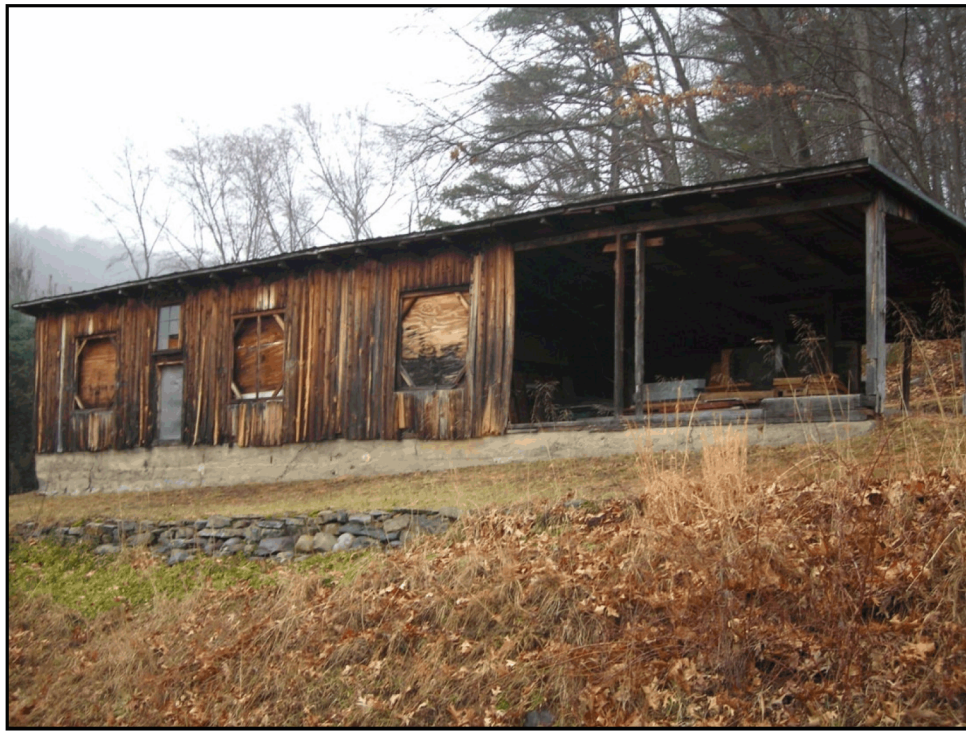
1. Photograph 3
2. Hummel Farmstead
3. Salem Township, Luzerne County
4. Storage Shed, Facing Northwest

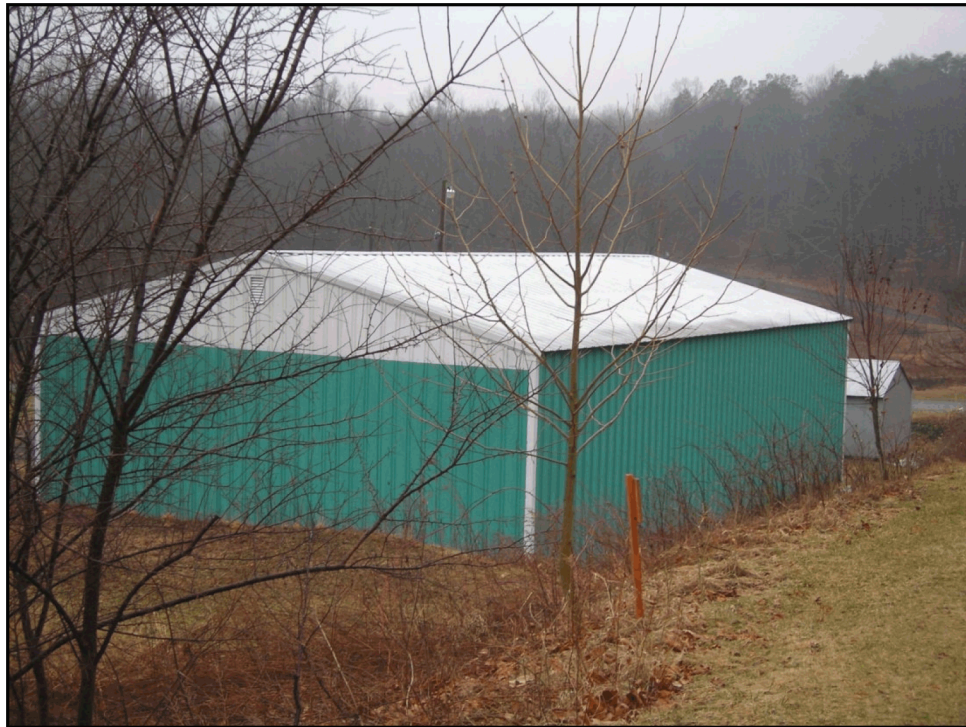
1. Photograph 4
2. Hummel Farmstead
3. Salem Township, Luzerne County
4. Modern Outbuildings, Facing West

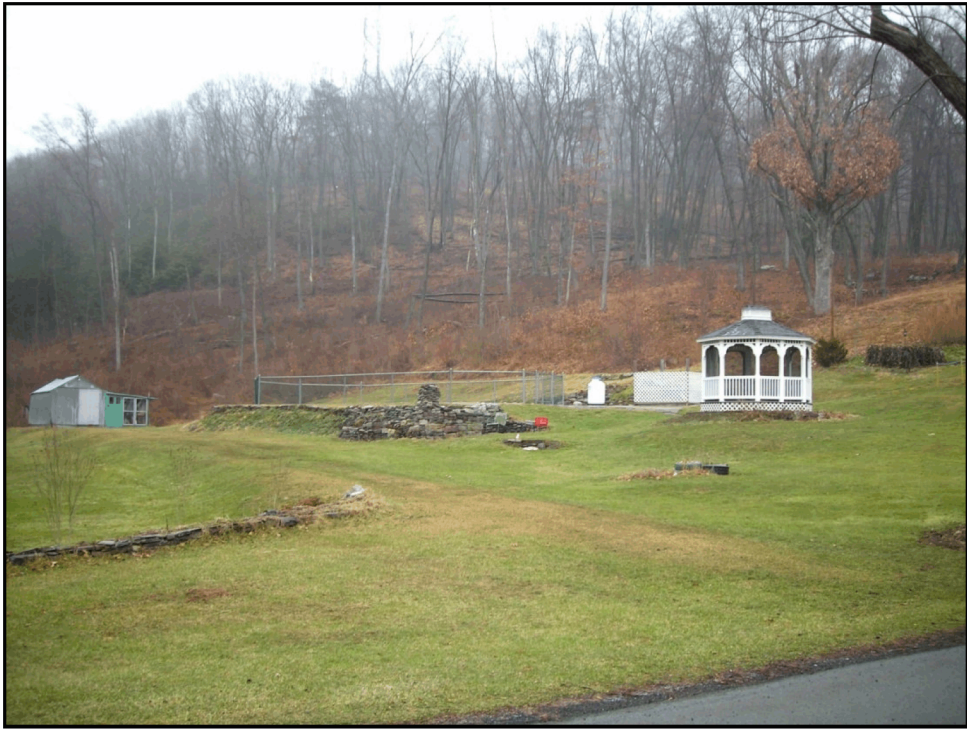
1. Photograph 5
2. Hummel Farmstead
3. Salem Township, Luzerne County
4. Shed #3 and Gazebo, Facing Northwest

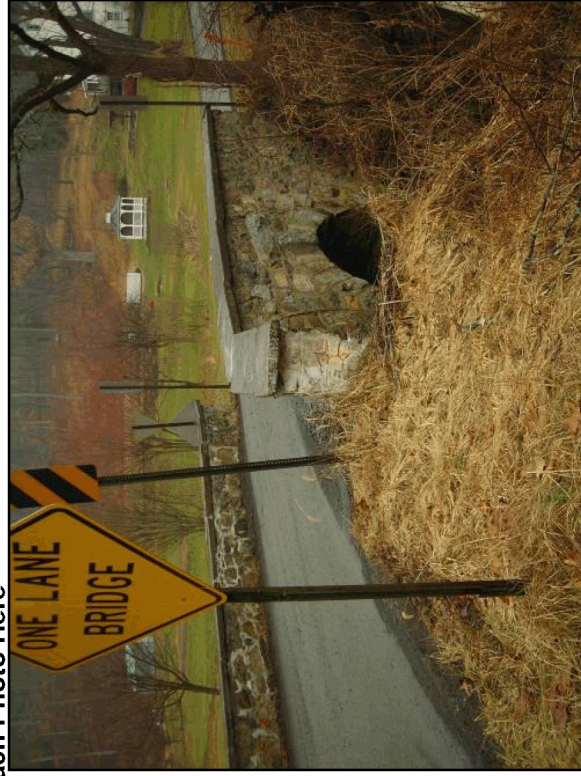
Number	Description of View	Direction of Camera
_____	Overview	<u>NE</u>
_____	_____	_____
_____	_____	_____
_____	_____	_____
_____	_____	_____

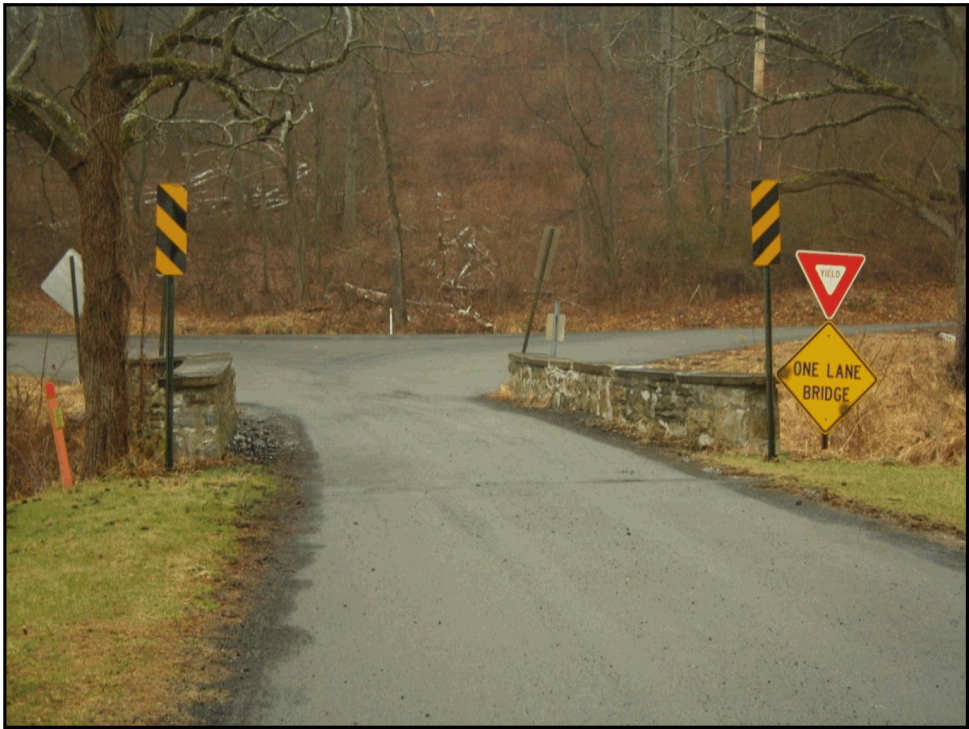
1. Photograph 1
2. Stone Arch Bridge
3. Salem Township, Luzerne County
4. Facing West

This bridge is not directly associated with any significant events or trends in local or regional history. As such, it is recommended not eligible for NRHP listing under Criterion A. No documentary evidence linking the bridge to any significant individuals in local or regional history could be identified. Therefore, this bridge is recommended not eligible for NRHP listing under Criterion B. This bridge, however, is a rare and well-preserved example of an early 20th-century stone arch bridge in the area. Therefore, it is recommended eligible for NRHP listing under Criterion C.

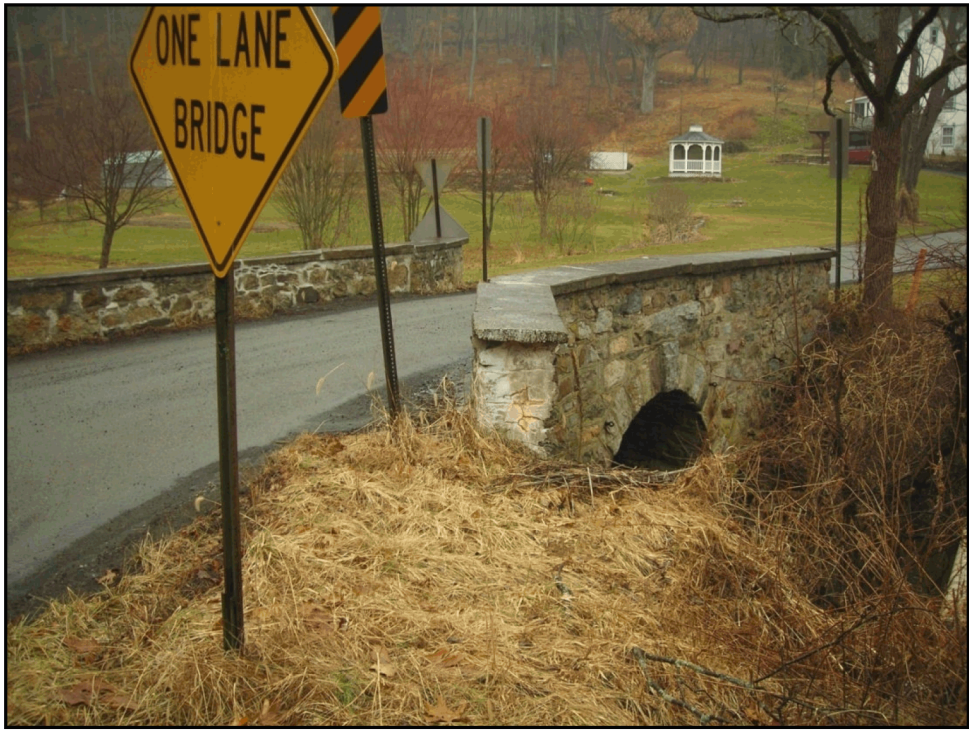
1. Photograph 2
2. Stone Arch Bridge
3. Salem Township, Luzerne County
4. Facing Northeast
