PROGRESS ENERGY FLORIDA
LEVY NUCLEAR PLANT
AND ASSOCIATED TRANSMISSION LINES

PA08-51B

WETLAND MITIGATION PLAN

April 23, 2010

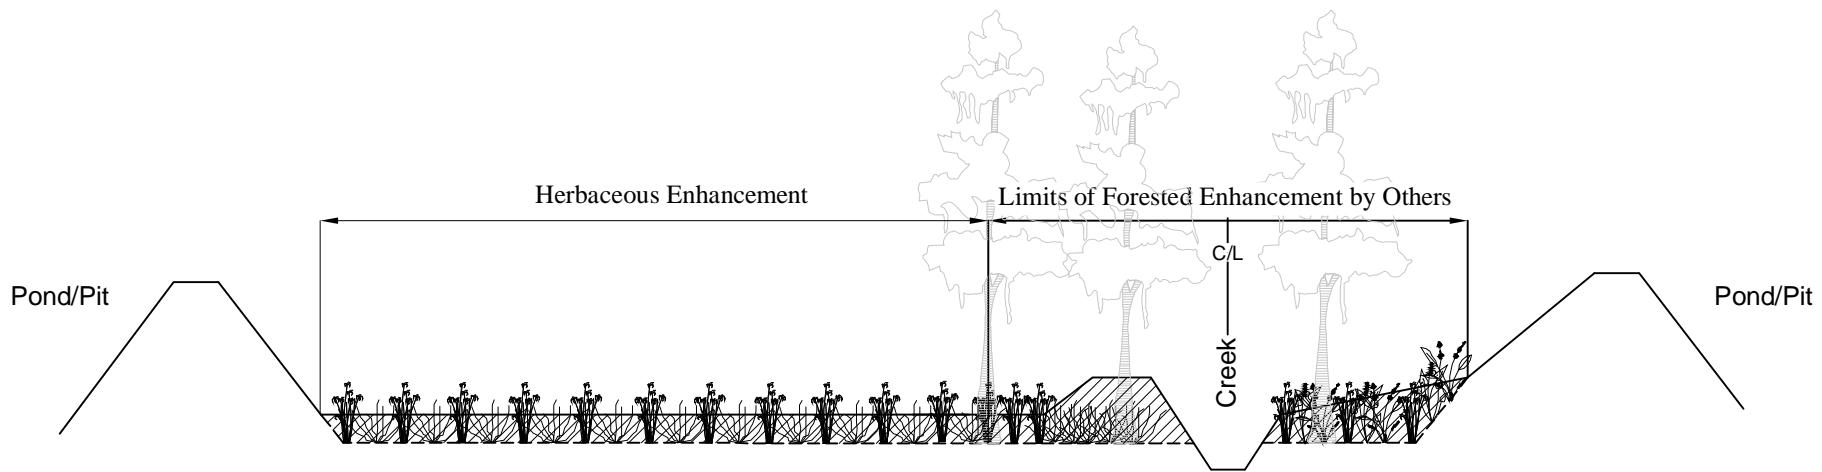
Typical Creek Cross Section A-A
N.T.S.
