SUBJECT: STAFF OBSERVATIONS OF TESTING FOR GENERIC SAFETY
ISSUE 191 DURING A JULY 12 TO JULY 14, 2010 TRIP TO THE
ALDEN TEST FACILITY FOR PCI STRAINER TESTS

Observations of Testing at Alden Research Laboratory
July 12 to 15, 2010

This trip was conducted to observe the emergency-core-cooling-system (ECCS) strainer head loss testing for the Watts Bar Plant. The staff considered that the test observations were necessary because the test protocol being used was the first of its kind for a Performance Contracting Inc. (PCI) strainer for operating pressurized water reactors (PWRs). Previous PCI strainer tests at Alden Labs had allowed near-field settling during the tests. The new test protocol is designed to minimize near-field settling. The test tank includes stirrers and flow distribution intended to ensure that effectively all debris transports to the test strainer. In addition, the staff has had concerns in the past regarding the consistency of debris preparation for fine fibrous debris. During previous observations of PCI strainer testing conducted at Alden Labs, the fibrous debris preparation for fine fiber was observed to be too coarse at times. The staff has concluded that usin

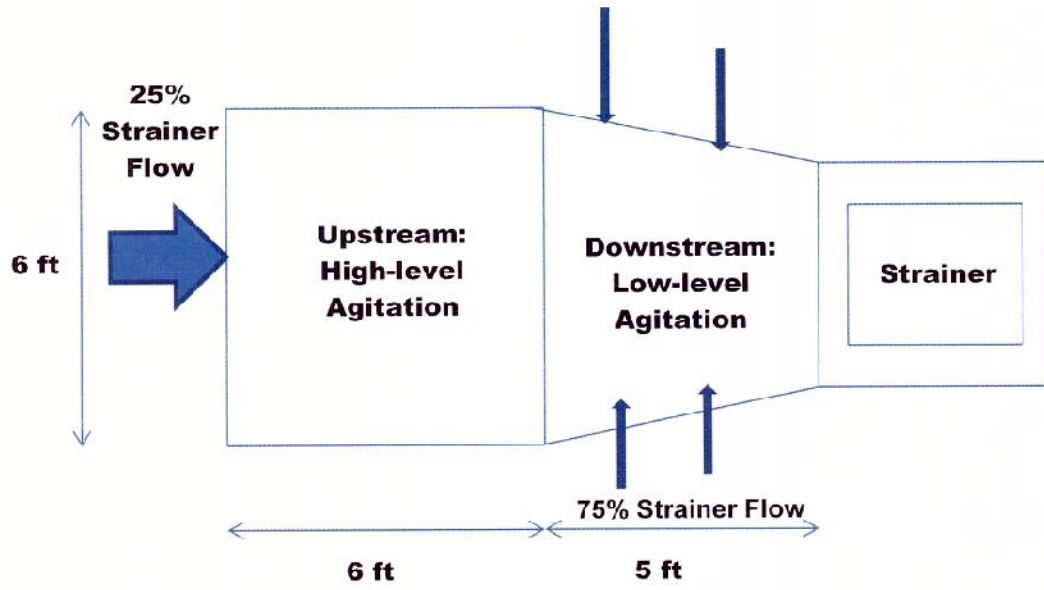
Figure 1 – Test Tank Arrangement

The test tank is about 14 ft long, 6 ft wide and 6 ft deep. The tank is wider at the end distant from the strainer where the debris is introduced and significant stirring energy is added to the fluid. The walls of the tank narrow as the strainer is approached. The walls surrounding the strainer on 3 sides form a rectangular area with spacing between the walls and strainer module intended to model the distance between strainer modules as installed in the plant. Between the high-turbulence area and the strainer is a perforated plate on the bottom of the tank through which most (about 90%) of the total flow through the strainer is introduced. This feature is designed to add sufficient turbulence to minimize any settling of debris in the tank. See Figure 1 for the test tank arrangement. Note that the drawing states that 75% of the flow is supplied to the low-agitation area, but according to the test personnel, for the Watts Bar test about 90% of the flow was supplied to the low-agitation area.

All tests observed by the staff were performed in one of the large test tanks. The large test loop is comprised of a large tank, a pump, piping, and a tank level control arrangement. There is also the ability to heat the tank water with an external loop. The test loop contains valves necessary to isolate or throttle flow, and fill and drain the tank. The pump is driven by a variable-speed motor to assist in controlling flow rate. Also installed are instrumentation for reading flow, pressure differential, and temperature. Some of the instrumentation is connected to a desktop computer for trending and data collection. Grab samples were taken to determine the pH of the water throughout the tests. The large test loop also has sample probes for taking samples to determine the amount of debris that bypasses the strainer.

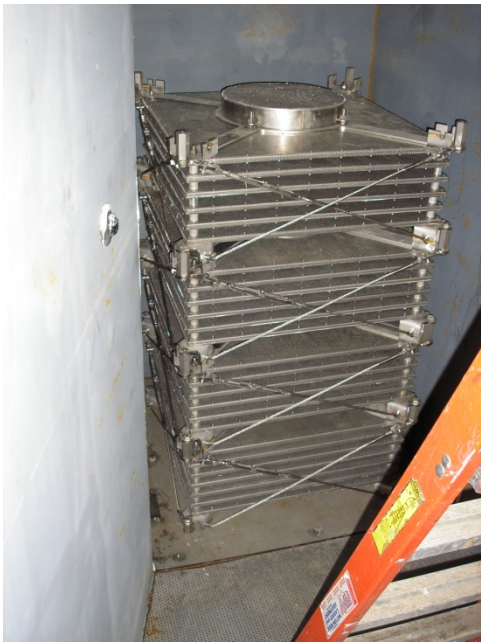
Photo 1-Strainer in Tank

The test tank contained a single Performance Contracting Inc. (PCI) strainer module connected to an outlet plenum. The outlet plenum was connected to the suction header for the test loop pump. The strainer array was contained within the steel walls of the tank (Photo 1). Watts Bar has a single large strainer array located in the basement of containment. The array is composed of 23 strainer modules. There are modules with two different areas due to some modules being taller than others. The total strainer area in the plant is about 4675 ft².

The test strainer module was typical of the PCI design which includes flow control to distribute flow more evenly among modules and within each module. The module was the same design as the modules installed at Watts Bar. The area of the test module was 216.5 ft², which represented about 4.838% of the total strainer area installed at Watts Bar considering 200 sq ft of sacrificial area. Flow in the plant is 19,100 gpm maximum and about 12,000 gpm maximum for the small break loss-of-coolant accident (SBLOCA) case. Test debris amounts and flows were scaled based on the ratio of the area of the plant strainer (minus sacrificial area) to the test strainer.

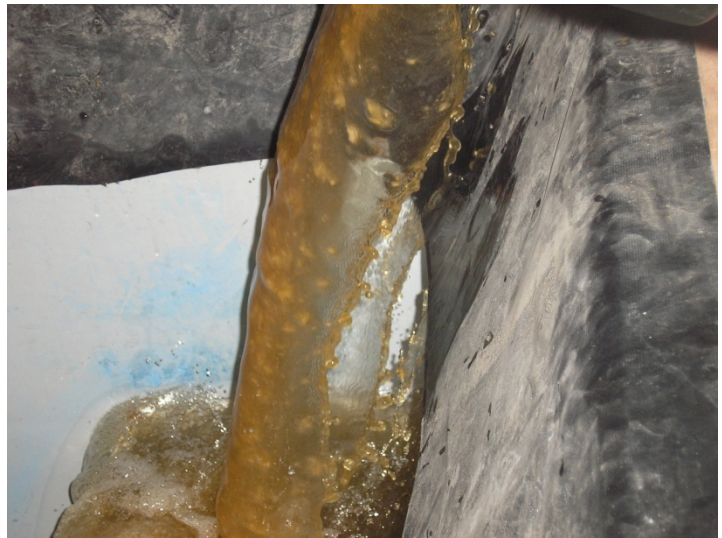
Photo 2-Debris Pour into Hopper

The particulate debris, with the exception of the dirt-dust mixture, was placed in trash cans, mixed with water, and poured into the hopper. The addition process ensured that the debris was well mixed throughout the test fluid. The Min-K was also placed in trash cans with water and mixed with a drill driven stirrer. There were coarse strings apparent in the mixture. It was also noted that some of the strings tangled in the mixer during its use (Photo 6). The strings were removed from the mixer and added back into the trash can before spilling it into the hopper. Some of the Min-K at the end of the pour was somewhat clumpy when it came out of the trash can, but the agitation in the hopper broke it up into fine particulate. The Interam was mixed similarly to the Min-K. Both the Min-K and Interam debris were created starting with the actual materials and rendering them into fine particles.

- 2) The debris preparation methodology used a new technique. Although the manual preparation of debris in large buckets resulted in clumpy, agglomerated debris, the use of a debris addition system to further dilute and agitate the debris was adequate to ensure that the debris was rendered into fine pieces prior to being introduced into the test tank.

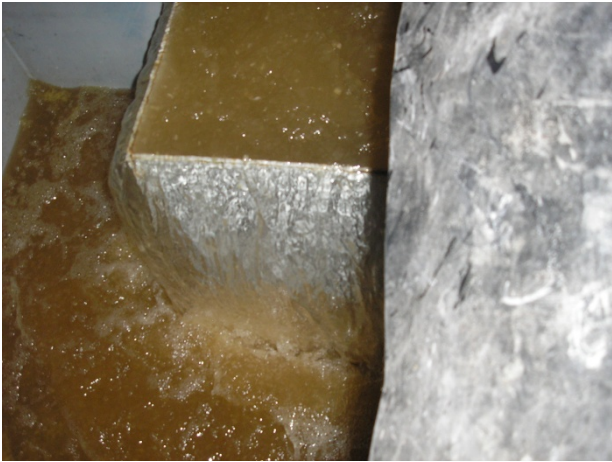
Photo 3-Debris from Hopper

The staff held an informal exit meeting with the licensee and test personnel and made the following observations about the testing. The staff stated that the debris preparation prior to pouring into the hopper and debris addition system was somewhat clumpy and agglomerated. However, the debris addition system was effective in rendering the debris into fine unagglomerated pieces. The final debris forms were determined to be acceptable. The staff noted that the agitation and transport within the tank appeared to inhibit settling and that almost all debris transported to the strainer. The debris bed did not appear to be affected by the agitation. The staff stated that the venting of the transmitter that resulted in an increase in head loss indication should be investigated and that test practices may need to be changed to include periodic venting of the transmitters to reduce uncertainties during the testing. The staff noted that the treatment of Min-K and Interam as fibrous debris was likely conservative and that the high head losses resulting from Min-K were unexpected. It was noted that the NRC Division of Component Integrity had been consulted and had confirmed that a settled volume of 6 ml was the correct one-hour settling criteria for aluminum oxyhydroxide for stirred tests per the SE for WCAP-16530. The staff stated that overall the test methods appeared to result in a conservative head loss for the Watts Bar plant. The staff stated that they appreciated the opportunity to witness the testing.

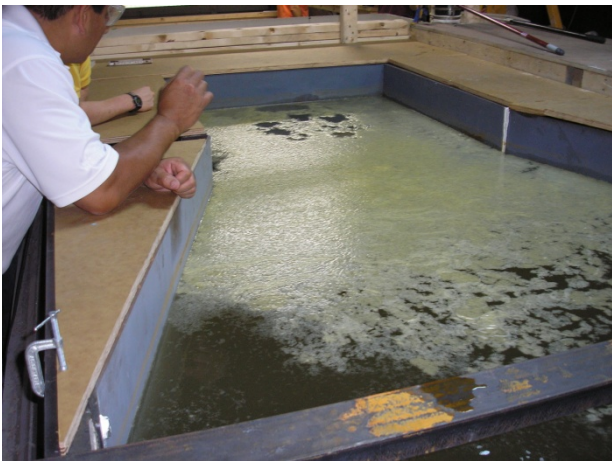
Photo 5-Fiber on Surface of Tank

There were five additions of 2.7 lb representing 1/16 inch theoretical fiber beds and one addition of 2.0 lbs representing the remainder of the available fiber. All fiber was considered fine. As discussed above the majority of the fiber represented sources that are constituents of Min-K and 3M Interam. Based on an inspection of the debris, the staff did not believe that the Interam would likely become a significant source of debris if subjected to a LOCA jet because it is relatively robust and covered with a thin steel sheet. However, the Min-K would be more likely to become debris. The amount of fibrous debris used in the debris bypass test was likely conservative because it included the full amount of fibrous debris from the Min-K and Interam, but some amount of these fiber sources would likely not be liberated. Photo 5 shows the test tank with some fibrous debris floating on the water surface during the fiber bypass test.

The staff left the test facility prior to drain down of the test tank, but test personnel reported that there was no debris settlement during the test and the strainer had a relatively uniform fluffy bed. The floating fibrous debris was skimmed off of the surface prior to drain down so that conditions in the tank and strainer could be better evaluated. Photographs of the test tank were taken following drain down which validated that little or no settling had occurred and that the debris bed on the strainer was relatively uniform. The head loss did not increase during the fiber bypass test.

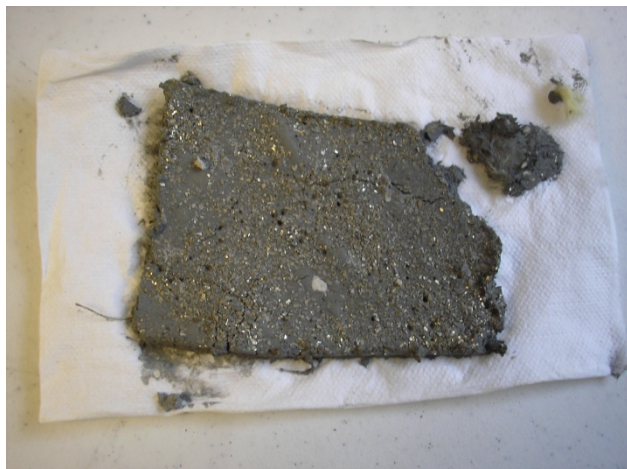
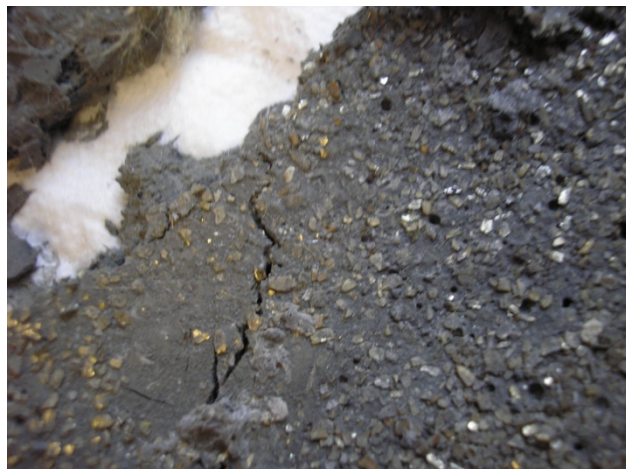
Pieces of the debris bed were saved for observation (Photos 7, 8, and 9). The bed was about ¼ inch thick and very dense. The bed behaved like relatively dry clay. Very fine fiber was evident in the bed, as was the coating particulate and larger particulate from the Interam. The fibers mostly appeared to be finer than Nukon. The bed was very uniform.

Photo 7-Debris Bed

Photo 8-Debris Bed

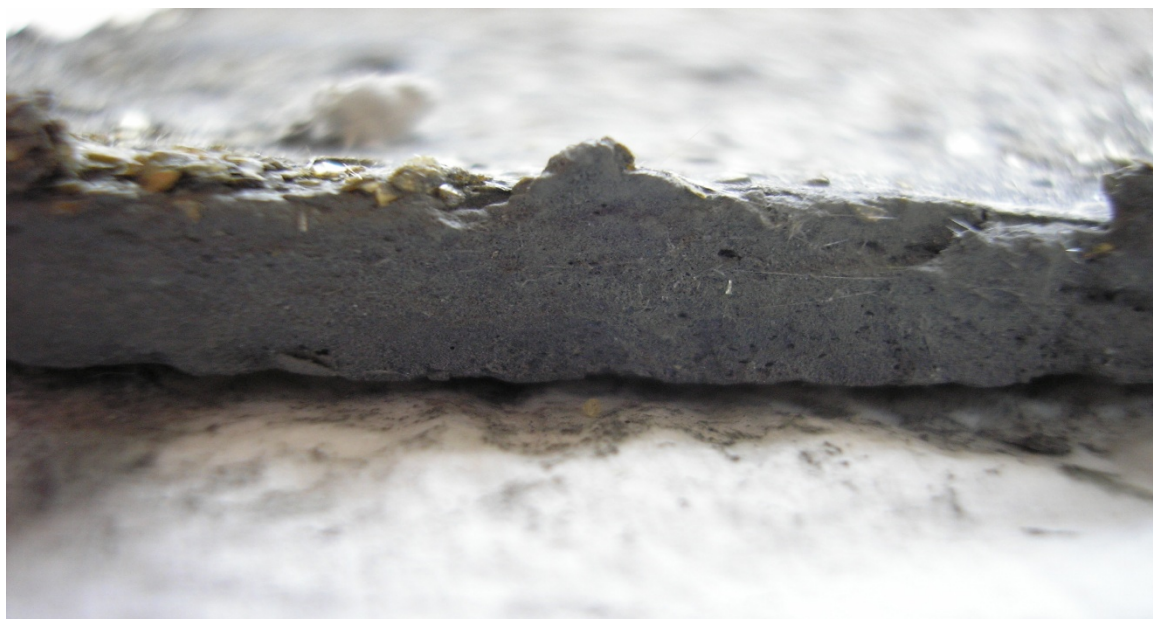
Photo 9-Debris Bed Cross Section

The head loss associated with the full debris load including chemicals was reported to be about 19 ft. The debris bed appeared to be a thin bed.
